## Building Inspection Report

Inspection Date: Thu, 12 Mar 2026

Property Address: 5 Dunoon Ct, Brighton East VIC 3187,  
Australia

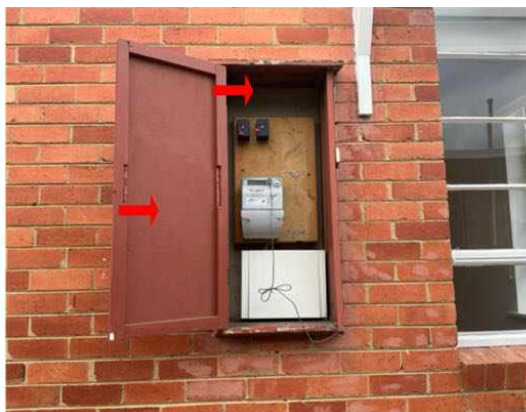
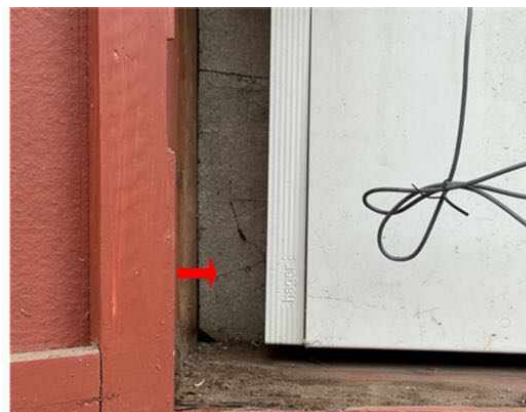
#### Defects 1.01

Building:	Main Building
Location:	Electrical Switchboard backing and door
Finding:	Asbestos - Suspected ACM Identified on Site
Information:	Reporting on Asbestos is outside the Scope of this Report. This suspected defect is highlighted as a caution only. We suspect, based on our experience in the building industry, that there is a higher risk of the identified building element containing asbestos.

As Asbestos Reporting is outside the scope of this report, we advise that you consider a separate Asbestos Inspection and Condition Audit, which can include the taking of samples for definitive confirmation of the presence of Asbestos.

In the interim, the client is advised to act with caution, especially when considering any damage to building materials general wear and tear renovations extensions demolition and general maintenance activities due to the suspected presence of Asbestos.

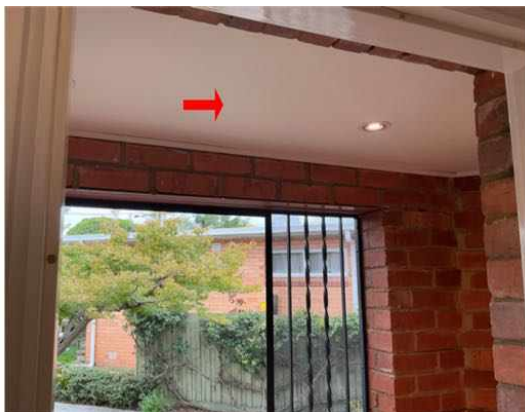
### Defects 1.03

Building:	Main Building
Location:	Entry
Finding:	Asbestos - Suspected ACM Identified on Site
Information:	Reporting on Asbestos is outside the Scope of this Report. This suspected defect is highlighted as a caution only. We suspect, based on our experience in the building industry, that there is a higher risk of the identified building element containing asbestos.

As Asbestos Reporting is outside the scope of this report, we advise that you consider a separate Asbestos Inspection and Condition Audit, which can include the taking of samples for definitive confirmation of the presence of Asbestos.

In the interim, the client is advised to act with caution, especially when considering any damage to building materials general wear and tear renovations extensions demolition and general maintenance activities due to the suspected presence of Asbestos.

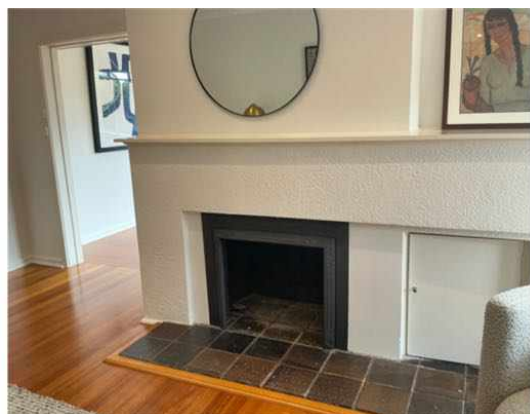
## Defects 1.04

Building:	Main Building
Location:	Lounge Room
Finding:	Fireplace
Information:	It is beyond the scope of this inspection report to comment on fireplaces, we recommend a professional chimney sweep check the safety of this fireplace prior to use.

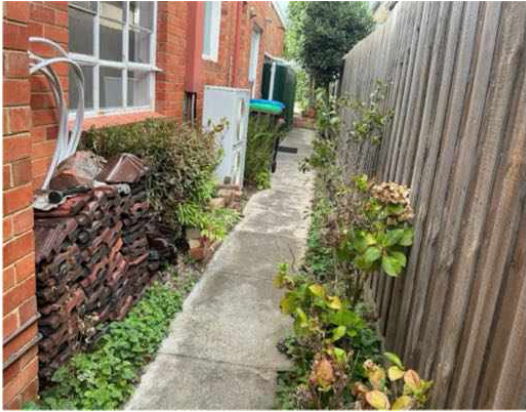
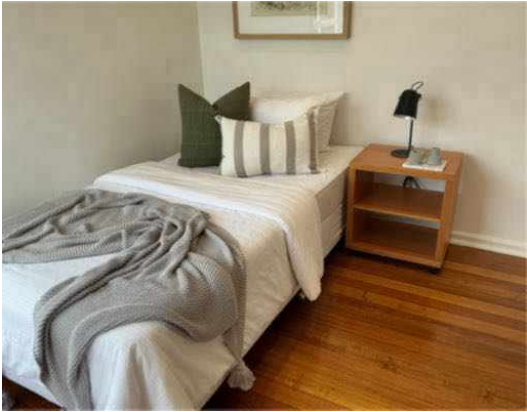
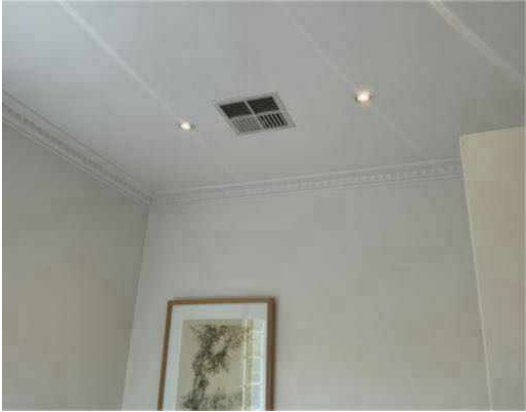
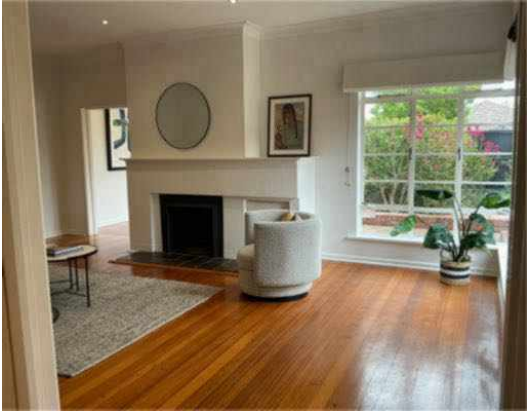
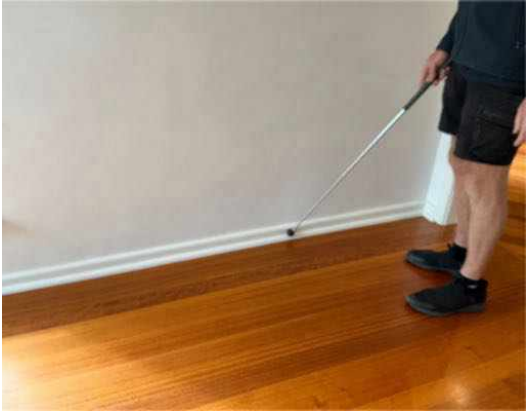
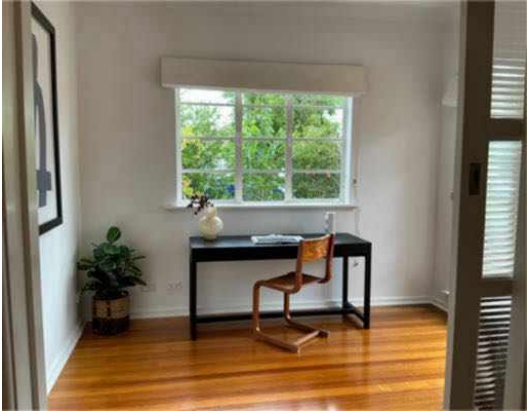
## Defects 3.01

Building:	Main Building
Location:	All Areas
Finding:	Additional Photos - Obstructions and Limitations
Information:	These photographs are an indication of the obstructions and limitations which impeded full inspection of the property at the time of inspection. These obstructions can hide an array of defects and should be removed to allow full inspection to be carried out. A re-inspection is recommended once the areas are made accessible.

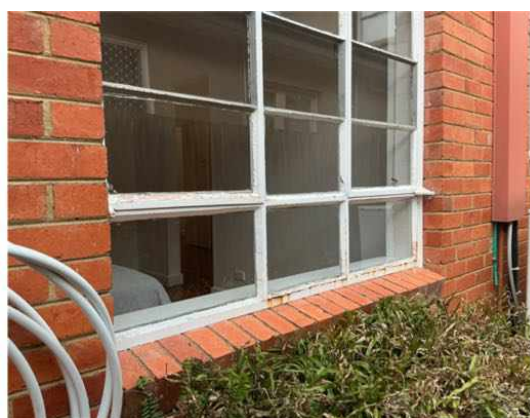
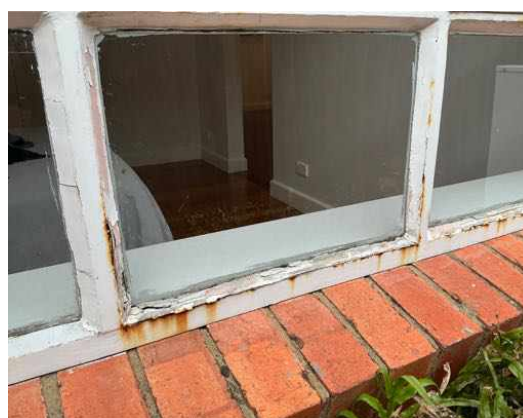
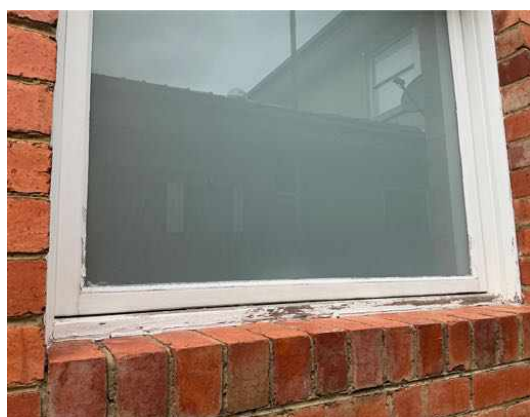
Defects 3.02

Building:	Main Building
Location:	Windows
Finding:	External painting deteriorated
Information:	Much of the external paintwork including but not limited to windows, fascias, guttering, veranda and other external fitments have been neglected and require attention to prepare and re-paint. Metal windows are showing signs of rust and mayonnaise some maintenance.

Whilst incomplete or missing paint finish is generally an appearance defect, it can also lead to the development of secondary building defects over time. Incomplete areas of paint finish expose the area to moisture, potentially accelerating the deterioration of underlying building materials.

Degraded paint finishes should be sanded back, filled, leveled and painted, as applicable. Where inadequate or missing paint protection has led to the deterioration of the associated building element, repair and/or replacement of this building element may be required.

A painting contractor should be appointed as soon as possible to perform necessary works to aid the appearance of the affected area and to ensure the area is protected against further deterioration. Alternatively, the homeowner following manufacturer instructions may perform these works.

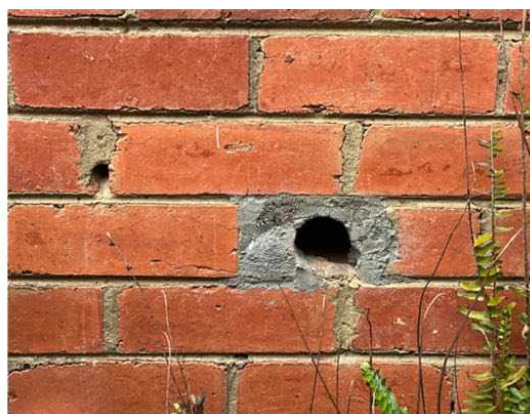
### Defects 3.03

Building:	Main Building
Location:	Exterior walls - right side
Finding:	External walls - Holes
Information:	Significant holes were identified around pipe penetrations in this wall section. It is suspected that the installation of this pipework was completed to a substandard level of workmanship or is incomplete.

Gaps and holes around pipework makes the area susceptible to insect and vermin ingress, as well as allowing water penetration to the cavity wall. As such, associated building elements are likely to deteriorate at an accelerated rate, and major implications are expected if holes around the pipework are left unmanaged.

All excessive holes, gaps or cracks should be adequately filled by a suitable sealant or trimmings as soon as possible to prevent any further damage. Such works may be conducted by a general handyman or licensed plumber.

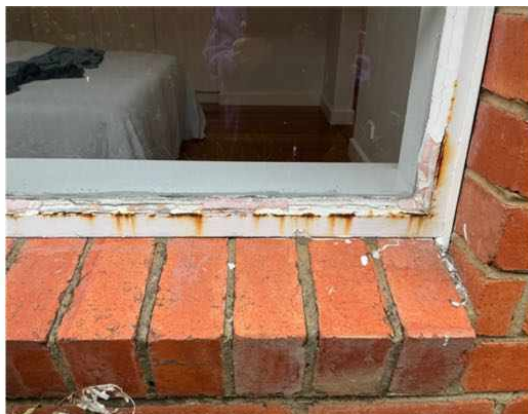
### Defects 3.04

Building:	Main Building
Location:	Side Metal Windows
Finding:	Building element - Rusted or corroded
Information:	This building element shows evidence of rusting and corrosion, which is likely to have developed as a result of excessive exposure to moisture and or inadequate coatings.

As surface rust provides no protection to the underlying iron, the deteriorating condition is likely to worsen if not addressed in the short-term future.

Where possible, the use of galvanized (treated) metals or aluminium coated metals aid in rust prevention, as does regular general maintenance. Rust formation can be controlled with coatings, such as paint, that isolate the iron from the environment.

Rusting and corrosion should be managed by ideally removing or limiting the affected

surface from exposure to moisture. A registered builder may be appointed to replace any building elements that have been severely affected by rust or water damage.

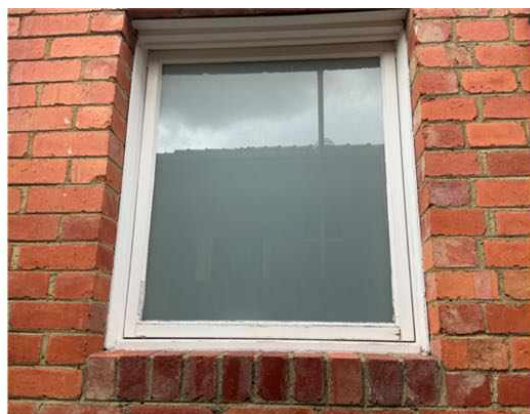
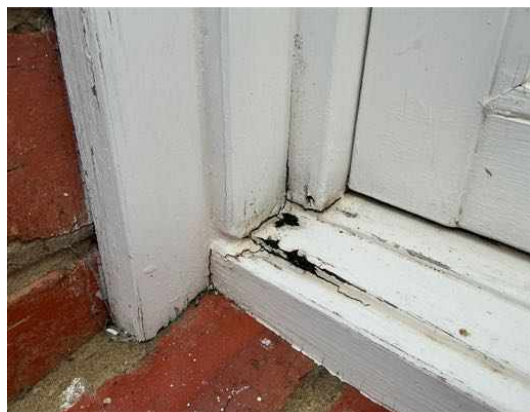
### Defects 3.05

Building:	Main Building
Location:	Timber Windows
Finding:	Windows - Wood rot
Information:	Wood rot was found to be affecting external windows. Wood rot, also known as Fungal Decay, occurs when timbers and other cellulose building materials are exposed to damp conditions on an ongoing basis.

It is likely that this wood rot has developed as a result of frequent exposure to rain and other weather conditions. It is suspected that failure to maintain the window frames over a prolonged period has resulted in them deteriorating at an accelerated rate, increasing their susceptibility to the development of wood rot. Leaks in roof plumbing or associated pipework may have also contributed to the formation of the wood rot in this area.

Early intervention and regular maintenance will prolong the useful life of these building elements. Prior to any works being performed, any associated pipework or roof plumbing should be inspected by a licensed plumber for faults or leaks.

Repair and/or replacement of affected window frames may be a necessary step in protecting surrounding building elements from such deterioration. Remedial works should be performed by a qualified carpenter or registered builder as soon as possible to prevent any further damage.

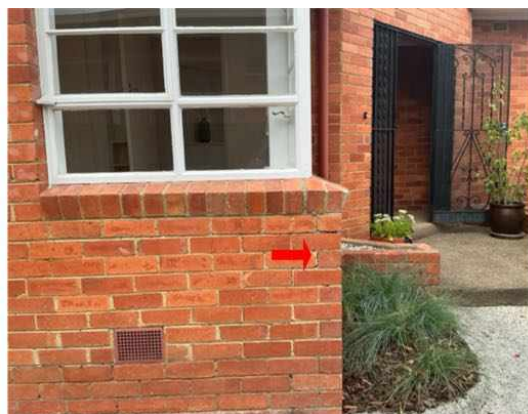
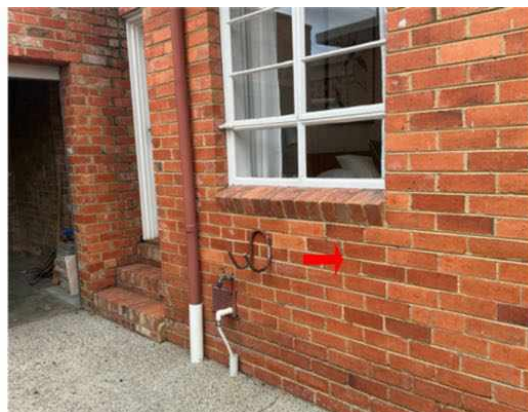
### Defects 3.06

Building:	Main Building
Location:	Exterior walls - front
Finding:	Brickwork - Step cracking
Information:	Step cracking was identified to the brickwork in this area at the time of inspection. Step cracking, which is similar to other forms of cracking, has a variety of possible causes. However, the most common is the subsidence of adjacent footings.

Step cracking is a relatively common defect, and is most likely to occur adjacent to windows, doors and other openings. Mortar failure in the gaps between affected bricks indicates the stresses and tensions affecting the wall.

Where step cracking is extensive or severe, the client is advised to consult a structural engineer. Minor step cracking can be used as a warning sign to address factors causing stress to the wall, which can include the effect of surrounding trees, water leaks, soil erosion, or even the presence of reactive soils in the surrounding area.

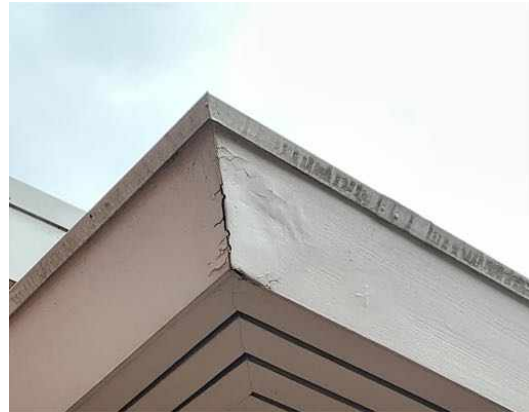
### Defects 3.07

Building:	Main Building
Location:	Fascias
Finding:	Fascias - Wood rot
Information:	Wood rot was found to be affecting fascias and barges in this area, evidenced by the presence of mould on the surface in some areas. Wood rot, also known as Fungal Decay, occurs when timbers and other cellulose building materials are exposed to damp conditions on an ongoing basis.

It is likely that this wood rot has developed as a result of faults in the roof plumbing, creating excessive moisture in this areas. Frequent exposure to rain and other weather conditions also make fascias and barges susceptible to accelerated deterioration.

Early intervention and regular maintenance will prolong the useful life of these building elements. Prior to any works being performed, the cause of the moisture that has created the visible wood rot should be identified and addressed in a suitable manner.

It is advised that a roof plumber be appointed to inspect all roof plumbing and subsequently identify the cause of the wood rot. Replacement of affected fascias and barges may then be a necessary step in protecting surrounding building elements from such deterioration.

A qualified plumber may be appointed to assess the cause of excessive moisture and

to provide advice on any remedial works as required. A qualified carpenter or registered builder may also be required to replace affected building materials.

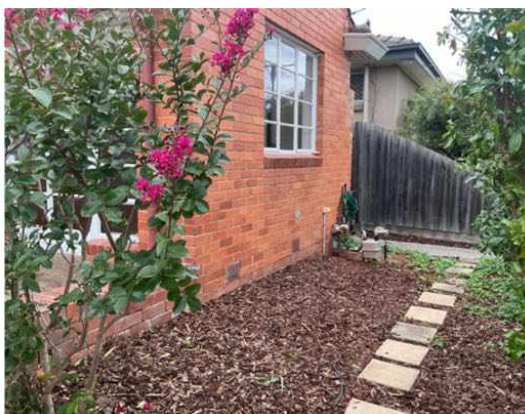
### Defects 3.08

Building:	Main Building
Location:	Subfloor
Finding:	Subfloor - Lack of ventilation
Information:	It was noted at the time of inspection that the subfloor area lacks adequate ventilation. Ventilation can be restricted by a variety of minor defects, including obstructions in the subfloor space, a lack of vents or a low clearance.

A well ventilated subfloor aids in maintaining dry conditions, preventing secondary damage such as wood rot and pest activity, as well as preventing the development of mould and mildew (which can lead to respiratory safety hazards for occupants).

The initial step in improving ventilation is to ensure that the subfloor area is free of any debris or stored items. Where ventilation is still inadequate, it is advised to ensure that all vents are clear of blockages, and additional vents may be installed.

The client may also consider mechanical ventilation (powered fans) to improve subfloor airflow. Remedial works should be conducted as a matter of urgency to protect against the development of potentially harmful subfloor conditions.

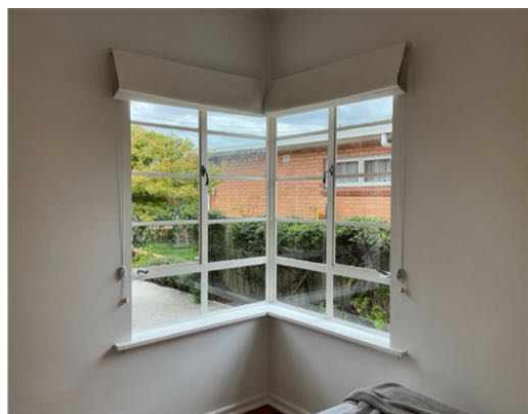
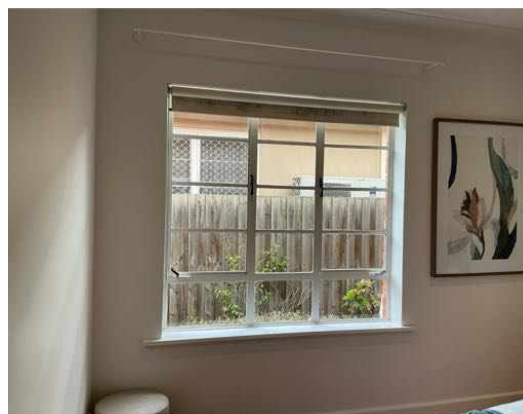
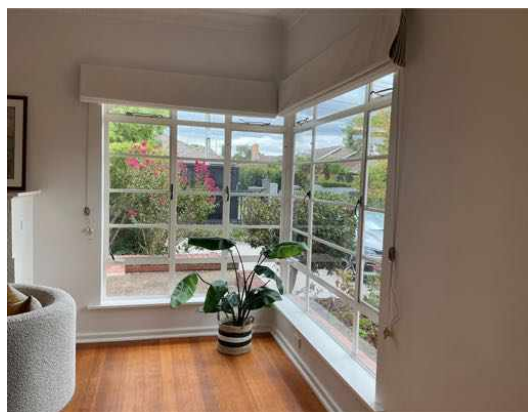
### Defects 3.09

Building:	Main Building
Location:	All Areas
Finding:	Building element - Not operating
Information:	Most windows were found to be in operable at the time of inspection, these windows require a service in order to be brought back to for working order Non-operational items should be addressed to ensure that the full function of the building structure is available. Where some building elements are not operating as intended, it is possible that secondary building defects could arise due to their non-operation.

Repair and/or replacement of the faulty building element is recommended. It is highly recommended that the relevant tradesperson be engaged to perform any necessary works.

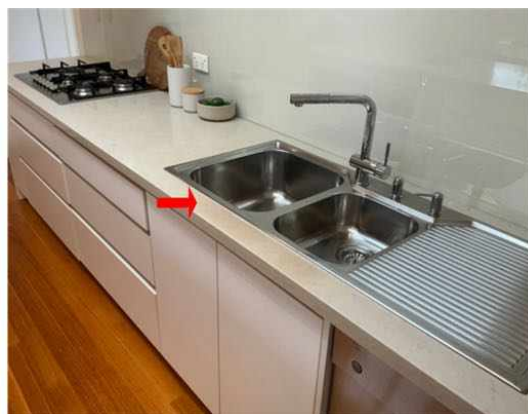
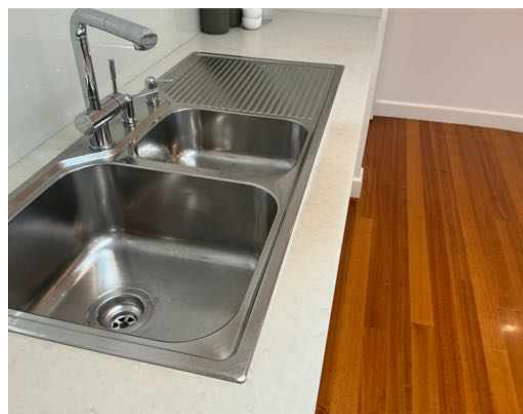
### Defects 3.10

Building:	Main Building
Location:	Kitchen
Finding:	Water staining
Information:	Water staining was evident in this area at the time of inspection. Water staining indicates that surfaces have been exposed to excessive moisture over time. The minerals and other elements in the water lead to staining, which may graduate to

corrosion and deterioration if left unmanaged.

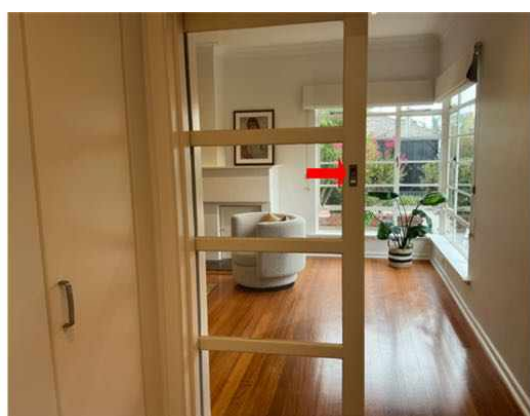
### Defects 3.12

Building:	Main Building
Location:	Lounge Room
Finding:	Door - stiff to slide
Information:	The door to this area was difficult to operate at the time of inspection. This is likely due to damaged wheels which help the door to operate in a smooth fashion.

Doors provide ventilation and exits to the adjoining area and should be at a fully operational level to ensure user comfort and safety. Restricted function of the door may also pose as a potential safety hazard if required for emergency egress from the building.

Generally, factors such as general age of the building element and a lack of maintenance are the usual causes for this type of defect.

Replacement of door running hardware may be required, as well as minor repairs and cleaning. A registered builder or general handy person will be required to repair the sliding door.

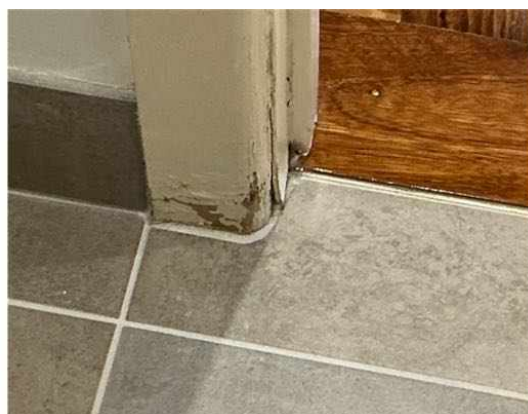
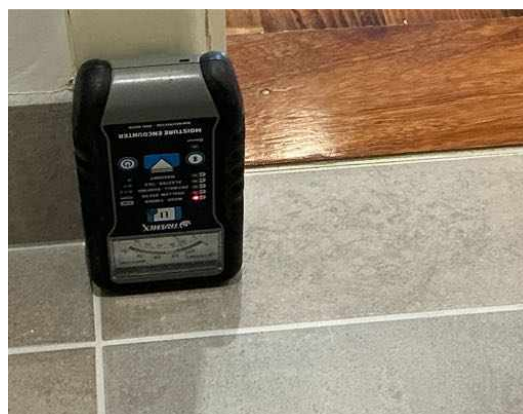
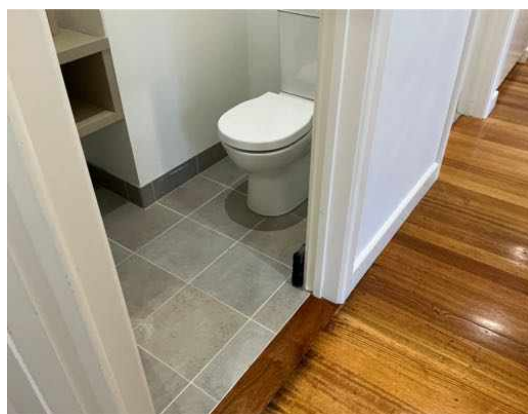
### Defects 3.13

Building:	Main Building
Location:	Powder Room

**Information:** Swollen building elements generally indicate that the building materials have been affected by excessive moisture over a prolonged period of time, and have swollen as a result. The formation and development of mould/fungi or mildew is also a likely consequence of excessive moisture, which may pose major respiratory issues for occupants, particularly the elderly, the very young and those with existing illnesses and could be potential health safety hazards. In these cases an appropriately qualified inspector/tester should also be contacted for advice and/or technical assistance.

The structural integrity of swollen building elements can not be guaranteed, and further damage is likely to develop if left unmanaged. Excessive moisture is likely to lead to the development of secondary damage to any associated building elements, which may necessitate major reparation works if prolonged.

Rectification of the cause of the water leak should be addressed prior to any remedial works to the swollen building elements. A licensed plumber should be appointed immediately to identify the cause of the leak and provide advice on remedial works as necessary, Repair and/or replacement of swollen building elements should be conducted as a matter of urgency by a registered builder or qualified carpenter.

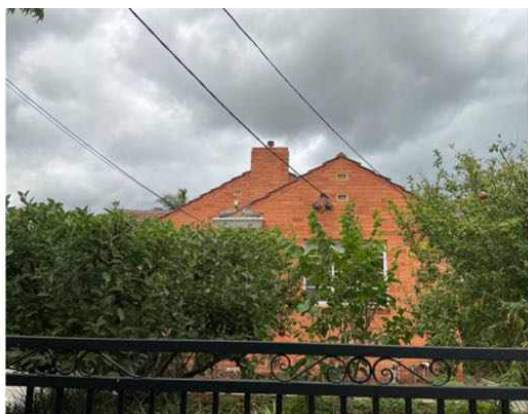
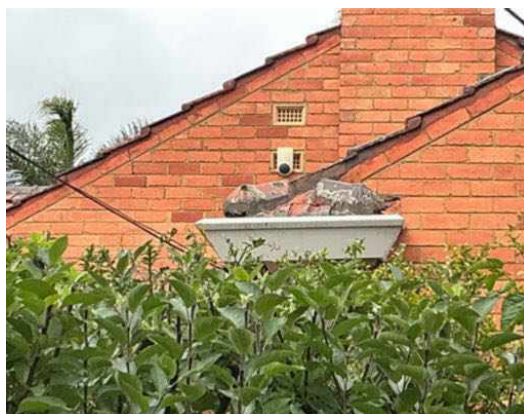
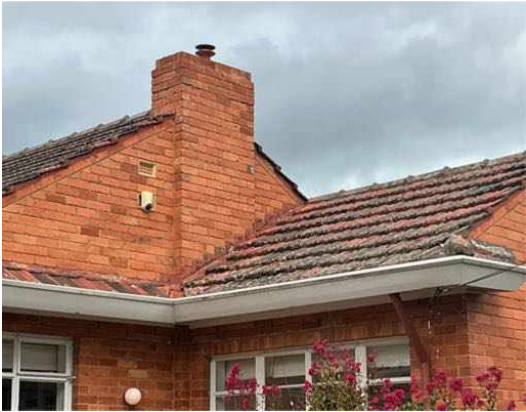
Isolated areas of mortar have come loose in the valleys and minor cracking is also present. Re-pointing and re-sealing the may be considered as an interim solution by the client to help preserve and extend the life span of the tiles.

Where left unmanaged, deteriorating roof tiles are likely to lead to a number of secondary defects, including minor water leaks and weather exposure to internal roofing structures.

Consultation with a roofing contractor is highly advised to gain advice on cost of remedial works that may be required in the short to medium term. Remedial works are likely to increase the longevity of the exterior roofing structure.

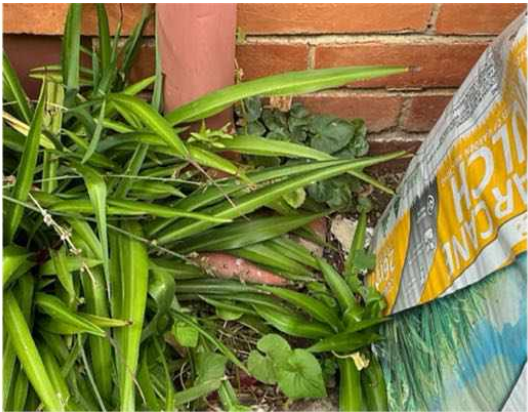
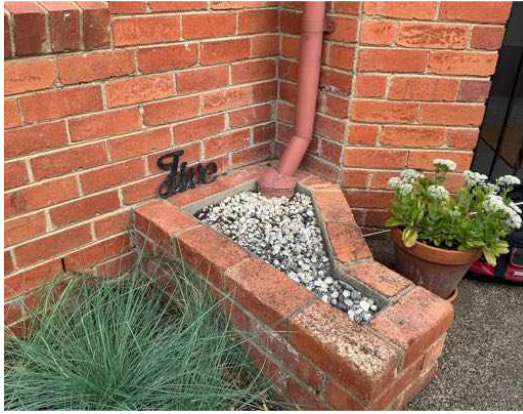
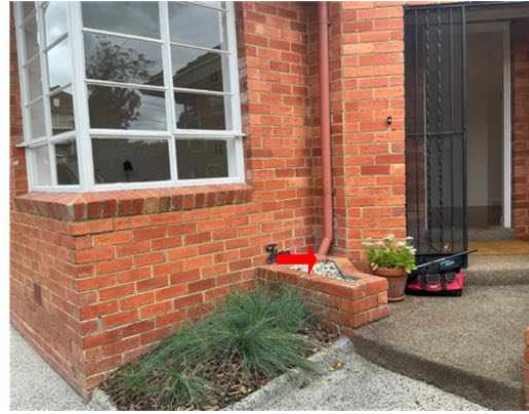
brittle nature of clay or terracotta pipes problems can begin to occur over time. Even if they're functioning fine now, clay pipes will need replacing eventually.

The average lifespan of a clay pipe sewer system is 60 years — which means an upgrade is decades overdue for many homes. For your peace of mind you may wish to have your sewer pipes inspected and replaced before a major problem occurs

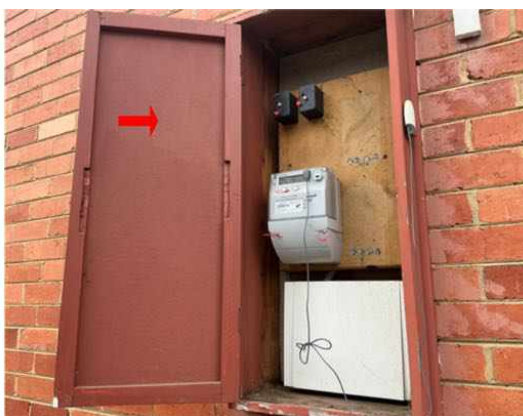
### Noted Item

Building: Main Building  
 Location: Electrical Switchboard  
 Finding: Termite Management System - no evidence of a chemical installation  
 Information: The application of a post-construction chemical termite barrier is highly recommended for all properties, particularly if live termite activity has been found on the site previously. Such barriers are highly effective in preventing termite attack on any timber building elements throughout the property.

The client may consider gaining further advice from a pest controller as to the costs and procedures involved with this application. It is recommended that obtaining such advice be a short-term priority.

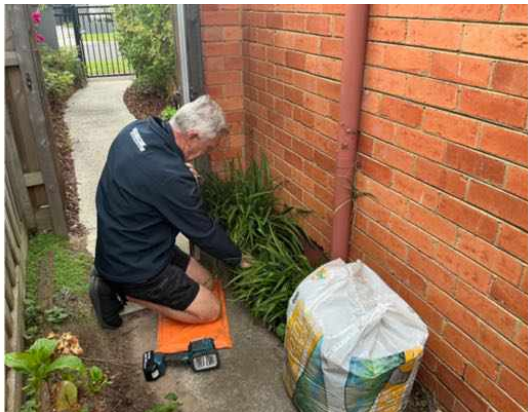
### Noted Item

Building: Main Building  
 Location: Subfloor

Finding: Subfloor access limitations  
Information: No access to the subfloor was present due to facts including but not limited to access hatch size or placement, for this reason access to the subfloor was no possible

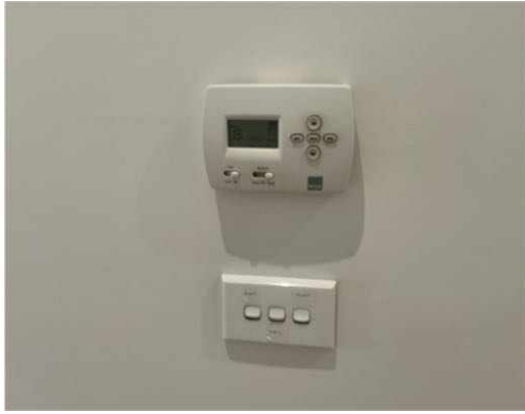
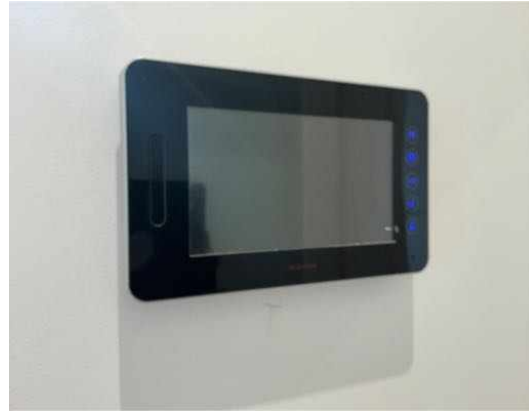
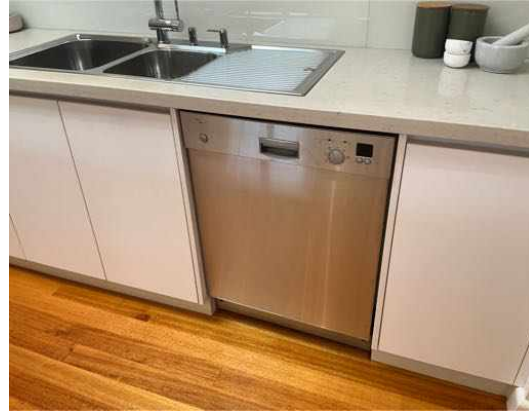
**Noted Item**

Building: Main Building  
 Location: Appliances  
 Finding: Warranty - Expired  
 Information: Where appliances are beyond their warranty period, the owner should be prepared to meet the cost of replacement or repair of the item at any time. The operation of the appliance can not be guaranteed and further inspection by an appropriately qualified tradesperson may be required.
