Building and Timber Pest Inspection Report

Inspection Date: Wed, 25 Mar 2026

Property Address: 27 Ferndale St, Newtown NSW 2042,
Australia

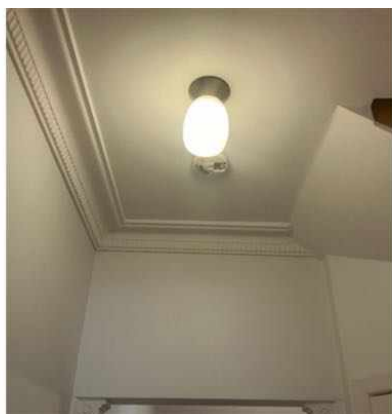
Please note that this defect is highlighted as a caution only. We suspect, based on our experience in the building industry, that the absence of smoke detectors, or their poor condition, should be addressed as a matter of urgency to improve occupant safety.

Always ensure sufficient working and suitable smoke detectors are installed prior to occupying any building. Additionally, it is advised that all smoke detectors be tested by the homeowner on a monthly basis.

Please refer to AS3786 and state based legislation, which may also apply.

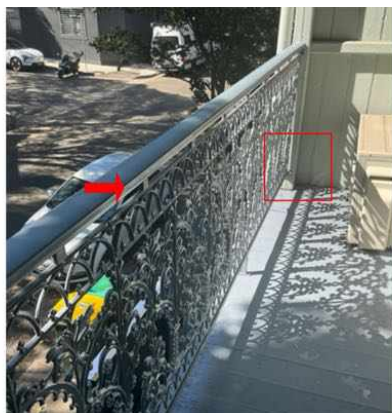
Finding 1.02

Building:	Main Building
Location:	All Internal Areas
Finding:	Balcony Handrail Movement
Information:	The balcony handrail was physically tested and was found to move when shaken, indicating it may not be adequately secured. This represents a potential safety hazard,

as handrails are required to be structurally sound and comply with the National Construction Code (NCC) performance requirements. Immediate further assessment and rectification by a licensed carpenter or builder is recommended to ensure the handrail is safe and compliant.

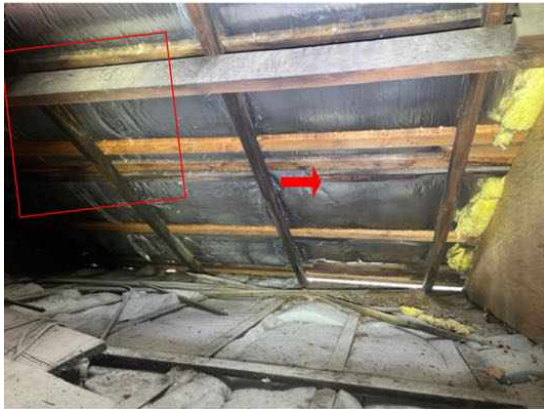
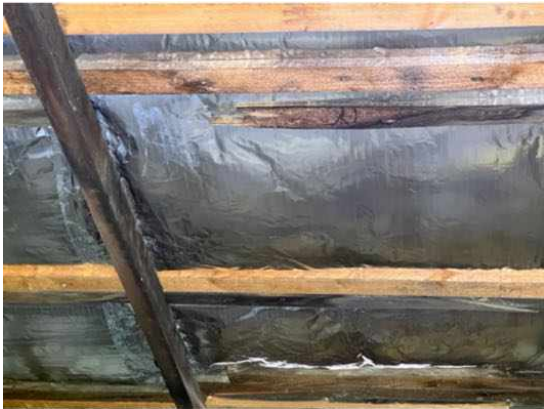
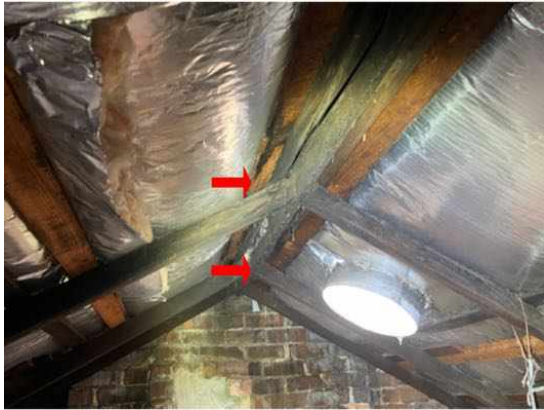
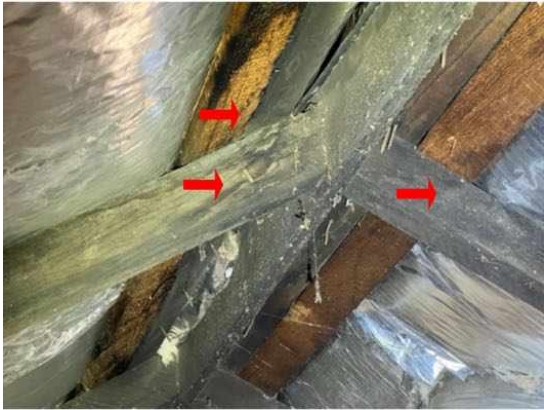
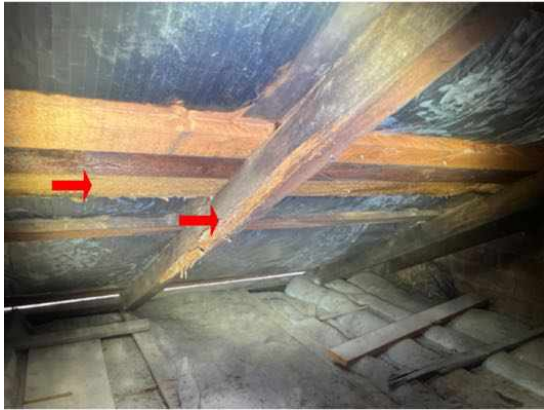
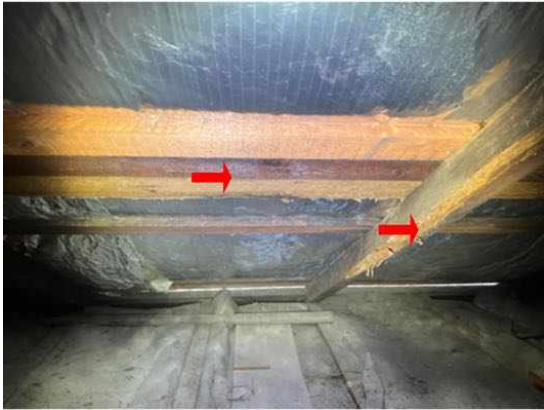
Finding 2.01

Building:	Main Building
Location:	Roof Void
Finding:	Chemical delignification identified to timber elements
Information:	Chemical delignification also known as wood defibration refers to the chemical breakdown of timber building elements. This breakdown of the Lignin deteriorates the wood impacting on the structural integrity and tensile strength of the affected building element.

Chemical delignification is most common near marine environments due to the high levels of salt in the air however this deterioration may also occur in other areas where timber elements are frequently exposed to damaging gases chemicals etc.

charring was observed on roof framing members adjoining the internal brick chimney wall, likely due to historic heat exposure, a further inspection by a licensed roofing carpenter is also recommended.

Where timber building elements have deteriorated repair and / or replacement is required immediately to ensure the safety of the associated structures. The likely cause of the defibration should also be investigated and dealt with accordingly.

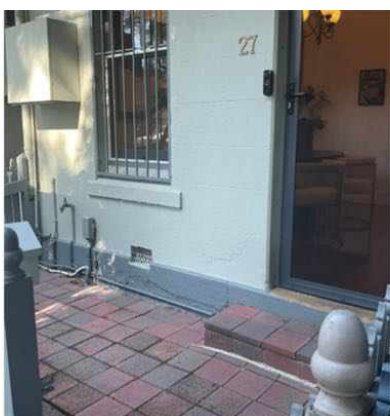
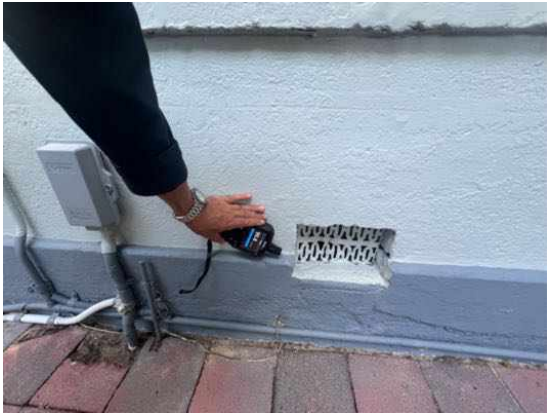
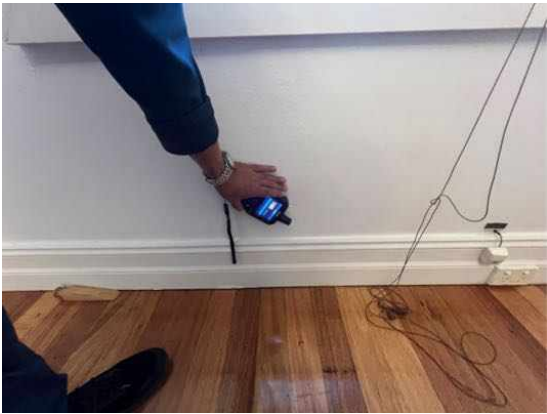
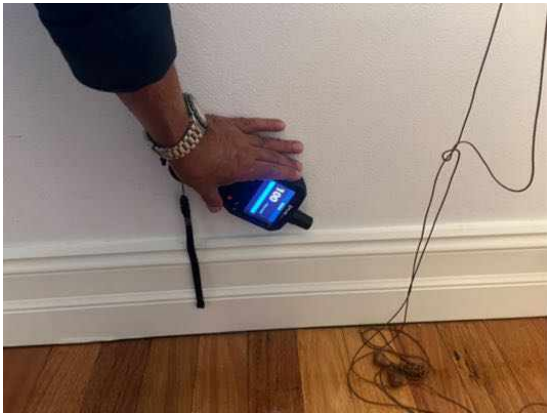
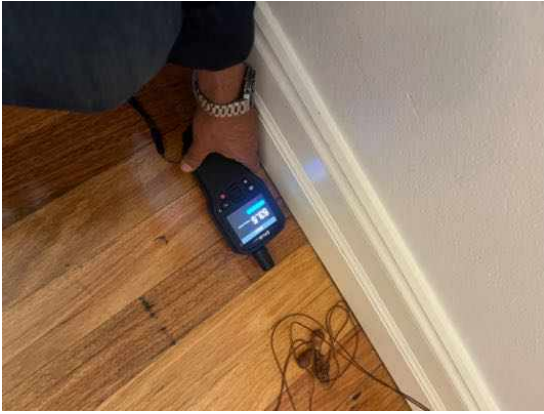
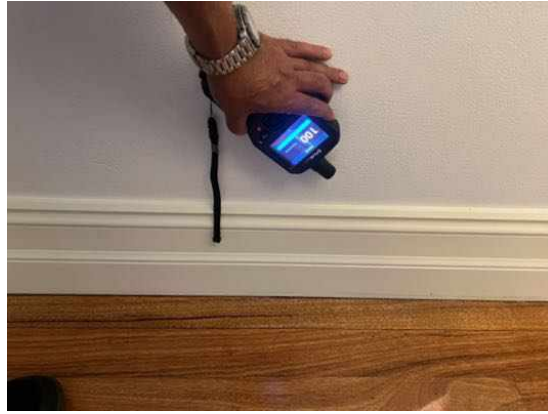
Finding 3.01

Building:	Main Building
Location:	All Areas
Finding:	Damp - Further investigation recommended
Information:	Damp (or structural damp) refers to the presence of unwanted moisture in the structure of a building, either as the result of intrusion from outside, or condensation from within the structure. Generally, structural damp is caused by rain penetration, rising damp, and leaks from plumbing pipes.

Unmanaged damp facilitates the formation and development of mould, fungi growth and wood rot, decaying associated building materials and compromising their structural integrity. Damage to finishes is also likely to occur, including lifting, bubbling, peeling and staining of paint, plaster and wallpaper.

It is important to address damp conditions, as the World Health Organisation notes that excess moisture leads - on almost all indoor materials - to growth of microbes such as moulds, fungi and bacteria, which subsequently emit spores and other matter into the indoor air. Exposure to these contaminants is associated with a wide range of respiratory and other health-related problems. Additionally, the development of damp in timber building elements also provides an environment that is conducive to termite / timber pest attack.

The first step in addressing damp is to diagnose the cause. The identified cause should be addressed first prior to repairing the appearance and other defects which have resulted from the rising damp. If the original cause is not resolved, further cases of damp are likely to ensue, resulting in secondary defects.

Consultation with a qualified plumber is advised immediately to identify the cause of damp and perform remedial works as required. Where excessive mould growth is present, further inspection by a specialist environmental health inspector should also be considered.

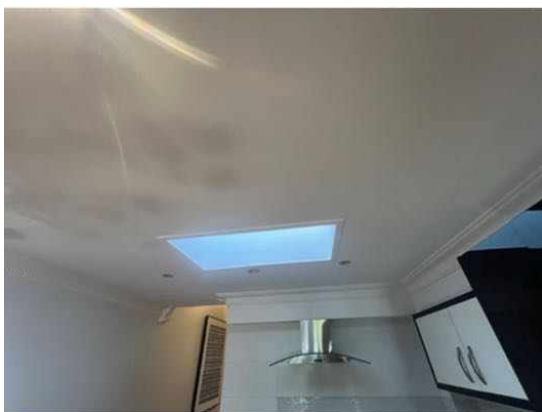
Finding 3.02

Building:	Main Building
Location:	All Internal Areas - Skylight
Finding:	Elevated Moisture – Further Investigation Recommended
Information:	Elevated moisture was recorded around skylight, although no significant structural damage was evident at the time of inspection, dampness can contribute to deterioration if left unaddressed. Skylight also required closer inspection as excessive use of sealant was evident. A further investigation by a licensed plumber or skylight specialist is recommended to confirm the source and ensure no concealed issues are developing.

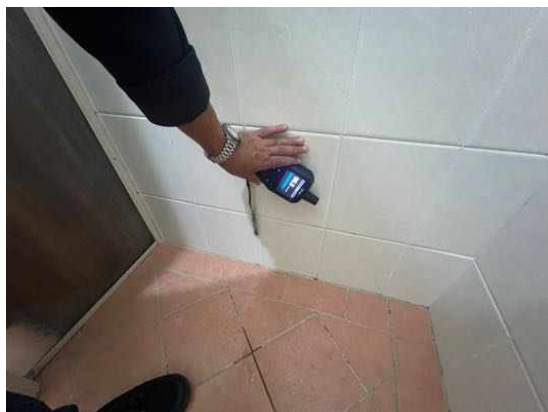
Finding 3.03

Building:	Main Building
Location:	Bathroom
Finding:	Elevated Moisture Bathroom
Information:	Elevated moisture levels were detected to tiled surfaces in bathroom/shower areas. Persistent moisture ingress can lead to concealed damage, including timber rot and mould growth.

Elevated moisture readings in tiled wet areas can occur from normal shower use, age/deterioration of waterproofing membranes, plumbing leaks or moisture absorption through grout lines. While no damage was visible, elevated readings may indicate moisture retention behind tiles, which can be a conducive condition for future deterioration if not monitored.

A wall adjacent to the bathroom also showed elevated moisture above typical thresholds.

Monitor the area over time for signs of drumming, efflorescence, tile movement, or grout deterioration. Further inspection by a licensed waterproofing is recommended (e.g., pressure testing, membrane assessment).

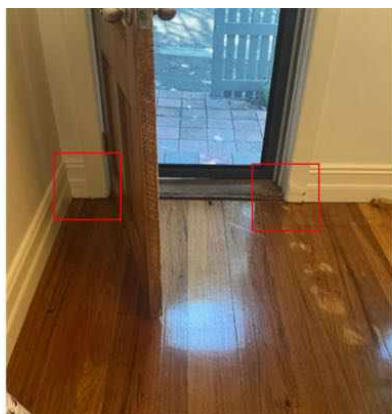
Finding 3.04

Building:	Main Building
Location:	All External Areas
Finding:	Wood rot to some areas
Information:	This building element shows evidence of wood rot. Wood rot, also known as Fungal Decay, occurs when timbers and other cellulose building materials are exposed to damp conditions on an ongoing basis. This could be the result of exposure to weathering over a prolonged period of time, or the attraction of excessive moisture from other abutting building materials. Contributing factors also include poor air ventilation in the area.

Wood rot is often associated with general damp problems and is evidenced by a

'musty' smell or mould and mildew occurring on surfaces. If left unmanaged, damp conditions can lead to further health problems and the decay of timbers will continue.

Early intervention and regular maintenance, particularly of exterior timbers, will prolong the useful life of these building elements. Prior to any works being performed, the cause of the moisture that has created the visible wood rot should be identified and addressed in a suitable manner. Replacement of affected timbers may then be a necessary step in protecting surrounding building elements from such deterioration.

A qualified plumber may be appointed to assess the cause of excessive moisture and to provide advice on any remedial works as required. A qualified carpenter or registered builder may also be required to replace affected building materials.

Even though Liverpool termite activity was not visible. A further invasive inspection by a licensed termite technician its also highly recommended to eliminate possibility of potential termite activity.

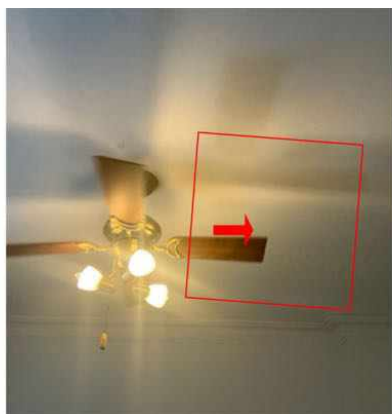
Location: Bedroom - Front
 Finding: Water staining
 Information: Water staining was evident in this area at the time of inspection. Water staining indicates that surfaces have been exposed to excessive moisture over time. The minerals and other elements in the water lead to staining, which may graduate to corrosion and deterioration if left unmanaged.

While mostly an appearance defect, water staining can be indicative of more serious defects, which may be currently concealed by other building elements.

Where water staining is active, a licensed plumber must be consulted to identify the cause of the staining and to provide advice on any reparation works that may be required. Replacement of any broken or damaged structures is advised.

Conversely, where water staining is old and inactive, affected building materials may be repaired or replaced at client discretion. A qualified carpenter or registered builder may be appointed to perform these works.

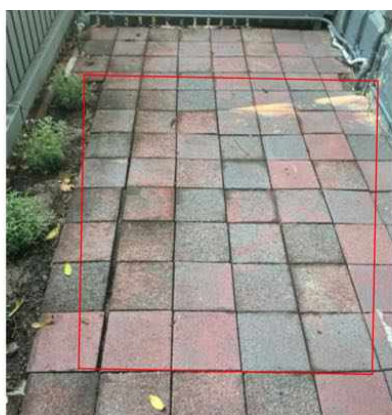
Where paving creates a trip hazard, personal injury may ensue if due caution is not taken by all persons within this area.

Re-paving of the area is required as soon as possible to remedy this situation. Further consultation with a specialist concreter is advised.

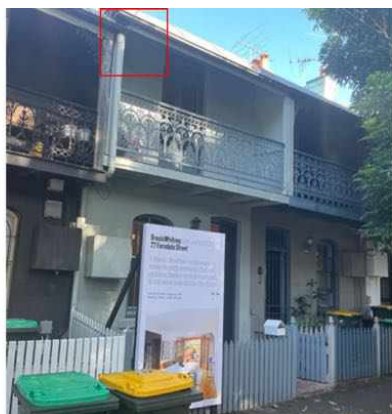
Finding 3.12

Building:	Main Building
Location:	All External Areas
Finding:	Building element - Rusted or corroded - Gutters
Information:	This building element shows evidence of rusting and corrosion, which is likely to have developed as a result of excessive exposure to moisture and or inadequate coatings.

Where possible, the use of galvanized (treated) metals or aluminium coated metals aid in rust prevention, as does regular general maintenance. Rust formation can be controlled with coatings, such as paint, that isolate the iron from the environment.

Rusting and corrosion should be managed by ideally removing or limiting the affected surface from exposure to moisture. A registered builder may be appointed to replace any building elements that have been severely affected by rust or water damage.

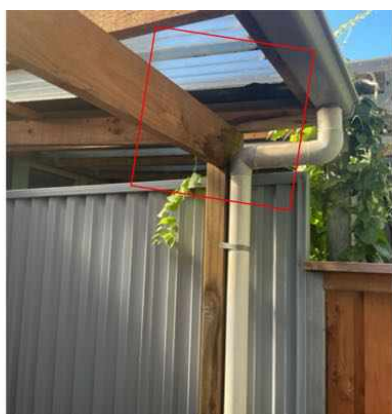
Finding 3.13

Finding: Water staining

Where water staining is active, a licensed plumber must be consulted to identify the cause of the staining and to provide advice on any reparation works that may be required. Replacement of any broken or damaged structures is advised.

Conversely, where water staining is old and inactive, affected building materials may be repaired or replaced at client discretion. A qualified carpenter or registered builder may be appointed to perform these works.

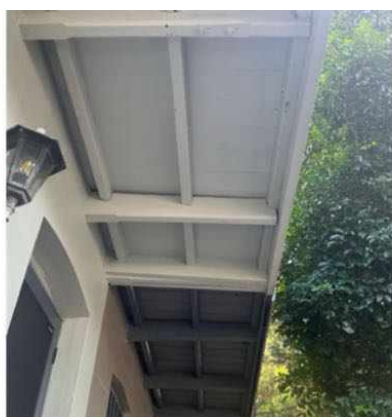
Finding 3.14

External timber structures are also constantly exposed to weather elements and can deteriorate in an accelerated manner, ongoing assessments are required.

It is highly recommended that a Structural Engineer further assess the external timber balcony or deck to inform the client of its load capacity. Regular maintenance inspections by competent practitioners is needed.

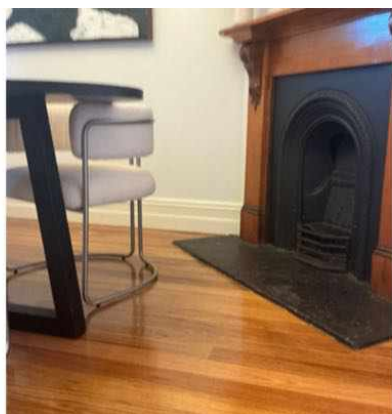
Finding 3.15

Building:	Main Building
Location:	All Internal Areas
Finding:	Gap between skirting and Floor
Information:	gap is visible between the skirting board and timber floor finish, indicating minor floor level variation or movement of the floating floor system. This condition is most consistent with minor slab/floor unevenness, floor finish movement or shrinkage. While primarily cosmetic/serviceability in nature, monitoring is recommended and further assessment may be warranted by a licensed builder if additional signs of structural movement become apparent.

Subfloor could not be inspection due to access limitations

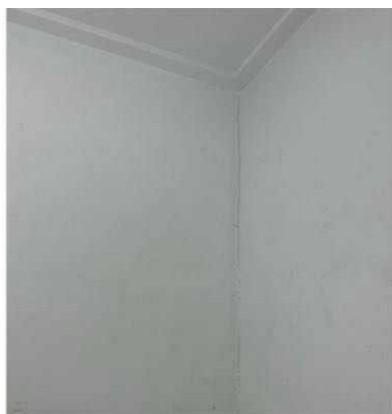
Finding 3.16

Building:	Main Building
Location:	All Internal Areas
Finding:	Flooring - Uneven to some areas
Information:	The internal flooring in this area is out of level and uneven. Uneven flooring is likely to indicate minor defects such as expected movement of the foundations of the property, but may also indicate subsidence of the associated subfloor stumps.

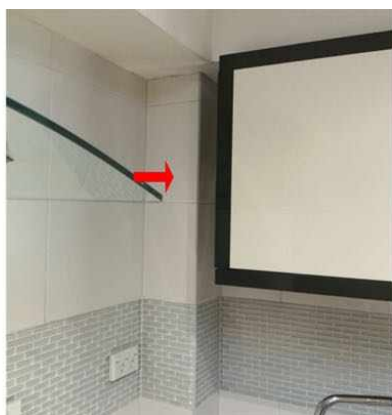
Tiled areas may swell and shrink with changes in air humidity if the area has sustained moisture damage. Any exposure to moisture is capable of causing tiled areas to become drummy and/or cracked over a prolonged period of time. Drummy tiled areas generally require removal and replacement of affected tiles, with adequate sealant and grouting.

Specialist trades are available for these types of services. A registered builder may be required to undertake works if damage is extensive or if secondary building defects have resulted. Otherwise, it is advised that a tiling contractor be appointed to perform works as necessary. Immediate action is recommended to ensure that no further damage is sustained in the affected area.

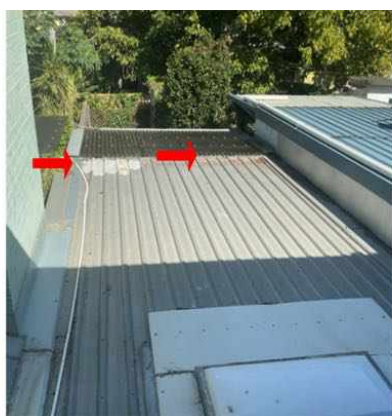
Finding 3.25

Building:	Main Building
Location:	Roof Exterior
Finding:	Building element - Rusted or corroded
Information:	This building element shows evidence of rusting and corrosion, which is likely to have developed as a result of excessive exposure to moisture and or inadequate coatings.

Rusting and corrosion should be managed by ideally removing or limiting the affected surface from exposure to moisture. A registered builder may be appointed to replace any building elements that have been severely affected by rust or water damage.

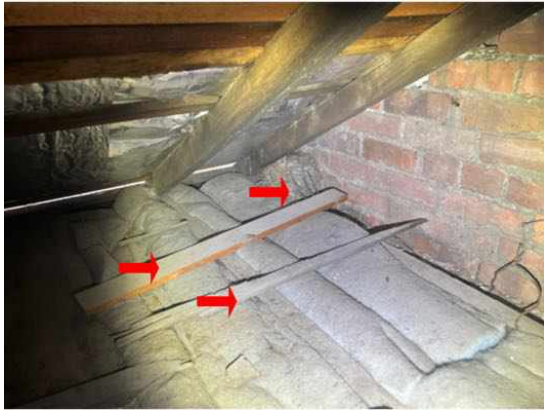
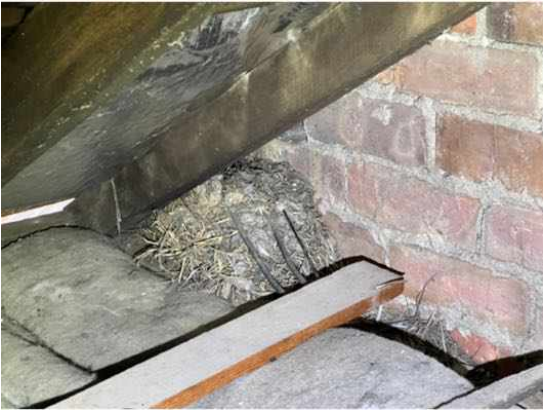
Finding 3.27

Building: Main Building
 Location: Roof Void
 Finding: Bird Nesting & Debris – Roof Void
 Information: A substantial bird nest and associated organic debris and loose timbers were identified in the roof space near the gable wall. This presents a potential fire hazard, can attract pests or vermin, and may contribute to poor air quality or odour transfer into the living areas. The presence of nesting material also indicates a possible entry point or ventilation gap in the roof cladding or eaves. Recommend safe removal by a pest controller or roofer and sealing of any potential entry paths to prevent recurrence.

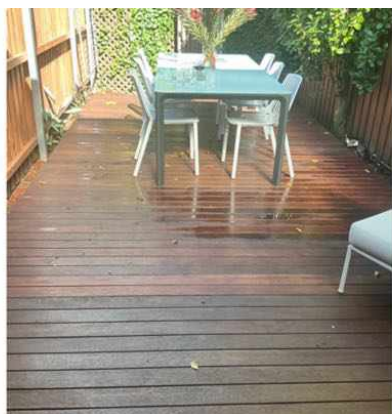
Finding 6.06

Building:	Main Building
Location:	All External Areas
Finding:	Bridging of termite barrier
Information:	Bridging of termite barriers occurs when termites bridge (usually by building a mud tunnel) a termite barrier or inspection zone or where termites have a passage allowing them to bridge the barrier.

Where bridging has occurred full inspection is prevented and termites may enter a property in a concealed or undetectable manner.

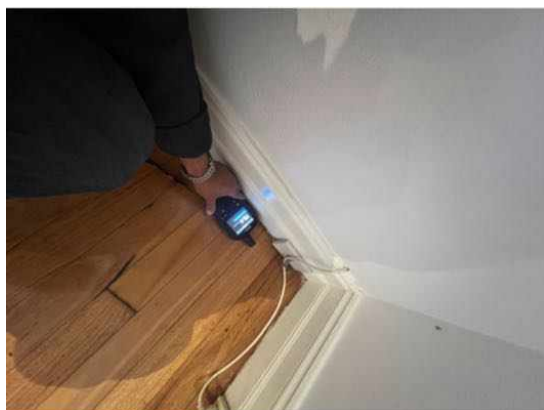
Finding 6.07

Building:	Main Building
Location:	All Internal Areas - Floorboards , Balcony Timbers
Finding:	Elevated moisture - identified
Information:	Elevated moisture can attract termites and produce conditions that promote fungal growth and wood decay.
