## Building and Timber Pest Inspection Report

Inspection Date: Mon, 23 Mar 2026

Property Address: 11 Hermies Ave, Milperra NSW 2214,  
Australia Updated to include asbestos lab  
test

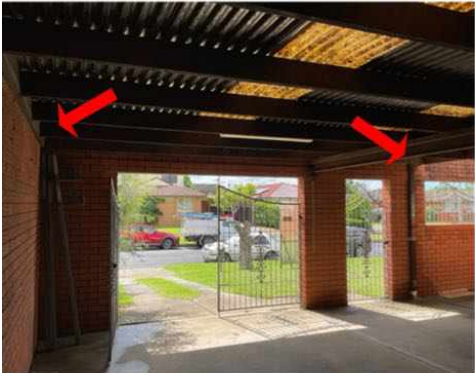
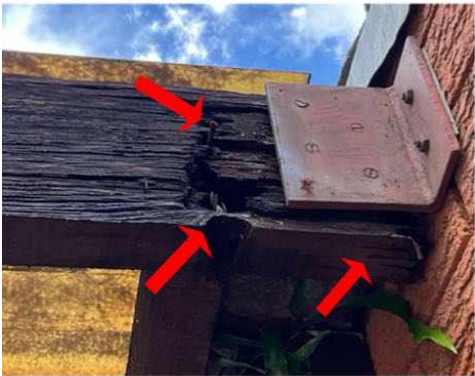
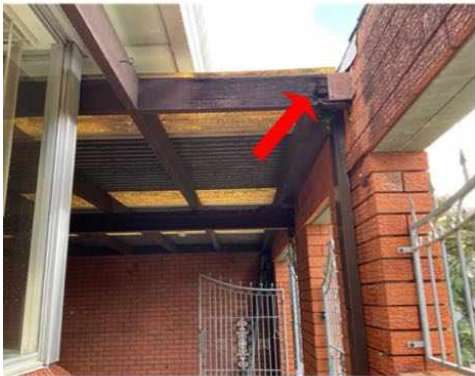
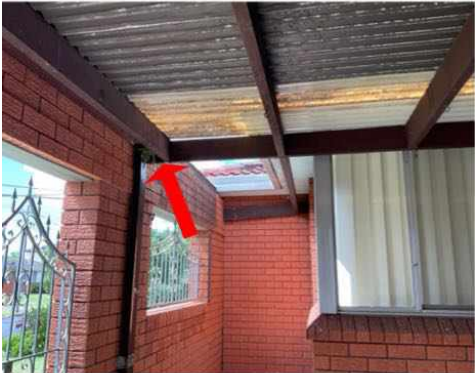
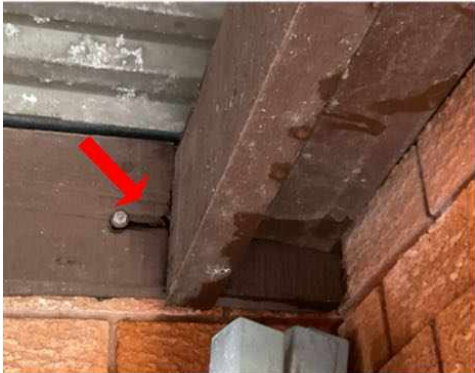
Building: Building 1  
Location: Front Pergola  
Finding: Wood rot  
Information: The front pergola shows evidence of wood rot to the front timbers on either side due to a full and leaking gutter and downpipes. Wood rot, also known as Fungal Decay, occurs when timbers and other cellulose building materials are exposed to damp conditions on an ongoing basis. Cleaning and repair of the front gutters is required regularly.

A qualified carpenter or registered builder is immediately required to replace the affected rotted pergola timbers and a plumber should repair the gutter/dpwnpipe.

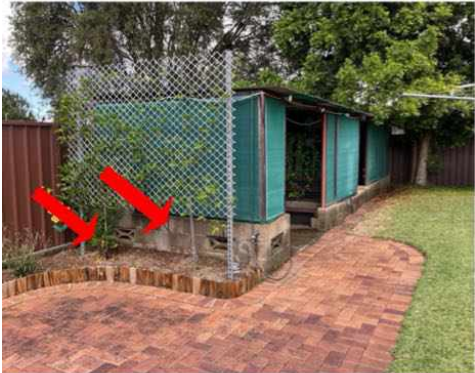
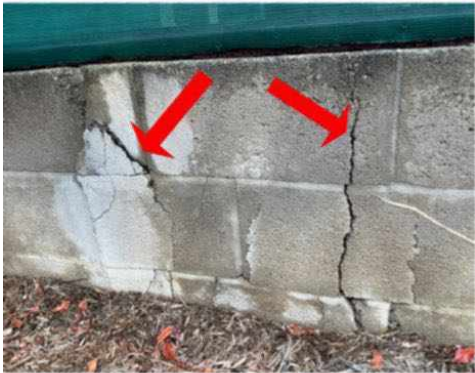
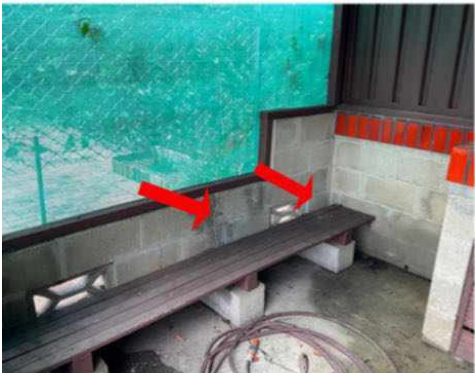
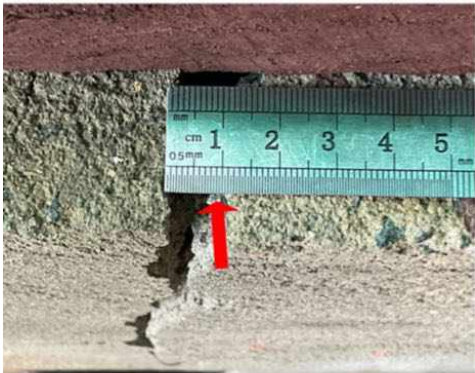
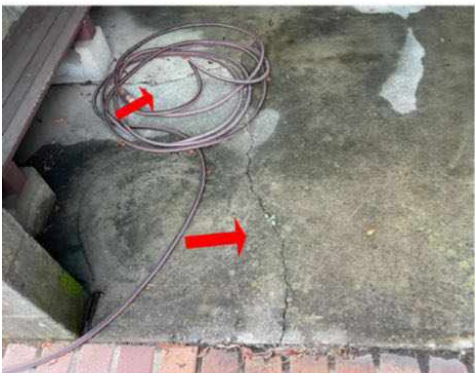
Building:	Building 3
Location:	Building 3 walls and concrete
Finding:	Step cracking to brickwork and floor concrete cracks - major
Information:	Step cracking was identified to the brickwork in the left rear besser block greenhouse at the time of inspection.

The NSW Standards and Tolerances 2017 states cracks over 5mm in width are a major defect requiring rectification work. This applies to the front greenhouse wall areas.

Cracks in the ground concrete over 10 mm were also found.

Step cracking, which is similar to other forms of cracking, has a variety of possible causes. However, the most common is the subsidence of adjacent footings.

Step cracking is a relatively common defect, and is most likely to occur adjacent to windows, doors and other openings. Mortar failure in the gaps between affected bricks indicates the stresses and tensions affecting the wall.

This step cracking can be used as a warning sign to address factors causing stress to the wall, which can include the effect of surrounding trees, water leaks, soil erosion, or even the presence of reactive soils in the surrounding area. As the greenhouse is constructed of besser blocks, this does not need replacement at this time and does not pose additional issues. This should be monitored annually and if further movement continues, a licensed builder should rebuild this wall.

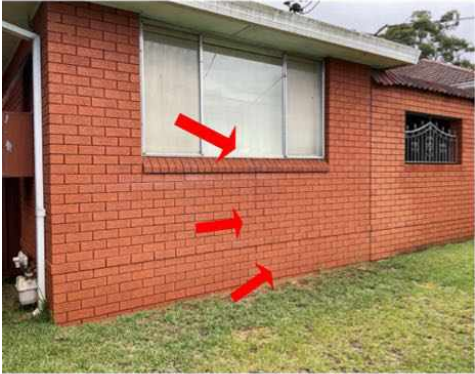
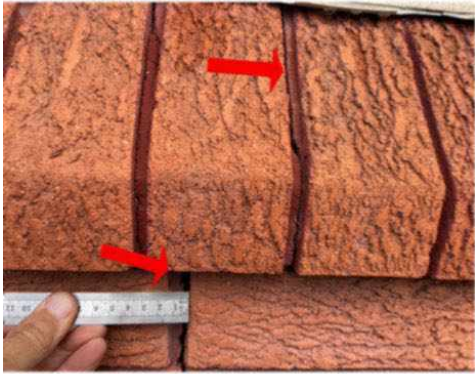
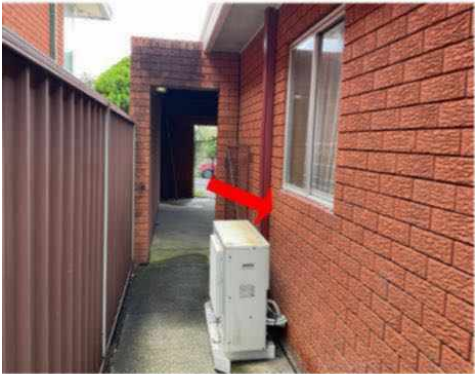
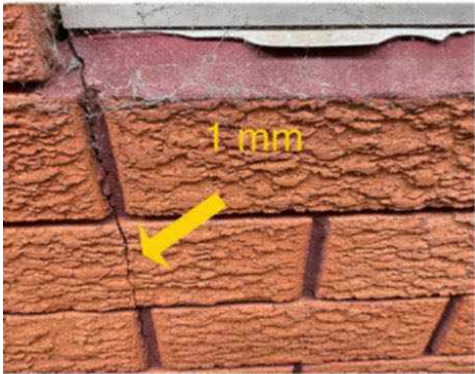
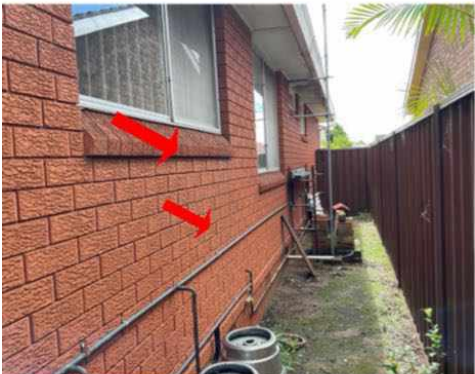
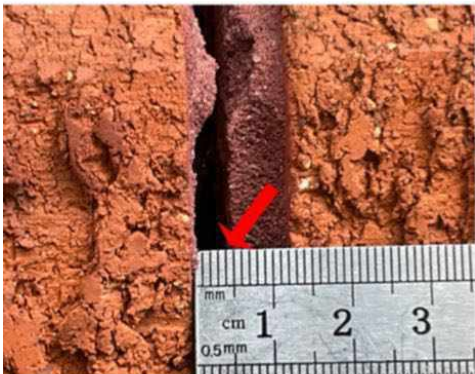
**Finding 3.01**

Building:	Building 1
Location:	Exterior front and side walls
Finding:	Step cracking to brickwork (minor under 5mm)
Information:	Step cracking of up to 4mm was identified to the brickwork in these areas at the time of inspection. Step cracking, which is similar to other forms of cracking, has a variety of possible causes. However, the most common is the subsidence of adjacent footings.

If any of this step cracking continues (ie, if this cracking reached 5mm or greater), the client is advised to consult a structural engineer.

Adding external drainage may slow or stop the cracking in these areas. This minor step cracking can be used as a warning sign to address factors causing stress to the wall, which can include the effect of surrounding trees, water leaks, soil erosion, or even the presence of reactive soils in the surrounding area.

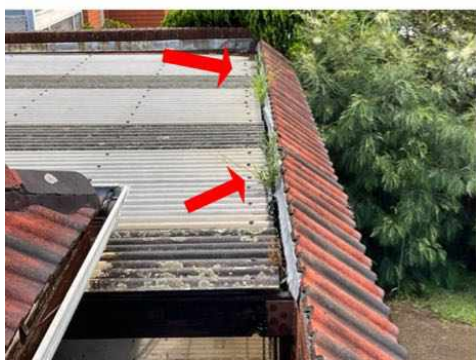
### Finding 3.02

Building:	Building 1
Location:	Roof Exterior - pergola
Finding:	Gutters - Water pooling
Information:	Water was found to be pooling in sections of the roof guttering. This is generally a secondary defect caused by blocked or partially blocked gutters. Such blockages and subsequent water pooling are likely to lead to rust and here have lead to water damage to the pergola. (See also wood rot in safety defects).

A roofing plumber should be appointed as soon as possible to rectify this issue. It is highly advised that all gutters be maintained on a frequent basis to ensure the condition of roof plumbing.

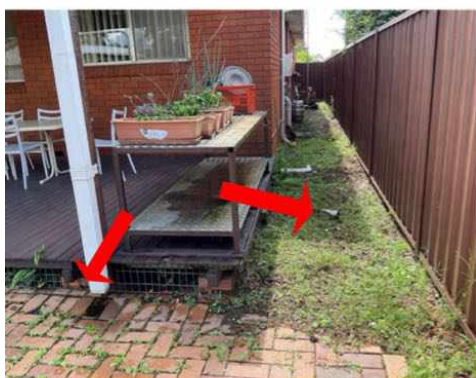
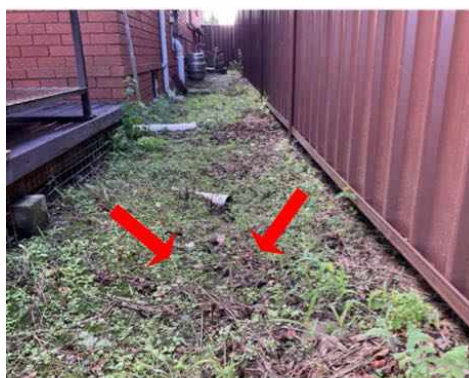
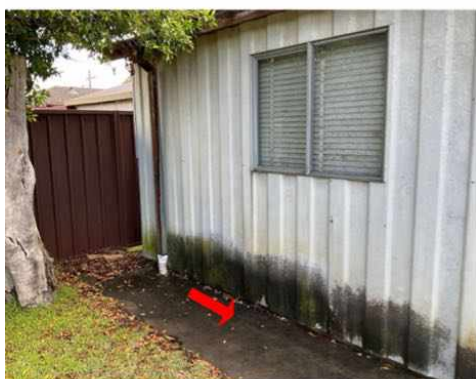
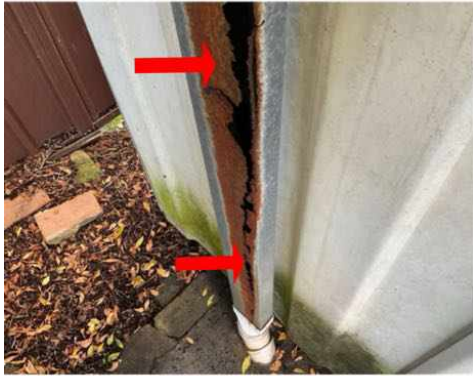
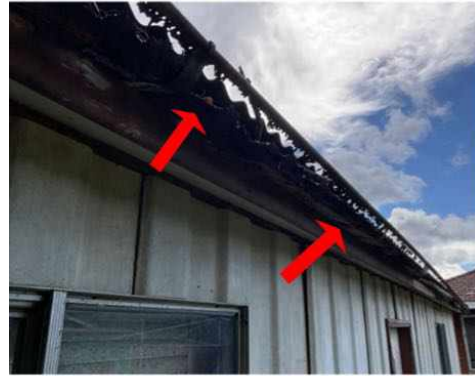
### Finding 3.03

Building:	Building 1
Location:	Wall areas, gutters, garage, yard rear left
Finding:	Site drainage - Inadequate
Information:	The site drainage in these areas was found to be inadequate on the left at the time of inspection, creating potential for subsequent water damage to associated building elements. Photos 1-4 show where water is pooling in rear areas due to poor drainage.

The air conditioner and wet area overflows run against the side house walls. The rear left downpipe and nearby drainage also empty on the left rear yard area. This ground in this area is really boggy as water has nowhere to go and can pool here. The garage downpipes and gutters have rusted out requiring replacement.

It is important that water does not lie against the base of walls; surrounding paths and ground levels should be sloped to drain water away from walls. Downpipes should not discharge stormwater onto lower walls or plinths. Stormwater should be carried away by large, regularly cleaned drains. Ground levels may need to be lowered to expose a buried DPC.

Where site drainage is inadequate, installation of an Agricultural (Aggie) Drain may be required. A qualified plumber should be appointed to further inspect the property and perform any remedial works as necessary. Secondary defects are likely to occur if left unmanaged.

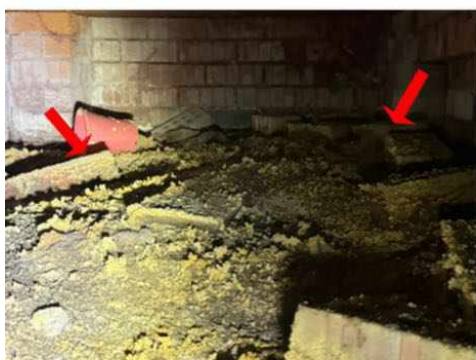
### Finding 3.04

Building:	Building 1
Location:	Subfloor
Finding:	Severe mould - Present in subfloor
Information:	Where evidence of severe mould growth was noted in the middle and left subfloor areas, there may be environmental, biological or health issues associated with the report. A specialist inspection by a suitably qualified environmental health inspector is warranted, where mould is extensive or where any queries regarding air quality spores or other related issues apply.

Subfloor mould is generally caused by moisture ingress, lack of external drainage, lack of adequate ventilation and subfloor debris present. These issues need rectification

Generally, the client is advised to ensure that the general environment is free of moisture and humidity to aid in the prevention of mould formation and development.

to stop mould development. Any mould found during the inspection should be cleaned immediately by a cleaning contractor.

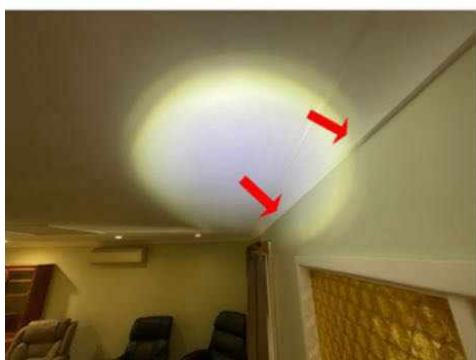
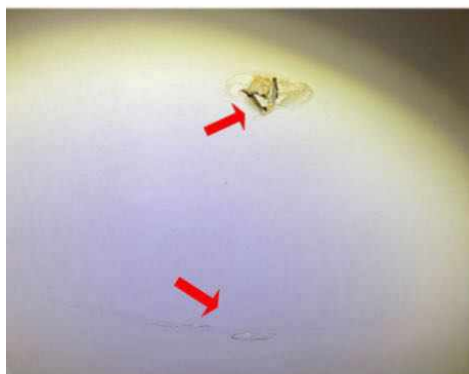
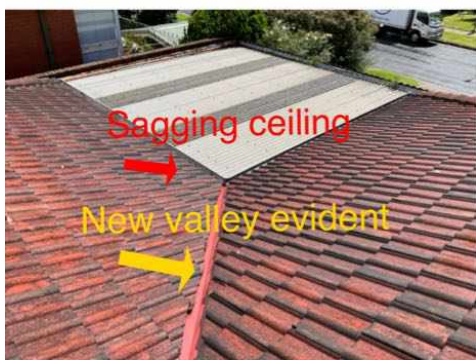
### Finding 3.05

Building:	Building 1
Location:	Lounge Room - front
Finding:	Ceiling - Sagging/deflection evident
Information:	The ceiling and cornice area in the front loungeroom was found to be sagging at the time of inspection. Sagging to the fixed ceiling structure generally indicates that the building materials have swollen, due to contact with water, or that fixings (e.g. nails or glue) have become loose and require reattachment.

Where minor sagging is evident here, comparatively minor works, such as re-gluing of ceiling sheets, may be required. Such works may be performed by relevant tradespeople, such as plasterers and painters. Where excessive moisture has caused the roofing structure to swell and sag, the source of the water leak should primarily be identified prior to any remedial works being performed. As no moisture was found and a new roof valley was evident above this area on the exterior roof, it is suspected this leak has been repaired. This area should be monitored annually for further roof leaks.

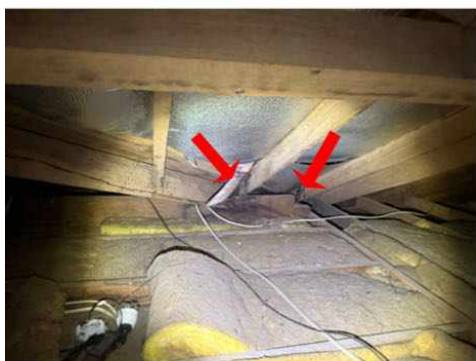
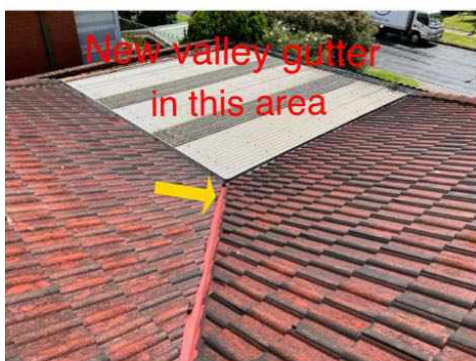
**Finding 3.06**

Building: Building 1  
 Location: Roof Cavity  
 Finding: Rafters - wood rot and rafter unsupported  
 Information: Minor timber staining and a disconnected (floating) rafter was found in the roof void above the front entry area.

It is likely that this staining has developed as a result of faults in the roof plumbing, however, it is again suspected the new roof valley repair that appears to have occurred has stopped the moisture creating the timber staining.

This external roof area should be monitored annually and a roofing contractor

engaged if any internal staining occurs.

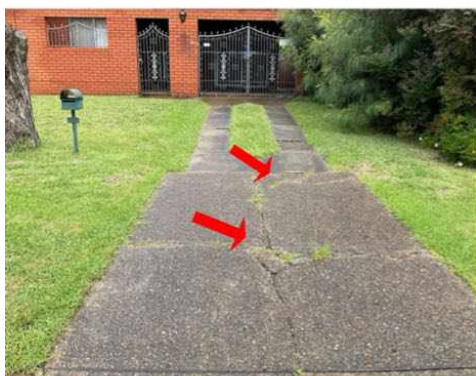
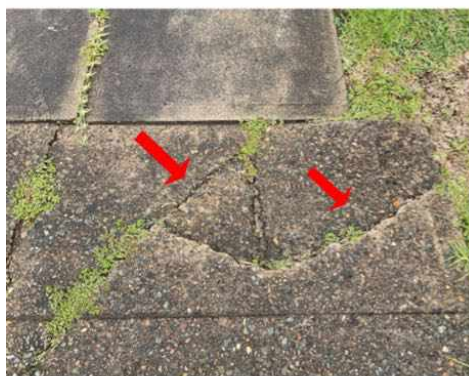
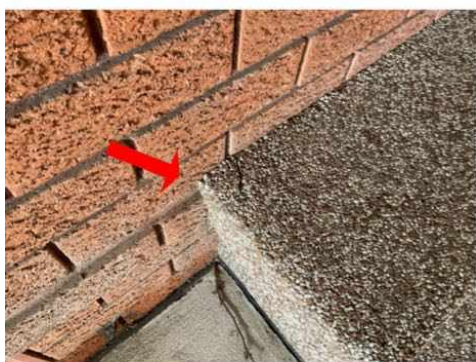
### Finding 3.07

Building: Building 1  
 Location: Yard - front & rear  
 Finding: Crack in concrete slab - Category 3  
 Information: A crack coded as Category 3 was identified in the slab. A Category 3 crack is described as a wide crack with obvious curvature or change in level, affecting the slab.

The approximate width of the crack to be considered Category 3 is greater than 2.0mm, or a change in offset of 15-25mm when a 3m straight edge is placed over the defect.

Category 3 cracks to slabs exceed allowable Standards and Tolerances, and are considered defects requiring rectification.

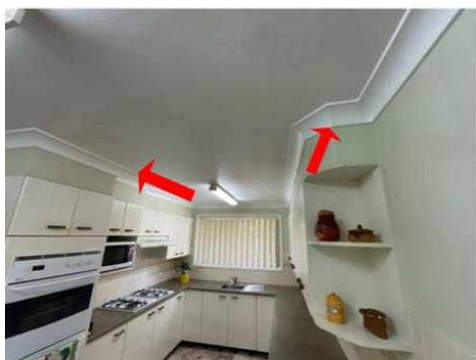
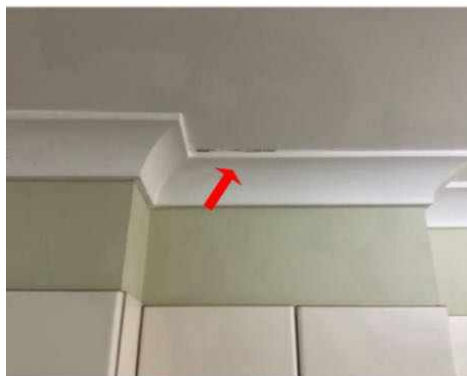
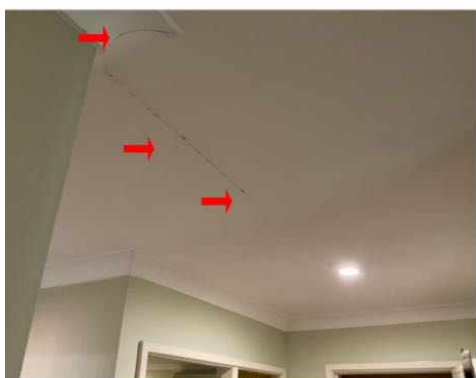
### Finding 3.08

Building:	Building 1
Location:	Kitchen & hall
Finding:	Cracking - Damage Category 2 - Noticeable (up to 5mm)
Information:	Noticeable cracks are a common occurrence as a result of many primary defects. Such causes may include age, general wear and tear, expected building movement, general expansion/contraction of building materials in different weather conditions, and/or minor failings in the installation or application of building materials.

Noticeable cracks may result in minor sticking or jamming of associated doors and windows, which require easement. However, noticeable cracks are easily filled and repaired. A plasterer can be consulted to install an expansion joint at this point to allow for this movement during different weather conditions.

Monitoring of all cracking should be conducted frequently. Always contact a building inspector should cracks widen, lengthen, or become more numerous.

Relevant tradespeople, such as carpenters, painters and plasterers, should be appointed to perform remedial works, as deemed necessary.

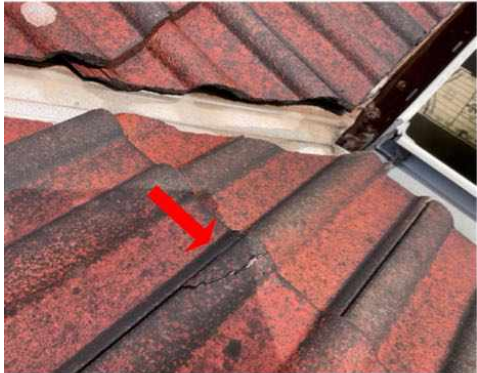
Building:	Building 1
Location:	Roof Exterior
Finding:	Roofing areas - Weathered requiring repair
Information:	Upon inspection of the exterior roofing, the majority of the roof areas were considered to be in a good condition. While weathering of these pictured areas is consistent with the age of the property, maintenance works are immediately required.

Re-sealing and replacing small areas of gaps, damage or rust the may be considered as an interim solution by the client to help preserve and extend the life span of these roofing areas. Where left unmanaged, deteriorating roofing materials are likely to lead to a number of secondary defects, including minor water leaks and weather exposure to internal roofing structures.

Remedial works are likely to increase the longevity of the exterior roofing structure.

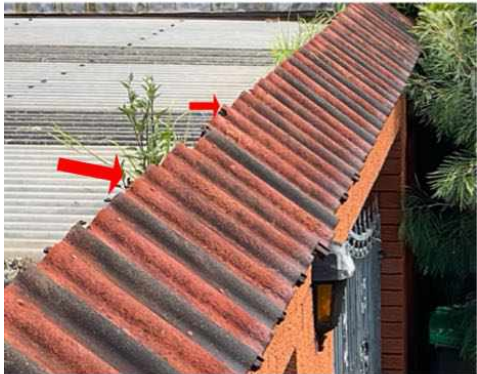
**Finding 3.11**

Building: Building 1  
Location: Pergola Roof Exterior  
Finding: Roof tiles - Slippage  
Information: Upon inspection of the exterior front pergola roof, it was noted that numerous tiles have slipped from their original fixing. Tiles may slip over time due to a number of minor causes, including breakage of tiles or fixings that may have failed.

Replacement of loose roofing tiles is recommended immediately to prevent the development of any secondary defects. A roofing restoration specialist should be appointed to complete such works as necessary.

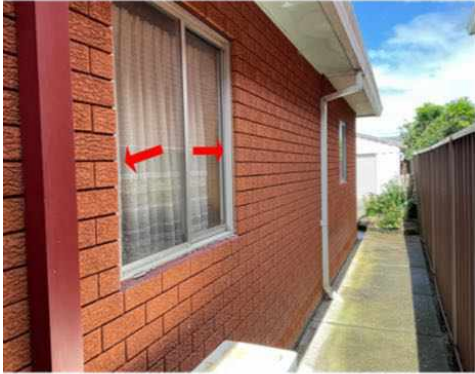
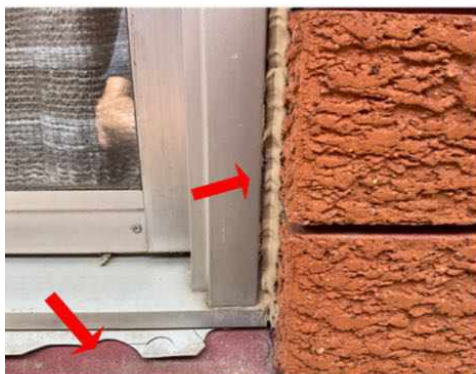
**Finding 3.12**

Building: Building 1  
Location: Pictured Areas  
Finding: Sealant or flashing (external) - Missing.  
Information: It was noted on inspection that areas of external sealant or flashing was missing to small areas of the external windows.

Flexible sealants should be applied to these affected areas to prevent any subsequent water damage that is likely to occur.

A sealant specialist or skilled handy person should be appointed to complete these works as soon as possible

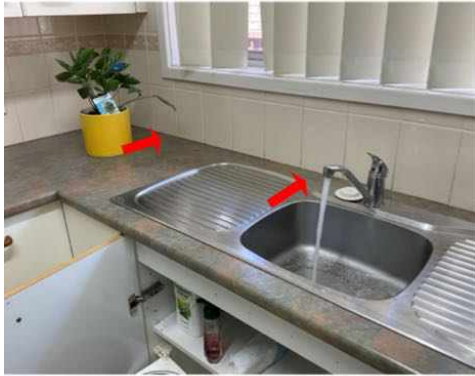
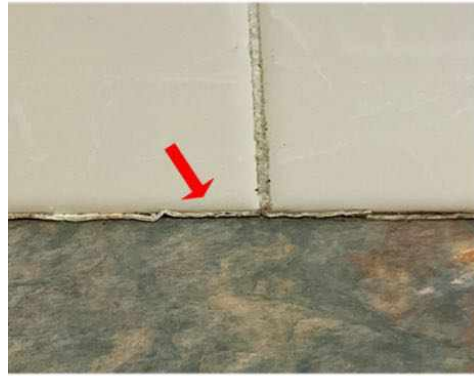
### Finding 3.13

Building:	Building 1
Location:	Kitchen
Finding:	Sealant and grouting - Missing or damaged
Information:	It was noted on inspection that sealant or grout is degraded to these pictured wet areas.

Different materials and floor areas move at different rates, generally causing cracking to grout or sealant at this point. A flexible sealant is required to allow for expected expansion and contraction, while keeping the joint water tight and protective of all associated building materials.

Flexible and mould resistant materials should be applied to affected areas to prevent any subsequent water damage that is likely to occur. Regular maintenance and replacement of damage or missing or damaged sealant and grout is highly recommended to the wet areas, as this is a regular wear and tear defect. Sealant and grouting in areas that come into regular contact with water should be maintained for the long term care of your property.

A sealant specialist or tiling contractor should be appointed to complete these works as soon as possible

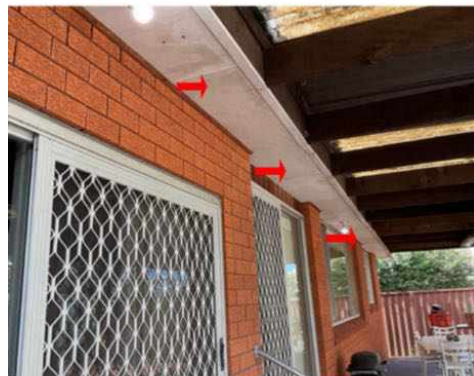
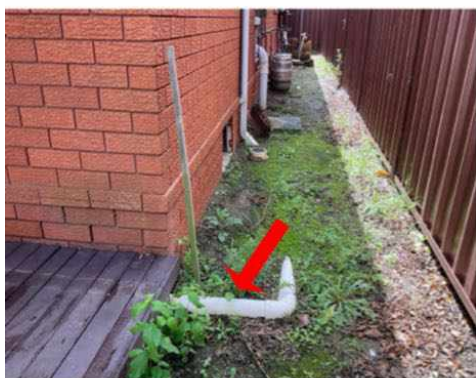
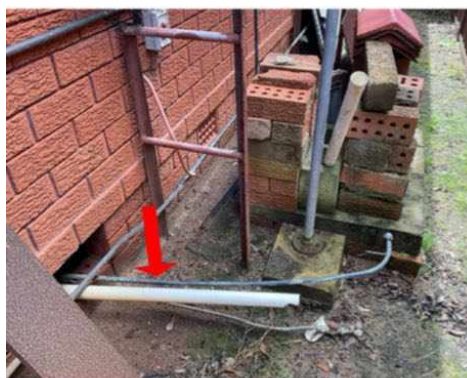
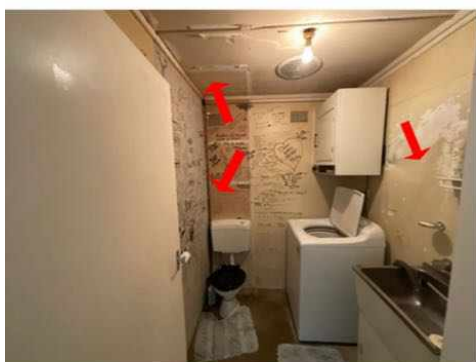
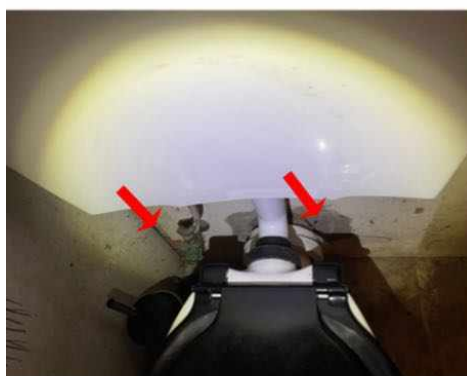
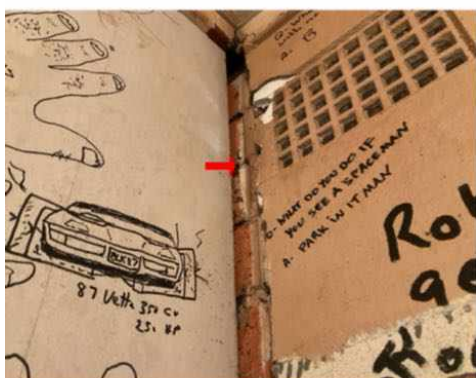
### Finding 3.14

Building: Building 1  
 Location: Exterior walls areas and laundry  
 Finding: Unfinished construction  
 Information: The construction of this structure appears to be incomplete. The safety of the structure can therefore not be ensured and the creation of secondary defects to surrounding building elements may be likely.

1. The eave joiners and paint are incomplete to some eave areas.
2. The plumbing protrudes from the ground allowing it to be easily damaged.
3. The laundry walls are unfinished.

A Registered Builder and plumber should be appointed immediately to complete this construction process.

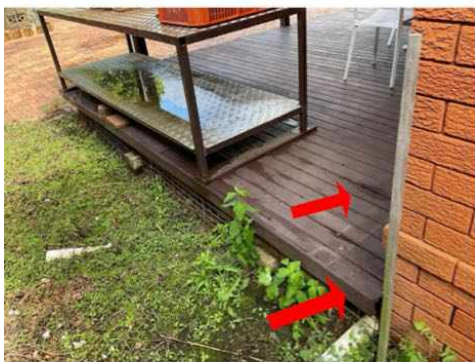
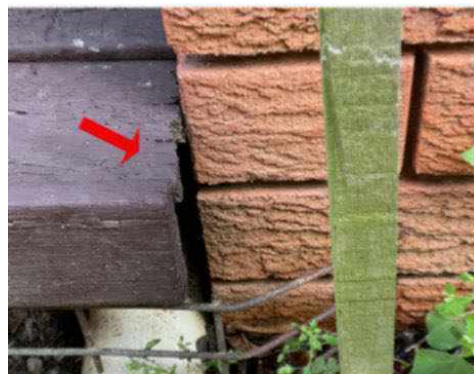
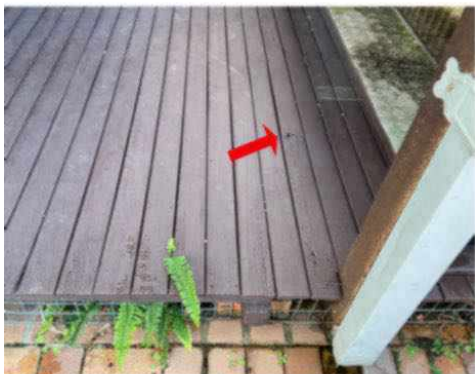
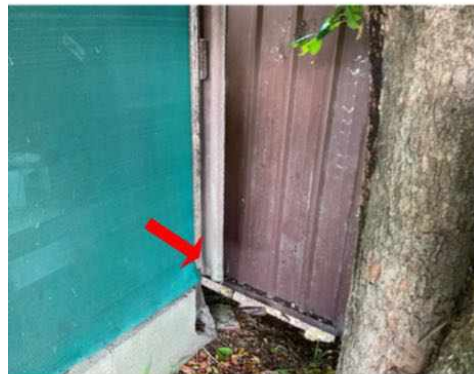
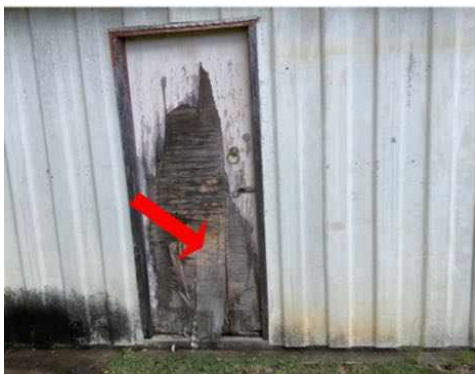
### Finding 3.15

Building:	Building 2
Location:	Pictured areas of buildings 2 & 3
Finding:	Wood rot to rear deck and rear buildings
Information:	These rear building elements shows evidence of wood rot. Wood rot, also known as Fungal Decay, occurs when timbers and other cellulose building materials are exposed to damp conditions on an ongoing basis. This could be the result of exposure to weathering over a prolonged period of time, or the attraction of excessive moisture from other abutting building materials. Contributing factors also include poor air ventilation in the area.

Wood rot is often associated with general damp problems and is evidenced by a

'musty' smell or mould and mildew occurring on surfaces. If left unmanaged, damp conditions can lead to further health problems and the decay of timbers will continue.

Early intervention and regular maintenance, particularly of exterior timbers, will prolong the useful life of these building elements. Prior to any works being performed, the cause of the moisture that has created the visible wood rot should be identified and addressed in a suitable manner. Replacement of affected timbers may then be a necessary step in protecting surrounding building elements from such deterioration.

A qualified plumber may be appointed to assess the cause of excessive moisture and to provide advice on any remedial works as required. A qualified carpenter or registered builder may also be required to replace affected building materials.

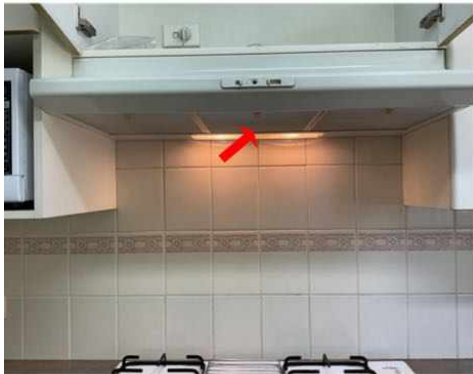
### Finding 3.17

Building: Building 1  
 Location: Kitchen  
 Finding: Rangehood - Fan not working  
 Information: While the range hood appears to be working at a satisfactory level, the fan to the structure was not working at the time of inspection.

Without a functional fan, a build-up of grease and evaporative moisture is likely to accelerate deterioration of the range hood and associated flue. This potential build up may also create a minor fire hazard, particularly if left uncleaned.

A licensed electrician should be appointed to replace the fan on the range hood to restore it to a fully operational state.

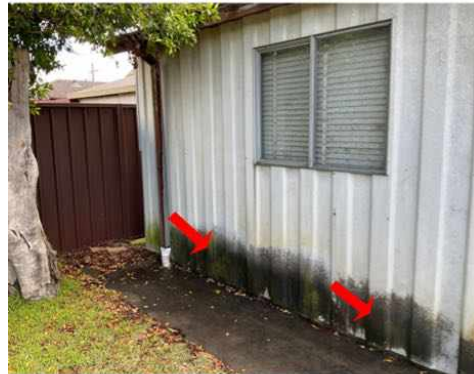
Building: Building 2  
 Location: Exterior walls - garage  
 Finding: Cladding damaged  
 Information: Evidence of damage was identified to the left side wall where the cladding has minor damage. A carpenter would be the trade responsible for rectification of this wall area.

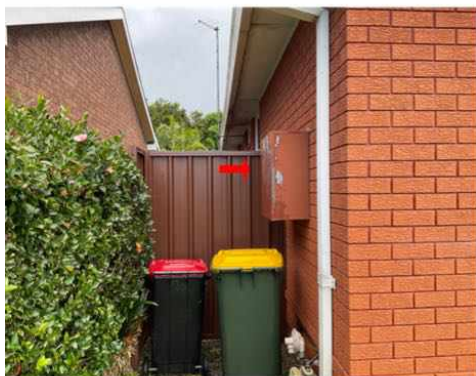
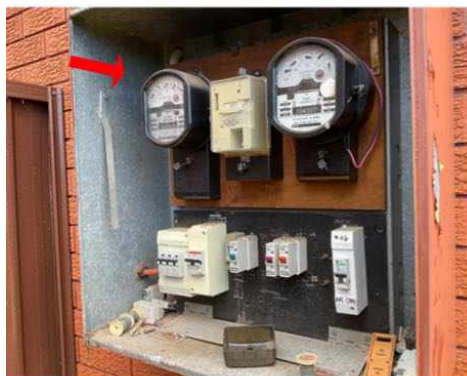
Building: Building 1  
 Location: Meter Box  
 Finding: Termite Management System - no evidence of a chemical installation  
 Information: The application of a post-construction chemical termite barrier is highly recommended for all properties. Such barriers are highly effective in preventing termite attack on any timber building elements throughout the property.

to suggest preventative works taking place since the property was built.

The client may consider gaining further advice from a pest controller as to the costs and procedures involved with a 'chemical' application. It is recommended that obtaining such advice be a short-term priority.

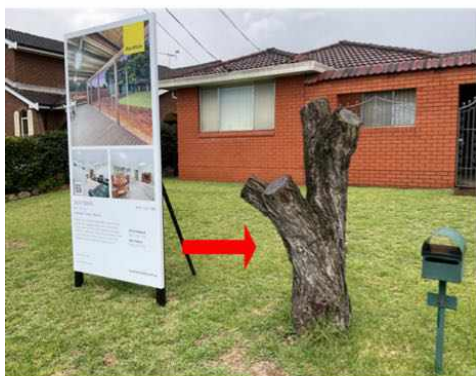
### Finding 6.03

Building:	Building 1
Location:	Pictured yard area
Finding:	Tree stumps - left in ground
Information:	Tree stumps left in ground provide opportunity for termite attack as they are likely to be subject to rot and decay providing an attractive food source. Treatment and/or Removal of the stump is highly recommended. A pest controller and tree removalist should be engaged to perform such works.

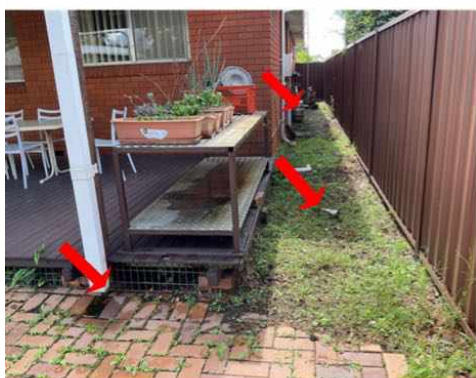
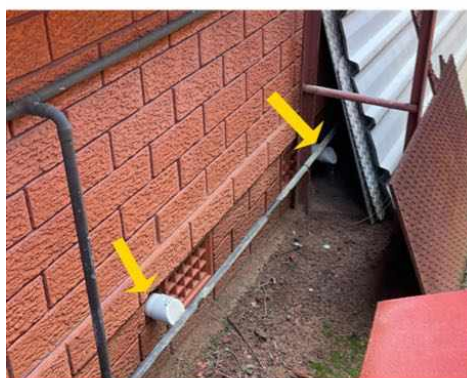
Rising damp is generally managed by the installation of a damp proof course during construction. A Damp Proof Course (DPC) is an impermeable barrier at the base of the wall above ground level. However, many 19th Century buildings have no damp course installed, or the materials have failed. The DPC may have been omitted as a consequence of poor workmanship, or it may have been bridged where materials built up against the side of the house allow moisture ingress above the DPC level.

These damp conditions can lead to secondary defects such as rot, rust or corrosion of associated building elements, the formation of fungal decay, or even the creation of potential slip hazards. When coupled with poor site drainage, pooling of water may also attract termite activity to this area. It is highly recommended that a qualified plumber be appointed to install adequate drainage to these areas. These works will ensure that the area remains dry and free of any secondary defects.

The first step in addressing rising damp is to diagnose the cause. The identified cause should be addressed first before addressing the appearance and other defects which have resulted from the rising damp. If the original cause is not resolved, further cases of damp are likely to ensue, resulting in secondary defects.

Consultation with a qualified plumber is advised immediately to identify the cause of the damp and perform remedial works as required.
