Building and Timber Pest Inspection Report

Inspection Date: Tue, 24 Mar 2026

Property Address: 18 Bounty Ave, Castle Hill NSW 2154,
Australia

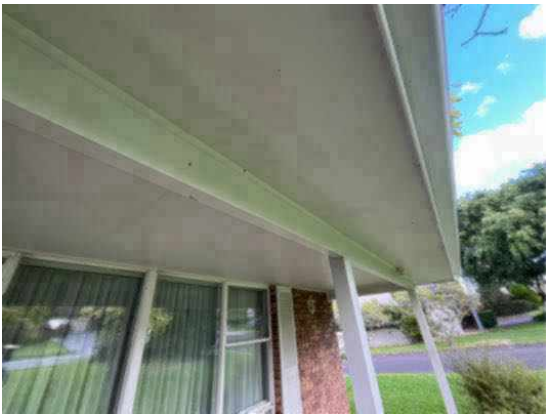
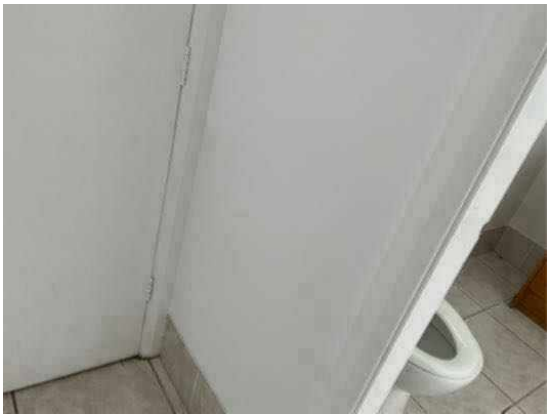
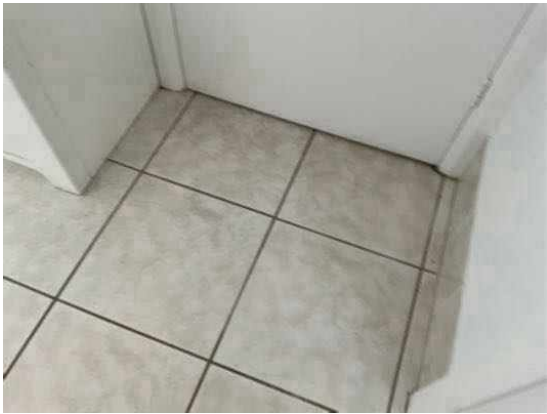
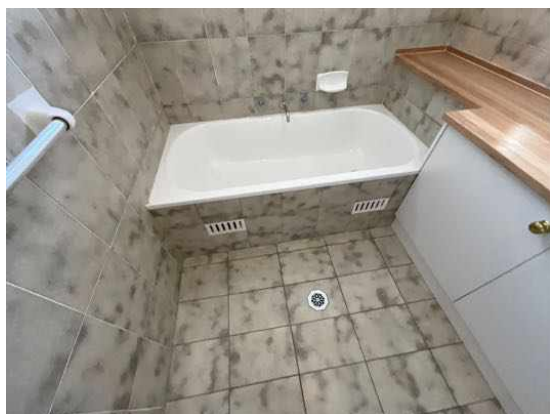
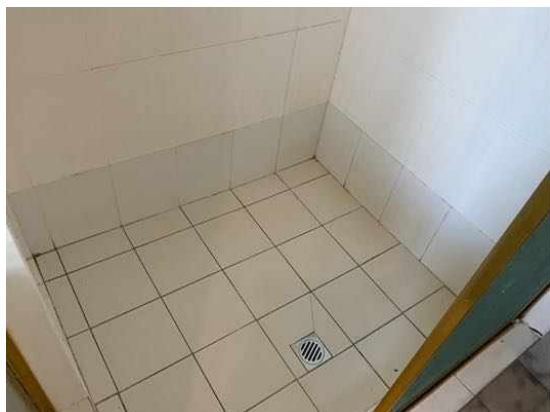
Building:	Main Building
Location:	All Areas
Finding:	Asbestos - Suspected ACM Identified on Site
Information:	Reporting on Asbestos is outside the Scope of this Report. This suspected defect is highlighted as a caution only. We suspect, based on our experience in the building industry, that there is a higher risk of the identified building element containing asbestos.

As Asbestos Reporting is outside the scope of this report, we advise that you consider a separate Asbestos Inspection and Condition Audit, which can include the taking of samples for definitive confirmation of the presence of Asbestos.

In the interim, the client is advised to act with caution, especially when considering any damage to building materials general wear and tear renovations extensions demolition and general maintenance activities due to the suspected presence of Asbestos.

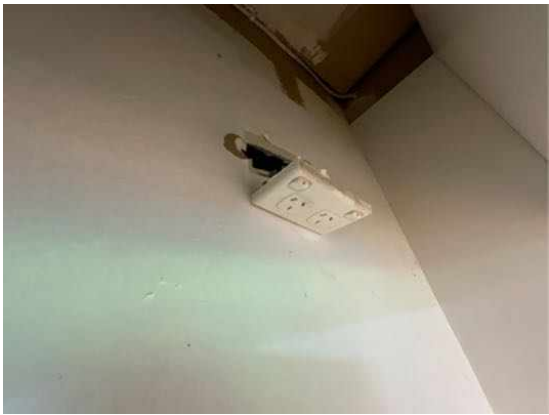
Building:	Main Building
Location:	Kitchen
Finding:	Electrical outlet improperly installed
Information:	The electrical outlet is improperly installed, with the faceplate detached and wires visibly exposed. The conduit or switch housing appears damaged or incomplete, leaving an open gap around the outlet. This may be due to improper installation, wear and tear, or accidental damage.

- ****Electrical Shock Hazard:**** Exposed wires pose a significant risk of electric shock if touched accidentally.
- ****Fire Hazard:**** Faulty wiring or exposed conductors could spark or overheat, increasing the risk of an electrical fire.
- ****Water Hazard:**** Given the proximity to what appears to be a sink, water exposure to the exposed wires could lead to short circuits, electric shock, or fire.
- ****Non-compliance:**** This setup likely violates electrical safety codes and standards, requiring immediate attention.

A licensed electrician should be contacted immediately to assess and repair the damage. The repair may involve reattaching or replacing the outlet, properly securing the wiring, and ensuring the installation meets safety standards.

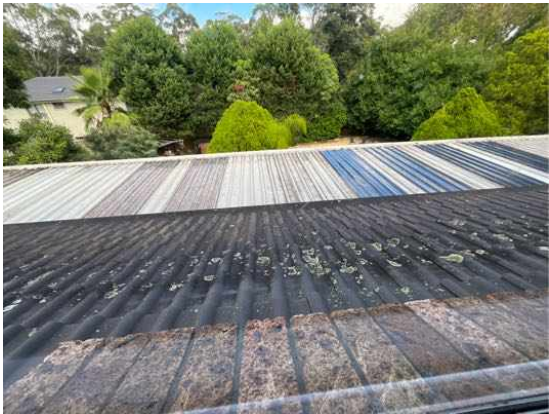
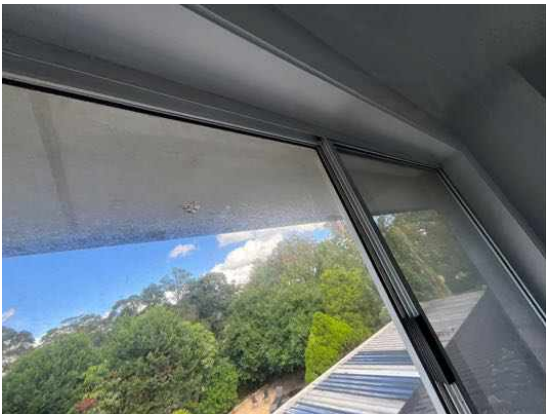
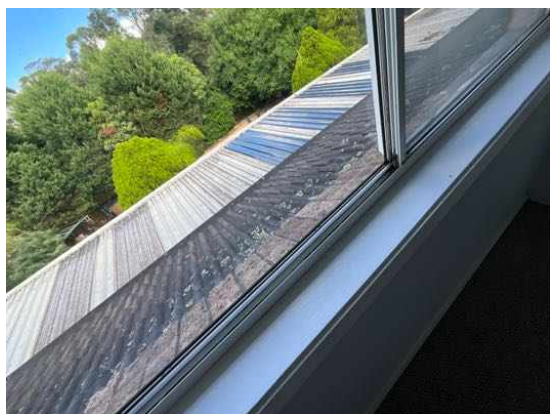
Finding 1.04

Building: Main Building
Location: All Areas
Finding: Window child lock missing
Information: The window in question lacks a child lock mechanism, which poses a potential safety risk to young occupants in the premises. As per Australian Standards windows accessible to children should be equipped with appropriate child safety locks to prevent accidental opening, reducing the risk of falls and ensuring compliance with safety regulations.

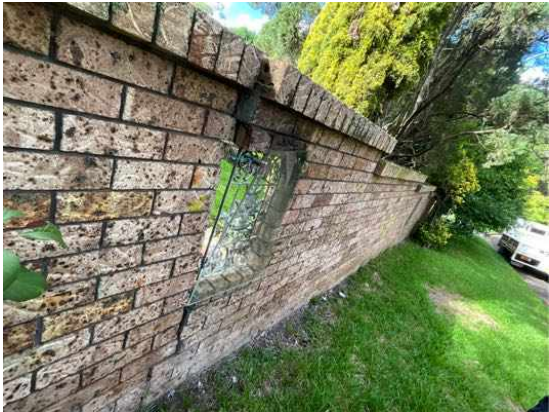
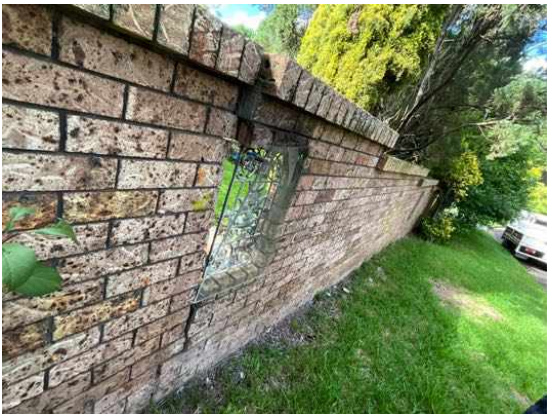
Information: A section of the masonry fence wall in boundary is leaning. The movement appears to originate from the base, suggesting inadequate footing, ground movement, or poor structural tie-back to adjoining walls or posts.

This is considered a defect under AS 4349.1-2007, as it poses a safety risk if movement continues or if the wall collapses. It may also indicate subsoil instability or

A qualified structural engineer or licensed bricklayer should assess the extent of displacement and recommend appropriate remedial action. This may involve partial demolition and reconstruction with reinforced footing or bracing to ensure long-term stability.

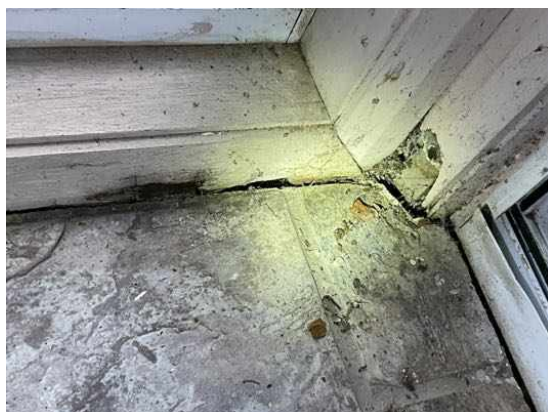
Building: Main Building
Location: Spa
Finding: Water damage
Information: The area has sustained water damage resulting in potential structural issues. This damage compromises both the aesthetic and functional aspects.

1 **Plumber:** If the water damage is due to plumbing issues, a plumber can fix leaks and ensure there are no further water-related problems.

2 **General Contractor:** If the damage is extensive and affects the surrounding area, a general contractor can coordinate the repair work, including any related structural or cosmetic repairs.

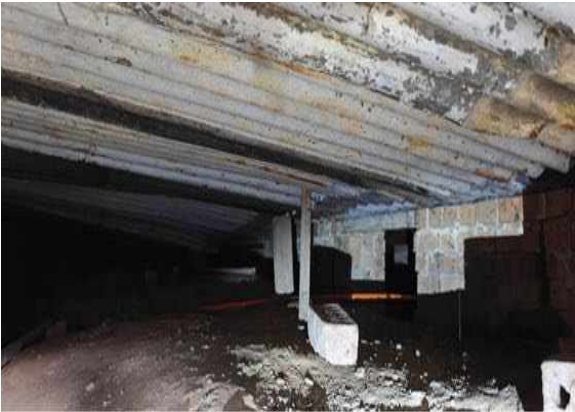
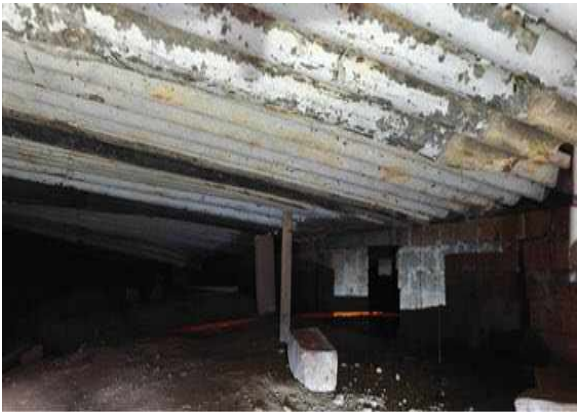
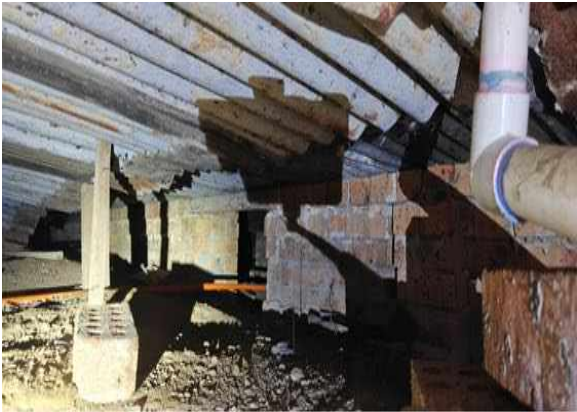
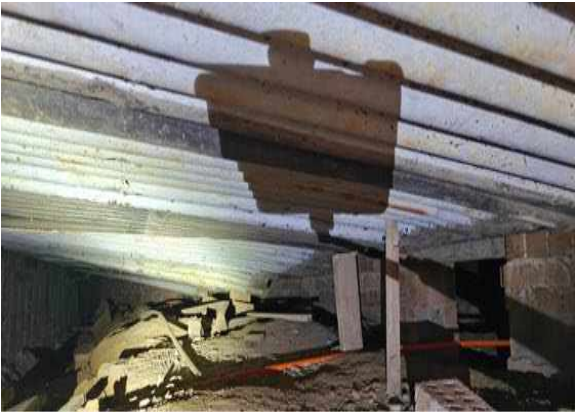
Building:	Main Building
Location:	Subfloor
Finding:	Subfloor Piers - Unstable or deteriorated
Information:	Piers to the subfloor structure are unstable, indicating that their structural integrity has been affected. The cause of this instability is likely to be movement by which piers deteriorate at a rapid rate.

The piers are suspected to be failing in their structural purpose, which is likely to lead to a range of major and minor defects. Further (potentially major) damage to the piers and structure may be imminent if left unattended.

Appointment of a Registered Builder specialising in re-stumping is required immediately to assess the condition of the stumps and provide advice on remedial works. This defect should not be left unmanaged.

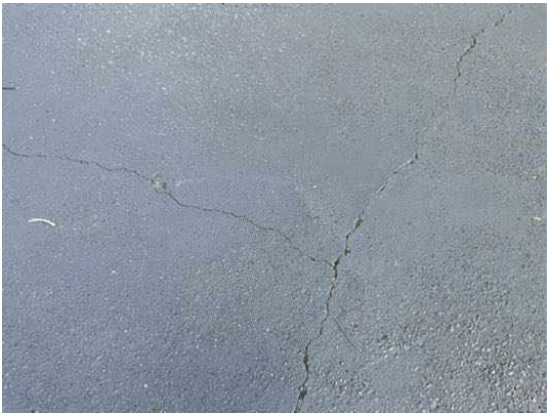
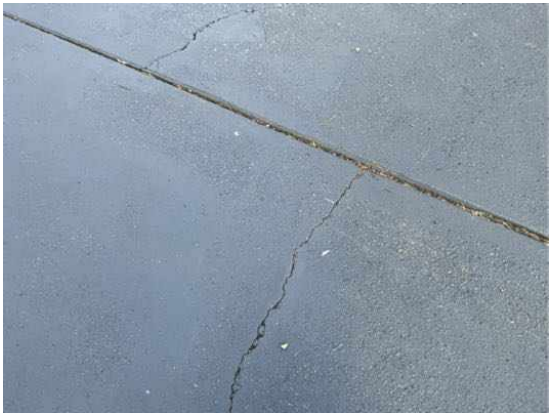
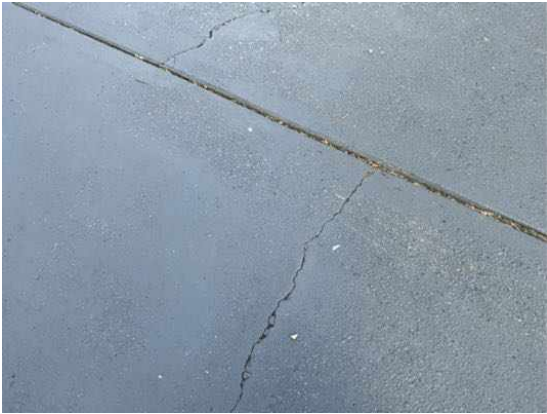
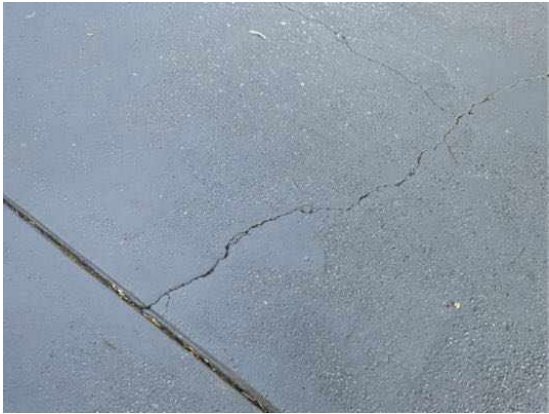
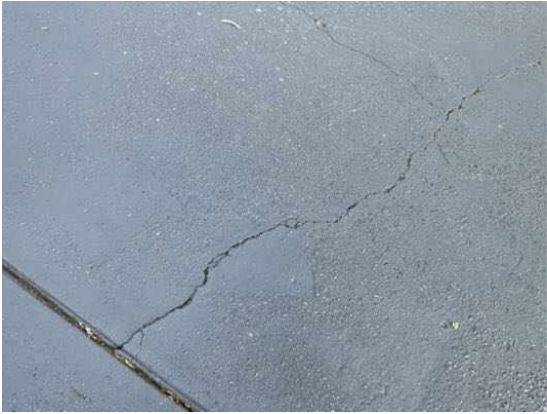
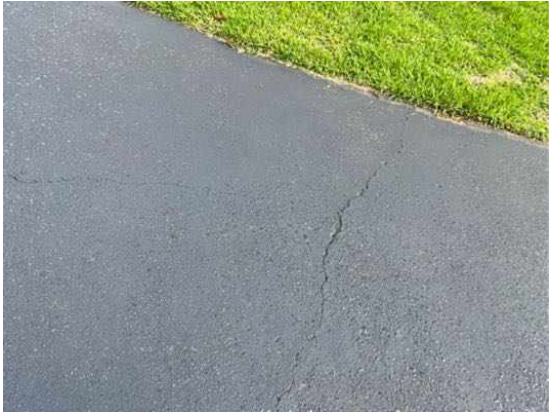
Finding 3.01

Building: Main Building
Location: All Areas
Finding: Noticeable Cracking in Concrete Slab

Information: Noticeable cracking has been observed in the concrete slab, failing to meet the required construction and quality standards.

- Cracks are visible on the surface and may extend through the depth of the slab.
- Evidence of improper curing or inadequate reinforcement leading to cracking.

- A structural engineer should be engaged to assess the extent of the cracking and recommend appropriate repair methods.
- A licensed contractor or concrete repair specialist should carry out the recommended repairs under the guidance of the structural engineer.

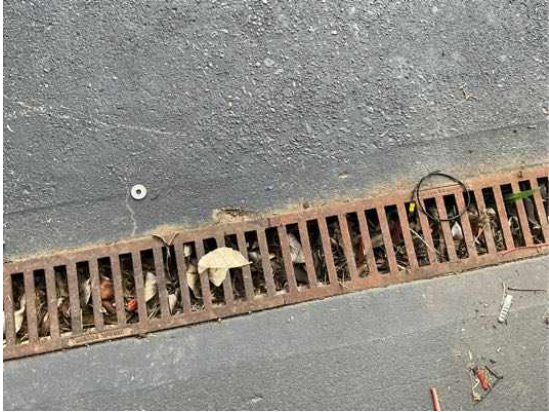
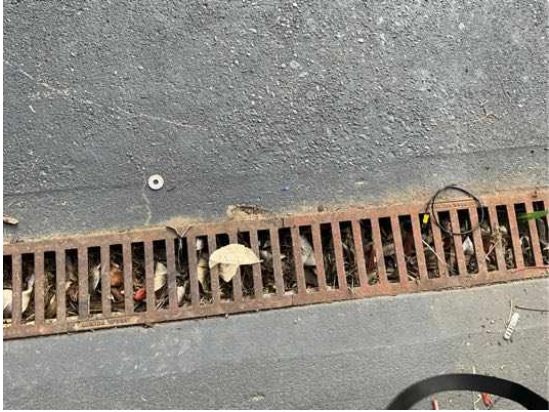
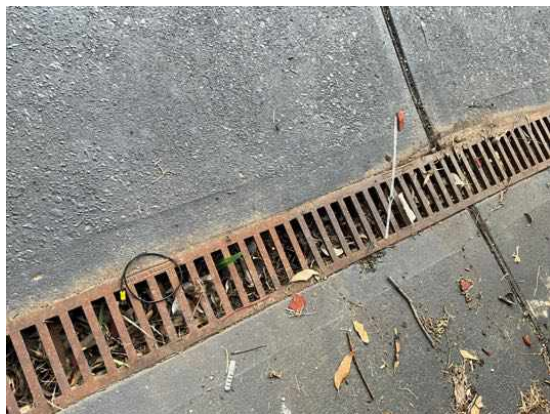
Finding 3.02

Building: Main Building
Location: Driveway
Finding: Blocked channel Drain
Information: Blocked channel Drain , observed vegetation grown in the gutter , advised channels to be cleaned.

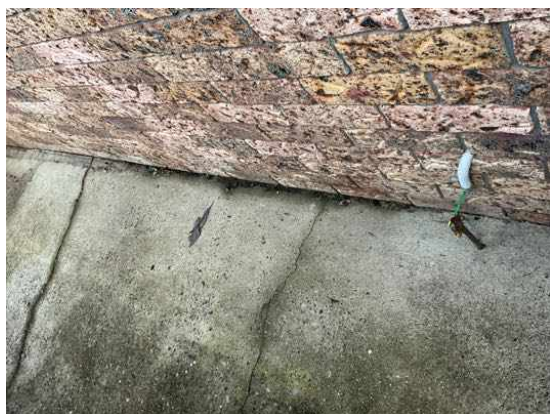
Finding 3.03

Information: The perimeter paving or ground levels were found to have an inadequate slope away from the adjoining building structure, creating potential for water pooling in this area.

Perimeter paving is required to fall from the building by a minimum of 25mm in the first metre and bare ground should fall away from the house by 50mm in the first meter. This standard ensures that excessive moisture does not pool around the base of building structures, which creates potential for water and structural damage, as well as making the area susceptible to termite and timber pest activity.

Where paving or ground levels do not have adequate fall, a licensed paving contractor should be appointed to install or remove and re-level pavement.

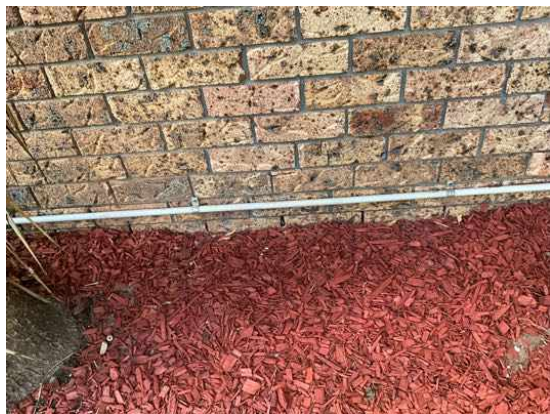
Building:	Main Building
Location:	All Areas
Finding:	Weep holes - Missing
Information:	The external masonry wall of the building lacks the necessary weepholes, which are crucial for the drainage and ventilation of the wall cavity.

A qualified bricklayer or masonry contractor should be contacted to assess and install the missing weepholes. They will:

- Drill or create gaps in the appropriate locations of the masonry wall to ensure effective drainage and ventilation.
- Ensure compliance with the Australian Standard AS 3700 (Masonry Structures) and the National Construction Code (NCC) requirements for weephole placement and spacing.
- Inspect the wall cavity for any existing moisture damage and recommend additional repairs if necessary.

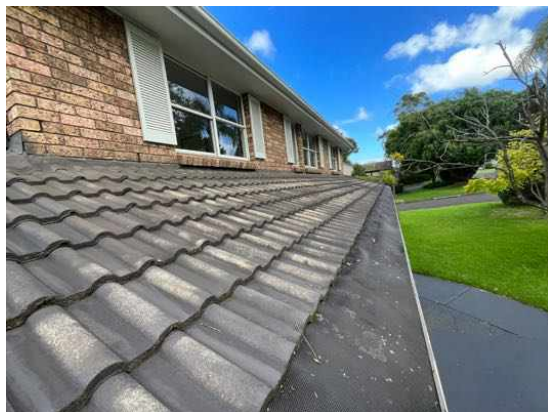
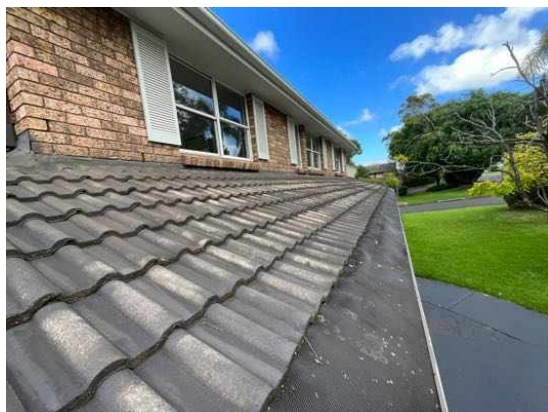
Finding 3.07

Building:	Main Building
Location:	All Areas
Finding:	Roof Weathered
Information:	Upon inspection of the exterior roofing, the majority of roof was not in a fair condition. While weathering of the roof is consistent with the age of the property, maintenance works are required.

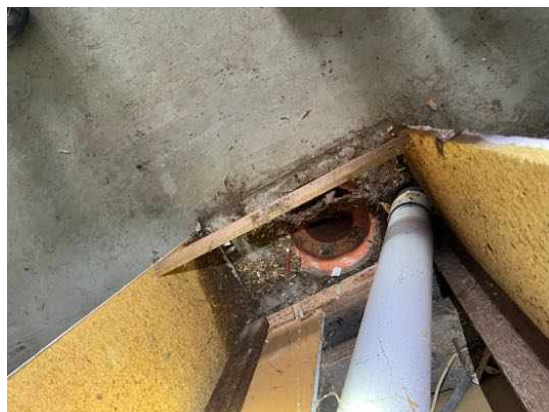
Finding 3.08

Building:	Main Building
Location:	Garage
Finding:	Water staining
Information:	Water staining was evident in this area at the time of inspection. Water staining indicates that surfaces have been exposed to excessive moisture over time. The minerals and other elements in the water lead to staining, which may graduate to corrosion and deterioration if left unmanaged.

Where water staining is active, a licensed plumber must be consulted to identify the cause of the staining and to provide advice on any reparation works that may be required. Replacement of any broken or damaged structures is advised.

Conversely, where water staining is old and inactive, affected building materials may be repaired or replaced at client discretion. A qualified carpenter or registered builder may be appointed to perform these works.

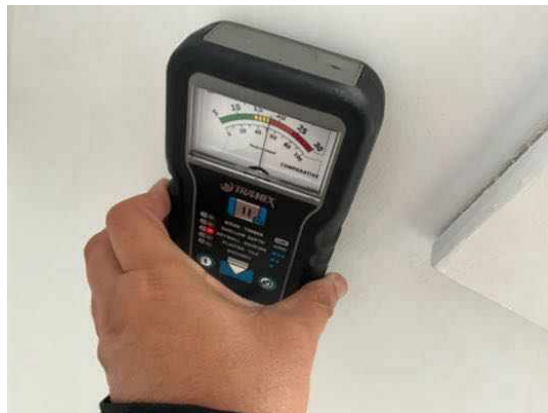
Finding 3.11

Building: Main Building
 Location: Laundry & Toilet
 Finding: Evidence of excessive moisture - Drywall

The prolonged presence of moisture can lead to mold growth, deteriorate the structure, and create an environment conducive to health hazards. Additionally, it may compromise the adhesive holding the tiles, leading to their detachment.

A licensed plumber or a qualified contractor specializing in water damage remediation should investigate the source of the moisture, fix any leaks, and address the damage. Additionally, replacing affected tiles and ensuring proper waterproofing are crucial to preventing future issues.

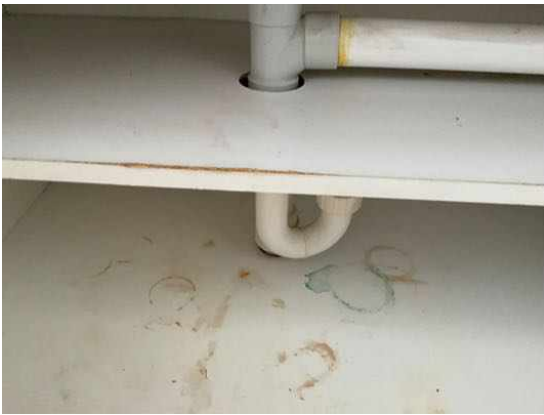
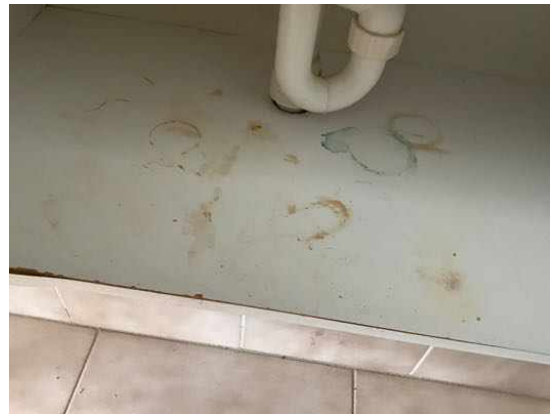
Finding 3.15

Building: Main Building
Location: Ensuite
Finding: Water Stains in Vanity
Information: "Water stains observed in the vanity area, compromising its appearance and potentially causing damage."

A licensed plumber or maintenance professional should assess and fix any leaks contributing to the water stains, while a cleaning or restoration service may be needed to address the visible stains and prevent further damage.

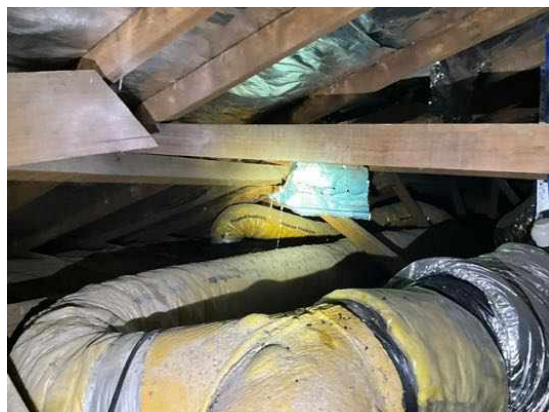
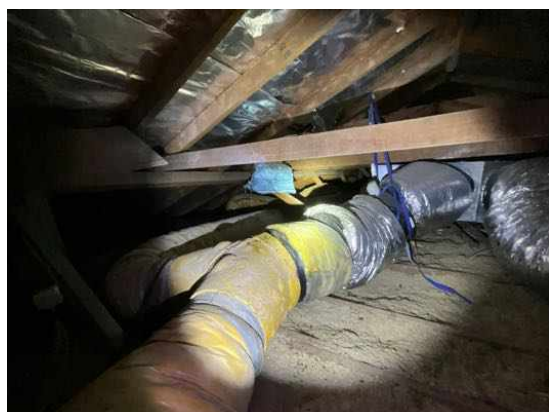
Finding 3.18

Building:	Main Building
Location:	Roof Void
Finding:	Sarking - Damaged
Information:	Sarking, a laminated aluminium foil applied to the interior of the roof covering, assists in insulating the property and acting as a vapour-barrier to the roof void and, subsequently, to the household.

Where sarking is damaged, both insulation and moisture protection of the property are inhibited. This creates a loss of energy and thus negatively impacts the energy efficiency of the property, allowing potential for moisture ingress from condensation or leaking roof tiles.

It is important to repair any holes or damaged sections of sarking to ensure that the building material is fully functional. A registered builder or qualified carpenter should be consulted to provide further advice on this defect and to perform rectification works at client discretion.

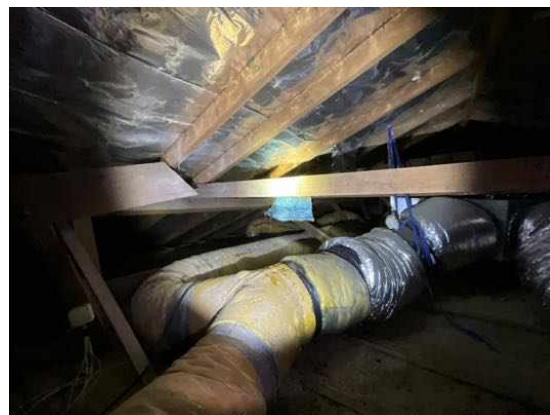
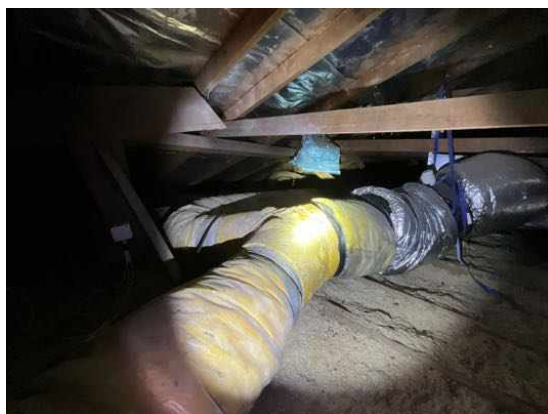
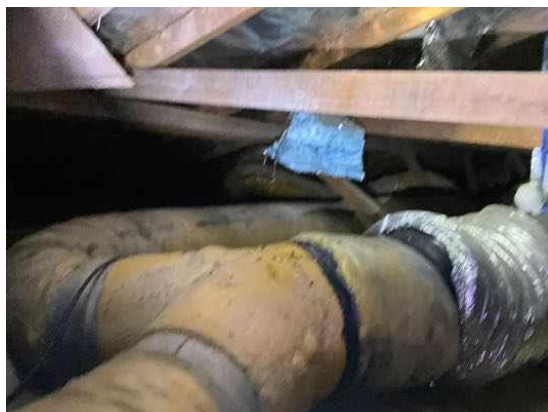
Finding 3.19

Building:	Main Building
Location:	Roof Void
Finding:	Air Conditioning Ducting (Unsupported / Lying on Insulation)
Information:	The air conditioning flexible ducting within the roof void is observed to be laid directly over the ceiling insulation and not adequately supported or suspended. This installation is not in accordance with good building practice and may not comply with relevant requirements of AS 4254 – Ductwork for Air-Handling Systems, which requires ductwork to be properly supported to prevent sagging, kinking, or restriction of airflow.
	Risk

It is recommended that a licensed HVAC technician (air conditioning contractor) be engaged to properly support and suspend the ducting using appropriate hangers/straps. The system should be reinstalled or adjusted to ensure compliance with relevant Australian Standards and optimal performance.

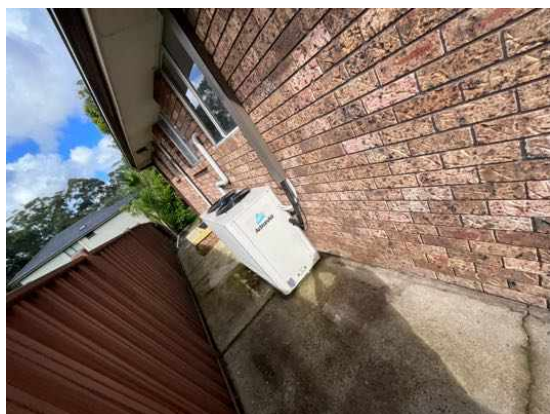
Where bridging has occurred full inspection is prevented and termites may enter a property in a concealed or undetected manner.

Recommended moving obstructions away from the external walls for further and future inspections.

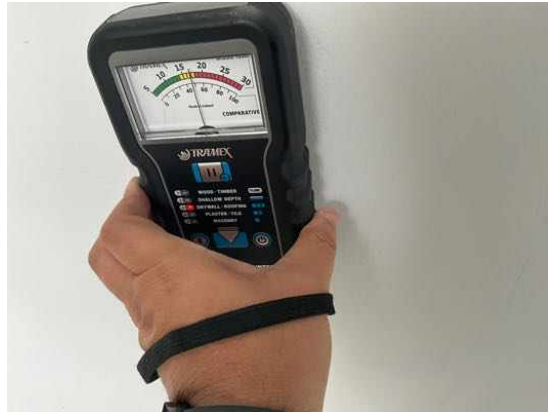
Finding 6.04

Building:	Main Building
Location:	Laundry & Toilet
Finding:	Excessive moisture - Conducive to Timber pest
Information:	Excessive moisture can attract termites and produce conditions that promote fungal growth and wood decay.

Prior to any remedial works being performed a qualified plumber should be appointed to further inspect the property and to identify the cause of the excessive moisture. Works to remove affected building elements may then be necessary and should be performed by an appropriate tradesperson.
