Building and Timber Pest Inspection Report

Inspection Date: Mon, 30 Mar 2026

Property Address: 12 Kotuku St, Coffs Harbour NSW 2450, Australia

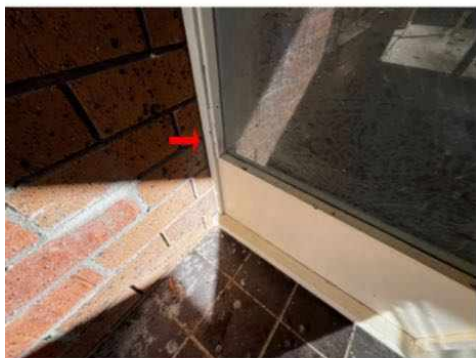
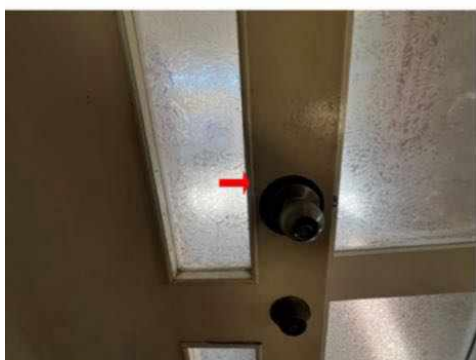
Finding: Entry - minor defects

Information: At the time of this inspection it was observed that there were a number of minor defects in the front entry area,

2 - It was observed that the timber entry door jamb, side light, door sill and entry door had minor damage and deterioration evident. It is recommended that a painter patch, sand and repaint all timber elements of the entry door unit. The locks should also be replaced.

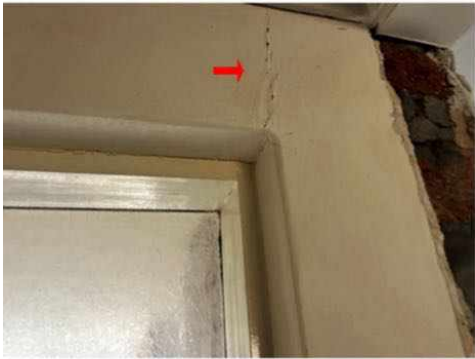
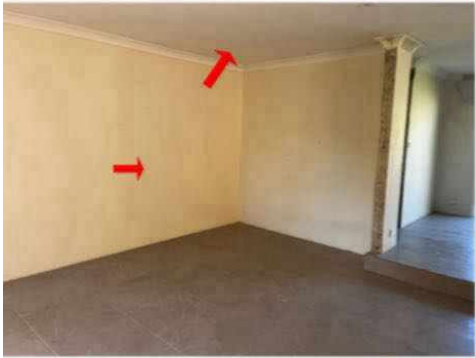
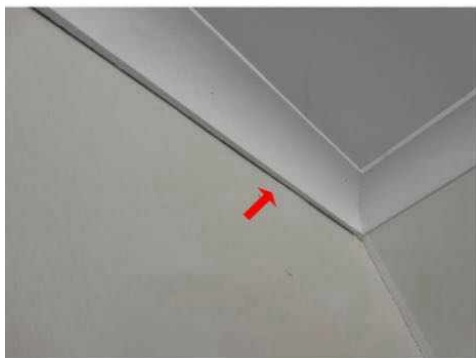
Finding 3.02

Building: Main Building
 Location: Entry/lounge Room
 Finding: Entry/lounge room - defects
 Information: At the time of this inspection it was observed that there were a number of defects and unfinished works to the entry/lounge room areas,

1 - There were several cracks to the masonry internal wall skin, the cracks should be patched.

2 - It was observed that there was a masonry nib wall and a gap in the masonry wall where a wall has been removed that required rendering and finishing, a renderer should complete this work.

4 - It was observed that there was a gap to the underside of the cornice/wall junction and a vertical crack to one internal wall junction, a painter should fill this gap.

6 - It was observed that the electrical works were not finished (switches fitting) in this room, an electrician should complete this work.

5 - All internal wall, ceiling and window trims require painting.

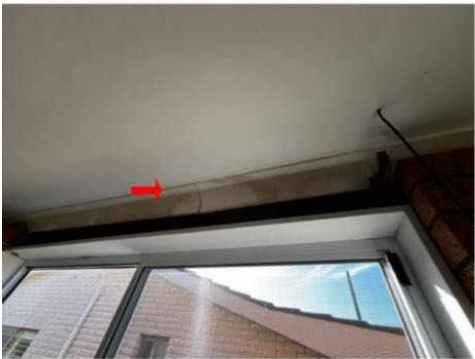
Finding: Garage - internal defects

Information: At the time of this inspection there were a number of defects and unfinished items in the garage,

- 1 - The external door and internal door and door jamb should be supplied and fitted.
- 2 - The window architrave should be fitted.
- 3 - The garage should have all items of materials removed and cleaned.
- 4 - All areas of the ceiling, cornice and trims should be painted.

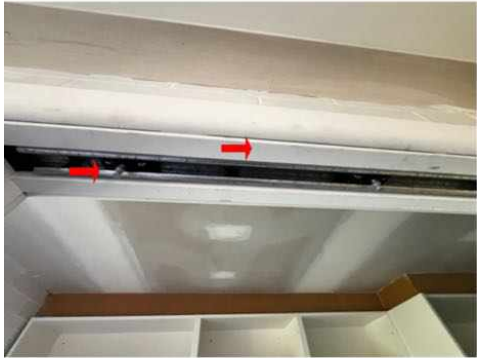
Building: Main Building
Location: Pantry - Walk In
Finding: Pantry defects
Information: At the time of this inspection it was observed that there were a number of defects and unfinished works in the walk in pantry,

- 1 - The cavity sliding door and trims should be fitted.
- 2 - The plasterboard ceiling has areas that require patching.
- 3 - All ceiling and joinery bulkheads and walls require painting.
- 4 - All wall/ceiling, walls trim junctions should be sealed by a tiler.
- 5 - All electrical fixtures and fittings should be supplied and fitted.

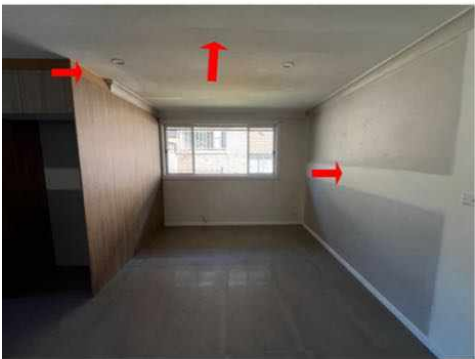
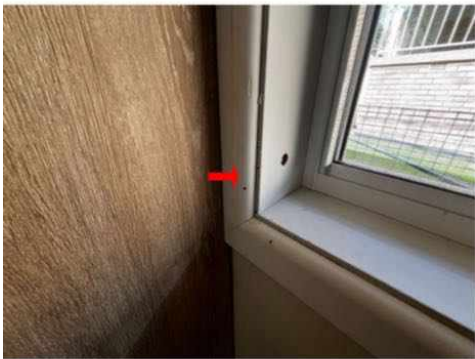
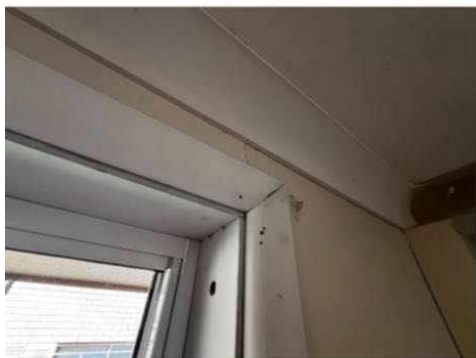
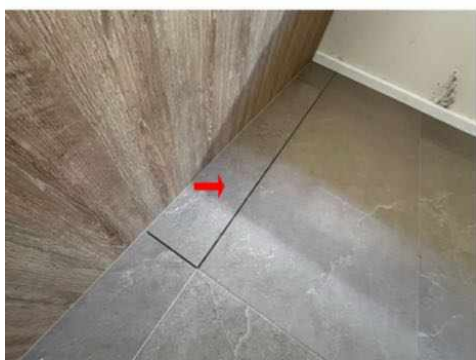
Finding 3.07

Building: Main Building
Location: Dining Room
Finding: Dining room - defects
Information: It was observed that there were a number of unfinished items in the dining room,

- 1 - There floor tiles require grouting in one area.
- 2 - All areas of the walls and ceiling require painting.

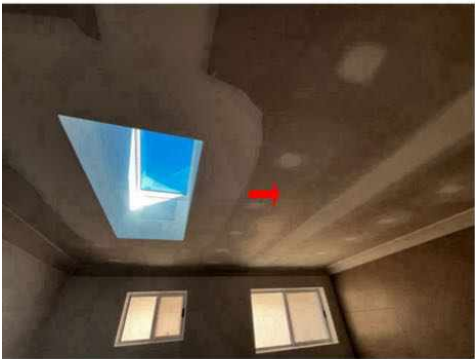
Finding 3.08

Building: Main Building
 Location: Bathroom
 Finding: Bathroom - defects
 Information: At the time of this inspection it was observed that there were a number of unfinished works in the bathroom area,

- 1 - The shower screen should be supplied and fitted.
- 2 - The shower rose/head should be supplied and fitted.
- 3 - The mirror should be supplied and fitted.
- 4 - The floor waste should be cut in and fitted.
- 5 - The plasterboard cornice should be completed.
- 6 - All painting to the ceiling and skylight should be completed.
- 7 - The electrical fixtures and fittings should be supplied and fitted.
- 8 - The cornice/wall tile junction should be sealed by a tiler.

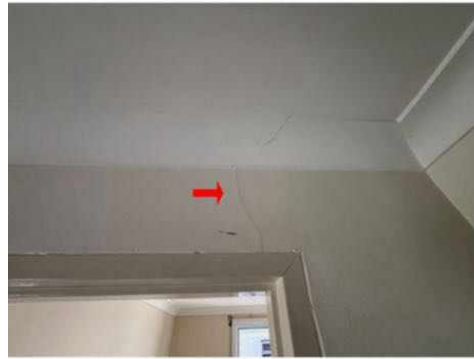
Finding 3.09

Finding: Hallway - defects

Information: At the time of this inspection it was observed that there was a number of minor defects and unfinished works present in hallway.

2 - Several wall cracks should be patched by a painter.

It is recommended that the renovation builder be asked to provide a waterproofing certificate for the bathroom.

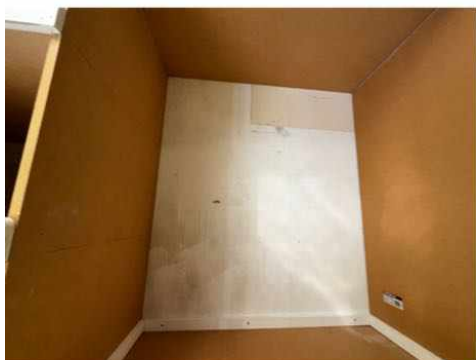
Finding 3.10

Building: Main Building
 Location: Bedroom - Master
 Finding: Bedroom 1 - defects
 Information: At the time of this inspection several defects and unfinished works were observed in the main bedroom,

4 - Fit cornice to back of wardrobe

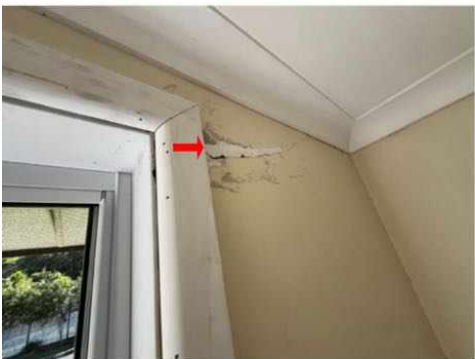
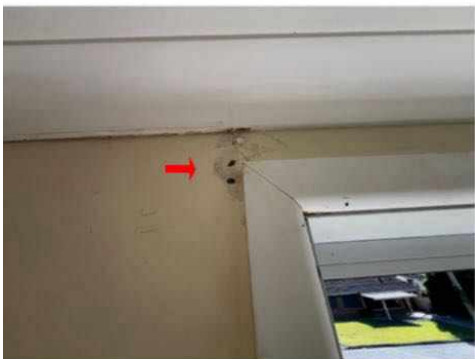
Building: Main Building
Location: Bedroom 2
Finding: Bedroom 2 - defects
Information: At the time of this inspection several defects and unfinished works were observed in bedroom 2,

- 1 - The wardrobe sliding door unit should be supplied and fitted.
- 2 - All walls and ceilings should be patched and painted.
- 3 - Fit missing cornice, fill gap at wall/cornice junction.
- 4 - Check roof tiles and flashings for leak where ceiling has water damage.
- 5 - Fit cornice to back of wardrobe and fill gap under cornice (wall/cornice junction).
- 6 - Paint wardrobe shelving.
- 7 - Tiler fit flexible sealant to floor tile expansion joints.
- 8 - All electrical fixtures and fittings should be supplied and installed.

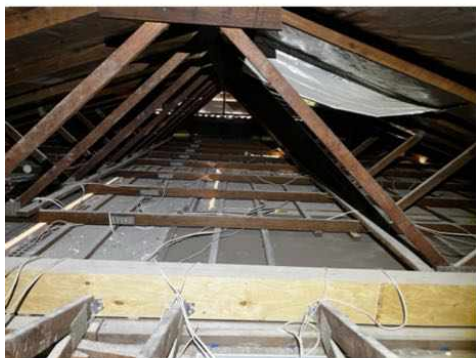
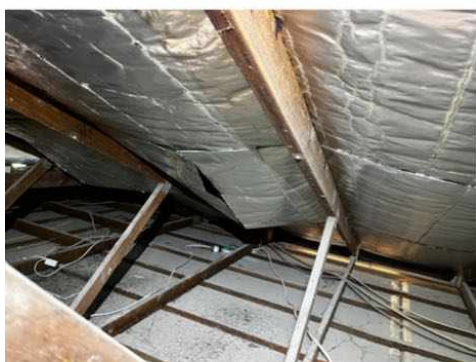
Building: Main Building
Location: Roof Void
Finding: Roof void
Information: The roof void appeared to be in fair condition, no insulation was present to the ceiling.

It was observed that there were several areas of damaged sarking to the roof tiles. It is recommended that a roofer repair the joins and any damage.

It was observed that there were big gaps between the roof tiles and roof flashing at the northern gable end, it is recommended that the gable end flashing be “dressed” down onto the roof tile surface.

It is recommended that the ceiling be insulated for thermal efficiency.

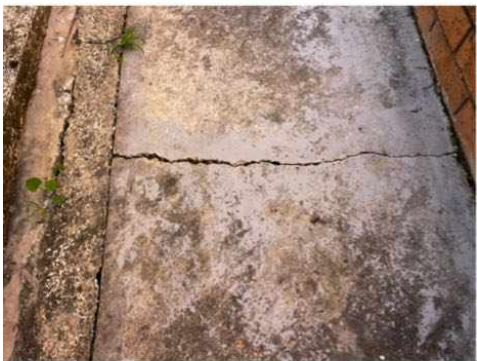
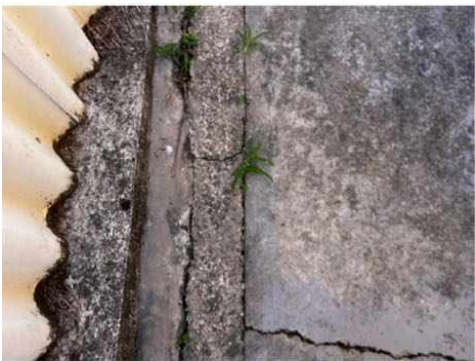
Finding 3.15

Building:	Main Building
Location:	External paths and paved areas
Finding:	External paths - defects
Information:	<p>It was observed at the time of this inspection that the concrete and paved paths to the exterior of the house were in poor condition,</p> <ol style="list-style-type: none"> 1 - There were numerous cracks to the concrete paths, a concreter should repair the paths where applicable. 2 - The paved section of path was in very poor condition, it is recommended that a landscaper replace the paving. 3 - The concrete paths had mould growth evident, the paths and front brick retaining wall should be pressure cleaned. 4 - It was also observed that a section of tile sill has missing from the rear sliding door, a tiler should replace the tiled sill.

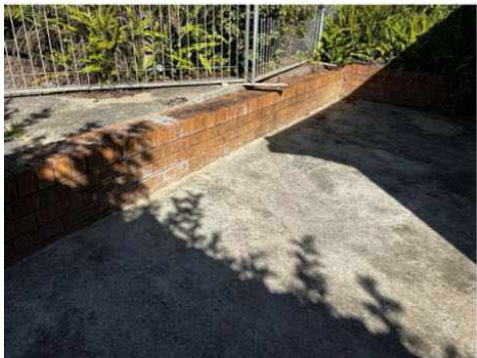
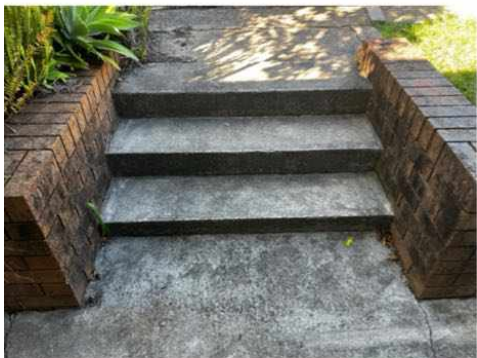
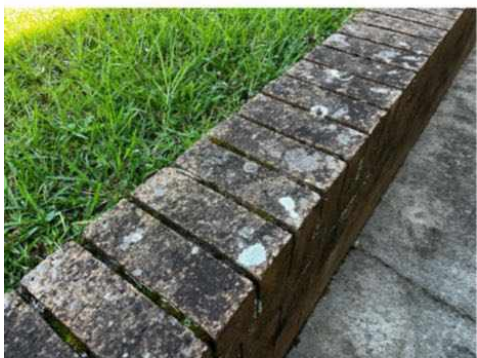
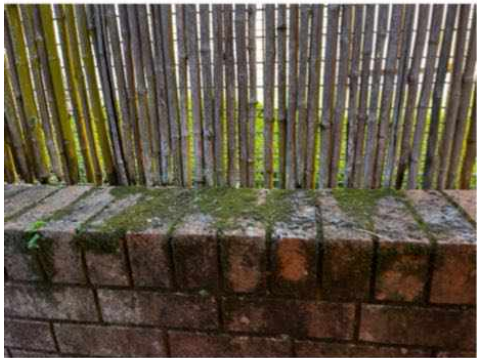
Finding 3.16

Building:	Main Building
Location:	Masonry retaining walls
Finding:	Retaining walls
Information:	At the time of this inspection, it was observed that the masonry retaining wall at the rear of the house had minor cracking due to the vegetation growth. The vegetation should be removed and a bricklayer repair the damage.

The retaining wall should be pressure cleaned to remove the moss and mould growth.

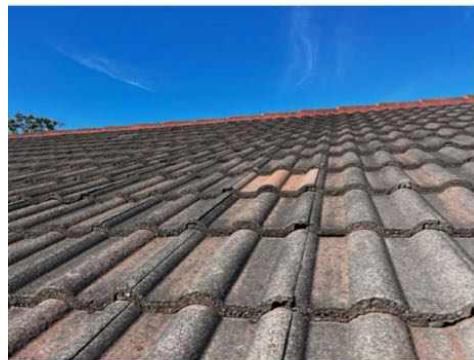
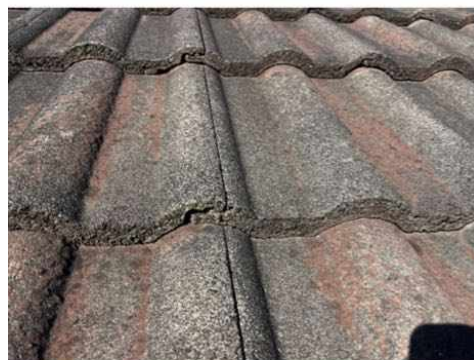
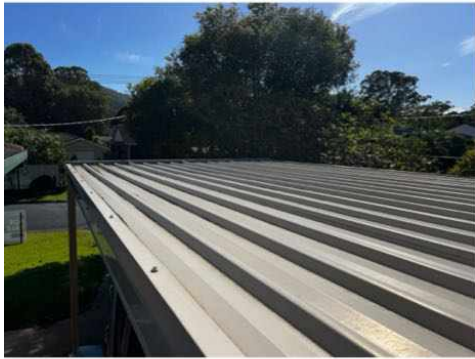
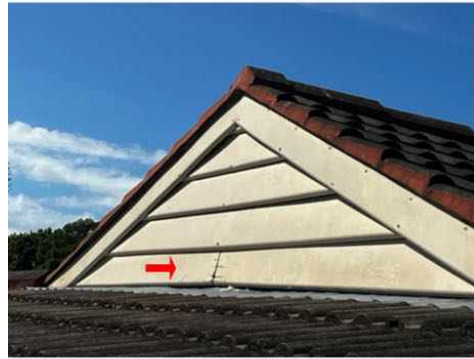
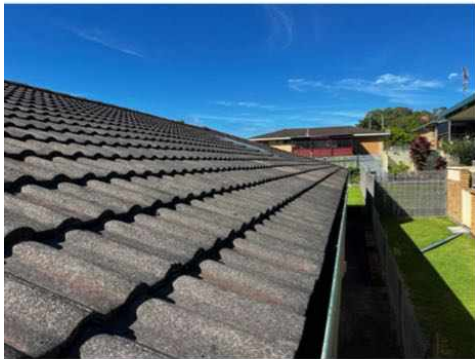
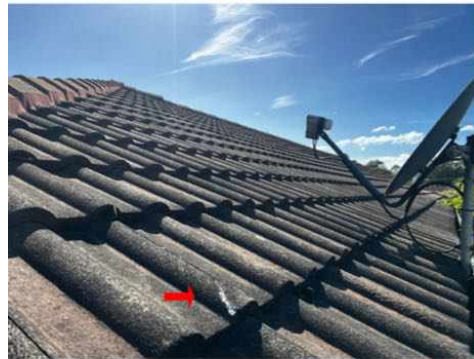
Finding 3.17

Building: Main Building
Location: Roof exterior
Finding: Roof exterior and guttering
Information: At the time of this inspection, the roof appeared to be in a weathered but fair condition with minor damage evident.

The roof sheeting to the carport had minor rusting to the sheeting evident in areas.

The guttering was in a damaged and poor condition and should be replaced.

It is recommended that a roofer thoroughly inspect the roof sheets, roof flashings and guttering.

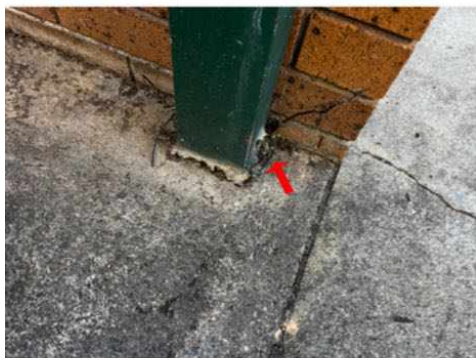
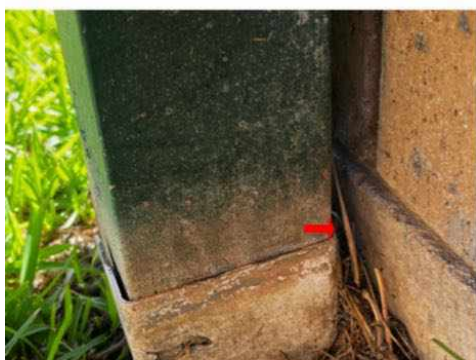
Finding 6.02

Building:	Main Building
Location:	All External Areas
Finding:	Possible concealed termite entry areas - conducive to termite attack
Information:	At the time of this inspection, numerous areas of possible concealed termite entry points were observed around the exterior of the building.

These areas are points on the exterior of the building where it is not possible to view the external cladding or slab/foundation edge because of close proximity of external members/features.

It was also observed that numerous areas around the perimeter of the building and deck had Timbers in contact with the ground. This has the potential to attract termites to the building and should be removed as soon as possible.

It is recommended that a timber pest expert provide and implement a Timber Pest Management Plan as soon as possible.

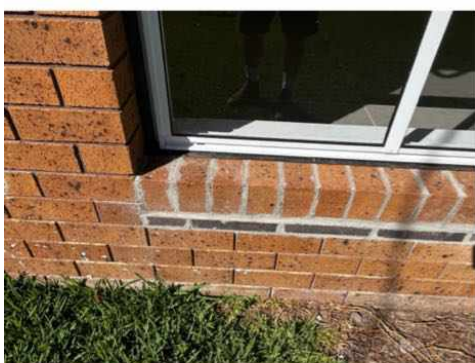
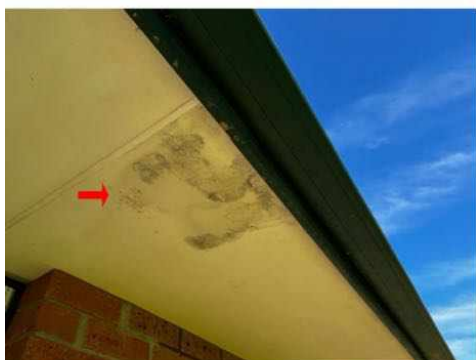
Finding 7.01

Building: Main Building
 Location: Exterior walls - front
 Finding: Exterior area front - defects
 Information: It was observed at the time of this inspection that there were a number of defects and unfinished works at the front of the house,

1 - It was noted that there new brickwork has been added to the external walls where the windows have been altered/replaced. It is recommended that all external brick walls be rendered and painted.

3 - It was observed that the timber barge board in this area had significant fungal decay (woof rot) present, it is recommended that a carpenter repair or replace the affected timber.

4 - It was observed that there was water staining and mould growth to the eaves

sheets in one area, also noted was that the eaves sheets were damaged and not fitted correctly, it is recommended that a roof tiler check the roof for leaks. It is further recommended that a carpenter repair the eaves sheets and all sheets be repainted.

5 - It was observed that's the guttering had minor rust and damage evident, the guttering and down pipes should be replaced by a plumber.

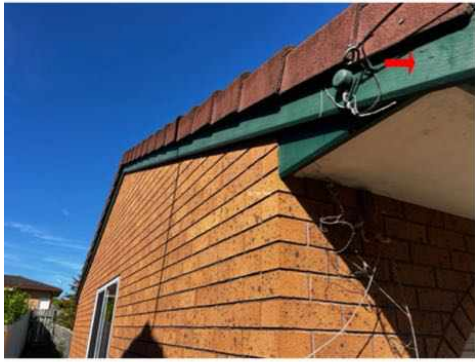
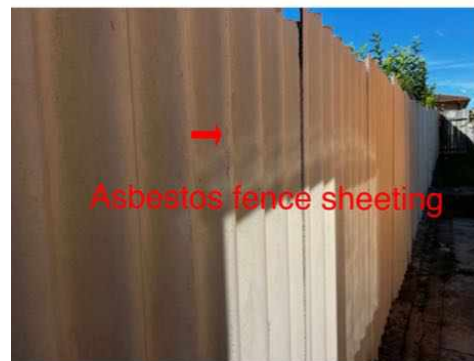
Finding 7.02

Building: Main Building
 Location: Exterior walls - left side
 Finding: Exterior area - left side
 Information: At the time of this inspection it was observed that there were a number of minor defects to the external walls on the left side of the house.

1 - It was observed that the timber fence panel to the side gate was damaged and should be replaced by a carpenter.

3 - It was observed that the timber barge board in this area had significant fungal decay (woof rot) present, it is recommended that a carpenter repair or replace the affected timber.

NOTE: It was observed that the left side fence was made from "Super six: sheeting, there was minor damage to the fence in areas. The fence contains asbestos and consideration should be given for removing the fence. No work should be carried out to the fence until the fence material has been sampled, tested and reported for asbestos.

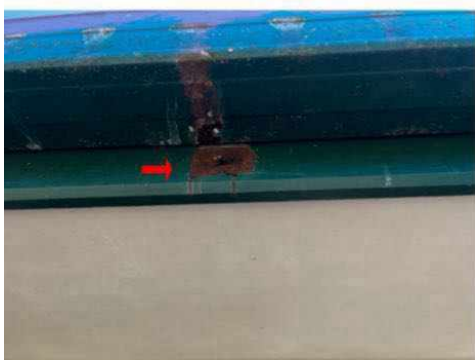
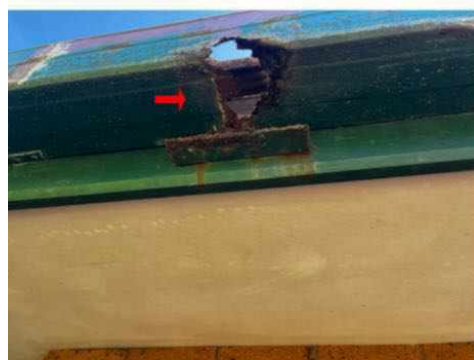
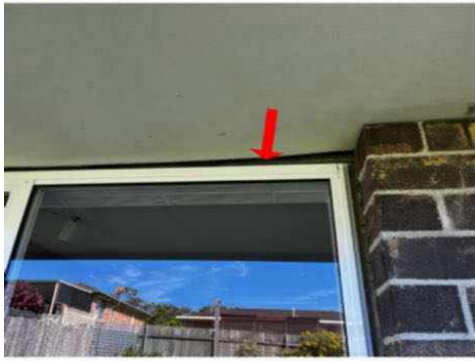
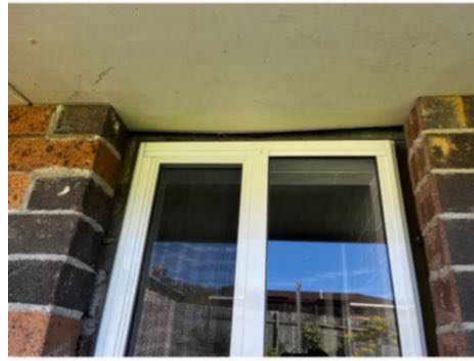
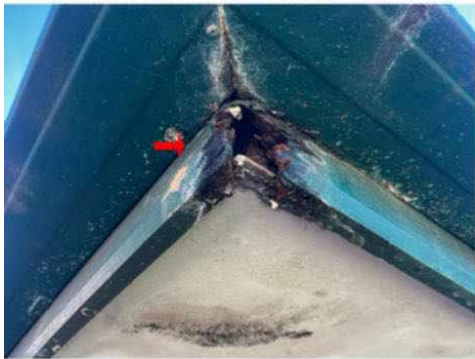
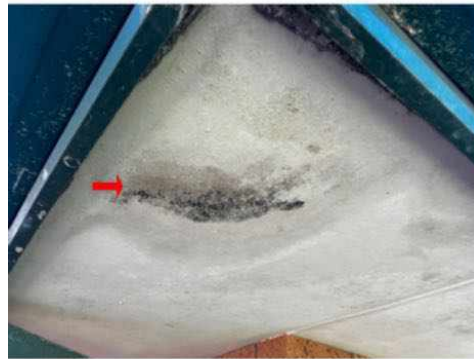
Finding 7.03

Building: Main Building
 Location: Exterior walls - rear
 Finding: Exterior rear - defects
 Information: It was observed at the time of this inspection that there were a number of minor defects and unfinished works to the rear of the house,

1 - It was noted that there new brickwork has been added to the external walls where the windows have been altered/replaced. It is recommended that all external brick walls be rendered and painted. Some cracking was observed to the west end of the

rear wall, it is assumed that minor movement in the foundation has caused the cracking over time. It is recommended that the crack be sealed with flexible sealant and rendered. If you are concerned by the cracking, a structural engineer should be consulted.

3 - It was observed that the timber fascia in this area had significant fungal decay (woof rot) present, it is recommended that a carpenter repair or replace the affected timber.

4 - It was observed that there was water staining and mould growth to the eaves sheets in one area, also noted was that the eaves sheets were damaged and not fitted correctly, it is recommended that a roof tiler check the roof for leaks. It is further recommended that a carpenter repair the eaves sheets and all sheets be repainted.

5 - It was observed that's the guttering had significant rust and damage evident, the guttering and down pipes should be replaced by a plumber.

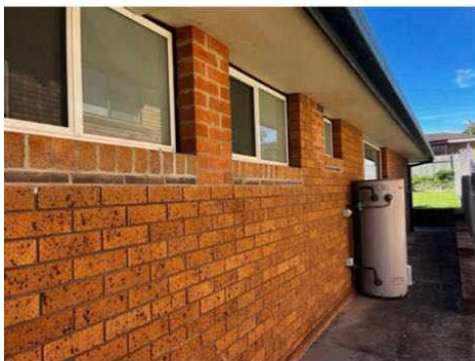
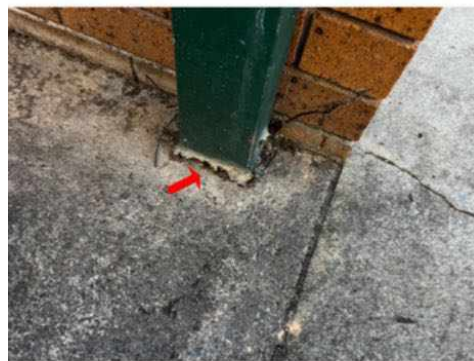
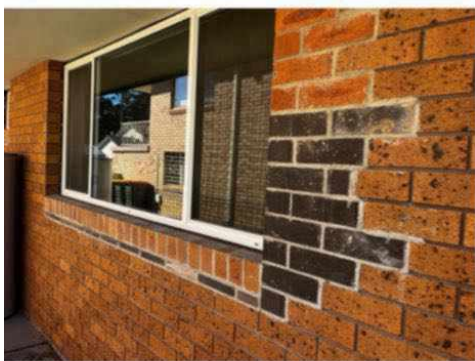
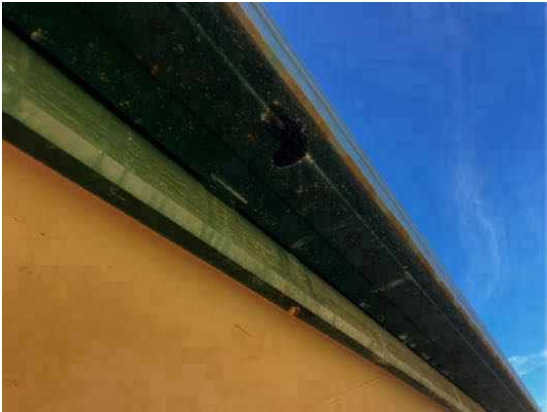
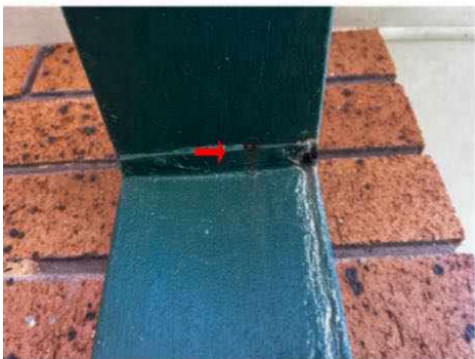
Finding 7.04

Building: Main Building
 Location: Exterior walls - right side
 Finding: Exterior area - right side
 Information: It was observed at the time of this inspection that there were a number of defects and unfinished works at the right side of the house,

1 - It was noted that there new brickwork has been added to the external walls where the windows have been altered/replaced. It is recommended that all external brick walls be rendered and painted.

3 - It was observed that the timber fascia in this area had minor fungal decay (woof rot) present, it is recommended that a carpenter repair or replace the affected timber.

4 - It was observed that there was water staining and mould growth to the eaves sheets in one area, also noted was that the eaves sheets were damaged and not fitted correctly, it is recommended that a roof tiler check the roof for leaks. It is further recommended that a carpenter repair the eaves sheets and all sheets be repainted.

5 - It was observed that's the guttering and down pipe had rust and damage evident, the guttering and down pipes should be replaced by a plumber.

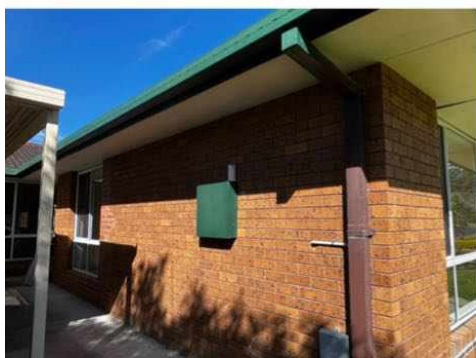
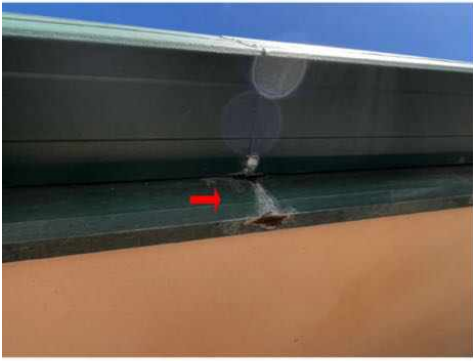
Finding 7.05

Building: Main Building
Location: Entry/carport wall
Finding: Entry carport wall - defects
Information: It was observed at the time of this inspection that there were a number of defects and unfinished works at the entry carport wall area,

1 - It was noted that there new brickwork has been added to the external walls where the windows have been altered/replaced. It is recommended that all external brick walls be rendered and painted.

3 - It was observed that the eaves sheets were damaged and not fitted correctly, it is recommended that a roof tiler check the roof for leaks. It is further recommended that a carpenter repair the eaves sheets and all sheets be repainted.

5 - It was observed that the guttering and metal fascia had minor rust and damage evident, the guttering and down pipes should be replaced by a plumber.

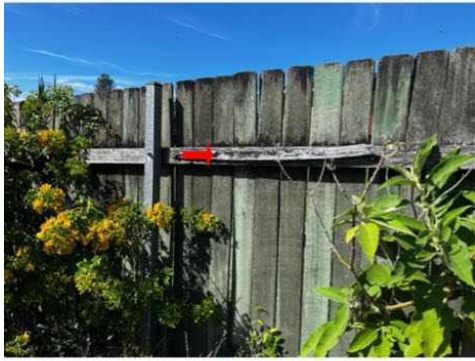
Finding 7.06

Building:	Main Building
Location:	Boundary fences
Finding:	Timber fence - fungal decay front boundary fence
Information:	At the time of this inspection it was observed that the timber fences appeared to have an older section and newer section.

The older section of timber fence was in a deteriorated state with mould and fungus growth evident and minor fungal decay (wood rot) observed.

A fencer should be engaged to repair or replace any affected sections and provide maintenance to all fences as required.

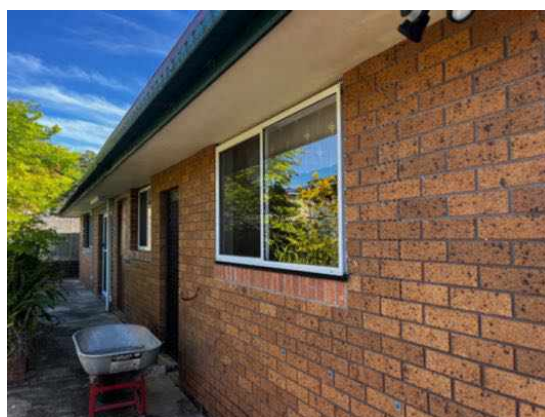
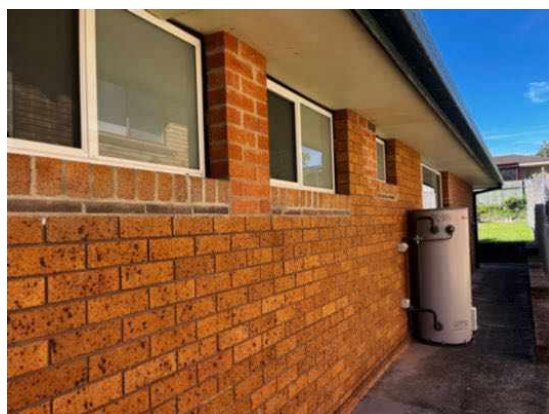
Building: Main Building
 Location: All External Areas
 Finding: Obstructions and Limitations External Areas
 Information: These photographs are an indication of the obstructions and limitations which impeded full inspection of external areas of the property at the time of inspection. These obstructions can hide an array of defects and should be removed to allow full inspection to be carried out. A re-inspection is recommended once the areas are made accessible.

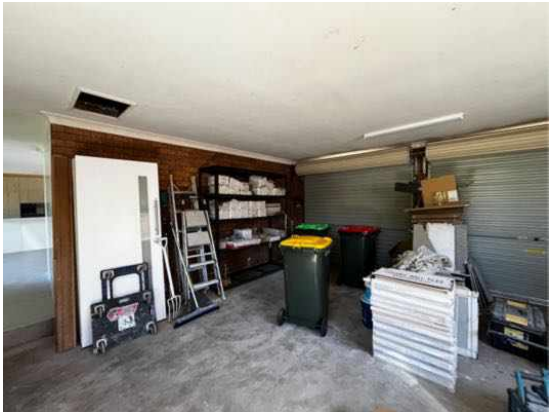
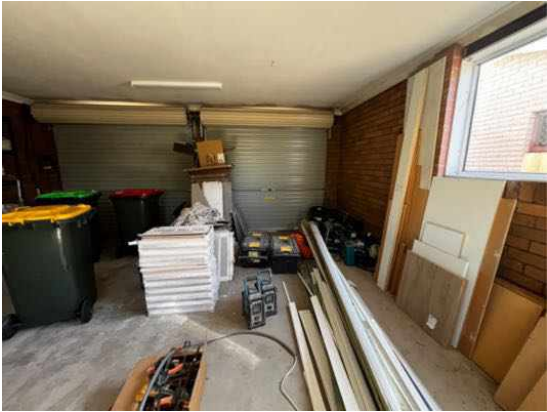
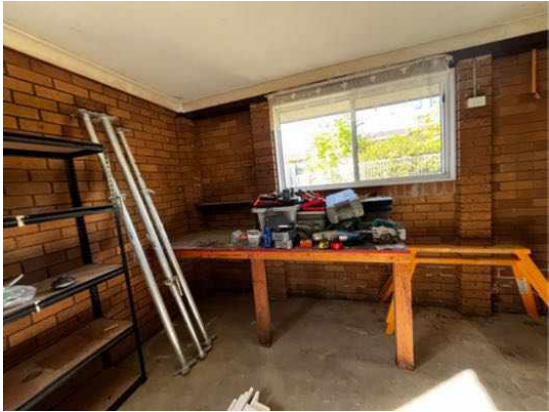
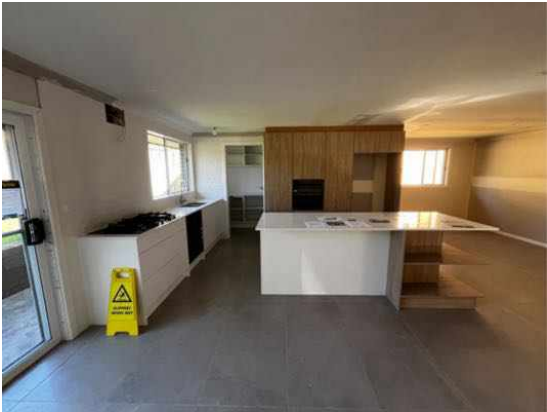
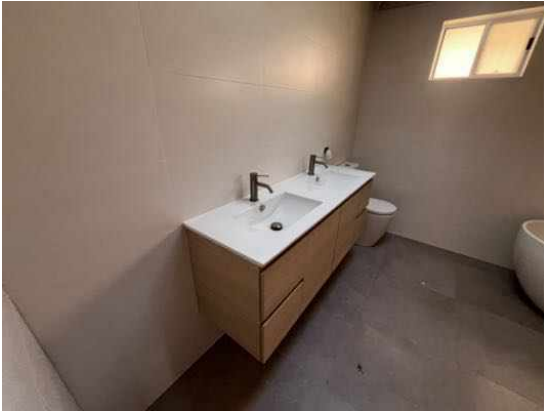
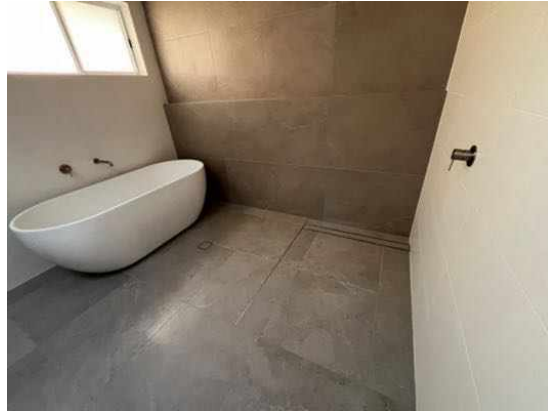
Building: Main Building
 Location: All Internal Areas
 Finding: Obstructions and Limitations Internal Areas
 Information: These photographs are an indication of the obstructions and limitations which impeded full inspection of internal areas of the property at the time of inspection.

These obstructions can hide an array of defects and should be removed to allow full inspection to be carried out. A re-inspection is recommended once the areas are made accessible.

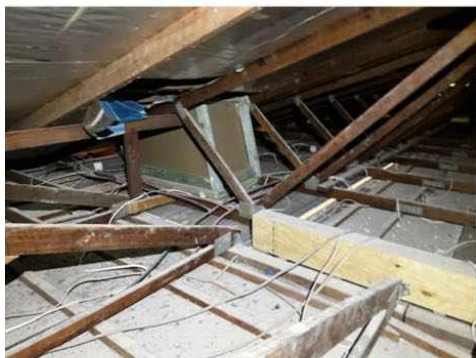
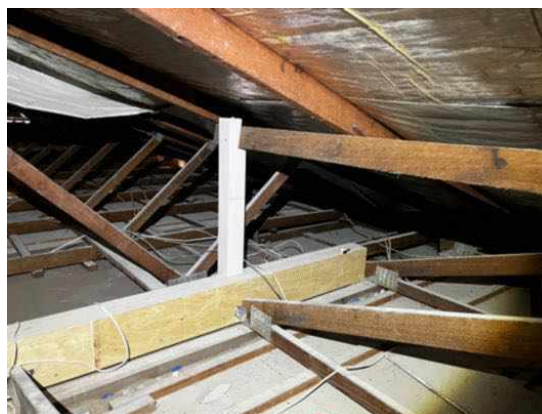
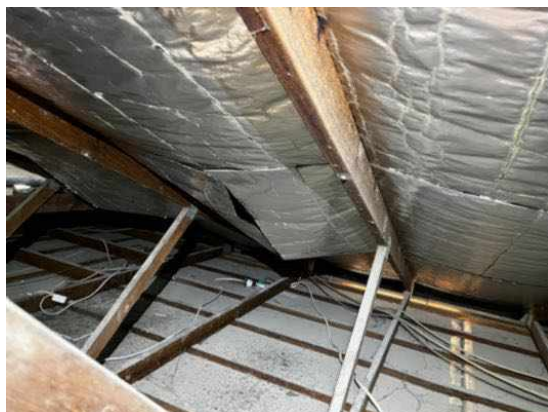
Building:	Main Building
Location:	Roof Void
Finding:	Obstructions and Limitations Roof Space Areas
Information:	These photographs are an indication of the obstructions and limitations which impeded full inspection of roof space areas of the property at the time of inspection. These obstructions can hide an array of defects and should be removed to allow full inspection to be carried out. A re-inspection is recommended once the areas are made accessible.
