Building Inspection Report

Inspection Date: Mon, 09 Feb 2026

Property Address: 1 Heber Cl, Cobbitty NSW 2570, Australia

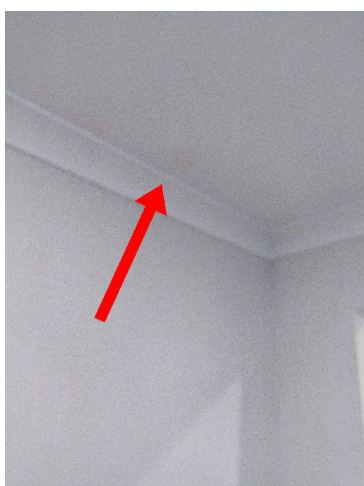
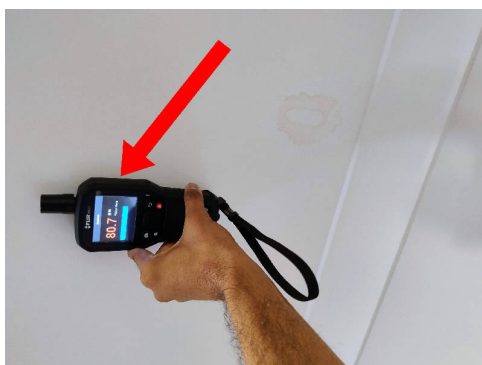
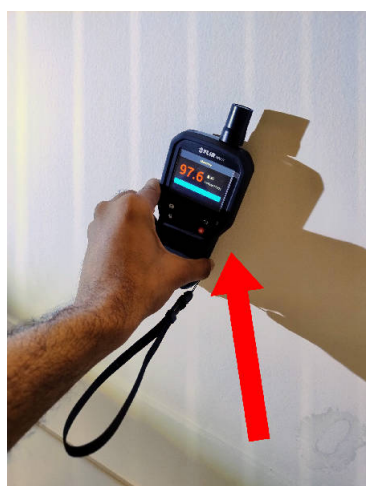
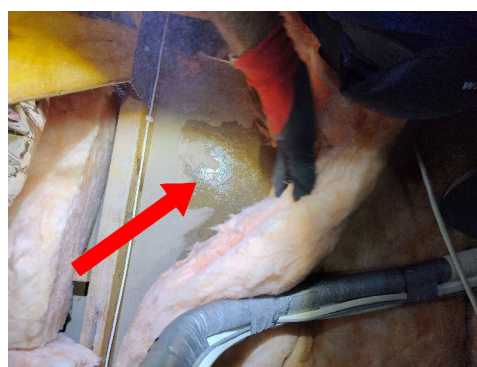
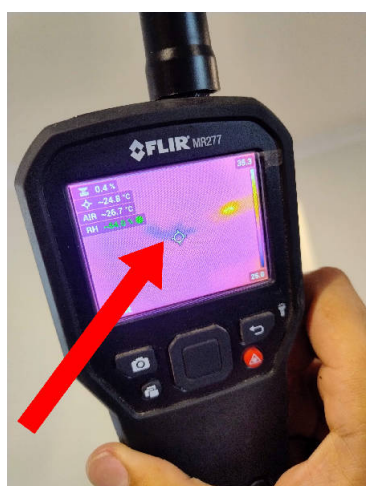
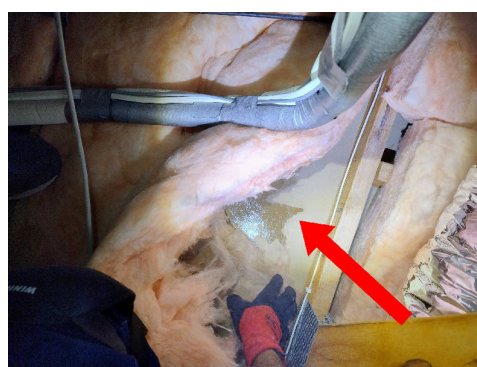
Defects 2.01

Finding: Air-conditioning unit - Leak - Roof Void

Information: Air condition unit leak was observed at the time of inspection. Leaking from an air-conditioning unit may be a result of several causes, including poor installation, blockages in internal drains, or a blockage to the drain hole.

Heavy leaking from the air-conditioning unit is likely to produce damp conditions in the surrounding area conditions which can affect the structural integrity of the roof structure. If left unattended, such leaking can develop into water pooling below the unit, creating potential for subsequent water damage to roof structure.

A refrigeration mechanic or licensed plumber should be appointed to assess the condition of the unit and to perform any remedial works on urgent basis.

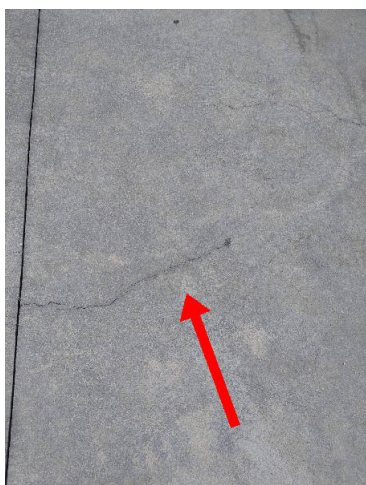
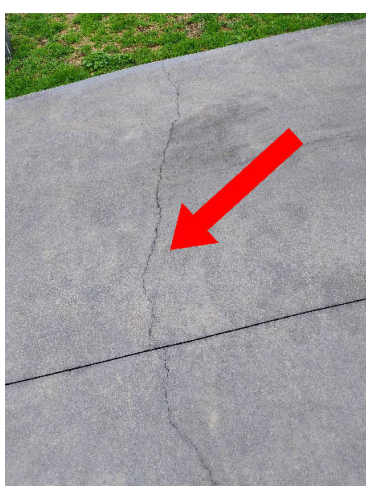
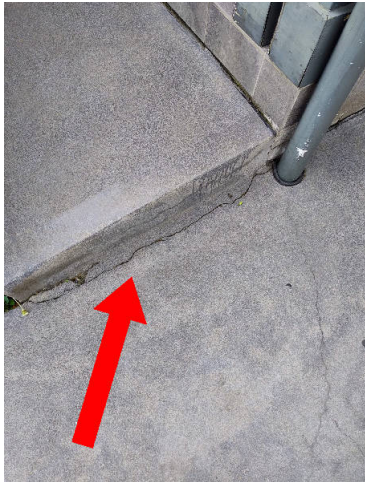
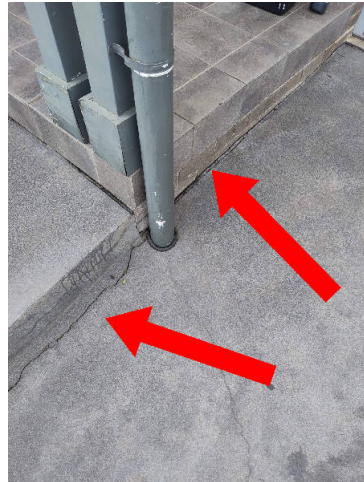
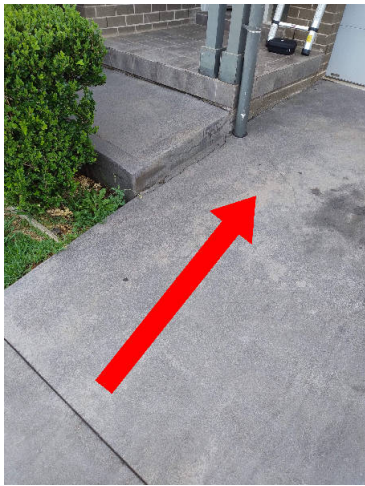
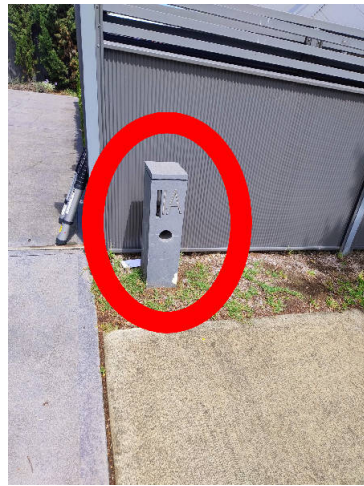
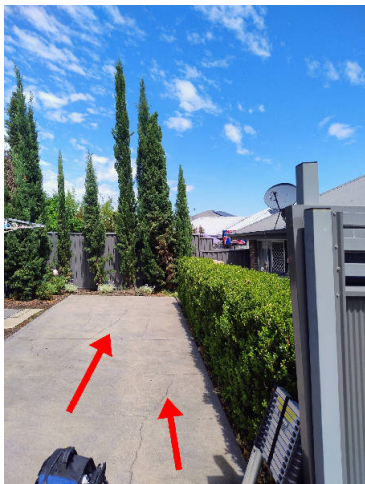
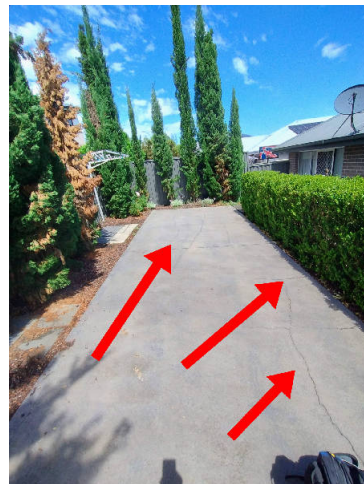
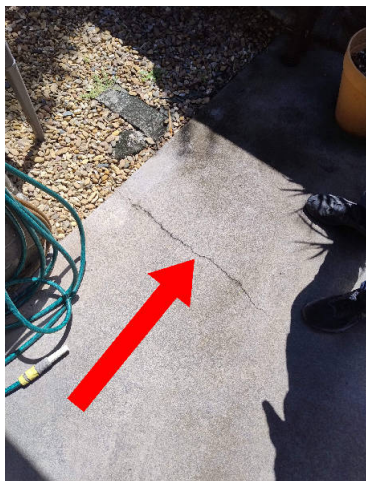
Defects 3.01

Finding: Crack in concrete slab - Category 2

Information: Cracks in driveway in Category 2 was identified in the slab at the time of inspection . A Category 2 crack is described as a distinct crack, with the slab being noticeably curved or changed in level.

To be considered Category 2, the approximate width of the crack is less than 2.0mm, or a change in offset of less than 15mm when a 3m straight edge is placed over the defect.

Category 2 cracks to slabs should be monitored for a period of 12 months. At the end of the monitoring period, cracks rated greater than Category 2 are considered defects that require rectification.

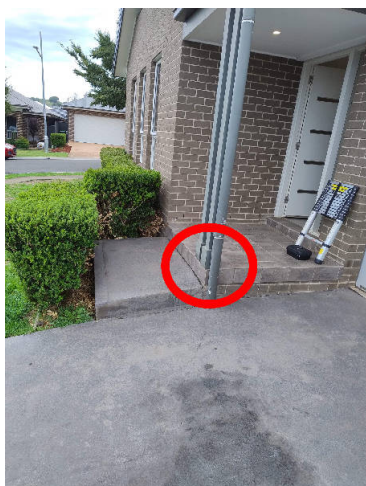
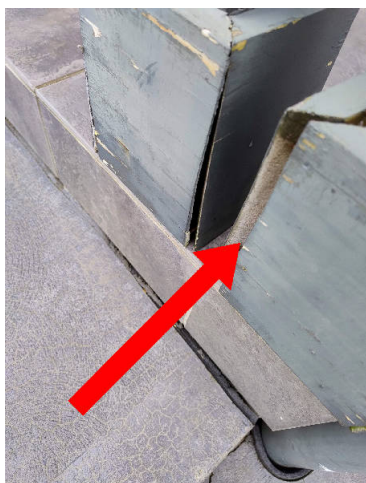
Defects 3.02

Finding: Exterior structure support timber Detoriorated

Information: During the inspection, it was observed that timber support members at the entrance, which provides structural support to the exterior roof, is in a degraded condition.

If left unmanaged can cause further deterioration to building elements.

Qualified trade person must be appointed for rectification on priority.

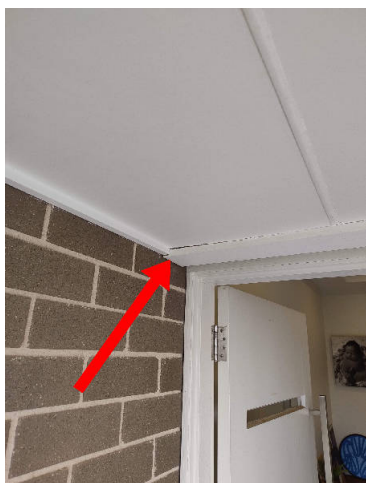
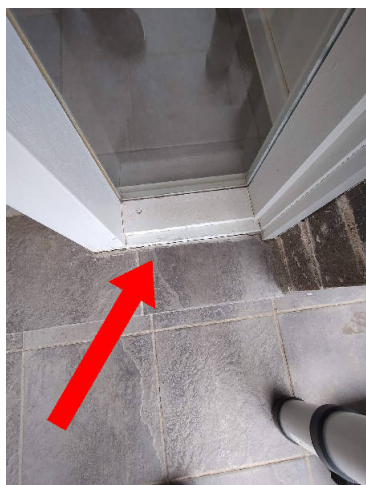
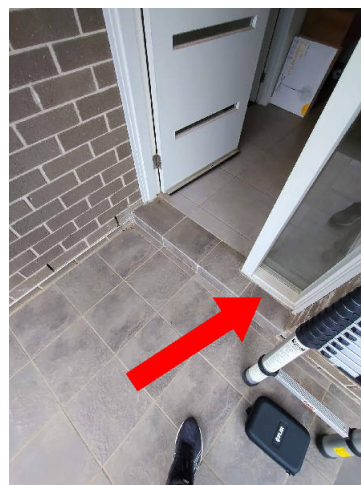
Defects 3.03

Finding: Cracking - Damage Category 2 - Noticeable (up to 5mm)

Information: Cracks been observed in ceiling and at the bottom near front door framing area.

Noticeable cracks are a common occurrence as a result of many primary defects. Such causes may include age, general wear and tear, expected building movement, general expansion/contraction of building materials in different weather conditions, and/or minor failings in the installation or application of building materials.

Noticeable cracks may result in minor sticking or jamming of associated doors and windows, which require easement. However, noticeable cracks are easily filled and repaired. A plasterer can be consulted to install an expansion joint at this point to allow for this movement during different weather conditions.

Relevant tradespeople, such as carpenters, painters and plasterers, should be appointed to perform remedial works, as deemed necessary.

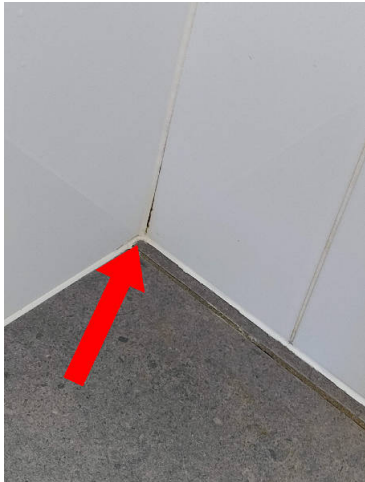
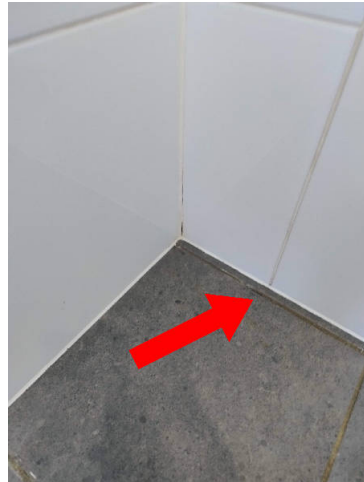
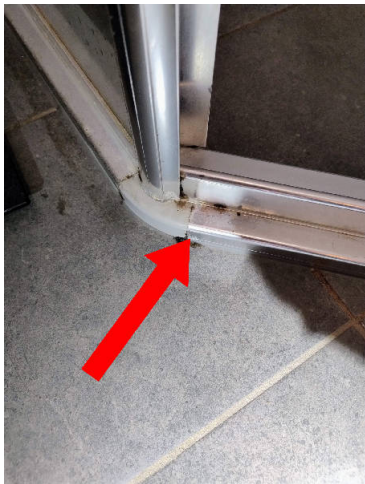
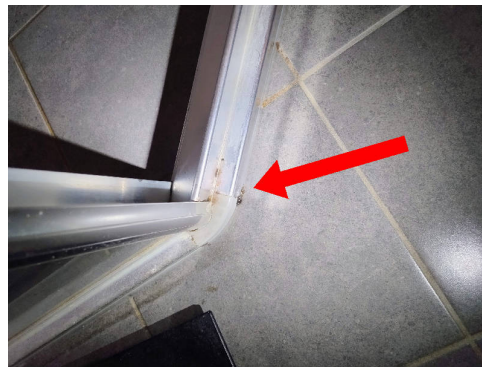
Defects 3.04

Finding: Sealant and Grouting - Damaged

Information: It was noted on inspection that sealant or grout is degraded to the tiled shower alcove and or other areas of the bathroom in master bedroom.

This can lead to water ingress into the shower base and creates conducive condition to termite activity. If left unmanaged can cause further deterioration to building elements.

Qualified trade person or plumber must be appointed for rectification on priority.

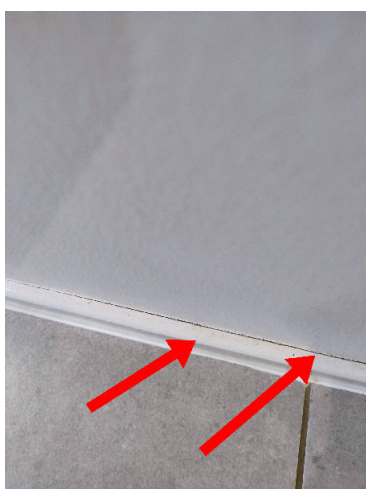
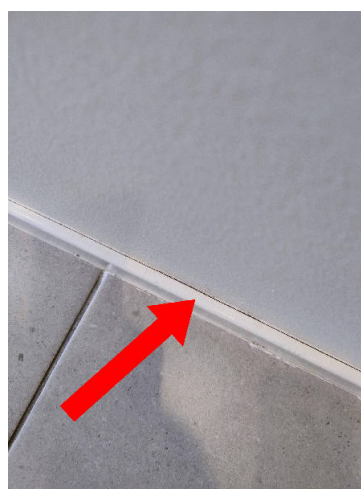
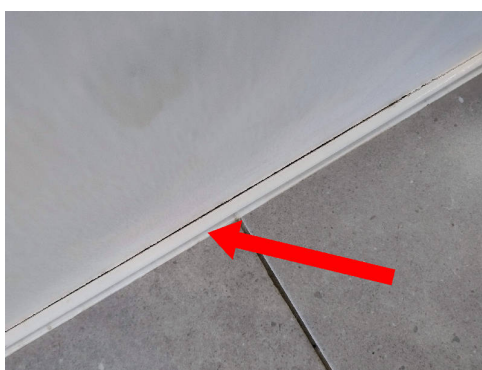
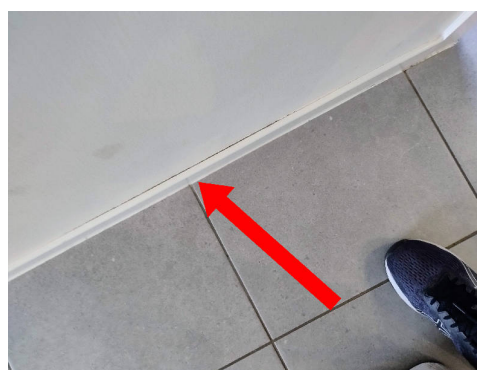
Defects 3.05

Building:	Main Building
Location:	Multiple locations
Finding:	Skirting tiles - Cracks

Cracks in Skirting tiles were observed in Multiple area at the time of inspection. Complete tiled skirting is important in preventing water ingress into the adjoining walls and flooring, protecting the areas against potential water damage. The incomplete skirting also detracts from the overall appearance of the area.

If left unmanaged, water ingress into adjoining areas may have major implications, and may potentially necessitate works to other building elements in the long-term future.

It is highly recommended that a tiling contractor be appointed to complete these minor works as soon as possible to prevent such damage from occurring.

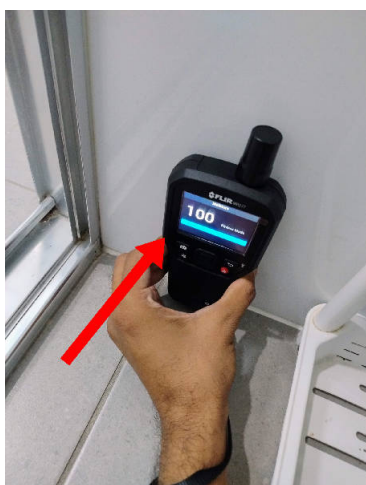
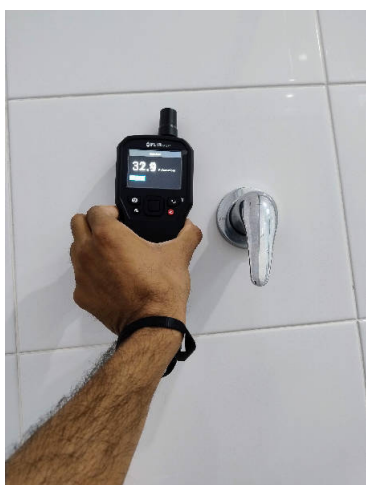
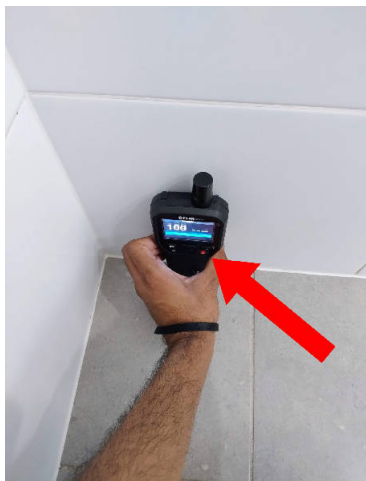
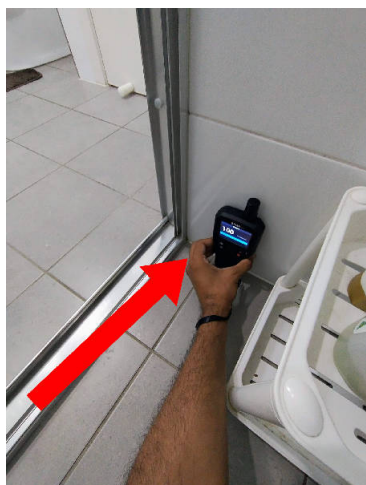
**Defects 3.06**

Finding: Evidence of Excessive moisture - identified

Information: Evidence of excessive moisture recorded by moisture meter in the bottom area of shower of common bathroom.

Excessive moisture can attract termites and produce conditions that promote fungal growth and wood decay.

Excessive moisture is generally caused by deteriorated, inadequate or missing roof drainage, leaking plumbing pipes or fixtures, poorly plumbed HWS overflows or condenser units and poor site drainage.

Prior to any remedial works being performed a qualified plumber should be appointed to further inspect the property and to identify the cause of the excessive moisture. Works to remove affected building elements may then be necessary and should be performed by an appropriate tradesperson.

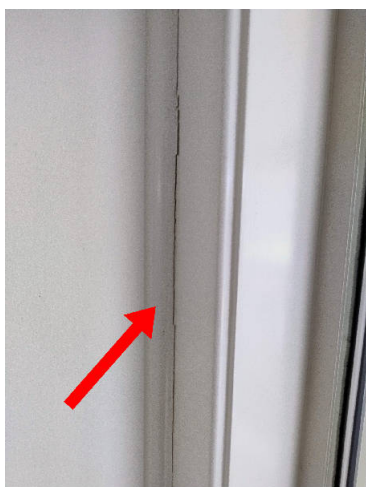
Defects 3.07

Finding: Cracking - Damage Category 2 - Noticeable (up to 5mm)

Information: Cracks have been observed at the time of inspection between sliding door frame and wall.

Noticeable cracks are a common occurrence as a result of many primary defects. Such causes may include age, general wear and tear, expected building movement, general expansion/contraction of building materials in different weather conditions, and/or minor failings in the installation or application of building materials.

Noticeable cracks may result in minor sticking or jamming of associated doors and windows, which require easement. However, noticeable cracks are easily filled and repaired. A plasterer can be consulted to install an expansion joint at this point to allow for this movement during different weather conditions.

Relevant tradespeople, such as carpenters, painters and plasterers, should be appointed to perform remedial works, as deemed necessary.

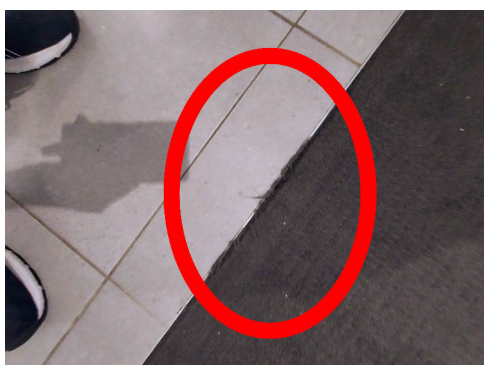
Defects 3.08

Finding: Carpet - Deteriorated

Information: Entrance area of the carpet floor covering in Media room appeared to be deteriorated. Deteriorated carpet pose health hazards by trapping allergens like dust mites and pet dander, which can trigger asthma and allergies. They can also hold bacteria, mould and fungi, especially if damp, leading to respiratory problems and infections,

Replacement of the carpet is suggested as a matter to ensure the safety of the area at client discretion. Where required, remedial works should be undertaken to any associated walls and flooring showing evidence of mould.

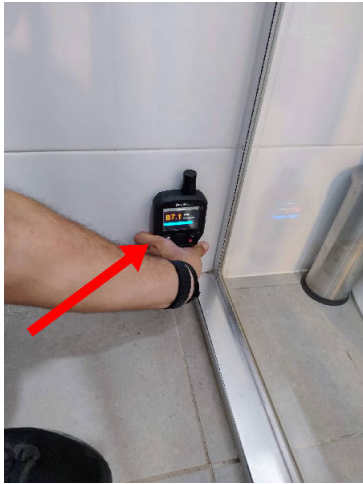
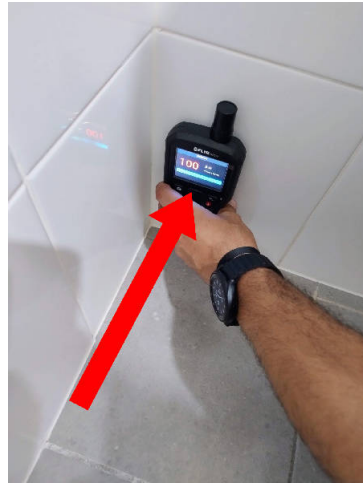
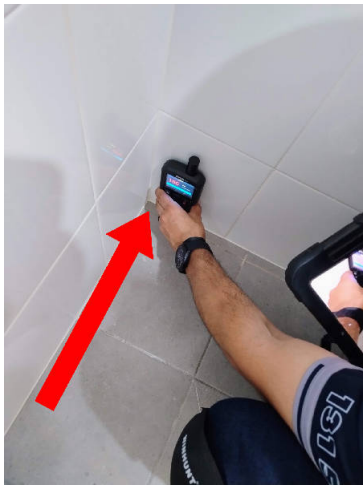
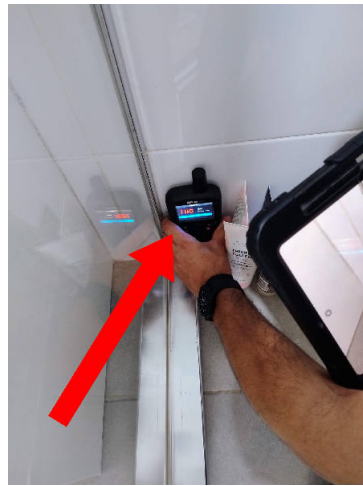
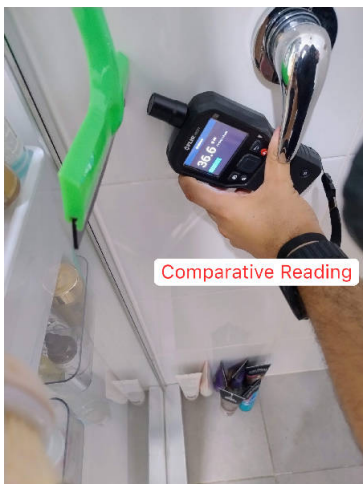
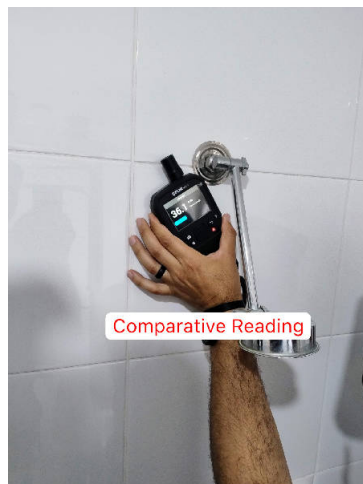
Defects 3.09

Building: Granny-Flat
 Location: Bathroom
 Finding: Evidence of Excessive moisture - identified
 Information: Excessive moisture readings were observed within bottom part of the shower wall at the time of inspection.

Excessive moisture can attract termites and produce conditions that promote fungal growth and wood decay.

Excessive moisture is generally caused by deteriorated, inadequate or missing roof drainage, leaking plumbing pipes or fixtures, poorly plumbed HWS overflows or condenser units and poor site drainage.

Prior to any remedial works being performed a qualified plumber should be appointed to further inspect the property and to identify the cause of the excessive moisture. Works to remove affected building elements may then be necessary and should be performed by an appropriate tradesperson.
