# Building and Timber Pest Inspection Report

Inspection Date: Mon, 9 Mar 2026

Property Address: U2/20 Dido St, Kiama NSW 2533, Australia

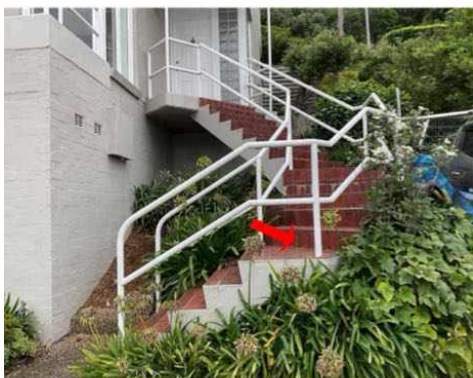
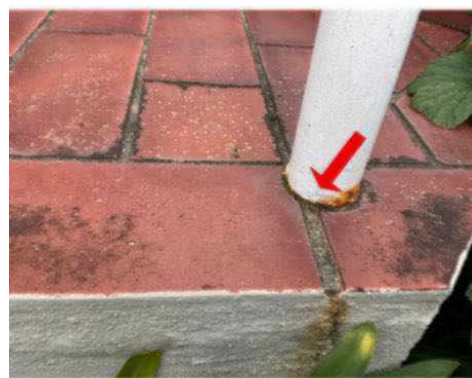
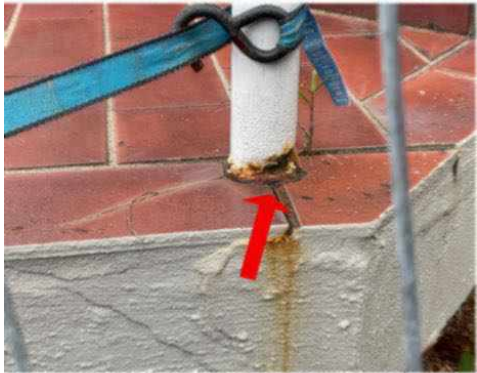
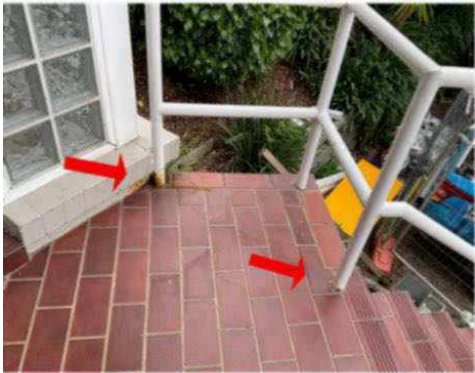
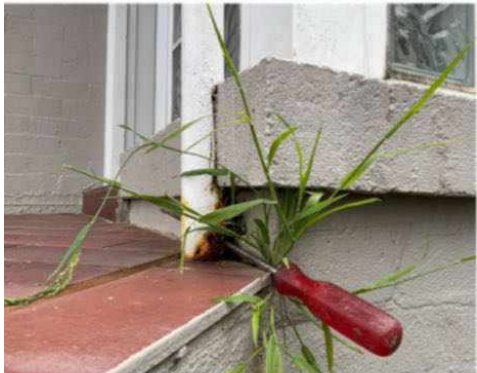
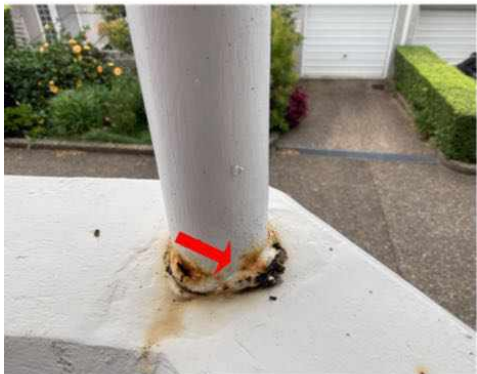
Building:	Main Building
Location:	Stairs and pergola areas
Finding:	Balcony & stair railings - rusted or corroded
Information:	These railings shows evidence of rusting and corrosion, which is likely to have developed as a result of excessive exposure to moisture and or inadequate coatings.

As surface rust provides no protection to the underlying iron, the deteriorating condition is likely to worsen if not addressed in the short-term future.

The garage door area also shows minor rust.

Rusting and corrosion should be managed by ideally removing or limiting the affected surface from exposure to moisture. A registered builder must be appointed to replace these railings that have been severely affected by rust or water damage.

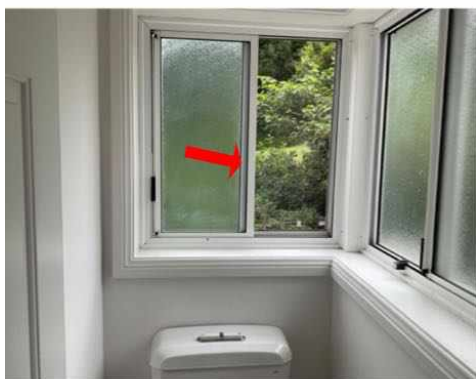
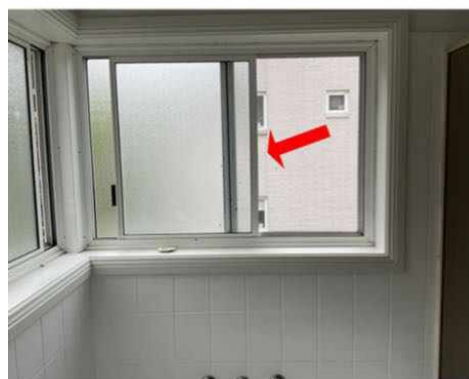
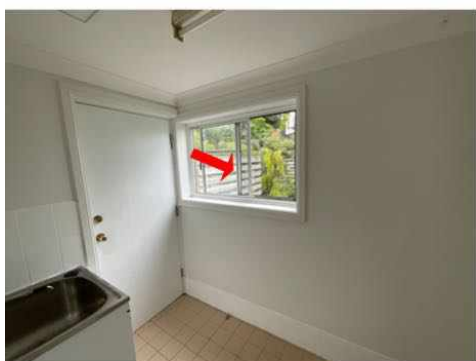
Finding 1.02

Building: Main Building  
 Location: Bathroom  
 Finding: Window opening restrictors missing.  
 Information: The Building Code of Australia rules require all openable windows (where the internal floor is more than 2m above the ground outside) in residential rooms to be fitted with a suitable screen or restrictor. Windows located 1.7m above the floor level do not require protection.

Window restrictors are required where people who are vulnerable to the risk of falling have access to windows. This means all windows above ground level which do not have another fall prevention safety measure in place, such as a balcony or balustrade should have a restrictor.

These need to be added urgently for the safety of all persons.

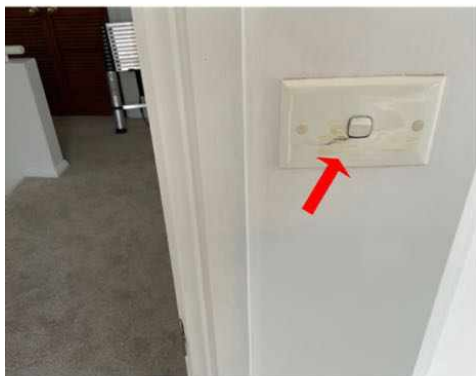
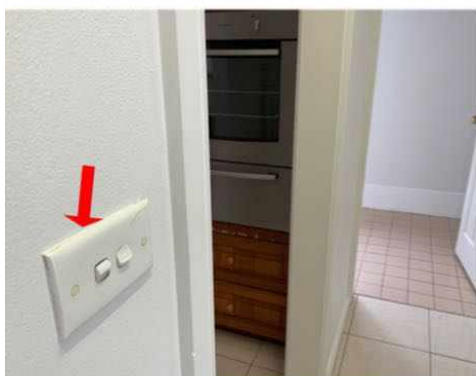
### Finding 1.03

Building: Main Building  
 Location: Bathroom, hall, lounge room  
 Finding: Switches - Damaged  
 Information: The switches in this area was found to be damaged at the time of inspection. This occurs generally when the building materials have either aged and decayed or as a result of impact damage (accidental or deliberate). This damage may also have

Repair and/or replacement of the switches is advised to ensure the fixture and its associated structures are safe and fully operational. A licensed electrician should be appointed to repair/replace the light switch as soon as possible.

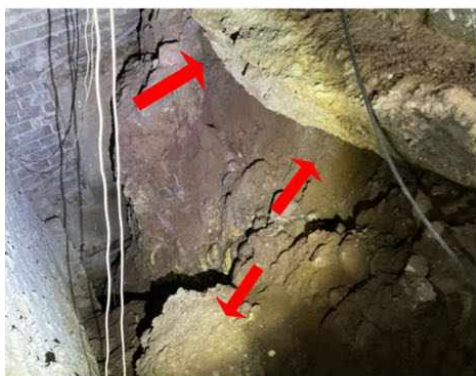
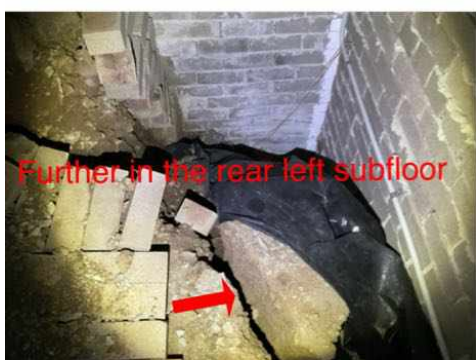
### Finding 2.01

Building:	Main Building
Location:	Subfloor
Finding:	Subsidence
Information:	It appears that the subfloor structure has been affected by movement of the ground foundations, often referred to as subsidence.

General subsidence is usually initiated by changes in soil moisture content. The most critical factor is identifying the specific causes, and identifying if this is a recurring or ongoing problem, or one that has been resolved by previous works in the past.

Subsidence can have complex and varying causes, which will influence the required remedial works. It is advised to begin by consulting a structural engineer to determine the required scope of works. A small area past this further in the subfloor also shows a crack opened up in the ground.

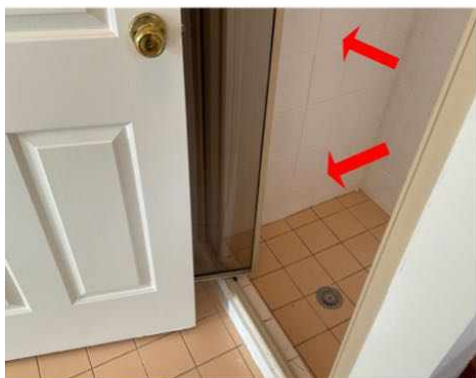
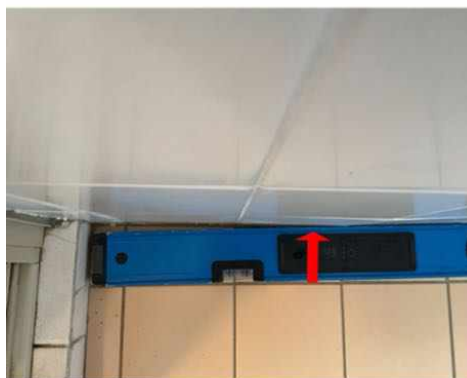
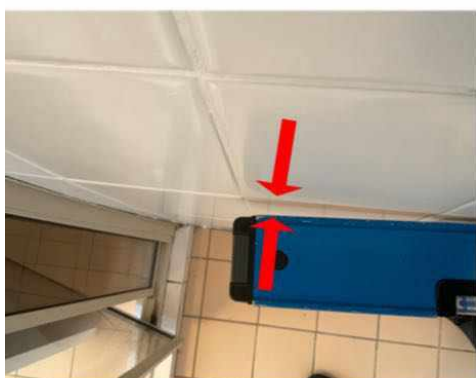
## Finding 2.02

Building:	Main Building
Location:	Ensuite - Master
Finding:	Internal walls - Bulging
Information:	Bulging was noted to the ensuite shower wall surface. It is suspected that this bulging is caused by lack of or failure in adhesion to framing, a common indication of substandard workmanship during the installation phase. This may also be from internal water damage inside the wall. The wall outside the shower door shows excessive moisture of 62.2 (see next defect).

Building works required to fix bulging building elements should be completed as the cause may be significant and may indicate a structural defect which would require extensive works in the long-term future, including works to floor structures, walls, and

Further invasive inspection is required to determine the actual cause. If the cause is structural it is advisable that an Engineer also inspects the building.

A builder will then be required to replace this wall then works to replace the waterproofing membrane, tiling etc will be required.

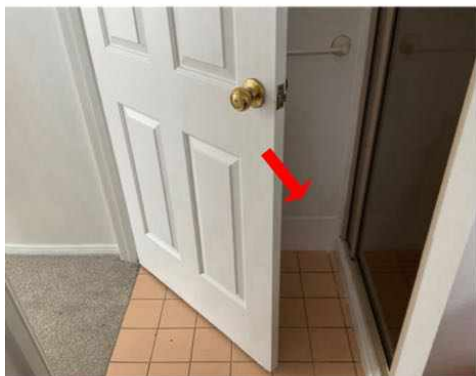
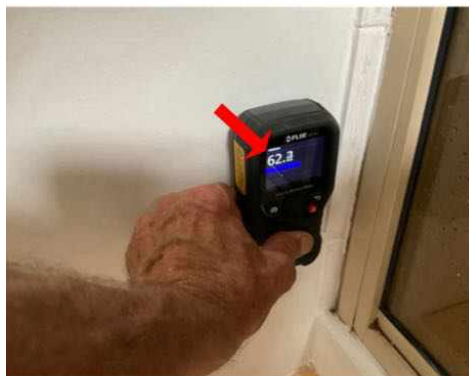
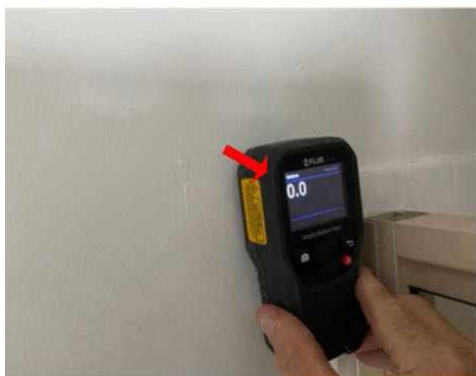
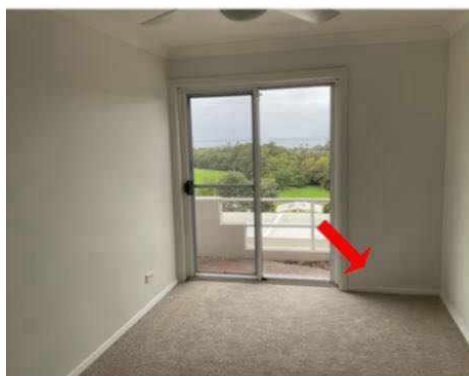
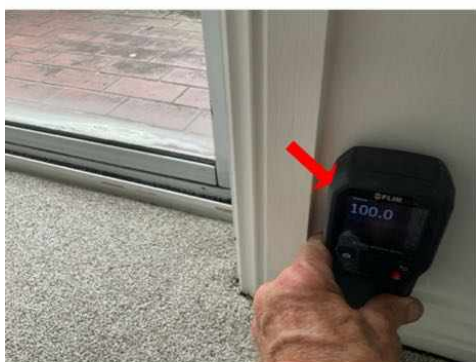
### Finding 3.01

Building:	Main Building
Location:	Ensuite - Master, south bedroom
Finding:	Evidence of excessive moisture was present at the time of inspection
Information:	Excessive moisture was found in two areas of the building. Readings of 62.2 and 100 were recorded in the ensuite left bathroom wall and loungeroom wall consecutively.

This excessive moisture can attract termites and produce conditions that promote termite attack fungal growth and wood decay.

Excessive moisture is generally caused by deteriorated inadequate or missing roof drainage and sealant, leaking plumbing pipes or fixtures poorly plumbed HWS

overflows or condenser units and poor site drainage (see also wall bulging defect in the ensuite).

It is highly recommended that all plumbing and drainage fixtures and fittings be maintained regularly in order to prevent excessive moisture being present in the internal property.

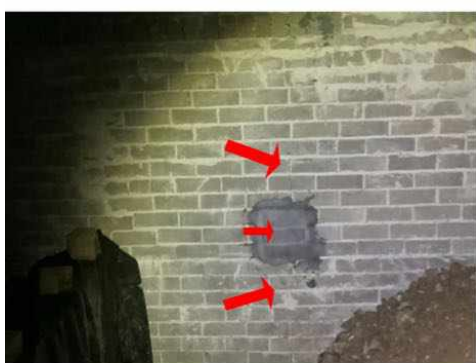
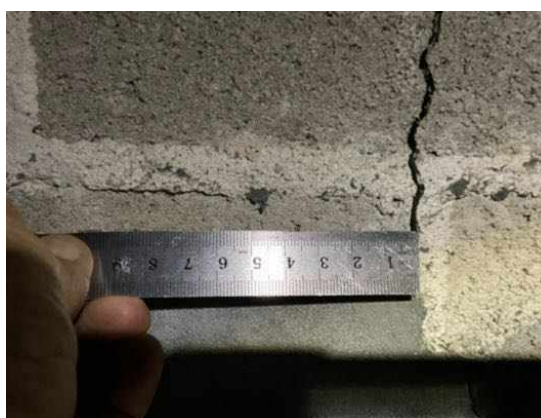
**Finding 3.02**

Building: Main Building  
 Location: Subfloor  
 Finding: Brickwork - Step cracking

Information: Step cracking of 2mm was identified to the brickwork in this left rear subfloor wall area at the time of inspection. Step cracking, which is similar to other forms of cracking, has a variety of possible causes. However, the most common is the subsidence of adjacent footings.

Step cracking is a relatively common defect, and is most likely to occur adjacent to windows, doors and other openings. Mortar failure in the gaps between affected bricks indicates the stresses and tensions affecting the wall.

Where step cracking is extensive or severe, the client is advised to consult a structural engineer. This minor step cracking can be used as a warning sign to address factors causing stress to the wall, which can include the effect of surrounding trees, water leaks, soil erosion, or even the presence of reactive soils in the surrounding area.

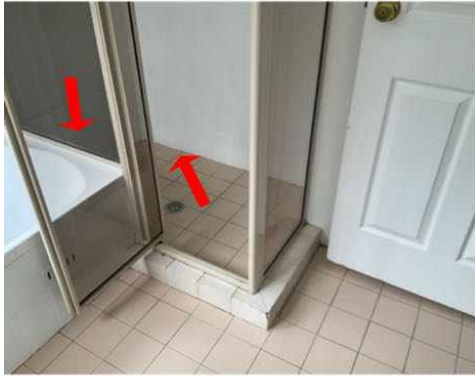
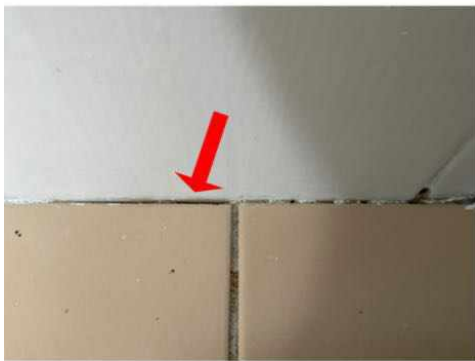
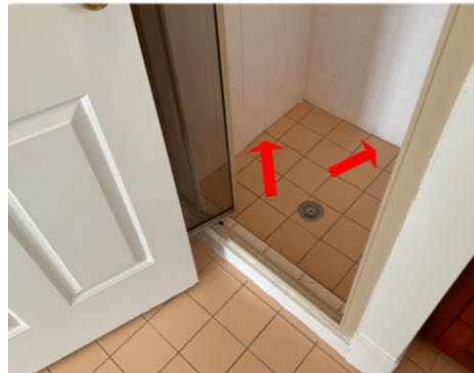
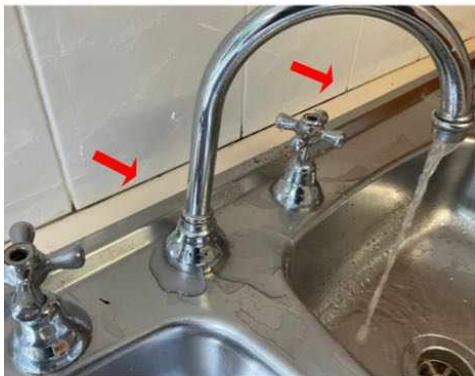
### Finding 3.03

Building: Main Building  
 Location: Laundry, kitchen and bathroom areas  
 Finding: Sealant and grouting - Missing  
 Information: It was noted on inspection that sealant or grout is missing to these pictured areas of the building.

Flexible and mould resistant materials should be applied to affected areas to prevent any subsequent water damage that is likely to occur.

A sealant expert is required to replace all damaged areas of sealing in the near future.

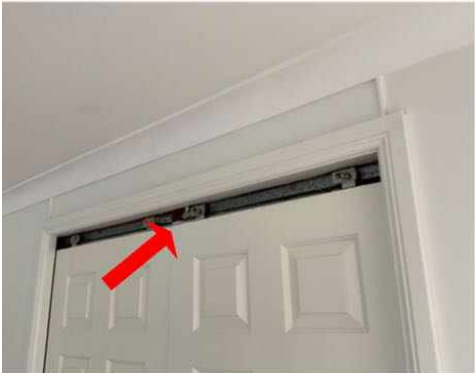
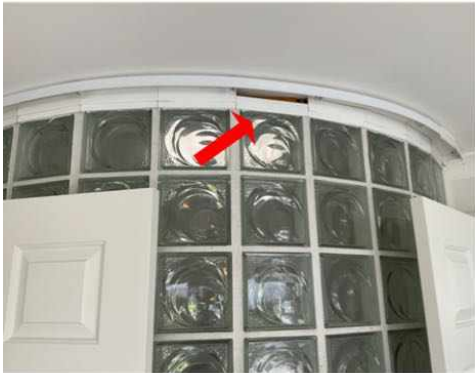
### Finding 3.04

Building: Building 1  
Location: Pictured internal Areas  
Finding: Building elements - Damaged  
Information: Evidence of damage was identified to the pictured top floor areas where some areas of trim are missing. A carpenter is required to repair these areas.

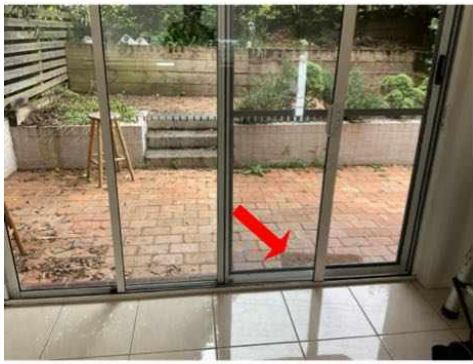
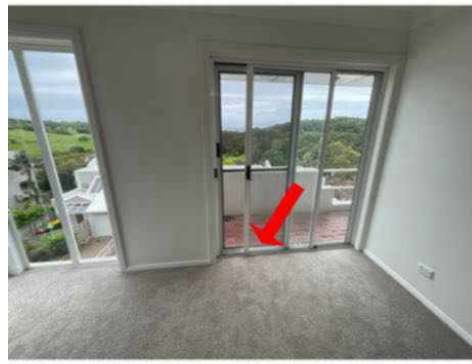
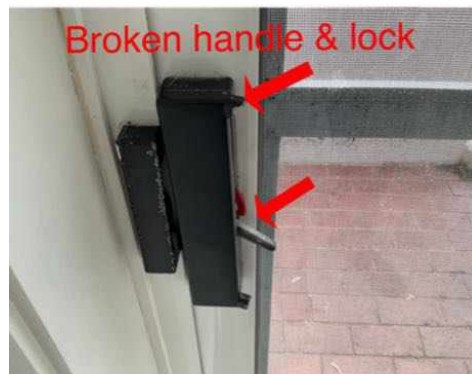
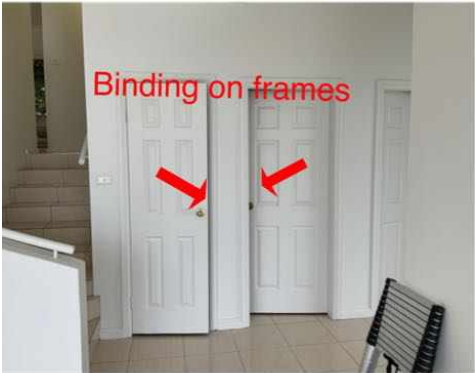
Building: Main Building  
Location: 3 sliding and other doors  
Finding: Doors - Stiff to slide/ binding/ broken  
Information: These doors were jammed and difficult to slide along the associated tracks at the time of the inspection. The upper rear door will not slide and has a broken handle and lock all requiring replacement.

Generally, factors such as general age of the building element and a lack of maintenance are the usual causes for this type of defect.

Replacement of door hardware or tracks may be required, as well as minor repairs and cleaning. A registered builder or general handy person will be required to repair the affected doors.

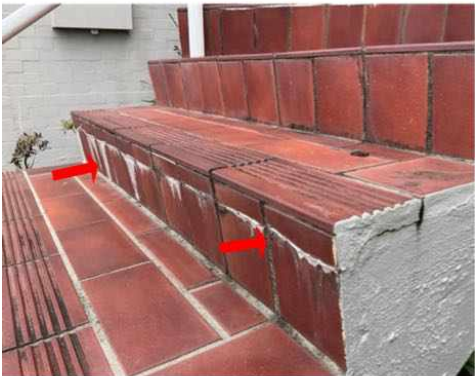
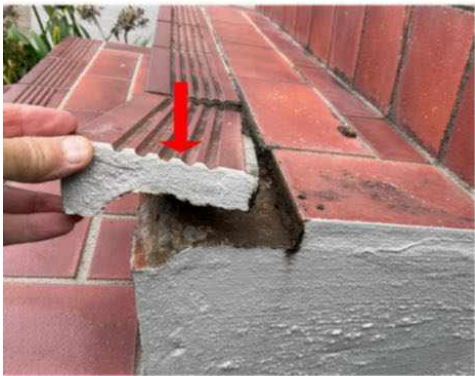
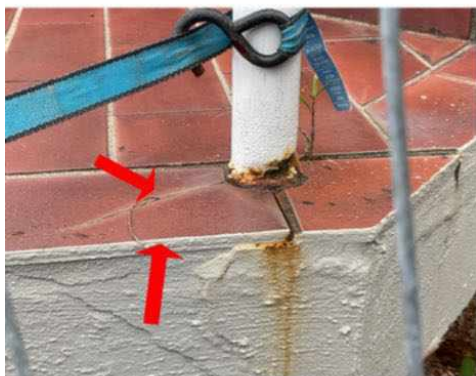
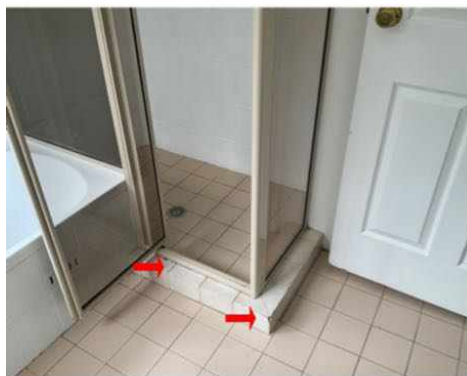
**Finding 3.07**

Building: Main Building  
Location: Stairs and bathroom areas  
Finding: Cracked and loose floor tiles  
Information: Cracking in the floor tiles was evident in this area at the time of inspection. It is suspected that this cracking has occurred as a result of water ingress.

Cracked tiles throughout the household detract from the overall appearance of the affected areas however it is unlikely to create or lead to any secondary defects.

While not considered a matter of urgency, replacement of cracked floor tiles is recommended at the clients discretion. A tiling contractor may be appointed to perform these works. Where cracks become more numerous, contact a licensed building inspector for further investigation.

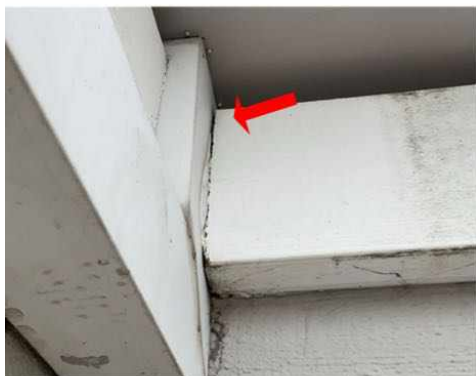
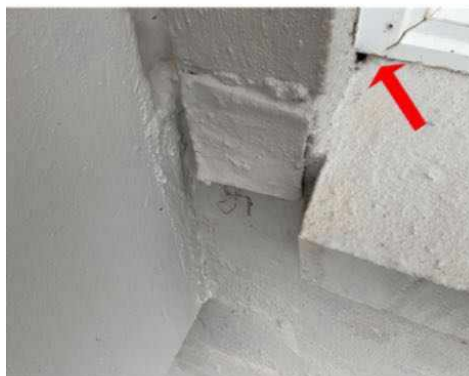
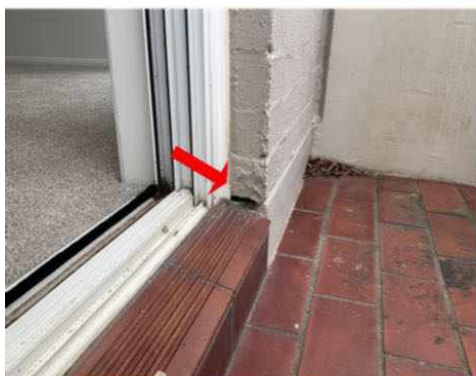
### Finding 3.08

Building:	Main Building
Location:	Exterior walls
Finding:	Sealant (external) - Missing.
Information:	It was noted on inspection that areas of external sealant was missing to small areas of the external walls.

Flexible sealants should be applied to these affected areas to prevent any subsequent water damage that is likely to occur.

A sealant specialist or skilled handy person should be appointed to complete these works as soon as possible

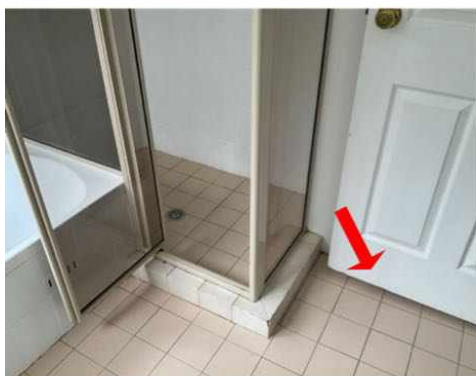
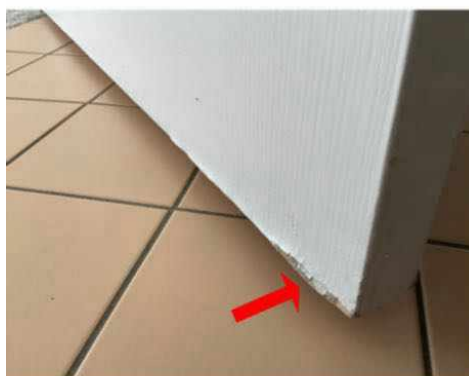
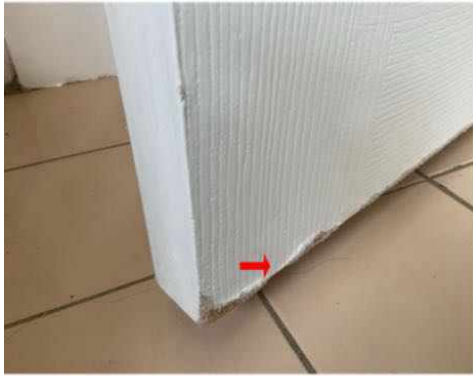
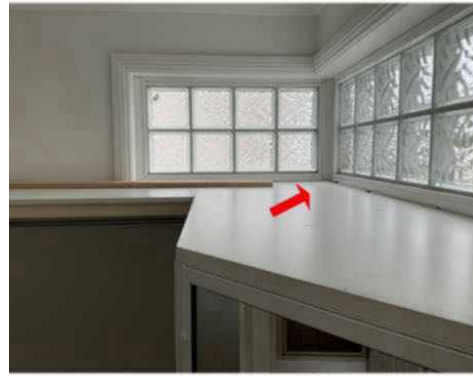
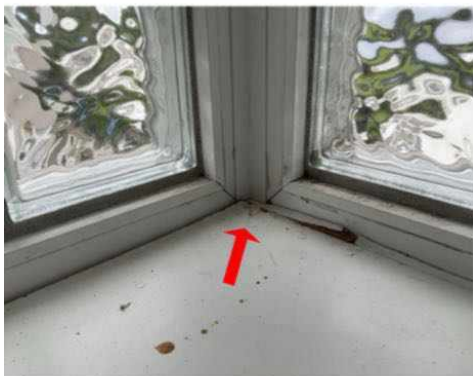
**Finding 3.09**

Building: Main Building  
 Location: Bathrooms , wardrobe,  
 Finding: Doors and cupboard areas - Swollen or damaged  
 Information: Swollen building elements (doors, cupboards) generally indicate that the building materials have been affected by excessive moisture over a prolonged period of time, and have swollen as a result.

Repair and/or replacement of swollen building elements should be conducted as a matter of urgency by a registered builder or qualified carpenter.

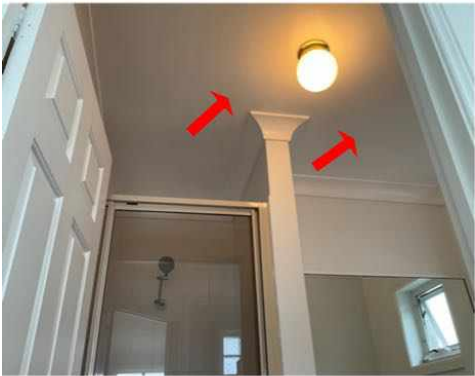
### Finding 3.10

Building: Main Building  
 Location: Ensuite - Master  
 Finding: Exhaust fan - Missing  
 Information:

An exhaust fan has not been installed in this area. Missing exhaust fans may lead to the development of more significant defects such as moisture damage to surrounding building materials from inadequate ventilation. Inadequate ventilation in internal areas creates an environment that is conducive to the formation and development of mould and other respiratory hazards. It is highly advised that a licensed electrician be appointed to retrospectively install an exhaust fan. Failure to perform works to aid the ventilation of the area may lead to the development of these secondary defects.

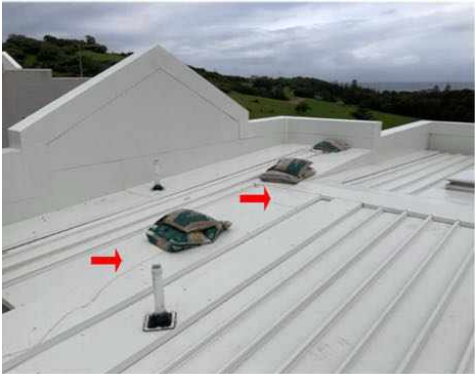
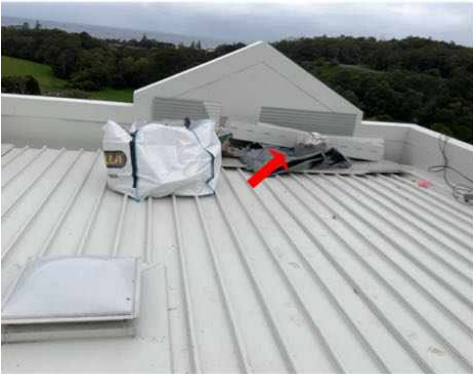
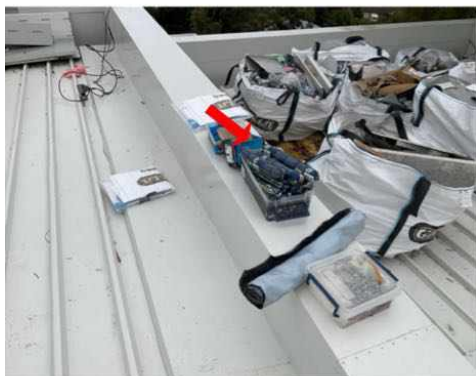
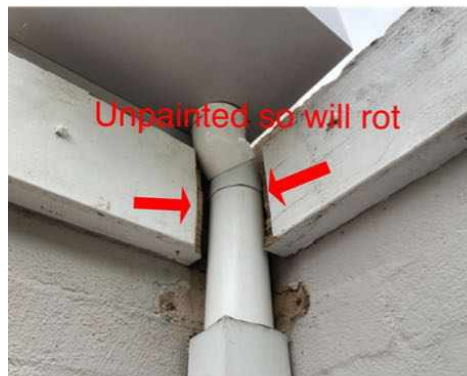
**Finding 3.11**

Building: Main Building  
Location: Roof Exterior  
Finding: Unfinished construction

Information: The construction of this structure appears to be incomplete. The safety of the structure can therefore not be ensured and the creation of secondary defects to surrounding building elements may be likely.

A Registered Builder should be appointed immediately to complete this construction process.

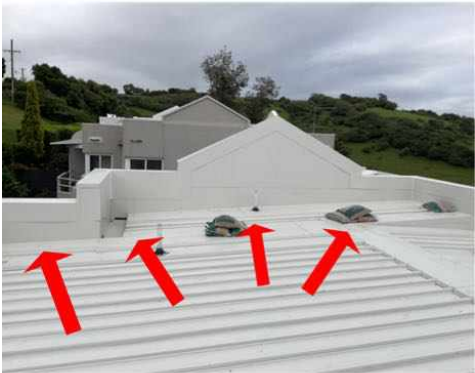
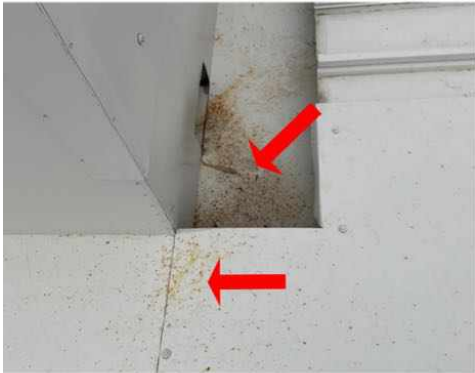
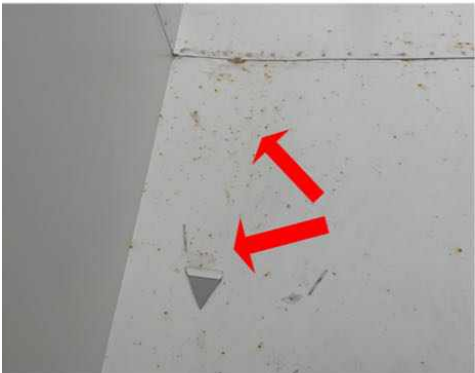
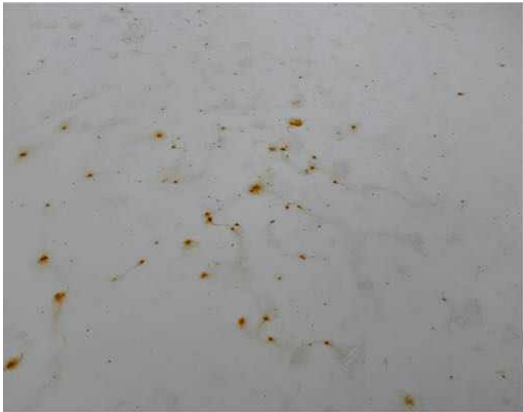
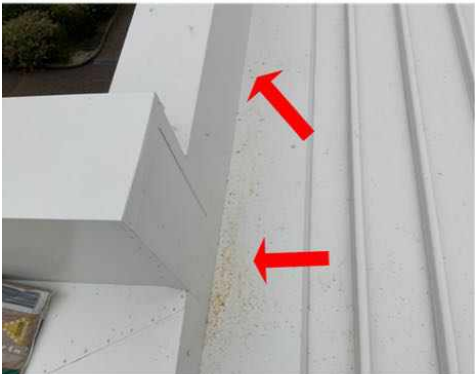
### Finding 3.12

Building:	Main Building
Location:	Roof Exterior
Finding:	Swarfing stains
Information:	Many roof areas shows evidence of rusting and corrosion, which is a result of swarfing.

Prevention of swarf staining is the responsibility of the installer. All these stains need to be cleaned before further rust ensues.

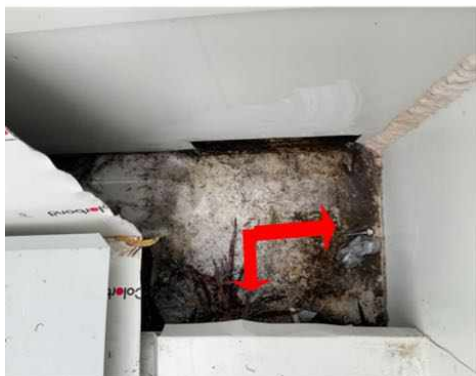
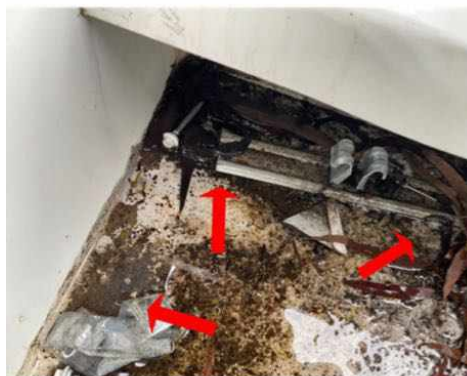
**Finding 3.13**

Building: Main Building  
Location: Roof Exterior  
Finding: Building waste in drains  
Information: Builders waste was found inside external drains at the time of the inspection. Builders waste left in these drains has the potential to interrupt the normal function of these drains and may lead to blockages and flooding of surrounding areas.

A handy person or plumber is required to remove this waste from these drains as soon a possible .

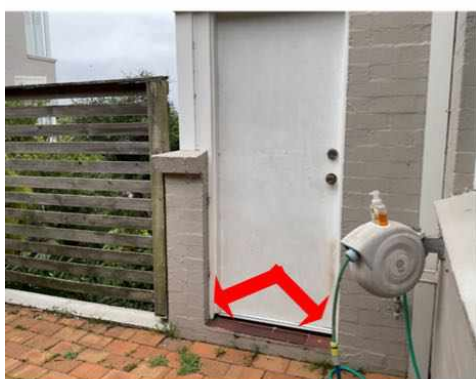
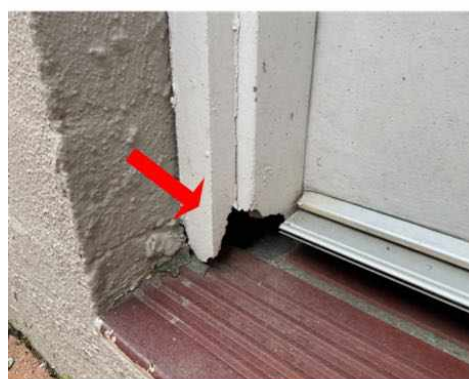
Finding: Wood rot

Information: The laundry door jamb shows evidence of wood rot. Wood rot, also known as Fungal Decay, occurs when timbers and other cellulose building materials are exposed to damp conditions on an ongoing basis. This could be the result of exposure to weathering over a prolonged period of time, or the attraction of excessive moisture from other abutting building materials.

Early intervention and regular maintenance, particularly of exterior timbers, will prolong the useful life of these building elements. Prior to any works being performed, the cause of the moisture that has created the visible wood rot should be identified and addressed in a suitable manner. Replacement of the affected jamb may then be a necessary step in protecting surrounding building elements from such deterioration.

A qualified carpenter or registered builder may also be required to replace affected building materials.

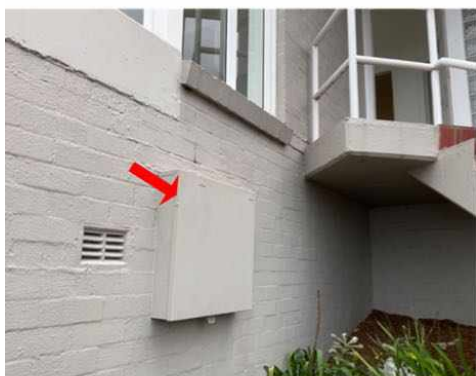
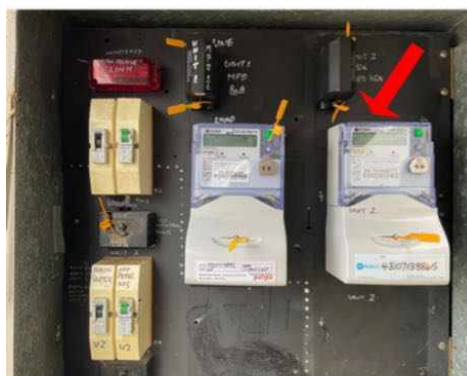
Building:	Main Building
Location:	Meter Box
Finding:	Termite Management System - no evidence of a chemical installation
Information:	The application of a post-construction chemical termite barrier is highly recommended for all properties, particularly if live termite activity has been found on the site previously. Such barriers are highly effective in preventing termite attack on any timber building elements throughout the property.

A durable notice should be placed in the switchboard unit to indicate current termite barriers. At the time of inspection, it appeared as though no termite management system has been installed, with no evidence to suggest preventative works taking place.

The client may consider gaining further advice from a pest controller as to the costs and procedures involved with this application. It is recommended that obtaining such advice be a short-term priority.

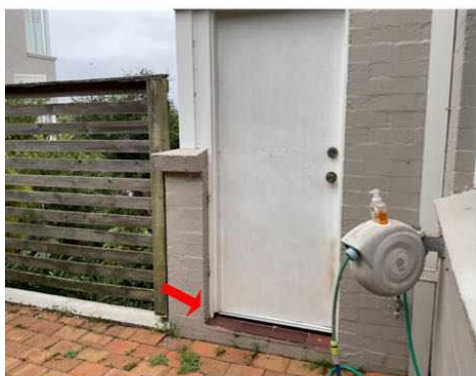
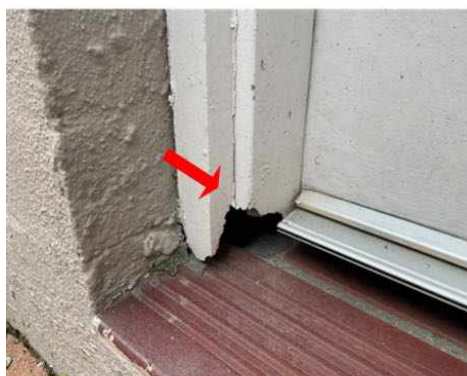
### Finding 6.02

Building:	Main Building
Location:	Laundry
Finding:	Fungal decay - present (localised)
Information:	Fungal decay also known as wood decay or wood rot generally refers to the deterioration of timber elements when in contact with excessive levels of moisture for a prolonged period of time.

The development of fungal decay is accelerated by temperatures from 5degreeC to 40degreeC as well as the presence of oxygen. Generally fungal decay develops on timber elements that are in use in an external environment which are exposed to rain penetration.

In this case, the affected timber element is in a decaying state and will need replacement by a carpenter or licensed builder.

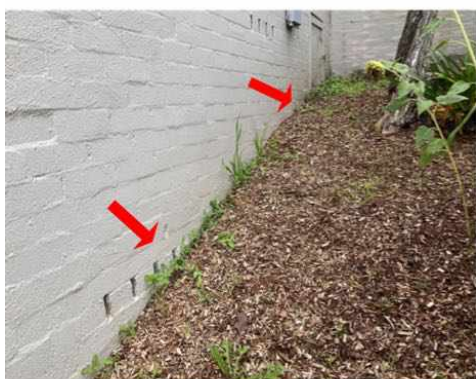
### Finding 6.03

If the slab edge is not properly exposed there is a high risk of termite attack. Sometimes, in order to determine the type of slab, a suitably qualified person such as an architect or builder may be required to consult the construction plans.

Where the slab edge cannot be properly inspected, it is highly recommended that termite or timber pest inspections be carried out every 6-12 months to aid protection of the property against infestation.

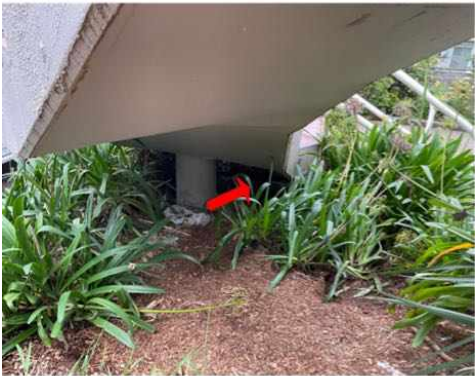
Building:	Main Building
Location:	Subfloor
Finding:	Additional Photos - Obstructions and Limitations of SUBFLOOR AREAS
Information:	These photographs are an indication of the obstructions and limitations which impeded full inspection of subfloor areas at the time of inspection. These obstructions can hide an array of defects and should be removed to allow full inspection to be carried out. A re-inspection is recommended once the areas are made accessible.
