Building and Timber Pest Inspection Report

Inspection Date: Wed, 8 Apr 2026

Property Address: 10/99 Heeb St, Ashmore QLD 4214,
Australia

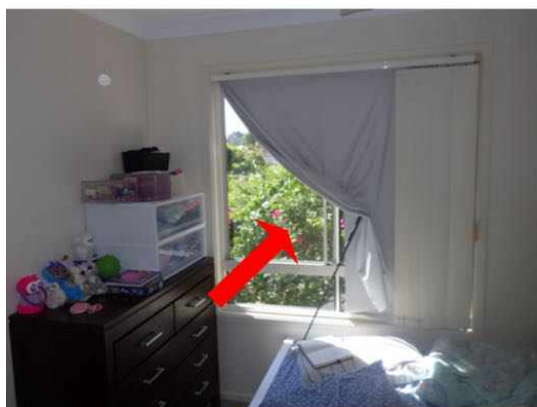
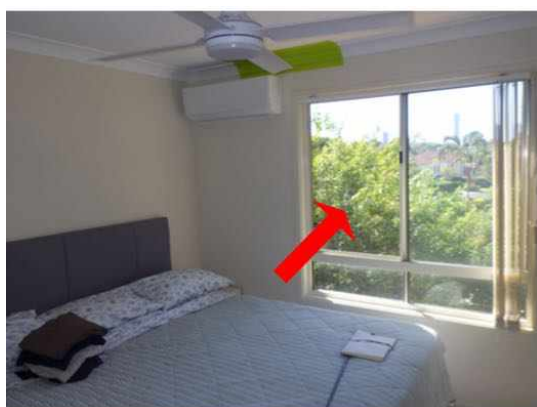
Building: Main Building
Location: Bedrooms > Existing
Finding: Window safety
Information: It was noted that the windows of the upper level bedrooms are less than 1.7m from the floor and have a fall greater than 2m on the exterior from the sill and as such are required to only open upto 125mm or have security grills fitted.

This is noted as a safety concern and this regulation may not have been in place at the time of construction.

Windows are defective if they do not comply with provision 3.9.2.5 of Volume 2 of the BCA that requires that a window opening must have protection if the floor below the window in a bedroom is 2 m or more above the ground surface beneath.

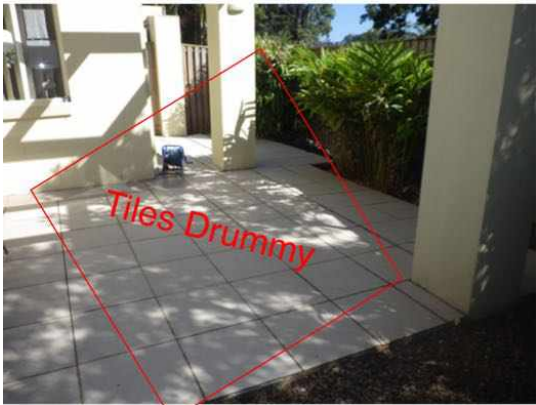
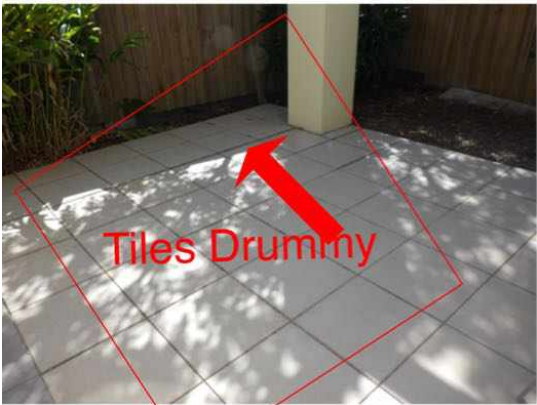
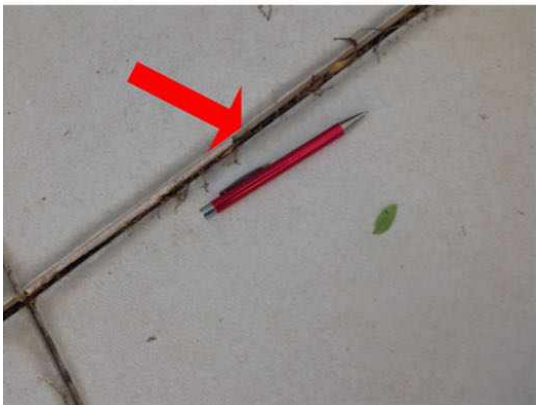
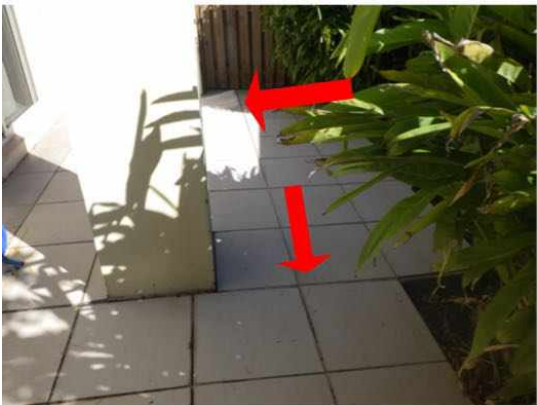
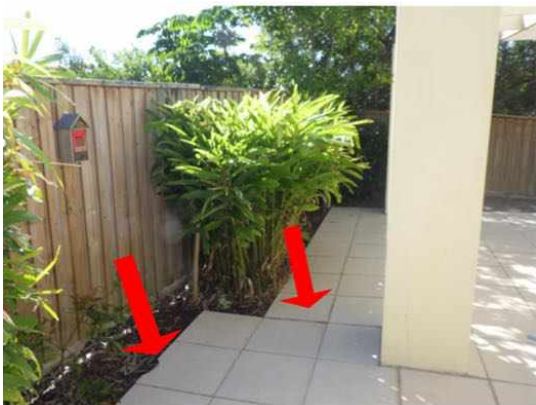
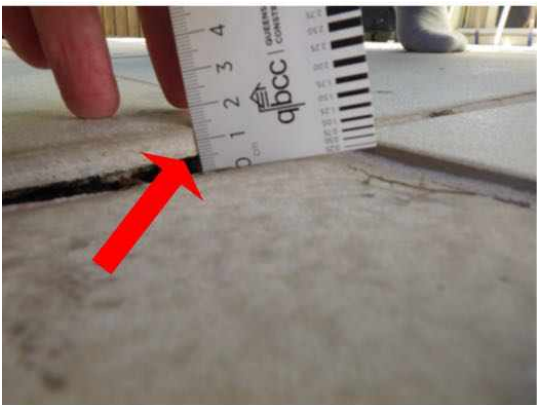
Finding 2.02

Building: Main Building
Location: Alfresco > Ground Level
Finding: Tiles - Cracked/ Drummy
Information:

Cracked, drummy and uneven tiles to the alfresco area were identified at the time of inspection. Such defects are generally caused by impact, significant ground movement and/or moisture exposure to the area. Cracked and drummy tiled areas may also be a direct result of poor workmanship during the construction process.

It is advised that a tiling contractor be appointed to perform repair works as necessary.

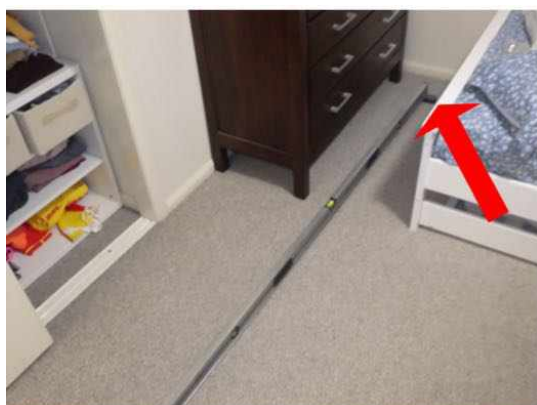
Finding 2.03

Building:	Main Building
Location:	Bedroom 2 > Rear Left
Finding:	Levelness of floors
Information:	At the time of inspection, although there was no obvious damage or cracking to wall and ceiling linings, the bedroom 2 area floor deviated in levelness by more than the recommended QBCC standard and tolerances. In this instance the bedroom 2 floor was found to be off level by 28mm over a 2.0m length.

Floor areas are defective if they differ in level by more than 10mm in any room or area, or more than a 12mm deviation over a three metre length under the QBCC Standards and Tolerances Guide.

A licensed builder or structural engineer should be engaged for further investigation and/or advice.

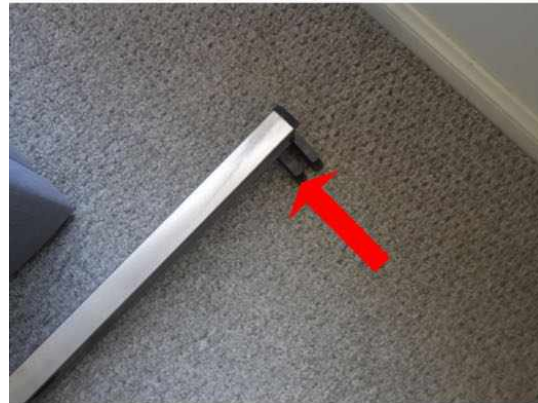
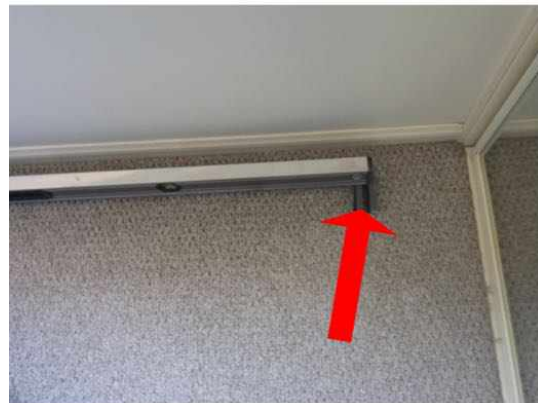
Finding 2.04

Building:	Main Building
Location:	Bedroom 3 > Rear Right
Finding:	Levelness of floors
Information:	At the time of inspection, although there was no obvious damage or cracking to wall

and ceiling linings, the bedroom 3 area floor deviated in levelness by more than the recommended QBCC standard and tolerances. In this instance the bedroom 3 floor was found to be off level by 26mm over a 2.0m length.

Floor areas are defective if they differ in level by more than 10mm in any room or area, or more than a 12mm deviation over a three metre length under the QBCC Standards and Tolerances Guide.

A licensed builder or structural engineer could be engaged for further investigation and/or advice.

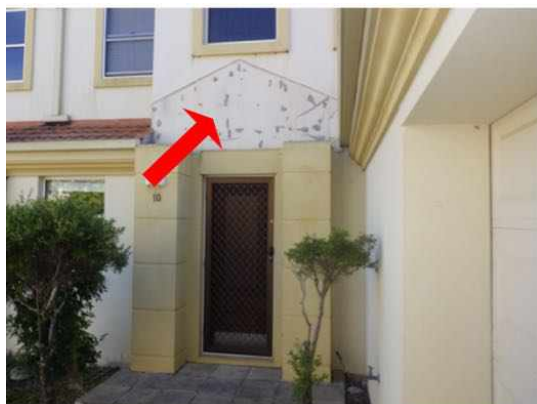
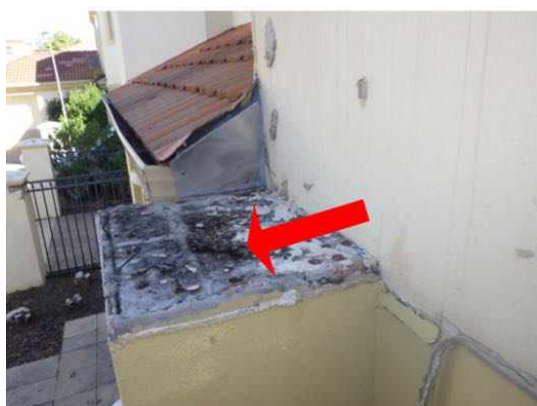
Finding 3.01

Building:	Main Building
Location:	Front Elevation > Centre
Finding:	Facade - Missing
Information:	At the time of inspection the decorative facade to the front entry area of the building was missing. It appeared the missing facade has been previously removed (reasons unknown).

The client could engage a licensed builder to replace the missing facade.

NOTE - Decorative facade replacement and or maintenance may be the responsibility of the buildings body corporate managers.

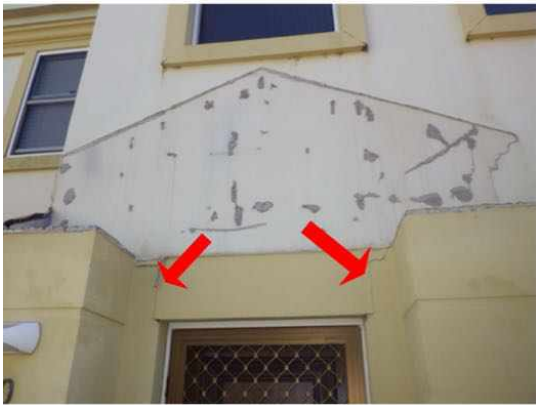
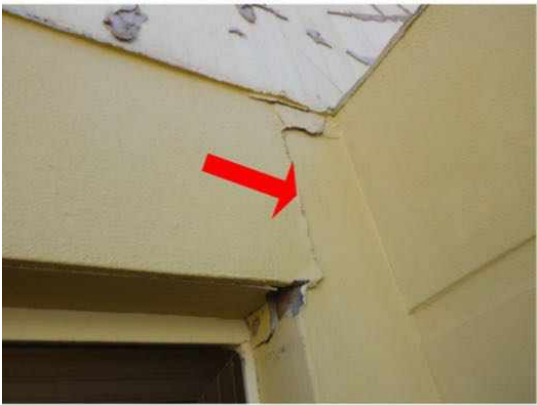
Finding 3.02

Building:	Main Building
Location:	Exterior walls > Existing
Finding:	Cracking - Walls
Information:	There is cracking to areas of the upper level exterior wall cladding and decorative mouldings (as per example photos). The cracking appears to be concentrated at the vertical joints of the wall sheeting and mouldings, and is generally minor in nature. It is assumed the cracking is the result of normal building movement or substandard workmanship at the time of construction.

A licensed solid plasterer or qualified painter could be consulted regarding rectification options.

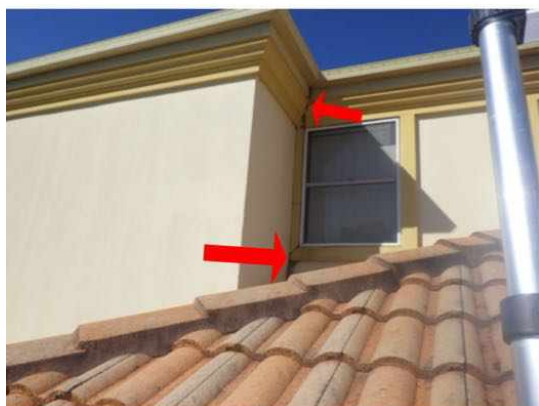
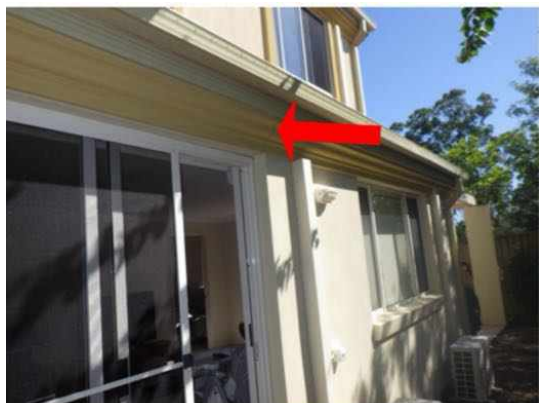
Finding 3.03

Building:	Main Building
Location:	Exterior walls > Existing
Finding:	Cracks to internal rendered surfaces - Category 1 - 2
Information:	It has been observed that cracking to external rendered surfaces has occurred (as per example photos).

The degree of damage falls within Category 1 - 2, described as noticeable cracks which are easily filled. Such cracking may cause doors and/or windows to stick slightly, and are generally less than 5mm in width.

Damage of this category is required to be monitored for a period of 12 months, after which time a crack rated at Category 2 or above is considered a defect that requires rectification. Always contact your building inspector should cracks widen, lengthen, or become more numerous.

NOTE - External wall area repairs and/or maintenance may be the responsibility of the building complex's body corporate managers.

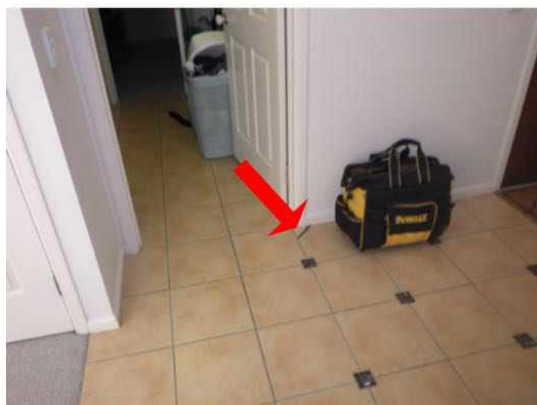
Building: Main Building
 Location: Entry > Centre Right
 Finding: Tile - Cracked
 Information: Cracked tiles to the entry floor area was identified at the time of inspection. Such defects are generally caused by impact. Cracked or broken tiled areas may also be a direct result of poor workmanship during the construction process.

A tiling contractor could be appointed to perform repair works at the clients discretion.

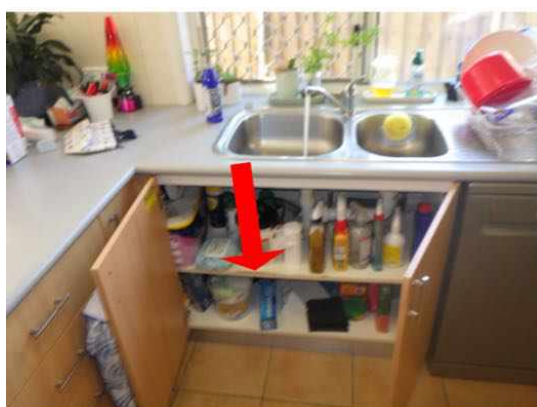
Building: Main Building
 Location: Kitchen > Centre Left
 Finding: Cabinetry - Deterioration
 Information: At the time of inspection the kitchen cabinetry showed signs of minor deterioration. The level of damage appears consistent with exposure to moisture or general wear and tear.

A qualified cabinet maker or general handyman could be engaged to undertake repair works at the clients discretion.

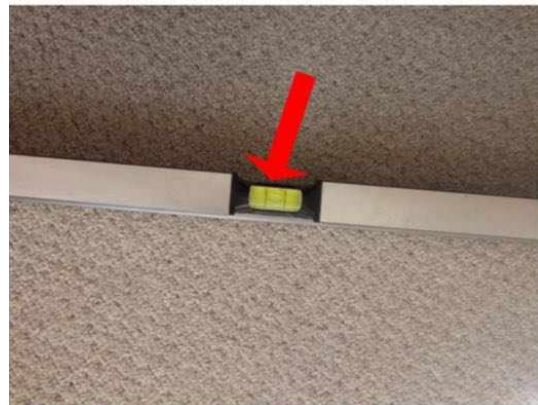
Finding 3.10

Building: Main Building
 Location: Living Room > Rear Right
 Finding: Levelness of floors
 Information: At the time of inspection, although there was no obvious damage or cracking to wall and ceiling linings, the living room area concrete floor deviated in levelness by more than the recommended QBCC standard and tolerances. In this instance the living room floor was found to be off level by 10mm over a 2.0m length.

Floor areas are defective if they differ in level by more than 10mm in any room or area,

or more than a 12mm deviation over a three metre length under the QBCC Standards and Tolerances Guide.

A licensed builder or structural engineer could be engaged for further investigation and/or advice.

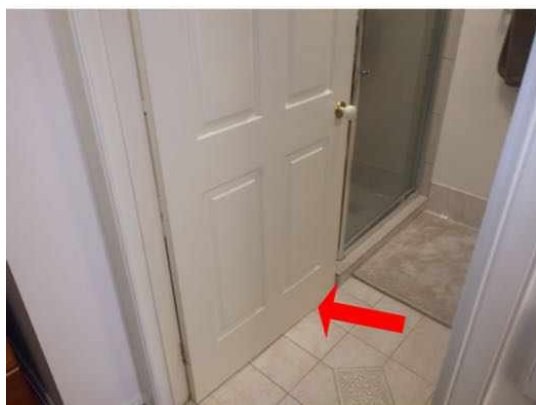
Building:	Main Building
Location:	Ensuite > Front
Finding:	Damaged Door
Information:	The door leading into the ensuite has suffered damage to the bottom edge.

Damage occurs generally when the building materials have aged and decayed, but in this instance the damage appears to be the result of exposure to moisture, possibly from the bottom and/or top edges of the door not being sealed with a suitable paint or sealant at the time of construction.

A qualified carpenter or general handyman could be appointed to repair/replace the door at the clients discretion.

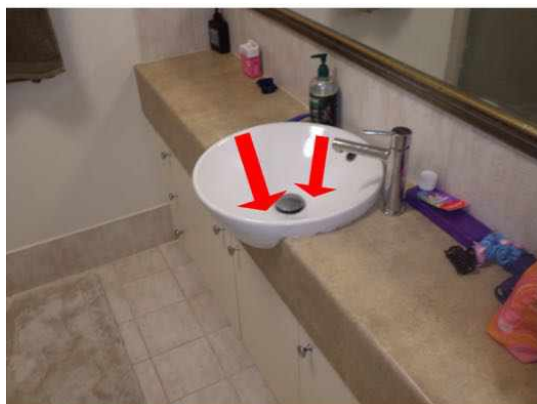
Finding 3.13

Building:	Main Building
Location:	Ensuite > Centre Right
Finding:	Basin - cracking
Information:	Fine cracking was evident to the ensuite basin at the time of inspection. While the cracking appears to be minor, any further impact damage sustained by the basin may lead to additional cracking.

The fine cracking may provide potential ingress for water and/or secondary water damage may occur to associated cabinetry if left unmanaged.

Consultation with a plumber regarding basin repair or replacement may be required.

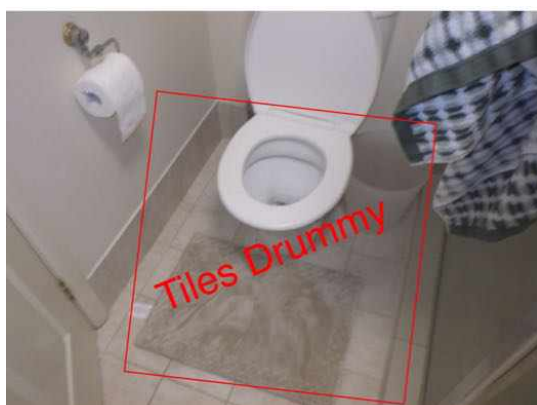
Finding 3.14

Building: Main Building
 Location: Ensuite > Front Left
 Finding: Tiles - Drummy
 Information: Drummy tiles were identified in the ensuite area floor at the time of inspection. The term 'drummy' refers to tiles that despite being in relatively good condition have a hollow sound when tapped on and may be inclined to crack from heavy impact whether accidental or deliberate. Drummy tiled areas may be a direct result of poor workmanship during the construction process.

A tiling contractor could be appointed to perform works if necessary.

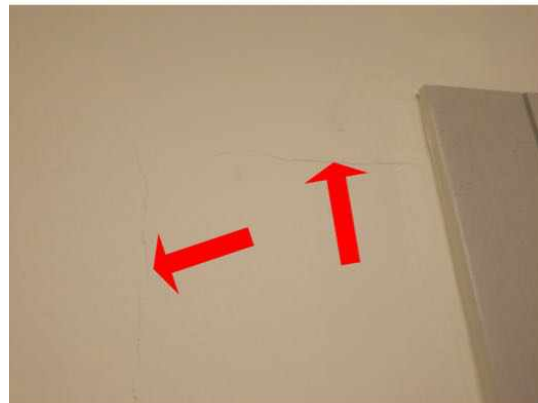
Finding 3.15

Building: Main Building
 Location: Ensuite > Centre Left
 Finding: Cracking - Wall

Information: There is cracking to an area of the wall lining in the ensuite area.

The cracking appears minor in nature and is generally only ever an appearance defect. While such cracking may be noticeable in some cases, it is quite common and does not indicate any structural damage.

Cracking of this nature can generally be repaired with minor sanding, filling and/or repainting. Such works should be performed by a qualified painter or a general handyman.

Monitoring of all cracking should be conducted frequently. Always contact a building inspector should cracks widen, lengthen, or become more numerous.

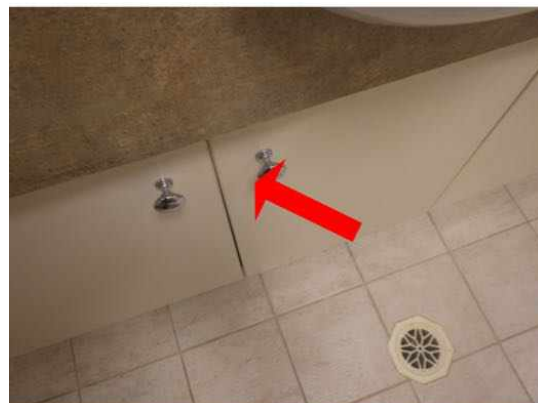
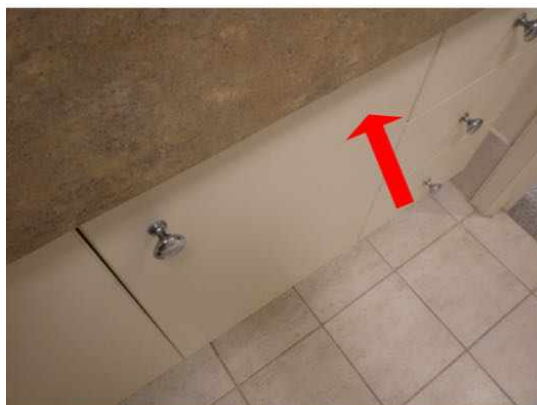
Finding 3.16

Finding: Cabinetry - Deterioration

Information: At the time of inspection the ensuite cabinetry showed signs of deterioration. The level of damage appears consistent with exposure to moisture or general wear and tear.

A qualified cabinet maker or general handyman could be engaged to undertake repair works at the clients discretion.

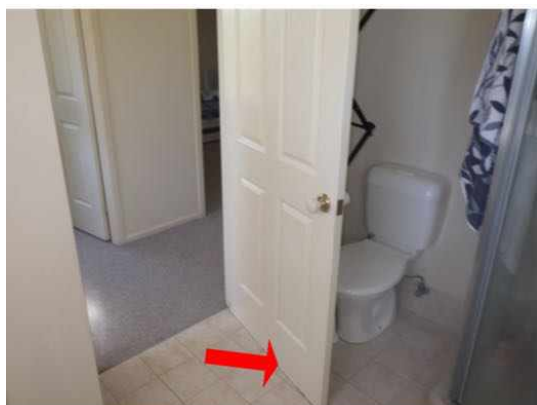
Finding 3.17

Building:	Main Building
Location:	Bathroom > Front
Finding:	Damaged Door
Information:	The door leading into the bathroom has suffered damage to the bottom edge.

Damage occurs generally when the building materials have aged and decayed, but in this instance the damage appears to be the result of exposure to moisture, possibly from the bottom and/or top edges of the door not being sealed with a suitable paint or sealant at the time of construction.

A qualified carpenter or general handyman could be appointed to repair/replace the door at the clients discretion.

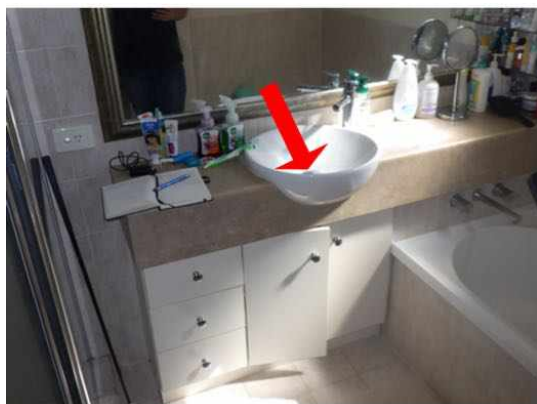
Finding 3.18

Building:	Main Building
Location:	Bathroom > Rear
Finding:	Basin - cracking
Information:	Fine cracking was evident to the bathroom basin at the time of inspection. While the cracking appears to be minor, any further impact damage sustained by the basin may lead to additional cracking.

The fine cracking may provide potential ingress for water and/or secondary water damage may occur to associated cabinetry if left unmanaged.

Consultation with a plumber regarding basin repair or replacement may be required.

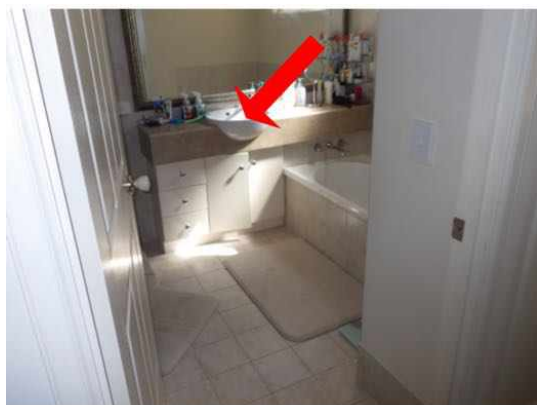
Finding 3.19

Building: Main Building
 Location: Bathroom > Centre, Rear
 Finding: Basin - Pop up waste stiff.
 Information: The bathroom basin pop up waste was stiff to operate at the time of inspection. It is advised that maintenance is carried out on the waste so as it functions as intended.

A handyman could be appointed to perform any remedial works where required.

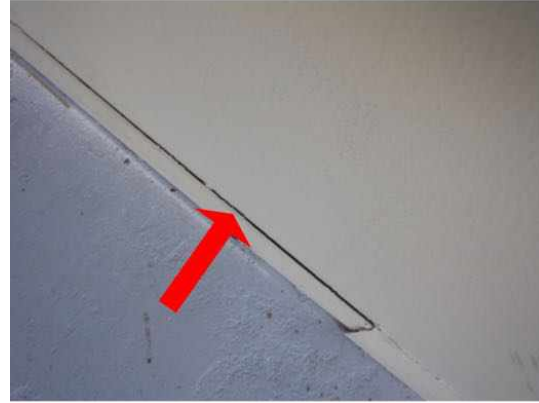
Finding 3.20

Building: Main Building
 Location: Garage > Front Right
 Finding: Skirtings Movement
 Information: It was noted that the timber skirting is separating from the internal wall linings and cracking in the garage area.

This is a common defect caused through contraction and expansion of the wall framing and/or through the settlement of buildings.

The client is advised to monitor the skirtings for any further signs of movement or deterioration .

A painter might be engaged to undertake minor repair works.

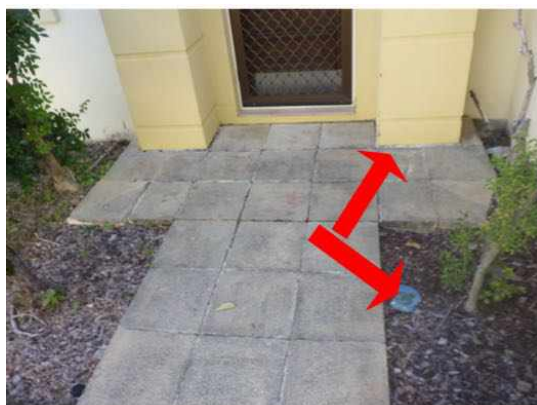
Building: Main Building
Location: Exterior walls > Existing
Finding: Termite Management System - no evidence of a chemical installation
Information: At the time of inspection, it appeared as though no current or active termite management system is installed on the property, with no evidence to suggest preventative works or regular inspections taking place. It was observed there has been previous in ground baiting stations and chemical treatment work undertaken but these systems appeared non-operational and/or expired.

The application of a post-construction chemical termite barrier is highly recommended for all properties, particularly if live termite activity has been found on the site previously. Such barriers are highly effective in preventing termite attack on any timber building elements throughout the property.

The client should consider gaining further advice from a licensed timber termite pest technician as to the costs and procedures involved with this application. It is highly recommended that obtaining such advice be a short-term priority.

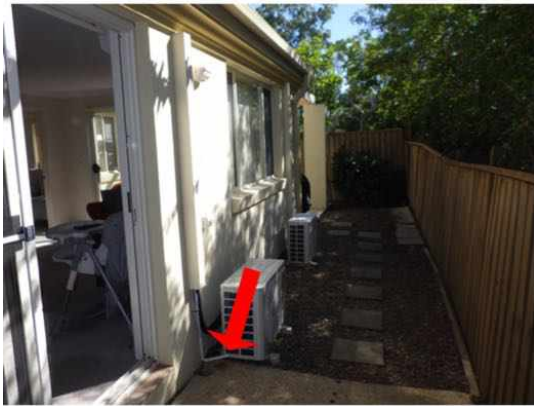
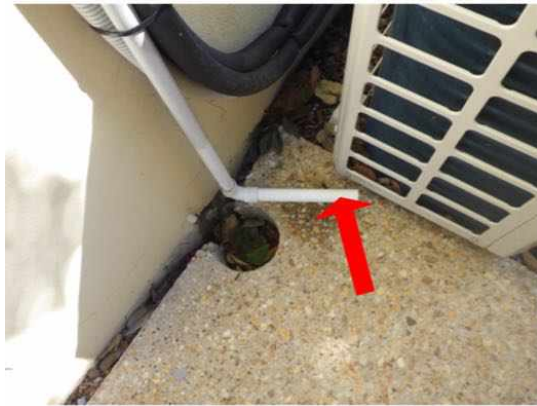
Finding 6.02

Building:	Main Building
Location:	Exterior walls - right side > Centre Right
Finding:	Overflow - Not plumbed for drainage
Information:	The air conditioning unit overflow is not plumbed or connected to suitable drainage, which can result in the surrounding area becoming excessively damp. These damp conditions can lead to secondary defects such as rot, rust or corrosion of associated building elements, the formation of fungal decay, or even the creation of potential slip hazards. When coupled with poor site drainage, pooling of water may also attract termite activity to this area. It is highly recommended that a qualified plumber be appointed to install adequate drainage to the overflow. These works will ensure that

the area remains dry and free of any secondary defects.

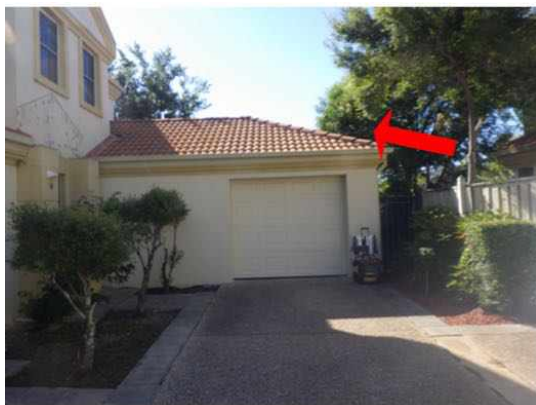
Finding 6.03

Building: Main Building
Location: Roof Exterior > Front Right
Finding: Vegetation
Information:

At the time of inspection there was vegetation growing over external roof areas. Consequently moisture or dampness may be present and the areas become conducive to termite activity. Plants against or very close to buildings provide cover, shade and can provide an environment that is attractive to termite infestation.

The grass and other vegetation heights should be maintained around the perimeter of the building to allow for an inspection zone around the building exterior.
