# Building and Timber Pest Inspection Report

Inspection Date: Fri, 13 Mar 2026

Property Address: 18 Narellan Cres, Bonnyrigg Heights NSW  
2177, Australia

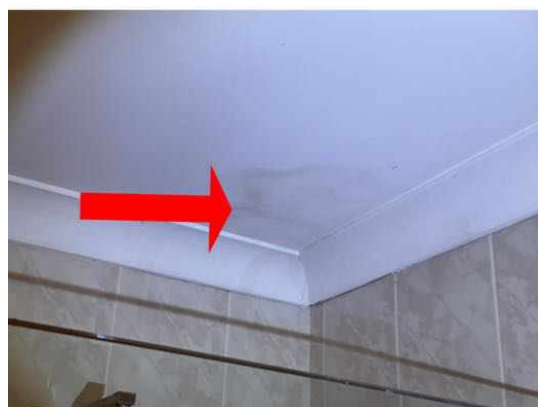
Building: Main Building  
 Location: Bathroom  
 Finding: Ceiling - Water damaged  
 Information: Water damage to the ceiling lining is generally an indication of excessive moisture being present in the roof void, usually via a leak to the roof covering.

Where water damage is evident to the ceiling, the primary requirement is to identify and rectify the source of the leak. A roofing plumber should be appointed as soon as possible to identify the leak and perform rectification works as necessary, ensuring the water damage is restricted.

Once the leak is repaired, consultation with relevant tradespeople, including plasterers and painters, is advised. Rectification works may include replacement of ceiling lining or minor repainting, depending on the extent of the damage.

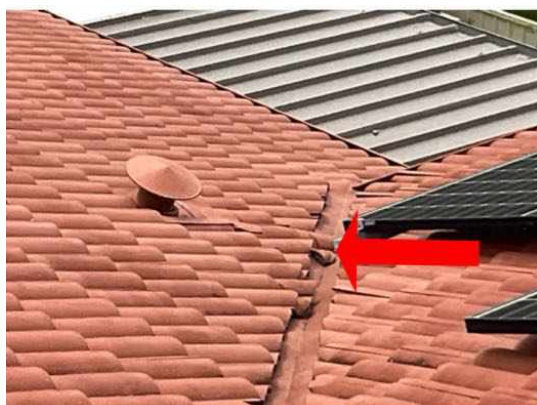
#### Finding 2.02

Building: Main Building  
 Location: Roof Exterior  
 Finding: Roof tiles - Slippage  
 Information: Upon inspection of the exterior roof covering, it was noted that numerous tiles have slipped from their original fixing. Tiles may slip over time due to a number of minor causes, including breakage of tiles, failings in the adjoining battens, or fixings that may have failed.

Roof tiles that have moved from their original position are very likely to allow water penetration into the roof void, exposing roofing structures to excessive moisture. This creates an environment that is conducive to water damage and accelerated deterioration of all associated building elements.

Replacement of loose or missing roofing tiles is recommended immediately to prevent the development of any secondary defects. A roofing restoration specialist should be appointed to complete such works as necessary.

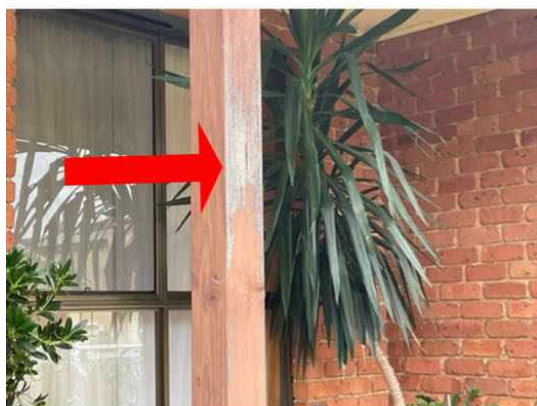
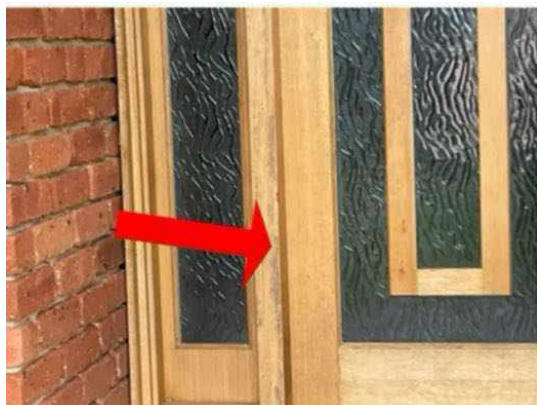
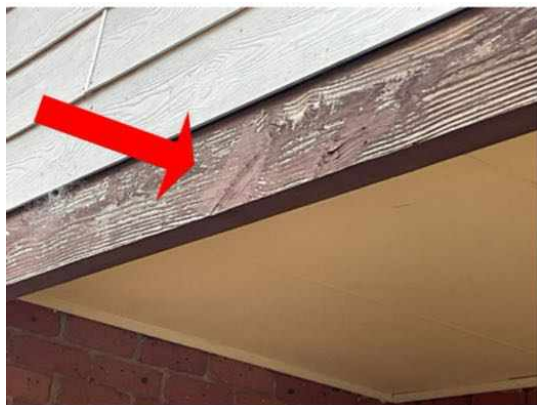
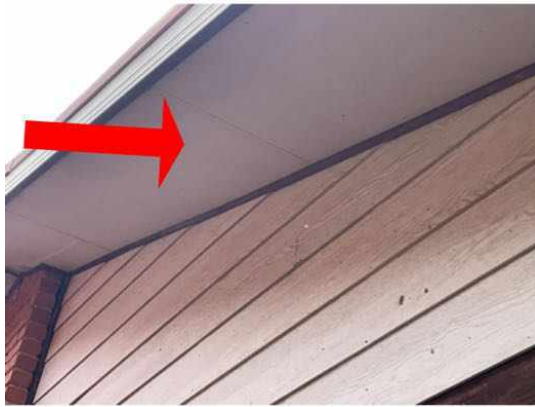
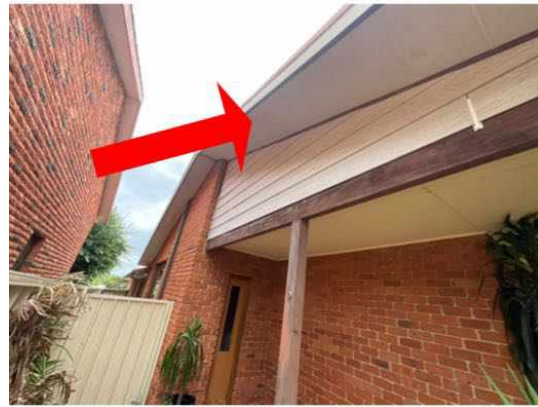
Building:	Main Building
Location:	All External Areas
Finding:	External painting deteriorated
Information:	Much of the external paintwork including but not limited to windows, fascias, guttering, veranda and other external fitments have been neglected and require attention to prepare and re-paint.

Whilst incomplete or missing paint finish is generally an appearance defect, it can also lead to the development of secondary building defects over time. Incomplete areas of

paint finish expose the area to moisture, potentially accelerating the deterioration of underlying building materials.

Degraded paint finishes should be sanded back, filled, leveled and painted, as applicable. Where inadequate or missing paint protection has led to the deterioration of the associated building element, repair and/or replacement of this building element may be required.

A painting contractor should be appointed as soon as possible to perform necessary works to aid the appearance of the affected area and to ensure the area is protected against further deterioration. Alternatively, the homeowner following manufacturer instructions may perform these works.

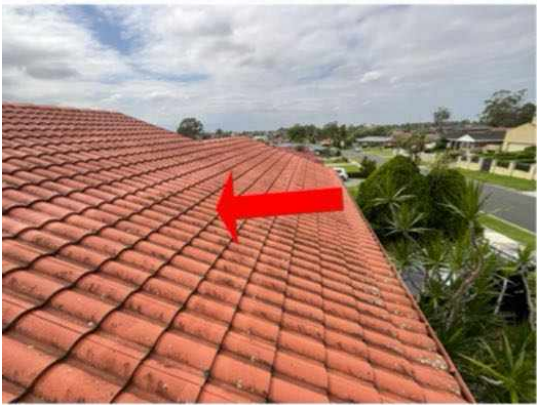
Building:	Main Building
Location:	Roof Exterior
Finding:	Roof tiles - Broken / Missing
Information:	Upon inspection of the exterior roof covering, broken / missing roofing tiles were identified. Broken and friable roof tiles are generally the result of ageing and weathering of what is essentially a porous material.

If left to further deteriorate, broken / missing and brittle roof tiles are likely to lead to water penetration via the roof into the ceiling space, causing secondary damage to ceiling linings, insulation and roof structures. Broken roof tiles are also likely to detract from the effectiveness of the roof drainage system, creating potential for secondary damage to the exterior roof covering and roof plumbing.

Replacement of broken tiles is required and should be performed by a roofing contractor as soon as possible.

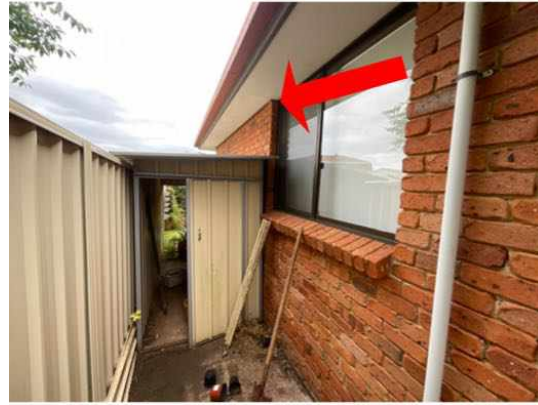
### Finding 3.07

Building:	Main Building
Location:	All External Areas
Finding:	Beads - damage
Information:	Where beading (also known as 'quad') are damaged from the eaves It was noted at the time of inspection that beading in this area has deteriorated. Beading is important in weatherproofing the surrounding building elements and preventing termite or pest ingress. Furthermore, beading works to protect the joints of building materials, which are more susceptible to deterioration and decay. Repair or replacement of the beading is advised to ensure the protection and longevity of any associated building elements. Such works may be performed by a general handyperson or qualified carpenter.

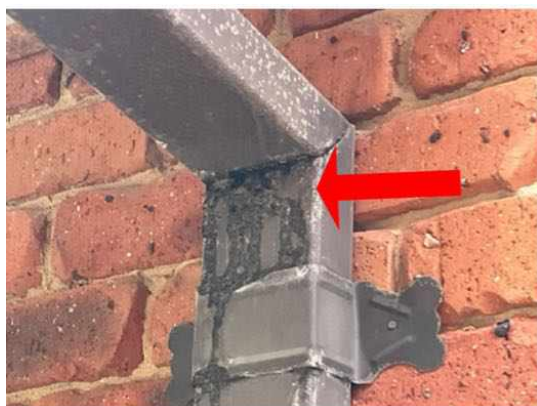
### Finding 3.08

Building:	Main Building
Location:	Roof Exterior
Finding:	Water Leak - Gutters
Information:	Water leaks were found to be present to exterior plumbing work. Leaks are generally caused by deterioration of the plumbing elements over time, due to exposure to weather conditions, but may have also been caused by minor impact damage.

Such leaking creates damp conditions in the affected area, causing potential for water pooling and subsequent water damage if left unattended. These conditions may also attract termite attack, particularly if the area is subject to minimal levels of sun throughout daylight hours.

It is highly advised that a licensed plumber be appointed to rectify any water leaks that may be present. Areas of repair and replacement of plumbing fittings and fixtures may be required and, as such, a quotation should be sought.

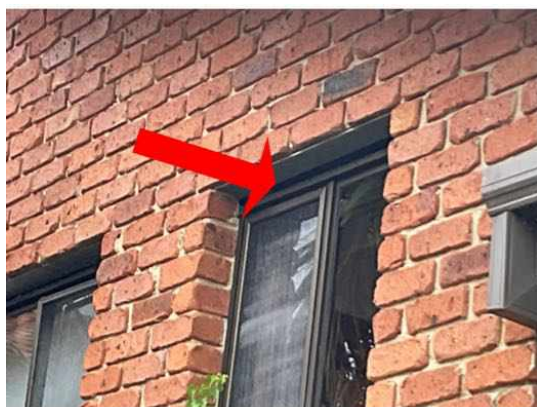
### Finding 3.09

Information: A significant gap was identified between the brick and window frame in this area. Where large gaps to the head appear, it may be indicative of a variety of defects, ranging from uneven framework, sagging hinges or uneven flooring.

A gap to the head of the window may also indicate movement of the foundation of the property, which is a common occurrence and does not indicate structural damage.

A qualified tradesman should be appointed to perform remedial works to restore the window to a fully operational level.

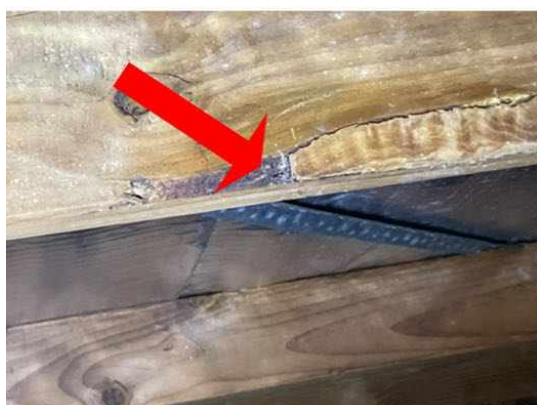
Building:	Main Building
Location:	Subfloor / Roof void
Finding:	Chemical delignification identified
Information:	Chemical delignification also known as wood defibration refers to the chemical breakdown of timber building elements. This breakdown of the Lignin deteriorates the wood impacting on the structural integrity and tensile strength of the affected building element.

Chemical delignification is most common near marine environments due to the high levels of salt in the air however this deterioration may also occur in other areas where timber elements are frequently exposed to damaging gases chemicals etc.

Where timber building elements have deteriorated repair and / or replacement is required immediately to ensure the safety of the associated structures. The likely cause of the defibration should also be investigated and dealt with accordingly.

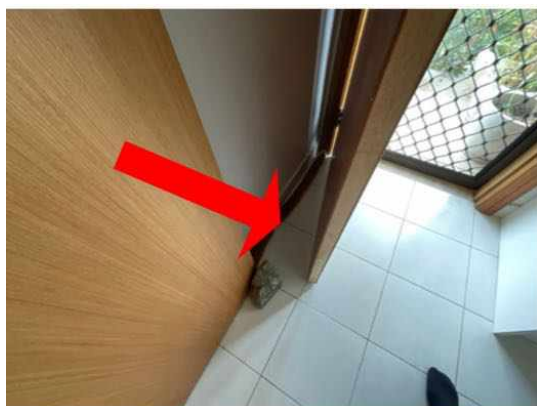
### Finding 3.12

Building:	Main Building
Location:	All Internal Areas
Finding:	Door stop - Missing
Information:	The door stop is missing or is inadequate to stop the door handle from damaging the wall. Although some building elements may seem irrelevant or unnecessary, all building elements play a key role in the operation and function of the overall structure and its performance.

Re-installation or replacement of the door stop is advised as soon as possible to prevent any subsequent damage to the door or associated structures. A general handyman may be appointed to perform these works at client discretion.

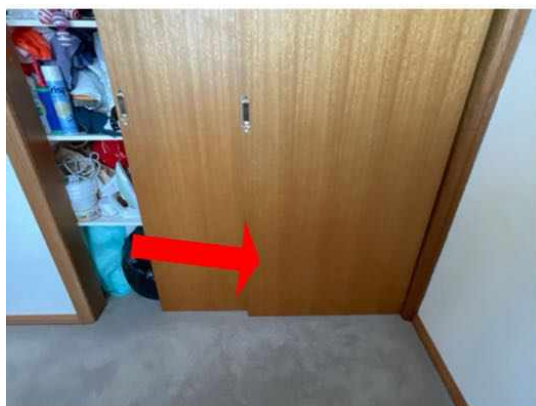
### Finding 3.13

Building:	Main Building
Location:	Bedrooms
Finding:	Sliding Door - Stiff to slide
Information:	The door in this area was jammed and difficult to slide along the associated tracks at the time of the inspection. Restricted function of the affected door may pose as a potential safety hazard if required for emergency egress from the building.

Generally, factors such as general age of the building element and a lack of maintenance are the usual causes for this type of defect.

Replacement of door hardware or tracks may be required, as well as minor repairs and cleaning. A registered builder or general handy person will be required to repair the affected doors.

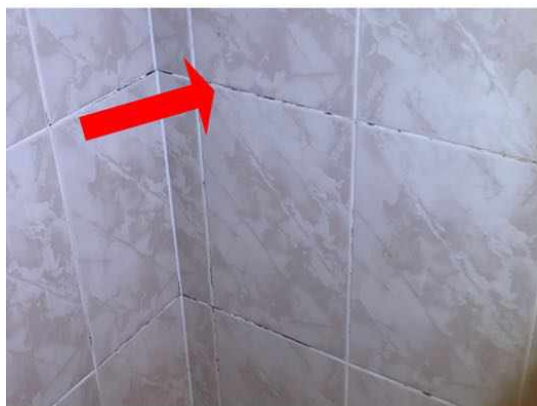
### Finding 3.15

Building:	Main Building
Location:	Bathroom
Finding:	Mould Growth to Sealant – Bathroom Area
Information:	Mould is visible to the silicone sealant at the junction between the basin / tiles and the wall tiles. Mould growth indicates excess moisture and inadequate maintenance, which may lead to deterioration of the sealant and potential water ingress into adjoining surfaces. Recommend removal and replacement of the affected sealant with a suitable mould-resistant silicone and ensuring proper cleaning and ventilation to prevent recurrence.

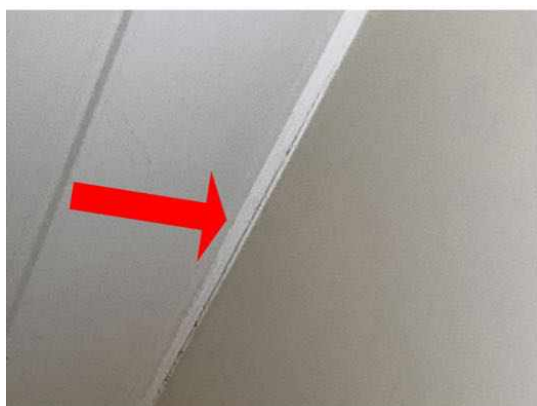
Building:	Main Building
Location:	All Internal Areas
Finding:	Cornices - Sagging
Information:	Sagging and uneven cornices generally indicate that the building materials have swollen, due to contact with water, or the movement of the ceiling joints or that fixings (e.g. nails or glue) have become loose and require reattachment. In some cases, sagging and uneven surfaces may also indicate that there are structural issues causing surfaces to warp, twist, or sag.

Where sagging appears to be major, appointment of a structural engineer is advised to further inspect the property. Otherwise, minor works such as re-gluing of wall/ceiling sheets may be required and should be performed by an aptly qualified plasterer or carpenter.

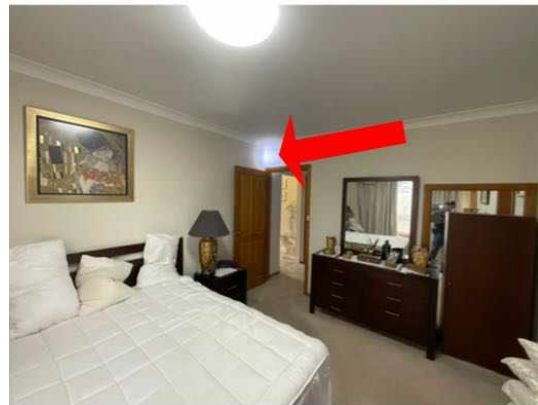
### Finding 3.18

Building:	Main Building
Location:	All Internal Areas
Finding:	Cracking - Damage Category 1 - Fine (up to 1mm)
Information:	Although fine cracks are quite noticeable, they are often only considered to be an appearance defect, and usually do not indicate any structural damage. Generally, the cause of a fine crack is indicative of a separation between building materials and finishes (e.g. paint, plaster, etc.) along joints.

Cracking of this nature can generally be repaired with minor sanding, filling and/or repainting. Such works should be performed by a qualified painter or a general handyman.

Monitoring of all cracking should be conducted frequently. Always contact a building inspector should cracks widen, lengthen, or become more numerous.

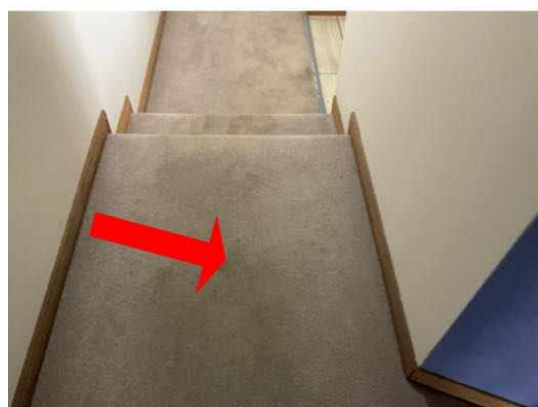
Bouncy floors generally indicate that the floorboards or the subfloor structures are coming loose from the joists that they are installed on. Bouncy flooring may also be the result of gaps between flooring and stumps or joist structures, which require packing.

The client is advised to seek quotations for required repairs from a Registered Builder specialising in re-stumping. The potential resolution may range from packing gaps in subfloor structures through to replacement of subfloors stumps and refixing of flooring.

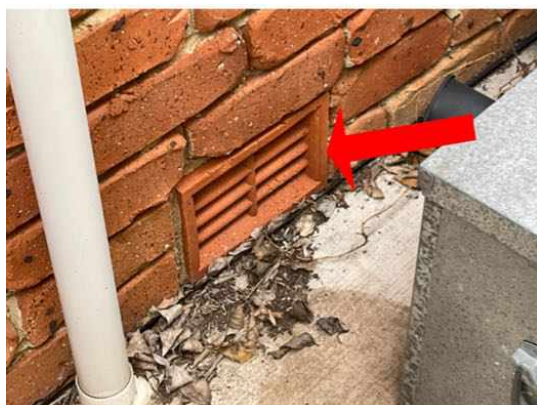
Weep holes in the exterior brickwork of the property are designed to allow condensation that may build up between the brickwork and subsequent timber framework to drain from within the wall hence preventing any deterioration of the timber building elements.

Additionally build-up of moisture is likely to occur if weep holes are covered further attracting termite activity to these areas.

It is highly recommended that weep holes are left exposed in all areas throughout the external property. Therefore if any termite activity leading into weep holes becomes easily detectable during frequent pest inspections.

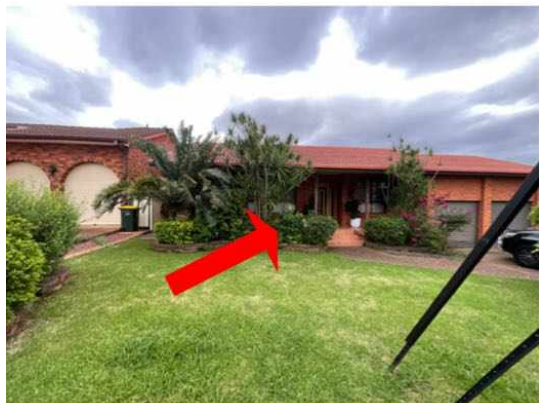
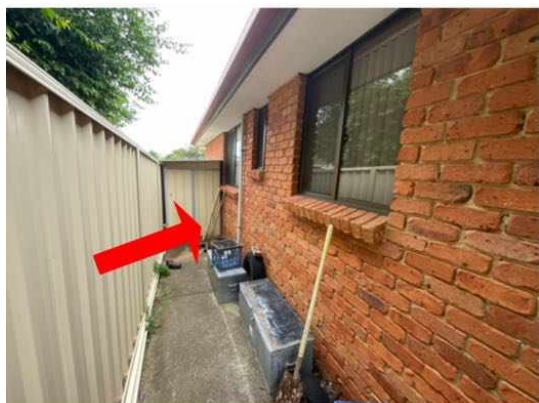
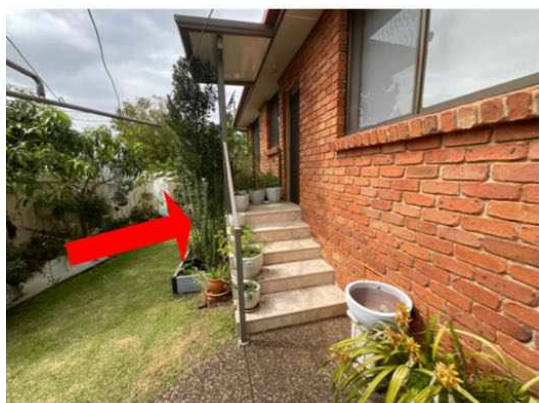
### Finding 6.02

Building:	Main Building
Location:	All Areas
Finding:	Bridging of termite barrier/inspection zones
Information:	Bridging is the spanning of a termite barrier or inspection zone so that subterranean termites are provided with passage over or around that barrier.

It is recommended that minimum 75mm clearance below the bottom of weep or ventilation holes be maintained where possible, otherwise annual inspections should be conducted by a licensed pest control company. Vegetation should also be kept clear of walls to allow regular inspection of all areas.

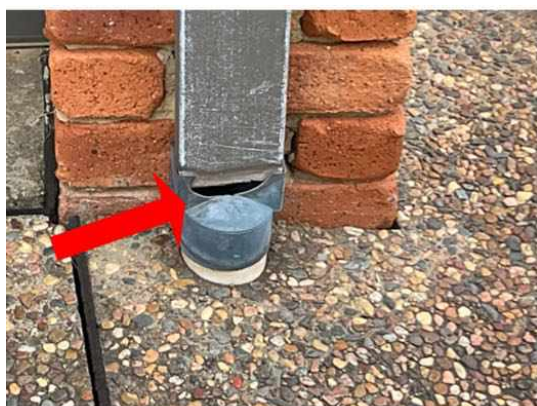
**Finding 6.04**

Building: Main Building  
 Location: All Areas  
 Finding: Overflow - Not plumbed for drainage  
 Information: The overflow is not plumbed or connected to suitable drainage, which has resulted in the surrounding area becoming excessively damp. These damp conditions can lead to secondary defects such as rot, rust or corrosion of associated building elements, the formation of fungal decay, or even the creation of potential slip hazards. When coupled with poor site drainage, pooling of water may also attract termite activity to this area. It is highly recommended that a qualified plumber be appointed to install adequate drainage to the overflow. These works will ensure that the area remains dry and free of any secondary defects.

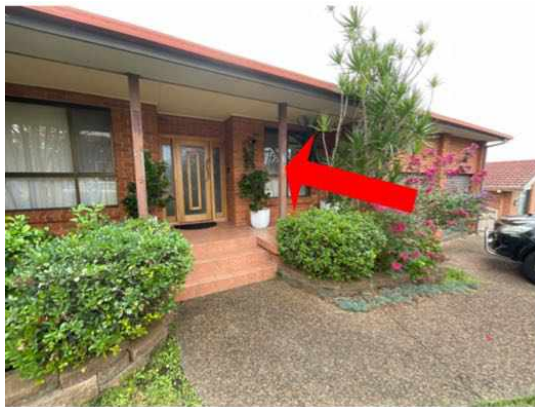
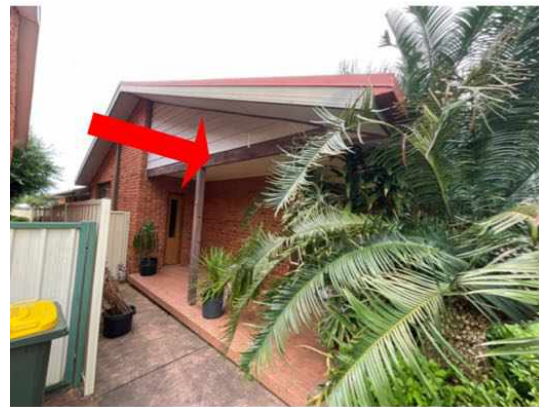
**Finding 6.05**

Building:	Main Building
Location:	All Areas
Finding:	Timber - exposed to weather
Information:	External timbers that are frequently exposed to harsh weather conditions require adequate protection in order to maintain their condition. Where timbers have not been painted or treated adequately, general deterioration is likely to occur at an accelerated rate.

If left unattended, replacement of these timbers is likely to be necessary in the short-term future. Adequate treatment of these timbers is required as soon as possible by a painting contractor or general handyman.

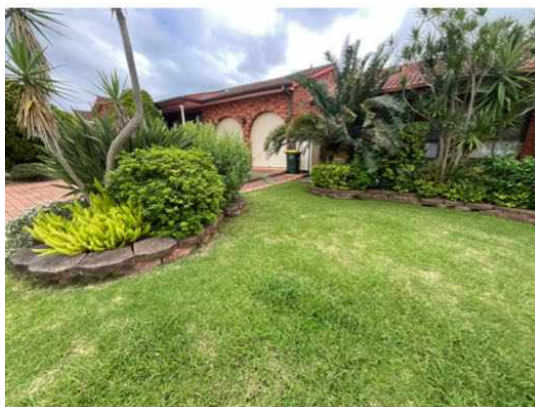
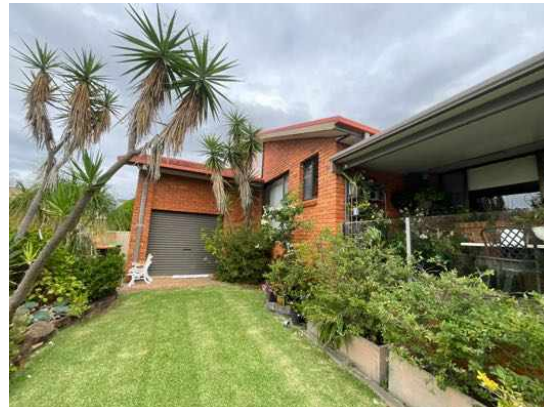
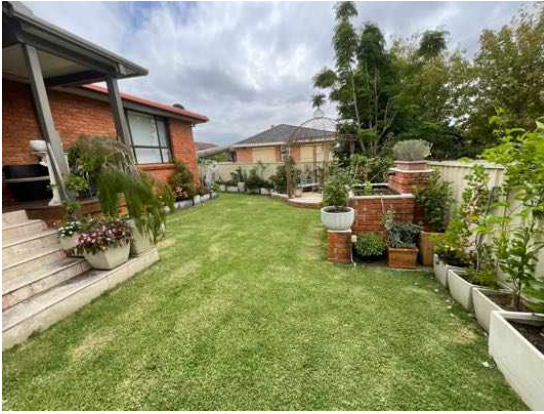
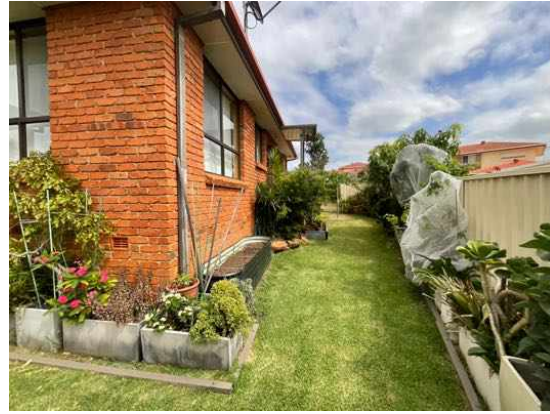
### Finding 6.06

Building:	Main Building
Location:	All Areas
Finding:	Garden Beds - Conditions Conducive to Termites
Information:	Garden beds were found to be evident in the garden area. These garden beds can include untreated timber, and with a combination of moisture from watering hosing can make conditions conducive to termite activity and termite ingress.

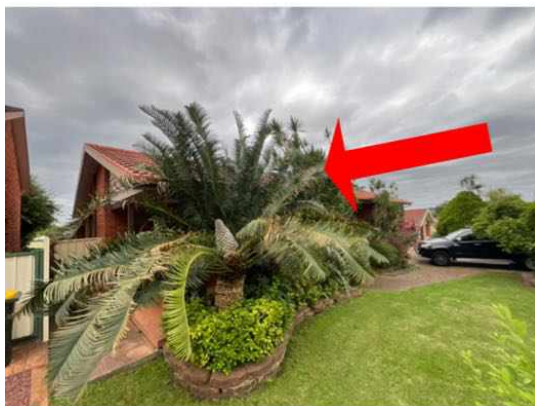
### Finding 6.07

Building:	Main Building
Location:	All Areas
Finding:	Trees - Overhanging and filling gutters
Information:	Overhanging trees often result in excessive amounts of leaf debris accumulating in gutters.

Such works should be performed by the homeowner; however, appointment of a landscape contractor or an arborist may be required. Consultation with a licensed roof plumber is required where guttering has been damaged.

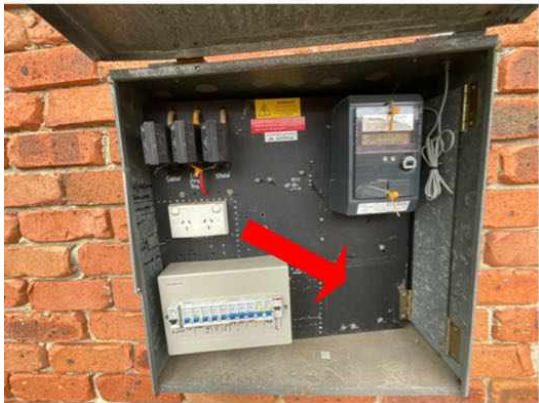
Building:	Main Building
Location:	All Areas
Finding:	Termite Management System - no evidence of a chemical installation
Information:	The application of a post-construction chemical termite barrier is highly recommended for all properties, particularly if live termite activity has been found on the site previously. Such barriers are highly effective in preventing termite attack on any timber building elements throughout the property.

The client may consider gaining further advice from a pest controller as to the costs and procedures involved with this application. It is recommended that obtaining such advice be a short-term priority.

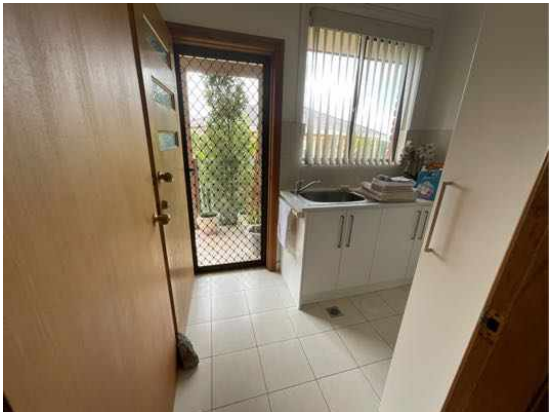
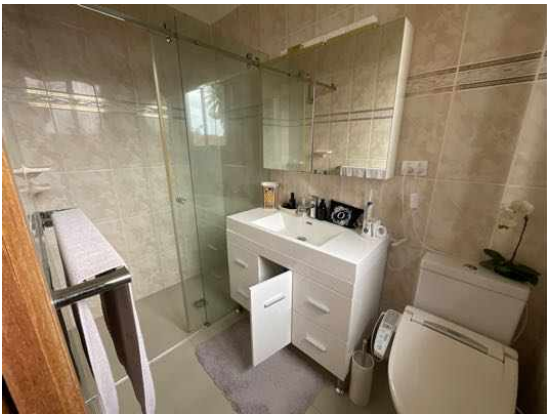
Building: Main Building  
Location: All Areas  
Finding: Water Proofing Membranes - Information Only  
Information: Internal Water Proofing Membranes, are crucial in preventing water ingress into the property is important to know that the Membrane System used is to Australian Standards and has been installed correctly. Please refer to the original Building Documents or Maintenance Schedule for the relevant information including; - Membrane used and Manufacturers Specifications. - The Installer and Installation Certification. Especially with older property's where this information is unavailable, all wet areas should be monitored. Generally new waterproofing with a certificate may only have a guarantee of 8yrs. If any leaks, water staining, peeling or bubbling of the paint become evident to any adjacent walls or ceilings below a licensed builder or waterproofing specialist is recommended to investigate further.
