Building and Timber Pest Inspection Report

Inspection Date: Fri, 27 Feb 2026

Property Address: 73 Willandra Cres, Windale NSW 2306,
Australia

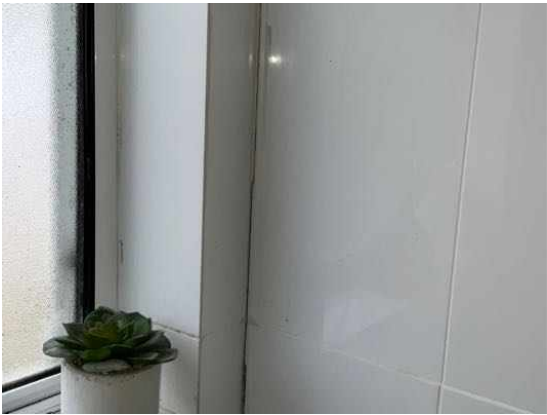
Building:	Main Building
Location:	Bathroom > Front Right
Finding:	Sealant and grouting - Missing or damaged
Information:	It was noted on inspection that sealant or grout is degraded to areas of the bathroom.

Different materials and floor areas move at different rates, generally causing cracking to grout or sealant at this point. A flexible sealant is required to allow for expected expansion and contraction, while keeping the joint water tight and protective of all associated building materials.

There appears to be excessive mould to the sealant and grout which will likely require scraping out and replacement.

Flexible and mould resistant materials should be applied to affected areas to prevent any subsequent water damage that is likely to occur. Regular maintenance and replacement of damage or missing or damaged sealant and grout is highly recommended to the wet areas, as this is a regular wear and tear defect. Sealant and grouting in areas that come into regular contact with water should be maintained for the long term care of your property.

A sealant specialist or tiling contractor should be appointed to complete these works as soon as possible

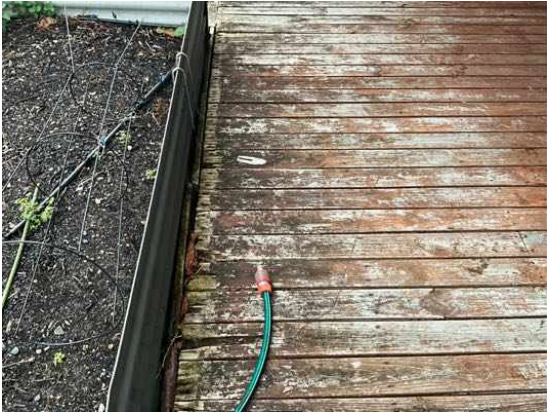
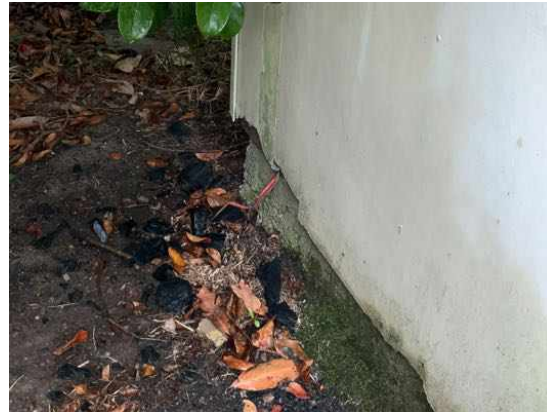
Building:	Main Building
Location:	Garage > Rear Left
Finding:	Garage - Defects
Information:	The rear garage and associated deck show a number of defects including wood rot to sections of the deck structure, the absence of a functional gutter due to damage, areas of bouncy decking, damaged fibro sheeting (potentially asbestos) to the lower sections, deteriorated deck staining, a weather-affected door, roof sheeting showing signs of corrosion, peeling paint, and wood rot to fascia and barge boards.

These defects indicate general deterioration and may allow further water ingress and material decay over time if not addressed.

It is recommended that a suitably qualified builder assess the structure and associated elements and undertake repairs or replacement as required. If the fibro sheeting is confirmed to contain asbestos, removal should be undertaken by a licensed asbestos

contractor.

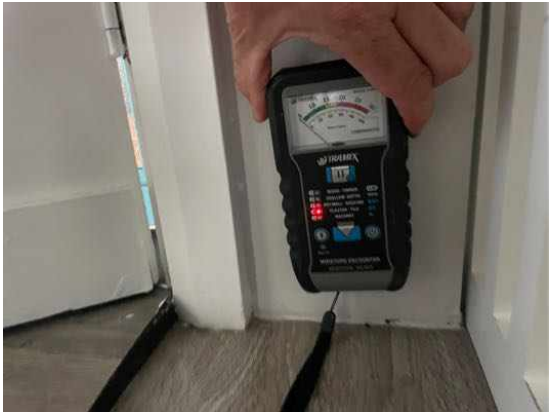
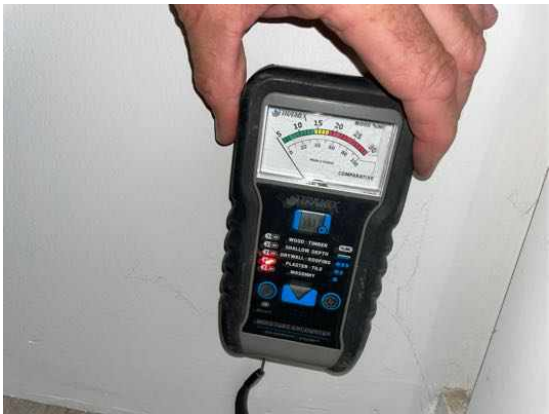
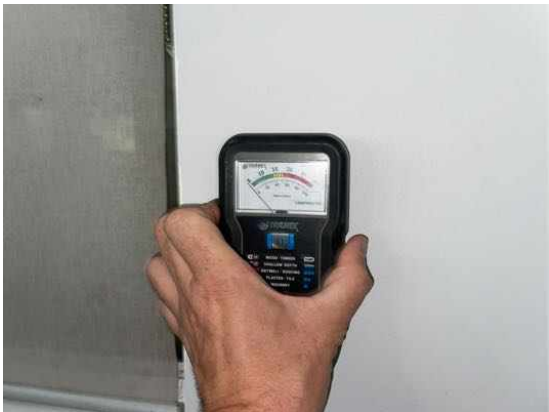
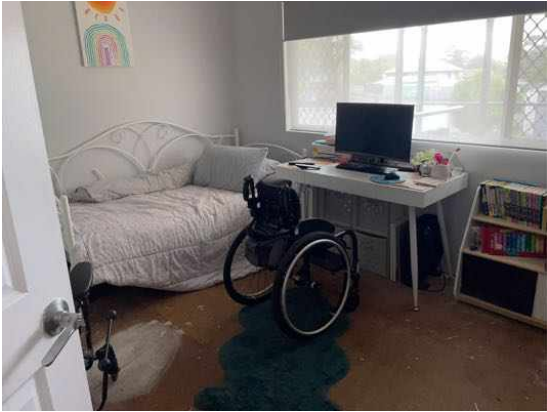
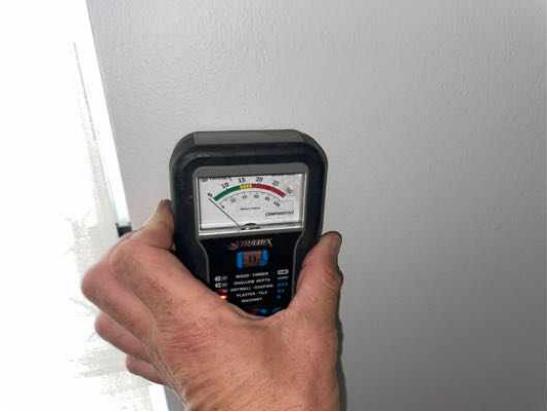
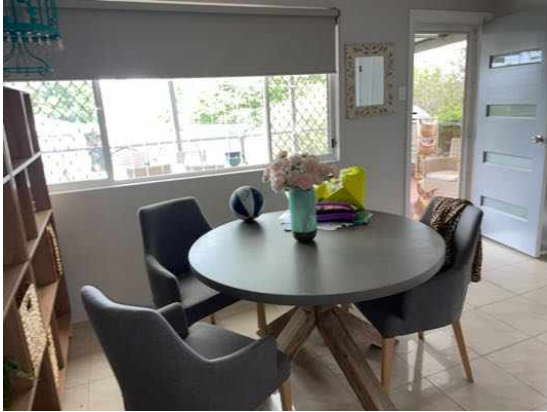
Building: Main Building
Location: All Internal Areas > All Areas
Finding: Moisture Readings
Information: Moisture readings were taken to the wet areas and below and beside windows.
