Building and Timber Pest Inspection Report

Inspection Date: Wed, 3 Dec 2025

Property Address: 11a Figtree Ave, Randwick NSW 2031,
Australia

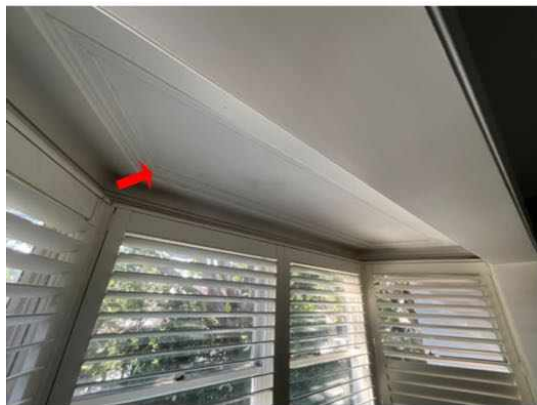
Finding 3.01

Building: Main Building
Location: Bedroom
Finding: Mould - Present
Information: Generally, the client is advised to ensure that the general environment is free of moisture and humidity to aid in the prevention of mould formation and development.

Any mould found during the inspection should be cleaned by a cleaning contractor or the homeowner as applicable.

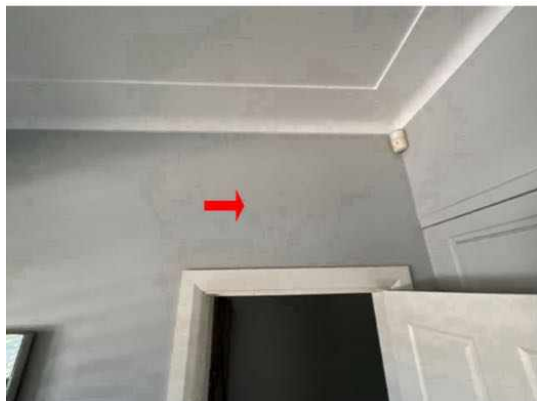
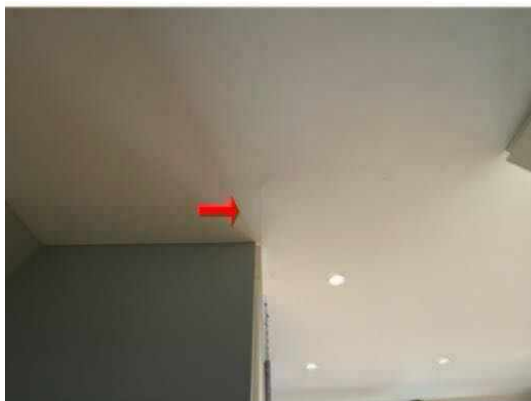
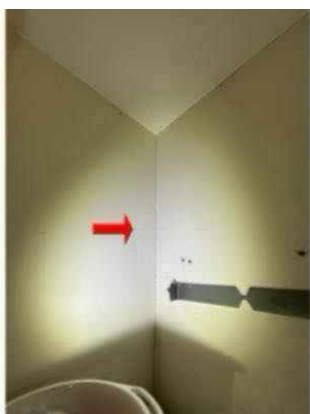
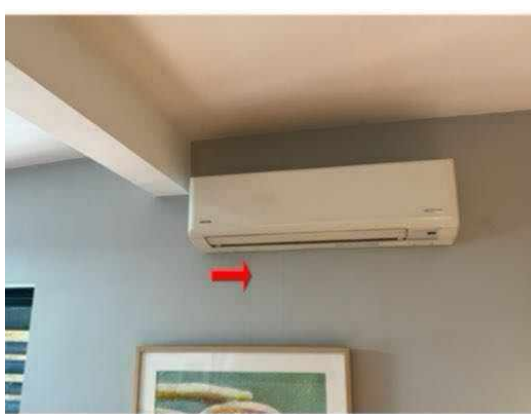
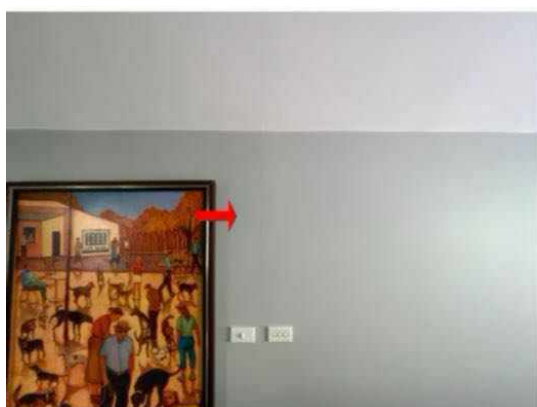
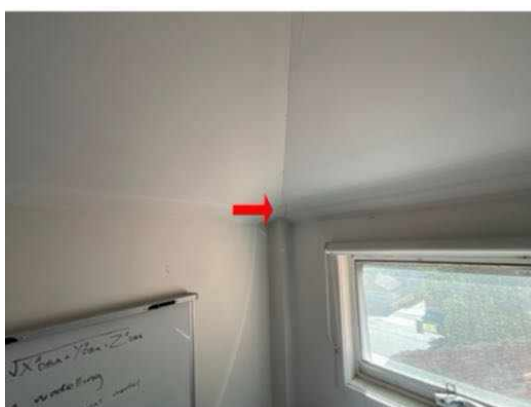
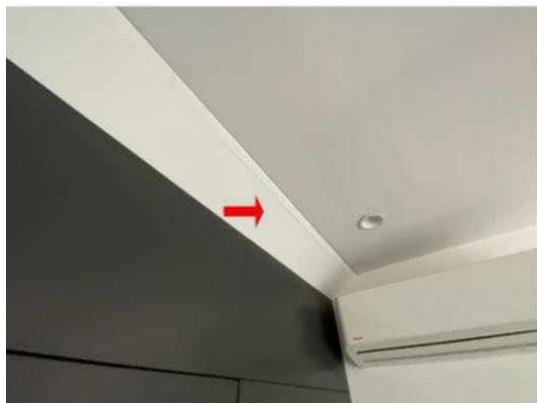
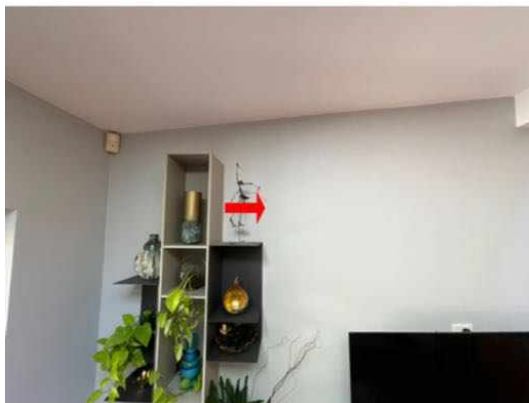
Finding 3.02

Building: Main Building
Location: Internal Areas
Finding: Cracking - Damage Category 1 - Fine (up to 1mm)
Information: Although fine cracks are quite noticeable, they are often only considered to be an appearance defect, and usually do not indicate any structural damage. Generally, the cause of a fine crack is indicative of a separation between building materials and finishes (e.g. paint, plaster, etc.) along joins.

Cracking of this nature can generally be repaired with minor sanding, filling and/or

repainting. Such works should be performed by a qualified painter or a general handyman.

Monitoring of all cracking should be conducted frequently. Always contact a building inspector should cracks widen, lengthen, or become more numerous.

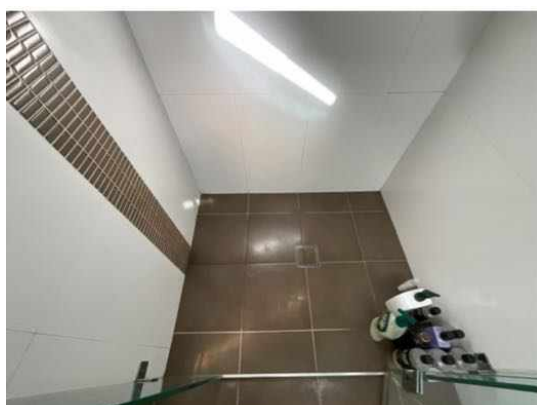
Finding 3.03

Building:	Main Building
Location:	Bathroom
Finding:	Sealant and grouting - Missing or damaged
Information:	It was noted on inspection that sealant or grout is degraded to the tiled areas.

Different materials and floor areas move at different rates, generally causing cracking to grout or sealant at this point. A flexible sealant is required to allow for expected expansion and contraction, while keeping the joint water tight and protective of all associated building materials.

Flexible and mould resistant materials should be applied to affected areas to prevent any subsequent water damage that is likely to occur. Regular maintenance and replacement of damage or missing or damaged sealant and grout is highly recommended to the wet areas, as this is a regular wear and tear defect. Sealant and grouting in areas that come into regular contact with water should be maintained for the long term care of your property.

A sealant specialist or tiling contractor should be appointed to complete these works.

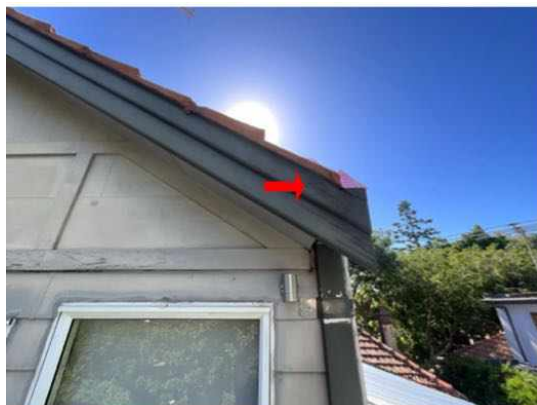
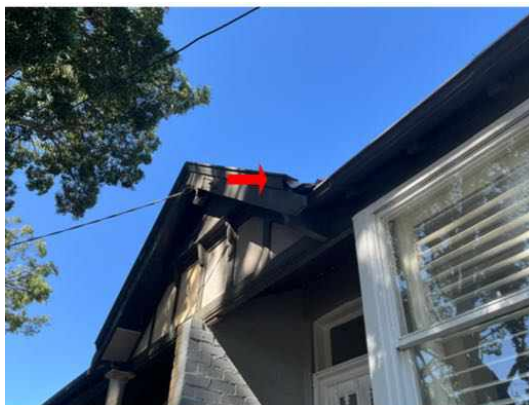
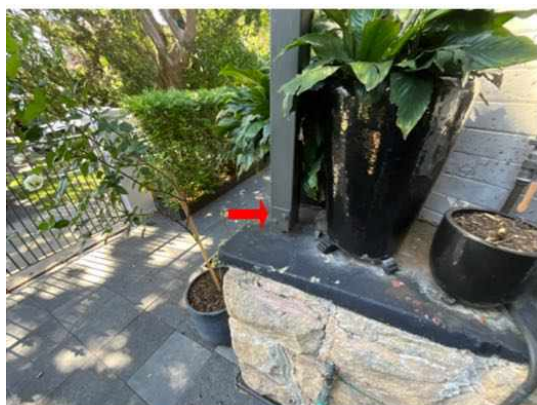
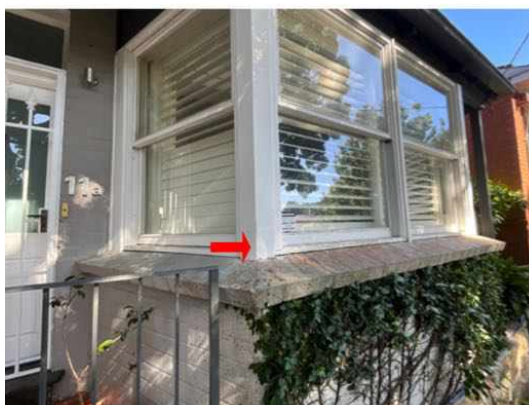
Finding 3.04

Location: External Areas
 Finding: Wood rot
 Information: This building element shows evidence of wood rot. Wood rot, also known as Fungal Decay, occurs when timbers and other cellulose building materials are exposed to damp conditions on an ongoing basis. This could be the result of exposure to weathering over a prolonged period of time, or the attraction of excessive moisture from other abutting building materials.

Early intervention and regular maintenance, particularly of exterior timbers, will prolong the useful life of these building elements. Prior to any works being performed, the cause of the moisture that has created the visible wood rot should be identified and addressed in a suitable manner. Replacement of affected timbers may then be a necessary step in protecting surrounding building elements from such deterioration.

A qualified carpenter or registered builder may also be required to replace affected building materials.

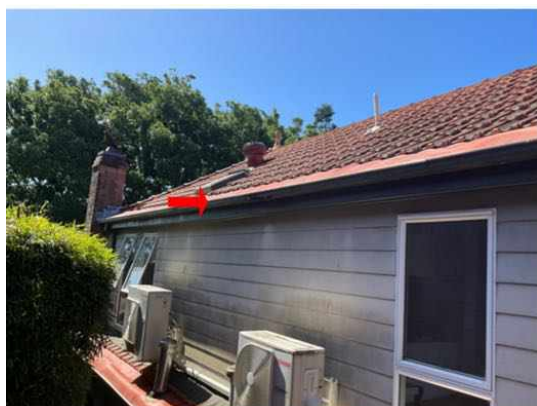
Finding 3.05

Building: Main Building
 Location: Roof Exterior
 Finding: Roof plumbing - Rusted or corroded
 Information: The roof plumbing has areas of rust and corrosion. It is suspected that this has been

caused by blockages, resulting in pooling or standing water, that have prematurely rusted elements of the roof plumbing.

Rusted roof plumbing will generally develop holes and leaks that can affect other building elements with poor drainage of storm water. Poorly drained roof areas will also lead to damp conditions surrounding the base perimeter of the building which, if left unmanaged, can lead to a range of secondary building defects.

Repair and/or replacement of rusted roof plumbing is highly required in order to reinstate the roof drainage system to a fully operational level. To further maintain these areas, gutters should be cleaned frequently, allowing the avoidance of any partial blockages.

A licensed plumber or specialist roof restoration company should be appointed to undertake these works.

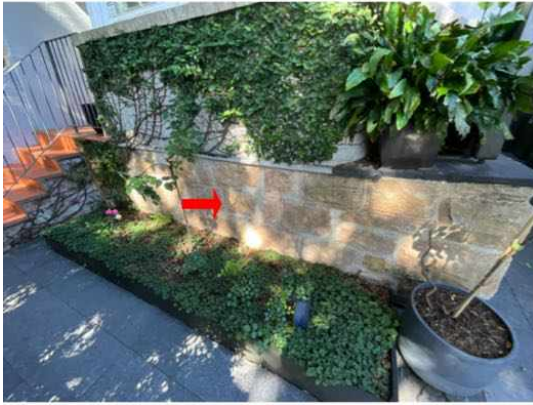
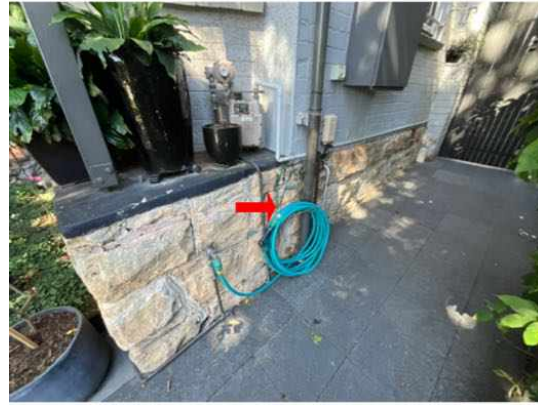
Finding 3.06

Building:	Main Building
Location:	Exterior walls - front
Finding:	Stone - Deteriorated mortar
Information:	Mortar, or 'bedding', is the material which fills joints and intersections between bricks/stone in masonry walls and structures. Sections of mortar in this stonework were identified as having deteriorated, which is generally expected for a property of this age and condition.

Mortar may deteriorate as a result of age of building materials, minor movement of bricks, or frequent exposure to weathering. Mortar should be replaced to ensure that stone blocks remain in their intended location and to prevent gaps, which would allow water or moisture ingress and secondary damage as a result.

Mortar deterioration can be addressed by a stonemason.

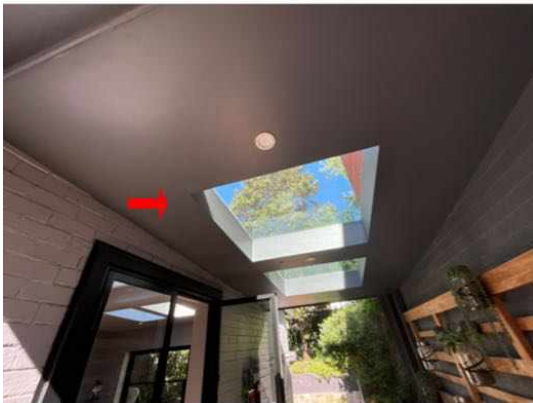
Finding 3.07

Location: Side Patio

Finding: Painted surface - Bubbling

Information: Sections of paint in this area was found to have bubbled and deteriorated. Paint bubbling is generally an indication of excessive moisture in the area past or present.

Although there was no moisture detected in the wall I would recommend monitoring this area.

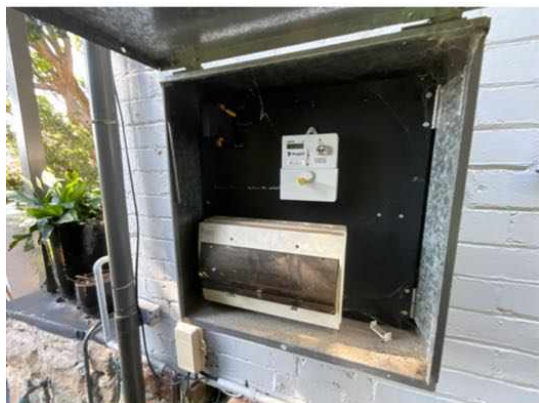
Finding 6.01

Building:	Main Building
Location:	All Areas
Finding:	Termite Management System - no evidence of a chemical installation
Information:	The application of a post-construction chemical termite barrier is highly recommended for all properties, particularly if live termite activity has been found on the site previously. Such barriers are highly effective in preventing termite attack on any timber building elements throughout the property.

A durable notice should be placed in the switchboard unit to indicate current termite barriers. At the time of inspection, it appeared as though no termite management system has been installed, with no evidence to suggest preventative works taking place.

The client may consider gaining further advice from a pest controller as to the costs and procedures involved with this application. It is recommended that obtaining such advice be a short-term priority.

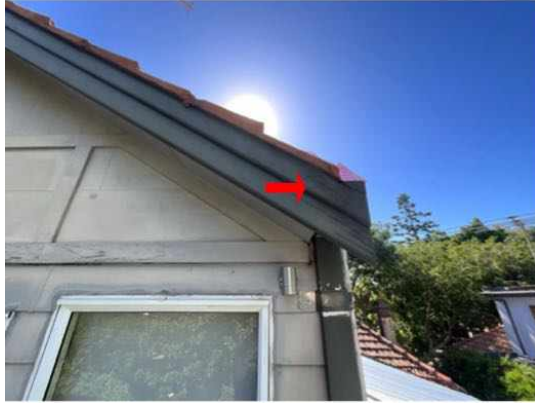
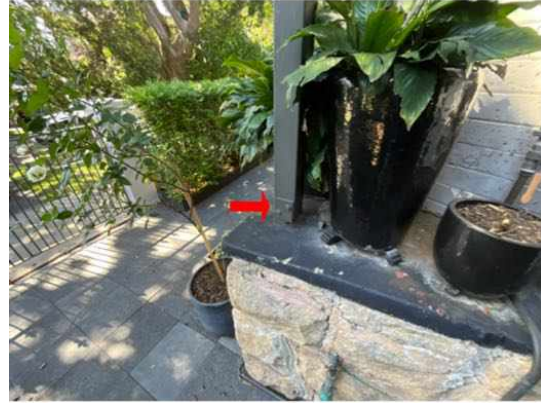
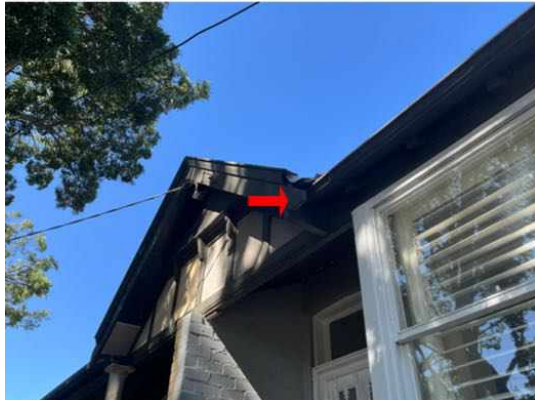
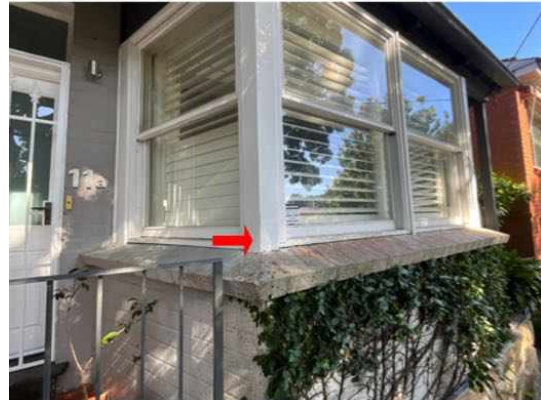
Finding 7.01

Building:	Main Building
Location:	External Areas
Finding:	Fungal decay - present (localised)
Information:	Fungal decay also known as wood decay or wood rot generally refers to the deterioration of timber elements when in contact with excessive levels of moisture for a prolonged period of time.

The development of fungal decay is accelerated by temperatures in the range of 5degreeC to 40degreeC as well as the presence of oxygen. Generally fungal decay develops on timber elements that are in use in an external environment which are exposed to rain penetration.

In this case although the affected timber element is in a decaying state the extent of any visible damage appears to be localised to a specific area and is yet to spread to other parts of the building element or affect adjoining structures. The fungal decay is therefore likely to be of a relatively superficial nature with minimal impact on the structural integrity or tensile strength of the timber element.
