Building Inspection Report

Inspection Date: Tue, 17 Feb 2026

Property Address: 6 Milparinka Way, Berwick VIC 3806,
Australia

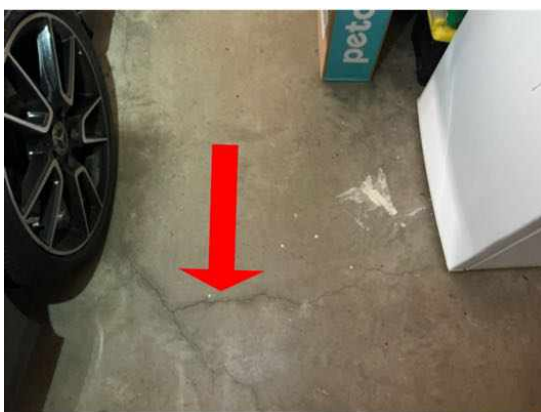
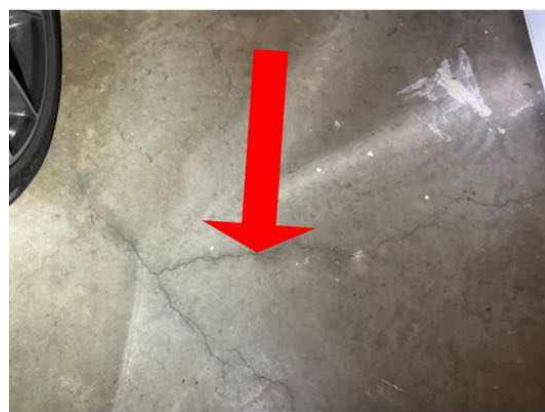
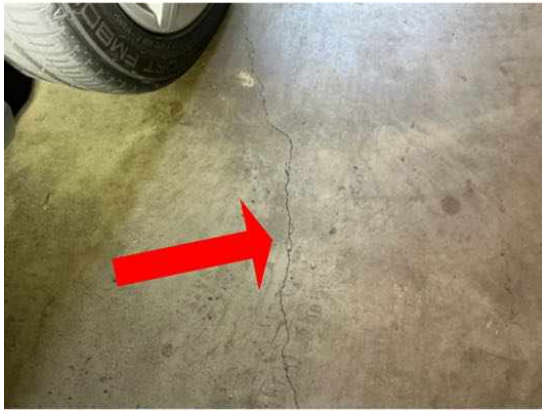
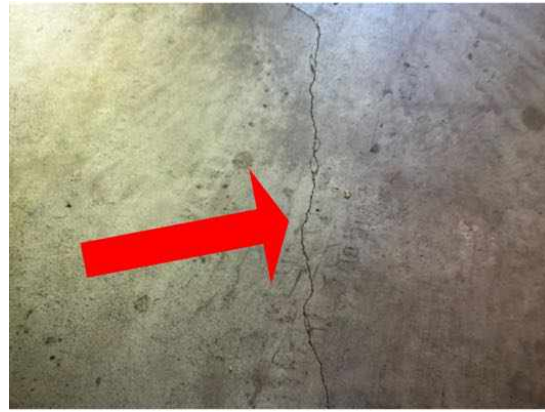
Defects 3.01

Building:	Main Building
Location:	Garage
Finding:	Noticeable cracks in concrete slab of the the garage floor
Information:	During the inspection, multiple noticeable cracks were identified in the concrete slab of the garage floor. These cracks vary in size and location, which may indicate underlying movement or stress within the slab. While they do not currently appear to significantly impact the structural integrity, their presence suggests potential early-stage deterioration.

It is recommended that the cracks be monitored closely over the next 12 months. If any of the cracks widen or worsen during this period, it is critical to engage a structural engineer immediately to assess the situation and recommend appropriate rectification measures to prevent further damage and ensure the long-term stability of the structure.

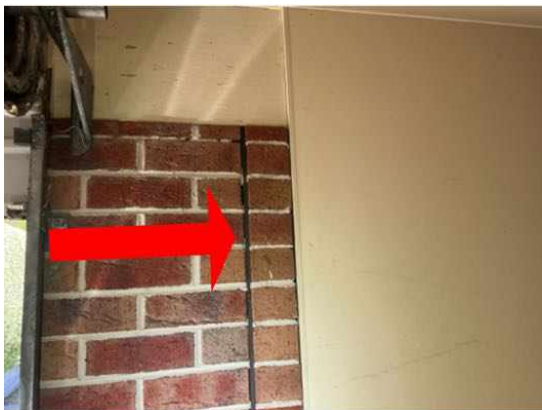
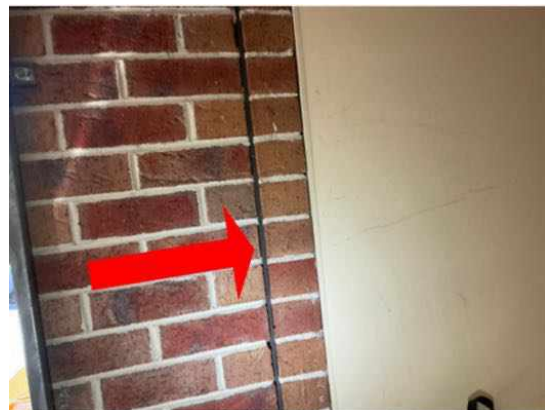
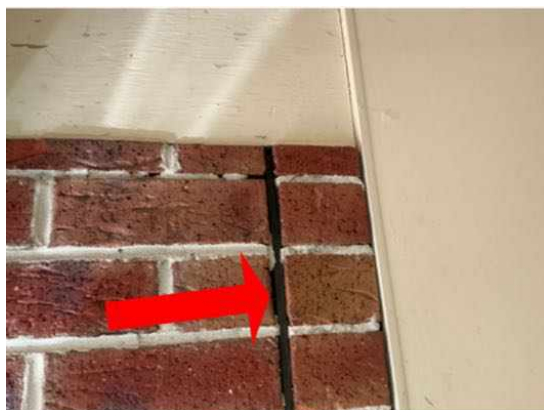
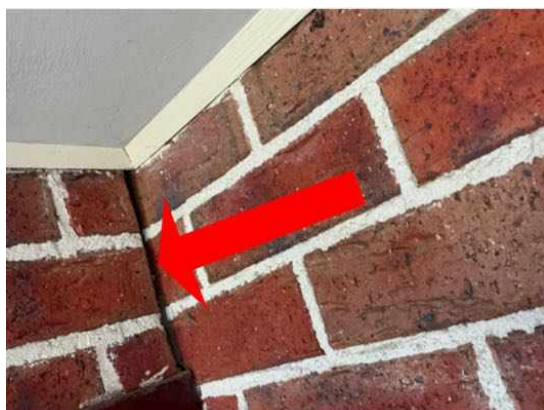
Defects 3.02

Finding: Brickwork expansion joint - Seal missing.

Information: During the inspection, it was noted that the seal for the brickwork expansion joint is missing on all exterior walls. Expansion joints in brickwork are critical as they accommodate the natural movement of building materials caused by thermal expansion, contraction, and other environmental factors. The absence of a proper seal in these joints can lead to several issues:

- Water Penetration: Without a seal, water can penetrate the expansion joint, potentially leading to water damage within the wall cavity and interior spaces. This can result in dampness, mold growth, and deterioration of building materials.

- Energy Efficiency: Gaps in the expansion joints can affect the building's insulation properties, leading to increased energy consumption for heating and cooling.

To address this issue, it is recommended that a qualified handyman, caulking specialist, or bricklayer be engaged to inspect and reseal the expansion joint. This will help maintain the integrity, durability, and appearance of the brickwork, as well as prevent potential water ingress and structural problems.

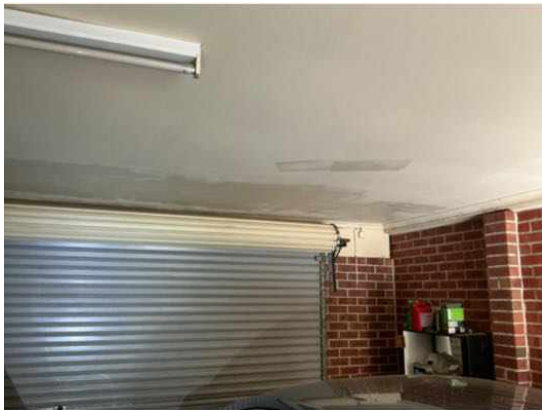
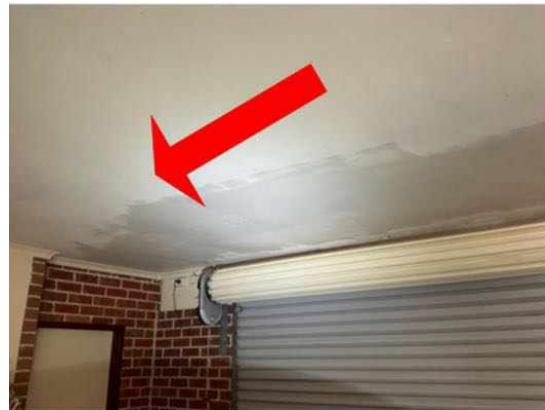
Defects 3.03

Building:	Main Building
Location:	Garage
Finding:	Ceiling sagging - garage
Information:	Sections of the ceiling were found to be slightly sagging at the time of inspection. Sagging in the fixed ceiling structure generally indicates that the building materials have swollen due to contact with water or that fixings (e.g., nails or glue) have become loose and require reattachment. This is a very common defect in garages due to their lack of insulation and susceptibility to moisture. Condensation builds up in the roof and rests on the plasterboard, softening it somewhat, which makes it more likely to sag and release from its fixing points.

In some cases, sagging ceiling linings may also indicate that there are structural issues causing surfaces to warp, twist, or sag. Where sagging appears to be major, the appointment of a structural engineer is advised to further inspect the property and identify the source and rectification works required.

Where sagging is evident, comparatively minor works, such as re-gluing of ceiling sheets, may be required. Such works may be performed by relevant tradespeople, such as plasterers and painters. Where excessive moisture has caused the roofing structure to swell and sag, the source of the water leak should primarily be identified prior to any remedial works being performed.

While damage is minimal at this stage, a licensed plasterboard contractor should be appointed to repair the ceiling. Insulating the area could be considered by the client once repaired.

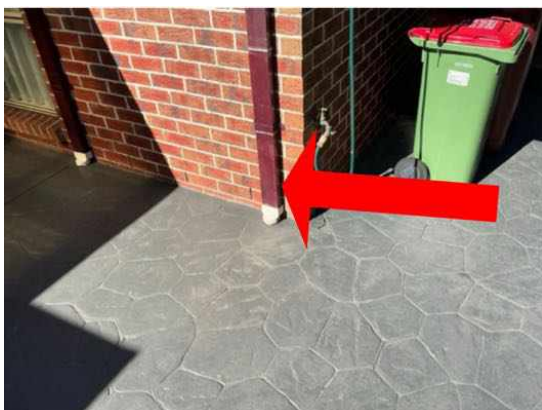
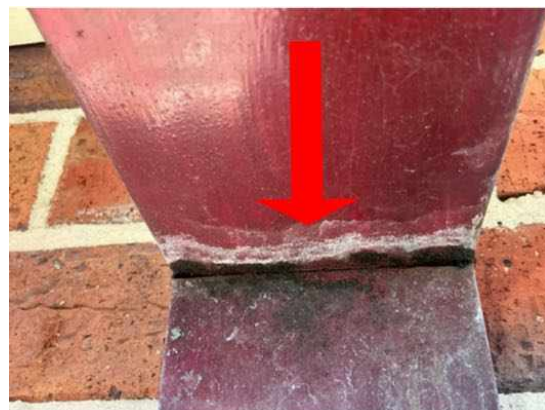
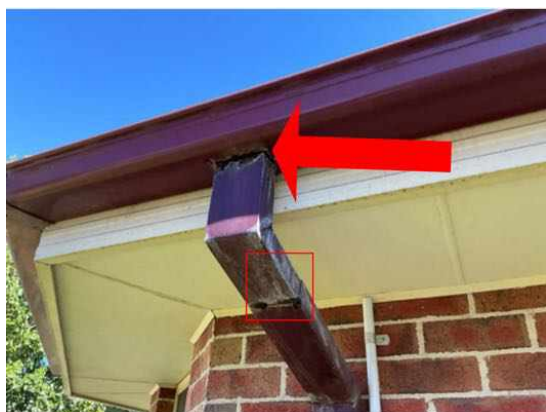
Defects 3.04

Building: Main Building
 Location: All External Areas
 Finding: Minor Leakage to Downpipes
 Information:

Several downpipes around the dwelling were observed to exhibit signs of minor leakage, with visible moisture staining and residue present to the pipe surfaces and adjacent areas.

Leaking downpipes may indicate loose joints, deteriorated seals, or minor connection defects. Ongoing leakage may result in localised moisture accumulation near wall bases and footings, which may contribute to surface deterioration and create conducive conditions for timber pest activity.

It is recommended that a licensed plumber inspect the affected downpipes, reseal or repair defective joints as required, and ensure that the stormwater drainage system is functioning effectively and discharging water correctly into the connected stormwater system.

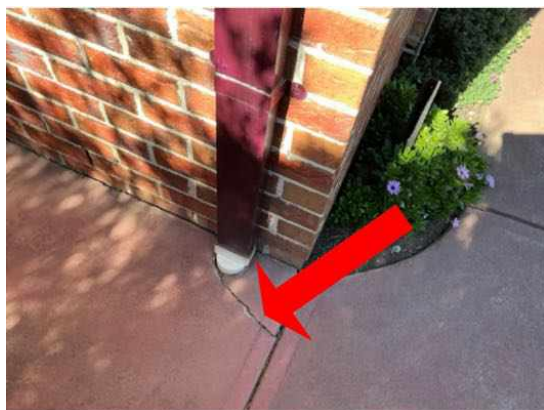
Defects 3.05

Building:	Main Building
Location:	All External Areas
Finding:	Cracking - External Concrete Paving Damage Category 3 - Wide Cracks (2mm - 4mm)
Information:	Wide cracks were identified in external concrete paving Wide cracks are significant and are likely to lead to the development of safety hazards and secondary defects if left unmanaged.

General age and expected deterioration of the paved areas is a common cause of this type of cracking. However, expansion and contraction of the slab may also have occurred due to environmental factors. Such factors include variable moisture and weather conditions, the presence of trees and their roots having a settling or lifting affect on the soil, or the effect of load bearing, e.g. heavy vehicles over a sustained period of time.

Cracking to this degree may also be due to poor original installation of the concrete. Factors such as poor compaction of the sub surface and/or inadequate reinforcing of the slab may create cracking and other secondary defects. Wide cracks may also have a more significant structural cause, such as subsidence of soils.

Where the crack is located adjacent to structural elements of the building, the advice of a Structural Engineer is advisable before undertaking repairs. Significant repair and likely replacement of the concrete paving is probable.

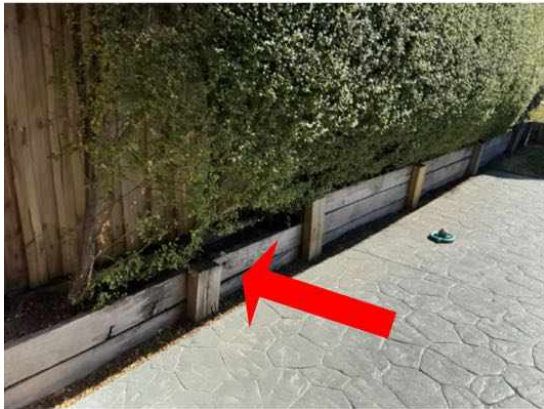
Defects 3.06

Building: Main Building
 Location: Retaining walls
 Finding: Deterioration to Retaining Walls
 Information:

The retaining walls surrounding the dwelling were observed to show signs of deterioration and moisture staining. Sections of the walls appear to be slightly out of alignment and no longer perfectly vertical.

Deterioration and movement to retaining walls may be associated with prolonged moisture exposure, inadequate drainage, or soil pressure over time. If movement progresses, it may lead to further displacement, cracking, or potential structural instability of the retaining system.

It is recommended that a qualified landscaper or retaining walls contractor inspect the retaining walls to assess their condition and structural adequacy. Any defective sections should be repaired, reinforced, or reconstructed as required, and appropriate drainage provisions should be ensured to prevent further moisture-related deterioration and movement.

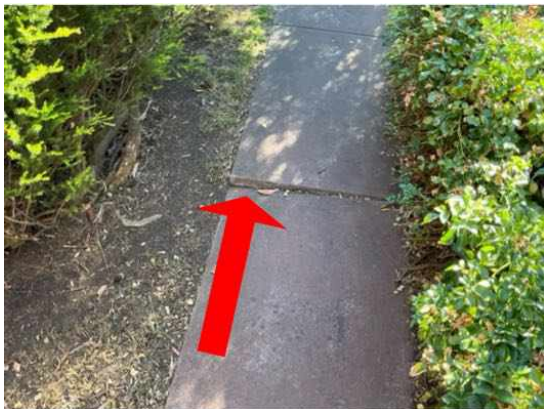
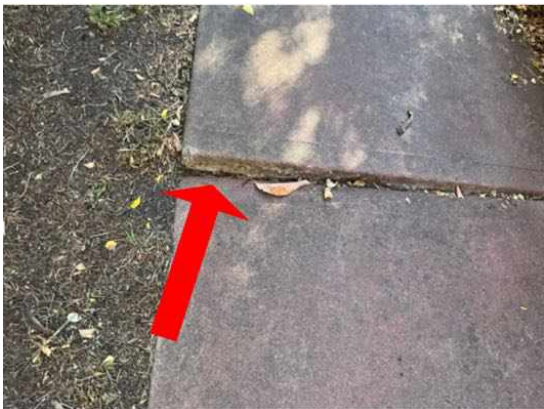
Defects 3.07

Building: Main Building
Location: Yard - Side
Finding: Uneven Concrete Paving to Side Yard
Information:

Sections of the concrete paving within the side yard were observed to have shifted and settled unevenly. Differential movement has resulted in height variation between adjoining slabs, creating a potential trip hazard.

Concrete movement may occur due to ground settlement, inadequate subgrade preparation, moisture variation within the soil, or tree root activity. If left unrectified, further displacement may occur, increasing safety risks and potential liability concerns.

It is recommended that a qualified concreter assess the affected paving areas. Uneven sections should be lifted and re-levelled on a properly compacted base, or removed and re-poured as required to eliminate trip hazards and restore a safe, even walking surface.

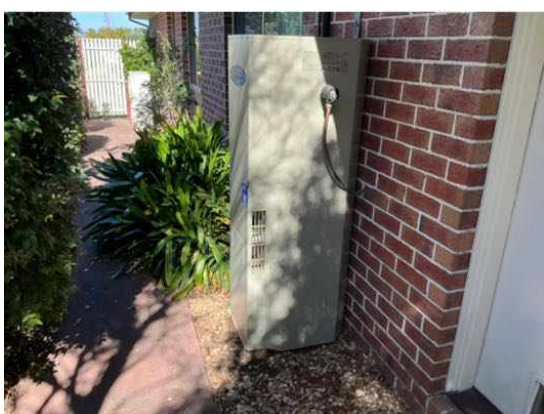
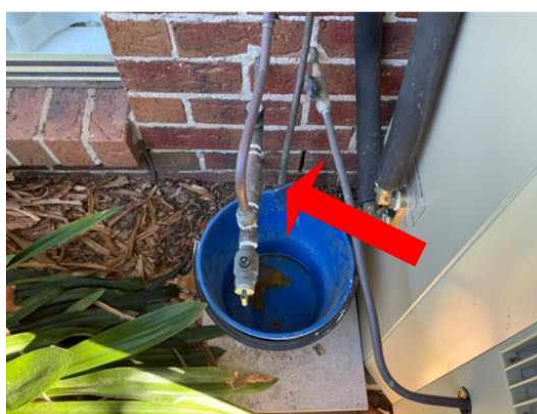
Defects 3.09

Building:	Main Building
Location:	Yard - Side
Finding:	HWS Overflow - Not Connected
Information:	The Hot Water System (HWS) overflow was found to be disconnected from storm water drainage and is creating excessive moisture in the surrounding area.

These damp conditions can lead to secondary defects such as rot, rust or corrosion of associated building elements, the formation of fungal decay, or even the creation of potential slip hazards. When coupled with poor site drainage, pooling of water may also attract termite activity to this area.

It is highly recommended that a licensed plumber be appointed to connect the HWS overflow in order to prevent such an environment from being created. These minor works should be carried out as soon as possible.

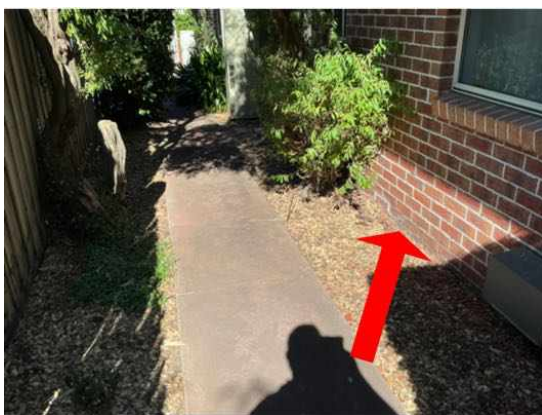
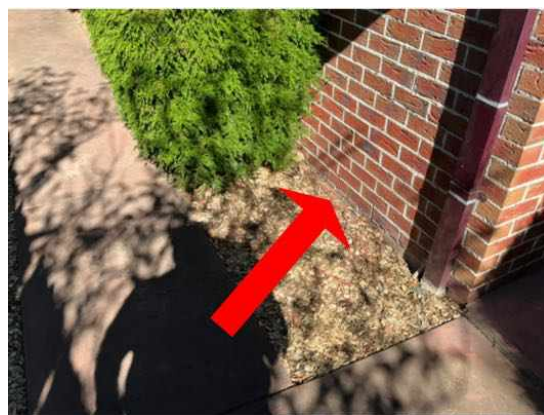
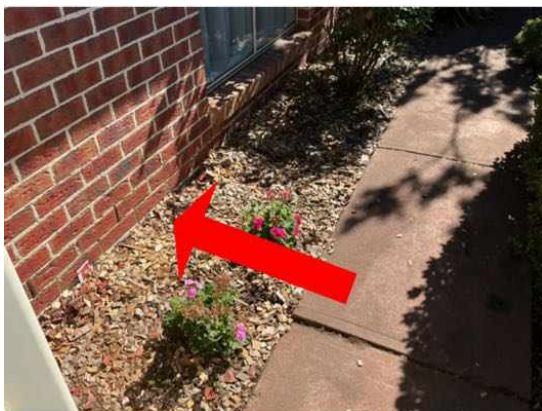
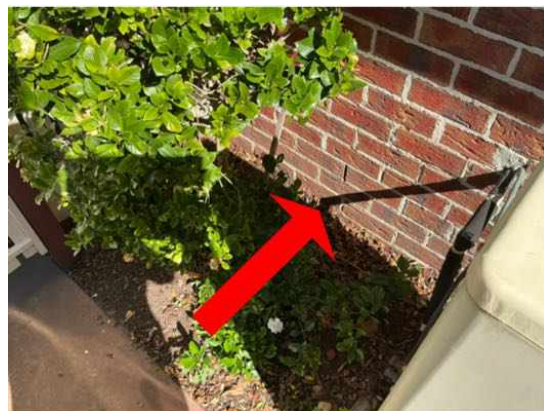
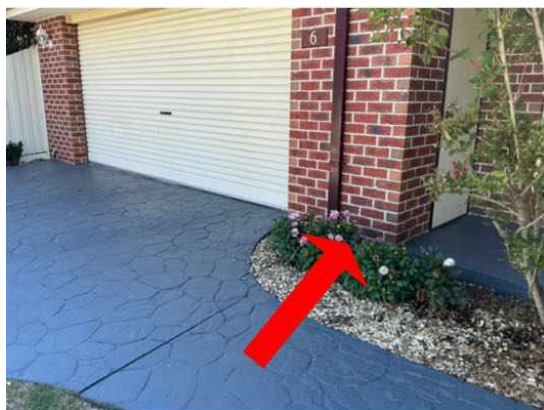
Defects 3.10

Building:	Main Building
Location:	All External areas
Finding:	Site drainage - Inadequate
Information:	The site drainage in sections of the yards was found to be inadequate at the time of

inspection, creating potential for subsequent water damage to associated building elements.

It is important that water does not lie against the base of walls; surrounding paths and ground levels should be sloped to drain water away from walls. Downpipes should not discharge stormwater onto lower walls or plinths. Stormwater should be carried away by large, regularly cleaned drains. Ground levels may need to be lowered to expose a buried DPC.

Where site drainage is inadequate, installation of an Agricultural (Aggie) Drain may be required. A qualified plumber should be appointed to further inspect the property and perform any remedial works as necessary. Water damage and secondary defects are likely to occur if left unmanaged.

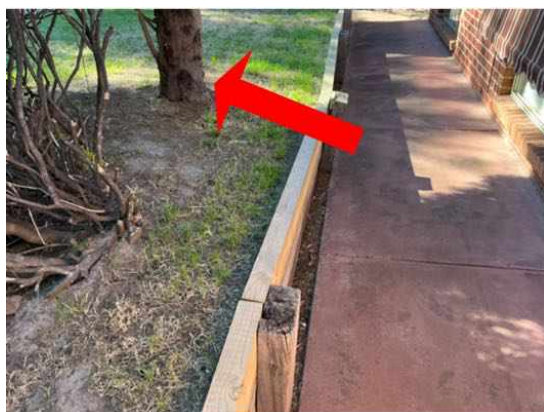
Defects 3.11

Building:	Main Building
Location:	Yard - Back
Finding:	Trees in close proximity to the building
Information:	Upon visual inspection, A tree was observed to be in close proximity to the perimeter of the house at the rear elevation. Trees situated close to the house can attract termites, which may lead to further issues with timber elements.

It is recommended that a an arborist assess the condition of the trees and their potential impact on the property. Regular monitoring of the trees, including their roots and potential for attracting pests, is advised to ensure they do not compromise the integrity of the house and surrounding features.

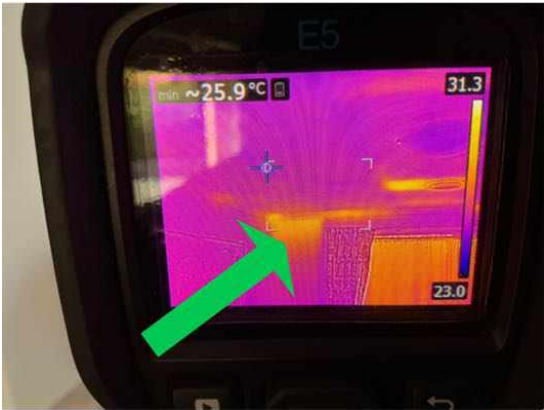
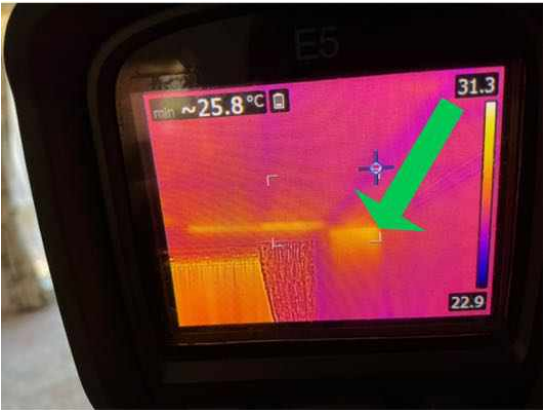
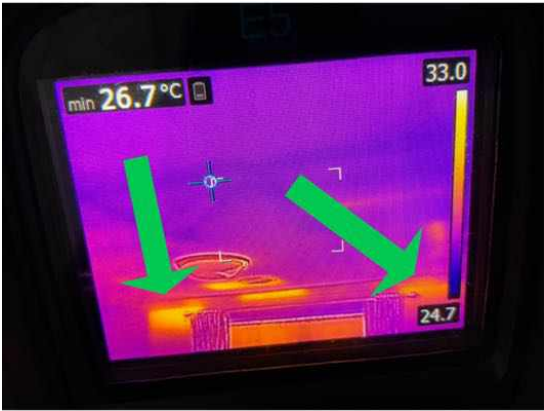
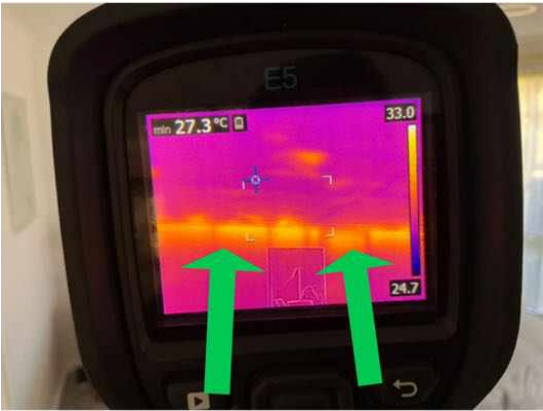
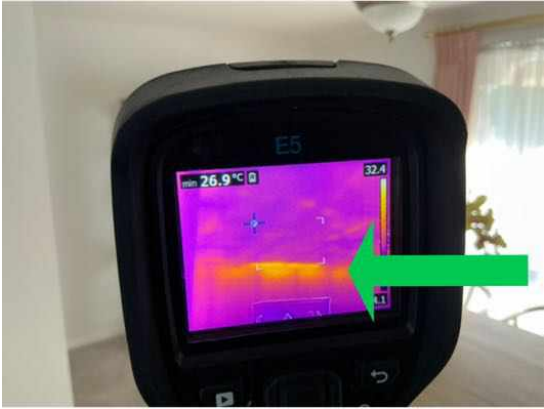
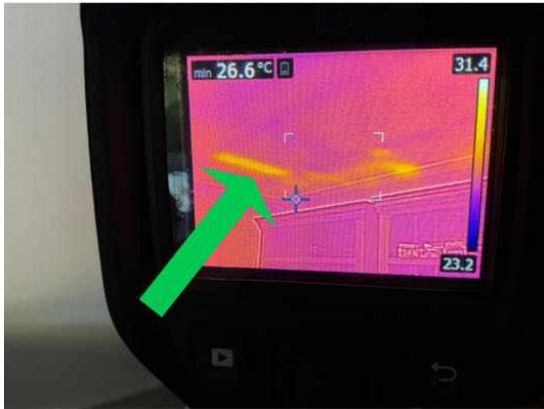
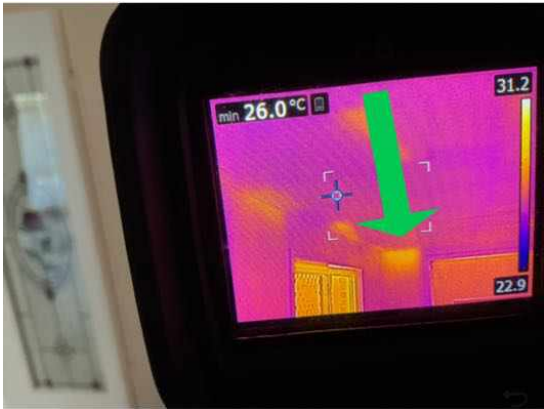
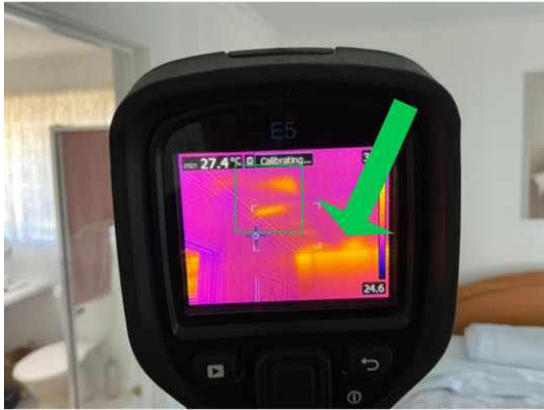
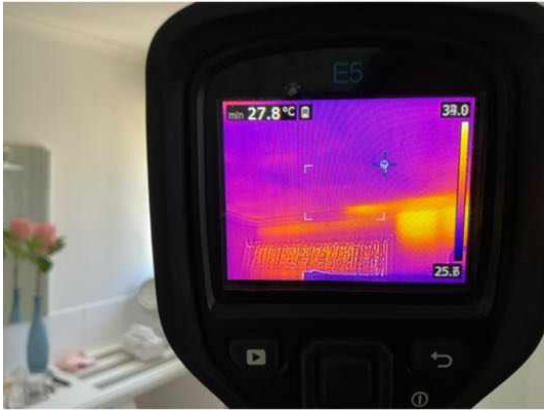
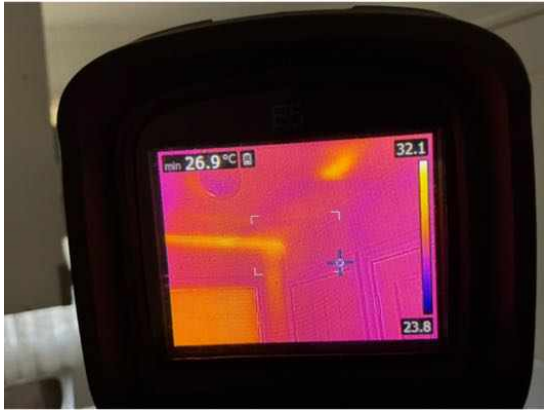
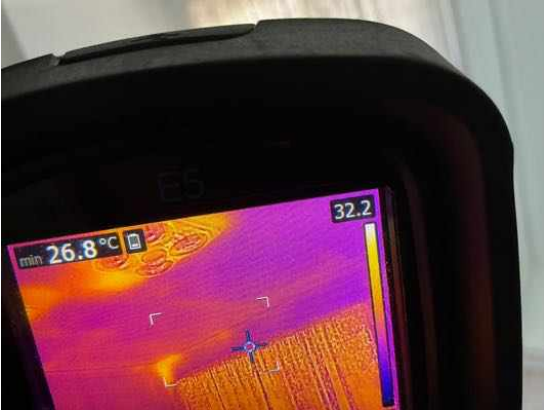
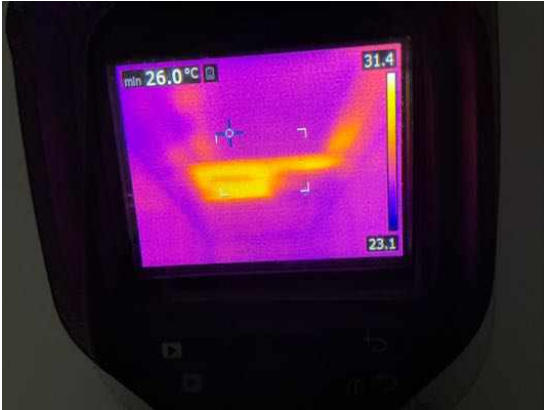
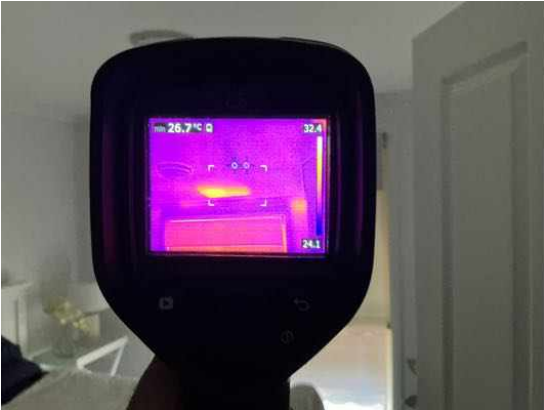
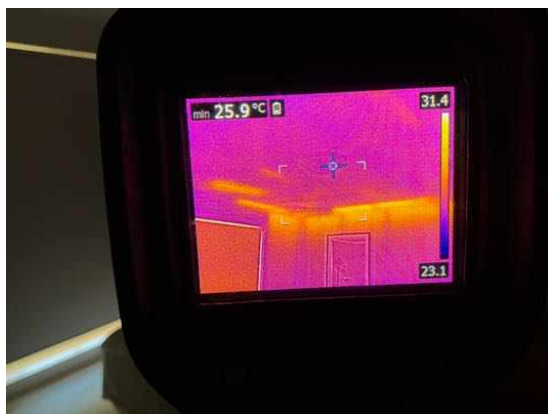
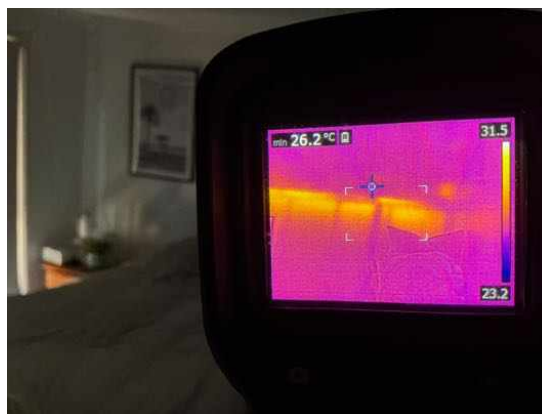
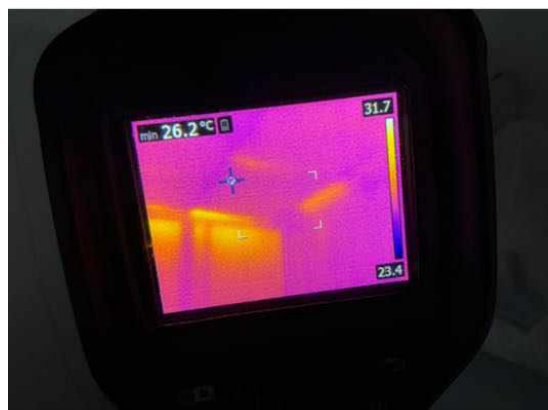
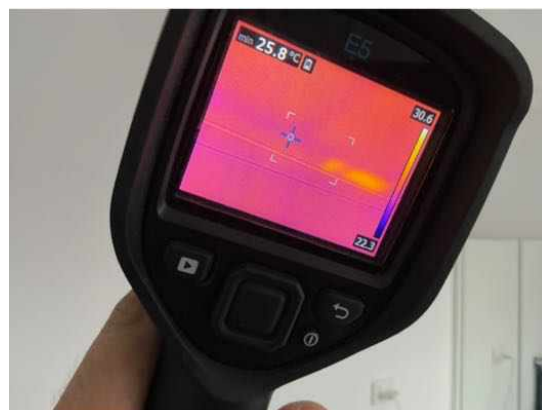
Defects 3.12

Building:	Main Building
Location:	All Internal Areas
Finding:	Inconsistent Thermal Performance to Ceiling Areas – Suspected Insulation Deficiencies
Information:	Thermal imaging conducted to internal ceiling areas at the time of inspection identified inconsistent heat patterns, which are indicative of variations in thermal performance across the roof space. These patterns are commonly associated with areas of

missing, displaced, or insufficient insulation above the ceiling linings.

Inadequate or uneven insulation coverage can reduce the energy efficiency of the dwelling, contribute to heat loss in cooler periods and heat gain in warmer conditions, and may result in reduced occupant comfort and increased heating and cooling costs. Due to the non-invasive nature of the inspection, the exact extent and condition of insulation could not be confirmed visually in all affected areas.

It is recommended that a qualified insulation contractor inspect the roof space, assess insulation coverage and condition, and top up or reinstate insulation where required to achieve consistent thermal performance throughout the property.

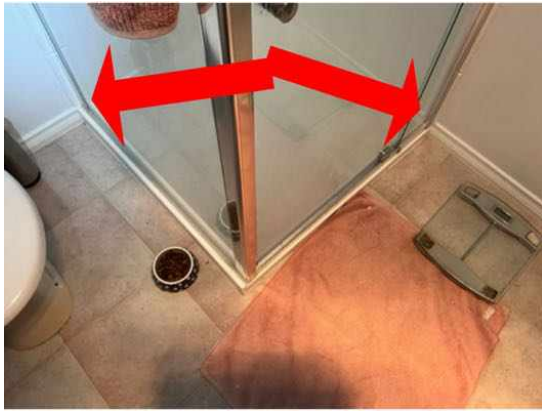
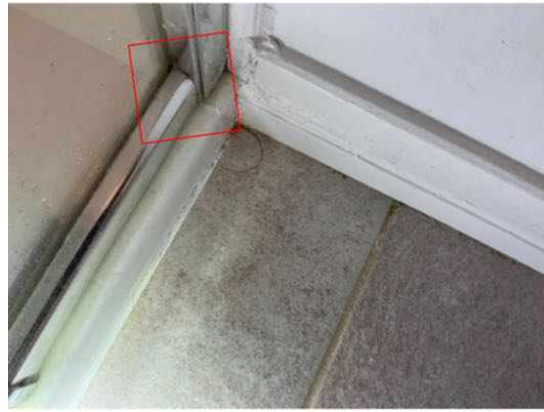
Defects 3.13

Building:	Main Building
Location:	Ensuite
Finding:	Shower screen - Leaking
Information:	Leaking was evident to the ensuite's shower screen at the time of inspection. It is suspected that the leaking has occurred as a result of deteriorated or missing caulking to the shower or general ageing of the building elements.

Leaking from the shower where left unattended, is likely to lead to water damage to adjoining flooring and walls. Such damage can lead to water damage and necessitate extensive remedial works being required. Active water leaks may also create an environment that is susceptible to the formation and development of mould.

Appointment of a caulking contractor is required to repair or replace the caulking to the shower area. Such works should be performed as soon as possible to ensure that no further damage occurs.

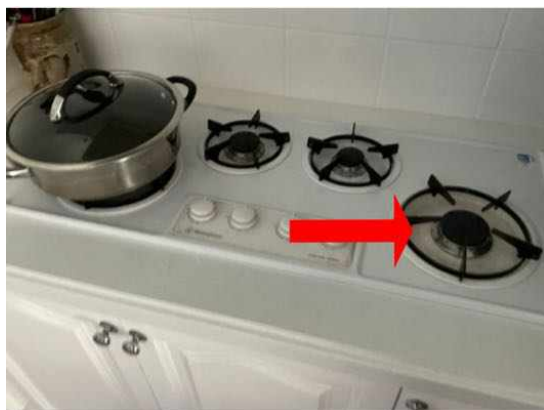
Defects 3.14

Building: Main Building
 Location: Kitchen
 Finding: Inoperative Ignition to Kitchen Burner
 Information:

The right-hand side kitchen cooktop burner was observed not to ignite using the automatic ignition function at the time of inspection. The burner was able to be manually ignited using an external lighter; however, the built-in ignition mechanism did not operate as intended.

A non-functioning ignition system may be due to a faulty igniter, wiring issue, moisture contamination, or internal component failure. Continued manual ignition is not ideal and may pose inconvenience or minor safety concerns if not properly managed.

It is recommended that a qualified gas appliance technician inspect the cooktop ignition system, diagnose the fault, and repair or replace defective components as required to restore proper automatic ignition functionality.

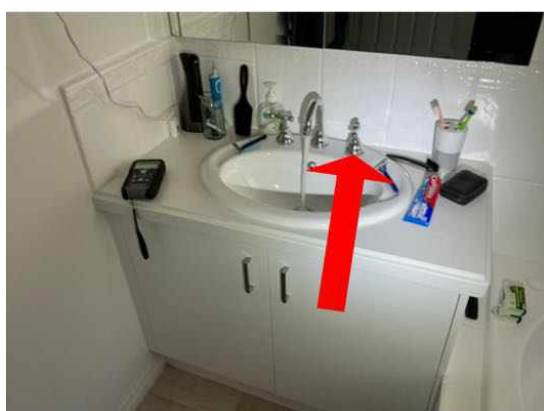
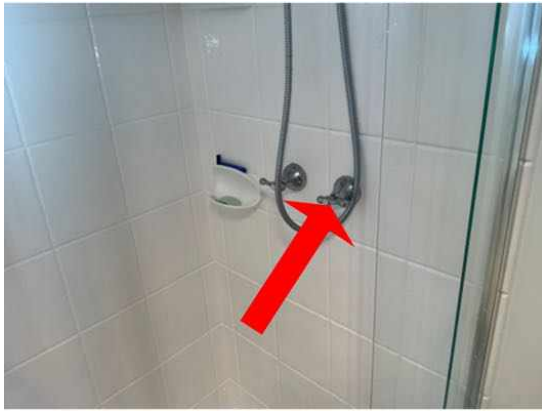
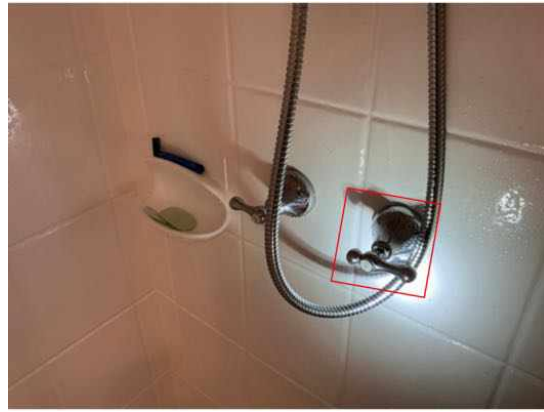
Defects 3.15

Information: The sink and shower taps show evidence of water hammer being present. Water hammer, a pressure surge resulting when a fluid is forced to suddenly change direction, is a common defect in plumbing fittings, particularly those that are aged and not frequently maintained. Water hammer is generally caused by factors that create high water pressure in the affected plumbing fixture, usually evidenced by a faint banging noise during operation of the affected tap.

Although water hammer is generally considered to be a minor defect, subsequent damage such as erosion of tap hardware and/or water damage to associated building elements is likely to occur if left unmanaged.

A licensed plumber should be appointed as soon as possible to replace any affected tap hardware and perform any remedial works as necessary. Please be advised that the appointment of a cabinet maker or qualified carpenter may be necessary if water damage to associated building elements has occurred.

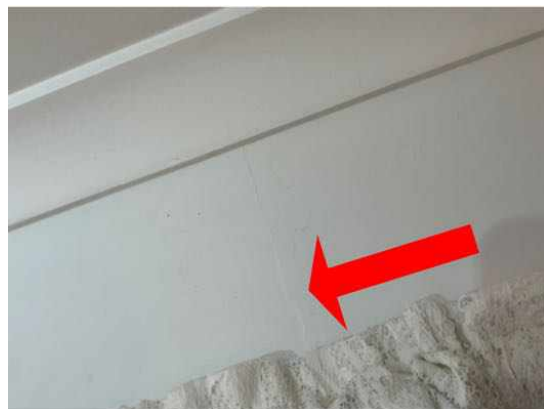
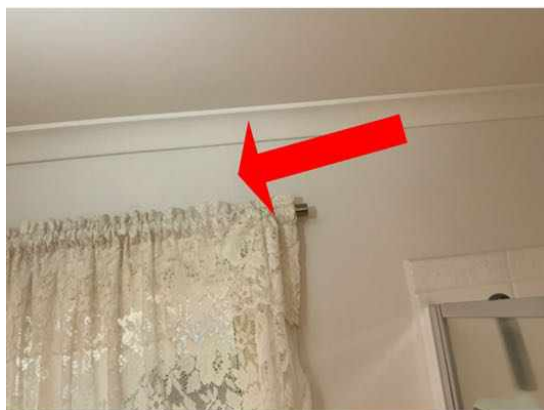
Defects 3.16

Building:	Main Building
Location:	Bedroom 2
Finding:	Cracking - Damage Category 1 - Fine (up to 1mm)
Information:	Although fine cracks are quite noticeable, they are often only considered to be an appearance defect, and usually do not indicate any structural damage. Generally, the cause of a fine crack is indicative of a separation between building materials and finishes (e.g. paint, plaster, etc.) along joins.

Cracking of this nature can generally be repaired with minor sanding, filling and/or repainting. Such works should be performed by a qualified painter or a general handyman.

Monitoring of all cracking should be conducted frequently. Always contact a building inspector should cracks widen, lengthen, or become more numerous.

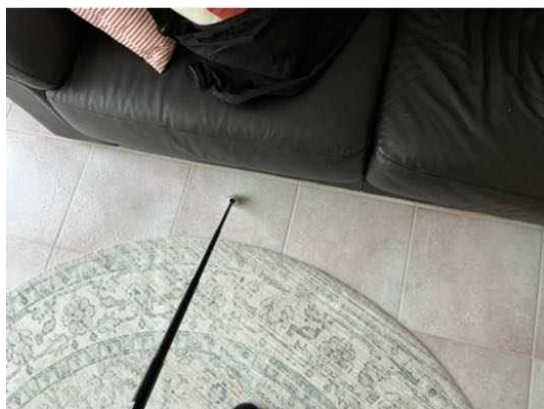
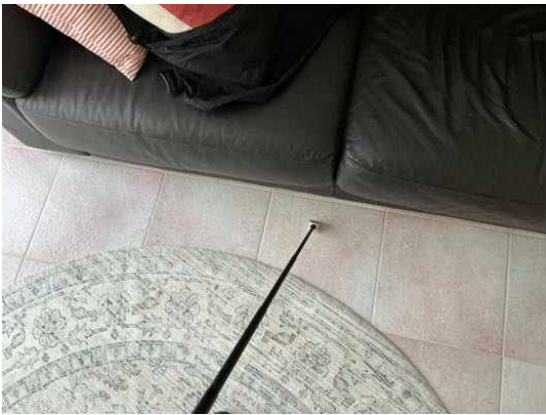
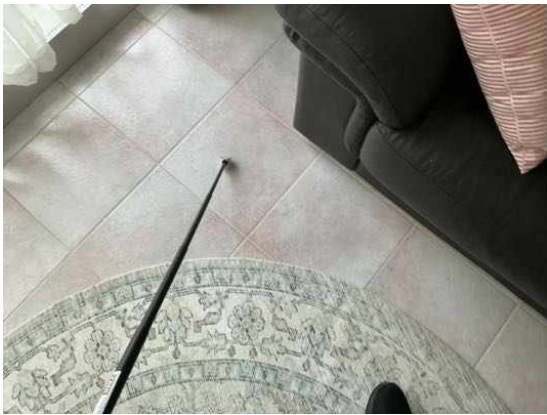
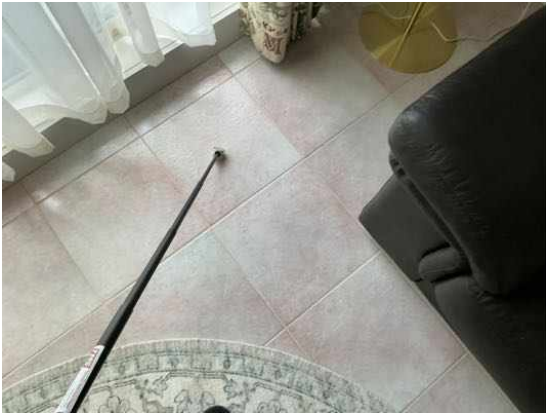
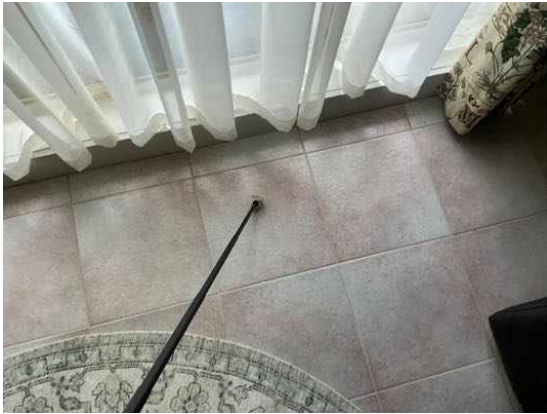
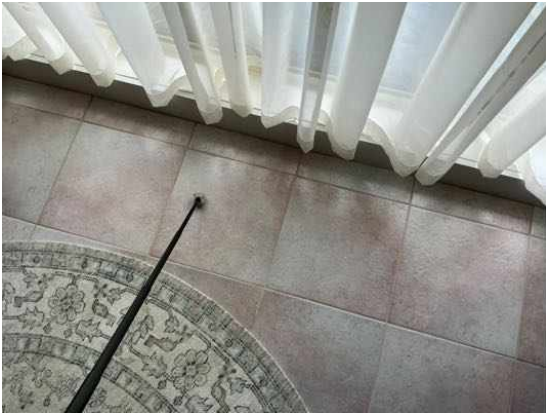
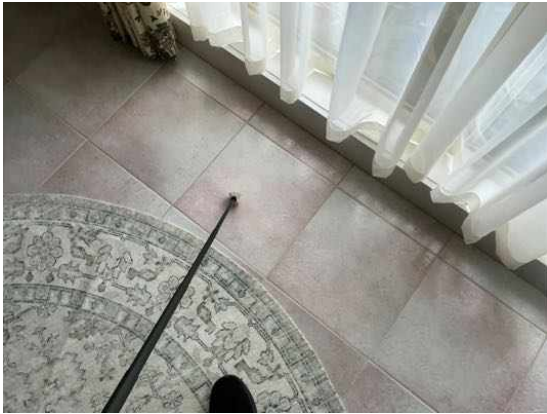
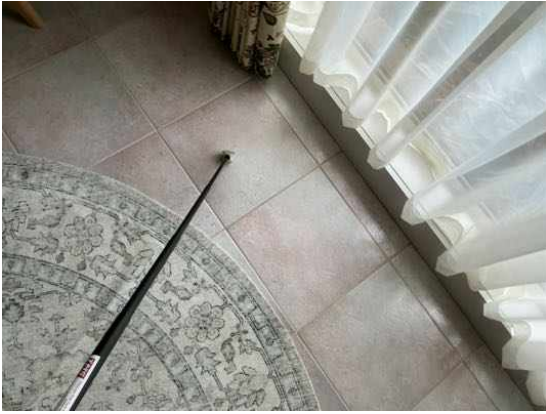
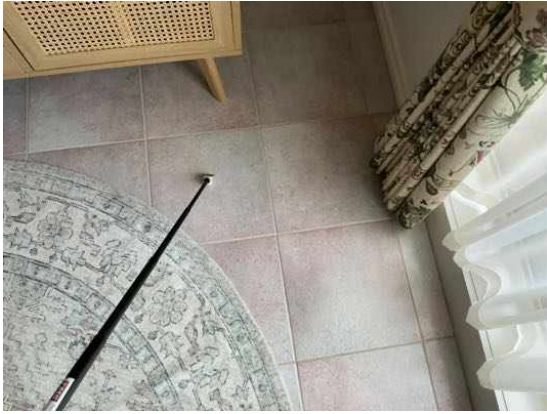
Defects 3.17

Information: Drummy tiled areas were identified at the time of inspection. The term 'drummy' refers to tiles that have become detached from their fixing, despite otherwise being in relatively good condition. Such defects are generally caused by physical or moisture damage to the area. Drummy tiled areas may also be a direct result of poor workmanship during the construction process.

Tiled areas may swell and shrink with changes in air humidity if the area has sustained moisture damage. Any exposure to moisture is capable of causing tiled areas to become drummy and/or cracked over a prolonged period of time. Drummy tiled areas generally require removal and replacement of affected tiles, with adequate sealant and grouting.

Specialist trades are available for these types of services. A registered builder may be required to undertake works if damage is extensive or if secondary building defects have resulted. Otherwise, it is advised that a tiling contractor be appointed to perform works as necessary. Immediate action is recommended to ensure that no further damage is sustained in the affected area.
