# Building Inspection Report

Inspection Date: Mon, 23 Feb 2026

Property Address: 12 Broomhill Ave, Blackburn VIC 3130,  
Australia

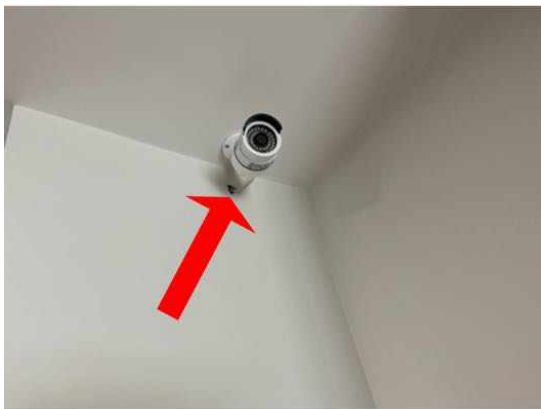
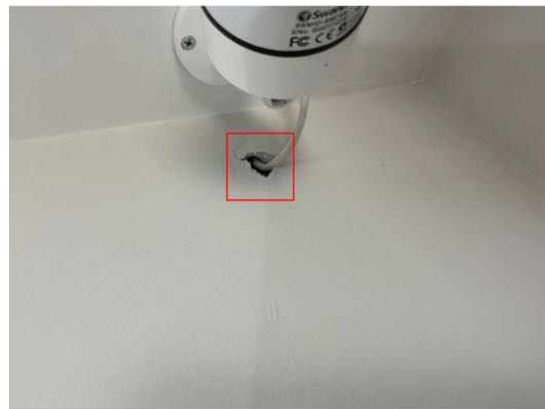
#### Defects 3.01

The plasterboard ceiling finish around the security camera wiring penetration is of poor workmanship. The cable entry point has been roughly cut, leaving an oversized and irregular opening with visible damage to the surrounding plasterboard and unfinished edges. The penetration has not been neatly trimmed, sealed, or properly finished to an acceptable standard.

This condition is indicative of substandard workmanship and does not meet the expected finish quality for a completed residential dwelling. Unsealed penetrations may also allow air leakage, dust ingress, and potential pest entry, and detract from the overall aesthetic presentation of the ceiling.

A qualified plasterer or carpenter should properly repair the affected area by trimming and reinstating the plasterboard as required, neatly sealing the cable penetration with an appropriate grommet or escutcheon plate, setting, sanding, and repainting to achieve a uniform and professional finish consistent with surrounding surfaces.

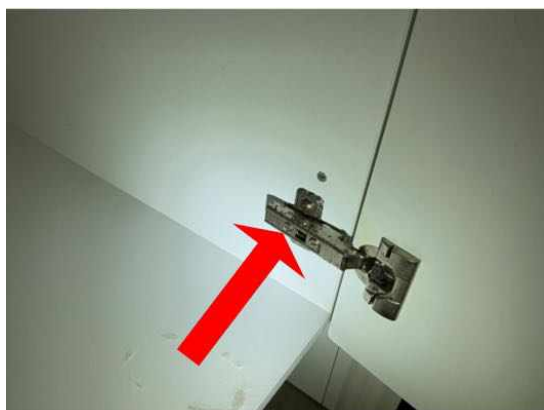
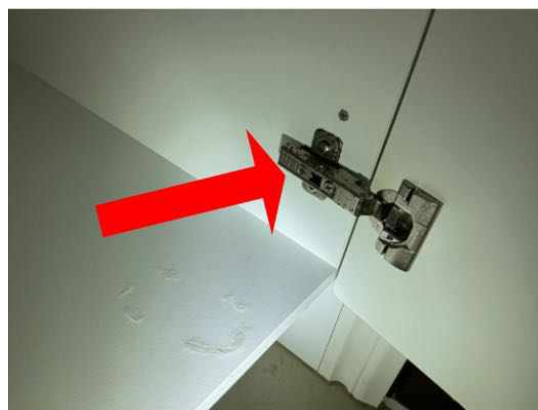
## Defects 3.02

Building: Main Building  
 Location: Laundry  
 Finding: Minor Surface Corrosion to Cabinet Hinge – Laundry  
 Information:

Minor surface rusting was observed to one hinge within the laundry cabinetry at the time of inspection. The corrosion appears localised to a single hinge and is currently superficial in nature, with no immediate impact noted to the operation of the cupboard door.

While the condition is not considered significant at present, untreated corrosion may progressively deteriorate the hinge over time, potentially leading to reduced functionality or premature failure of the hardware, particularly in moisture-prone areas such as laundries.

It is recommended that the affected hinge be treated to remove surface corrosion and protected with an appropriate anti-corrosive product, or alternatively replaced with a suitable corrosion-resistant hinge by a qualified handyman or cabinetmaker to ensure long-term durability and proper operation.

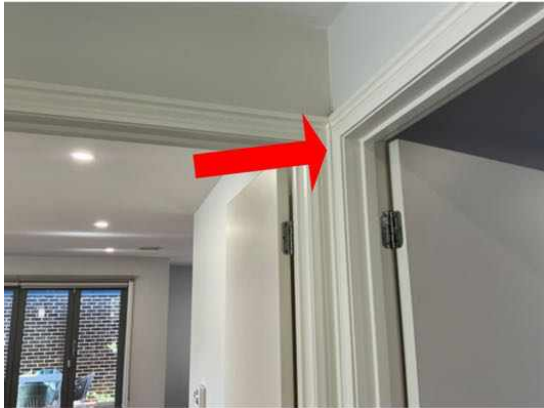
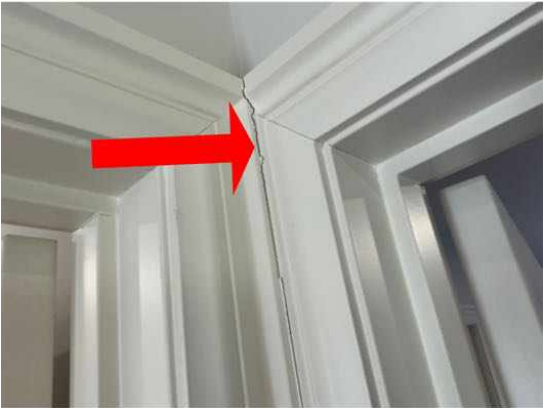
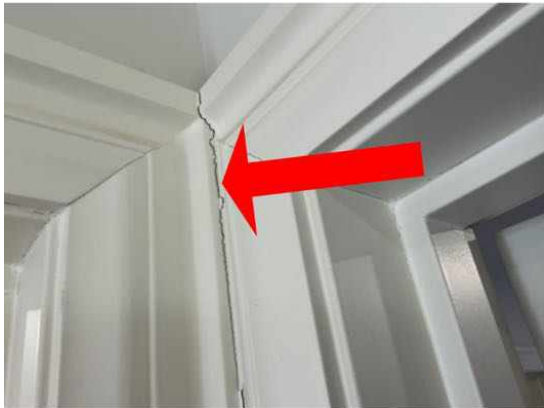
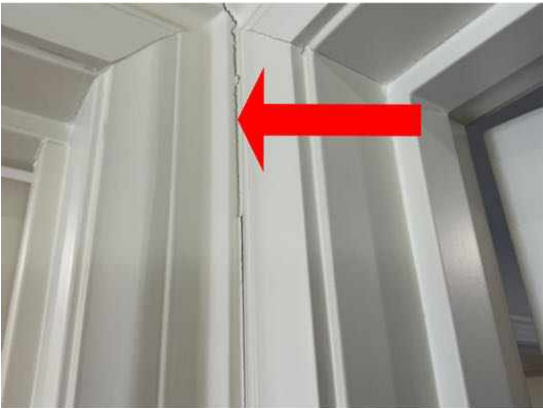
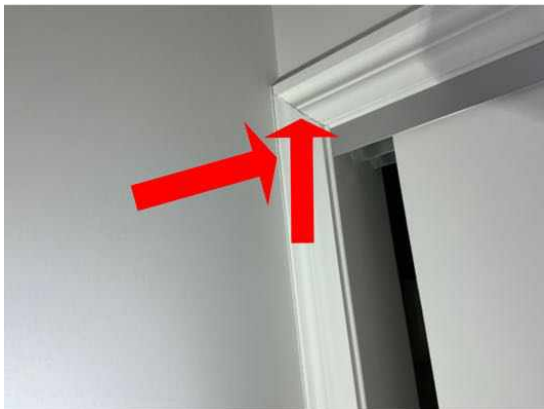
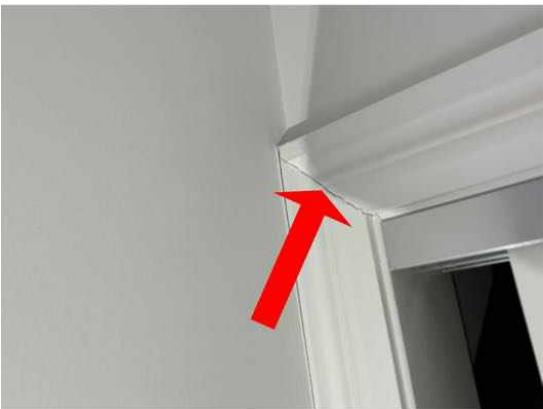
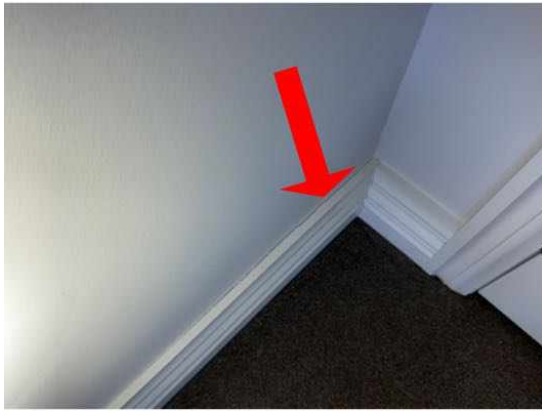
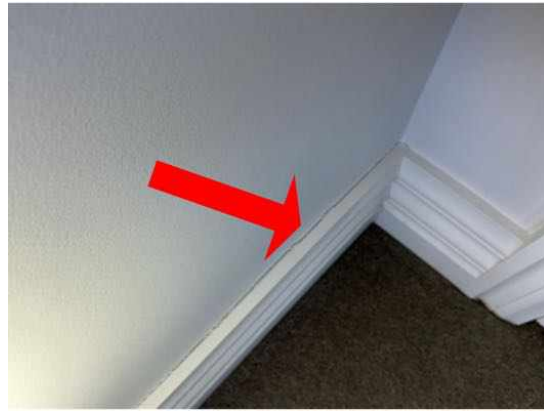
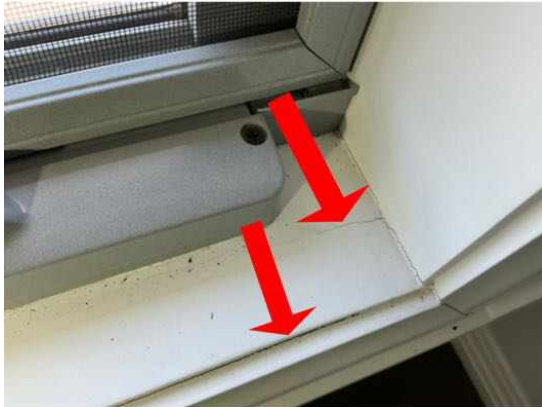
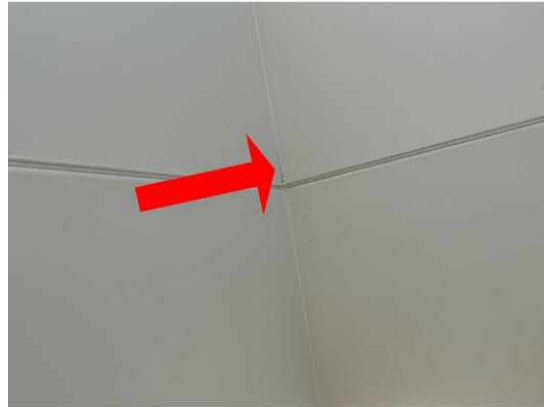
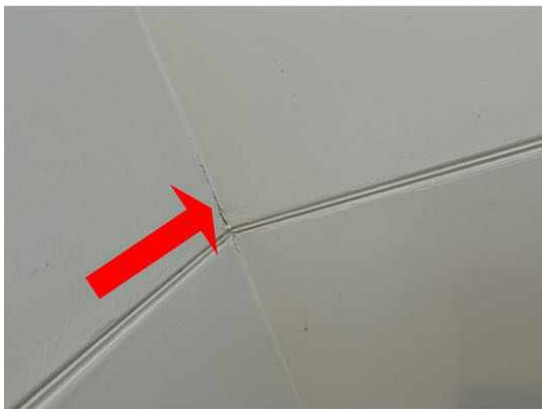
## Defects 3.03

Building: Main Building  
 Location: All Internal Areas  
 Finding: Minor Shrinkage and Settlement Cracking – Internal Finishes  
 Information:

Minor cracking and small separations were observed around selected door frames, window frames, window sills, skirting boards, and to sections of plasterboard walls including areas adjacent to the staircase. The cracks are narrow and consistent with typical shrinkage and minor settlement movement commonly experienced in residential dwellings over time.

The observed cracking appears cosmetic in nature and is not considered structural at

the time of inspection. Such cracking is generally attributable to normal building movement, material shrinkage, and minor ground movement, particularly during seasonal moisture changes.

If considered unsightly, a qualified handyman or painter can undertake cosmetic rectification works including filling, sanding, and repainting to restore a uniform finish. Ongoing monitoring is recommended, and if cracking widens significantly or becomes progressive, further assessment by a suitably qualified building practitioner would be advised.

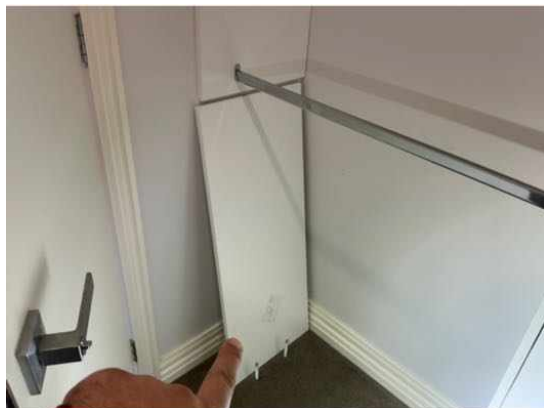
### Defects 3.04

Building: Main Building  
 Location: Walk-In Robe - Master  
 Finding: Detached Shelf – Walk-In Robe Joinery  
 Information:

The bottom shelf within the walk-in robe cabinetry was found to be detached from its fixings and not securely installed at the time of inspection. The shelf was observed leaning against the wall rather than being properly supported within the joinery unit.

This condition indicates incomplete installation or failure of the original fixings. In its current state, the shelf is non-functional and may present a minor safety risk if it falls or is incorrectly reinstalled. The defect affects the usability and finish quality of the

cabinetry.

A qualified cabinetmaker should attend to refix or reinstall the shelf using appropriate brackets, supports, and fixings to ensure it is securely installed, level, and capable of supporting intended loads in accordance with acceptable trade standards.

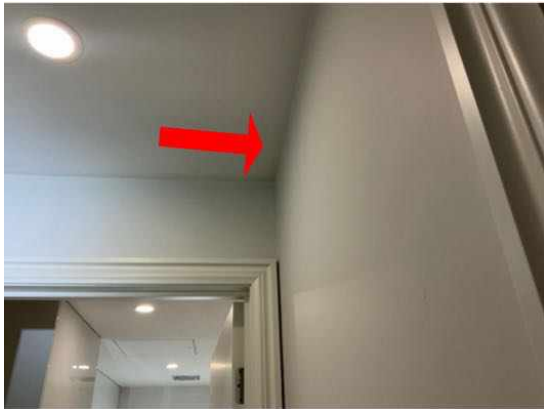
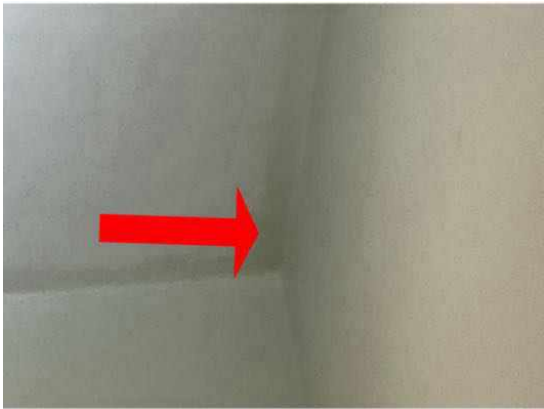
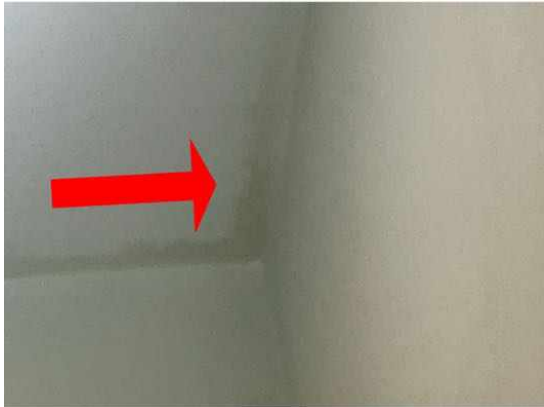
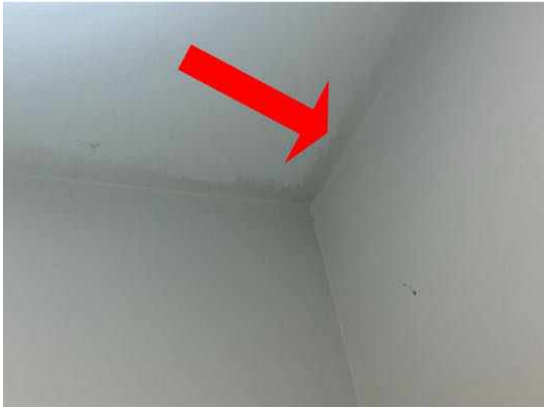
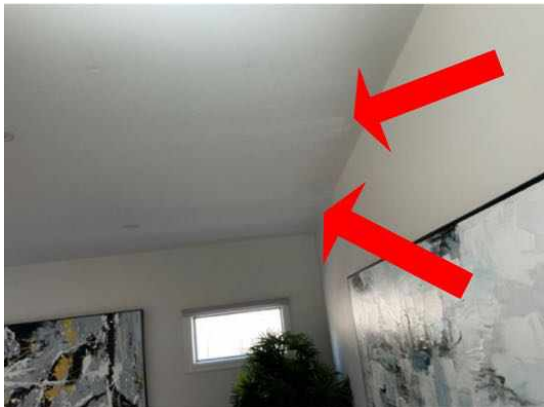
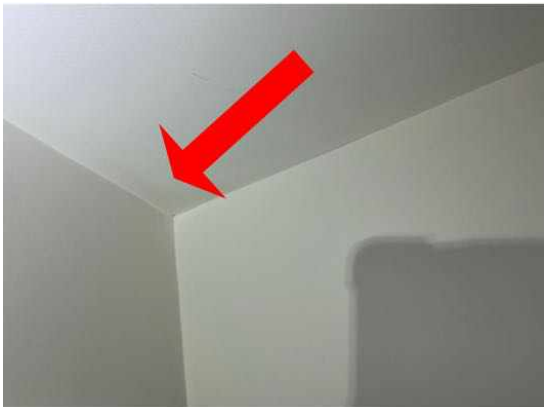
### Defects 3.05

Building: Main Building  
 Location: All Internal Areas  
 Finding: Ceiling Paint Discolouration at Perimeter Edges  
 Information:

Multiple areas to the internal ceilings, particularly at the downstairs level, exhibited visible paint discolouration and inconsistent finish along the ceiling perimeter edges. The affected areas appear patchy and uneven in tone compared to adjacent surfaces. Non-invasive moisture testing was undertaken at the time of inspection and returned normal readings, with no evidence of elevated moisture detected.

Based on the visual presentation and moisture results, the condition is considered most likely attributable to paint overspray or inconsistent application during the painting process rather than active moisture ingress. While this issue appears cosmetic in nature, it detracts from the overall finish quality and presentation of the dwelling.

For rectification, a qualified painter should prepare the affected areas by lightly sanding as required and applying appropriate primer and finish coats to achieve a smooth, consistent, and uniform finish in line with acceptable industry standards.

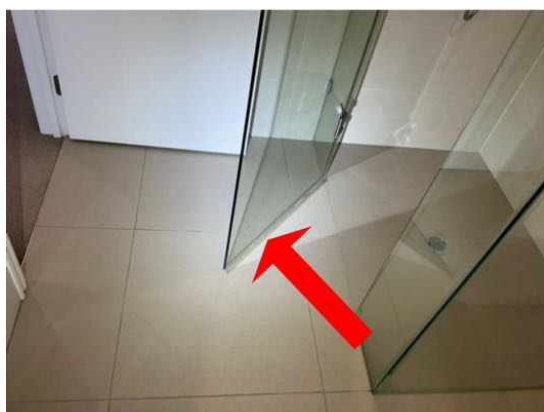
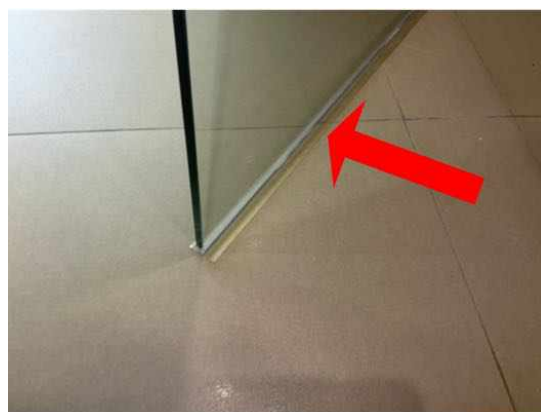
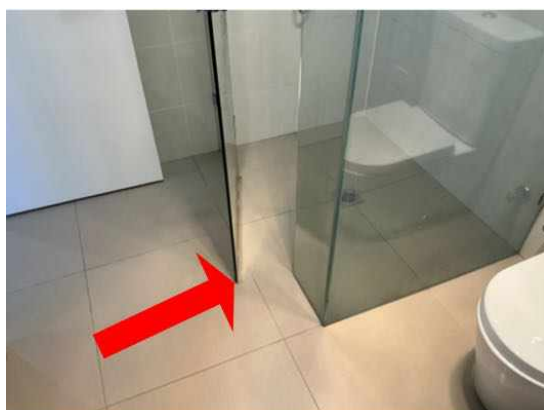
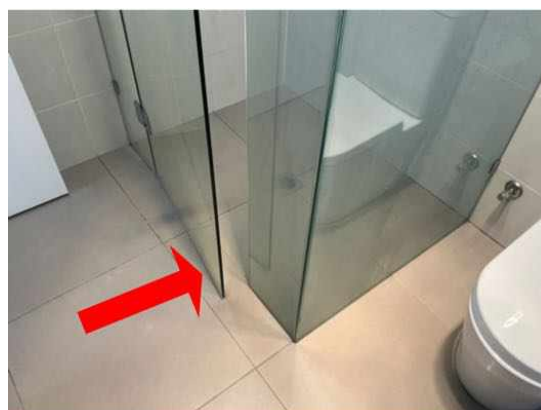
**Defects 3.06**

Building: Main Building  
 Location: Ensuite - Master  
 Finding: Glass Shower Door Misalignment – Master Ensuite  
 Information:

The frameless glass shower door to the master ensuite was observed to be misaligned, with excessive friction occurring between the bottom edge of the door (including the water seal strip) and the finished floor surface. The door is difficult to open and close smoothly, and noticeable resistance is present during operation.

Continued friction of the glass panel against the floor surface may place undue stress on the glass and associated hardware, increasing the risk of premature wear, hinge

failure, or in a worst-case scenario, cracking or shattering of the glass panel. The condition presents both a functional and potential safety concern.

A qualified shower screen installer or bathroom specialist should be engaged without delay to properly realign and adjust the shower door, including hinges and clearances, to ensure safe, smooth operation with adequate clearance above the finished floor level.

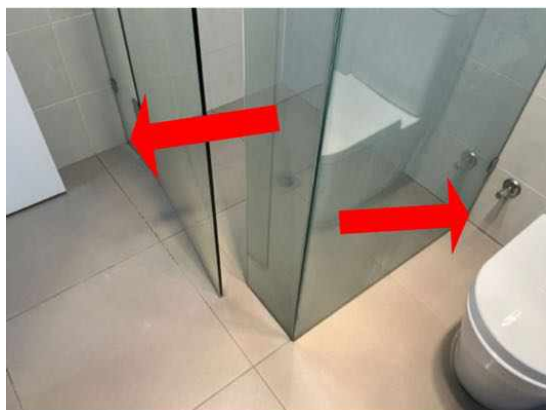
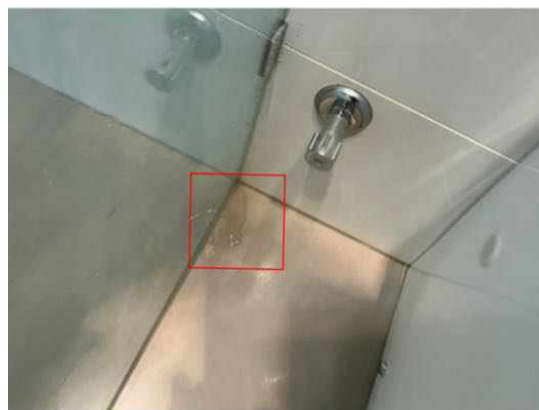
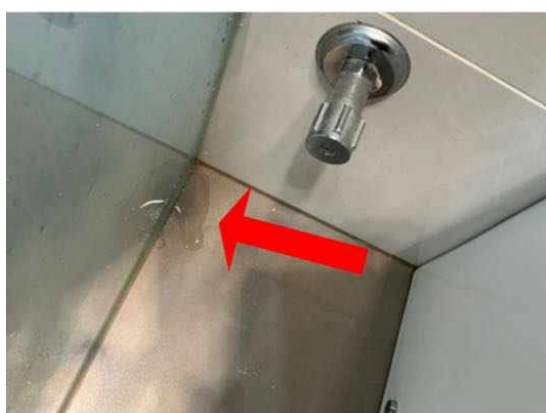
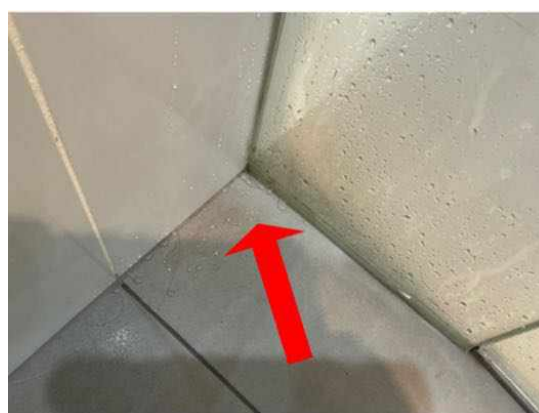
### Defects 3.07

Building:	Main Building
Location:	Ensuite - Master
Finding:	Shower screen - Leaking
Information:	Leaking was evident to the downstairs master shower screen at the time of inspection. It is suspected that the leaking has occurred as a result of deteriorated or missing caulking to the shower or general ageing of the building elements.

Leaking from the shower where left unattended, is likely to lead to water damage to adjoining flooring and walls. Such damage can lead to water damage and necessitate extensive remedial works being required. Active water leaks may also create an environment that is susceptible to the formation and development of mould.

Appointment of a caulking contractor is required to repair or replace the caulking to

the shower area. Such works should be performed as soon as possible to ensure that no further damage occurs.

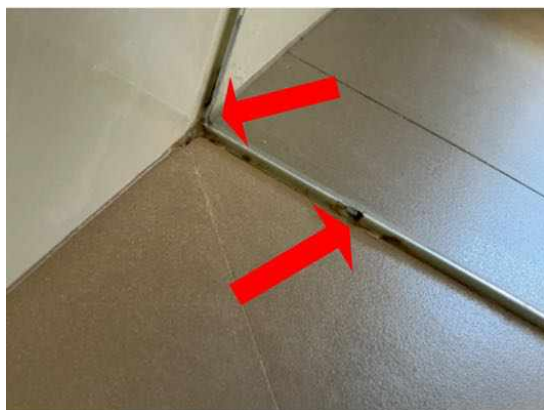
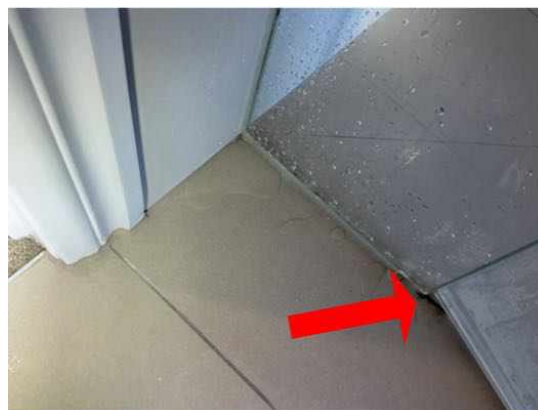
### Defects 3.08

Building: Main Building  
 Location: General bathroom upstairs  
 Finding: Deteriorated Sealant – Upstairs General Bathroom Shower  
 Information:

The silicone sealant to the base of the shower screen in the upstairs general bathroom was observed to be deteriorating, with minor mould growth visible in sections. The sealant appears aged and is beginning to lose its integrity in localized areas.

Deteriorated or mould-affected sealant may compromise the watertightness of the shower enclosure over time, potentially allowing water to penetrate adjacent floor or wall junctions, which can lead to concealed moisture damage if not addressed.

It is recommended that the existing sealant be carefully removed and replaced with new, mould-resistant sanitary-grade silicone by a qualified handyman or bathroom maintenance specialist to ensure the shower enclosure remains properly sealed and watertight.

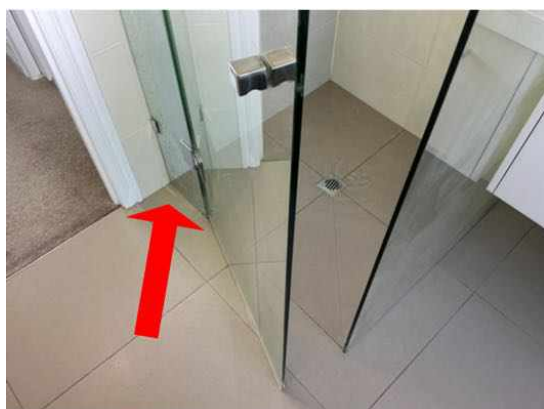
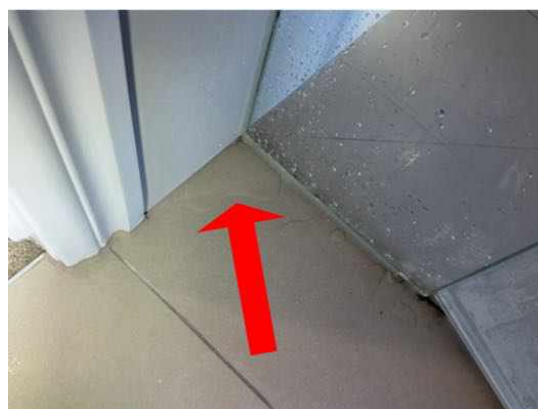
### Defects 3.09

Building:	Main Building
Location:	General bathroom upstairs
Finding:	Shower screen - Leaking
Information:	Leaking was evident to the upstairs general shower screen at the time of inspection. It is suspected that the leaking has occurred as a result of deteriorated or missing caulking to the shower or general ageing of the building elements.

Leaking from the shower where left unattended, is likely to lead to water damage to adjoining flooring and walls. Such damage can lead to water damage and necessitate extensive remedial works being required. Active water leaks may also create an environment that is susceptible to the formation and development of mould.

Appointment of a caulking contractor is required to repair or replace the caulking to the shower area. Such works should be performed as soon as possible to ensure that no further damage occurs.

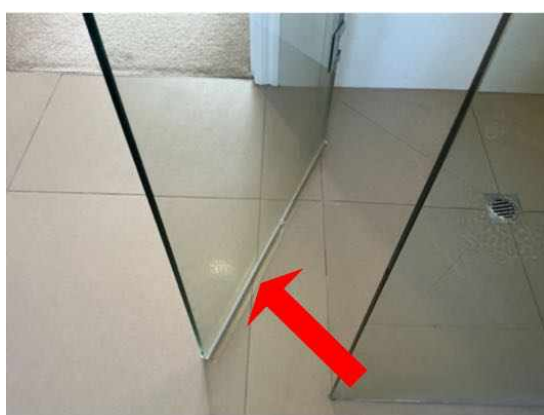
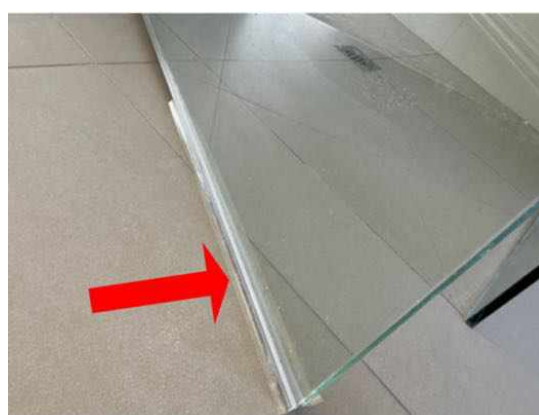
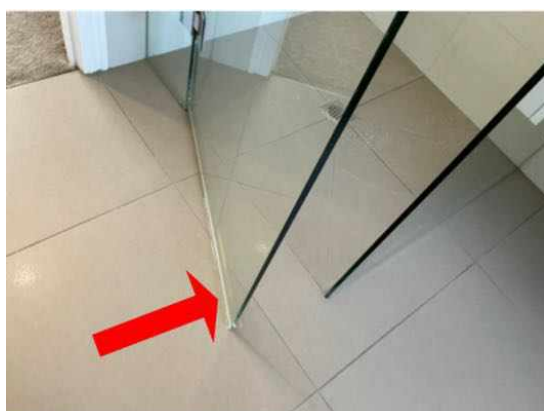
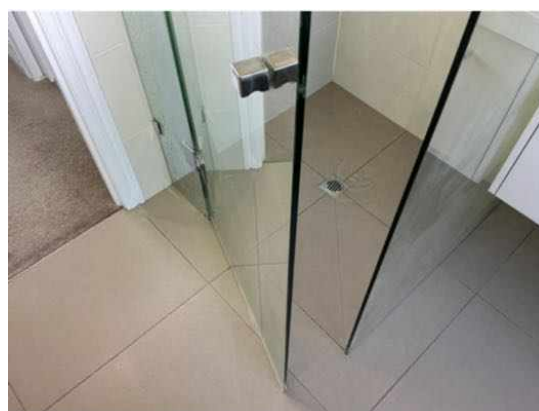
### Defects 3.10

Building:	Main Building
Location:	General bathroom upstairs
Finding:	Glass Shower Door Misalignment – Upstairs General Bathroom

Information: The glass shower door to the upstairs general bathroom was similarly found to be misaligned, with the lower edge of the door and water seal strip rubbing against the finished floor surface. The door does not operate freely and requires force to open and close.

This ongoing friction may cause stress to the glass panel and hardware components over time, potentially leading to glass damage, hinge deterioration, or safety risks if left unaddressed. Proper clearance should be maintained to prevent contact between the glass and floor finishes.

A qualified shower screen installer or bathroom specialist should attend to adjust and realign the door assembly to ensure correct positioning, adequate floor clearance, and safe, unobstructed operation.

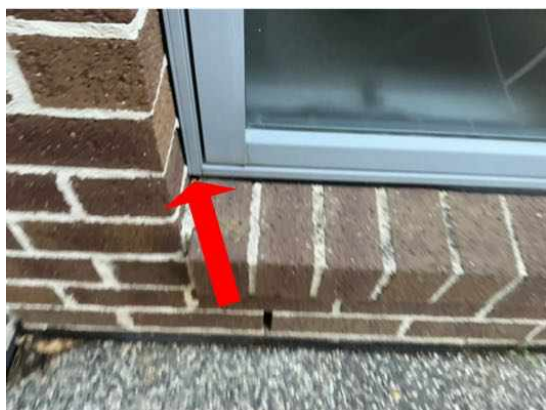
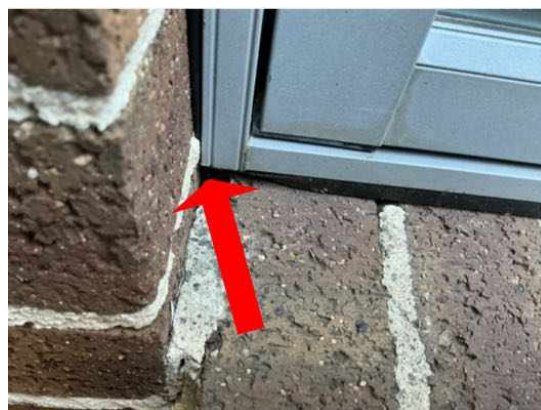
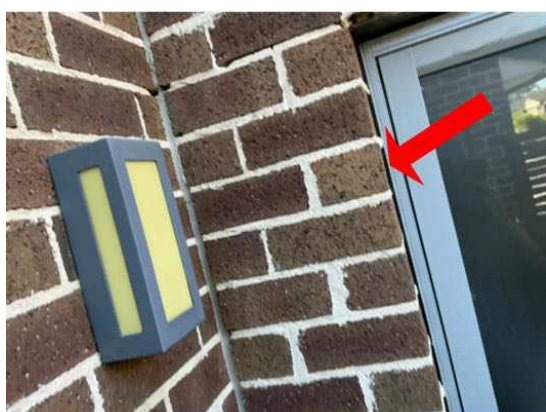
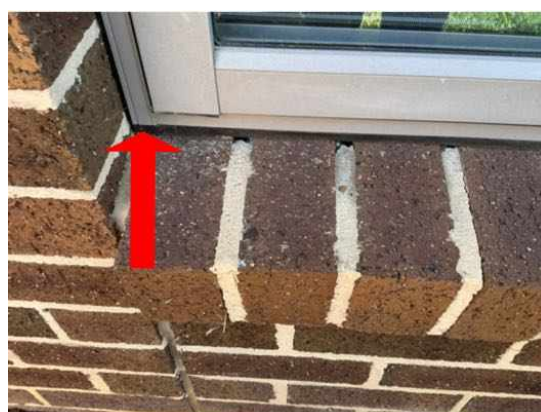
### Defects 3.11

Building: Main Building  
 Location: All External Areas  
 Finding: Window seals - deteriorated  
 Information: The window seals have deteriorated and are in a generally poor condition. Due to frequent exposure to weather conditions and subsequent moisture, deterioration of window seals is expected in a property of this condition and age.

Where window seals have deteriorated, the window is no longer weather-tight; rain penetration and subsequent water damage is therefore likely to ensue. Insulation of the area against external weather conditions will also be compromised.

It is recommended that all deteriorated window seals be replaced by a general handyman or sealant expert to prevent any further damage and to restore the window to a fully functional level.

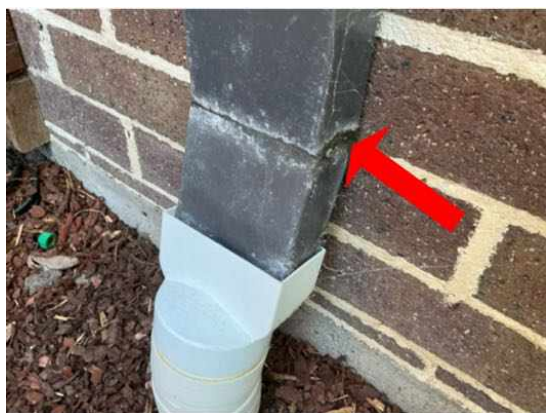
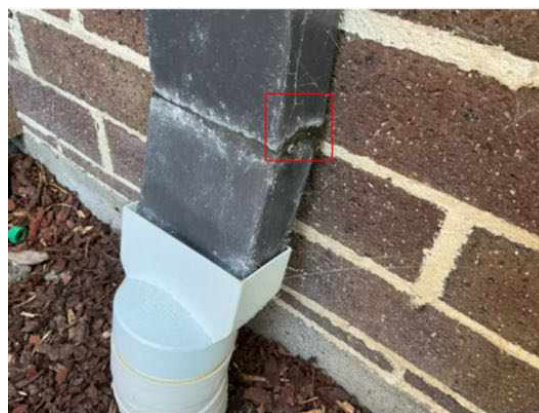
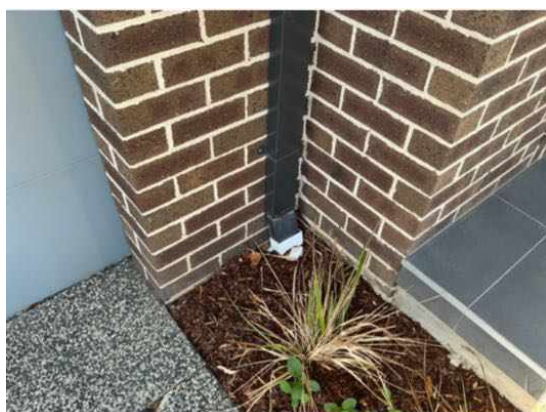
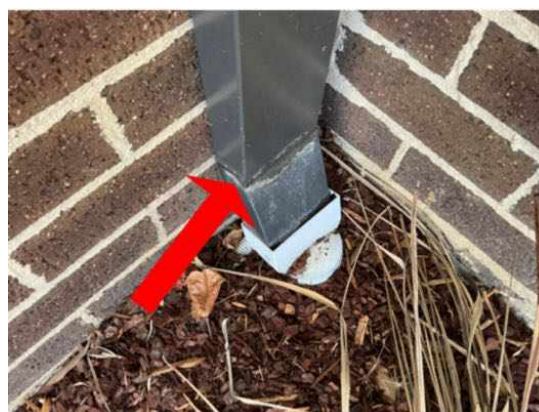
### Defects 3.12

Building:	Main Building
Location:	All External Areas
Finding:	Water Staining to Downpipe Joints – Front and Rear Elevations
Information:

Water staining was observed to the lower joints of one downpipe at the front elevation and one downpipe at the rear elevation. Discolouration and residue were visible around the connection points near the base of the pipes.

Such staining may indicate minor leakage at the downpipe joints, particularly during periods of heavy rainfall when water flow is increased. If left unaddressed, ongoing leakage may contribute to moisture accumulation around the base of the wall or footing area, potentially leading to deterioration of adjacent building elements over time.

It is recommended that a licensed plumber inspect the affected downpipes and reseal, refit, or replace the relevant joints as required to ensure they are watertight and functioning correctly, thereby preventing further water discharge at the base connections.

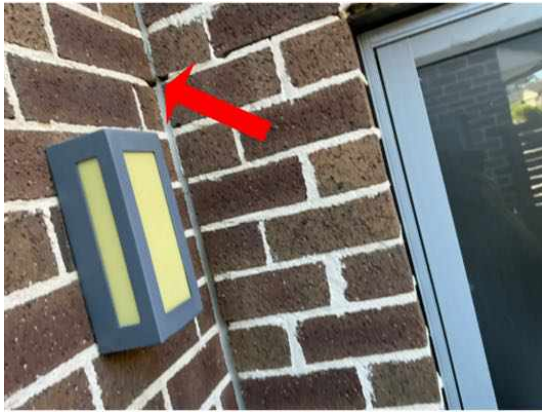
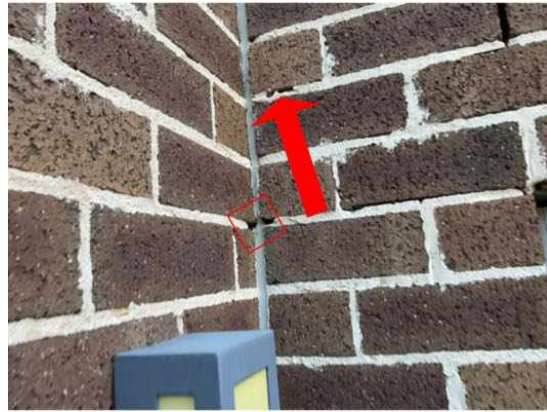
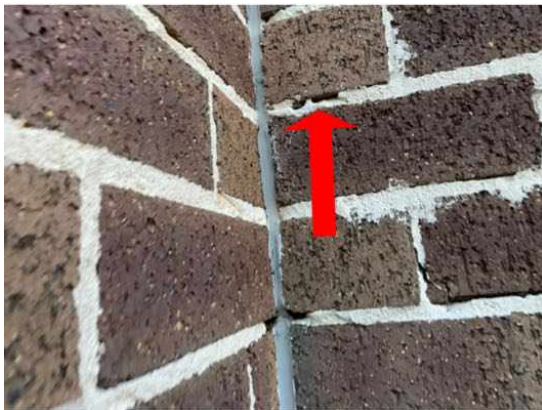
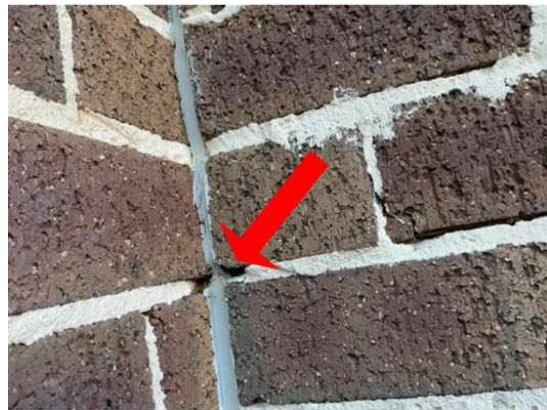
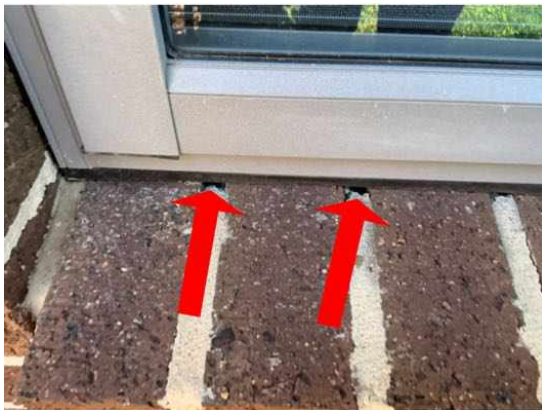
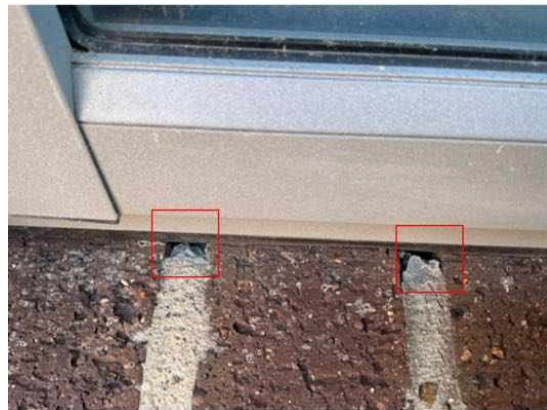
### Defects 3.13

Building:	Main Building
Location:	All External Areas
Finding:	Brickwork - Deteriorated mortar
Information:	Mortar, or 'bedding', is the material which fills joints and intersections between bricks in masonry walls and structures. Sections of mortar in this brickwork were identified as having deteriorated, which is generally expected for a property of this age and condition.

Mortar may deteriorate as a result of age of building materials, minor movement of bricks, or frequent exposure to weathering. Mortar should be replaced to ensure that bricks remain in their intended location and to prevent gaps, which would allow water or moisture ingress and secondary damage as a result.

Mortar deterioration can be addressed by a bricklayer where areas of deterioration are localised and easily accessible. Alternatively, appointment of a registered builder is advised, to repoint large areas of decaying mortar. Where secondary structural

defects have become evident, consultation with a structural engineer may be required.

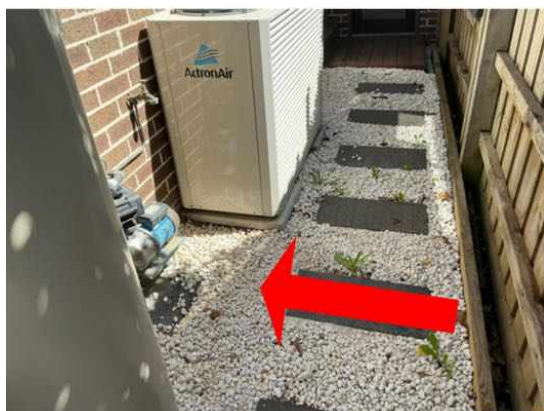
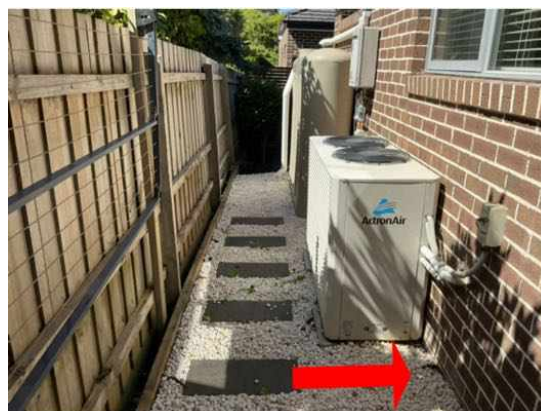
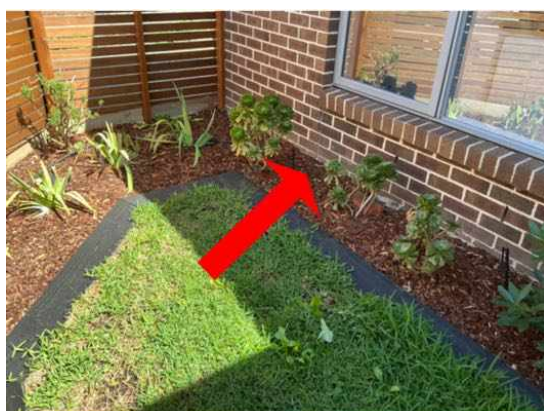
### Defects 3.14

Building:	Main Building
Location:	All External Areas
Finding:	Site drainage - Inadequate
Information:	The site drainage in sections of the backyard and sideyard were found to be inadequate at the time of inspection, creating potential for subsequent water damage to associated building elements.

ground levels should be sloped to drain water away from walls. Downpipes should not discharge stormwater onto lower walls or plinths. Stormwater should be carried away by large, regularly cleaned drains. Ground levels may need to be lowered to expose a buried DPC.

Where site drainage is inadequate, installation of an Agricultural (Aggie) Drain may be required. A qualified plumber should be appointed to further inspect the property and perform any remedial works as necessary. Water damage and secondary defects are likely to occur if left unmanaged.

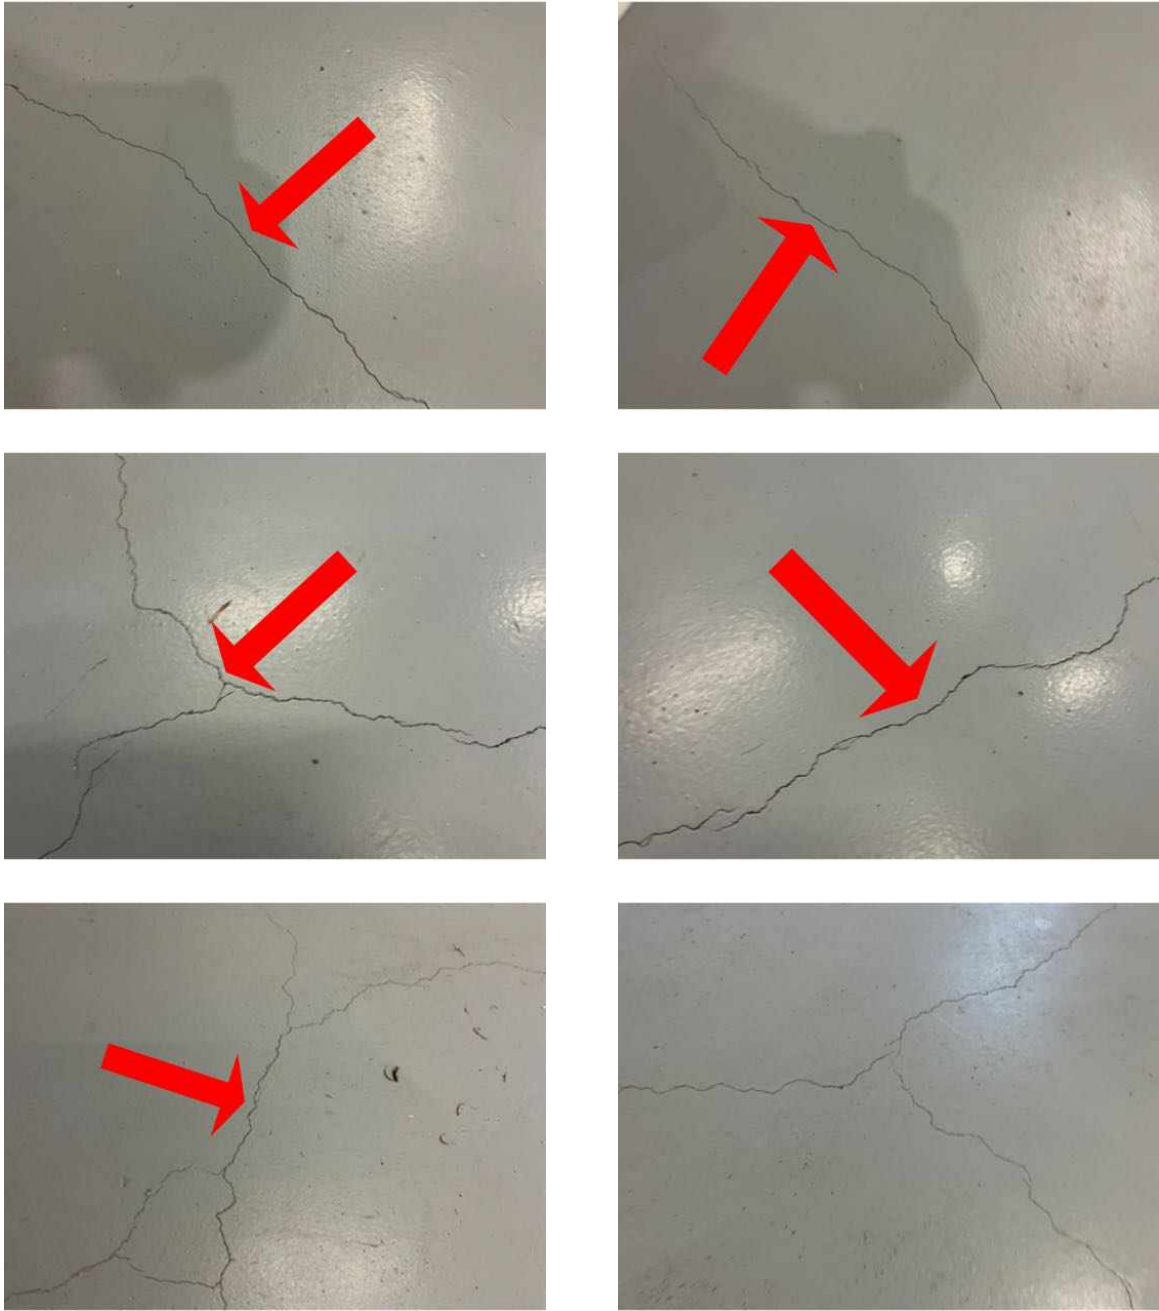
### Defects 3.15

Building:	Main Building
Location:	Garage
Finding:	Noticeable cracks in concrete slab of the the garage floor
Information:	During the inspection, multiple noticeable cracks were identified in the concrete slab of the garage floor. These cracks vary in size and location, which may indicate underlying movement or stress within the slab. While they do not currently appear to significantly impact the structural integrity, their presence suggests potential early-stage deterioration.

It is recommended that the cracks be monitored closely over the next 12 months. If any of the cracks widen or worsen during this period, it is critical to engage a

structural engineer immediately to assess the situation and recommend appropriate rectification measures to prevent further damage and ensure the long-term stability of the structure.

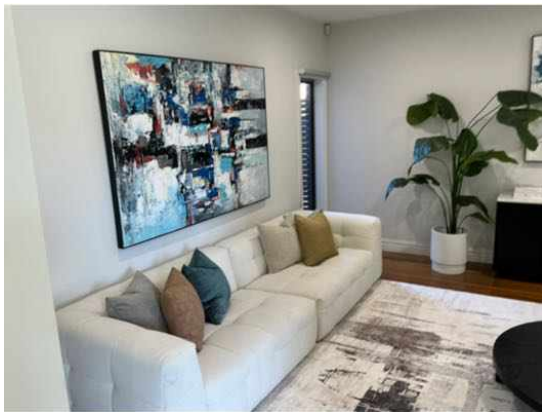
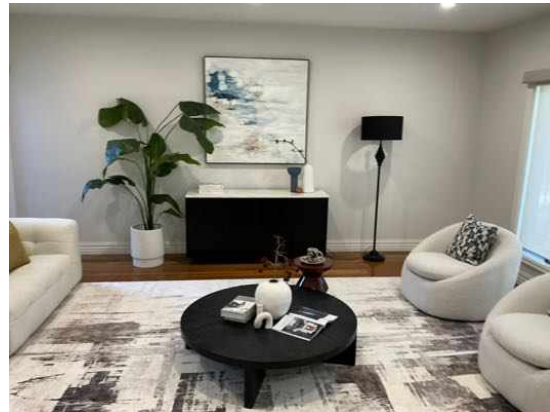
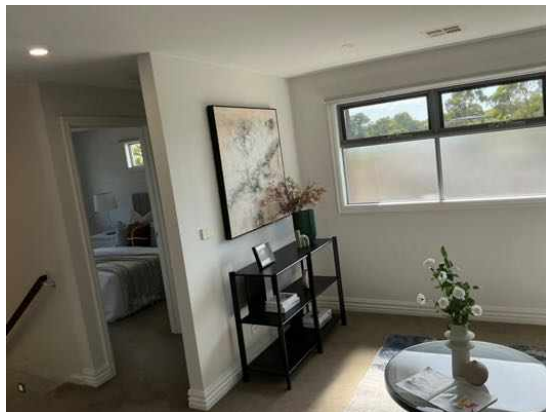
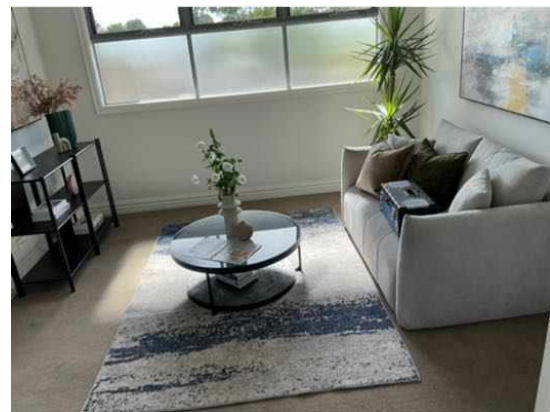
#### Noted Item

Building: Main Building  
 Location: All Internal Areas  
 Finding: Obstructions and Limitations - Interior  
 Information: These photographs are an indication of the obstructions and limitations which impeded the inspection of the internal areas of the property at the time of inspection. These obstructions can hide an array of defects and should be removed to allow full inspection to be carried out. A re-inspection is recommended once the areas are made accessible.

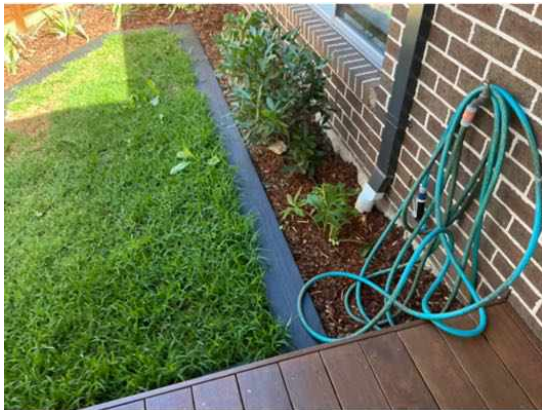
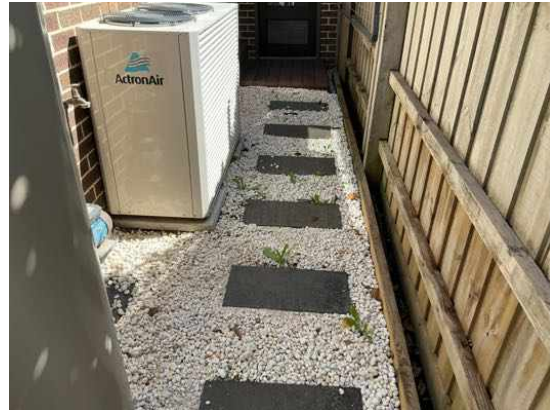
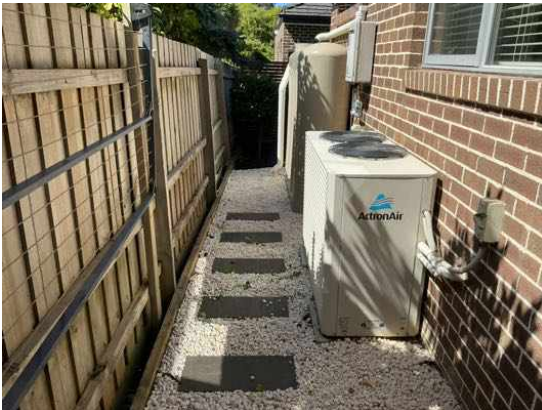
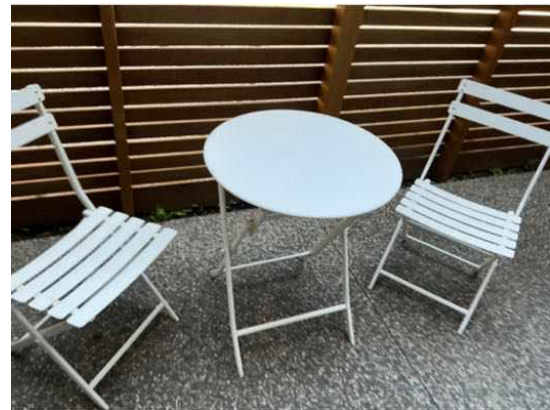
#### Noted Item

Building: Main Building  
 Location: All External Areas  
 Finding: Obstructions and Limitations - Exterior  
 Information: These photographs are an indication of the obstructions and limitations which impeded the inspection of the external areas of the property at the time of inspection.

These obstructions can hide an array of defects and should be removed to allow full inspection to be carried out. A re-inspection is recommended once the areas are made accessible.

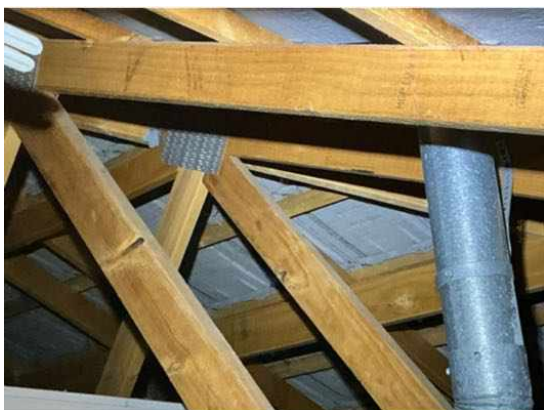
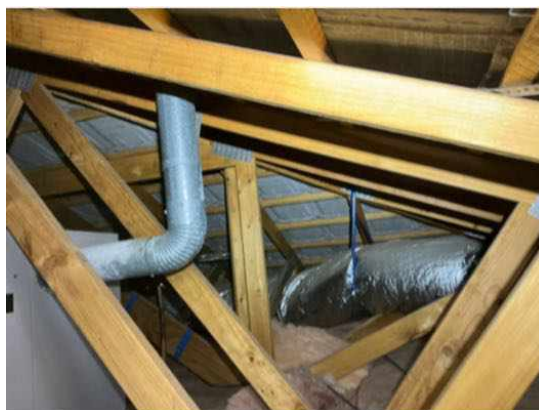
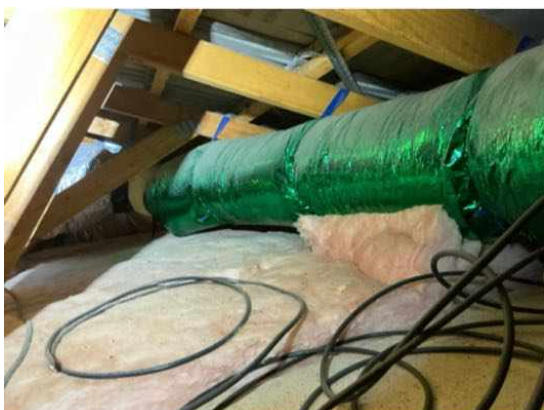
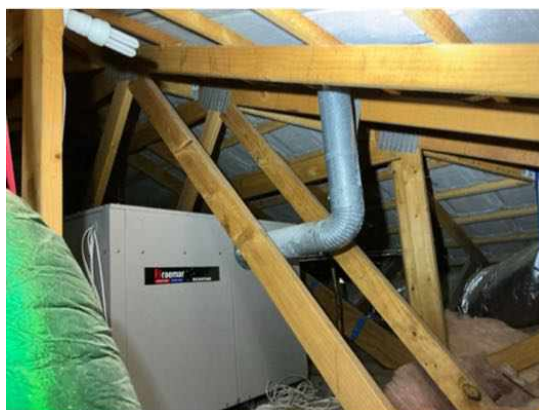
### Noted Item

Building:	Main Building
Location:	Roof Void
Finding:	Obstructions and Limitations - roof cavity
Information:	These photographs are an indication of the obstructions and limitations which impeded the inspection of the roof cavity area of the property at the time of inspection. These obstructions can hide an array of defects and should be removed to allow full inspection to be carried out. A re-inspection is recommended once the areas are made accessible.

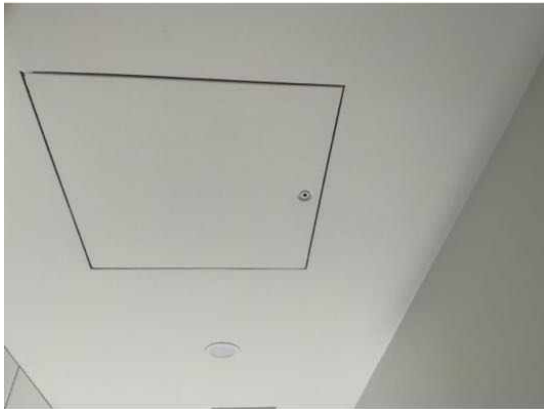
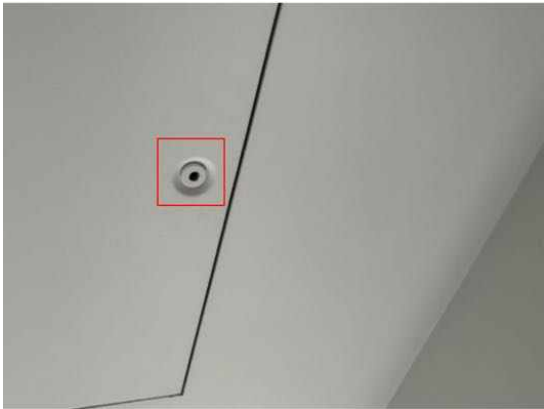
### Noted Item

Building: Main Building  
 Location: Laundry  
 Finding: Damaged Manhole Latch – Laundry Ceiling (Subfloor Void Not Inspected)  
 Information:

The manhole access located to the downstairs ceiling area (laundry) was found to have a damaged latch mechanism. The slotted latch designed to be operated using a screwdriver was deformed and would not properly engage with standard tools, preventing the panel from being opened at the time of inspection. The upstairs manhole access was inspected and found to be serviceable; however, the downstairs access panel could not be opened.

As a result of the damaged latch, access to the concealed subfloor/intermediate floor void between the ground floor and Level 1 was not possible, and this area was therefore not inspected. Concealed areas such as these may contain defects that are not visible externally.

It is recommended that a qualified carpenter or handyman repair or replace the damaged latch mechanism to restore proper access. A re-inspection of the subfloor/intermediate floor void is advised once safe and reasonable access has been provided.
