Building and Timber Pest Inspection Report

Inspection Date: Mon, 9 Mar 2026

Property Address: 178 Camden St, Enmore NSW 2042,
Australia

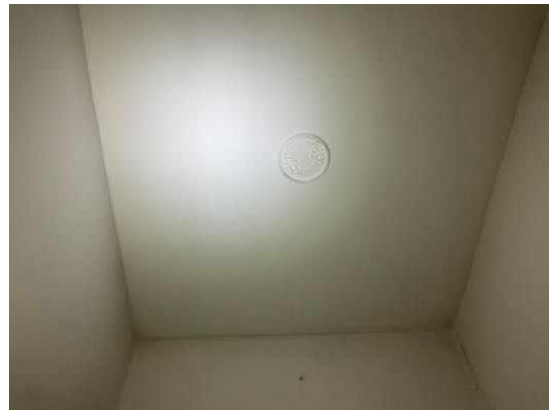
Please note that this defect is highlighted as a caution only. We suspect, based on our experience in the building industry, that the absence of smoke detectors, or their poor condition, should be addressed as a matter of urgency to improve occupant safety.

Always ensure sufficient working and suitable smoke detectors are installed prior to occupying any building. Additionally, it is advised that all smoke detectors be tested by the homeowner on a monthly basis.

Please refer to AS3786 and state based legislation, which may also apply.

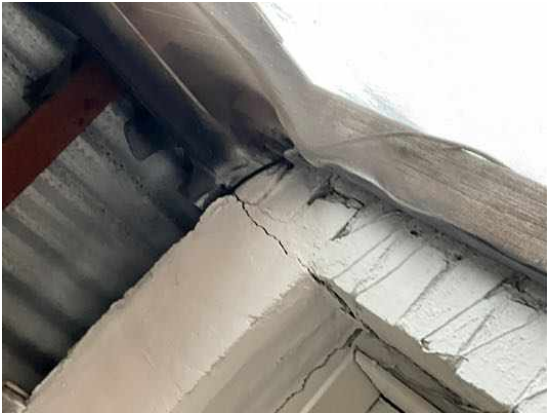
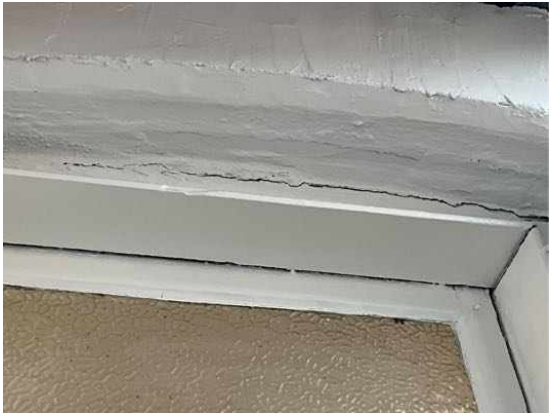
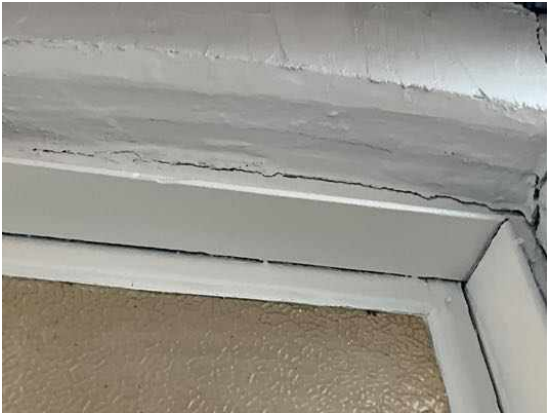
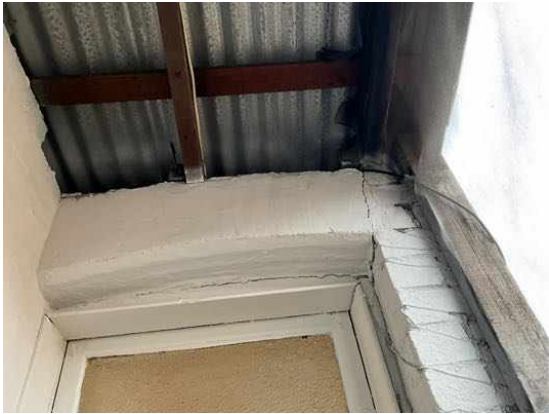
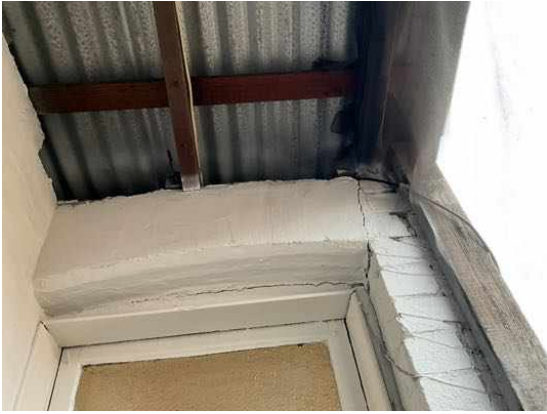
Finding: Brickwork - Cracking [Repair required]

Information: Major cracking was identified to the brickwork in this area. Cracks of this type are likely to have been caused by movement of building elements, but may also have a structural cause that is more significant.

A crack of this size may be repaired by extensive filling. Additionally, further remedial works to associated building elements, such as eave sheeting or external door frames, is likely to be required.

A qualified bricklayer should be contacted immediately to estimate and perform repair and restoration works. Consultation with a structural engineer may be required where structural instability is found to be the underlying cause of the cracking.

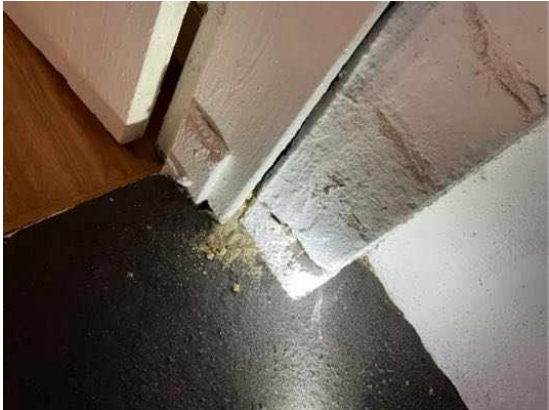
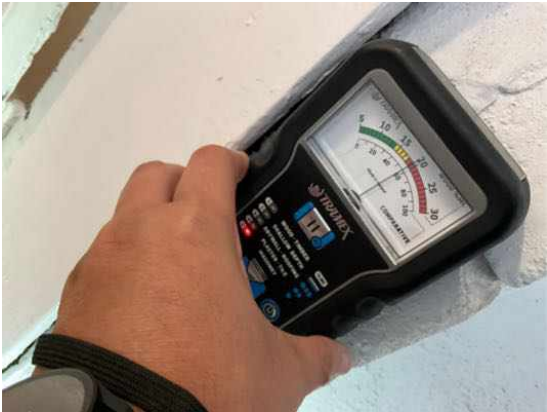
Finding 2.03

Building: Main Building
Location: Void
Finding: Evidence of excessive moisture - Drywall
Information: Excessive moisture is present at the time of , indicating a potential water leakage issue within the wall.

The prolonged presence of moisture can lead to mold growth, deteriorate the structure, and create an environment conducive to health hazards. Additionally, it may compromise the adhesive holding the tiles, leading to their detachment.

A licensed plumber or a qualified contractor specializing in water damage remediation should investigate the source of the moisture, fix any leaks, and address the damage. Additionally, replacing affected tiles and ensuring proper waterproofing are crucial to preventing future issues.

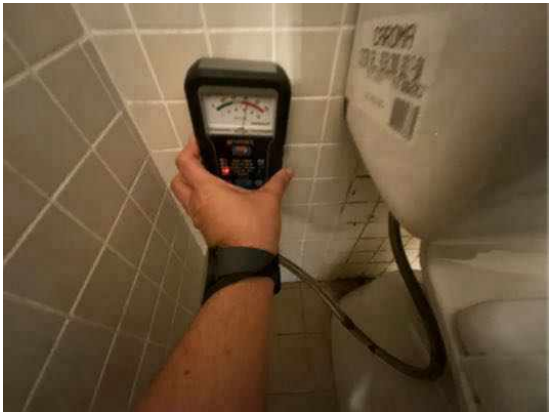
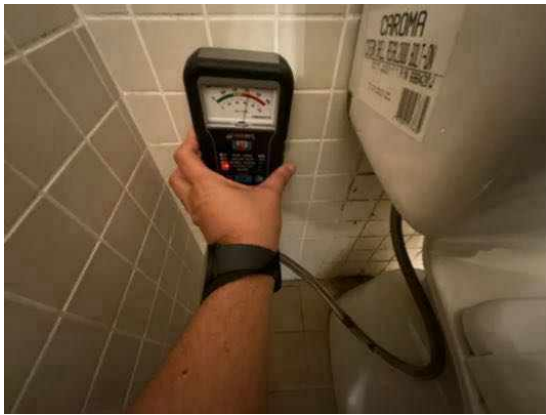
Finding 2.04

Building: Main Building
 Location: Bathroom
 Finding: Evidence of excessive moisture was present at the time of inspection
 Information: Excessive moisture is present behind the bathroom tiles, indicating a potential water leakage issue within the wall.

The prolonged presence of moisture can lead to mold growth, deteriorate the structure, and create an environment conducive to health hazards. Additionally, it may compromise the adhesive holding the tiles, leading to their detachment.

A licensed plumber or a qualified contractor specializing in water damage remediation should investigate the source of the moisture, fix any leaks, and address the damage. Additionally, replacing affected tiles and ensuring proper waterproofing are crucial to preventing future issues.

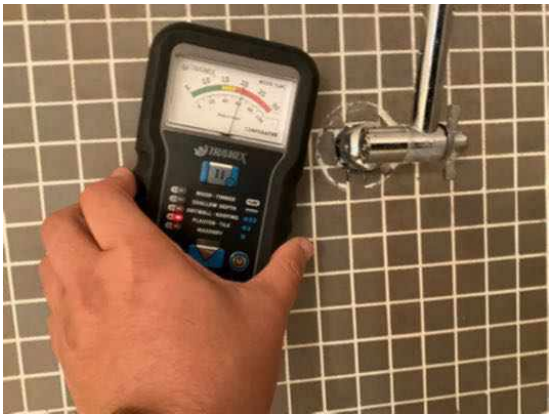
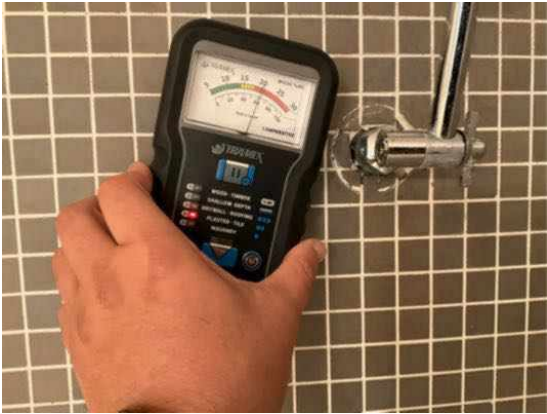
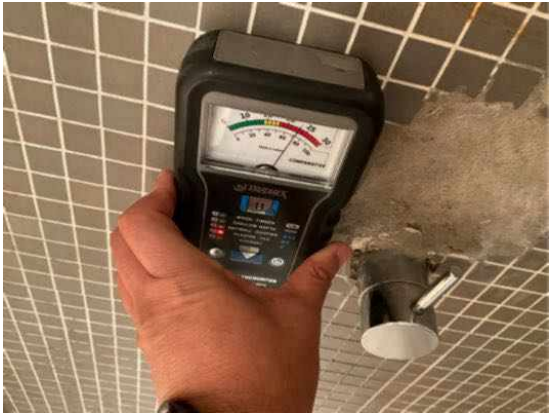
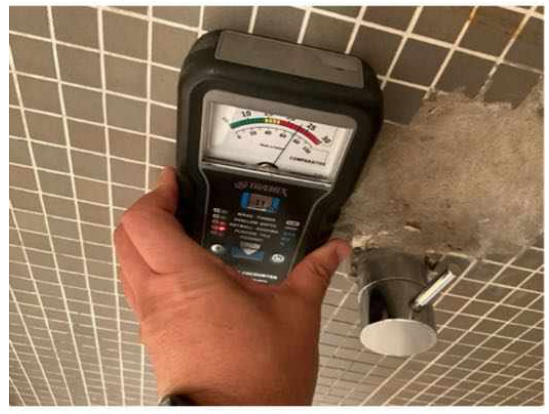
Finding 2.05

Building:	Main Building
Location:	Bathroom
Finding:	Evidence of excessive moisture was present at the time of inspection
Information:	Excessive moisture is present behind the bathroom tiles, indicating a potential water leakage issue within the wall.

The prolonged presence of moisture can lead to mold growth, deteriorate the structure, and create an environment conducive to health hazards. Additionally, it may compromise the adhesive holding the tiles, leading to their detachment.

A licensed plumber or a qualified contractor specializing in water damage remediation should investigate the source of the moisture, fix any leaks, and address the damage. Additionally, replacing affected tiles and ensuring proper waterproofing are crucial to preventing future issues.

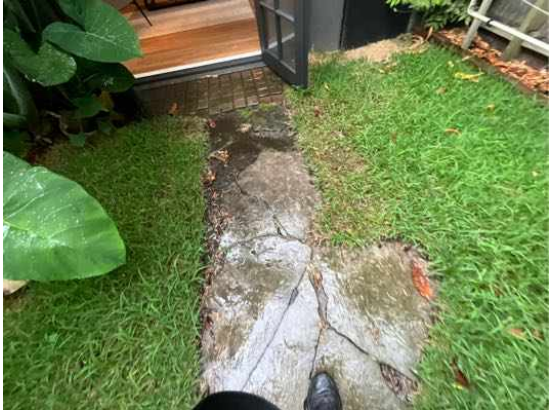
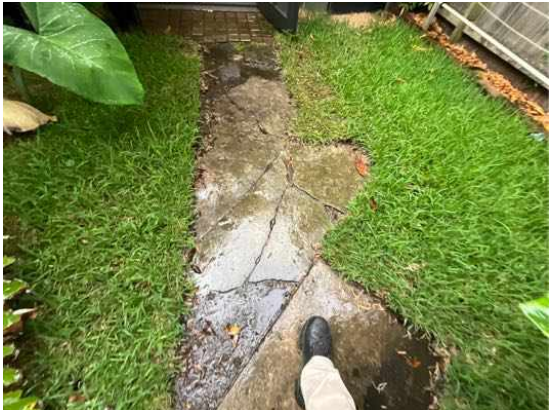
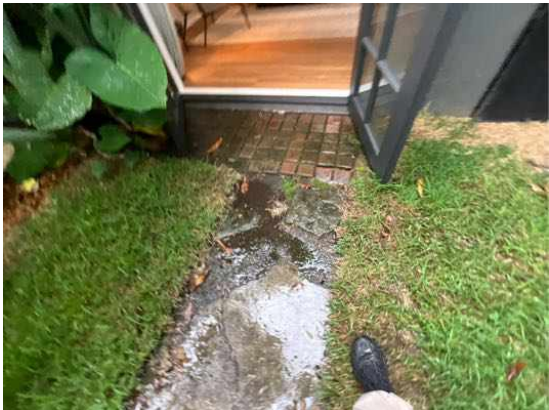
Building:	Main Building
Location:	All Areas
Finding:	Noticeable Cracking in Concrete Slab
Information:	Noticeable cracking has been observed in the concrete slab, failing to meet the required construction and quality standards.

- Cracks are visible on the surface and may extend through the depth of the slab.
- Evidence of improper curing or inadequate reinforcement leading to cracking.

- Compromised structural integrity of the slab, potentially leading to failure under load.
- Water ingress through cracks, causing corrosion of reinforcement and further weakening the structure.
- Potential trip hazards and aesthetic issues, reducing the overall value and safety of the property.
- Increased maintenance and repair costs due to ongoing deterioration.

- A structural engineer should be engaged to assess the extent of the cracking and recommend appropriate repair methods.
- A licensed contractor or concrete repair specialist should carry out the recommended repairs under the guidance of the structural engineer.

A detailed inspection should be conducted post-repair to confirm compliance with the required standards and to ensure that the structural integrity of the concrete slab has been restored.

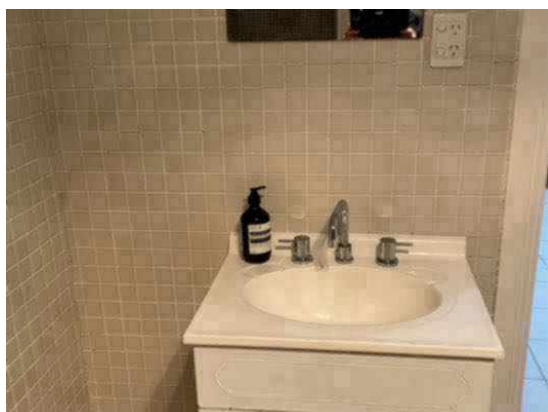
Finding: Tiles - Cracked or damaged

Information: Cracking was evident to the tiling in this area at the time of inspection. This area is frequently exposed to water, allowing potential for water penetration into adjoining sections of walls or flooring.

If left unmanaged, water penetration to these areas may lead to subsequent water damage, which is likely necessitate repair work to affected building elements.

A tiling contractor should be appointed to ensure that no further water damage occurs. The re-application of silicone and grouting throughout remaining tile work is also advised, to further protect the area against water penetration.

Where water penetration has led to water damage, appointment of a relevant tradesperson may be required to repair damaged building elements.

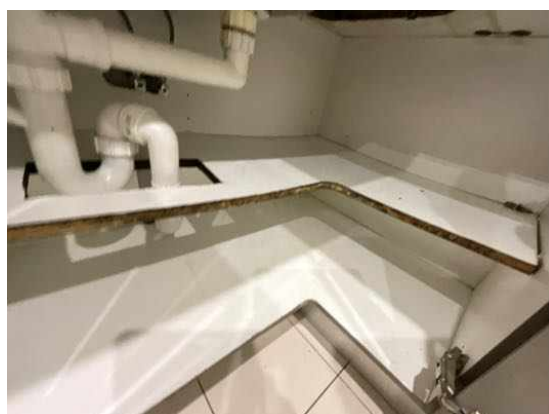
Building:	Main Building
Location:	Kitchen
Finding:	Water damage / Vanity
Information:	"The vanity in the shower area has sustained water damage, resulting in swelling and discoloration of the wood, as well as potential structural issues. This damage compromises both the aesthetic and functional aspects of the vanity."

1. **Carpenter or Woodworker:** They can assess and repair the damage to the vanity, potentially replacing any irreparable parts.

2. **Plumber:** If the water damage is due to plumbing issues, a plumber can fix leaks and ensure there are no further water-related problems.

3. **General Contractor:** If the damage is extensive and affects the surrounding area, a general contractor can coordinate the repair work, including both the vanity and any related structural or cosmetic repairs.

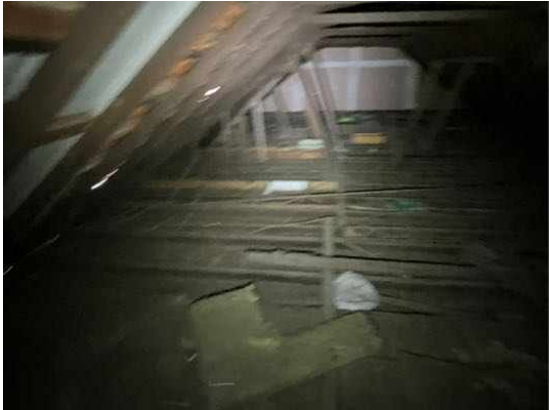
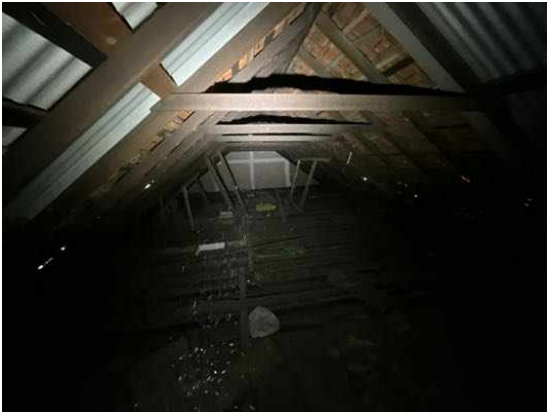
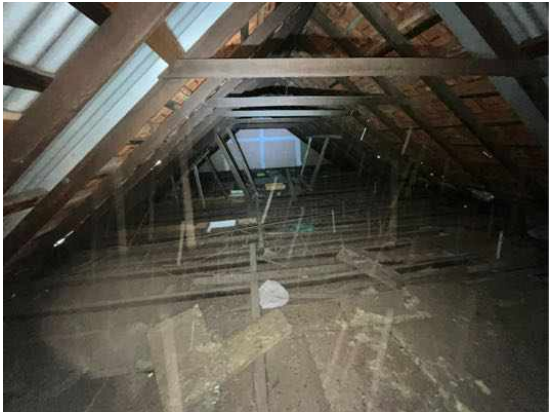
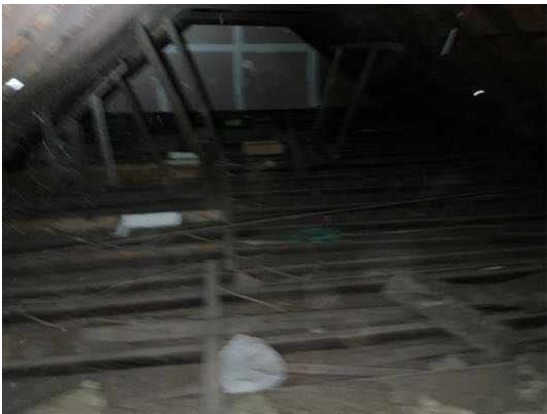
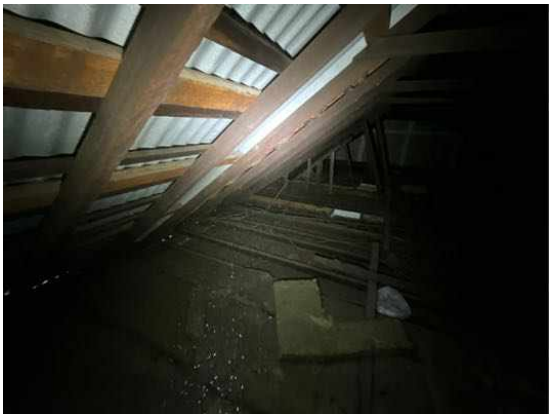
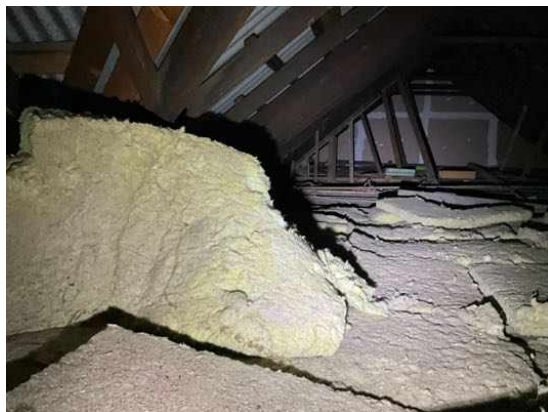
Building: Main Building
Location: Roof Void
Finding: Roof void - Brickwork incomplete
Information: Incomplete or missing brickwork was observed in the roof cavity. This section of the wall is not fully built up to meet the roof line, leaving gaps that compromise the integrity of the building envelope.

- Pest Entry: Open areas may allow vermin or insects to enter the roof space, leading to infestations and associated health hazards.
- Structural Integrity: Depending on the extent of the missing brickwork, there may be a reduction in the overall strength and stability of the wall, especially under wind load or other stresses.

- A licensed bricklayer or builder experienced in remedial work should be engaged to assess and complete the missing brickwork to ensure proper sealing and support.
- A structural engineer may be required to assess the impact of the missing brickwork on the structural integrity of the building and specify any necessary reinforcement.

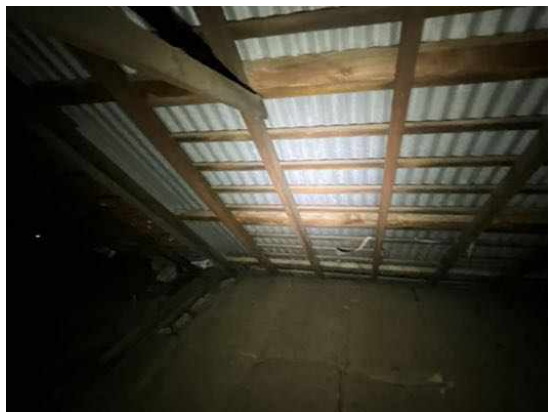
Finding 3.09

Building:	Main Building
Location:	Roof Void
Finding:	Sarking - Missing
Information:	Sarking is missing under the roof sheeting. Sarking acts as an insulator that helps with noise reduction and protects against water penetration. Sarking plays a key role in the operation and function of the overall roofing structure and its performance.

Although not a requirement at the time of construction, replacement of any missing building element is advisable (although this can be quite expensive to do after the time of construction). Where sarking is missing, regular inspections of the roof tiles for cracking and potential moisture penetration is required.

Sarking may be retrospectively fitted by a registered builder at the discretion of the client.

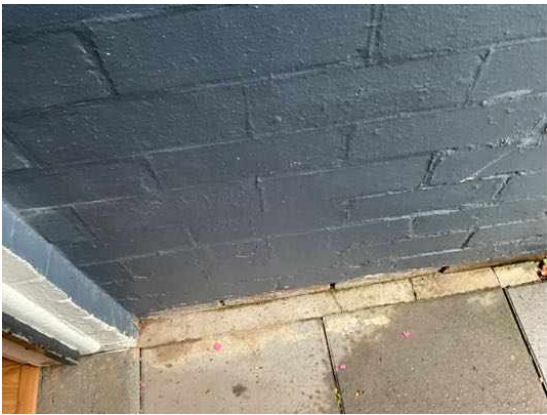
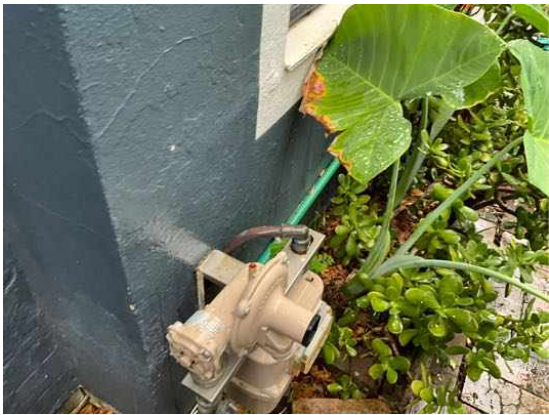
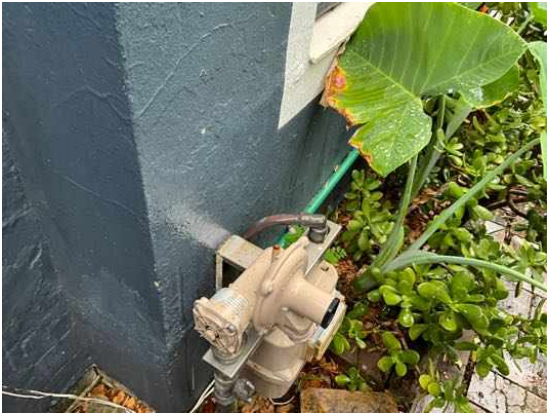
Building: Main Building
 Location: Front porch
 Finding: No Evidence of Termite Management System - Durable notice / Legible Sticker
 Information: The application of a pre & post-construction chemical termite barrier is highly recommended for all properties. Such barriers are highly effective in preventing termite attack on any timber building elements throughout the property.

Client must seek further information from the vendor or real estate agent if the conditions of termite management systems were maintained.

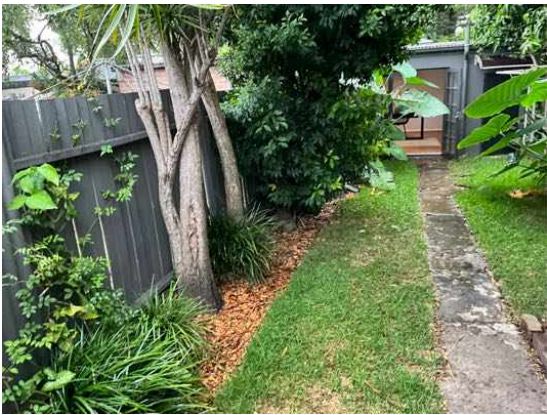
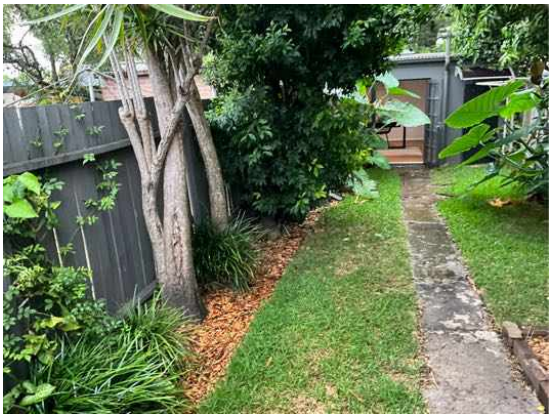
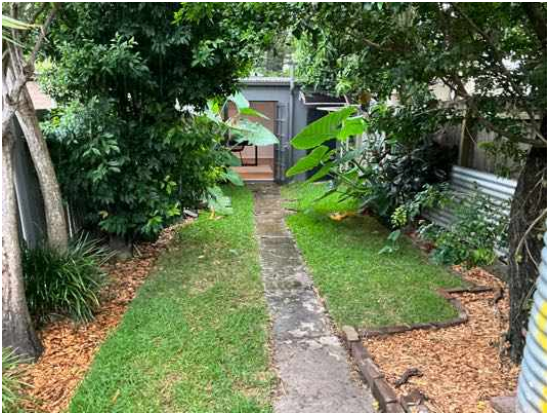
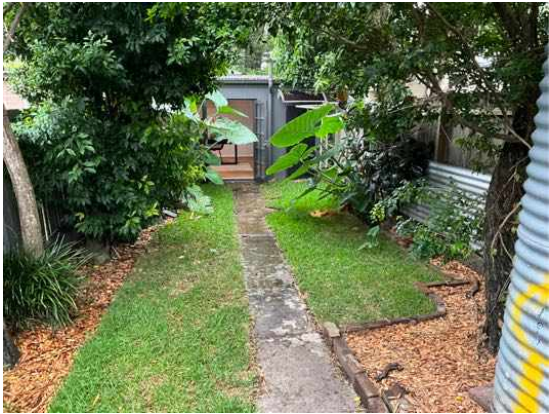
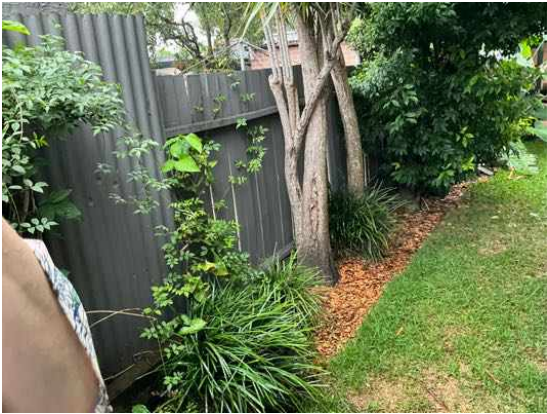
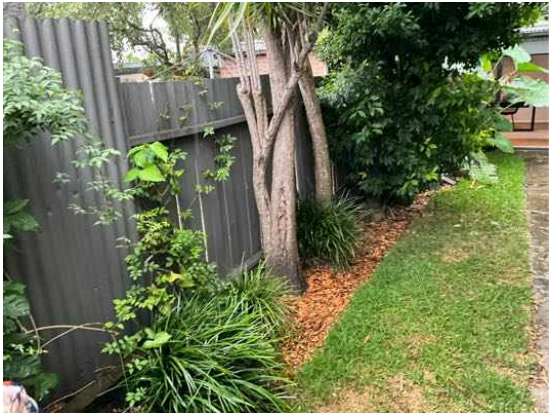
Finding 6.03

Building: Main Building
Location: All Areas
Finding: Dense vegetation around a property can increase the risk of termite infestation
Information: The presence of dense vegetation around a property can increase the risk of termite infestation, as it provides a conducive environment for them. To address this, consider maintaining a clear space between the vegetation and your home. If you suspect a termite issue, it's advisable to consult with a licensed pest control professional for inspection and treatment.

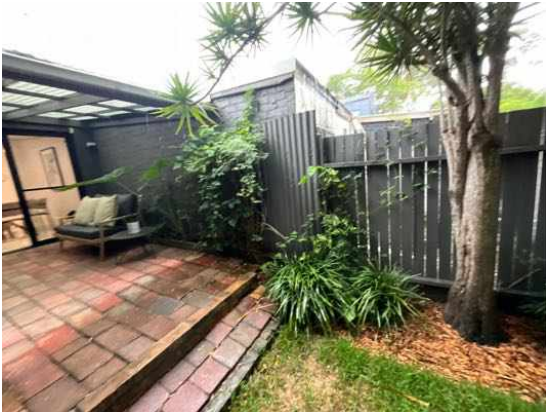
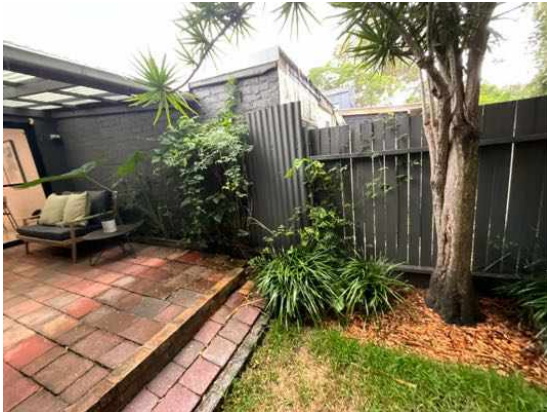
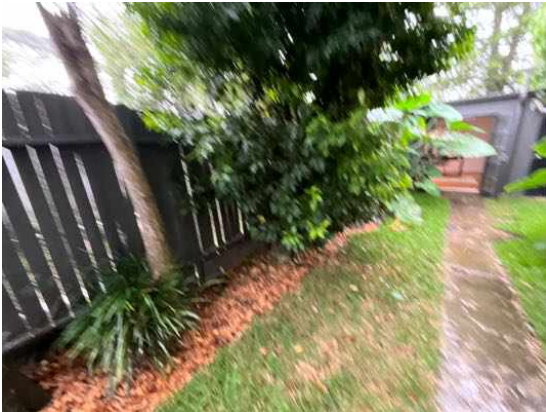
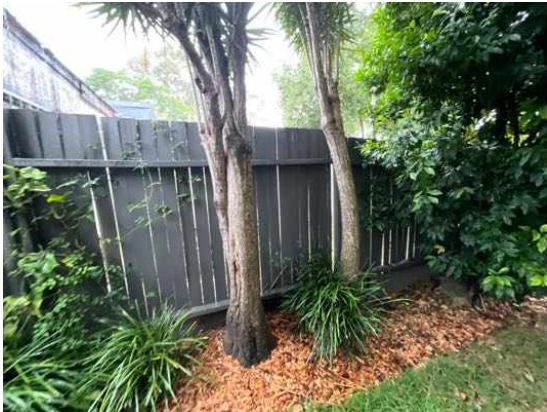
Building:	Main Building
Location:	All Areas
Finding:	Timber on ground / conducive conditions to termite damage
Information:	Timber on the ground is indeed conducive to termite damage. Termites are known to thrive in moist environments, and wood in contact with soil or moisture is more

susceptible to infestation.

To prevent this, it's important to keep timber elevated and away from direct ground contact. Regular inspections and proper termite control measures are also essential to protect your wooden structures from termite damage.

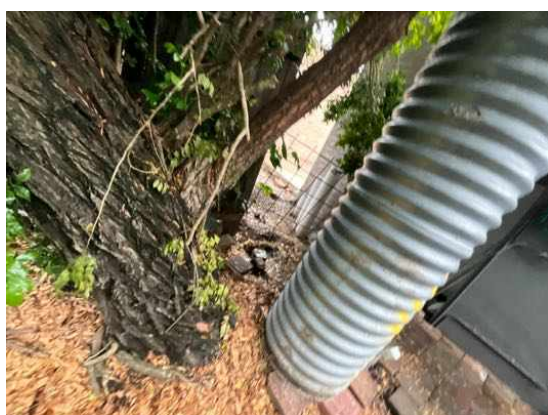
Finding 6.06

Building:	Main Building
Location:	All Areas
Finding:	Bridging or Obstruction Conducive environment for Termites
Information:	Bridging of termite barriers occurs when termites bridge (usually by building a mud

Where bridging has occurred full inspection is prevented and termites may enter a property in a concealed or undetected manner.

Recommended moving obstructions away from the external walls for further and future inspections.
