Building and Timber Pest Inspection Report

Inspection Date: Tue, 20 Jan 2026

Property Address: 44 Glenora Dr, Ingle Farm SA 5098,
Australia

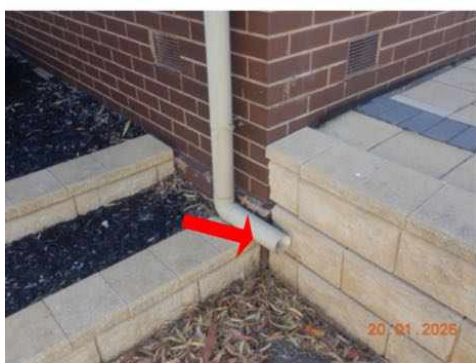
Building:	Building 1
Location:	Front Elevation
Finding:	Stormwater drain - Not connected or leaking

Information: The roof plumbing is not adequately connected to stormwater drainage or is leaking in several areas on the site. This issue negatively impacts the functional capacity of the roof plumbing. It appears that the rear stormwater drainage is contained and run out to the road however the front pipes appear to spill directly adjacent the dwelling.

Where roof plumbing doesn't drain adequately, the area at the base perimeter can become excessively damp, potentially creating an environment that is susceptible to rust and corrosion of surrounding building elements, as well as attracting termites and other pests.

It is highly recommended that a plumber be appointed to further inspect the area and to install or repair drainage equipment where necessary.

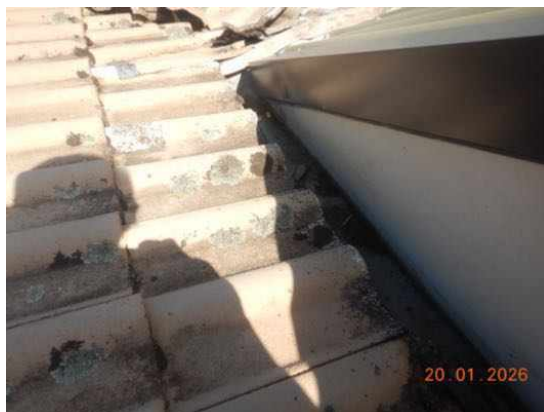
Finding 2.02

Building: Building 1
 Location: Roof Exterior
 Finding: Gutters - Blocked
 Information: Roof plumbing structures, such as guttering and downpipes, should be free of all debris to prevent blockages. Blockages of the guttering and downpipes will lead to pooling and accumulated water overflows, which is likely to subsequently flood eaves and exterior walls.

Blocked gutters are likely to lead to high levels of moisture in the affected areas. Such moisture will not only cause rust and decay of the associated building materials, but can also provide conditions that are conducive to termite and timber pest activity. Blockages in gutters should therefore be removed immediately to ensure dry conditions are maintained.

Consult a Licensed Plumber for further specific advice on remedial works that may be required. In the interim, it is highly advised that blocked gutters be removed by the homeowner or a general handyperson as a matter of urgency.

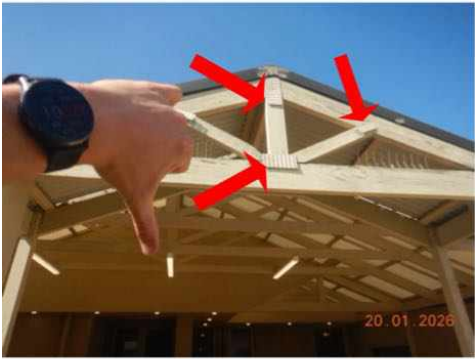
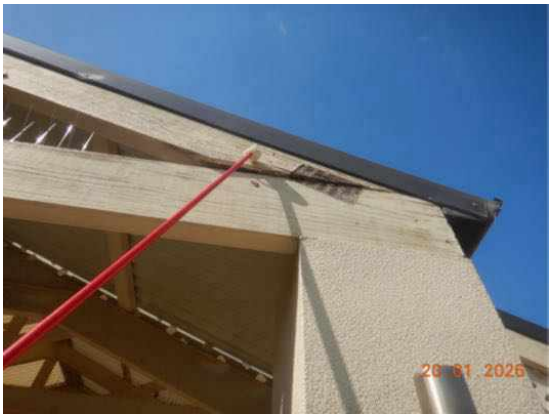
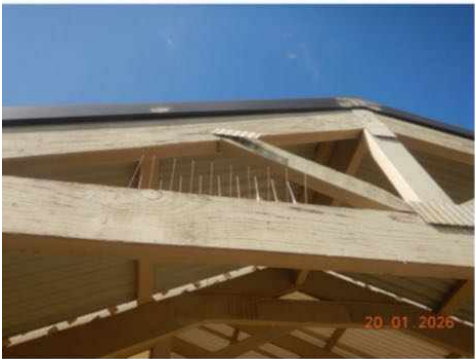
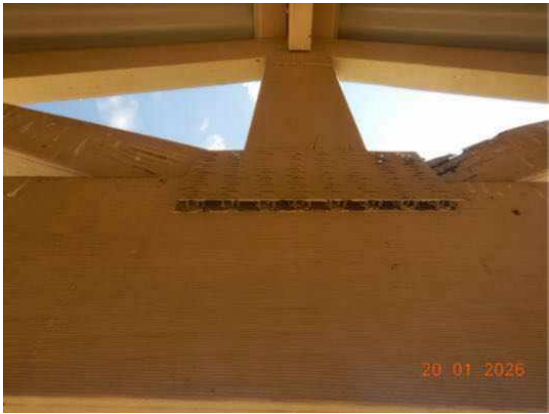
Finding 2.03

Building: Building 1
 Location: Pergola
 Finding: Trusses - Nail plate back out
 Information: There were several nail plates evident to the pergola roof trusses at the time of inspection that are backing out of their original positions.

This could be due to one or more of several reasons including faulty, nail plates, varying moisture levels, and exposure to the elements. Secondary defects can be created, worth of which being to structural failure and collapse.

The issue appears to be effecting relatively few truss plates (estimated 10%) and as such repair is likely possible. There is however rot evident to several trusses which will repair repair or replacement.

A structural engineer would be required to provide recommendations to be carried out by a licensed builder ASAP to prevent any further deterioration and to prevent a hazard being created.

Replace damaged pergola trusses

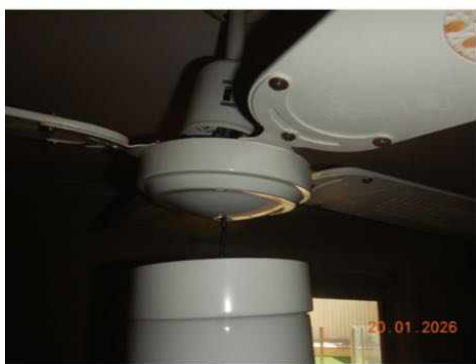
Finding 2.04

Building: Building 1
Location: Bathroom 3
Finding: Light fitting - Loose
Information: The light to bedroom 3 was found to be loose at the time of inspection. Breakage occurs generally when the building materials have aged and decayed, but may also be indicative of impact damage to the building element (accidental or deliberate).

Left unmanaged, the fitting is unlikely to further deteriorate. However, the broken or loose fitting may expose electrical works, and may create a safety hazard if there is potential contact with persons in the area.

Repair and/or replacement of the broken fitting is advised. A Licensed electrician should be appointed to repair/replace the fitting immediately.

Repair damaged light to bedroom

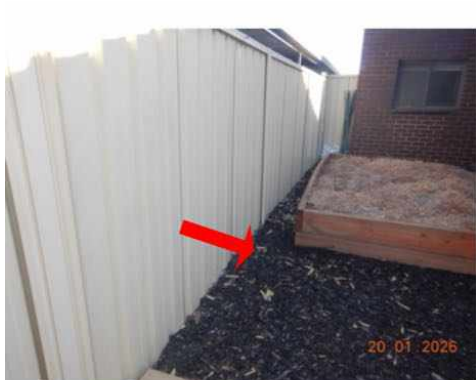
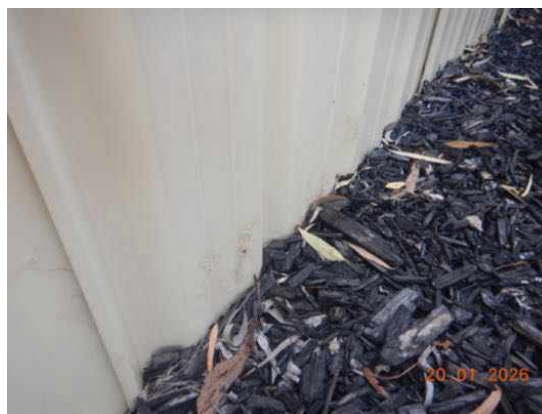
Finding 3.01

Building: Building 1
Location: All External Areas
Finding: Fencing - Fill placed against.
Information: It was noted at the time of inspection that sections of the fencing at the left side of the property had fill placed against it at the time of inspection.. The rear fence, while solid, was found to be leaning also.

Where fill is placed against the fence, it is likely that the fencing will deteriorate at an accelerated rate if not addressed.

A landscaper or handyperson could be appointed to remove the fill against the fence might install some form of retaining at the base at the discretion of the client.

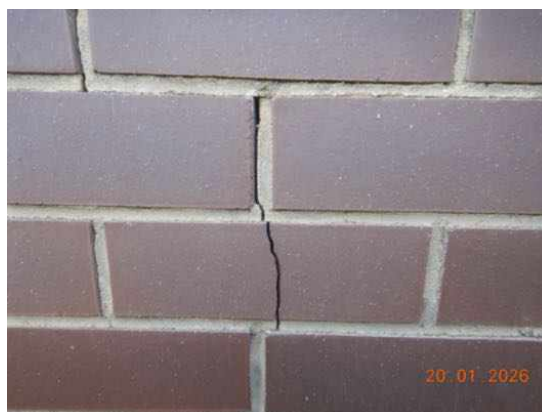
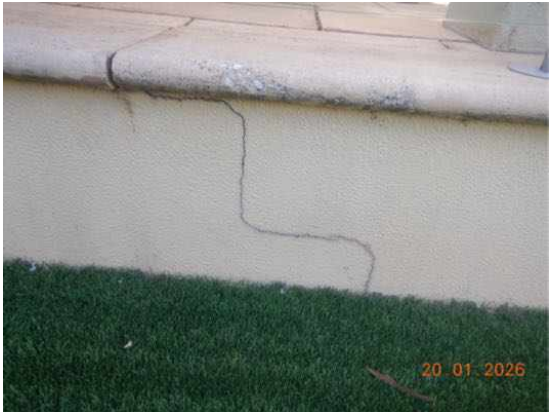
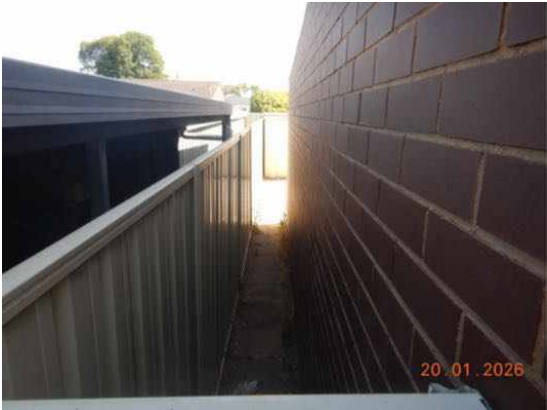
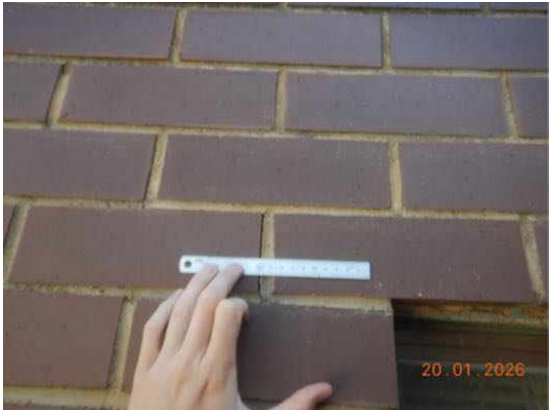
Finding 3.02

Building:	Building 1
Location:	Exterior walls
Finding:	Brickwork - Cracking [Fine]
Information:	There were fine cracks evident to the external brickwork at the time of inspection.

Although fine cracks are quite noticeable, they are often only considered to be an appearance defect and usually do not indicate any structural damage. Generally, the cause of a fine crack is indicative of a separation between brickwork and mortar throughout the structure, but single bricks may also show cracks of this nature.

Cracking of this nature can generally be repaired with minor filling and should be conducted by a qualified bricklayer.

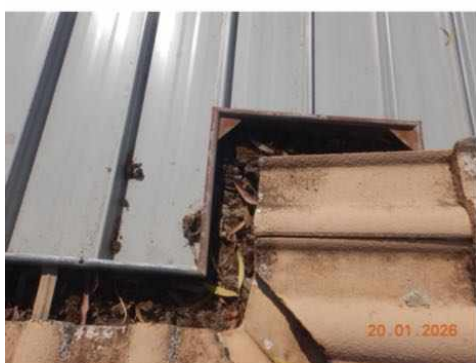
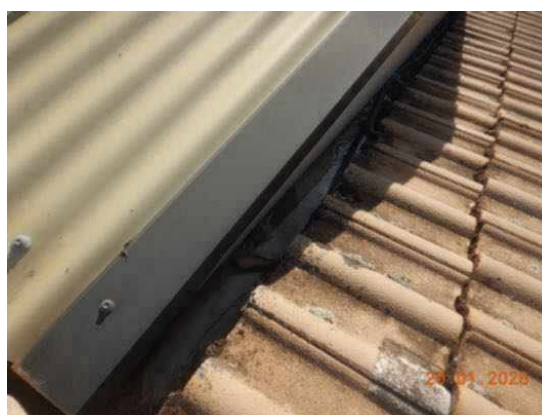
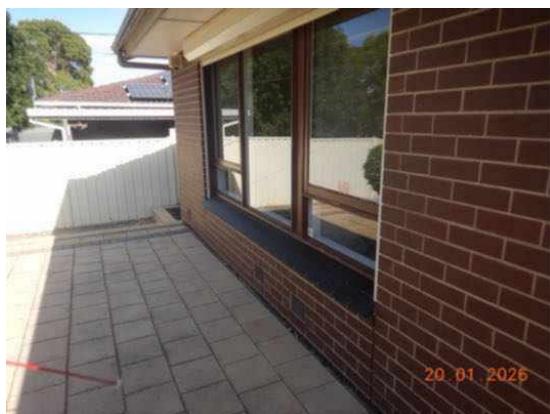
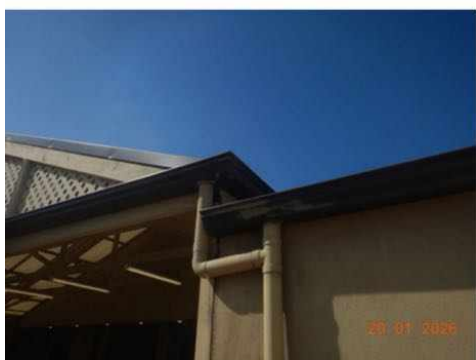
Finding 3.03

Building: Building 1
Location: Roof Exterior
Finding: Roof plumbing - Rusted or corroded
Information: The roof plumbing has areas of rust and corrosion. While most of the gutters appeared to have been replaced, there appears to be small sections of original guttering to the rear of the property. There is also corrosion to several small areas of the new guttering which requires re sealing.

It is suspected that this has been caused by blockages, resulting in pooling or standing water, that have prematurely rusted elements of the roof plumbing.

Rusted roof plumbing will generally develop holes and leaks that can affect other building elements with poor drainage of storm water.

Repair and/or replacement of rusted roof plumbing is highly required in order to reinstate the roof drainage system to a fully operational level.

A licensed plumber or specialist roof restoration company should be appointed to undertake these works. If leaking occurs work should be carried out to prevent further deterioration.

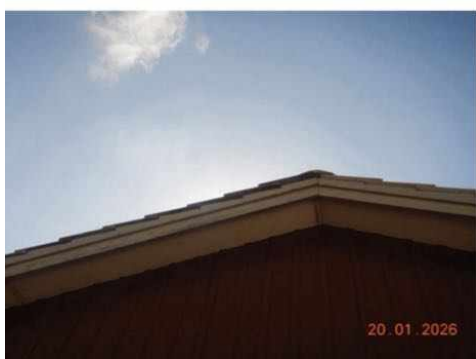
Building:	Building 1
Location:	All External Areas
Finding:	External painting deteriorated
Information:	Much of the external paintwork including but not limited to exterior fascia timbers, eaves linings and other elements, have been neglected and require attention to prepare and re-paint.

Whilst incomplete or missing paint finish is generally an appearance defect, it can also lead to the development of secondary building defects over time. Incomplete areas of paint finish expose the area to moisture, potentially accelerating the deterioration of underlying building materials.

Degraded paint finishes should be sanded back, filled, leveled and painted, as applicable. Rust to steel beams should be ground out and treated.

A painting contractor should be appointed as soon as possible to perform necessary works to aid the appearance of the affected area and to ensure the area is protected against further deterioration. Alternatively, the homeowner following manufacturer instructions may perform these works.

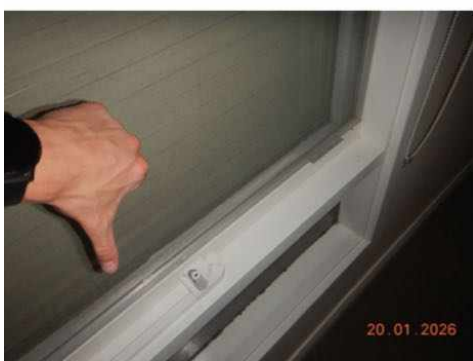
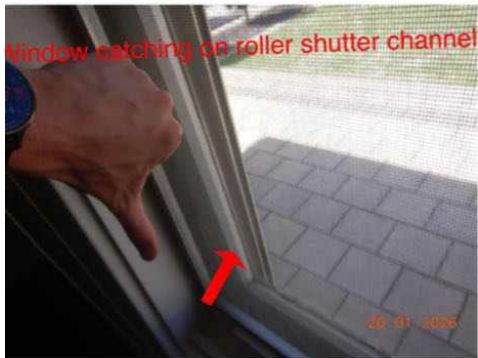
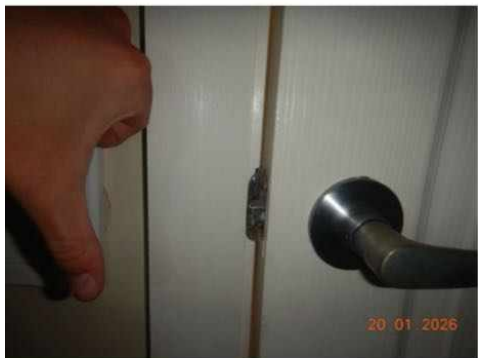
Finding 3.06

Building: Building 1
Location: All Internal Areas
Finding: Door and window not functioning as intended.
Information: Several doors and windows throughout the dwelling we're not functioning properly at the time of inspection. Several door doors were rubbing on the frame and or latches not striking to the door frame correctly. Several windows were hitting the exterior roller shutters therefore restricting functionality and also window winders were missing their handles.

Windows and doors are an integral part of the property and restricted functionality can create a safety hazard in emergency situations.

Repair of the windows and doors is highly recommended to ensure the functionality of all elements.

Consultation with a licensed carpenter or a general handy person is required to make repairs at the discretion of the client.

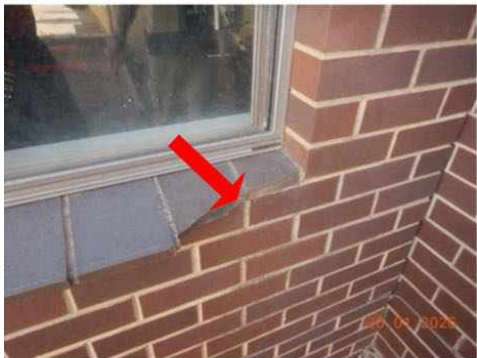
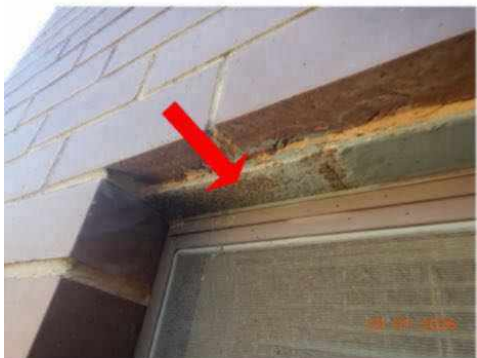
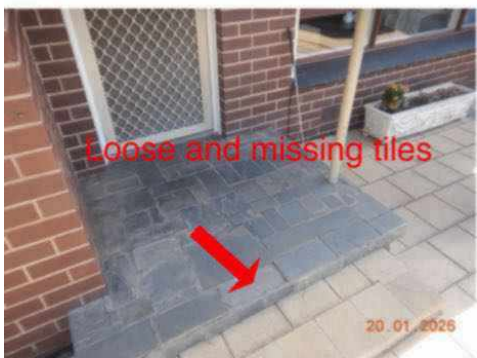
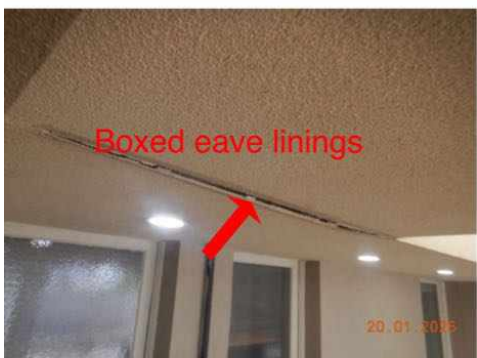
Finding 3.07

Building: Building 1
 Location: All Areas
 Finding: Minor defects present
 Information: There were several age and maintenance related defects evident to the dwelling at the time of inspection. These defects include but are not limited to

- Sill bricks damaged
- Rust to lintels
- Loose tiles to front porch
- Minor cracking/ damage to rear boxed eave linings
- We could not get the kitchen down lights working at the time of inspection.

Appropriate licensed trades people could be appointed to make repairs at the discretion of the client.

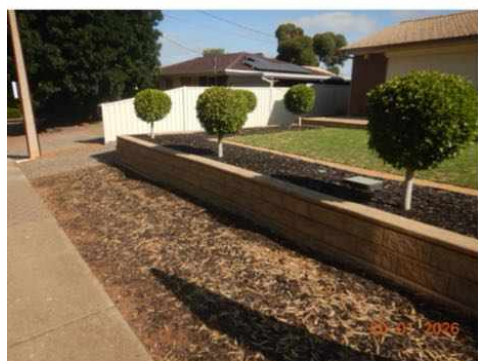
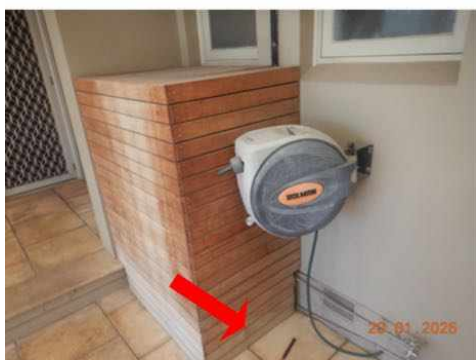
Building:	Building 1
Location:	All External Areas
Finding:	Untreated or non-durable timbers in a hazardous environment
Information:	To reduce the risk of timber pest attack it is essential that timber used in a hazardous environment (e.g. in direct contact with the ground or frequently exposed to damp conditions) is of sufficient durability and/or is adequately preservative treated. Additionally any timber lying around or timber stumps should be removed.

Untreated timbers in direct contact with the ground are likely to develop severe wood rot and/or fungal decay if left unattended creating attraction for subterranean termites to infest the timbers from surrounding areas.

If untreated or non-durable timbers are found to be in a hazardous environment it is highly advised that replacement of these building elements be performed as soon as possible to aid the protection of the property against termite / timber pest attack. Failing this close monitoring is recommended in an attempt to identify termite infestation at an early stage.

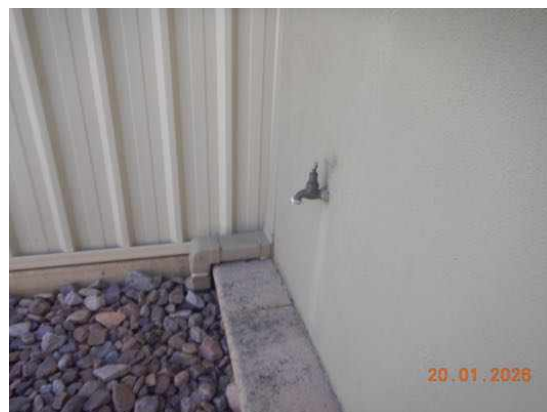
Building:	Building 1
Location:	All External Areas
Finding:	Air conditioner and or external tap - No drainage
Information:	Moisture around the perimeter of the building should be minimised to ensure that the area is kept dry and stable which in turn reduces the risk of water damage and termite infestation.

There appears to be no drainage points set up to the air conditioning unit, and or the external tap. While this is not a legal requirement it is recommended to reduce the risk of moisture related issues and the creation of an environment conducive to termite activity.

It is recommended that a licensed plumber be appointed to set up drainage in order to prevent such an environment from being created.

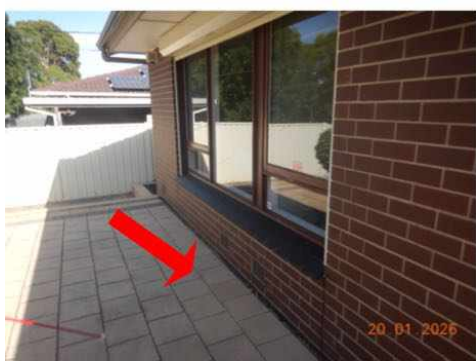
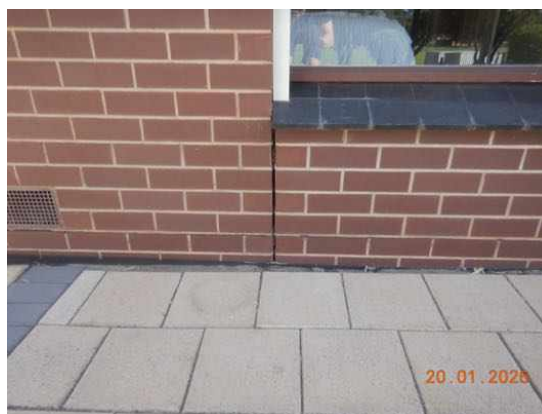
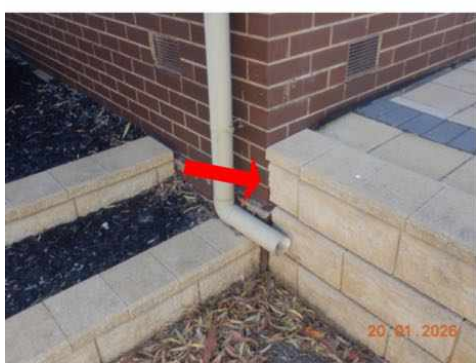
Generally this takes the form of finished ground levels external paving or concrete being retrospectively installed above the damp course level the adjacent internal floor level or weep and ventilation holes.

Where bridging has occurred full inspection is prevented and termites may enter a property in a concealed or undetectable manner.
