Building and Timber Pest Inspection Report

Inspection Date: Wed, 25 Feb 2026

Property Address: 8 King Rock Road, Austral, NSW 2179

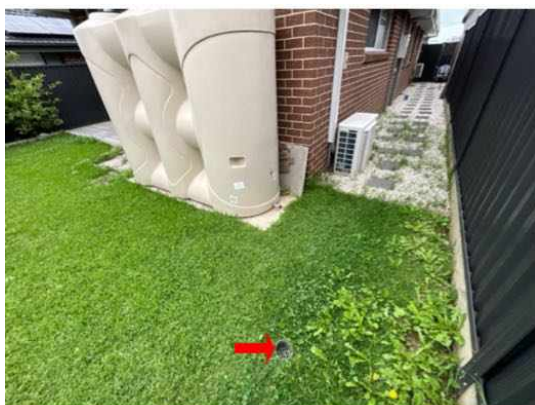
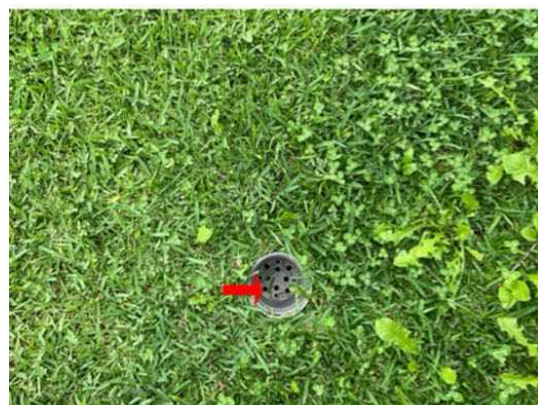
Building: Main Building
 Location: Backyard
 Finding: Unconventional handyman work
 Information: This handyman work appears to have been completed to a substandard level and does not comply with regular building practices. Where handyman work is not completed satisfactorily, accelerated deterioration of the associated building elements is likely to occur and secondary defects to surrounding structures may develop.

It is highly recommended that the substandard work be rectified by professional services. Works to improve this area are likely to increase the safety and the operation of the associated building elements.

The client should exercise care when coming into the immediate vicinity of the substandard works. Rectification works are advised as soon as possible by the appropriate trades.

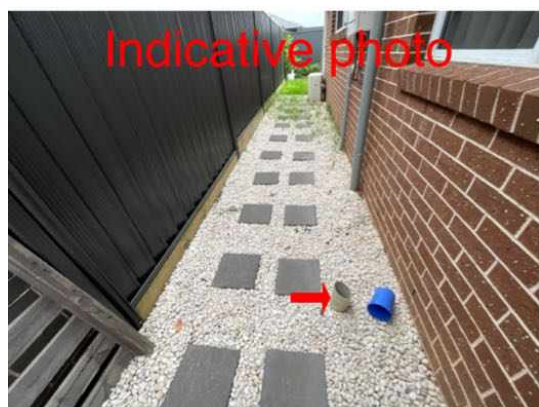
Finding 3.02

Building: Main Building
 Location: Yard - side

Finding: Site drainage— Inadequate
 Information: The site drainage throughout was found to be inadequate at the time of inspection, creating potential for subsequent water damage to associated building elements. This is additionally conducive to termite activity.

It is important that water does not lie against the base of walls; surrounding paths and ground levels should be sloped to drain water away from walls. Downpipes should not discharge stormwater onto lower walls or plinths. Stormwater should be carried away by large, regularly cleaned drains. Ground levels may need to be lowered to expose a buried DPC.

Where site drainage is inadequate, installation of an Agricultural (Aggie) Drain may be required. A licensed plumber should be appointed to further inspect the property and perform any remedial works as necessary. Water damage and secondary defects are likely to occur if left unmanaged.

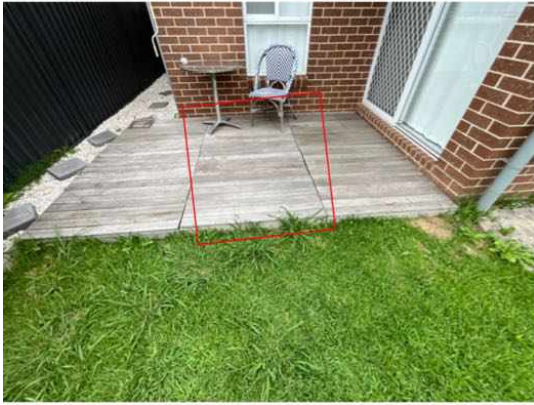
Finding 3.03

Building: Main Building
 Location: Deck
 Finding: Timber - exposed to weather
 Information: External timbers that are frequently exposed to harsh weather conditions require adequate protection in order to maintain their condition. Where timbers have not been painted or treated adequately, general deterioration is likely to occur at an accelerated rate.

If left unattended, replacement of these timbers is likely to be necessary in the short-term future. Adequate treatment of these timbers is required as soon as possible by a painting contractor or general handyman.

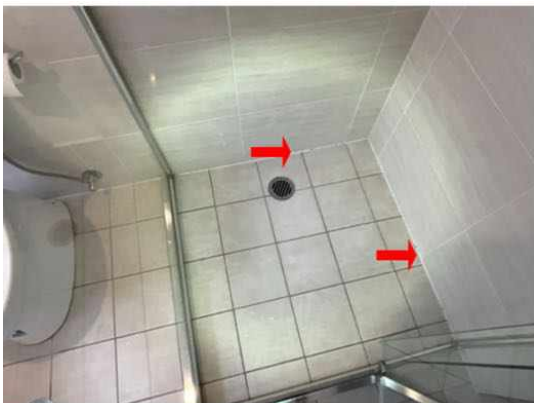
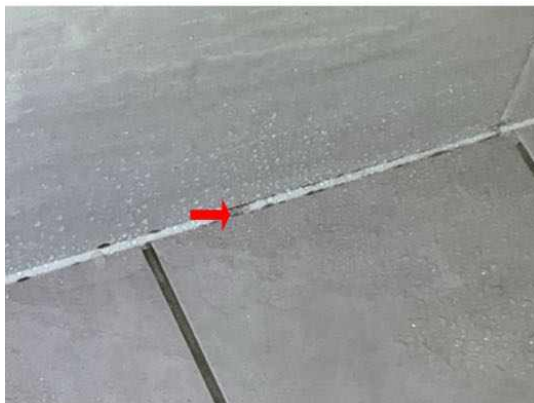
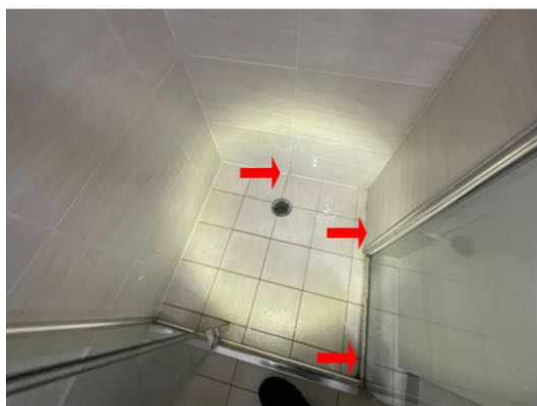
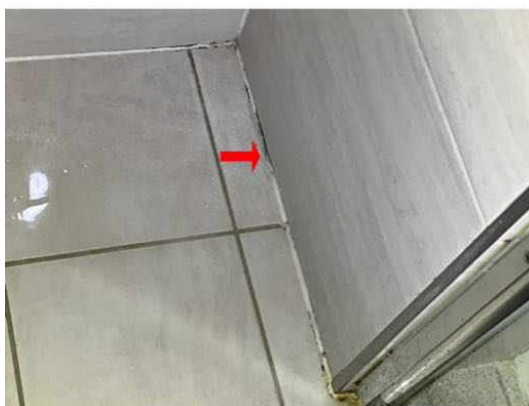
Finding 3.04

Building: Main Building
 Location: All Wet Areas
 Finding: Sealant and grouting - Missing or damaged
 Information:

It was noted on inspection that sealant or grout is degraded to this area.

Different materials and floor areas move at different rates, generally causing cracking to grout or sealant at this point. A flexible sealant is required to allow for expected expansion and contraction, while keeping the joint water tight and protective of all associated building materials.

Flexible and mould resistant materials should be applied to affected areas to prevent any subsequent water damage that is likely to occur. Regular maintenance and replacement of damage or missing or damaged sealant and grout is highly recommended to the wet areas, as this is a regular wear and tear defect. Sealant and grouting in areas that come into regular contact with water should be maintained for the long term care of your property.

A sealant specialist should be appointed to complete these works as soon as possible.

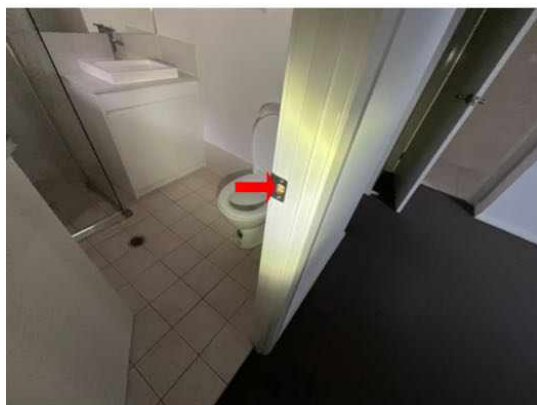
Finding 3.05

Building:	Main Building
Location:	Ensuite
Finding:	Door - Striker plate misaligned
Information:	The striker plate to this door appears to have become misaligned and has consequently resulted in the door's operation being compromised.

This is a common defect and is expected in a property of this age, whether being due to substandard installation or general deterioration of the door hardware.

Readjustment of the striker plate is recommended at client discretion. Works such as these can be completed by a general handyman or qualified carpenter.

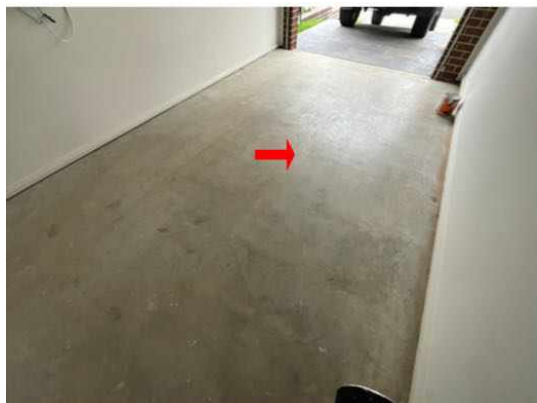
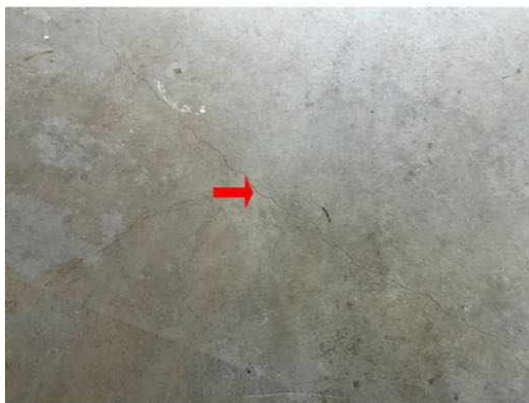
Finding 3.06

Building:	Main Building
Location:	Garage
Finding:	Crack in concrete slab - Category 0
Information:	A crack coded as Category 0 was identified in the slab. A Category 0 crack is described as a hairline crack, representing insignificant movement of slab from level.

The approximate width of the crack to be considered Category 0 is 0.3mm, or change in offset of less than 8mm when a 3m straight edge is placed over the defect.

No rectification is required at this time. However, all cracking should be monitored over a 12 month period to identify any further damage in the area.

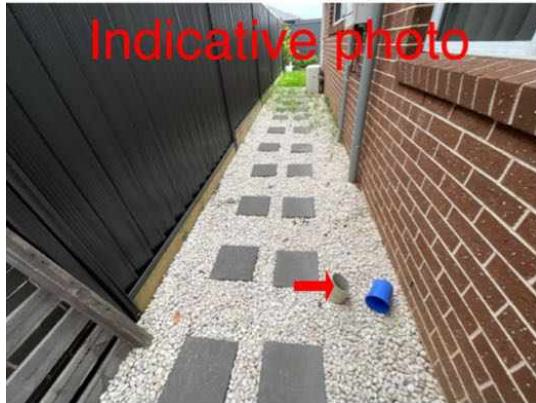
Building:	Main Building
Location:	Yard - side
Finding:	Site drainage— Inadequate
Information:	The site drainage throughout was found to be inadequate at the time of inspection, creating potential for subsequent water damage to associated building elements. This is additionally conducive to termite activity.

It is important that water does not lie against the base of walls; surrounding paths and ground levels should be sloped to drain water away from walls. Downpipes should not discharge stormwater onto lower walls or plinths. Stormwater should be carried away by large, regularly cleaned drains. Ground levels may need to be lowered to expose a buried DPC.

Where site drainage is inadequate, installation of an Agricultural (Aggie) Drain may be required. A licensed plumber should be appointed to further inspect the property and perform any remedial works as necessary. Water damage and secondary defects are likely to occur if left unmanaged.

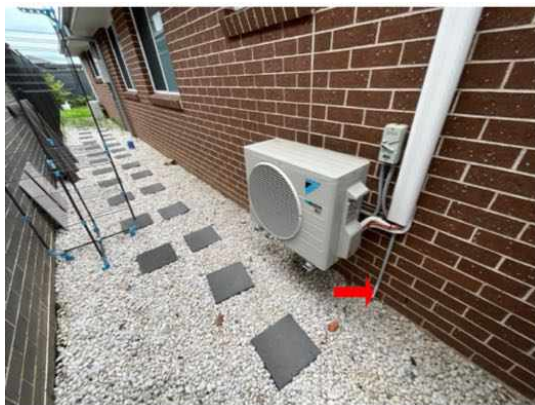
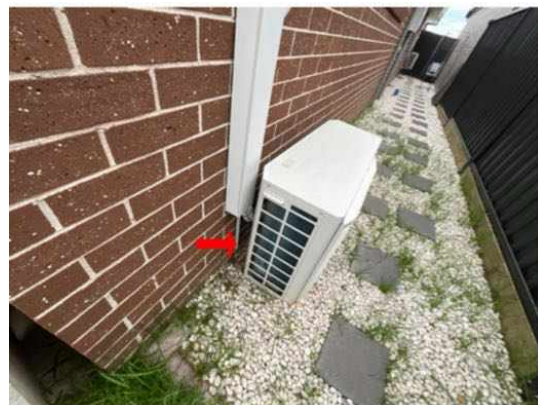
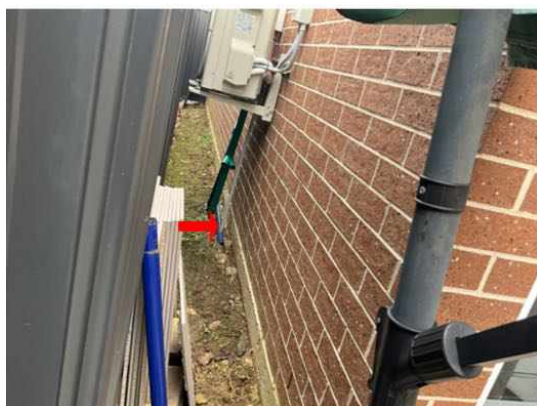
Finding 6.02

Building:	Main Building
Location:	Yard - Side
Finding:	Overflow - Not plumbed for drainage
Information:	The overflow is not plumbed or connected to suitable drainage, which can result in the surrounding area becoming excessively damp.

These damp conditions can lead to secondary defects such as rot, rust or corrosion of associated building elements, the formation of fungal decay, or even the creation of potential slip hazards. When coupled with poor site drainage, pooling of water may also attract termite activity to this area.

It is highly recommended that a licensed plumber be appointed to install adequate drainage to the overflow. These works will ensure that the area remains dry and free of any secondary defects.

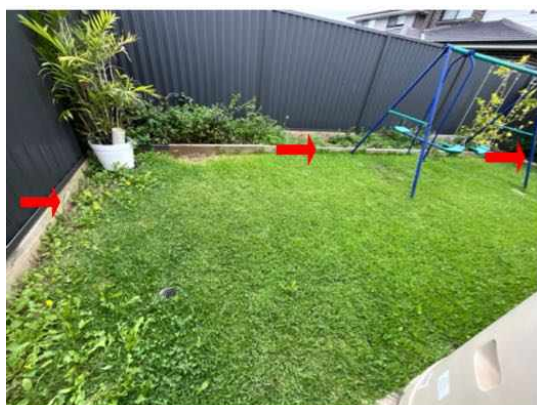
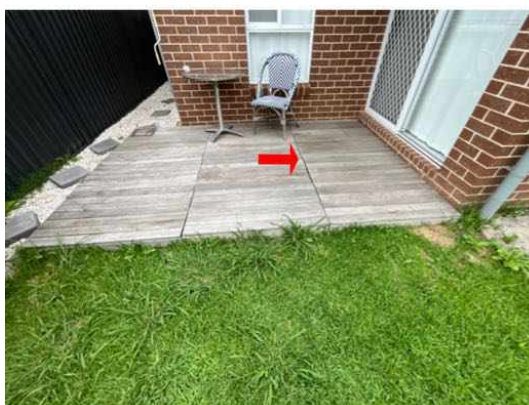
Finding 6.03

Building:	Main Building
Location:	Fencing & Landscaping
Finding:	Building materials in direct ground contact - conducive to termites
Information:	Where timber elements are in direct contact with the ground and consequently moisture or dampness they become conducive to termite activity. Whether timber is used as a building element part of a fencing structure or stored as an unused item they can provide an environment that is attractive to termite infestation.

When met with excessive moisture timber begins to decay and develop wood rot. Any timbers that are in direct contact with external grounds especially if left untreated or non-durable also provide ingress for subterranean termites into that particular element.

The removal of any such materials that may be conducive to termite activity should be removed as soon as possible to minimise the risk of termite attack.

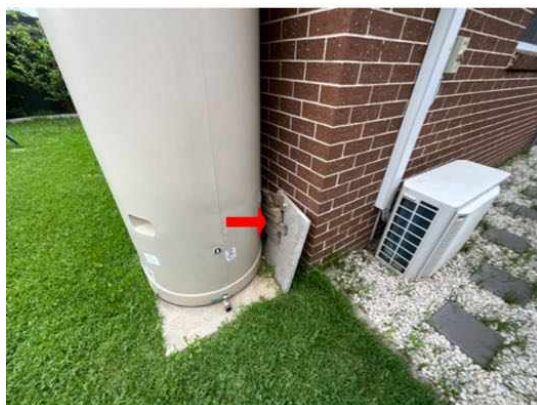
Finding 6.04

Building:	Main Building
Location:	Yard
Finding:	Stored timbers - subfloor space or external area
Information:	The storing of timbers in the subfloor space or around the external property increases

the risk of termite activity being present. As they are likely to come into contact with weather conditions or excessive moisture wood rot is likely to develop on timbers that are not treated.

It is highly recommended that any stored timbers be immediately removed from areas in which they may attract any termite / timber pest attack. Minimisation of risk / prevention of termite attack is far more adequate than dealing with the presence of termite activity.

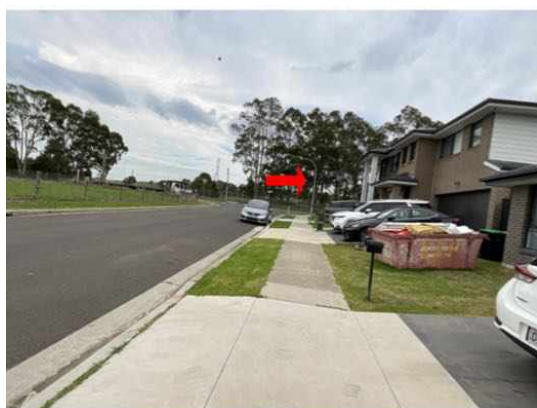
Finding 6.05

Building:	Main Building
Location:	
Finding:	Surrounding bushland - Conductive
Information:	Home and or building is situated in a high risk area for termite activity, due to close proximity to surrounding bushland.

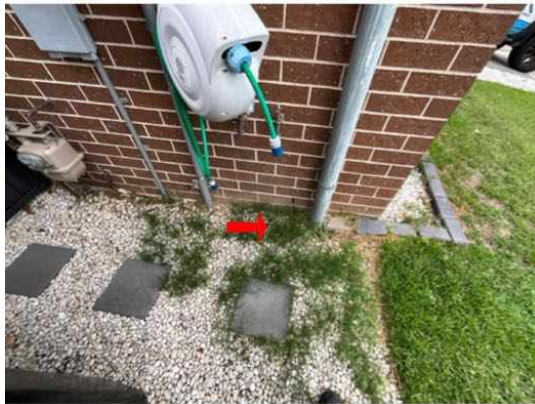
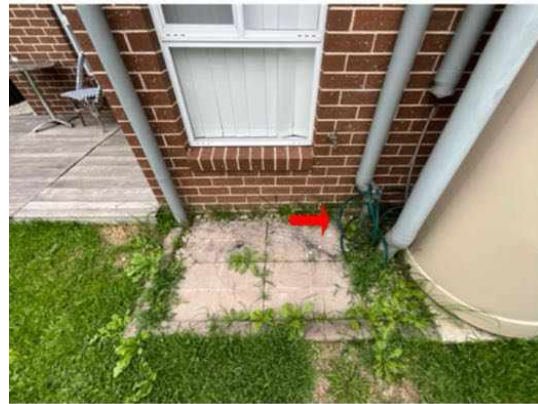
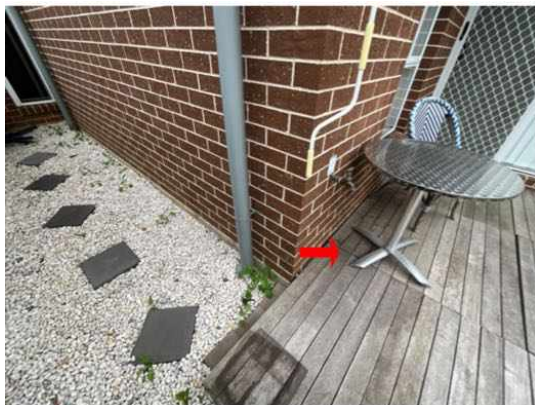
Finding 6.06

Building:	Main Building
Location:	External tap
Finding:	Tap - No drain
Information:	The external tap in this area was noted to have no drain at the time of inspection.

This keeps the surrounding surfaces damp while using the tap, which becomes conducive to termite activity.

A licensed plumber must be appointed to ensure an appropriate drain is installed.
