Building and Timber Pest Inspection Report

Inspection Date: Fri, 6 Mar 2026

Property Address: 52 Old Punt Rd, Seelands NSW 2460,
Australia

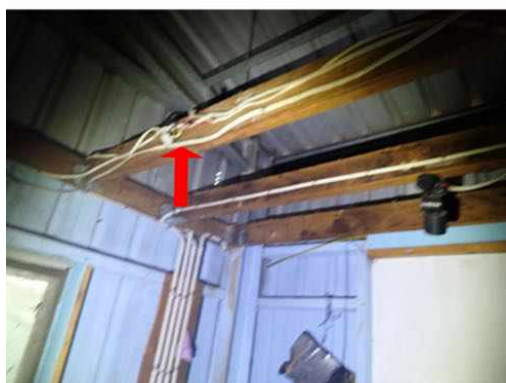
Finding 1.01

Building:	Shed
Location:	Shed
Finding:	Exposed Electrical Wiring to Shed
Information:	Exposed electrical wiring was identified to the shed at the time of inspection. Exposed wiring can present a safety hazard and may be susceptible to damage from weather, impact, or pests if not properly protected. This condition may be due to previous alterations, deterioration, or incomplete installation. It is recommended that a qualified electrician assess the wiring and carry out repairs or install appropriate protection and securing as required to ensure the electrical installation is safe and compliant. Repairs should be carried out as deemed necessary.

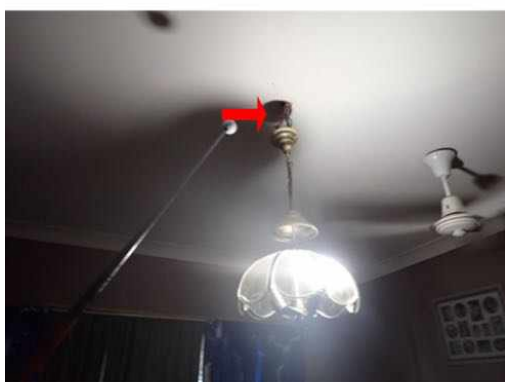
Finding: Loose Light Fitting in Bedroom

Information: A light fitting in the bedroom was found to be loose at the time of inspection. Loose light fittings may present a safety hazard and can lead to damage to the fitting or associated wiring if not secured. This condition may be due to deterioration of fixings, previous alterations, or incomplete installation. It is recommended that a qualified electrician inspect the fitting and secure or repair it as required to ensure it is safe and properly installed. Repairs should be carried out as deemed necessary.

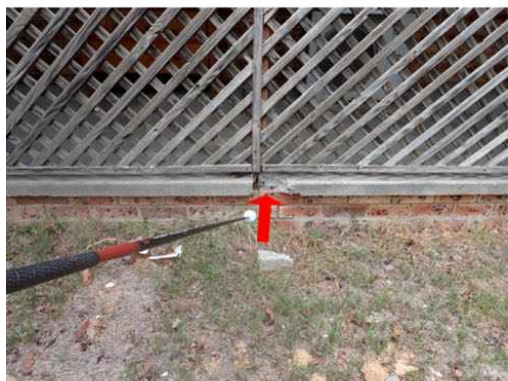
Finding 2.01

Finding: Damage to Edge of Concrete Slab at Left-Hand Side of Patio Area

Information: Damage was identified to the edge of the concrete slab on the left-hand side of the patio area at the time of inspection. Edge damage to concrete can occur due to impact, ground movement, or general wear over time and may worsen if left

unaddressed. It is recommended that a qualified concreter assess the affected area and carry out repairs as required to prevent further deterioration and maintain the integrity of the concrete. Repairs should be carried out as deemed necessary.

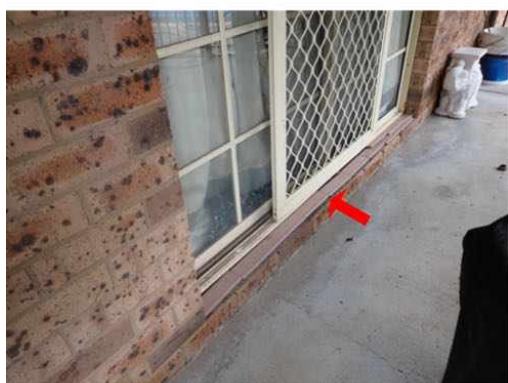
Finding 2.02

Building:	Main Building
Location:	Patio area
Finding:	Loose and Poorly Laid Sill Tiles to Bedroom Sliding Door Threshold
Information:	Loose and poorly laid sill tiles were identified to the bedroom sliding door threshold at the time of inspection. Movement of tiles in this location may allow water penetration and can lead to further deterioration of the tiles and surrounding materials if not addressed. This condition may be due to poor installation, inadequate adhesive, or general wear over time. It is recommended that a qualified tiler assess the affected area and re-fix or replace the tiles as required to ensure they are properly secured and sealed. Repairs should be carried out as deemed necessary.

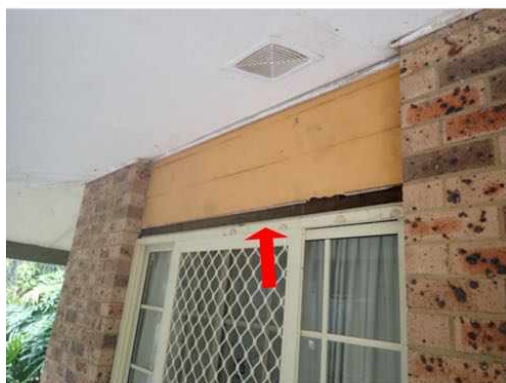
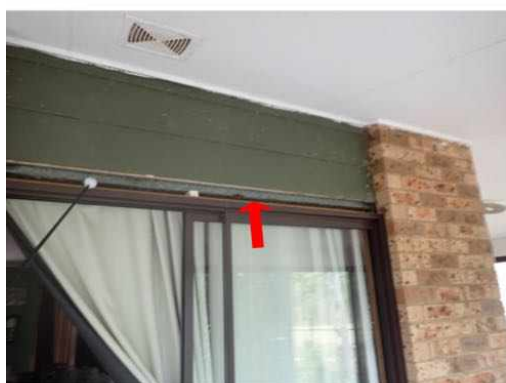
Finding 2.03

Building:	Main Building
Location:	Patio area
Finding:	Missing Sliding Door Architraves Below External Cladding
Information:	Architraves were missing below the sliding door where it meets the external cladding

at the time of inspection. Missing trim elements may allow moisture, pests, and debris to enter gaps around the door frame and may contribute to deterioration of surrounding building materials if left unaddressed. This condition may be due to previous alterations, incomplete installation, or removal of the trim. It is recommended that a qualified carpenter install appropriate architraves or trim to the affected area to provide proper finishing and protection to the door opening. Repairs should be carried out as deemed necessary.

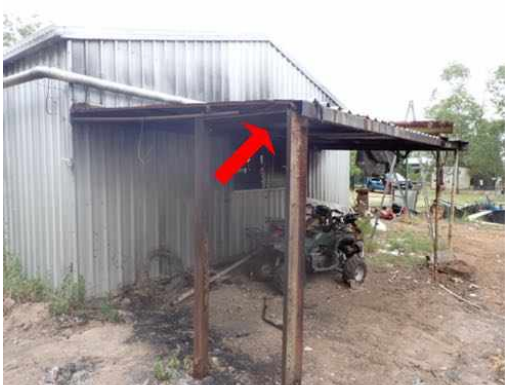
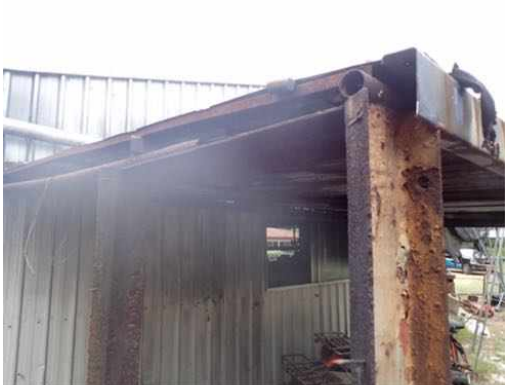
Finding 2.08

Building:	Shed
Location:	Lean to roof on the left hand side of main shed
Finding:	Possible Fire Damage to Lean-to Roof on Left-Hand Side of Main Shed
Information:	What appeared to be fire damage was identified to the lean-to roof on the left-hand side of the main shed at the time of inspection. Damage of this nature may affect the integrity and durability of the roofing materials and supporting structure. The extent of the damage could not be fully determined during the visual inspection. It is recommended that a qualified builder assess the affected roof structure and carry out repairs or replacement of any damaged materials as required to ensure the roof structure remains safe and serviceable. Repairs should be carried out as deemed necessary.

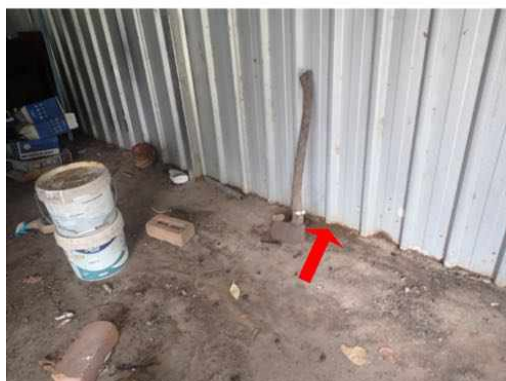
Finding 2.09

Building: Shed
Location: Shed
Finding: Rust to Bottom of Shed Wall Cladding
Information: Rust was identified to the bottom of the shed wall cladding at the time of inspection. Corrosion to metal cladding commonly occurs in lower sections where moisture, debris, or ground contact may be present and may worsen over time if not addressed. Continued deterioration can lead to weakening of the cladding and potential openings that allow moisture ingress. It is recommended that a qualified builder or metal contractor assess the affected areas and carry out repairs or replacement of the rusted sections as required. Repairs should be carried out as

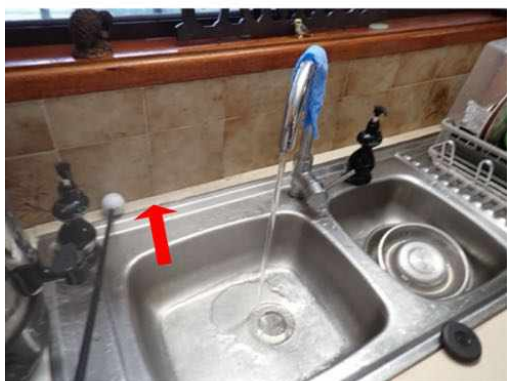
Finding: Kitchen in Average Condition with Multiple Defects Identified

Information: The kitchen was found to be in average condition at the time of inspection. Defects observed included missing kick boards, a swollen bench top around the sink area, missing tiles behind the oven, a swollen cupboard carcass below the sink, and duct tape wrapped around the sink waste plumbing which may indicate a previous or ongoing leak. Deterioration to cabinetry and benchtops is commonly associated with prolonged moisture exposure, particularly around sink areas. It is recommended that a qualified carpenter or kitchen installer assess the cabinetry and benchtop and carry out repairs or replacement as required, and that a qualified plumber inspect the sink waste plumbing to identify and rectify any leaks to prevent further damage. Repairs and maintenance should be carried out as deemed necessary.

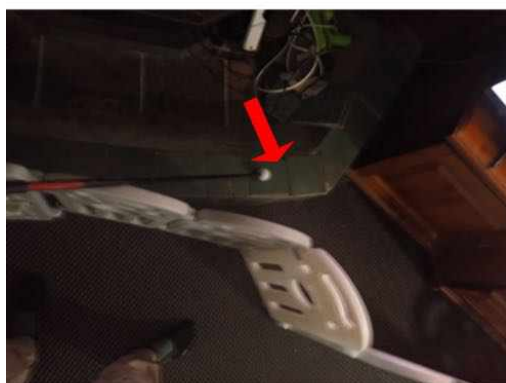
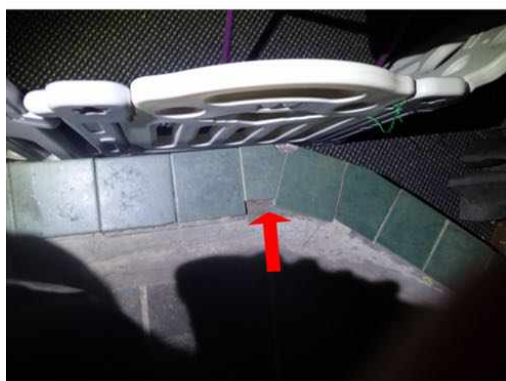
Finding 2.13

Building:	Main Building
Location:	Living Room
Finding:	Poorly Laid and Damaged Tiles Around Fireplace
Information:	Tiles around the fireplace were observed to be poorly laid and damaged at the time of inspection. Poor installation and damaged tiles may allow movement of the tiles and can lead to further deterioration of the tiled surface if not addressed. This condition may be due to poor workmanship, inadequate adhesive, or general wear over time. It is recommended that a qualified tiler assess the affected area and carry out repairs or replacement of the damaged tiles as required to prevent further deterioration. Repairs should be carried out as deemed necessary.

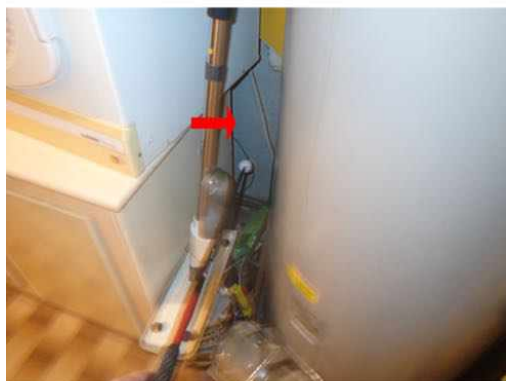
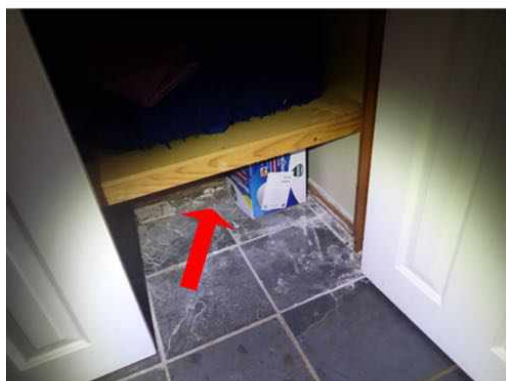
Building: Main Building
Location: Laundry and linen cupboard
Finding: Removed Laundry Wall Cladding and Water Damage Adjacent to Shower
Information: Wall cladding had been removed in the laundry to the wall that backs onto the shower, and water damage was identified in the linen cupboard which also backs onto the shower at the time of inspection. These conditions may indicate possible water ingress from the renovated bathroom or associated plumbing and waterproofing. The extent of any concealed damage could not be determined during the visual inspection. It is recommended that a qualified plumber investigate the shower plumbing and that a

qualified builder assess the affected wall areas and carry out repairs as required to prevent further deterioration. Further investigation and rectification works should be carried out as deemed necessary.

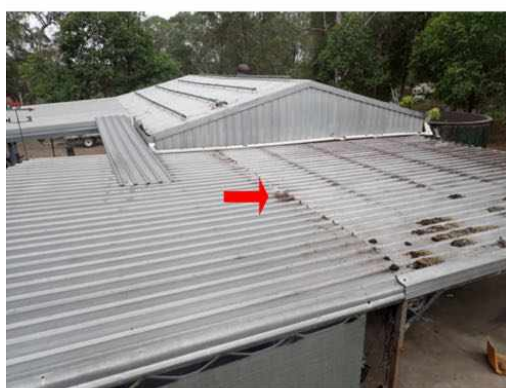
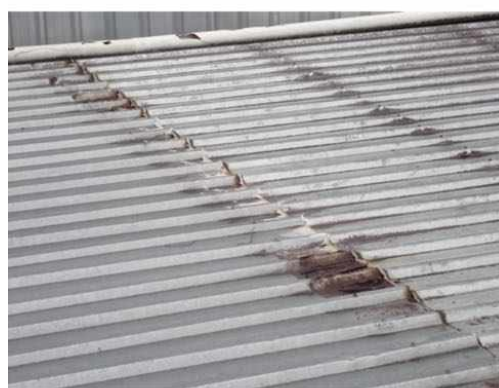
Finding 2.19

Building:	Carport
Location:	External roof
Finding:	Rust to Carport Roof Cladding
Information:	Rust was identified to the carport roof cladding at the time of inspection. Corrosion to metal roofing can occur over time due to exposure to weather and moisture and may worsen if not addressed. Continued deterioration may lead to weakening of the roofing material and further leaking. It is recommended that a qualified roofer or metal roofing contractor assess the affected areas and carry out cleaning, treatment, repair, or replacement as required to prevent further deterioration. Repairs should be carried out as deemed necessary.

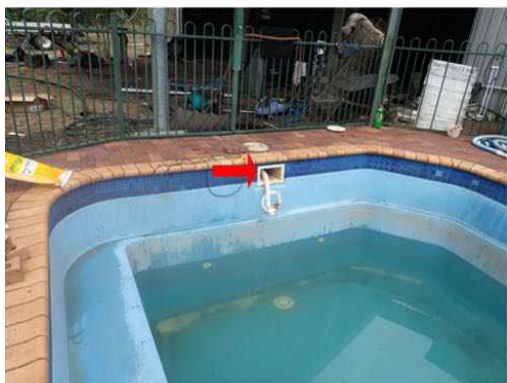
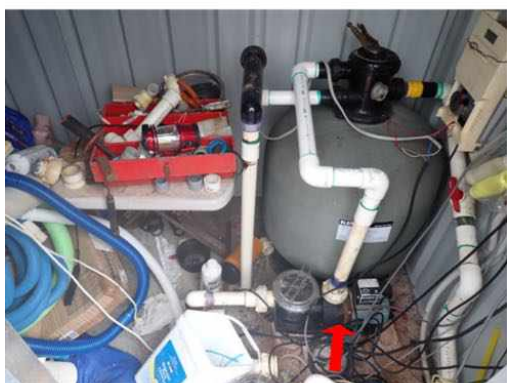
Finding 2.21

Building:	Yard
Location:	Pool
Finding:	Pool Pump Not Operating at Time of Inspection – Equipment in Average Condition
Information:	The pool pump and associated plumbing were found to be in average condition at the time of inspection; however, the pump was not operating at the time of inspection. The reason for the pump not functioning could not be determined during the visual inspection. It is recommended that a qualified pool technician or electrician inspect the pump and associated equipment to determine the cause of the issue and carry out repairs as required to ensure the system is functioning correctly. Repairs should be carried out as deemed necessary.

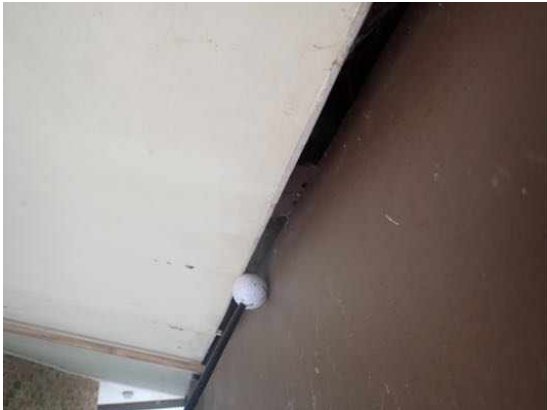
Finding 3.01

Building:	Main Building
Location:	Ceiling around patio area
Finding:	Patio Ceiling Cladding Damage, Poor Paint Finish and Missing Timber Trim
Information:	The ceiling around the patio area was found to be in poor condition at the time of inspection. Defects observed included a hole in the ceiling cladding, a poor-quality paint finish, and missing timber trim to the right-hand side of the patio ceiling. These issues may allow deterioration to progress and reduce the overall durability and appearance of the area. This condition may be due to ageing materials or previous poor-quality repairs or installation. It is recommended that a qualified carpenter and/or painter carry out repairs to the ceiling cladding, replace missing trims, and rectify the paint finish to prevent further deterioration. Regular maintenance of external ceiling areas will assist in preventing similar issues in the future. Repair or replacement should be carried out as deemed necessary.

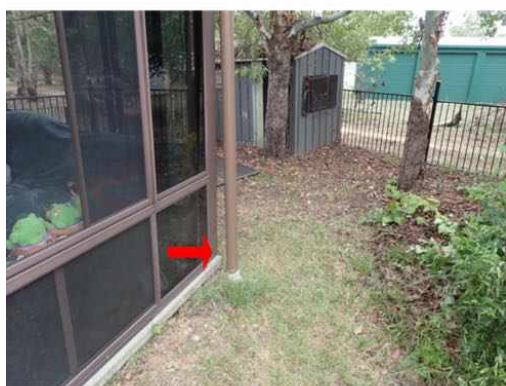
Finding 3.02

Building:	Main Building
Location:	Rear left hand corner of building
Finding:	Downpipe Not Secured to Wall at Rear Left Corner of Building
Information:	A downpipe at the rear left-hand corner of the building was observed to be connected to the gutter but not properly secured along the wall at the time of inspection. Downpipes should be adequately fixed to the wall to provide support and prevent movement or damage during normal use and weather events. This condition may be due to missing or loose brackets or previous repairs. It is recommended that a qualified plumber or handyman secure the downpipe to the wall with appropriate brackets to ensure it is adequately supported and functioning as intended. Repairs should be carried out as deemed necessary.

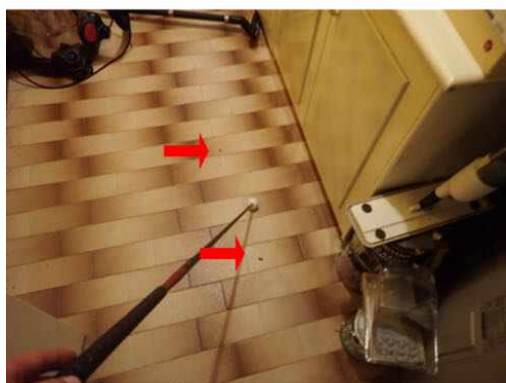
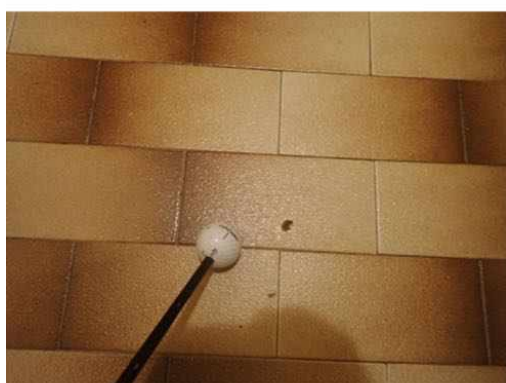
Finding 3.05

Building:	Main Building
Location:	Laundry
Finding:	Chipped Floor Tiles to Laundry
Information:	Chipped floor tiles were identified in the laundry at the time of inspection. Damage to floor tiles can occur due to impact, general wear, or movement and may worsen over time if not repaired. It is recommended that a qualified tiler assess the affected tiles and carry out repairs or replacement as required to maintain the condition of the floor surface. Repairs should be carried out as deemed necessary.

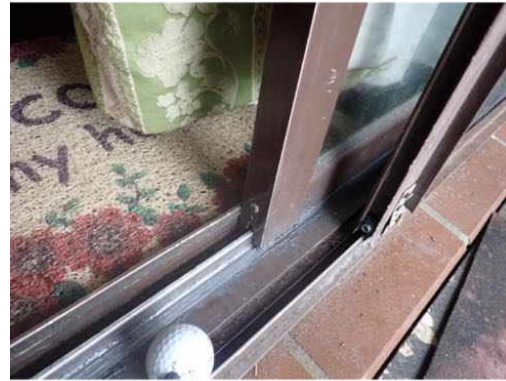
Finding 3.09

Building:	Main Building
Location:	Rear sliding doors
Finding:	Rear Sliding Doors Difficult to Operate
Information:	The rear sliding doors were found to be hard to slide during normal operation at the time of inspection. Difficulty operating sliding doors can be caused by worn rollers, misalignment, debris in the tracks, or general wear over time. It is recommended that a qualified carpenter or suitably experienced handyman inspect the doors and carry out adjustments, repairs, or replacement of worn components as required to ensure the doors operate smoothly. Repairs should be carried out as deemed necessary.

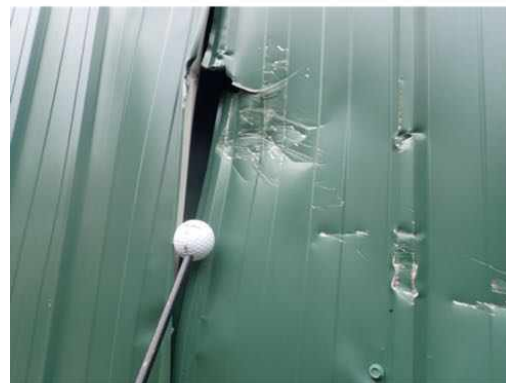
Finding 3.10

Building:	Shed
Location:	Left hand side
Finding:	Impact Damage to Right-Hand Wall Cladding of Green Shed
Information:	Impact-related damage was identified to the right-hand wall cladding of the green shed at the time of inspection. Damage of this nature can compromise the protective function of the cladding and may allow moisture to enter the wall structure if not repaired. This condition may have been caused by accidental impact. It is recommended that a qualified builder or handyman assess the affected cladding and carry out repairs or replacement as required to prevent further deterioration. Repairs should be carried out as deemed necessary.

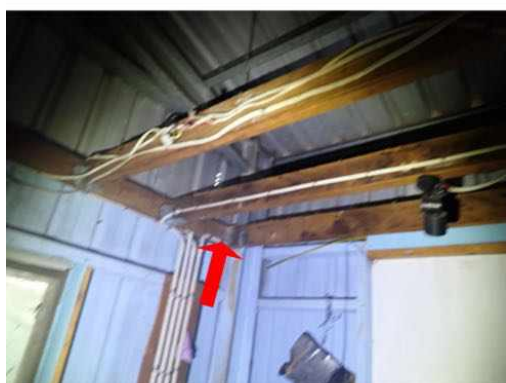
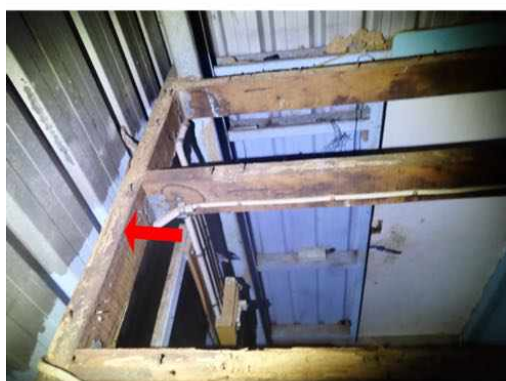
Location:	Shed
Finding:	Termite Damage to Timber at Right-Hand Front Corner of Shed Near Toilet
Information:	Termite damage was identified to timber at the right-hand front corner of the shed near the toilet at the time of inspection. Timber affected by termite activity may have reduced structural strength. This condition indicates previous or possible ongoing termite activity in the area. It is recommended that a licensed pest control specialist carry out a further assessment and implement appropriate termite management measures, and that a qualified carpenter or builder repair or replace any damaged timber as required. Further investigation and rectification works should be carried out as deemed necessary.

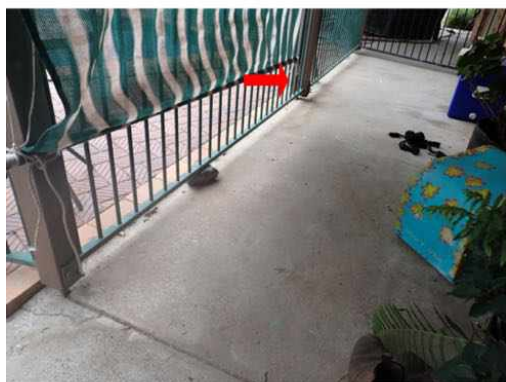
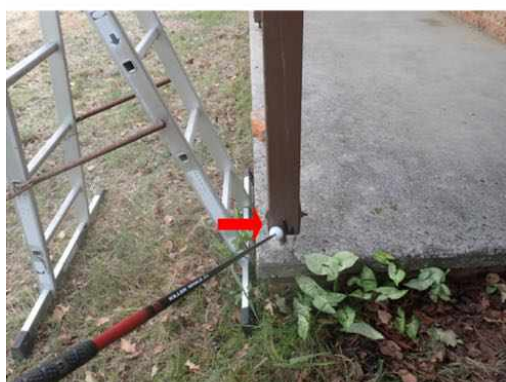
Finding 7.01

Building:	Main Building
Location:	Patio area
Finding:	Wood Rot to Bottom of Timber Veranda Posts
Information:	Wood rot was identified to the bottom of the timber veranda posts at the time of inspection. Deterioration to structural timber elements can reduce the strength and durability of the posts and may worsen if left unaddressed. This condition is commonly caused by prolonged moisture exposure, timber in close proximity to ground level, or inadequate protection of the timber from weather and moisture. It is recommended that a qualified carpenter or builder assess the affected posts and carry out repairs or replacement as required. Ensuring timber posts are adequately sealed, protected from moisture, and maintained will assist in preventing further deterioration. Repair or replacement should be carried out as deemed necessary.

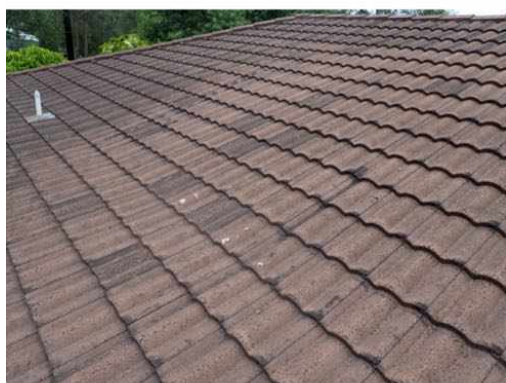
Building:	Main Building
Location:	External roof
Finding:	Roof Tiles Faded but in Fair Condition
Information:	The roof tiles were found to be in fair condition at the time of inspection, however general fading of the tile surface was noted. Fading of roof tiles commonly occurs over time due to ageing and prolonged exposure to the elements and is typical for roof coverings of this age. It is recommended that the roof covering continue to be maintained and monitored as part of normal property maintenance. Any repairs or replacement of damaged tiles should be carried out by a qualified roofer as deemed necessary.
