## Building and Timber Pest Inspection Report

Inspection Date: Wed, 11 Mar 2026

Property Address: 2/43 Cambridge Ave, Vaucluse NSW 2030,  
Australia

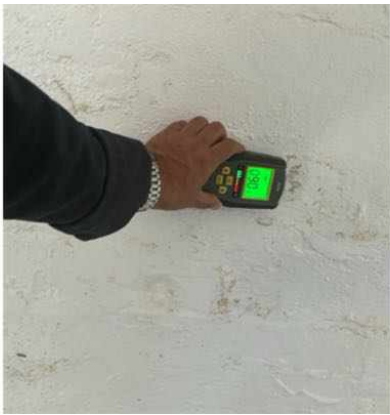
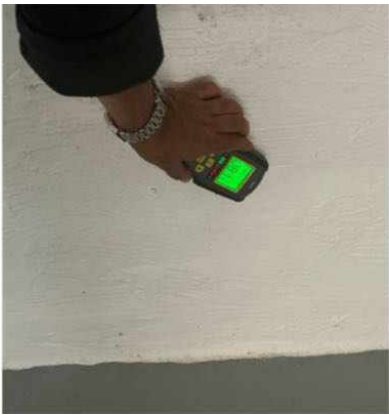
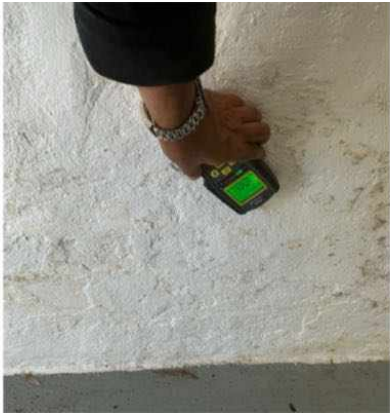
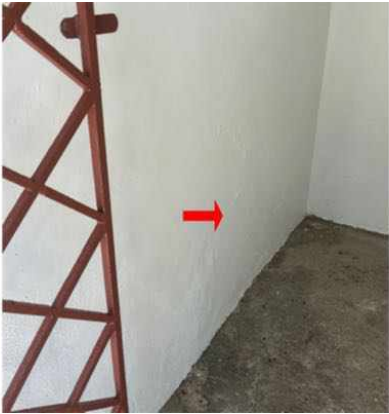
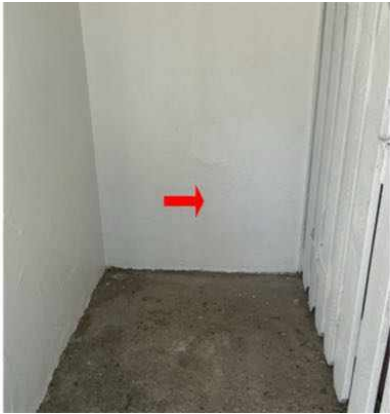
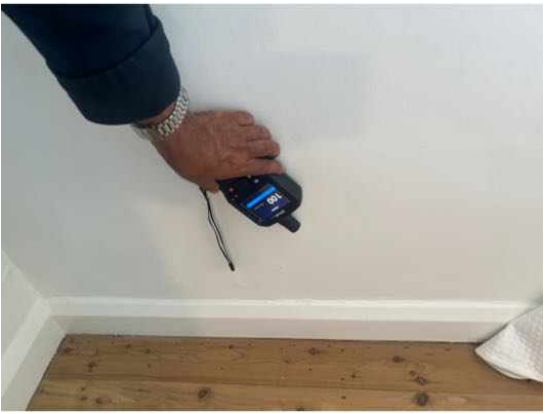
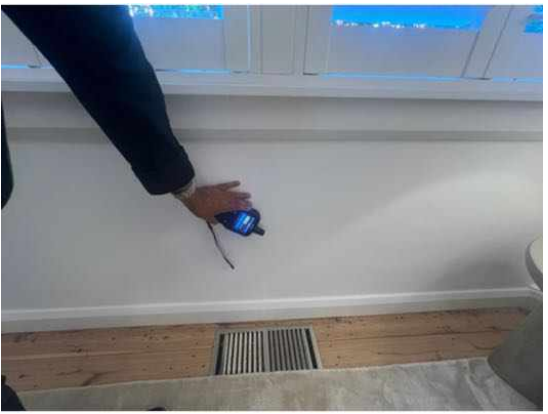
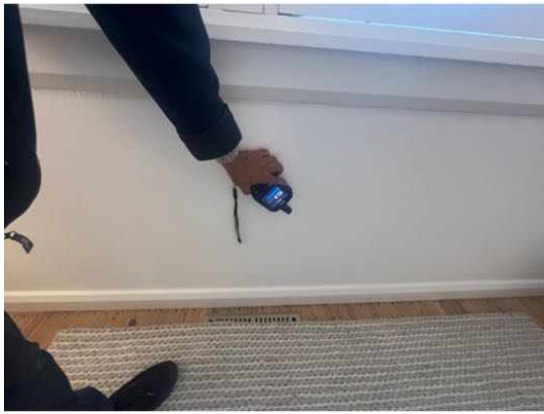
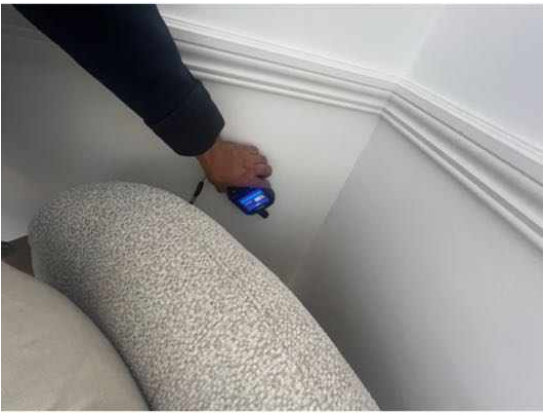
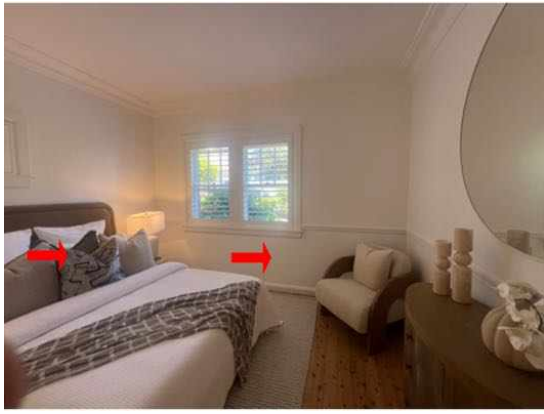
Building: Main Building  
Location: Garage , Internal Exterior walls  
Finding: Damp  
Information: Damp (or structural damp) refers to the presence of unwanted moisture in the structure of a building, either as the result of intrusion from outside, or condensation from within the structure. Generally, structural damp is caused by rain penetration, rising damp, and leaks from plumbing pipes.

Unmanaged damp facilitates the formation and development of mould, fungi growth and wood rot, decaying associated building materials and compromising their structural integrity. Damage to finishes is also likely to occur, including lifting, bubbling, peeling and staining of paint, plaster and wallpaper.

It is important to address damp conditions, as the World Health Organisation notes that excess moisture leads - on almost all indoor materials - to growth of microbes such as moulds, fungi and bacteria, which subsequently emit spores and other matter into the indoor air. Exposure to these contaminants is associated with a wide range of respiratory and other health-related problems. Additionally, the development of damp in timber building elements also provides an environment that is conducive to termite / timber pest attack.

The first step in addressing damp is to diagnose the cause. The identified cause should be addressed first prior to repairing the appearance and other defects which have resulted from the rising damp. If the original cause is not resolved, further cases of damp are likely to ensue, resulting in secondary defects.

Consultation with a qualified plumber is advised immediately to identify the cause of damp and perform remedial works as required. Where excessive mould growth is present, further inspection by a specialist environmental health inspector should also be considered.

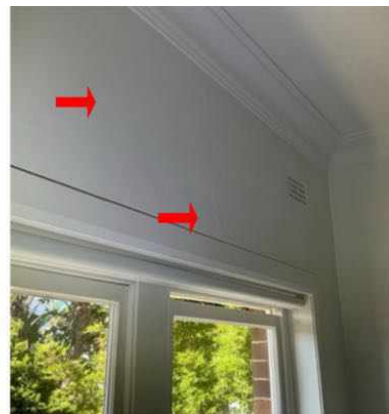
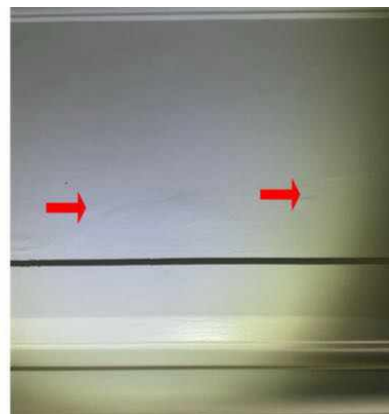
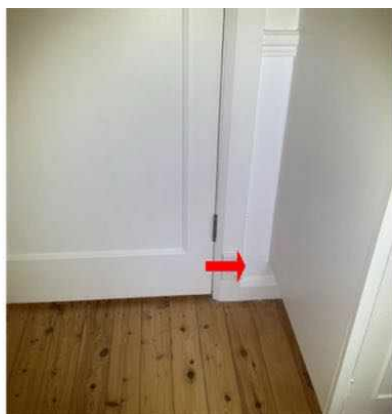
### Finding 3.01

Building: Main Building  
Location: All Internal Areas - Rear bedroom , bedroom front  
Finding: Painted surface - Bubbling to some areas  
Information: Sections of paint in this area was found to have bubbled and deteriorated. Paint bubbling is generally an indication of excessive moisture in the area, that is currently hidden by the painted surface.

The presence of excessive moisture can have major implications on associated building elements if left unattended. While only seemingly minor at this stage, the damage cannot be determined due to the paint obstructing any further inspection of the damage.

It is highly advised that the affected paint be cleaned to allow a further, more invasive inspection by a licensed plumber. Failure to act on this defect may necessitate major works in the future.

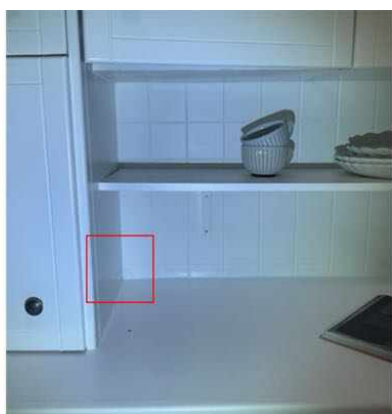
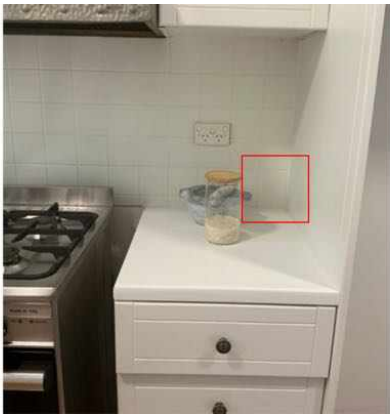
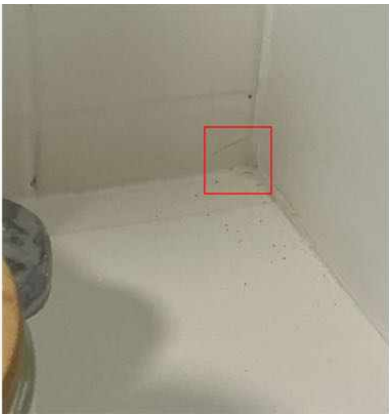
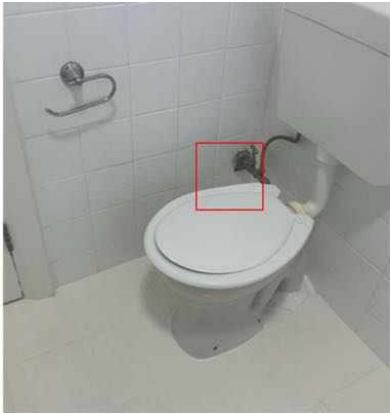
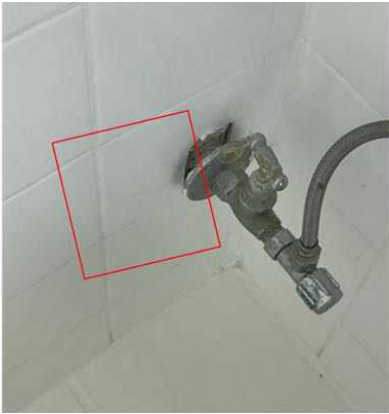
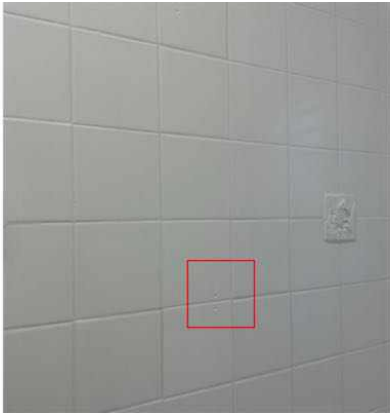
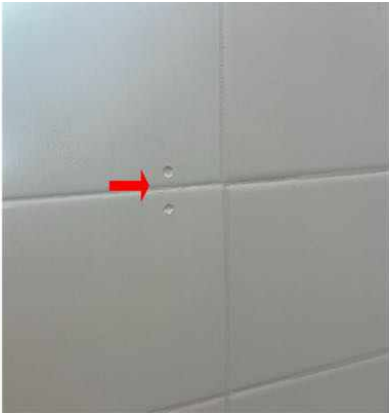
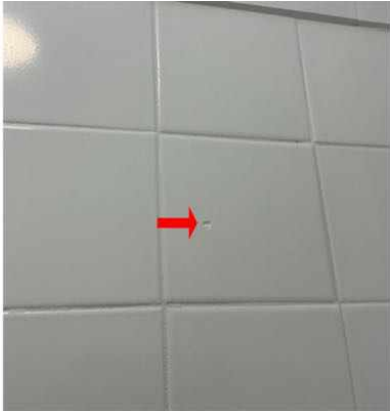
Building:	Main Building
Location:	All Internal Areas - kitchen , bathroom
Finding:	Tiles - Cracked or damaged
Information:	Cracking was evident to the tiling in this area at the time of inspection. While the cracking appears to be minor, this area is frequently exposed to water, allowing potential for water penetration into adjoining sections of walls or flooring.

If left unmanaged, water penetration to these areas may lead to subsequent water damage, which is likely necessitate repair work to affected building elements.

A tiling contractor should be appointed to ensure that no further water damage occurs. The re-application of silicone and grouting throughout remaining tile work is also advised, to further protect the area against water penetration.

Where water penetration has led to water damage, appointment of a relevant tradesperson may be required to repair damaged building elements.

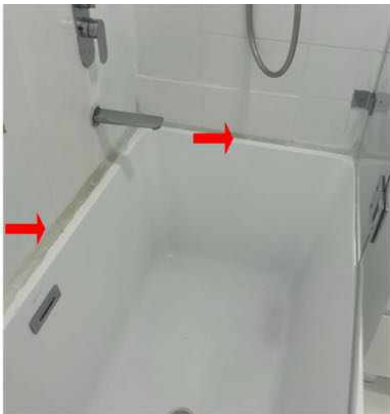
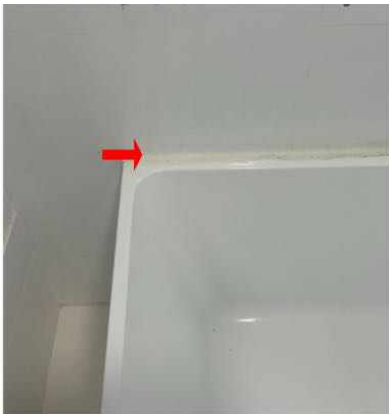
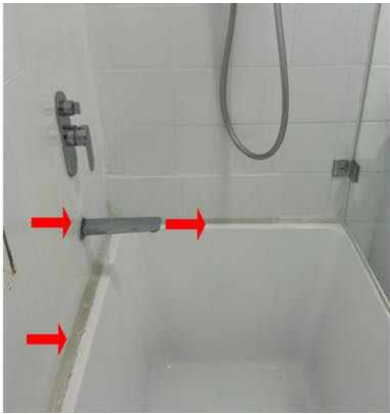
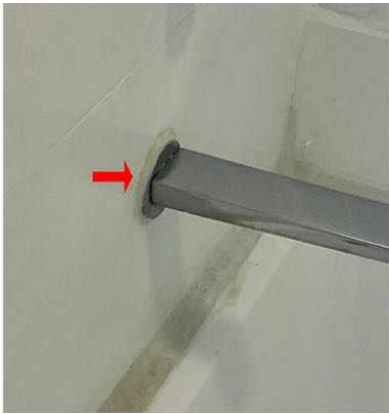
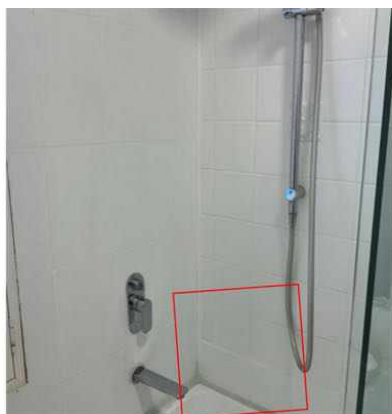
Finding 3.04

Building: Main Building  
Location: Bathroom  
Finding: Installation - substandard or incomplete - Excessive sealant , uneven tiles  
Information: The installation of this building element appears to have been completed to a substandard level of workmanship or is incomplete. Generally substandard repairs or installation are related to poor workmanship, the use of inappropriate materials, or a failure to complete installation to a suitable standard.

Where installation is substandard and/or incomplete, the client should contact the responsible trade to undertake rectification. Unfinished and substandard building works are likely to degrade more quickly and may create potential for secondary defects to associated building elements.

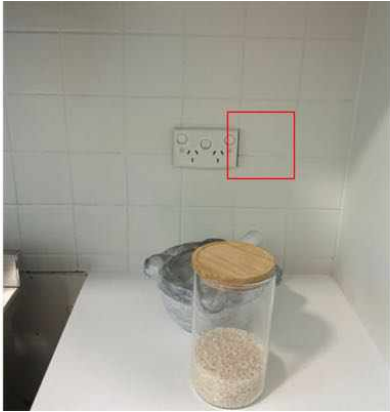
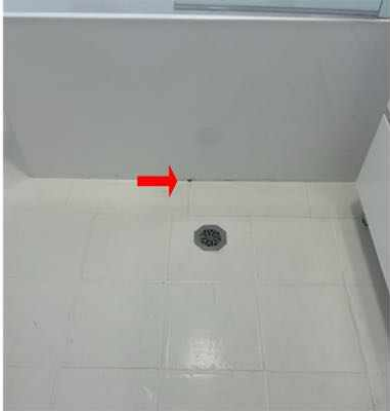
### Finding 3.05

Building:	Main Building
Location:	All Internal Areas
Finding:	Sealant and grouting - Missing or degraded
Information:	It was noted on inspection that sealant or grout is degraded. There is also evidence of poor workmanship and excessive use of sealant. Silicone should never be used as a first line of defence against waterproofing. Further inspection by a licensed waterproofing contractor is highly recommended.

Different materials and floor areas move at different rates, generally causing cracking to grout or sealant at this point. A flexible sealant is required to allow for expected expansion and contraction, while keeping the joint water tight and protective of all associated building materials.

There appears to be excessive mould to the sealant and grout which will likely require scraping out and replacement.

Flexible and mould resistant materials should be applied to affected areas to prevent any subsequent water damage that is likely to occur. Regular maintenance and replacement of damage or missing or damaged sealant and grout is highly recommended to the wet areas, as this is a regular wear and tear defect. Sealant and grouting in areas that come into regular contact with water should be maintained for the long term care of your property.

A sealant specialist or tiling contractor should be appointed to complete these works as soon as possible.

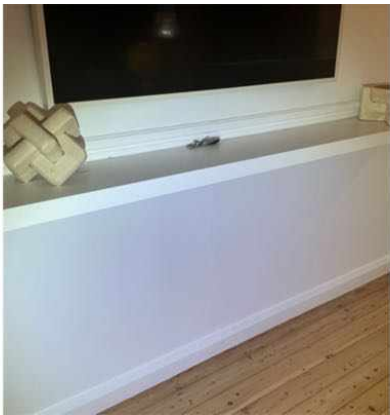
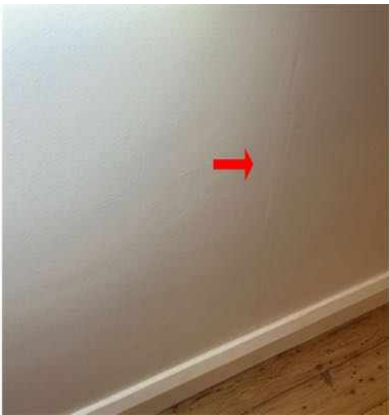
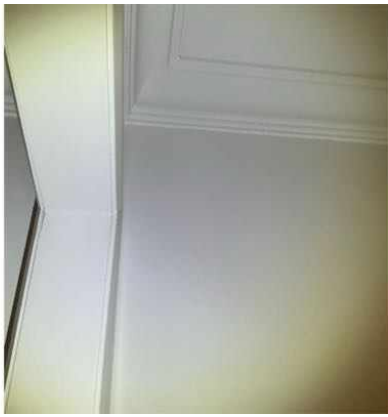
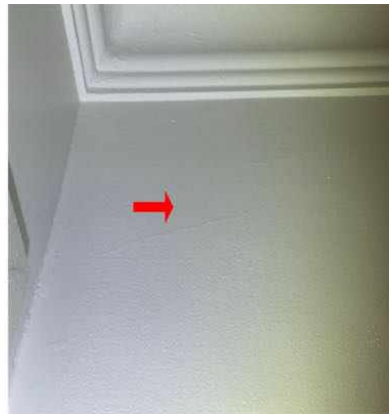
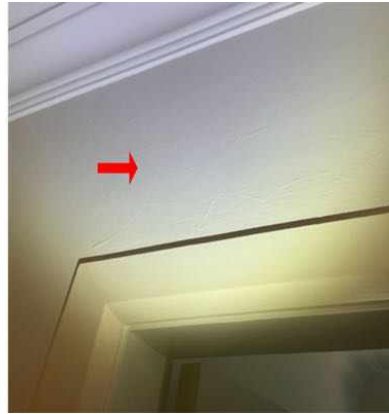
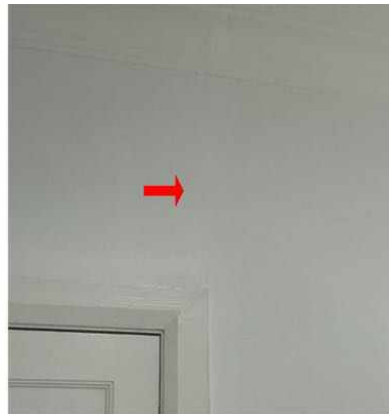
**Finding 3.06**

Building: Main Building  
Location: All Internal Areas  
Finding: Cracking & Past Repairs  
Information: Cracking and evidence of past repairs were noted in this area. The extent and adequacy of any previous repair work cannot be confirmed during a visual inspection. Ongoing monitoring is recommended, and further evaluation by a suitably qualified contractor or structural engineer may be required if concerns persist.

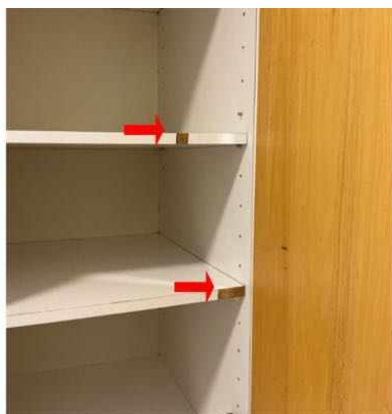
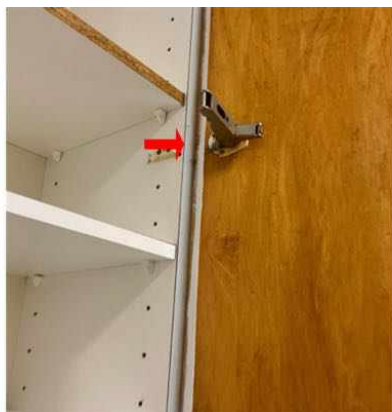
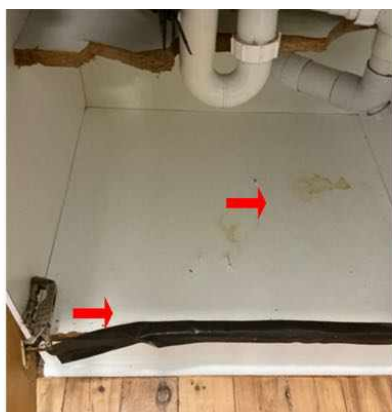
Building:	Main Building
Location:	All Internal Areas
Finding:	Building element - Damaged - kitchen cupboard chipping , hallway misaligned doors
Information:	Breakage occurs generally when the building materials have either aged and decayed, or as a result of damage (accidental or deliberate).

Repair and/or replacement of broken elements is advised to ensure that additional secondary defects do not arise as a consequence. Such works are necessary, as all building elements play a key role in the operation and function of the overall structure and its performance.

A relevant tradesperson should be appointed to repair or replace the affected building element prior to any subsequent damage being caused.

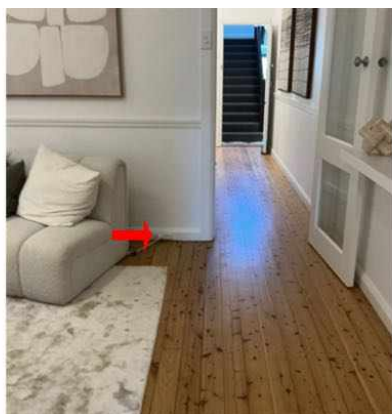
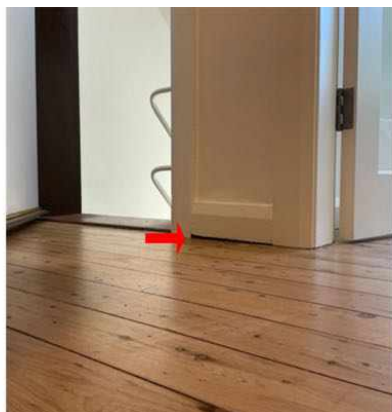
### Finding 3.09

Building:	Main Building
Location:	All Internal Areas
Finding:	Gap between skirting and Floor to some areas
Information:	A localised gap is visible between the skirting board and the laminate/timber floor finish, indicating minor floor level variation or movement of the floating floor system. This condition is most consistent with minor slab/floor unevenness, floor finish movement or shrinkage. While primarily cosmetic/serviceability in nature, monitoring is recommended and further assessment may be warranted by a licensed builder if additional signs of structural movement become apparent.

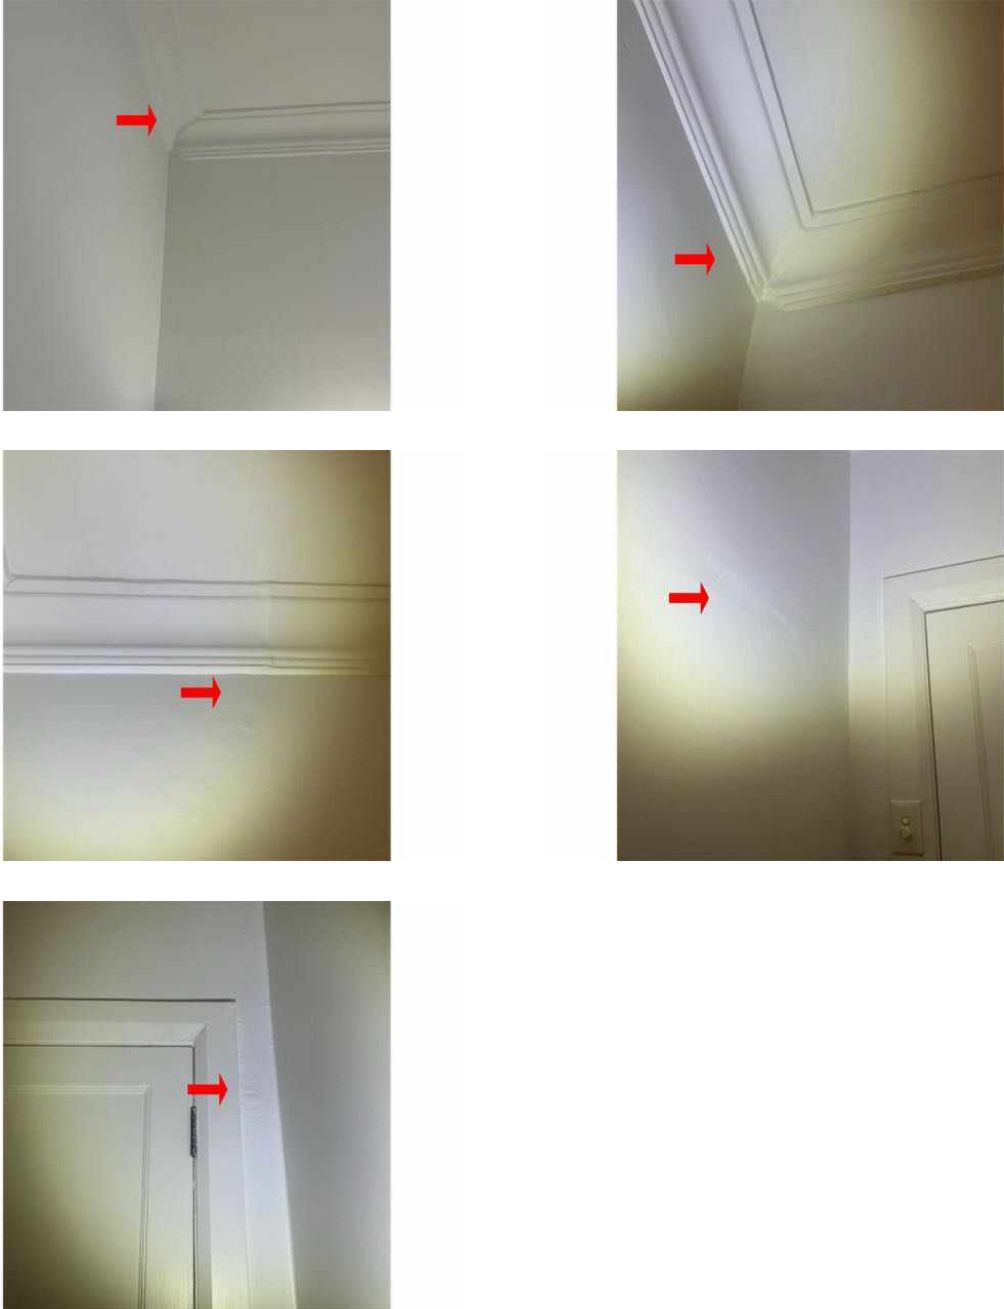
### Finding 3.10

Building:	Main Building
Location:	All Internal Areas - Master bed
Finding:	Paint finish - Substandard to some areas
Information:	The paint finish in this area was found to have been completed to a substandard level. Substandard painting is generally classified as an appearance defect. However, the substandard appearance may also be indicative of poor surface preparation and substandard workmanship.

If this applies, further areas of poor and incomplete finishes could develop over time. Furthermore, substandard paint finishes in areas exposed to moisture, e.g. external areas or wet areas, could lead to deterioration of underlying building materials.

Substandard paint finishes should be sanded back, filled, leveled and repainted, as applicable. Where inadequate paint protection has led to the deterioration of the associated building element, repair and/or replacement of this building element may be required.

A painting contractor should be appointed as soon as possible to perform necessary works to aid the appearance of the affected area and to ensure that the area is protected against further deterioration. Alternatively, the homeowner following manufacturer instructions may be able to provide this service.

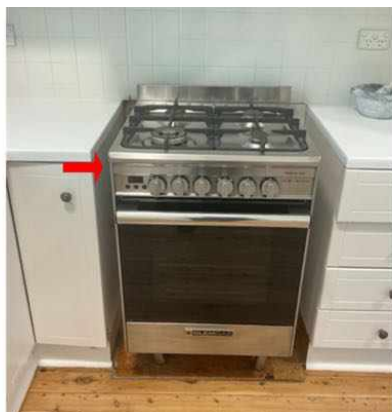
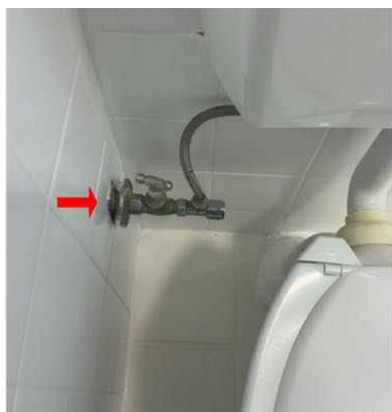
**Finding 3.11**

Building: Main Building  
Location: All Internal Areas  
Finding: Installation - substandard or incomplete - Oven not fixed possible safety , Fixing not flush to wall  
Information: The installation of this building element appears to have been completed to a substandard level of workmanship or is incomplete. Generally substandard repairs or installation are related to poor workmanship, the use of inappropriate materials, or a failure to complete installation to a suitable standard.

Where installation is substandard and/or incomplete, the client should contact the

responsible trade to undertake rectification. Unfinished and substandard building works are likely to degrade more quickly and may create potential for secondary defects to associated building elements.

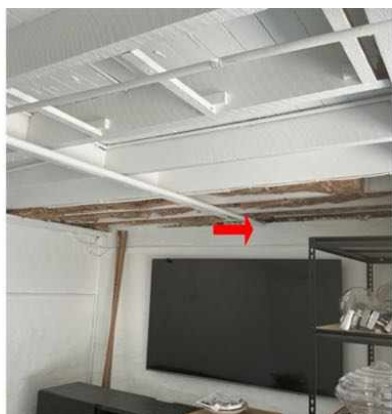
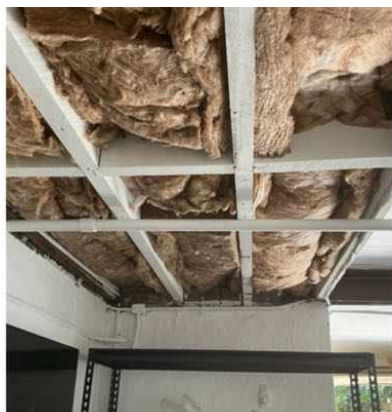
### Finding 3.12

Building:	Main Building
Location:	Garage
Finding:	Installation - substandard or incomplete - Exposed insulation
Information:	The installation of this building element appears to have been completed to a substandard level of workmanship or is incomplete. Generally substandard repairs or installation are related to poor workmanship, the use of inappropriate materials, or a failure to complete installation to a suitable standard.

Where installation is substandard and/or incomplete, the client should contact the responsible trade to undertake rectification. Unfinished and substandard building works are likely to degrade more quickly and may create potential for secondary defects to associated building elements.

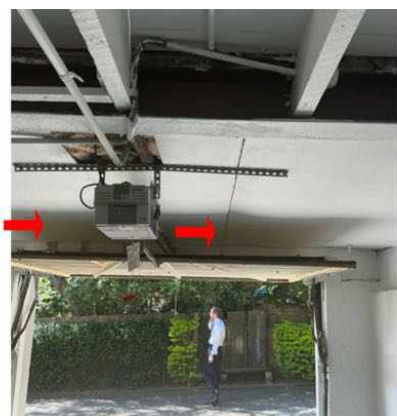
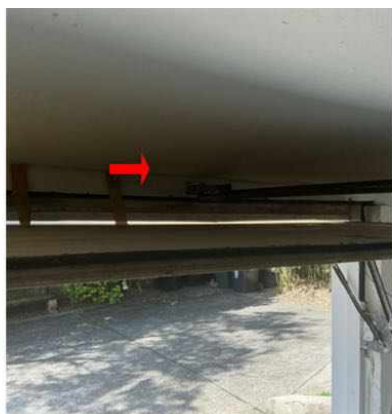
### Finding 3.13

Information: Sections of the ceiling were found to be sagging at the time of inspection. Sagging to the fixed ceiling structure generally indicates that the building materials have swollen, due to contact with water, or that fixings (e.g. nails or glue) have become loose and require reattachment.

In some cases, sagging ceiling linings may also indicate that there are structural issues, causing surfaces to warp, twist or sag. Where sagging appears to be major, appointment of a structural engineer is advised to further inspect the property and identify the source and rectification works required.

Where minor sagging is evident, comparatively minor works, such as re-gluing of ceiling sheets, may be required. Such works may be performed by relevant tradespeople, such as plasterers and painters. Where excessive moisture has caused the roofing structure to swell and sag, the source of the water leak should primarily be identified prior to any remedial works being performed.

The appropriate action should be taken by the client as soon as possible to ensure that any potential further damage is limited.

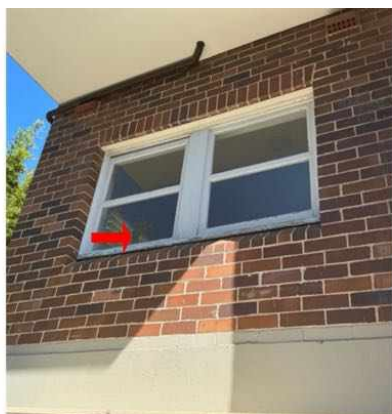
### Finding 3.14

Building:	Main Building
Location:	All External Areas
Finding:	External painting deteriorated (Windows)
Information:	Whilst incomplete or missing paint finish is generally an appearance defect, it can also lead to the development of secondary building defects over time. Incomplete areas of paint finish expose the area to moisture, potentially accelerating the deterioration of underlying building materials.

Degraded paint finishes should be sanded back, filled, leveled and painted, as applicable. Where inadequate or missing paint protection has led to the deterioration of the associated building element, repair and/or replacement of this building element may be required.

A painting contractor should be appointed as soon as possible to perform necessary works to aid the appearance of the affected area and to ensure the area is protected against further deterioration. Alternatively, the homeowner following manufacturer instructions may perform these works.

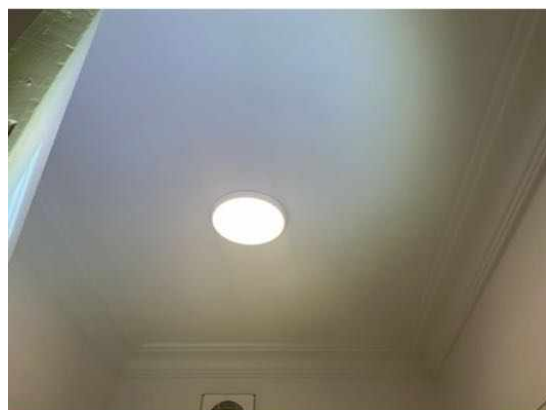
### Finding 3.15

Building:	Main Building
Location:	Bathroom
Finding:	Building element - Missing - no ventilation
Information:	Although some building elements may seem irrelevant or unnecessary, all building elements play a key role in the operation and function of the overall structure and its performance.

Replacement of any missing building element should be conducted as soon as possible to ensure that no damage or functional issues occur to associated building materials.

The appropriate tradesperson should be appointed as soon as possible to replace the missing building element.

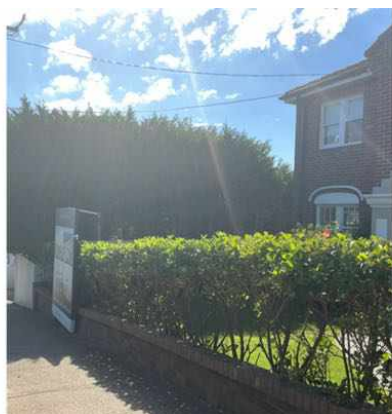
### Finding 6.01

Building:	Main Building
Location:	All External Areas
Finding:	Trees within 50m
Information:	Trees within 50m of the property can be conducive to termite activity. It is recommended an invasive inspection of all trees with 50m to the property be carried out by a qualified pest control expert.

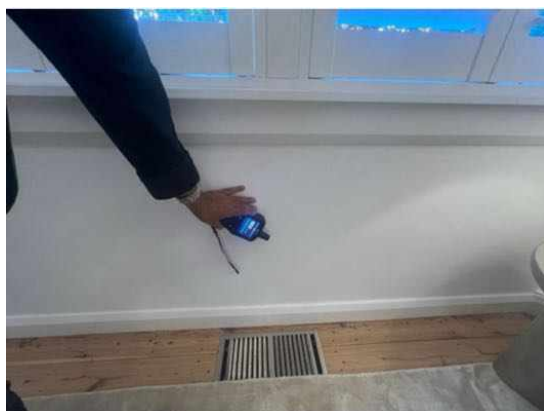
### Finding 6.02

Building:	Main Building
Location:	All External Areas
Finding:	Damp
Information:	Damp (or structural damp) refers to the presence of unwanted moisture in the structure of a building, either as the result of intrusion from outside, or condensation from within the structure. Generally, structural damp is caused by rain penetration, rising damp, and leaks from plumbing pipes.

Unmanaged damp facilitates the formation and development of mould, fungi growth and wood rot, decaying associated building materials and compromising their structural integrity. Damage to finishes is also likely to occur, including lifting, bubbling, peeling and staining of paint, plaster and wallpaper.

The first step in addressing damp is to diagnose the cause. The identified cause should be addressed first prior to repairing the appearance and other defects which have resulted from the rising damp. If the original cause is not resolved, further cases of damp are likely to ensue, resulting in secondary defects.

Consultation with a qualified plumber is advised immediately to identify the cause of damp and perform remedial works as required. Where excessive mould growth is present, further inspection by a specialist environmental health inspector should also be considered.

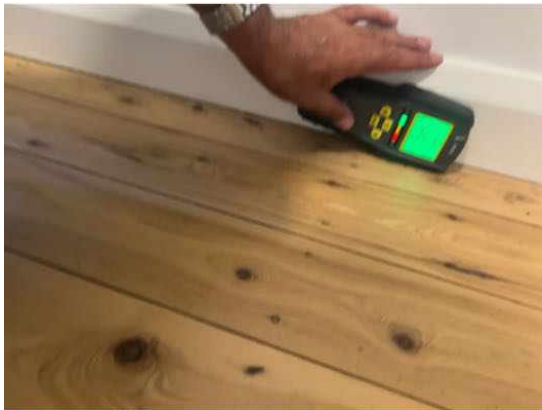
### Finding 6.03

Building:	Main Building
Location:	All Internal Areas - Skirting , Flooring to some areas
Finding:	Elevated moisture - identified
Information:	Elevated moisture can attract termites and produce conditions that promote fungal growth and wood decay.

Elevated moisture is generally caused by deteriorated, inadequate or missing roof drainage, leaking plumbing pipes or fixtures, poorly plumbed HWS overflows or condenser units and poor site drainage.

Prior to any remedial works being performed a qualified plumber should be appointed to further inspect the property and to identify the cause of the excessive moisture.

Works to remove affected building elements may then be necessary and should be performed by an appropriate tradesperson.
