# Building and Timber Pest Inspection Report

Inspection Date: Tue, 13 Jan 2026

Property Address: 2/198 Old Kent Rd, Greenacre NSW 2190,  
Australia

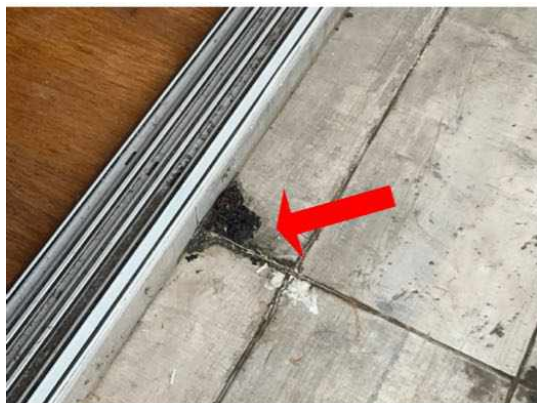
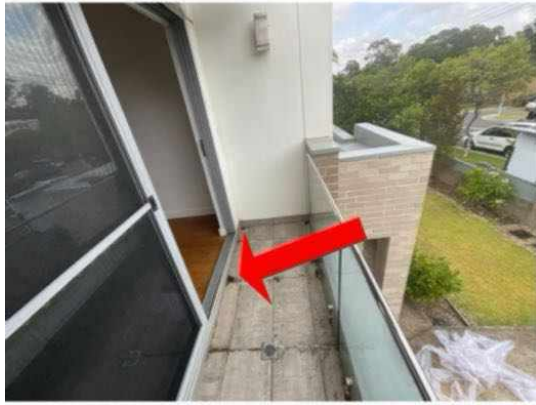
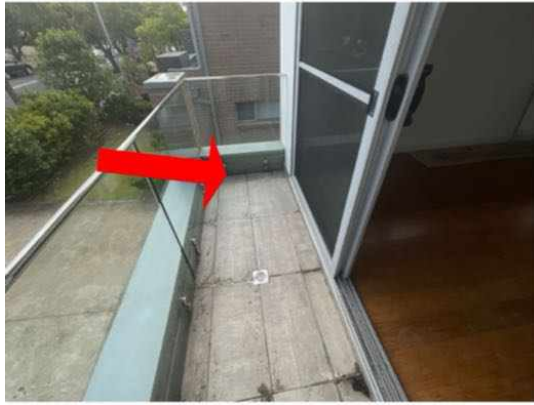
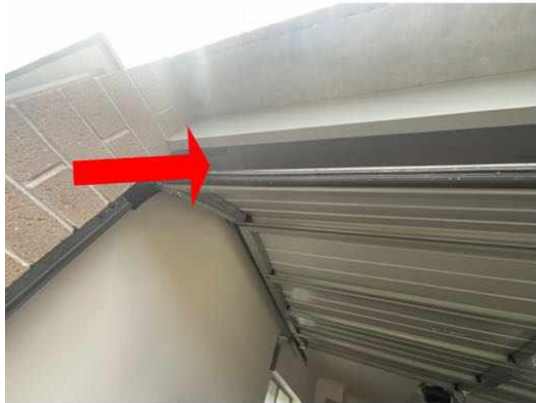
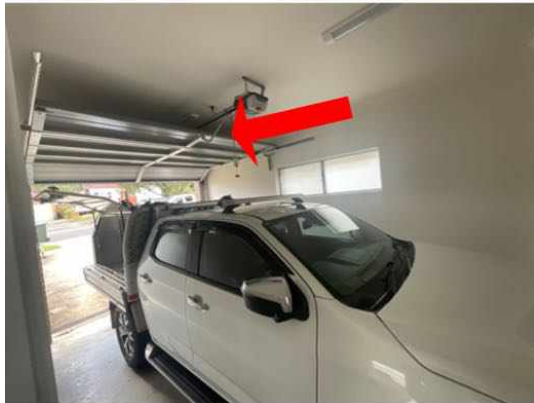
Building: Main Building  
Location: Balcony  
Finding: Water Damage to Garage Ceiling (Below Balcony)  
Information: Water staining and damage were observed to the garage ceiling beneath the balcony above. This condition is indicative of moisture ingress, likely due to failure or deterioration of the balcony waterproofing system, inadequate drainage, or defective sealing to the balcony floor, drainage outlet, or door threshold.

Water ingress to this area may lead to ongoing deterioration of ceiling linings and potential concealed damage if not addressed. It is recommended that a suitably qualified contractor investigate the source of the leak, carry out necessary waterproofing rectification works to the balcony, and repair or replace the affected ceiling linings as required.

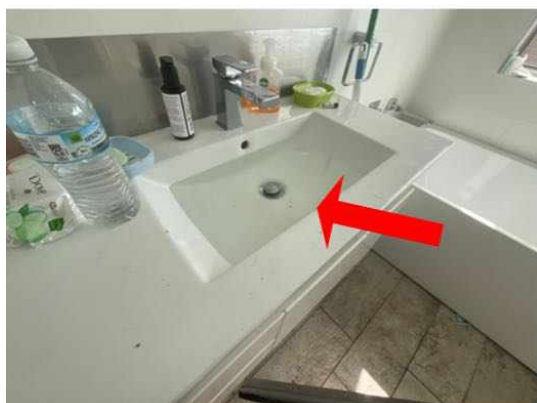
### Finding 3.01

Building: Main Building  
 Location: Bathroom  
 Finding: Internal drains (vanity) - Blockages  
 Information: Vanity drains throughout the property have blocked at the time of the inspection. Vanity drains are vital in removing the water in vanity bowl and should be fully functional. Minor blockages create potential for the development of moisture damage over time.

All vanity drains should be assessed by the building contractor and cleared or replaced where applicable.

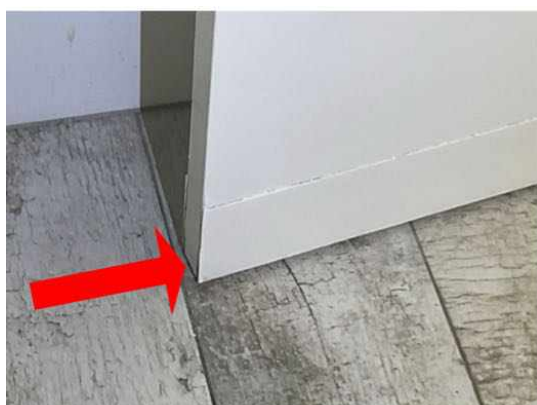
### Finding 3.02

Building: Main Building  
 Location: All Internal Areas > Ground Level  
 Finding: Door - swelling and damage at the bottom edge  
 Information: Swollen and damaged door base in bathroom due to moisture exposure. Edges show fraying and surface degradation.

Replace or seal the affected door. Ensure door edges are properly sealed to prevent future water damage.

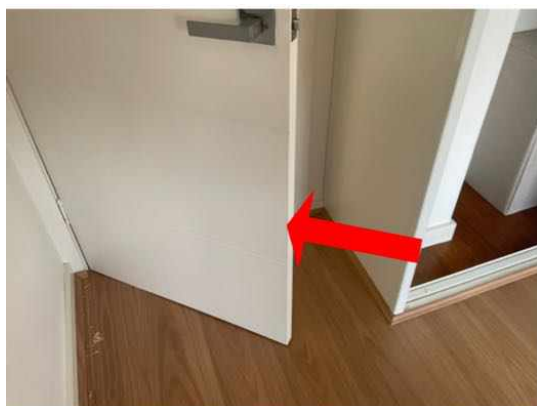
### Finding 3.03

Building: Main Building  
 Location: All Internal Areas  
 Finding: Door frames - not square  
 Information: It appears that one and / or more doors have been installed in a manner which is not consistent with acceptable standards of workmanship. The door frames are not square and or plumb and require rectification.

Deviation from the manufacturer's installation instructions is considered a defect with reference to Standards and Tolerances.

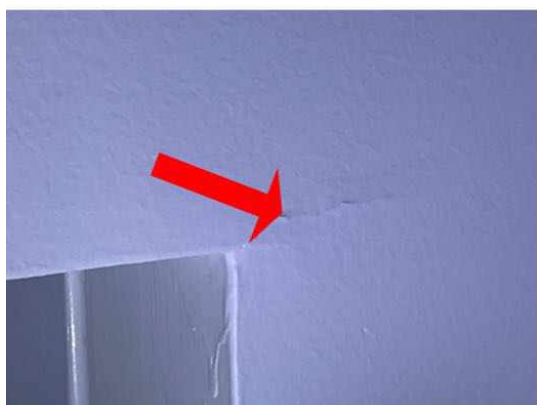
### Finding 3.04

Building:	Main Building
Location:	All Internal Areas
Finding:	Cracking - Damage Category 1 - Fine (up to 1mm)
Information:	Although fine cracks are quite noticeable, they are often only considered to be an appearance defect, and usually do not indicate any structural damage. Generally, the cause of a fine crack is indicative of a separation between building materials and finishes (e.g. paint, plaster, etc.) along joins.

Cracking of this nature can generally be repaired with minor sanding, filling and/or repainting. Such works should be performed by a qualified painter or a general handyman.

Monitoring of all cracking should be conducted frequently. Always contact a building inspector should cracks widen, lengthen, or become more numerous.

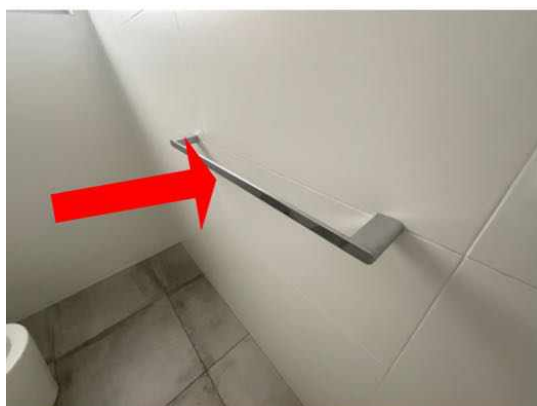
### Finding 3.05

Building:	Main Building
Location:	Powder Room / Ensuite
Finding:	Bathroom holders - Loose
Information:	The bathroom holder was found to be loose at the time of inspection. While not a

major operational defect, function can deteriorate if the problem is left unmanaged.

It is advised that the homeowner performs remedial works to re-attach the bathroom holder to its original fixing. A general handyman may be required to perform these works.

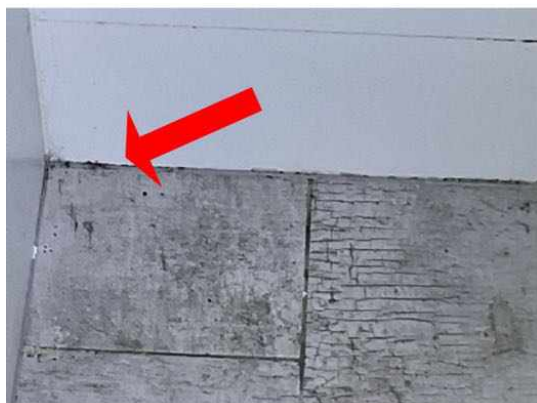
### Finding 3.06

Building:	Main Building
Location:	Ensuite
Finding:	Sealant and grouting - Missing or damaged
Information:	It was noted on inspection that sealant or grout is degraded to the tiled shower alcove and or other areas of the bathroom.

Different materials and floor areas move at different rates, generally causing cracking to grout or sealant at this point. A flexible sealant is required to allow for expected expansion and contraction, while keeping the joint water tight and protective of all associated building materials.

There appears to be excessive mould to the sealant and grout which will likely require scraping out and replacement.

Flexible and mould resistant materials should be applied to affected areas to prevent any subsequent water damage that is likely to occur. Regular maintenance and

replacement of damage or missing or damaged sealant and grout is highly recommended to the wet areas, as this is a regular wear and tear defect. Sealant and grouting in areas that come into regular contact with water should be maintained for the long term care of your property.

A sealant specialist or tiling contractor should be appointed to complete these works as soon as possible

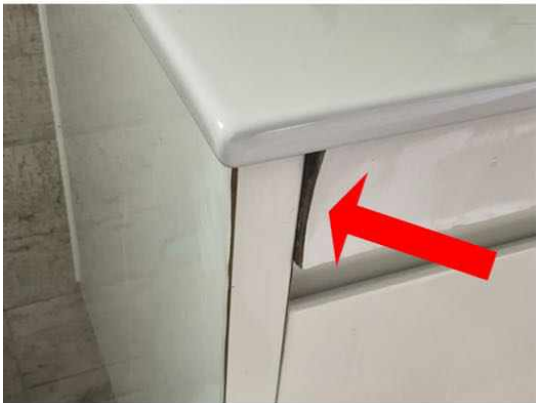
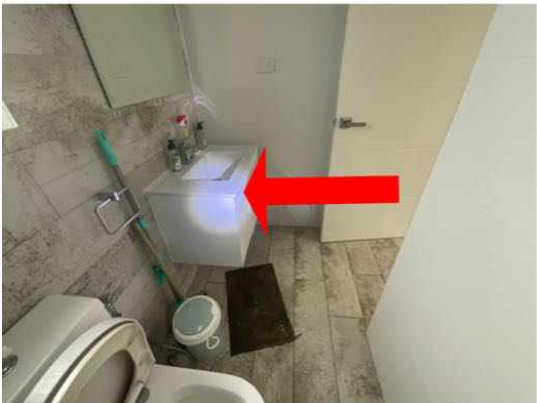
### Finding 3.07

Building:	Main Building
Location:	Ensuite
Finding:	Delamination of timbers
Information:	Delamination is one means by which composite materials (e.g. layered timber composites) may fail over time. In laminated materials, repeated cyclic stresses may lead to the formation of mini-structures of separate layers, with significant loss of mechanical toughness. Water penetration or the presence of excessive moisture also generally contributes to delamination.

Where building materials have become delaminated, they lose their structural strength, and are likely to have a variety of appearance and serviceability defects as a result.

Delamination of timbers may be repaired where the area affected is minor and/or easily accessible, by gluing and screwing layers back together. However, this is an interim repair, and where delamination has occurred, the client should plan for the replacement of affected timbers sooner than would otherwise be expected.

All timber structures affected by delamination should be replaced as soon as possible to avoid any further damage. Repair and replacement estimates should be sought from a registered builder or qualified carpenter.

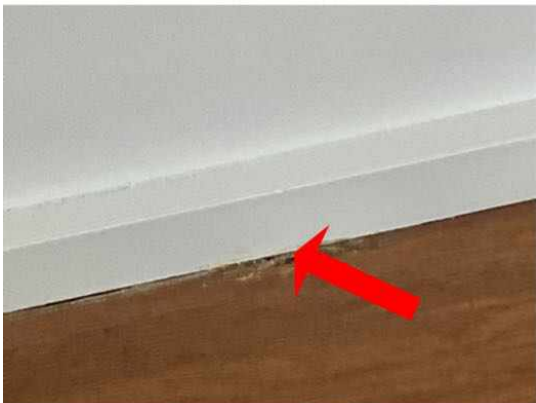
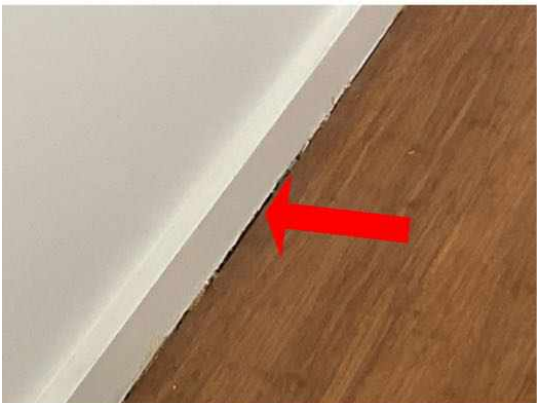
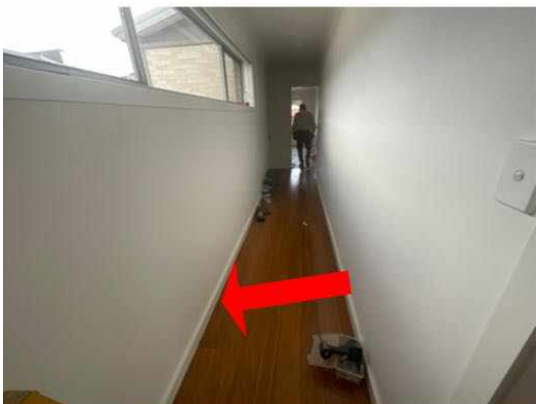
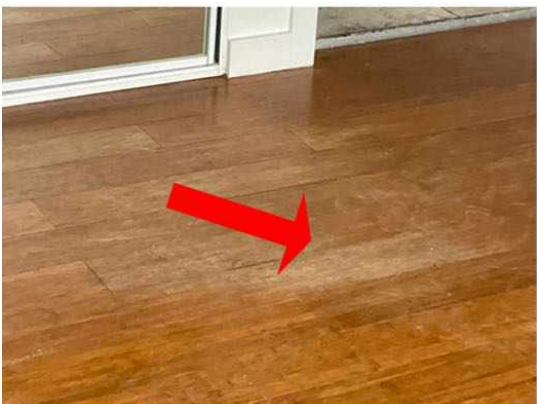
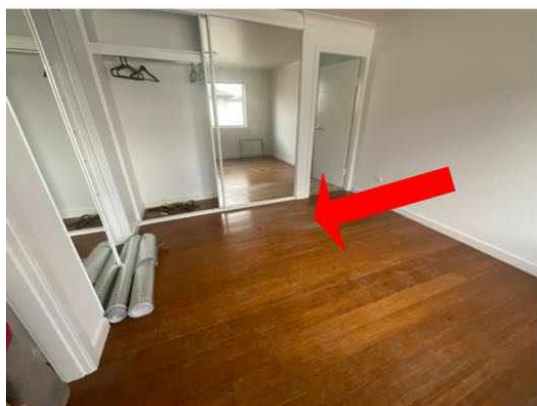
**Finding 3.08**

Building: Main Building  
Location: All Internal Areas  
Finding: Float Timber flooring - damaged / gap  
Information: Damages / gaps to float laminate flooring were found during inspection. The laminate timber flooring is typically resistant to water damage, but standing water and large amount of moisture that gets under the floor (as the water has no place to evaporate) can eventually destroy the floor and delaminate the product.

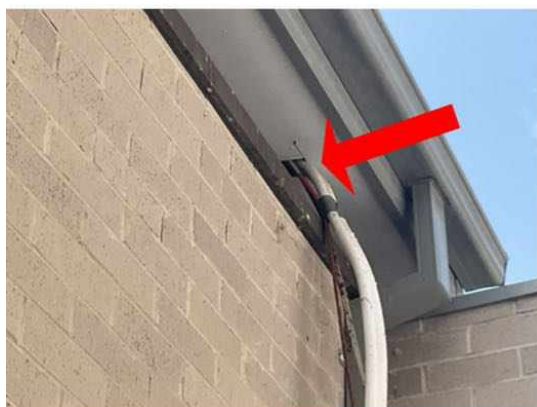
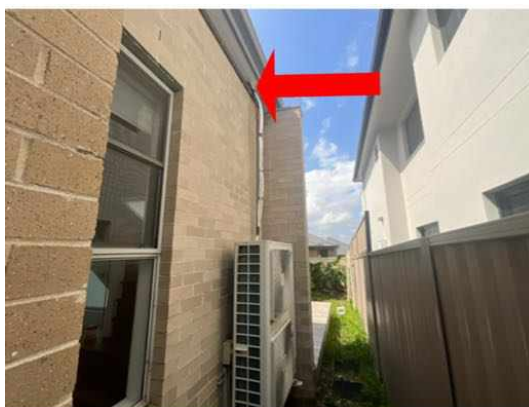
### Finding 3.09

Building:	Main Building
Location:	All External Areas
Finding:	External areas - Gaps and Holes
Information:	Significant gaps and holes were identified in these elevated sections. It is suspected that the installation of these building items were completed to a substandard level of workmanship or is incomplete. Gaps and holes makes the area susceptible to insect and vermin ingress, as well as allowing water penetration to the cavity wall. As such, associated building elements are likely to deteriorate at an accelerated rate, and major implications are expected if gaps and holes are left unmanaged. All excessive holes, gaps or cracks should be adequately filled by a suitable sealant or trimmings as soon as possible to prevent any further damage. Such works may be conducted by a general handyperson.

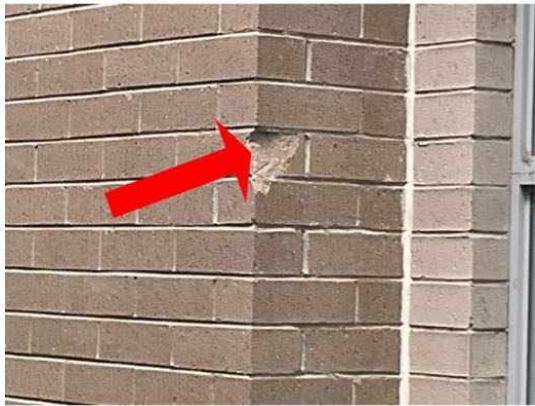
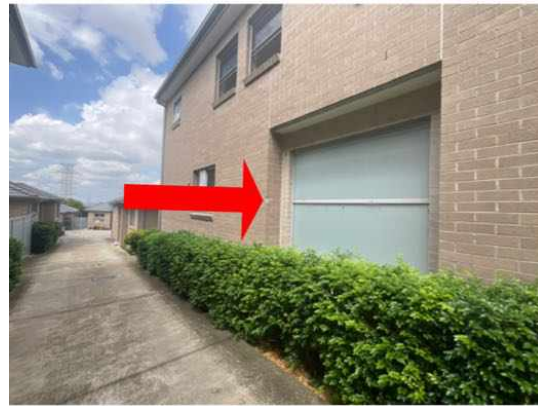
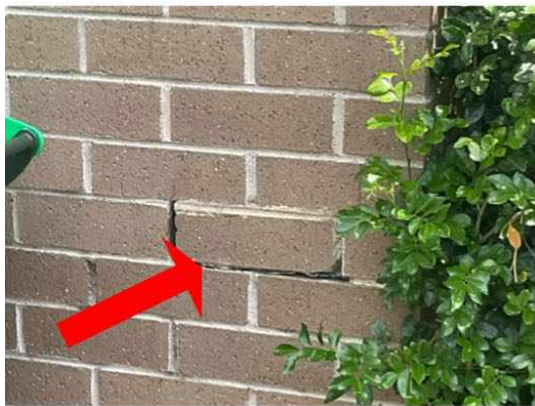
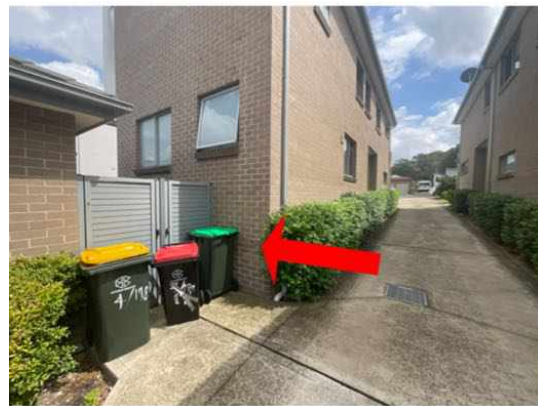
### Finding 3.10

Building:	Main Building
Location:	All External Areas
Finding:	Damaged / crack brickwork
Information:	At the time of inspection, damaged or crack bricks were identified. Where this is due to the contractor workmanship, building age or damage as the building structure moving. While being an appearance defect, such damage is expected during

construction of a property.

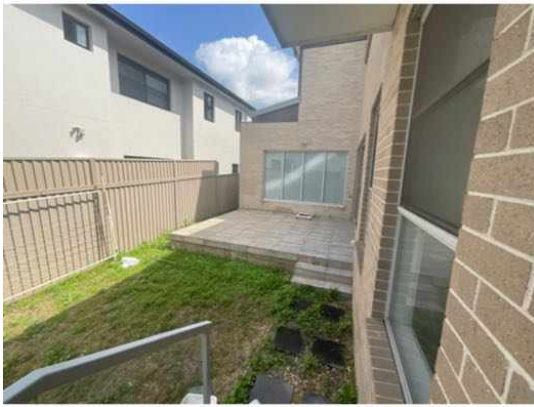
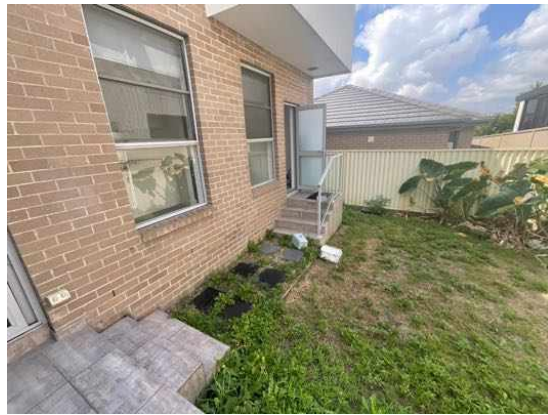
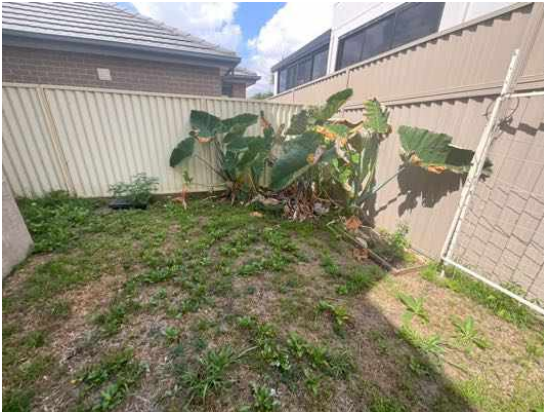
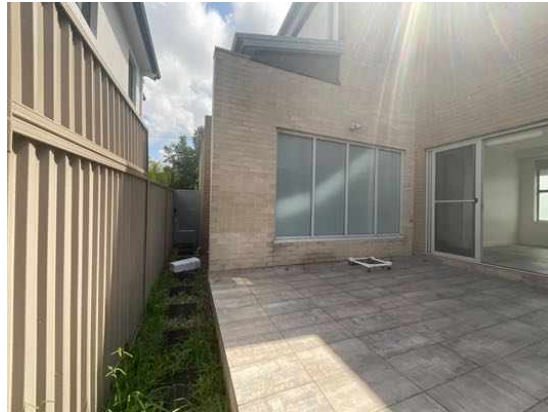
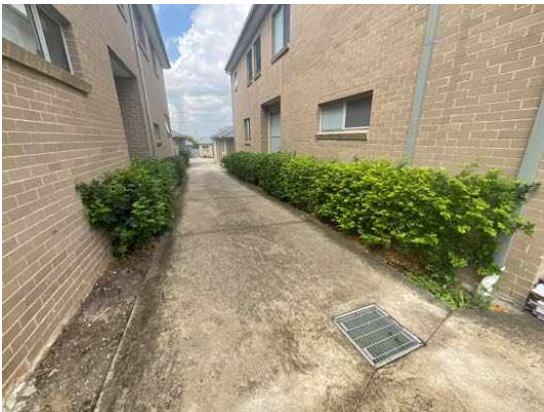
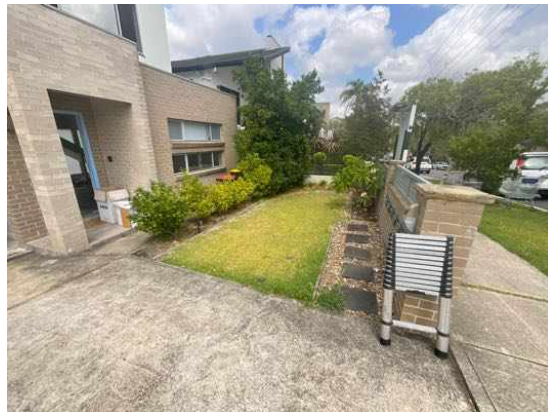
#### Finding 6.01

Building:	Main Building
Location:	All Areas
Finding:	Garden Beds - Conditions Conducive to Termites
Information:	Garden beds were found to be evident in the garden area. These garden beds can include untreated timber, and with a combination of moisture from watering hosing can make conditions conducive to termite activity and termite ingress.

- Clear any debris, garden beds or soil covering weep holes or vent holes (to prevent concealed termite entry). (If this is not possible then the installation of a Chemical Termite management system is even more highly recommended). Consult a suitably qualified termite expert for further advice.

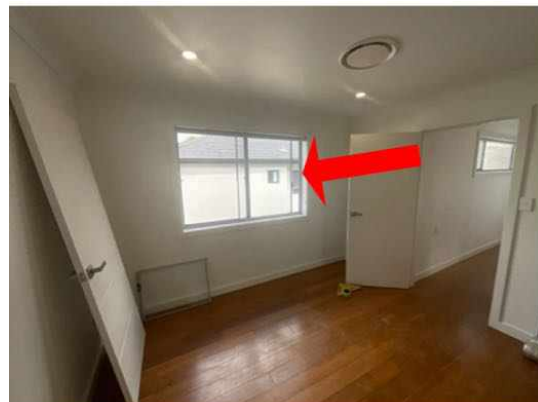
Building:	Main Building
Location:	Kitchen
Finding:	Window restriction - missing stopper to bedroom
Information:	<p>The handle to the window was missing at the time of the inspection. Absence of the window stopper limits the operation of the window and may pose as a safety risk. Installation of the stopper should be conducted as soon as possible. A general handy person or qualified carpenter should be appointed to perform these works to improve the operational state of the affected window and improve the safety of the internal area. The NCC sets the minimum requirements for the design, construction and performance of buildings throughout Australia. To limit the risk of a child falling through an openable window, the NCC states that if the floor below the window in a bedroom is 2.0 m or more above the surface beneath and the lowest level of the window opening is less than 1.7 m above the floor, a restriction (device or screen) is required to:</p> <ul style="list-style-type: none"> <li>• Restrict window openings to less than 125mm; to not permit a sphere of 125mm diameter to pass through the window opening or barrier screen; while resisting an outward horizontal force through the opening of 250 newtons (equivalent to 25.49Kg) while the window is restrained by a restriction device or barrier screen protecting the opening.</li> <li>• Have a child resistant release mechanism, thus the screen or device is unable to be removed, unlocked or overridden.</li> </ul>
