Building Inspection Report

Inspection Date: Tue, 17 Mar 2026

Property Address: Unit 6/12 Brennand St, FITZROY NORTH,
VIC, 3068, Australia

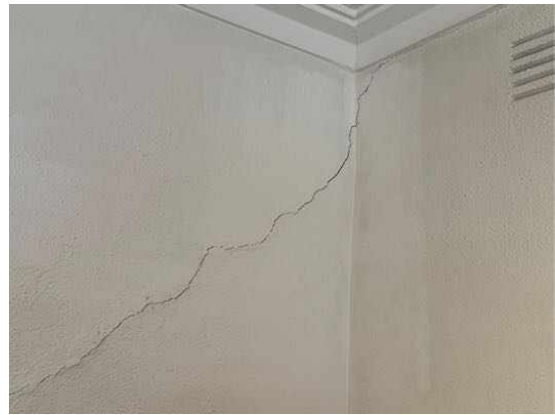
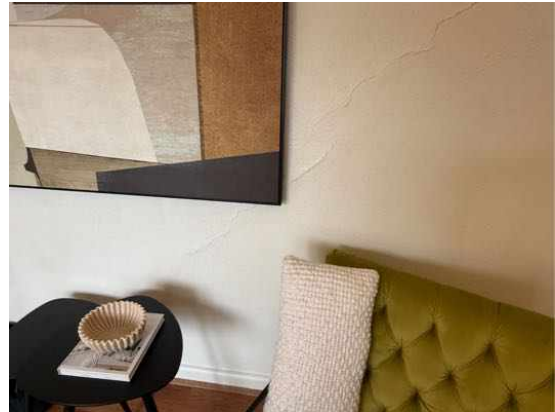
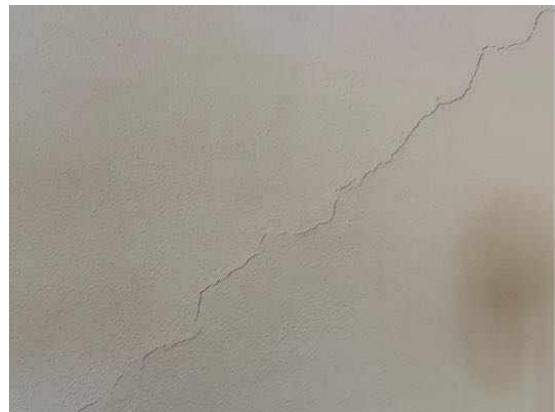
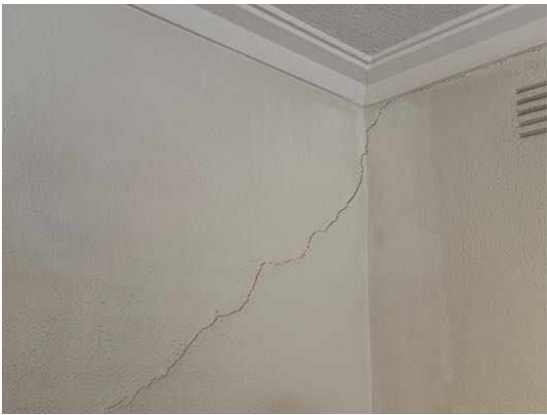
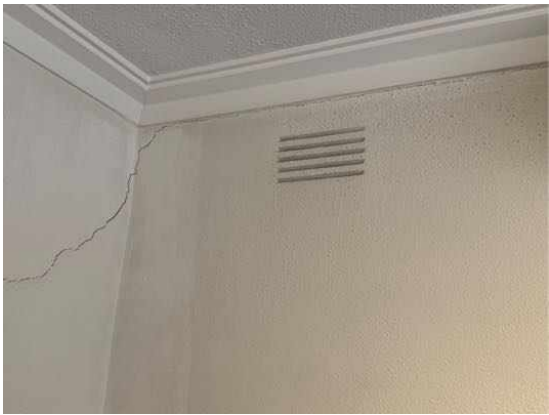
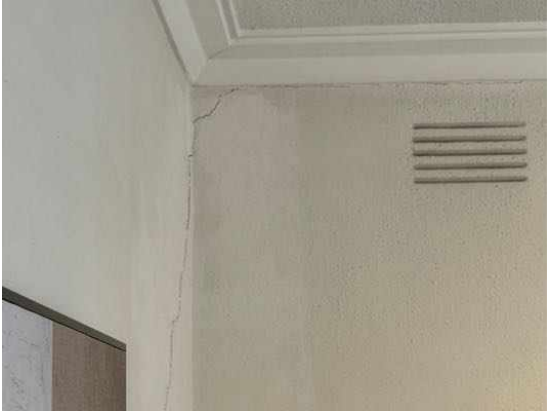
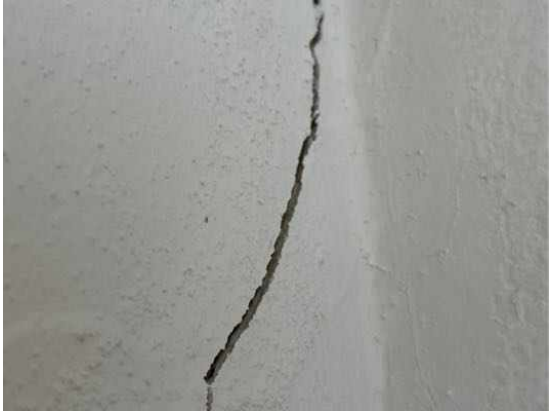
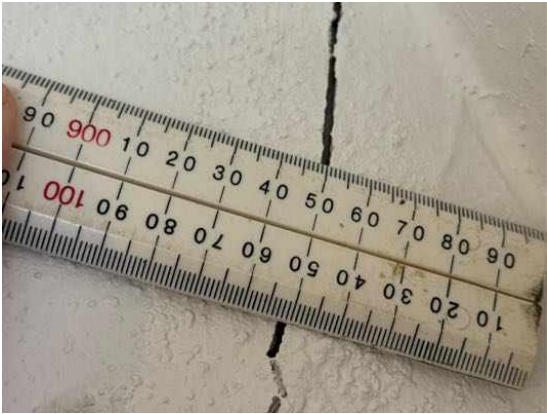
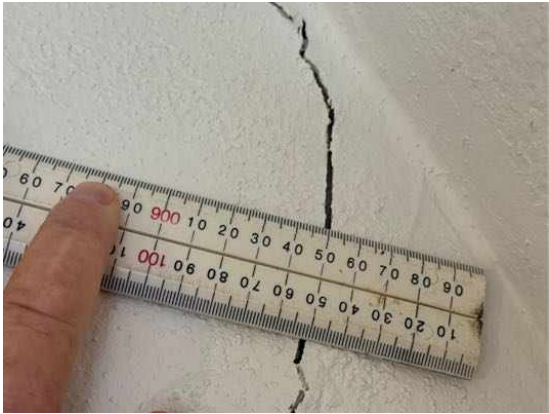
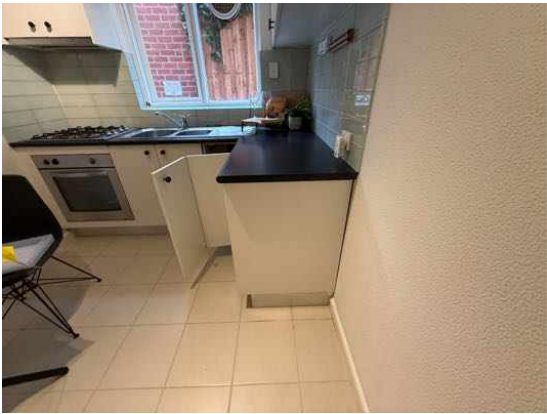
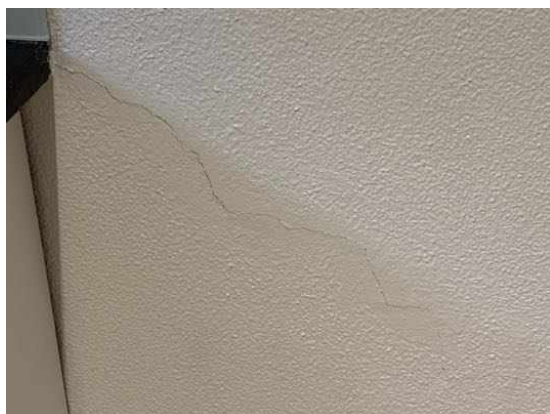
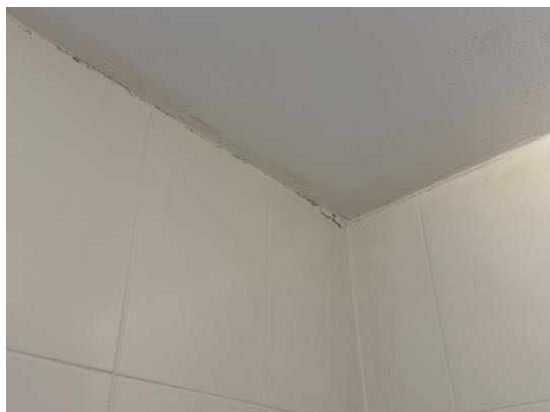
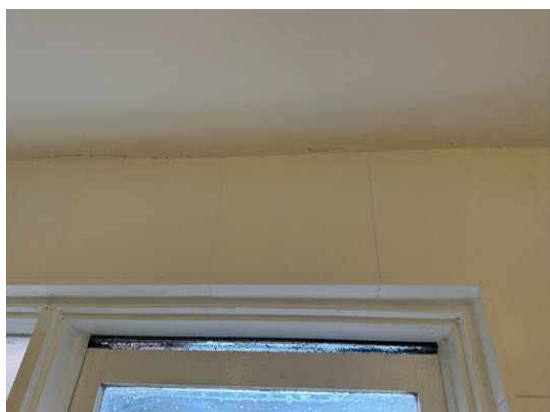
Defects 2.01

Building: Building 1
Location: Living Room > All Areas
Finding: Major wall cracks to the Living room plaster walls
Information: Major wall cracks was observed to the Living room plaster walls at the time of the inspection. This crack is very noticeable and requires the client to appoint a Structural Engineer to further inspect this area. It is considered to be a crack which cannot be just repaired and painted over.

Cracks of this type are suspected and likely to have been caused by expected movement throughout the unit /home. Movement and cracking of this degree may result in further damage and deterioration and or the development of secondary defects. It is highly recommended to appoint a Structural engineer before any repairs and restoration works are carried out. Always contact a Structural engineer or a licensed builder should cracks widen, lengthen or become more numerous.

For the client's attention, major wall cracks was observed to the Living room plaster walls at the time of the inspection. This crack is very noticeable and requires the client to appoint a Structural Engineer to further inspect this area. It is considered to be a crack which cannot be just repaired and painted over. Cracks of this type are suspected and likely to have been caused by expected movement throughout the unit /home. Movement and cracking of this degree may result in further damage and deterioration and or the development of secondary defects. It is highly recommended to appoint a Structural engineer before any repairs and restoration works are carried out. Always contact a Structural engineer or a licensed builder should cracks widen, lengthen or become more numerous.

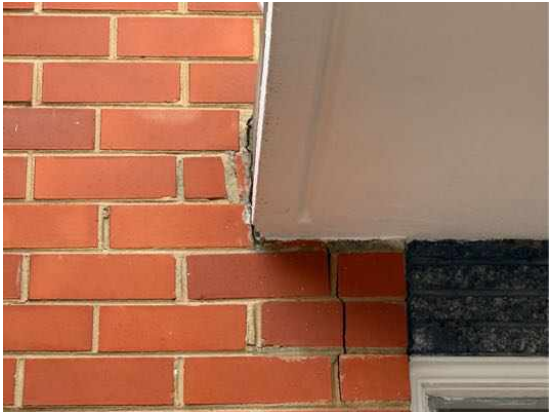
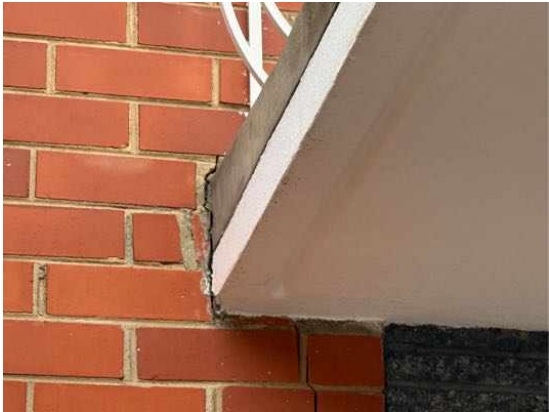
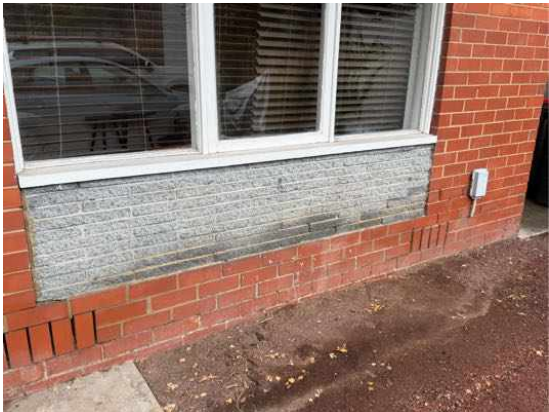
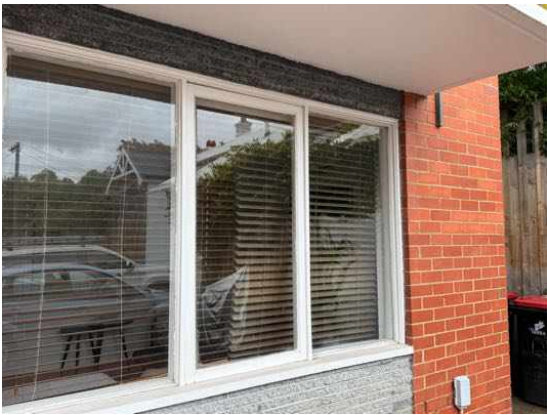
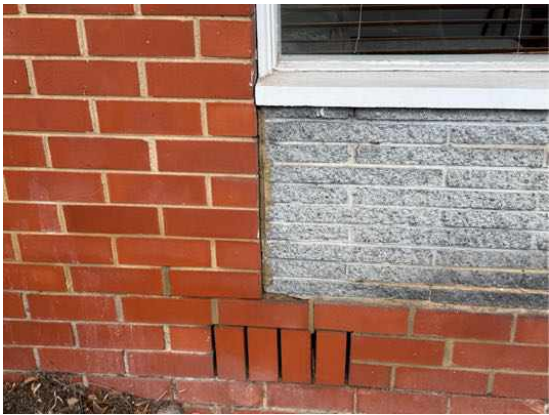
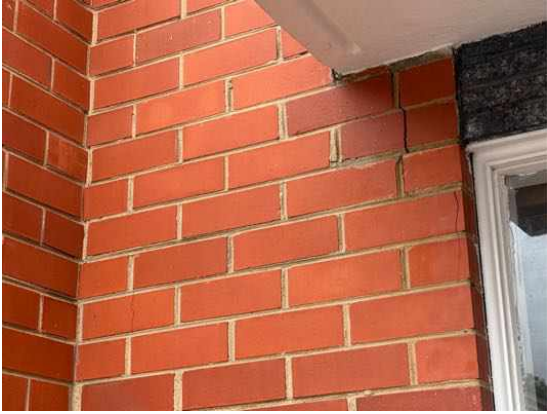
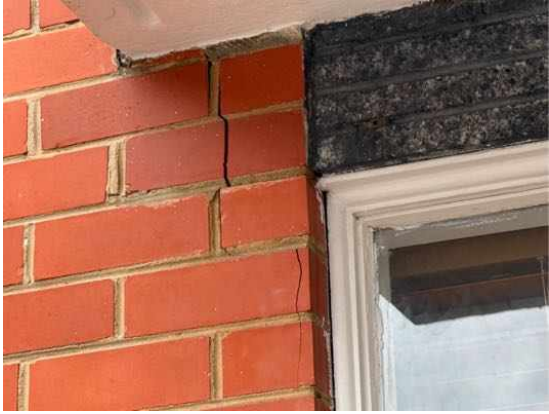
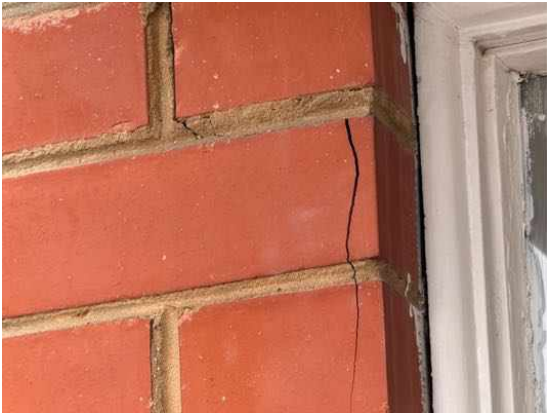
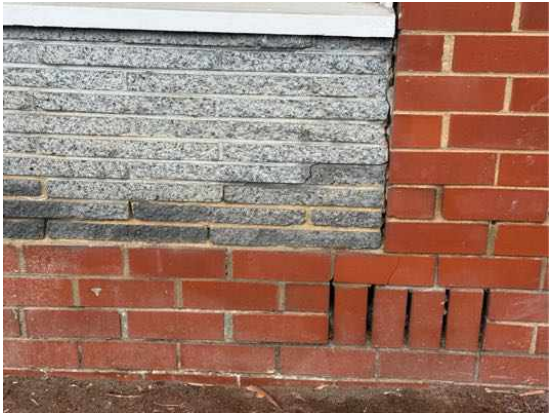
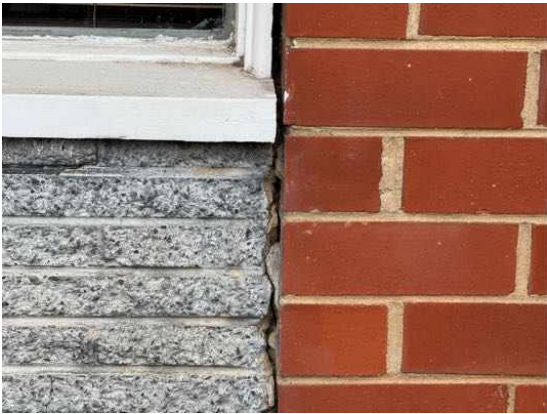
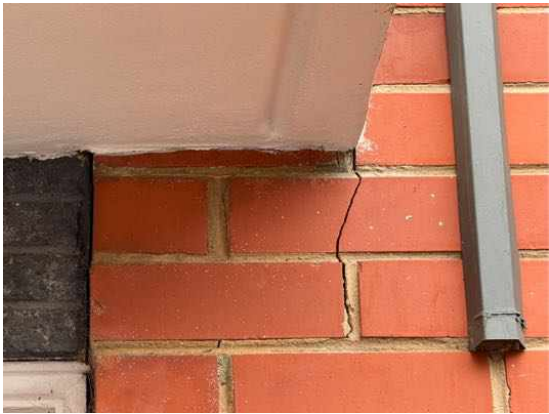
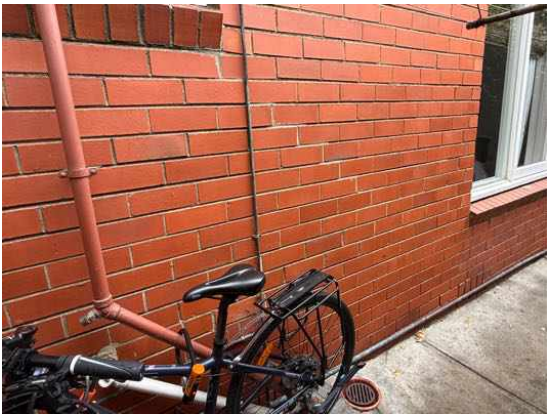
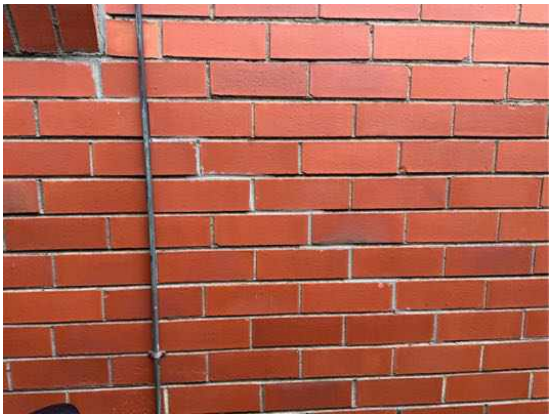
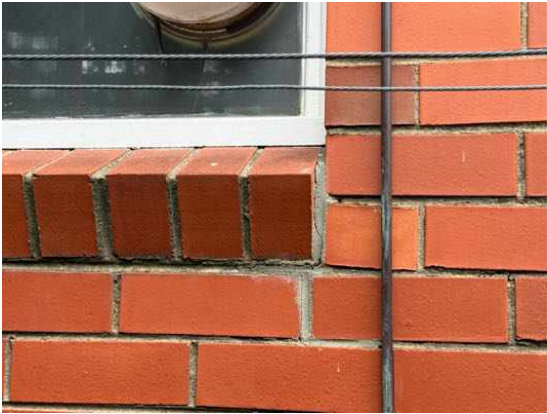
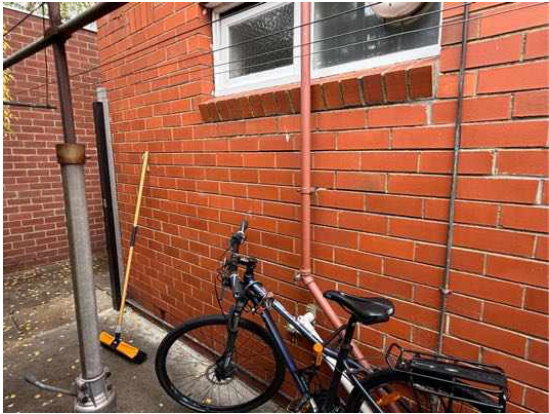
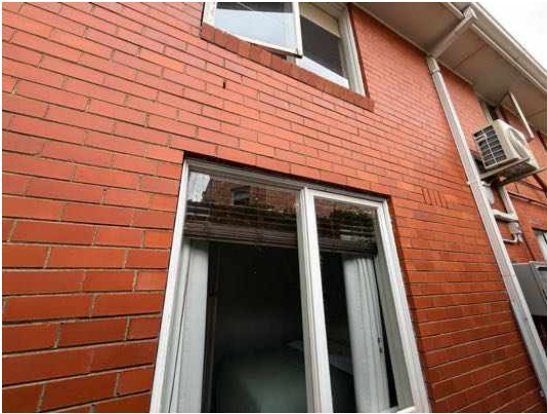
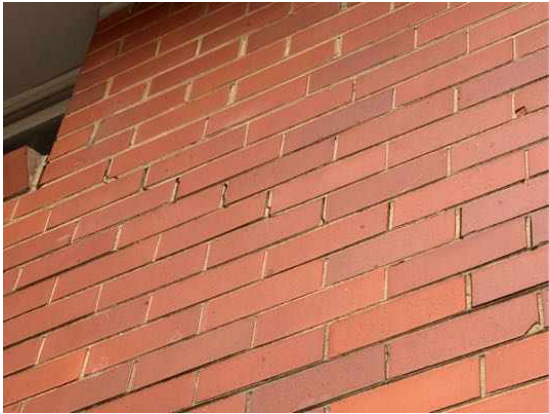
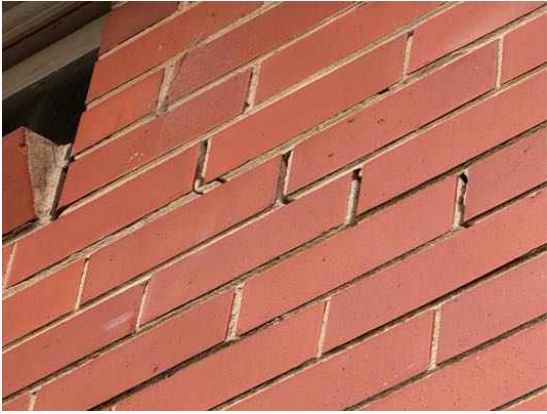
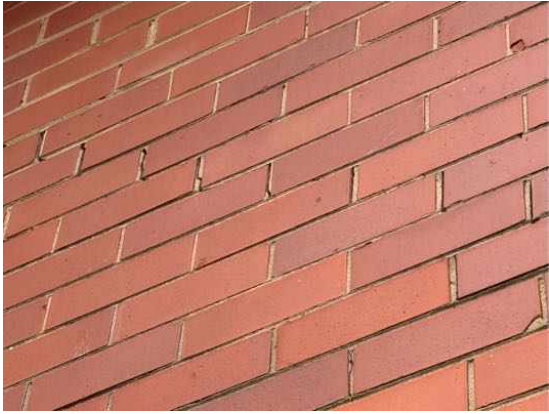
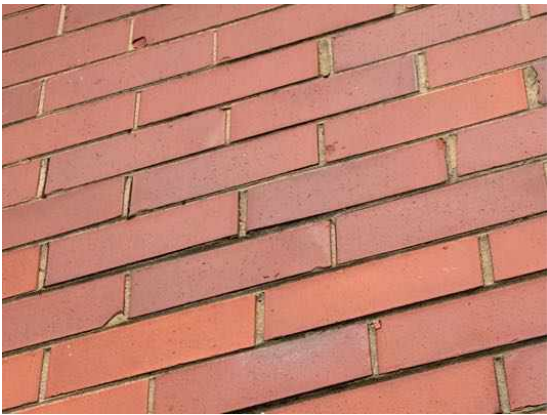
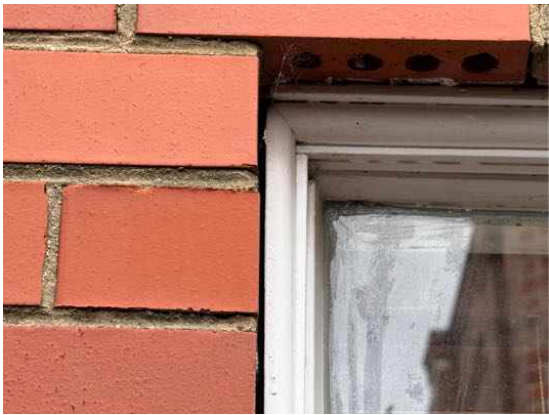
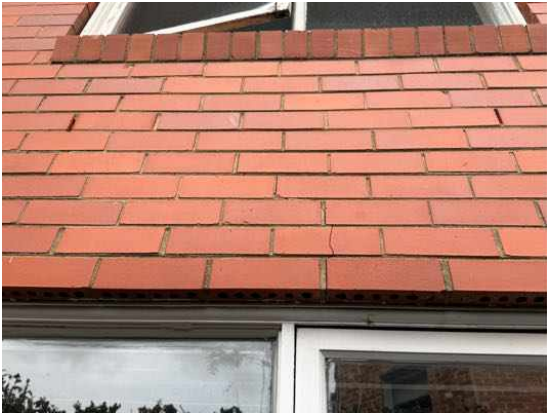
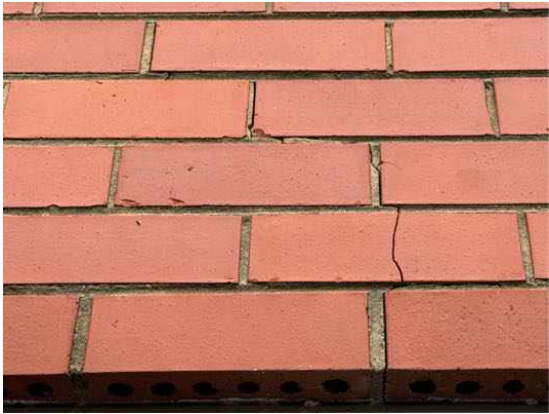
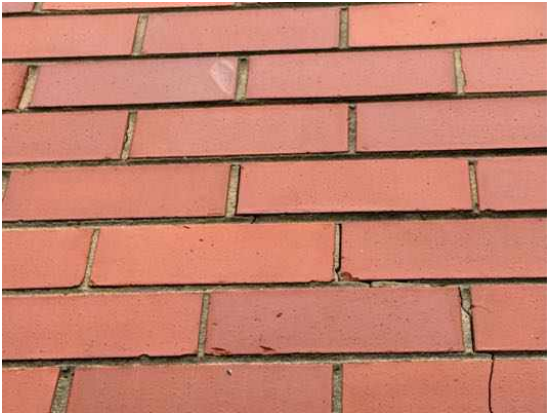
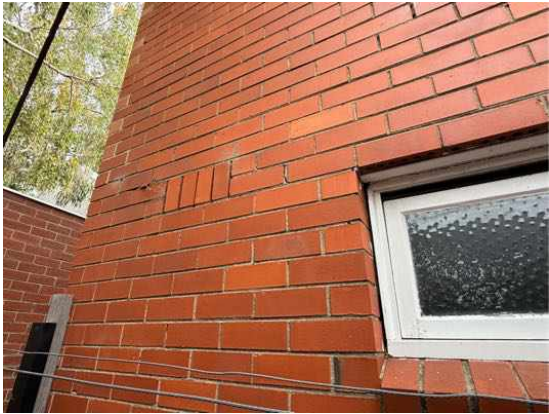
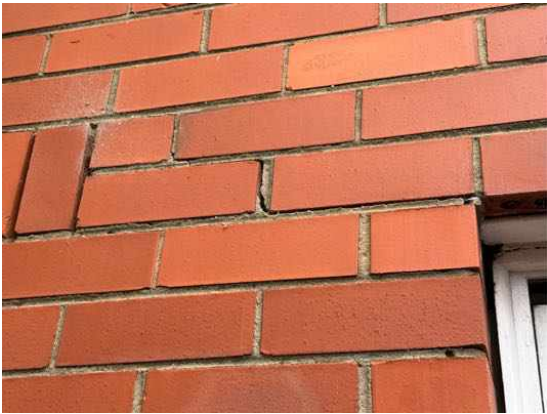
Defects 2.02

Building:	Building 1
Location:	All Areas > All Areas
Finding:	Brickwork - Cracking and movement
Information:	Major and minor areas of brickwork cracking were observed throughout the exterior brickwork of the unit and the unit above. These types of structural issues would require consultation and suspected permission from the Body corporate in charge of these premises. When managing this degree of cracking, major expensive repair work is generally required. If client was intending to repair these areas it is likely to involve the client appointing a structural engineer to advise on the repair or replacement of sections of affected brickwork.

Structural issues are generally the underlying cause of such cracking. It is suspected that this damage has been created due to movement of key structural elements and or general subsidence of associated footings. A structural engineer and bricklayer should be appointed immediately to inspect the structural integrity of the affected brickwork and to assess the safety of the associated structures. The engineer can also nominate a scope of works required for rectification. Always contact a building engineer should cracks widen lengthen or become more numerous, even after repair works have been completed.

For the client's attention, major and minor areas of brickwork cracking were observed throughout the exterior brickwork of the unit and the unit above. These types of structural issues would require consultation and suspected permission from the Body corporate in charge of these premises. When managing this degree of cracking, major expensive repair work is generally required. If client was intending to repair these areas it is likely to involve the client appointing a structural engineer to advise on the repair or replacement of sections of affected brickwork. Structural issues are generally the underlying cause of such cracking. It is suspected that this damage has been created due to movement of key structural elements and or general subsidence of associated footings. A structural engineer and bricklayer should be appointed immediately to inspect the structural integrity of the affected brickwork and to assess the safety of the associated structures. The engineer can also nominate a scope of works required for rectification. Always contact a building engineer should cracks widen lengthen or become more numerous, even after repair works have been completed.

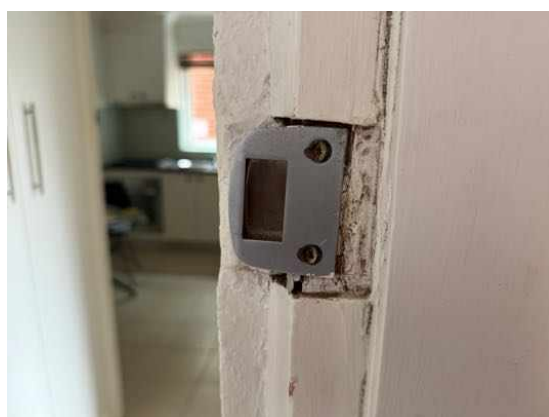
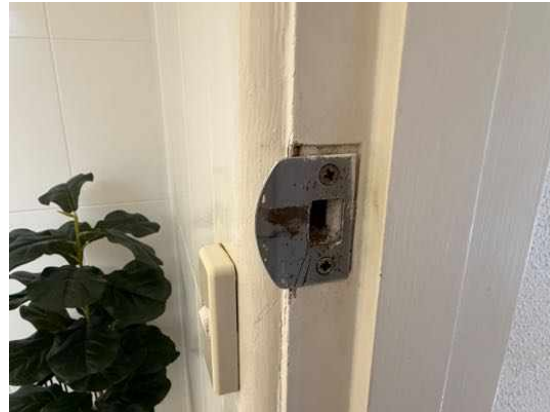
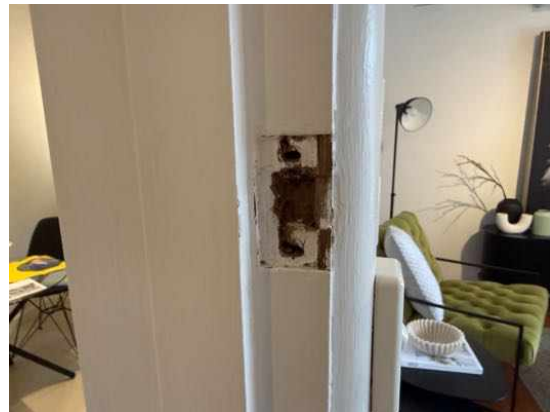
Defects 3.01

Building: Building 1
Location: Bedroom > All Areas
Finding: Door handles and latches
Information: It was noted that the door into bathroom was not operating and not latching as it should during normal operation. The bathroom door handle or latch was observed to be stuck. This door should not be shut until this door receives the immediate remedial work to repair or replace this door handle. If left unmanaged, someone or occupants will eventually be stuck in this area and unable to exit. Whilst detracting from the functionality of this building element, this minor defect may also be a safety hazard to all occupants, and may therefore have serious implications if occupants were not able to egress at the time of an emergency.

It is suspected that this defect has occurred due to minor issues after poor installation and or through general wear and tear, which is expected for building elements of this age. A qualified carpenter may be appointed to perform rectification works as necessary. If left unattended, further functional impairment is likely to occur.

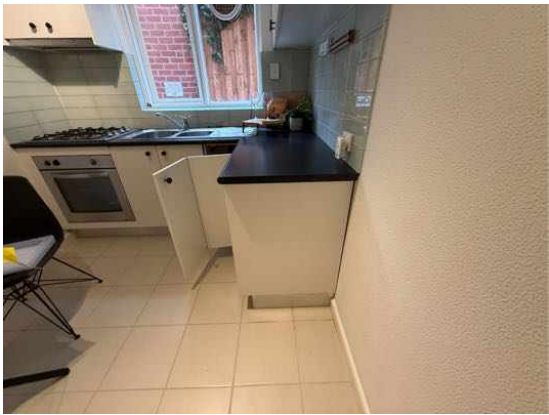
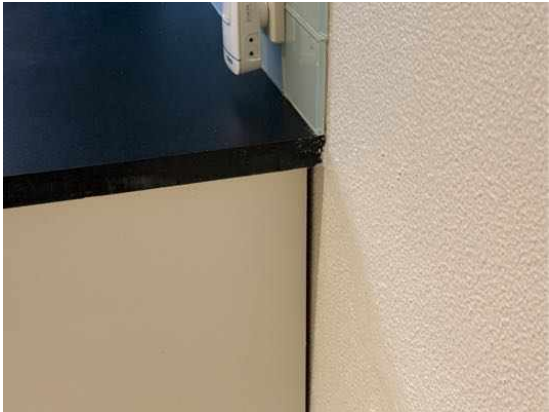
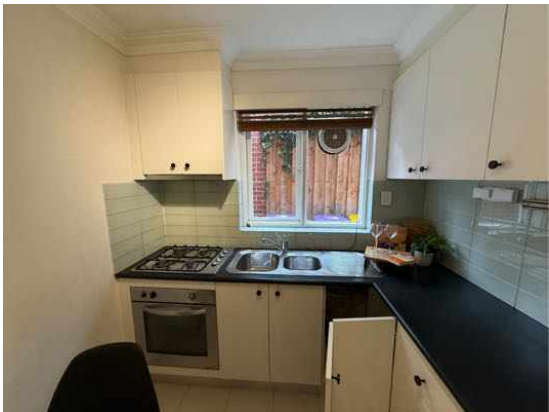
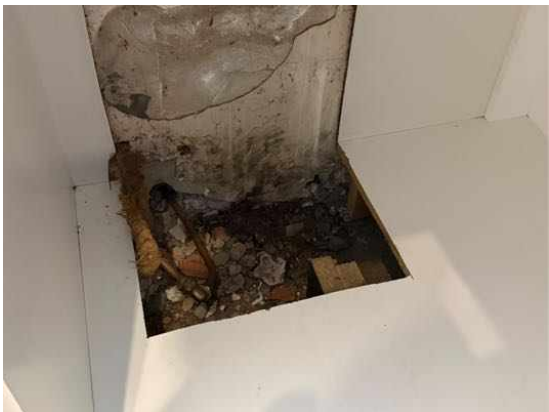
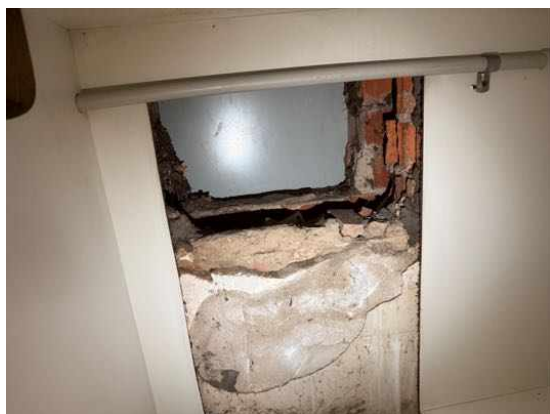
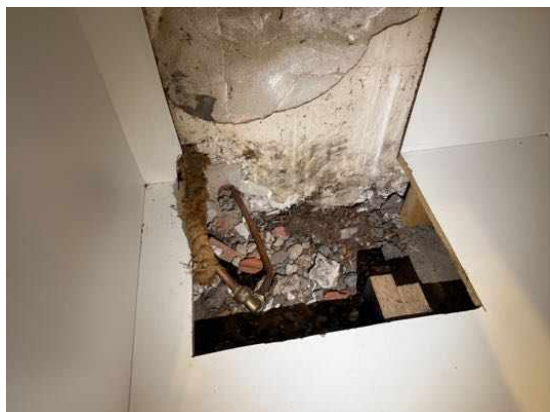
Defects 3.03

Building:	Building 1
Location:	Kitchen > All Areas
Finding:	Kitchen cabinetry
Information:	The kitchen cabinetry to the right hand side of the kitchen sink showed signs a suspected hot water service had been previously removed. No remedial work to repair the large opening and hole left by the HWS had taken place. Client will therefore be required to appoint a cabinet maker or other relevant tradespersons to rectify the kitchen cabinets to make good. If left unmanaged this area has a high likelihood of attracting vermin and pests into these areas. Immediate repair of this area is highly recommended.

All were observed to have some wear and deterioration, they are considered to require some maintenance, remedial work or repair to ensure further deterioration does not continue further. Although these defects may detract from the overall looks of the cabinetry, in most cases it does not necessarily affect the operational state of the cabinetry.

To improve the operation of these affected cabinets, cabinet doors or drawers, a qualified cabinet maker or carpenter may be appointed to rejuvenate rectify or repair any cabinetry as deemed to be necessary. Such works should be completed at discretion of the client.

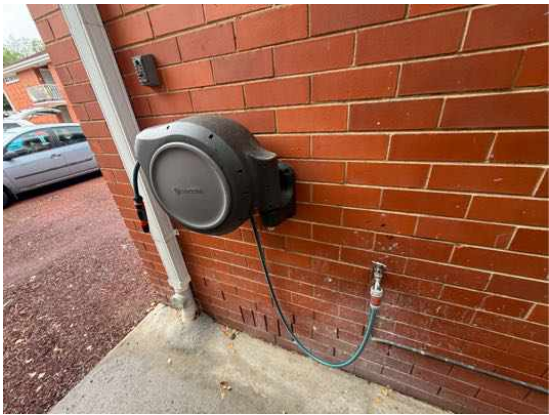
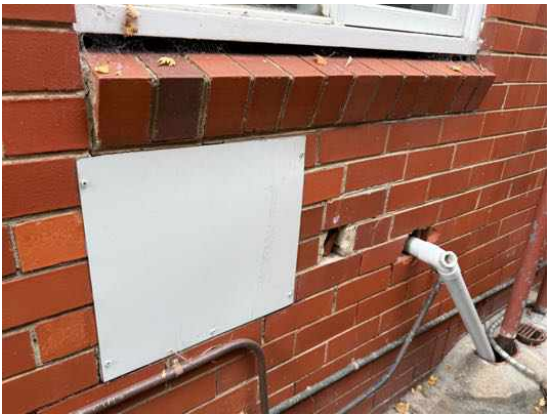
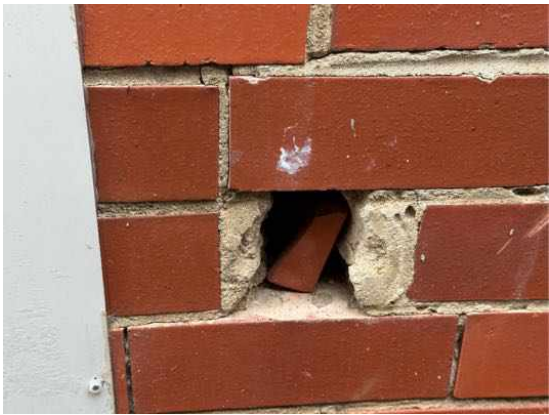
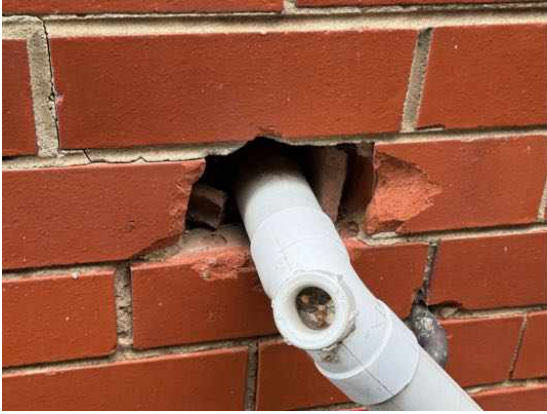
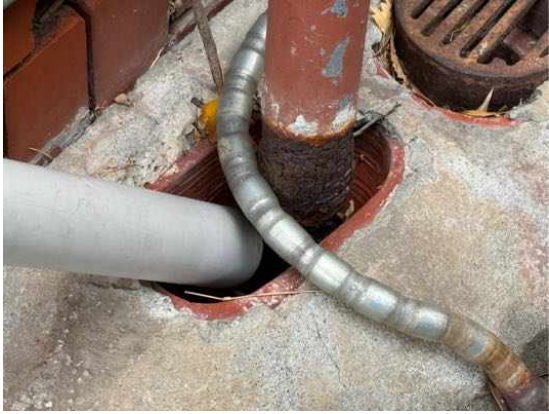
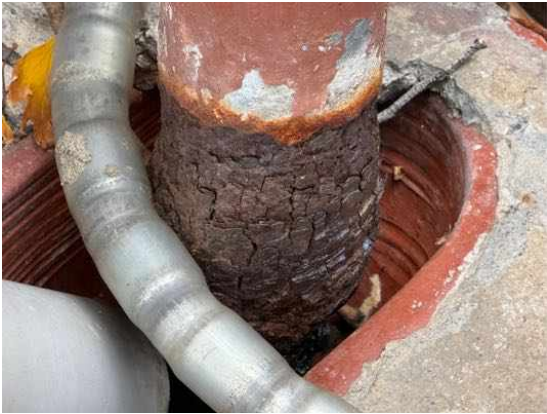
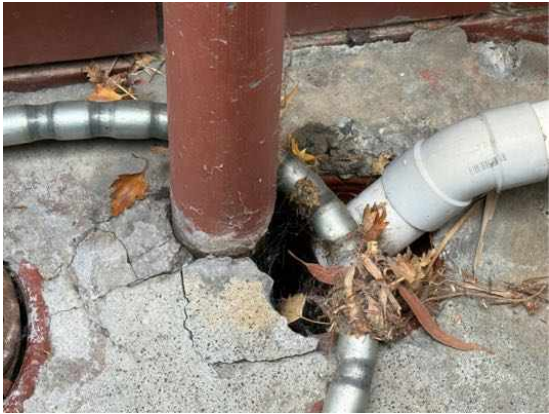
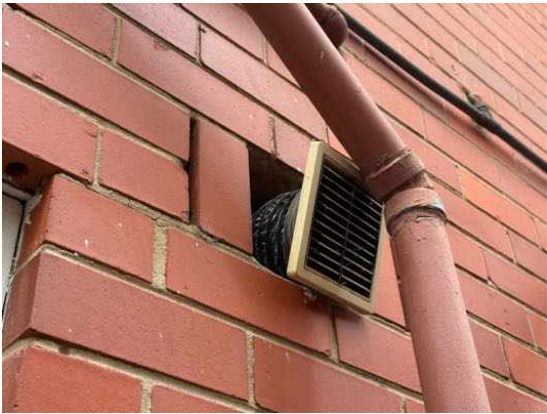
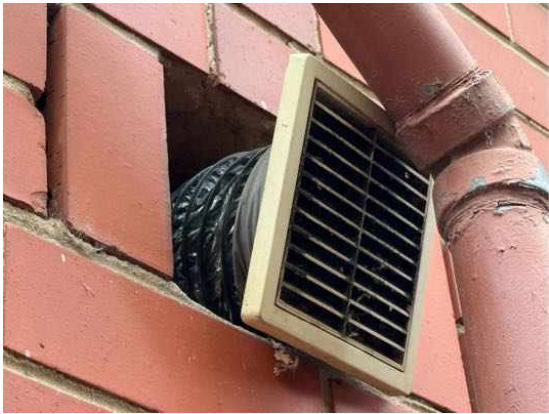
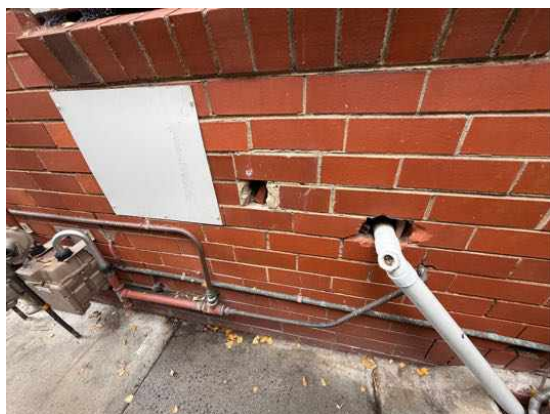
Defects 3.05

Building:	Building 1
Location:	All Areas > All Areas
Finding:	Brickwork - holes or minor voids
Information:	At the time of the inspection of the brickwork, some holes or voids were observed in the right hand side brickwork. Any missing mortar or voids or holes should be filled and patched to ensure that bricks remain in their intended location. All exterior brickwork in masonry walls and structures are required to be fully filled in and patched to prevent frequent exposure to weathering. Gaps, holes and voids will allow insect, pests, vermin, water or moisture to ingress into the wall cavities. If left unmanaged this type of defect can create secondary defects and damage as a result in the future.

When mortar is found to be missing in brickwork it is normally as a result of poor installation procedures, poor trade practices or where trades have fitted other external fixtures etc. Holes and voids should always be properly filled or patched by a qualified bricklayer or other relevant tradespersons to ensure further deterioration does not develop further in the future. When these repairs are carried out, the bricklayer must ensure the mortar colour and consistency are as near as possible to the existing mortar and remains as close as possible to the original installation of the brickwork.

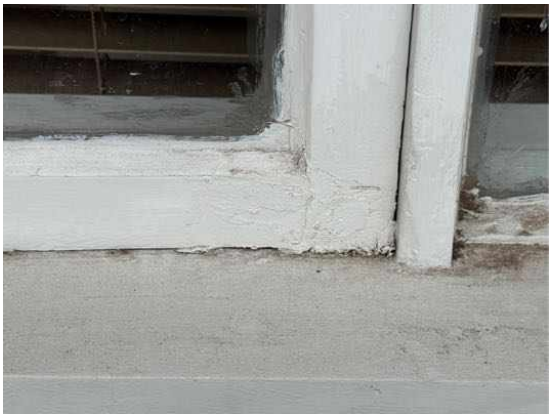
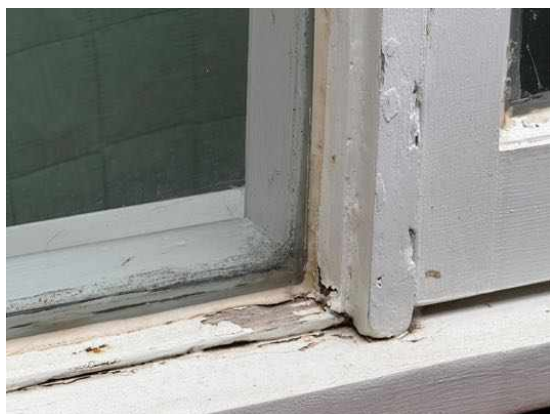
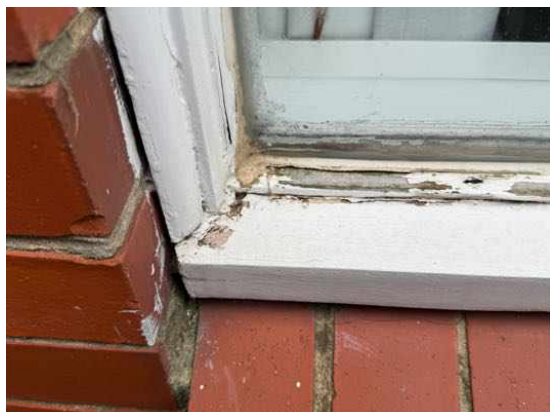
Defects 3.06

Building:	Building 1
Location:	All Areas > All Areas
Finding:	Wood rot
Information:	Wood rot was observed to be affecting the rear exterior windows of the home. Wood rot, also known as Fungal Decay, occurs when timbers and other cellulose building materials are exposed to damp conditions on an ongoing basis.

Due to exterior, extreme weather conditions and frequent exposure these types of building elements are highly susceptible to accelerated damage and deterioration. Keeping timber and other susceptible building elements away from excessive moisture and providing early intervention and regular maintenance such as painting will prolong the useful life of these building elements. Prior to any works being performed, the cause of the moisture that has created the visible wood rot should be identified and addressed in a suitable manner.

It is advised that the relevant tradespersons be appointed to inspect and subsequently identify the cause of the numerous areas of wood rot. Replacement of affected building elements and materials may then be a necessary step in protecting surrounding areas from secondary damage and deterioration. A qualified carpenter or builder and other specialists may be appointed to assess the cause of excessive moisture and to provide advice on any remedial works as required. A qualified carpenter or registered builder may also be required to replace affected building materials.

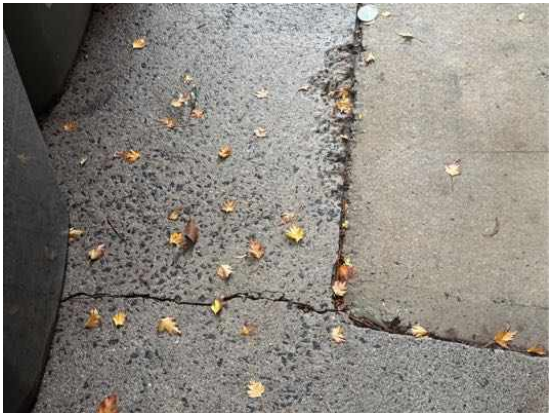
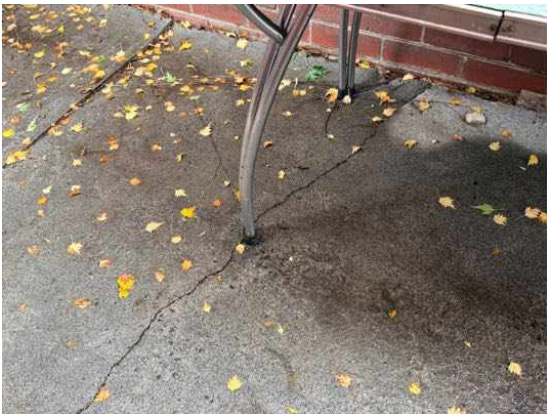
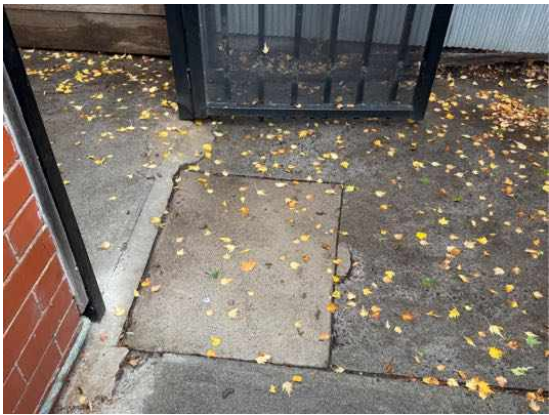
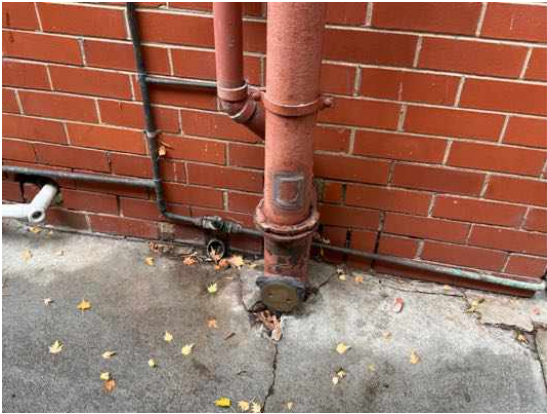
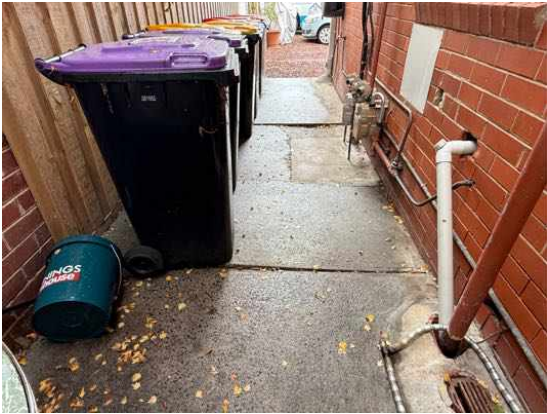
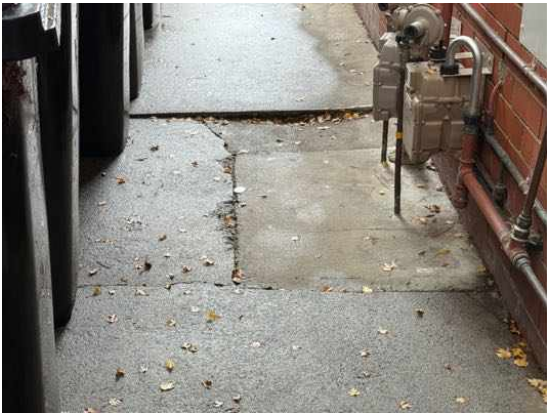
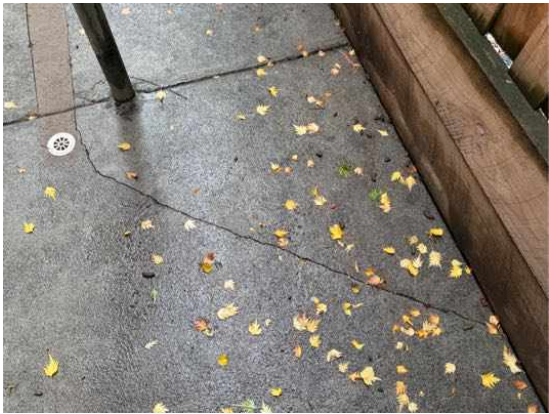
Defects 3.07

Building:	Building 1
Location:	All Areas > All Areas
Finding:	Paving tripping hazards - Uneven and undulations
Information:	Sections of the external concrete paved areas were observed to be uneven and undulating, creating a potential trip hazards. It appears as though the paved areas has been subject to suspected some movement, either from surrounding tree roots or poor installation, sections of the concrete have dropped or lifted due to surrounding trees or poor preparation in the substrate before concrete is laid.

Numerous concrete cracks were observed in the rear and RHS concrete at the time of the inspection. Concrete cracks are a common occurrence as a result of many primary defects. Such causes may include age, general wear and tear, expected movement, general expansion/contraction of building materials in different weather conditions, and/or minor failings in the installation or application of building materials. Monitoring of all cracks should be conducted periodically. Contact a relevant tradespersons should cracks widen, lengthen, or become more numerous.

Where paving creates a trip hazard, personal injury may ensue if due caution is not taken by occupants and all other persons within this area. Client may consider re-concreting these areas, where required or deemed necessary to remedy these types of situations. Further consultation with a concreter, landscaper or other specialists in these areas is recommended.

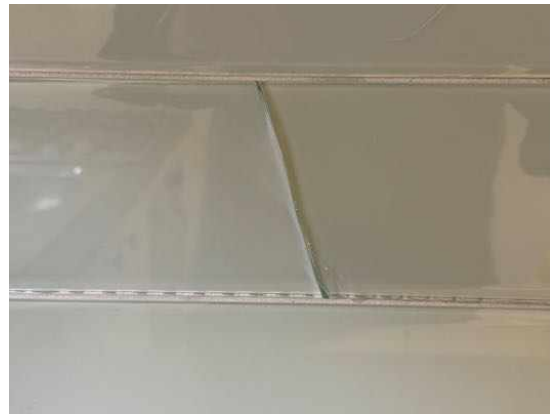
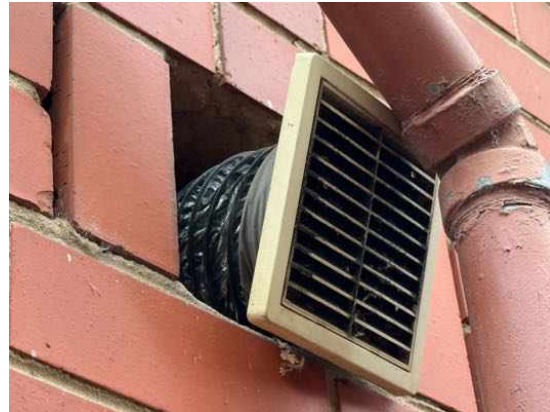
Noted Item

Building: Building 1
Location: All Areas > All Areas
Finding: Additional Photos
Information: Additional photos are provided for either future maintenance items for clients attention and or general reference. Arrows may have been included to highlight areas of importance. Please discuss these photos with your building consultant for clarification.
