# Building and Timber Pest Inspection Report

Inspection Date: Mon, 16 Mar 2026

Property Address: 53 Gericke Rd, Woondum QLD 4570,  
Australia

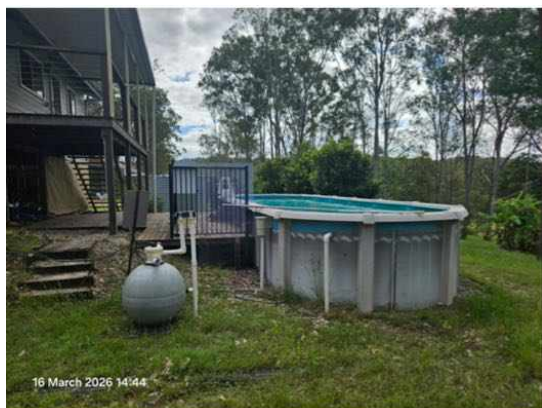
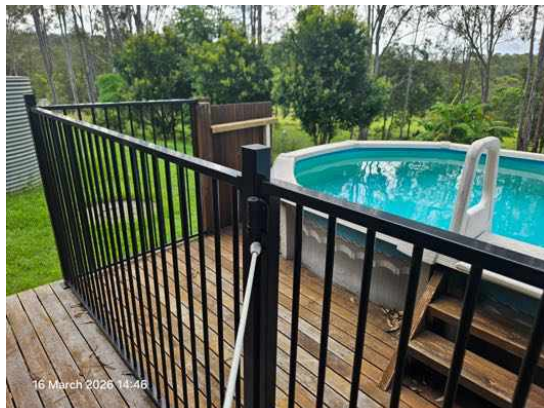
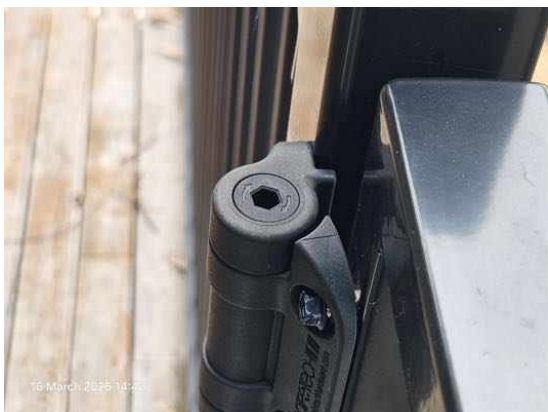
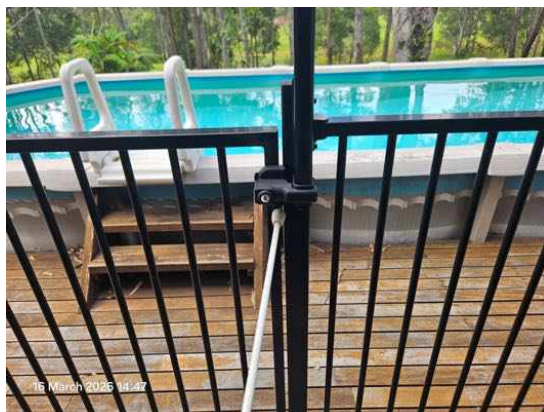
#### Finding 1.01

Building: Yard  
 Location: Pool area  
 Finding: Pool fencing - gate to be repaired  
 Information: The gate of the pool area was inspected on the day and found that it did not to comply with the Australian Standards and does not appear to be safe.

The gate requires adjustments in the following form:

1. The gate hinges are broken and require replacement.
2. Latch will require adjustment after repair.

This should be read in conjunction with the advice of the pool safety inspection.

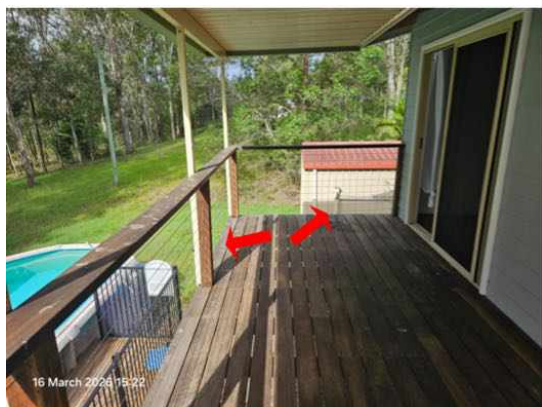
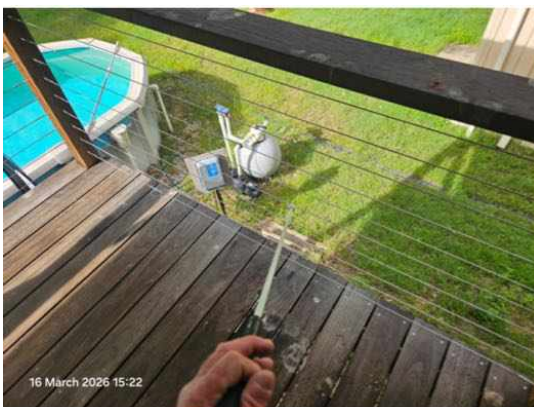
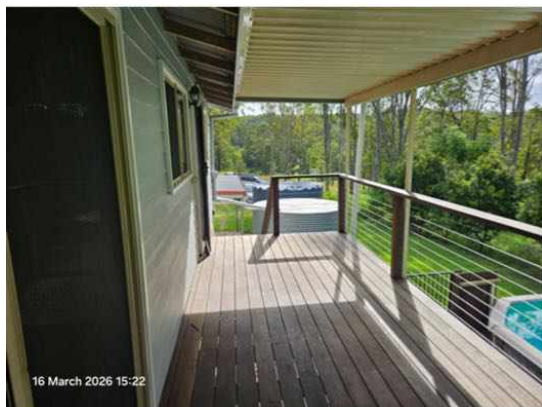
#### Finding 1.02

Building: Main Building

Location: Deck  
 Finding: Balustrade - wires loose.  
 Information: The handrail wires of the handrail to the rear verandah are and require re-tensioning.

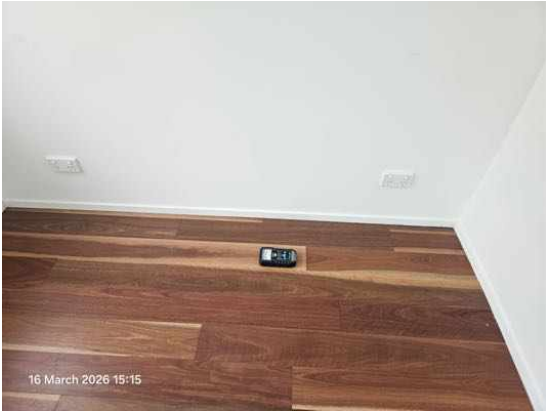
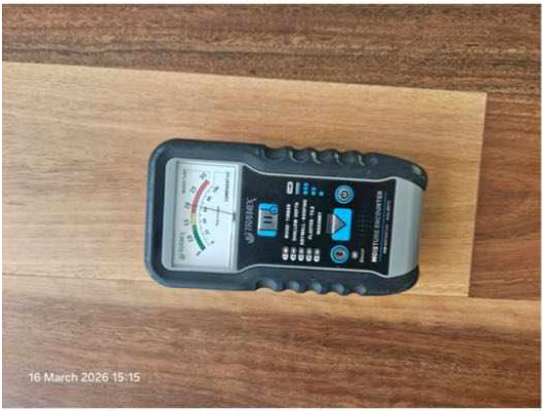
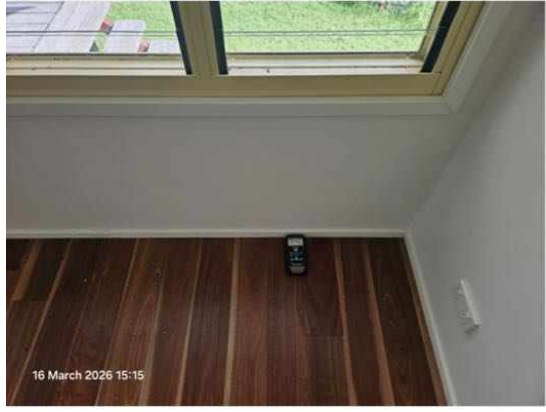
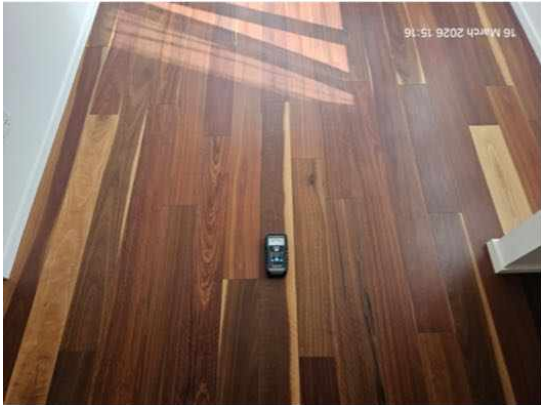
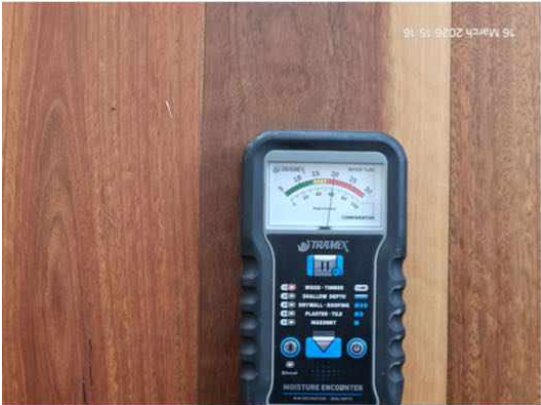
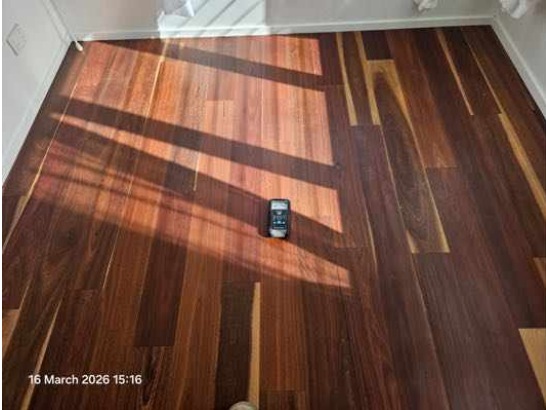
### Finding 2.01

Building: Main Building  
 Location: Front elevation  
 Finding: Wood rot / fungal decay  
 Information: The timber flooring (particleboard) layed over of the original decking of the verandah, which has been converted to extend the two front bedrooms show evidence of establish wood rot in sections of the material exposed to exterior of the wall. The flooring has been poorly waterproofed by using an aluminium / bitumen flashing, which has not provided adequate coverage or protection. The resultant decay has begun penetrating the interior of the floor. This is shown by the elevated moisture readings in the floating floor adjacent to the walls when compared with reading further into the room.

Wood rot, also known as Fungal Decay, occurs when timbers and other cellulose building materials are exposed to damp conditions on an ongoing basis. This could be

the result of exposure to weathering over a prolonged period of time, or the attraction of excessive moisture from other abutting building materials.

The flooring will require cutting back and the installation of suitable flashing such as colorbond will be required to provide adequate water resistance and protection.

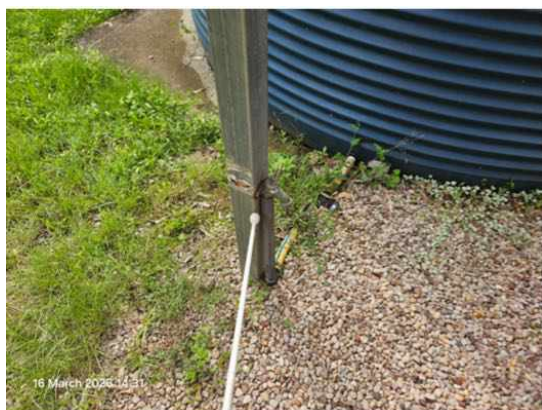
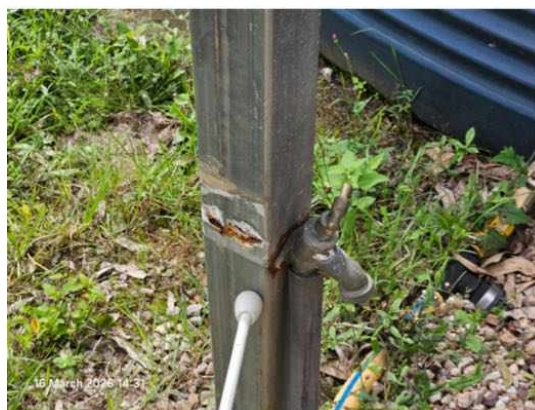
### Finding 3.01

Building:	Out Building
Location:	Carport
Finding:	Carport steel frame - surface rust present.
Information:	On the day of inspection it was noted that the steel post of the front carport had surface rust on the lower portion. The surface coating has deteriorated. It is advised that an application of a suitable moisture resistant protective coating and a rust treatment method be implemented.

Engaging the services of a licensed painter or suitably qualified handy person could assist with providing a solution.

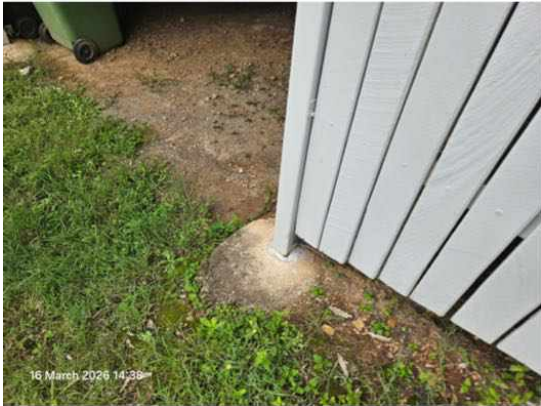
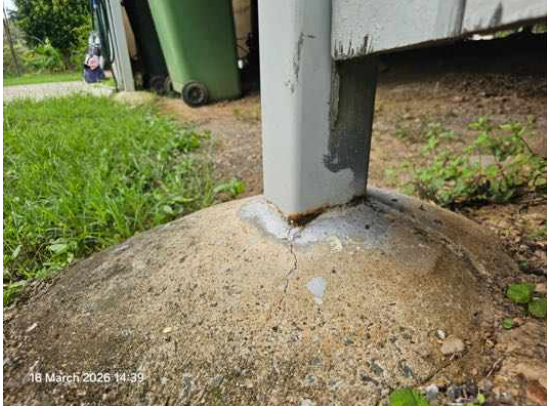
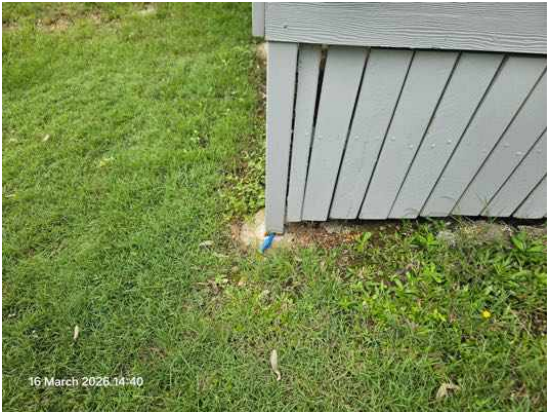
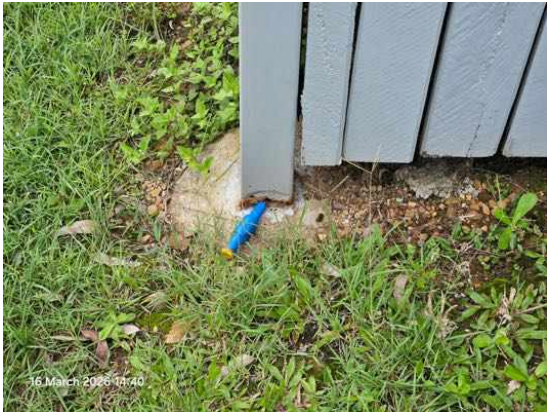
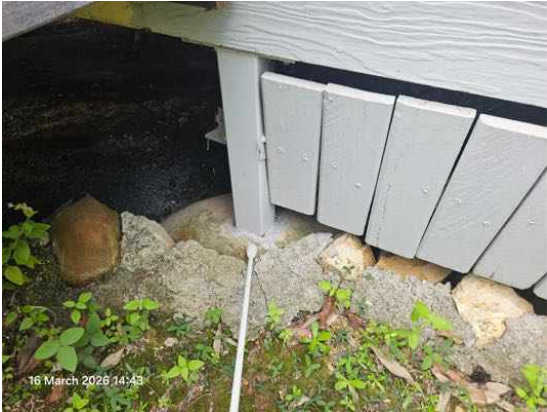
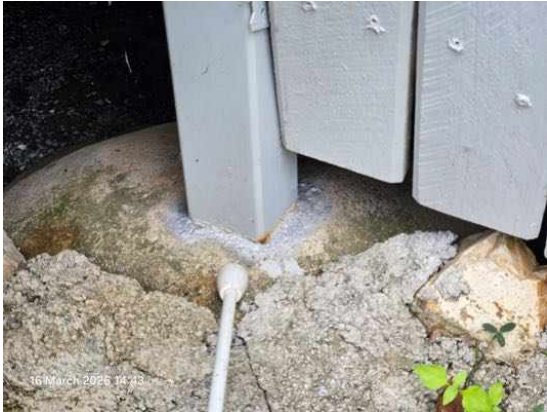
### Finding 3.02

Building:	Main Building
Location:	As shown
Finding:	Post base - rusting.
Information:	It was noted at the time of inspection that surface rust is developing at the base of the house subfloor posts. These should be treated and coated to prevent possible further

deterioration. The corner post will require repair.

A licensed painter and qualified carpenter could be engaged to carry out the required task.

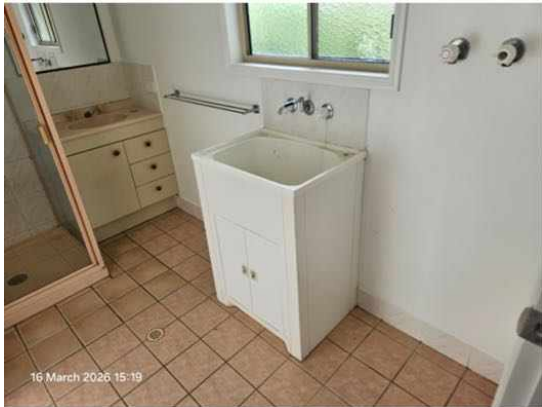
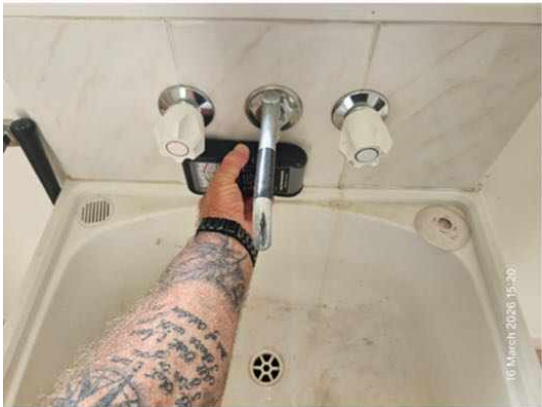
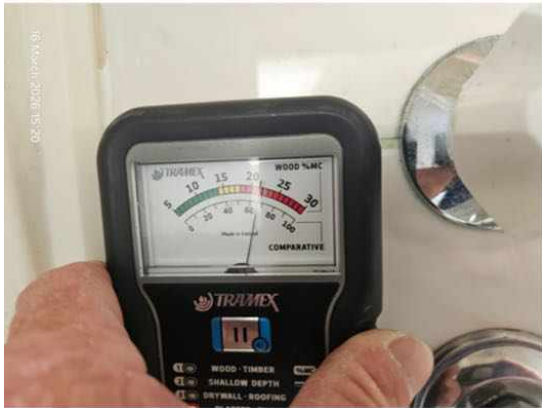
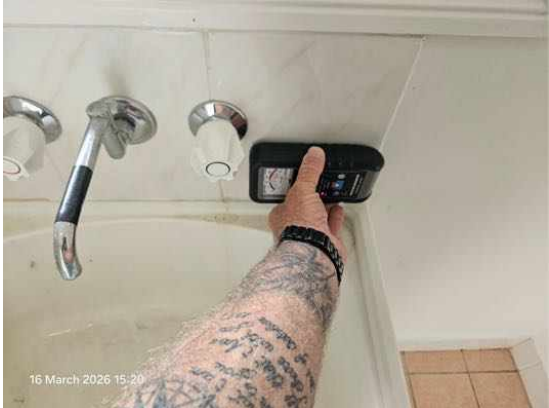
**Finding 3.03**

Building: Main Building  
 Location: Laundry  
 Finding: Moisture noted around taps - laundry  
 Information: During the inspection elevated moisture was observed around the taps of the laundry splashback.

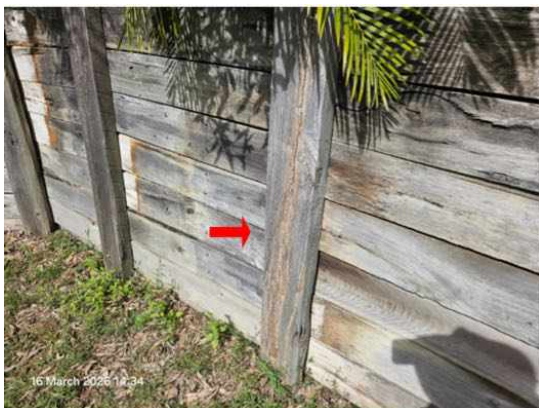
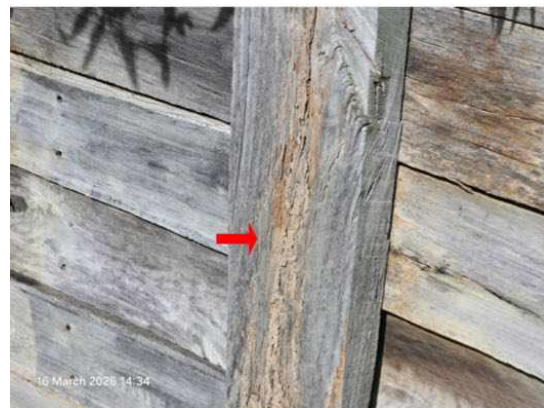
### Finding 5.01

Building:	Yard
Location:	Retaining wall
Finding:	Evidence of previous inactive termite damage
Information:	On the day of inspection an area of minor inactive termite damage was noted in the sleeper retaining wall.

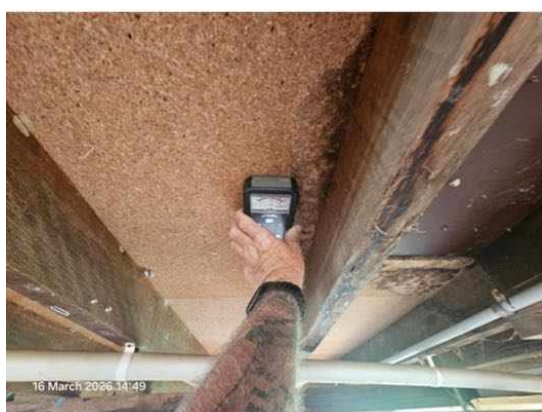
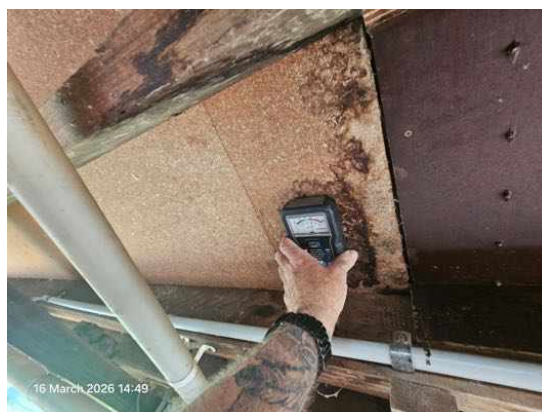
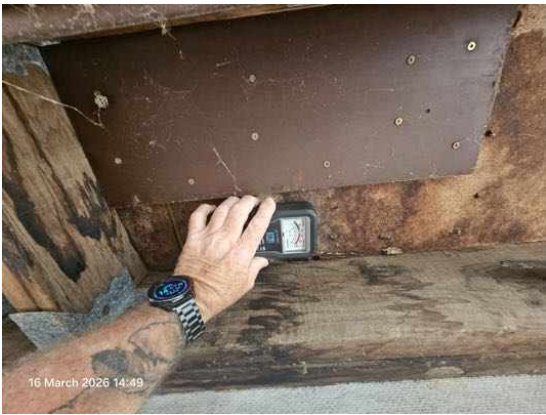
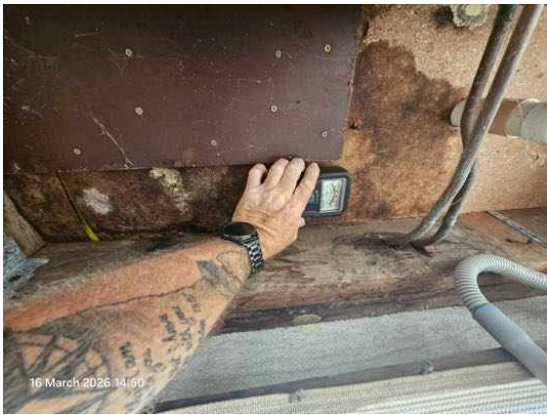
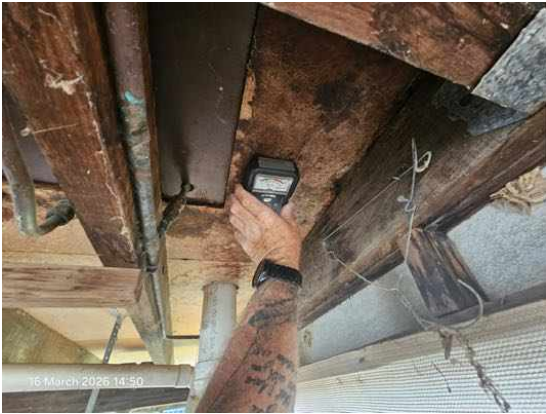
Building: Main Building  
Location: Bathroom  
Finding: Floor sheets - Water stained  
Information: Water staining to underside of the floor sheets beneath the bathroom were evident at the time of inspection. Water staining indicates that surfaces have been exposed to moisture over time. The stains did not read as high in moisture on the day of inspection; however they should be monitored over time and if they indicate an increase in moisture level, the floor surfaces and plumbing fixtures in these areas should be assessed.

The minerals and other elements in the water lead to staining, which may graduate to corrosion and deterioration if left unmanaged. While mostly an appearance defect, water staining can be indicative of more serious defects, which may be currently concealed.

Conversely, where water staining is old and inactive, affected building materials may be repaired or replaced at client discretion. In this case it appears that the stains developed before shower repairs were carried out.

Where water staining is active, a licensed plumber must be consulted to identify the cause of the staining and to provide advice on any reparation works that may be required. Replacement of any damaged structures is advised.

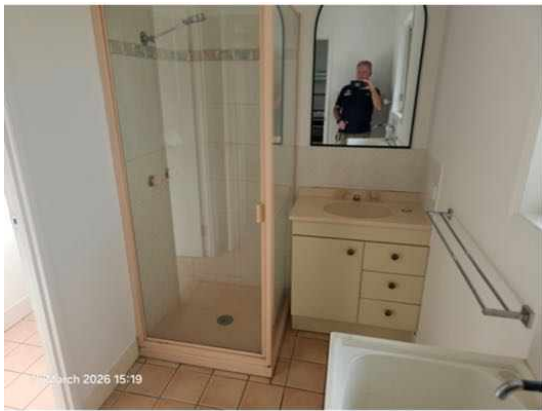
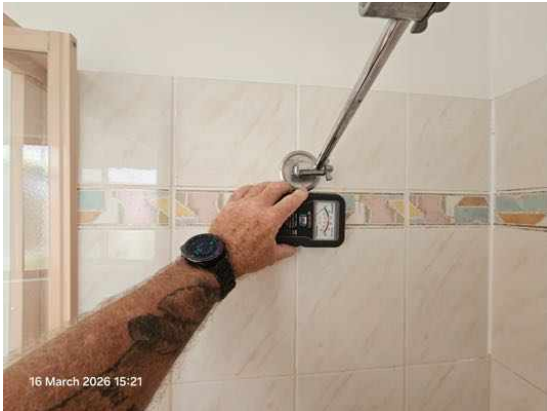
Building: Main Building  
Location: Bathroom  
Finding: No moisture detected in bathroom  
Information: On the day of inspection the shower in the bathroom was measured for moisture using a "Tramex" moisture meter. During this inspection no moisture was detected in this area and the tiled / sheeted surfaces appear to be in reasonably good order. Some silicone is missing and will require replacement.

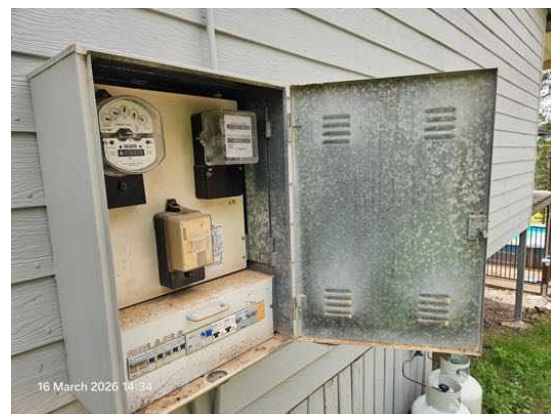
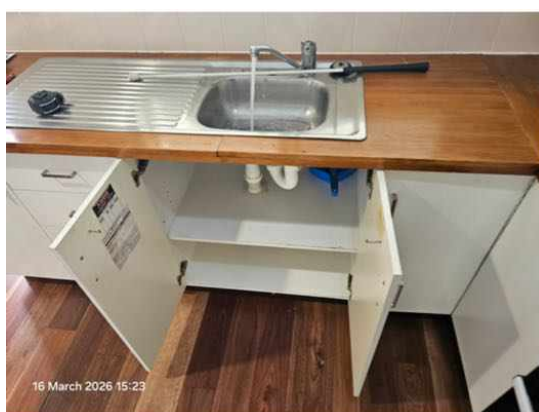
Building: Main Building  
 Location: Meter box, kitchen cupboard  
 Finding: Durable pest inspection notice - not assessable  
 Information: On the day of inspection it was noted that the durable timber pest inspection / treatment notice was missing, not visible or out of date. These notices / stickers are to

It is recommend that a licensed timber pest controller be contacted to assess the properties needs and provide costings for an annual inspection programme.

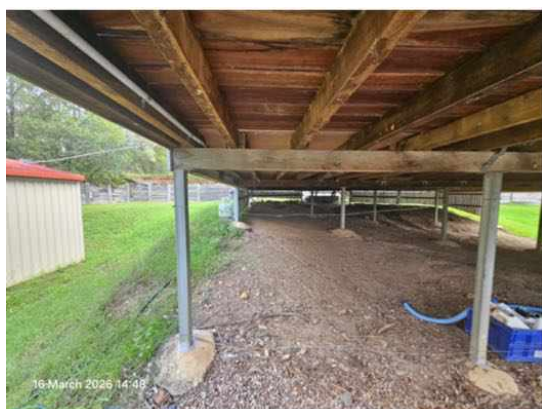
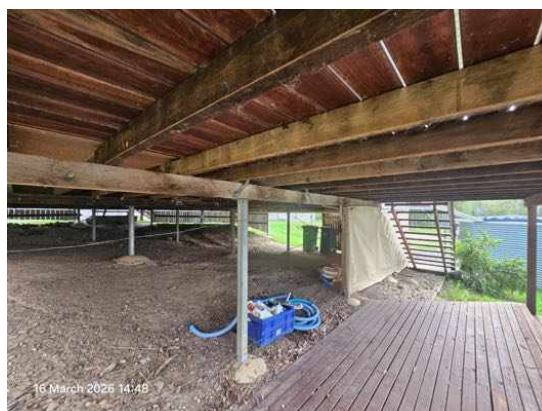
The building employs a visual inspection zone to the subfloor as a barrier system.

In order for a barrier system to be effective, the property must have regular inspections at intervals of not greater than 12 months. Depending on the risk profile attributed to the property, these inspections may be recommended at lesser time periods.
