Building and Timber Pest Inspection Report

Inspection Date: Tue, 18 Nov 2025

Property Address: 193 Birrell St, Waverley NSW 2024,
Australia

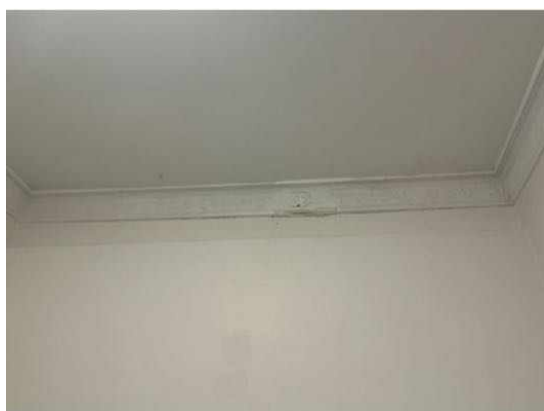
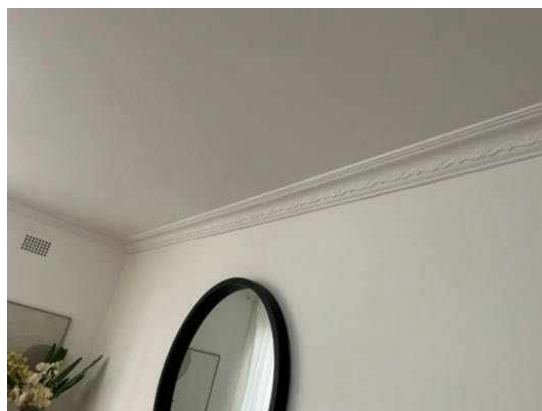
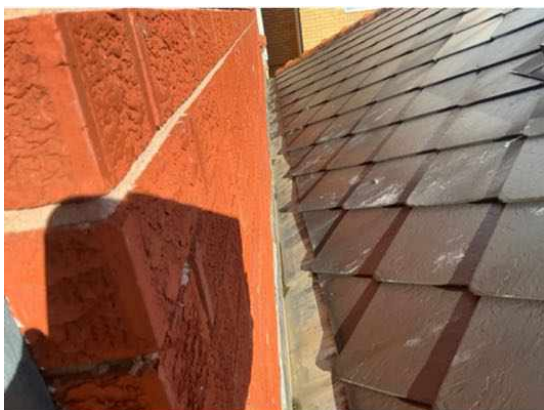
Building: Main Building
Location: Laundry
Finding: Evidence of Leak from Roof / Box Gutter Above
Information: Evidence of moisture ingress was observed internally, which appears to be associated with the roof area directly above. The location of the staining suggests the leak may be coming from the box gutter or associated flashings in this area. Moisture penetration through the external masonry wall may also be contributing, with dampness tracking down and affecting the laundry area below.

Defects to box gutters, flashings, or masonry can allow water to enter the structure and travel internally before becoming visible.

It is recommended that a licensed roof plumber and/or builder be consulted to inspect the box gutter, flashings, and adjoining wall to determine the exact source of the leak and carry out the necessary repairs.

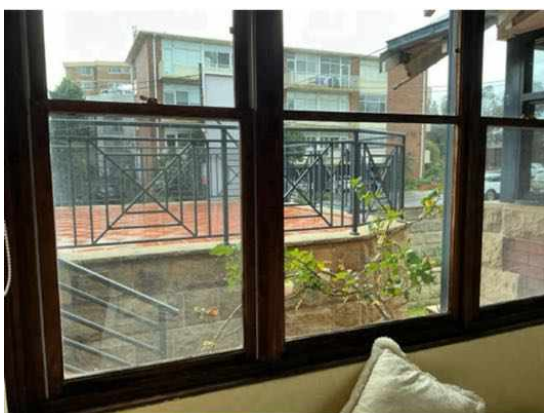
Finding 3.02

Building:	Main Building
Location:	Bedroom
Finding:	Windows - Sash balances broken
Information:	Sashes are the moveable panes of windows that primarily slide vertically over each other to expose one half of the window area. Each sash is provided with springs balances and/or compression weather-stripping, which act to hold the window in place in one position. The sash balance mechanism will need replacement to allow the window to function as intended. Such works may be completed by a qualified carpenter or registered builder.

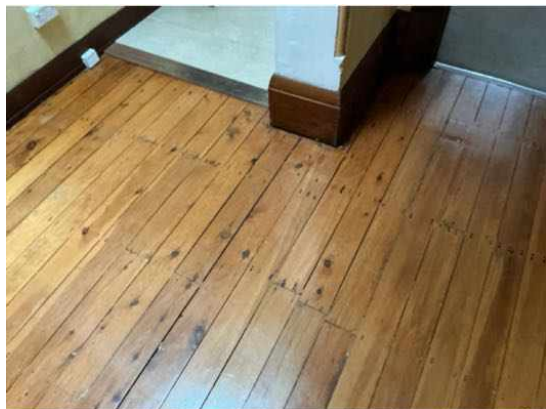
Finding 3.03

Building:	Main Building
Location:	Hallway
Finding:	Flooring Bouncy
Information:	The flooring in this area was identified as being bouncy at the time of inspection. Bouncy flooring generally presents as a discernible change in level as they are walked across.

Bouncy flooring generally indicate that the boards or the subfloor structures are coming loose from the joists that they are installed on. Bouncy flooring may also be the

result of deterioration of the subfloor timbers or piers.

The potential resolution may range from packing gaps in structures through to replacement of subfloors piers, repair of damaged or deteriorated timbers and refixing of boards. A carpenter or builder can be appointed as soon as possible to carry out repairs as required.

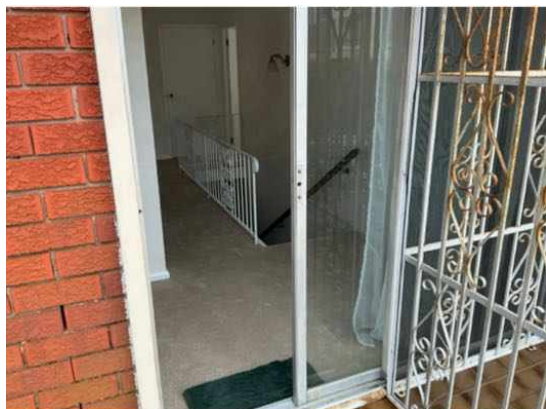
Finding 3.04

Building:	Main Building
Location:	Rear Elevation
Finding:	Door - Stiff to slide
Information:	The door in this area was jammed and difficult to slide along the associated tracks at the time of the inspection. Restricted function of the affected door may pose as a potential safety hazard if required for emergency egress from the building.

Generally, factors such as general age of the building element and a lack of maintenance are the usual causes for this type of defect.

Replacement of door hardware or tracks may be required, as well as minor repairs and cleaning. A registered builder or general handy person will be required to repair the affected doors.

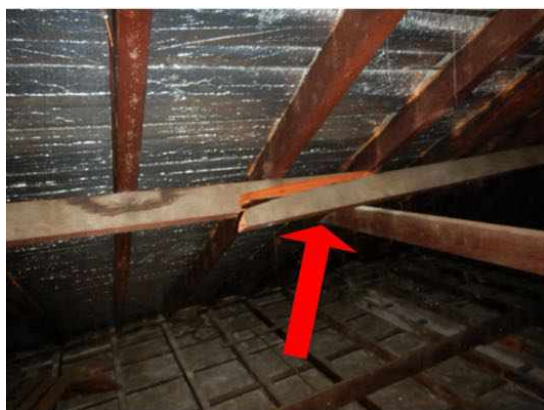
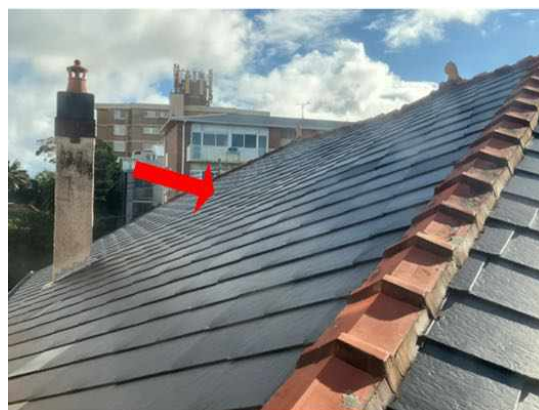
Finding 3.05

Building:	Main Building
Location:	Roof Void
Finding:	Damaged roofing timber
Information:	The roofing structure was found to have a broken supporting timber in the roof void. This damage is likely due to a defective or substandard timber being used.

Damaged roof structures are likely to create strain on associated building elements, creating potential for secondary damage including the deterioration of roof coverings. It is advised that a carpenter or builder be appointed as soon as possible to carry out repairs.

While it would appear that this defect has been present for a long period of time repair is recommended in the short term to ensure the longevity and structural integrity of the dwelling.

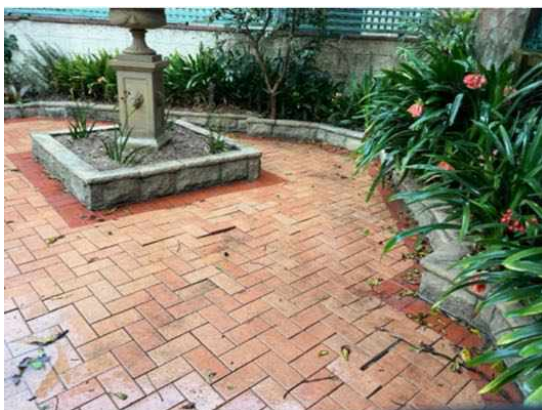
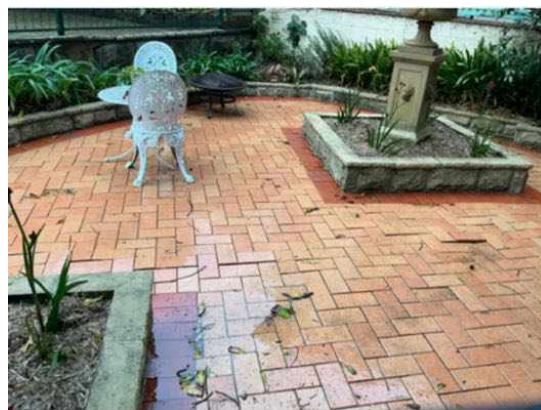
Finding 3.06

Building:	Main Building
Location:	Yard - Back
Finding:	Paving uneven
Information:	Sections of the external paved area are uneven and brick steps throughout the exterior of the property are damaged. This defect may have several causes including substandard compacting the base of the paving before the pavers were laid, excess stormwater flows or unmanaged stormwater drainage around the property or tree roots growing below the affected areas. Trip hazards and continued deterioration may occur if the paving continues to move. Paving of the area is required to repair affected areas. Further consultation with a paver or landscaper is recommended and repairs can be carried out at the client's discretion.

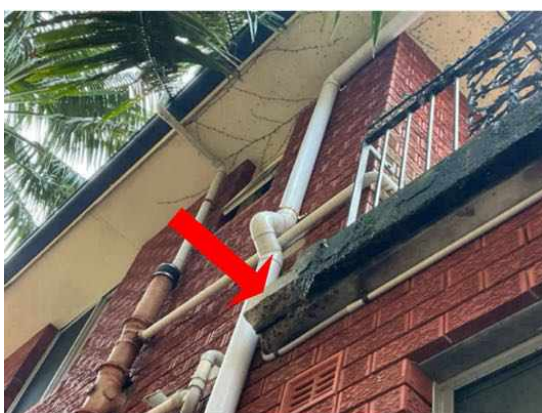
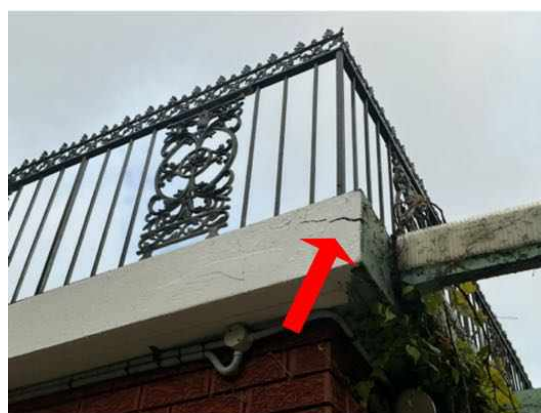
Finding 3.07

Building:	Main Building
Location:	Exterior walls - right side
Finding:	Concrete - Spalling
Information:	This area appears to be affected by spalling concrete. Concrete spalling is the common term used to describe a number of factors which cause concrete construction to deteriorate. Generally, water penetration causes the concrete reinforcement to rust and expand, creating stresses on the surrounding concrete and in turn causing it to spall (or break away). Alternatively, if the cement component is too alkaline, reactions with the general atmosphere occurs and star-shaped cracks appear which allow rainwater to penetrate.

Repair works will generally involve works, including removal of affected concrete and the treatment or replacement of any exposed steel. Some injection of resins or special mortars may also be possible, however this depends on the size and extent of consequent damage. Left unmanaged, the problem is likely to worsen over time, potentially leading to the development of major structural defects.

A structural engineer should be appointed to further inspect the area and determine the severity of the damage and what repairs are required.

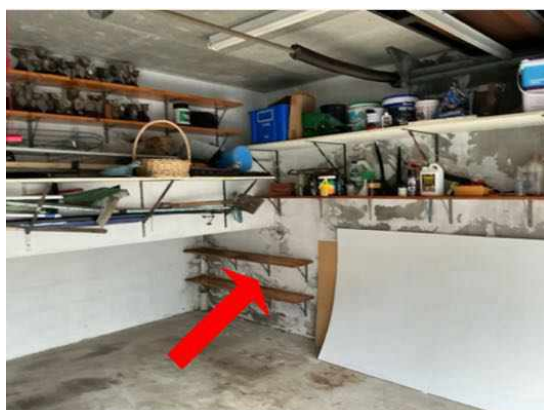
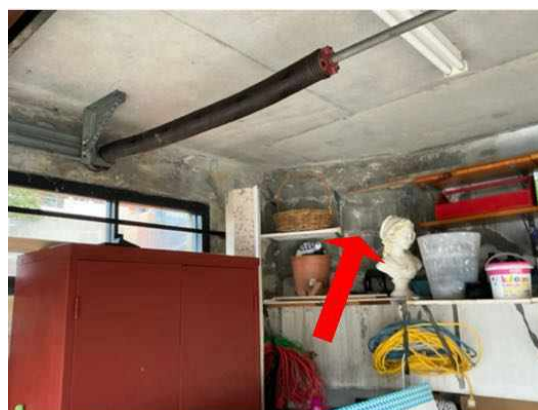
Finding 3.08

Building:	Main Building
Location:	Garage
Finding:	Damp Penetration Brick (Garage)
Information:	Rain penetration (also known as penetrating damp) is a common form of dampness that can occur through walls.

Common cause of this issue is the original construction of the building is full brick construction. With no cavity between the exterior brick wall and the interior brick wall, moisture can penetrate through to the interior wall. Damaged roof plumbing can also attribute to excess moisture in the full brick walls.

Although not generally considered a defect as the garage is not a habitable room, measure can be taken at the clients discretion to prevent moisture penetration to the interior wall.

Consultation with a damp specialist can be carried to advise on methods to prevent moisture getting to internal areas.

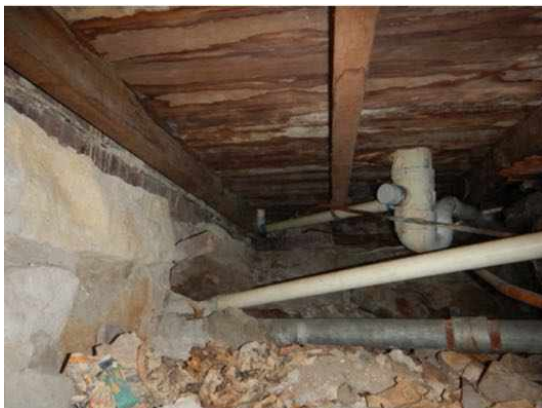
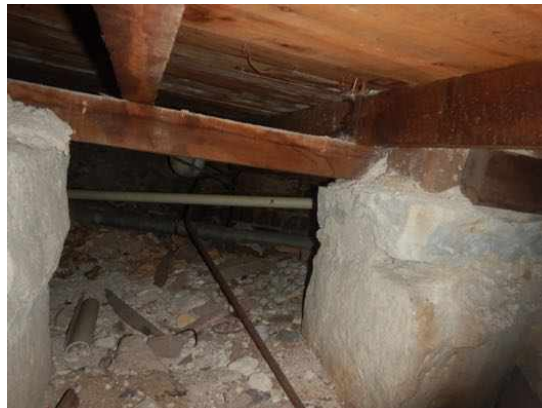
Finding 3.09

Building:	Main Building
Location:	Subfloor
Finding:	Subfloor - Debris
Information:	An array of debris was found in the subfloor area at the time of inspection. Debris in this area creates potential for concealed pest entry. Stored timbers and other materials may also make the area susceptible to termite activity and wood rot.

A clear and empty subfloor will be better ventilated and easier to maintain in a dry condition. The removal of any timber debris is vital in minimising the risk of termite or wood borer activity.

Debris in the subfloor should be removed as soon as possible. Depending on the location and amount of debris and stored items, the homeowner may elect to undertake this task. Alternatively there are a large number of rubbish removal subcontractors that could undertake these works.

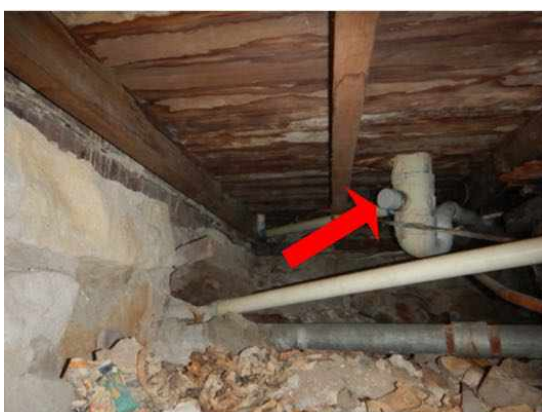
Finding 3.10

Finding: Pipework - Leaking

Information: Evidence of a leak was showing in the pipe work at the time of inspection. Leaks can have a number of causes, including deterioration of plumbing fixtures and fittings, or substandard original installation or blockage or damage to pipework.

Where water leaks are active, moisture is likely to cause water damage to associated structures and building elements in this area, which can have a range of implications.

A plumber should be appointed as soon as possible to primarily identify the cause of the leak, and to provide subsequent repair works if necessary.

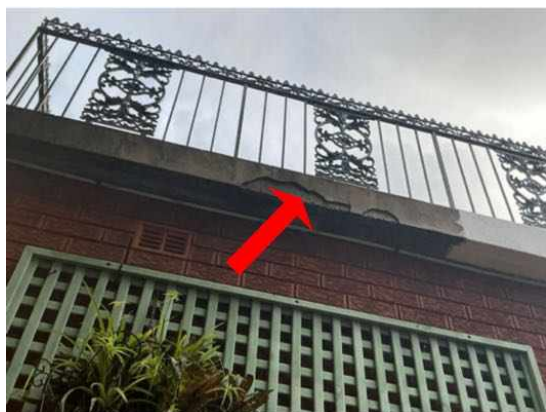
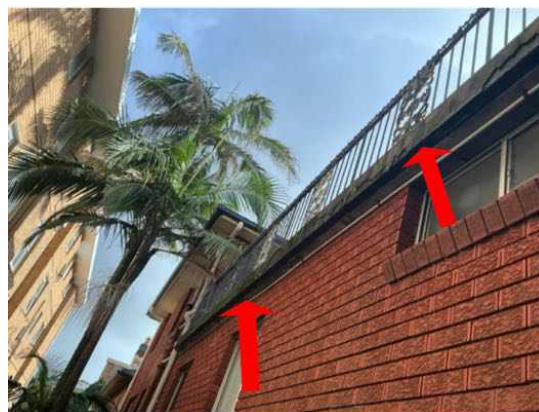
Finding 3.11

Such defects are generally caused by physical damage to the area. Drummy render may also be a direct result of poor workmanship during the construction process.

Render may swell and shrink with changes in air humidity if the area has sustained moisture damage. Any exposure to moisture is capable of causing rendered areas to become drummy and/or cracked over a prolonged period of time. Drummy render generally requires chipping off and re-rendering or painting.

A cement renderer can be appointed to carry out repairs on affected areas.

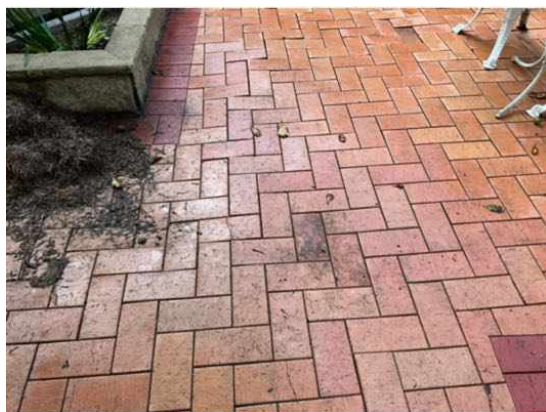
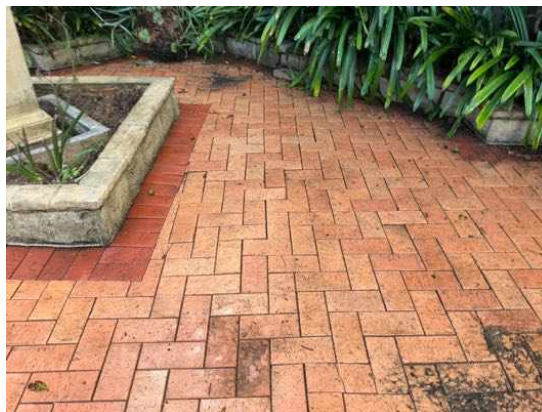
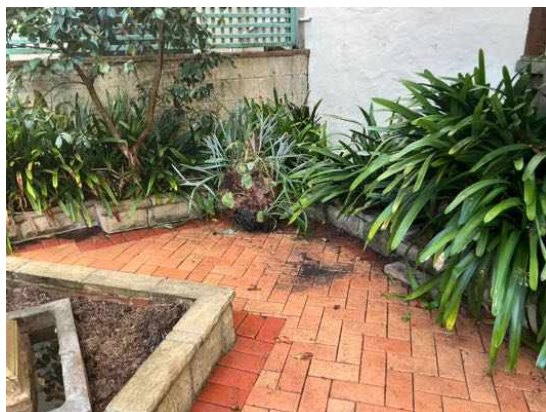
Finding 3.12

Building:	Main Building
Location:	Yard - Back
Finding:	Uneven Pavers in External Areas
Information:	Uneven pavers were noted in various external areas around the property. This condition is commonly caused by insufficient compaction of the sub-base during installation, tree root growth beneath the surface, or unmanaged stormwater flows that lead to subsurface movement.

While the unevenness does not currently present a significant trip hazard, it may worsen over time, affecting both safety and drainage.

Rectification can be carried out by a qualified landscaper or paving specialist and may involve re-levelling the pavers, addressing any underlying root issues, and/or improving stormwater management to prevent further movement.

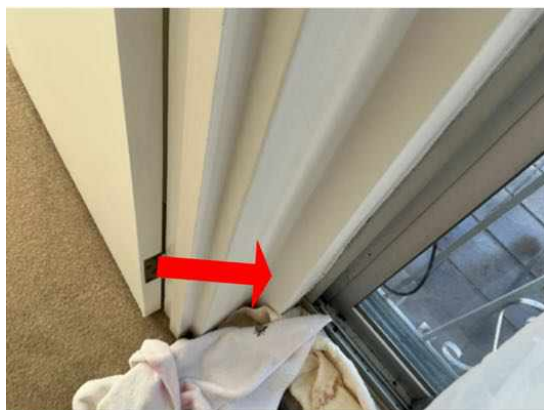
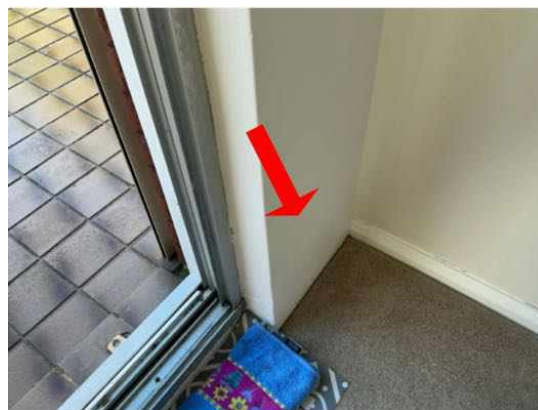
Finding 3.13

Building:	Main Building
Location:	Rear Elevation
Finding:	Damp - Moisture penetration walls
Information:	Damp penetration is a common form of dampness that can occur through walls, roofs or openings.

Common causes include faulty or missing flashing or bridging of cavities. Moisture penetration can also occur when water tracks over cavities or by tracking across wall ties.

The cause of the damp can be further inspected by a plumber or damp specialist to determine the cause of the damp and advise if repairs are required.

Trades responsible for such repairs may include builders or damp specialists.

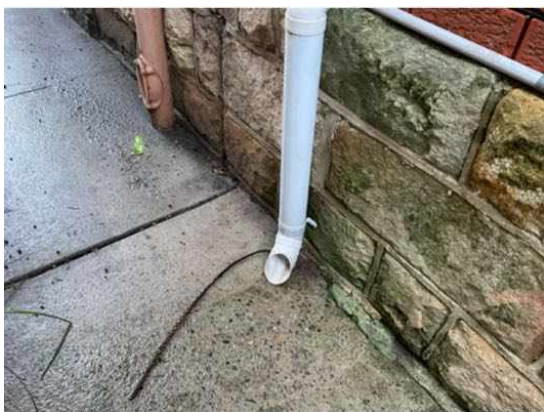
Where roof plumbing doesn't drain adequately, the area at the base perimeter can become excessively damp, potentially creating an environment that is susceptible to rust and corrosion of surrounding building elements, as well as attracting termites and other pests.

It is highly recommended that a plumber be appointed to further inspect the area and to install adequate drainage equipment where necessary.

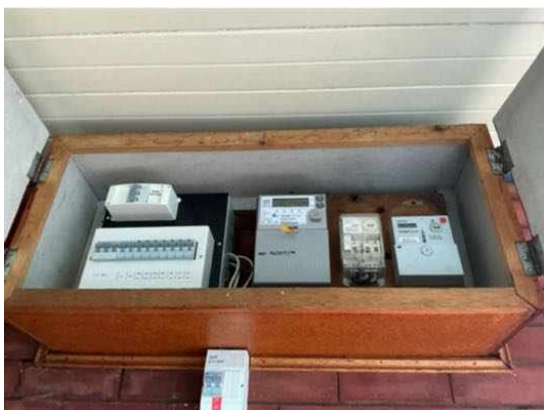
Finding 6.02

Building:	Main Building
Location:	Electrical circuit box
Finding:	Termite Management System No Evidence of Installation
Information:	The application of a post-construction termite barrier is highly recommended for all properties. Such barriers are highly effective in preventing termite attack on any timber building elements throughout the property.

A durable notice should be placed in the switchboard unit to indicate current termite barriers. At the time of inspection, it appeared as though no termite management system has been installed, with no evidence to suggest preventative works taking place.

The client may consider gaining further advice from a pest controller as to the costs and procedures involved with this application. It is recommended that obtaining such advice be a short-term priority.

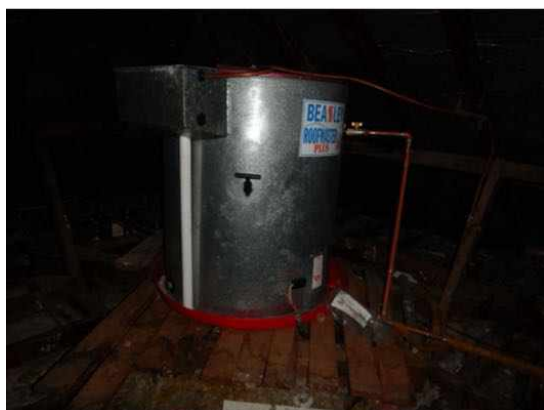
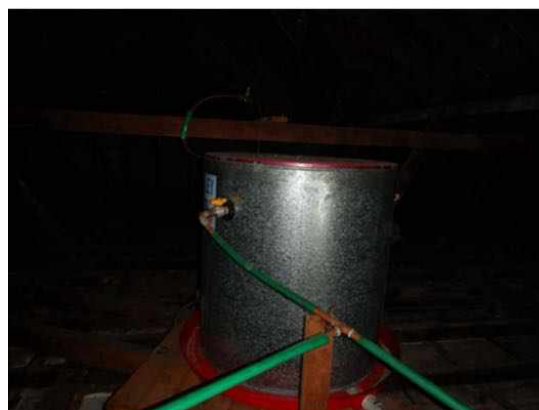
A gravity-fed HWS is also likely to reduce water efficiency, as it is not compatible with water-saving shower heads and other tapware. Failure to replace the system is therefore likely to result in poor water efficiency throughout the household.

While it is a costly exercise, replacement of the gravity-fed HWS is advisable in the short to medium term. Further consultation with a licensed plumber is advised to gain further advice on replacement options.

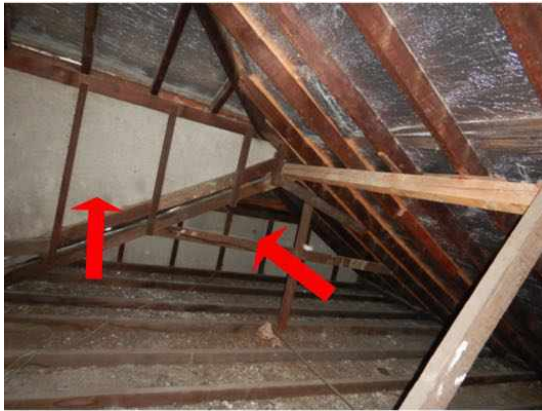
Noted Item

Building:	Main Building
Location:	Roof Void
Finding:	Asbestos Containing Material Suspected
Information:	Reporting on Asbestos is outside the Scope of this Report. This suspected defect is highlighted as a caution only. We suspect, based on our experience in the building industry, that there is a higher risk of the identified building element and other possible areas of the house containing asbestos.

As Asbestos Reporting is outside the scope of this report, we advise that you consider a separate Asbestos Inspection and Condition Audit, which can include the taking of samples for definitive confirmation of the presence of Asbestos.

In the interim, the client is advised to act with caution, especially when considering any damage to building materials general wear and tear renovations extensions demolition and general maintenance activities due to the suspected presence of Asbestos.
