Building and Timber Pest Inspection Report

Inspection Date: Wed, 1 Apr 2026

Property Address: 114 Armoury Road, Jordan Springs NSW
2747

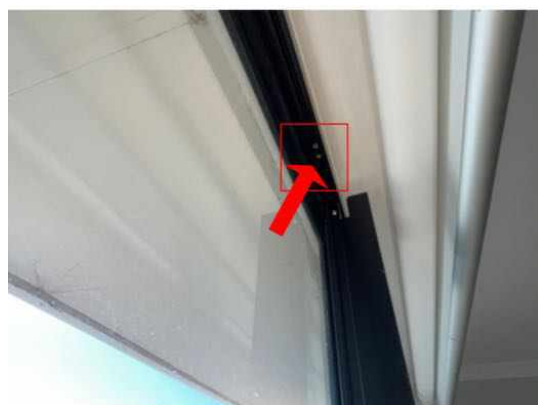
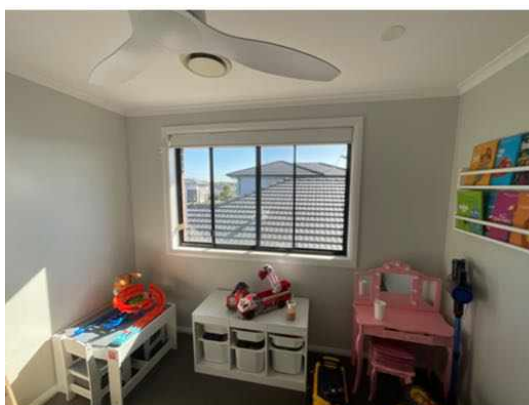
Building:	Main Building
Location:	Bedroom > Upstairs
Finding:	Caution: Missing Window Restriction Devices.
Information:	Please note that this is highlighted as a caution only.

It has been noted that window restriction devices have been removed on some windows.

It is strongly recommended that window restrictors be installed to mitigate this safety hazard. A qualified window specialist should be appointed to fit the appropriate safety devices as soon as possible to comply with safety standards and ensure the protection of occupants.

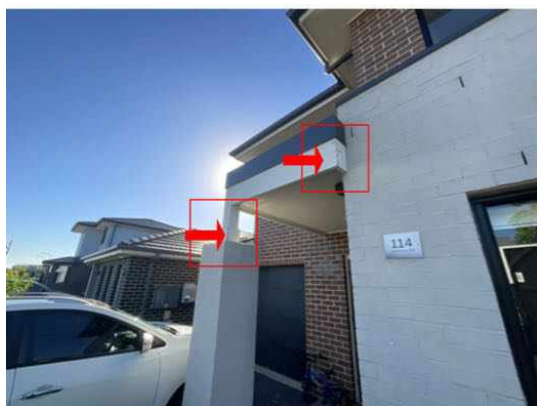
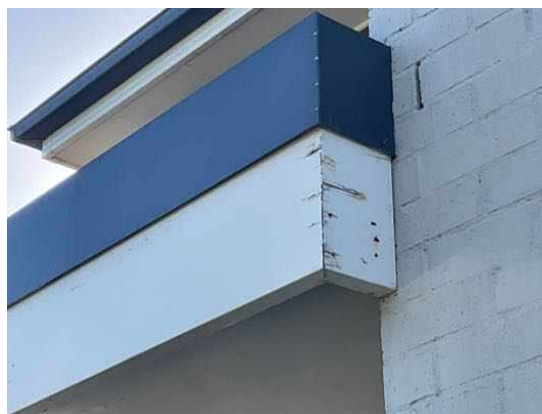
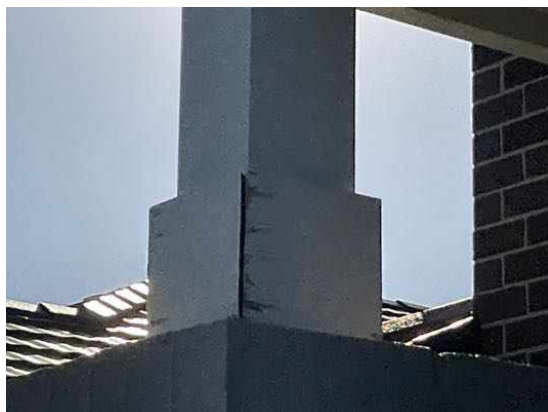
- External timber components of the building, which are frequently exposed to harsh weather conditions, show signs of wear and lack adequate protective treatment.
- In areas where timbers have not been properly painted or sealed, deterioration is likely to progress at an accelerated rate due to constant exposure to moisture, UV radiation, and temperature changes.
- Without timely intervention, the condition of these timbers may continue to degrade, potentially requiring replacement in the short-term future.

- Where timber elements have already deteriorated beyond restoration, repairs or replacement will be necessary.
- A qualified carpenter should be appointed to assess and carry out any required structural or cosmetic timber repairs.

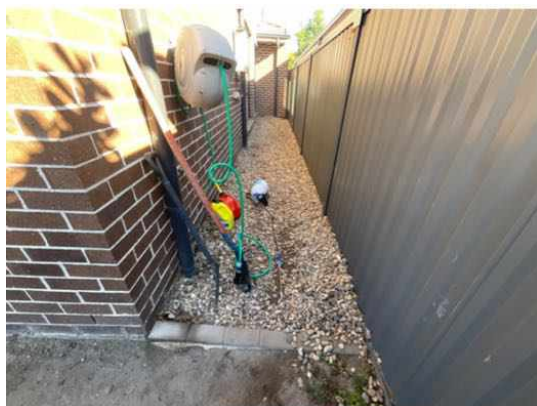
Finding 3.02

Building: Main Building
 Location: Exterior - left side
 Finding: Site/Yard Drainage – Below Average.
 Information: Defect – Below Average Site Drainage

Site drainage in the inspected areas appears to be below average, with no surface drains observed at the time of inspection. Ground surfaces and paved areas adjacent to the building do not appear to be adequately graded to facilitate effective surface water runoff.

Failure to meet these minimum drainage falls increases the risk of water ingress, foundation issues, and secondary building defects.

- A licensed plumber and/or landscaping contractor should be engaged to:
 - Evaluate the current site grading and surface runoff conditions
 - Install or upgrade surface water drainage (e.g. strip drains, spoon drains, grated channels) as required
 - Improve grading around the building to ensure water flows away from the structure

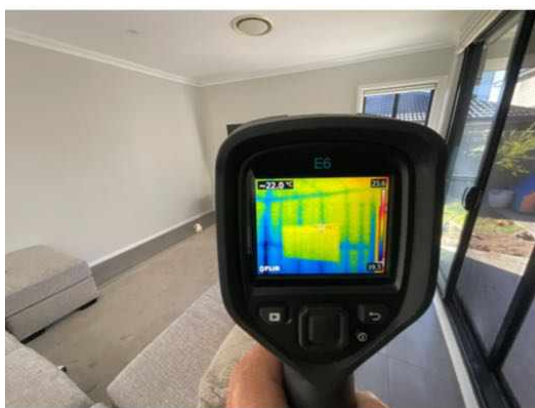
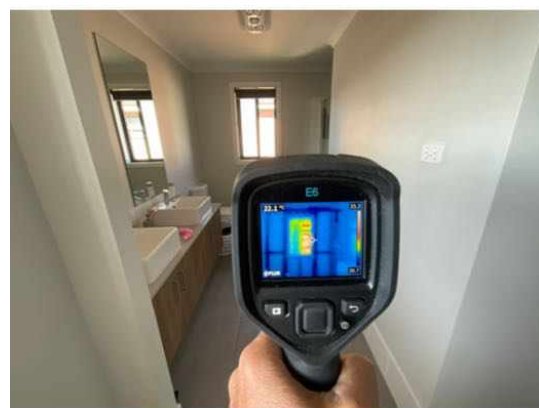
Termites release heat in the form of carbon dioxide and build mud tubes with high moisture content, which can create irregular heat patterns on surfaces such as walls, ceilings, and floors.

At the time of the inspection, no abnormalities indicating live termite activity were observed. However, it's important to note that various factors—such as obstructions, ambient temperature, and wall material/thickness—can impact the accuracy of thermal readings. In cases where surfaces are visually restricted or obstructed, a comprehensive thermal scan may not always be feasible.

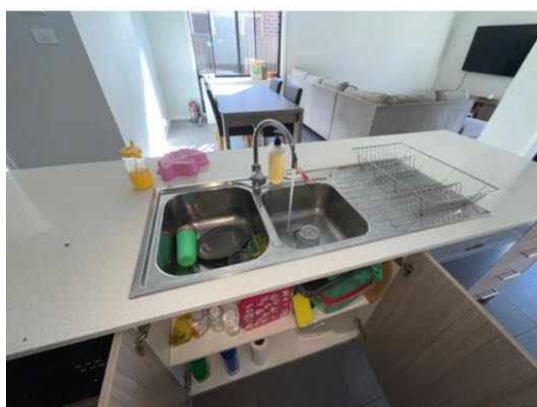
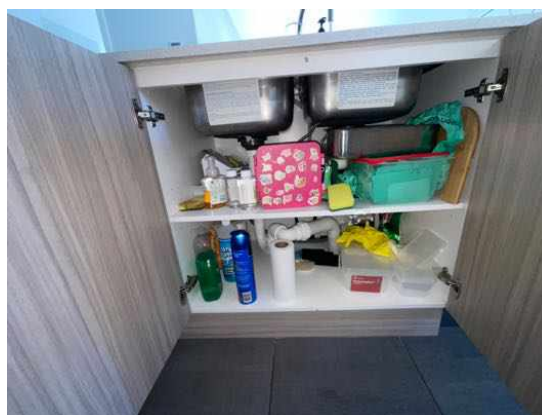
Building: Main Building
 Location: Kitchen
 Finding: Kitchen Sink – Overall Condition & Recommendations.
 Information: Observations:

- Further monitoring and testing are recommended once the tap(s) are in constant use, to identify any drainage issues or signs of slow leaks not evident during the limited inspection.
- It is recommended that the stored items beneath the sink be removed to allow for a full re-inspection of the plumbing and cabinetry, ensuring no concealed defects are present.

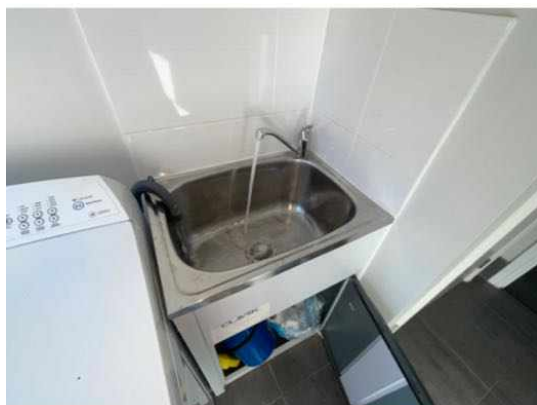
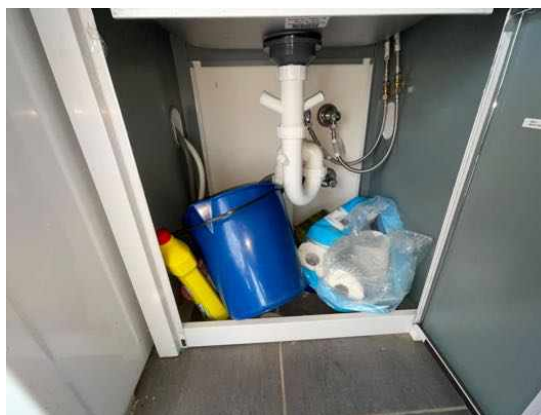
Building: Main Building
 Location: Laundry
 Finding: Laundry - Taps/Plumbing/Drainage.
 Information: Observation: Laundry Tub – Taps, Plumbing, and Cabinetry

- Further monitoring or testing is recommended once the taps are placed into regular use, to ensure no leaks develop over time and that the drainage system continues to perform adequately.
- Regular maintenance and prompt replacement of missing or deteriorated sealant is

highly recommended, as this is a common wear-and-tear issue.
