Building and Timber Pest Inspection Report

Inspection Date: Thu, 9 Apr 2026

Property Address: 1-41 Paxton st Malvern east

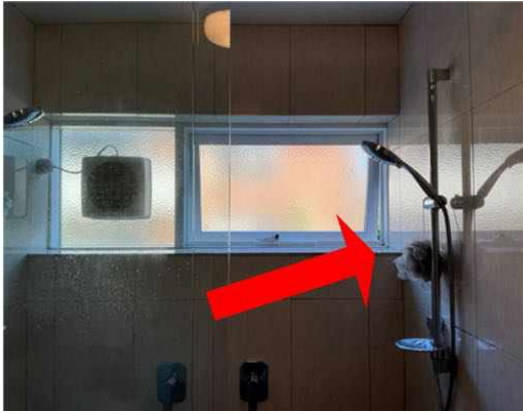
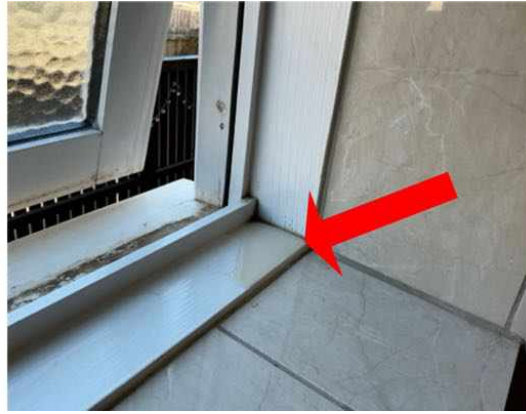
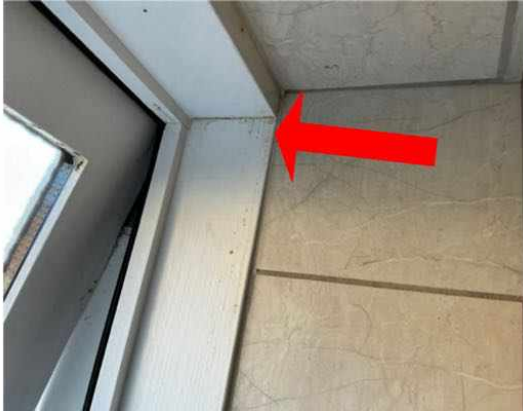
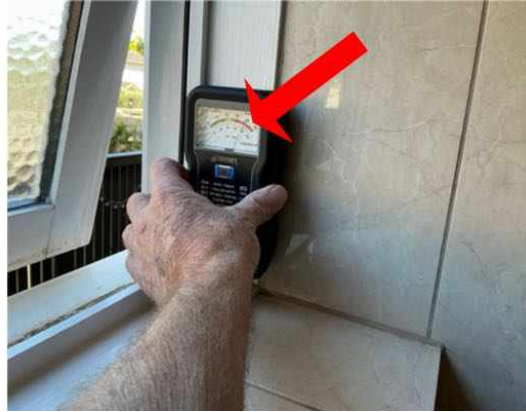
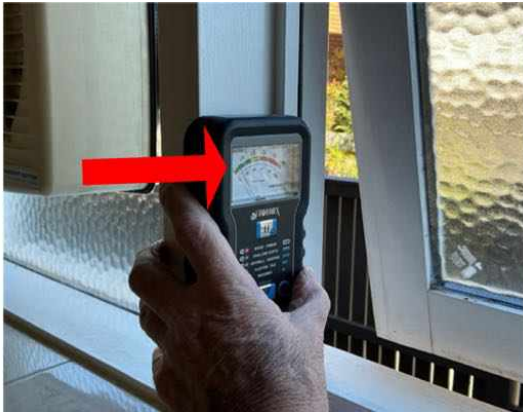
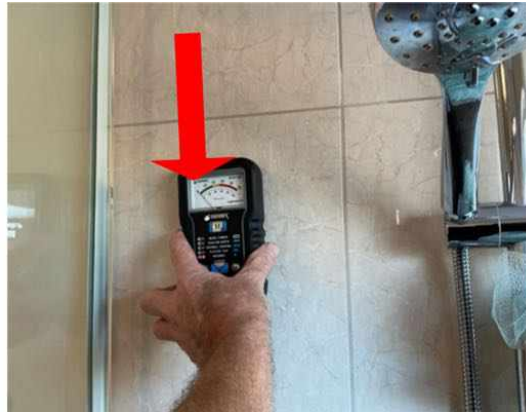
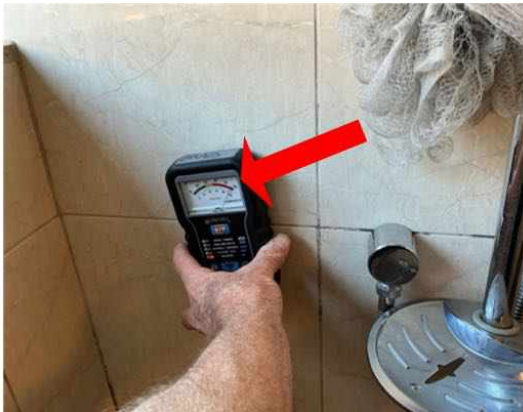
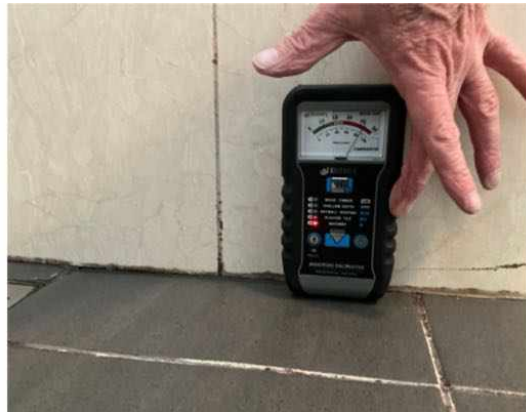
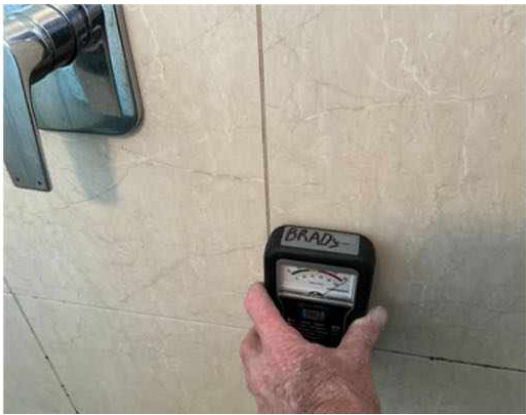
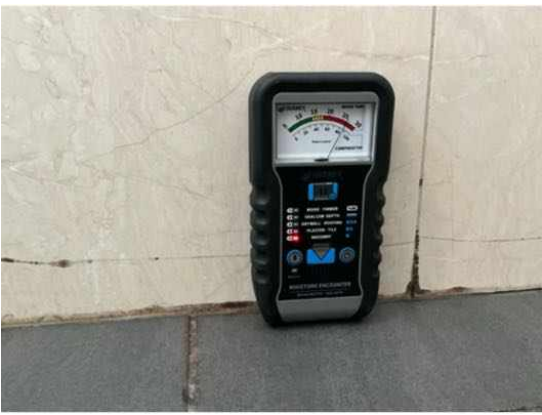
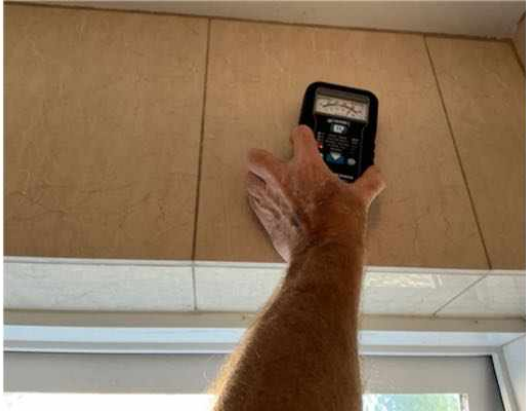
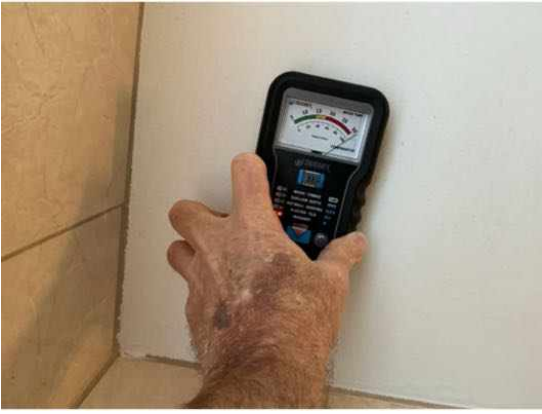
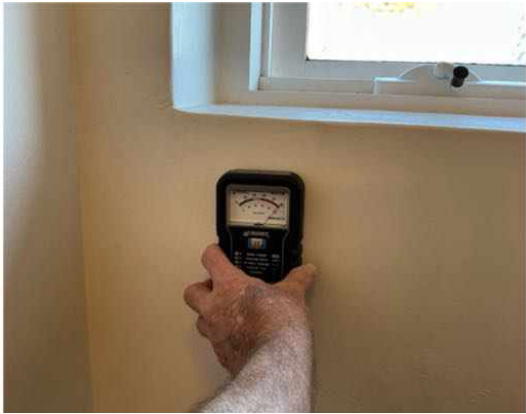
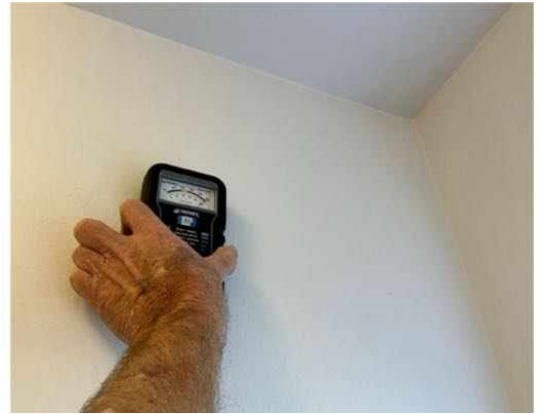
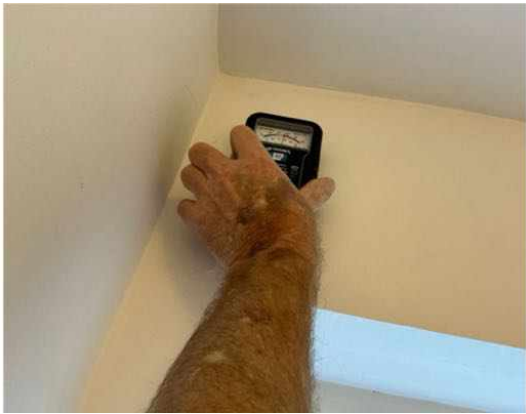
Building:	Main Building
Location:	Bathroom
Finding:	Suspected shower leak detected - elevated moisture readings identified
Information:	During a non-invasive inspection of the shower area, I noticed water pooling on the window sill with moisture stains running down the window, excessive moisture readings were recorded, to various parts of the bathroom walls and ceilings using a moisture meter. In addition, further testing of the toilet walls and ceiling also indicated elevated moisture levels. These findings suggest the presence of abnormal moisture accumulation, consistent with a potential water leak within the wall or ceiling cavities.

This condition is assessed as a major structural defect until rectified.

As the defect is concealed and ongoing in nature, the full extent of damage cannot be determined without invasive investigation. However, moisture affecting multiple building areas across different levels of the dwelling substantially increase the likelihood of structural involvement.

The presence of persistent moisture within wall structures can lead to concealed water, damage, deterioration of internal building materials, and potential mould growth, which may compromise indoor air quality and structural integrity over time. Left unaddressed, such leaks can result in costly repairs and pose health and safety concerns for occupants.

During a non-invasive inspection of the shower area, I noticed water pooling on the window sill with moisture stains running down the window, excessive moisture readings were recorded, to various parts of the bathroom walls and ceilings using a moisture meter. In addition, further testing of the toilet walls and ceiling also indicated elevated moisture levels. These findings suggest the presence of abnormal moisture accumulation, consistent with a potential water leak within the wall or ceiling cavities.

It is strongly recommended that a licensed plumber be engaged as a matter of urgency to undertake a comprehensive invasive inspection. The purpose of this inspection is to determine the exact source of the water ingress, carry out any necessary repairs, and insure appropriate waterproofing measures are reinstated to prevent future recurrence. Prompt action will help mitigate further damage and preserve the condition of the property.

It is strongly recommended that a licensed plumber be engaged as a matter of urgency to undertake a comprehensive invasive inspection. The purpose of this inspection is to determine the exact source of the water ingress, carry out any necessary repairs, and insure appropriate waterproofing measures are reinstated to prevent future recurrence. Prompt action will help mitigate further damage and preserve

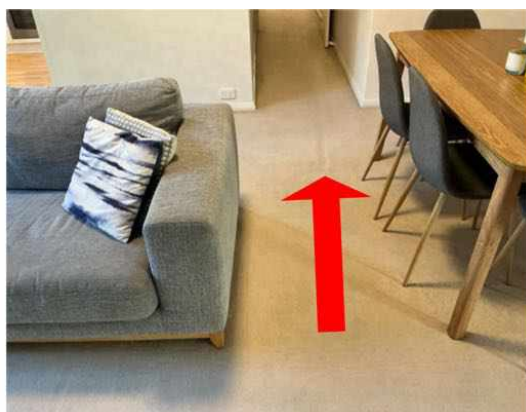
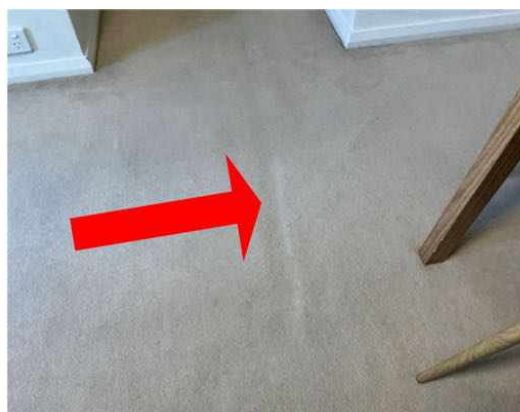
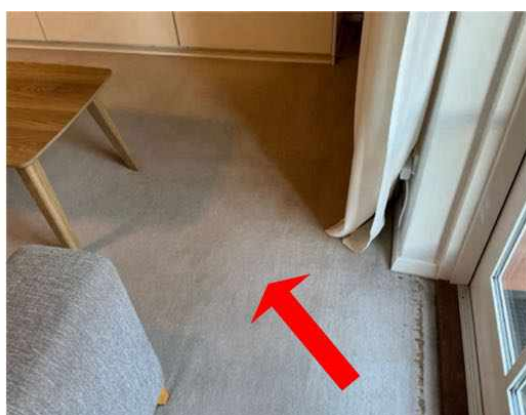
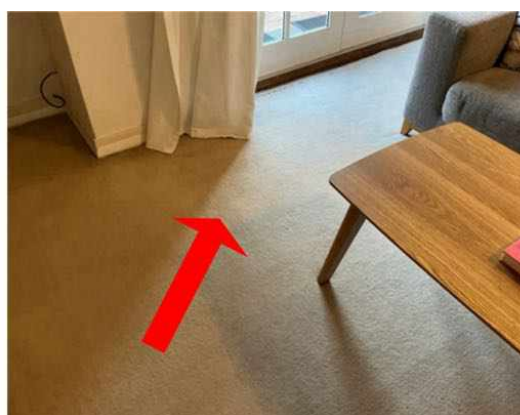
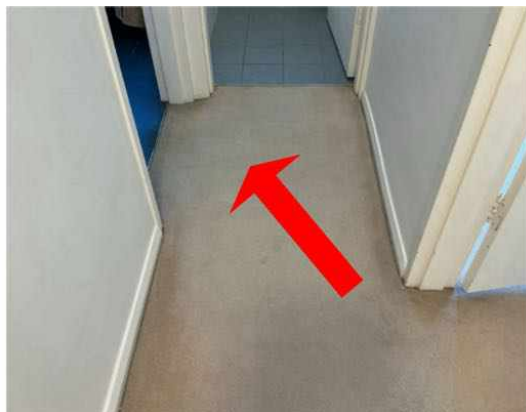
Finding 2.02

Building: Main Building
Location: Living Room and the front of the bathroom/toilet area
Finding: Suspected slab crack/deflection
Information: During a visual inspection of the apartment unit, multiple indicators of potential structural failure were observed in the flooring system. These defects are consistent with possible deterioration or failure of the concrete slab or supporting structural elements.

If left unaddressed these defects may result in progressive slab failure, increased risk of trip hazards and occupant injury, compromise structural integrity of the unit and potentially adjoining units and reduce the property value.

The defects identified are consistent with a major structural issue affecting the slab system. Given the buildings age and the nature of the symptoms observed, urgent professional assessment is required by a structural engineer to determine the extent of the damage and appropriate remediation measures.

During a visual inspection of the apartment unit, multiple indicators of potential structural failure were observed in the flooring system. These defects are consistent with possible deterioration or failure of the concrete slab or supporting structural elements.

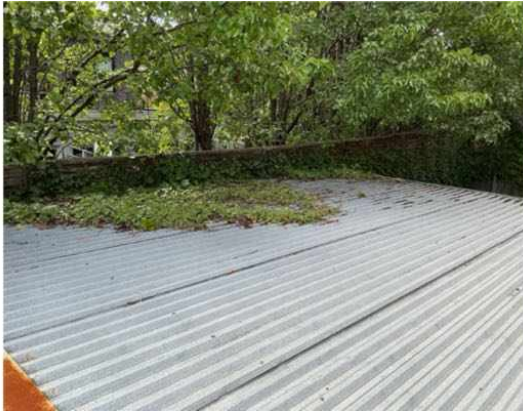
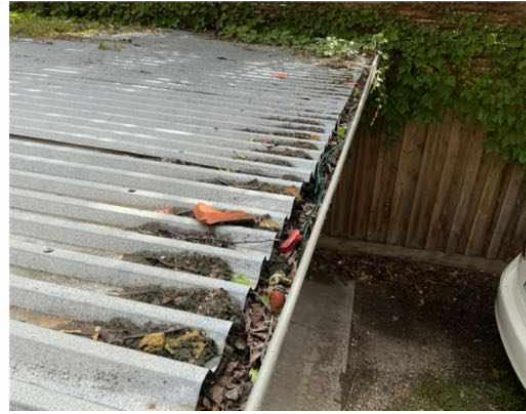
Finding 3.01

Blocked gutters are likely to lead to high levels of moisture in the affected areas. Such moisture will not only cause rust and decay of the associated building materials, but can also provide conditions that are conducive to termite and timber pest activity. Blockages in gutters should therefore be removed immediately to ensure dry conditions are maintained.

Consult a Licensed Plumber for further specific advice on remedial works that may be required. In the interim, it is highly advised that blocked gutters be removed by the homeowner or a general handyperson as a matter of urgency.

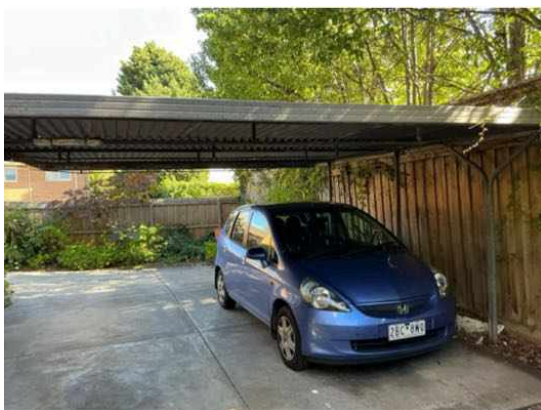
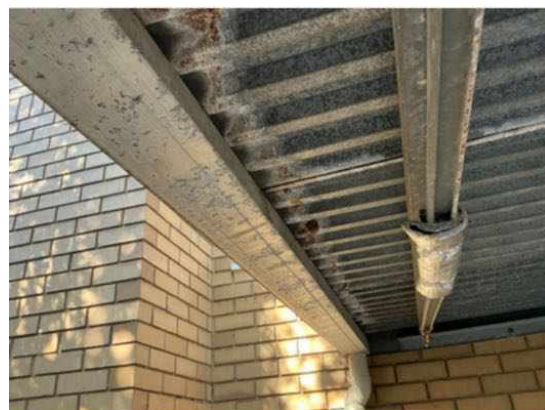
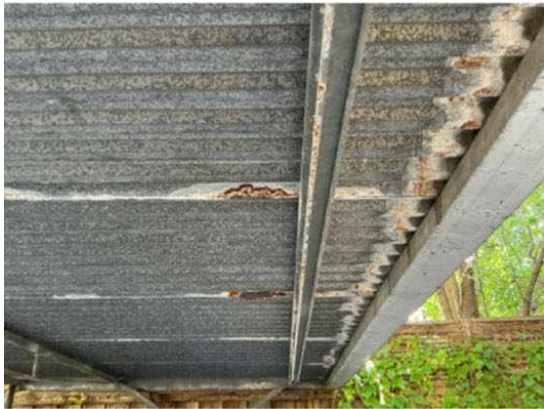
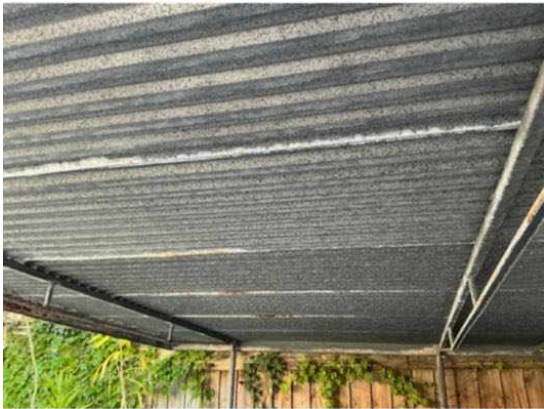
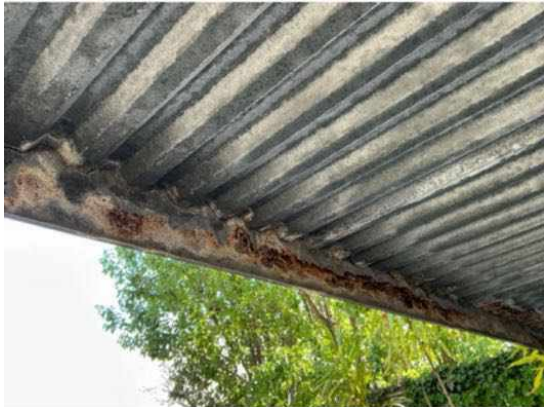
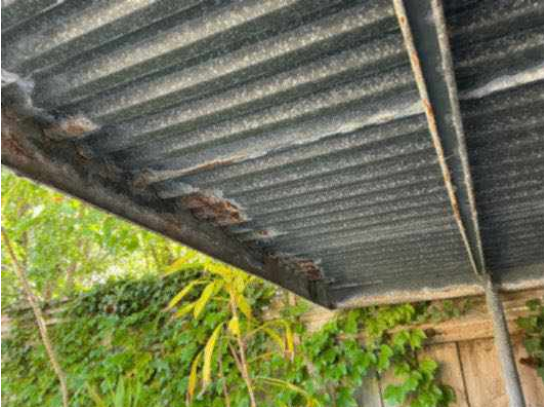
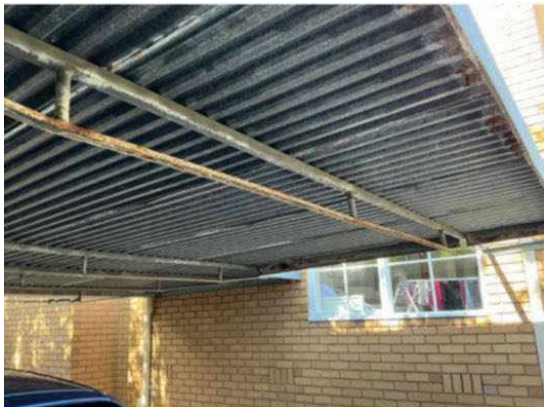
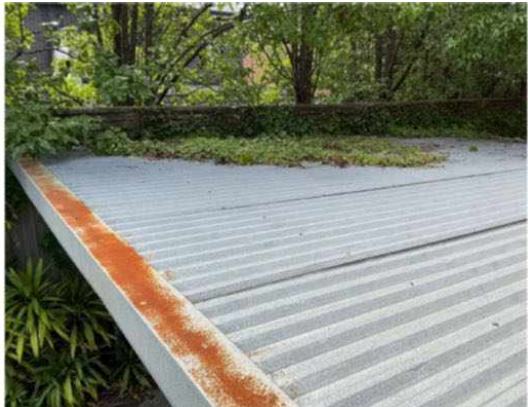
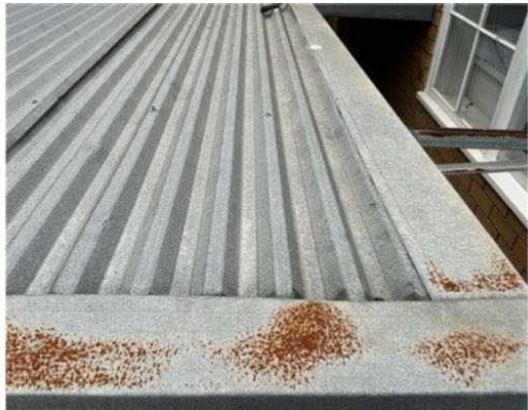
Finding 3.02

Building:	Main Building
Location:	Carport
Finding:	Roof and framing rusted
Information:	On inspection it was noticed that parts of the carport roof and framing is rusted due to deterioration overtime. Recommend engaging a plumber to repair/replace to reduce the risk of rust worsening and spreading as soon as possible.

As surface rust provides no protection to the underlying iron, the deteriorating condition is likely to worsen if not addressed in the short-term future.

Where possible, the use of galvanized (treated) metals or aluminium coated metals aid in rust prevention, as does regular general maintenance. Rust formation can be controlled with coatings, such as paint, that isolate the iron from the environment.

Rusting and corrosion should be managed by ideally removing or limiting the affected surface from exposure to moisture.

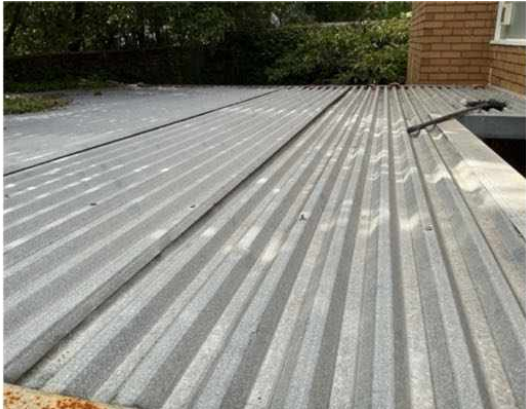
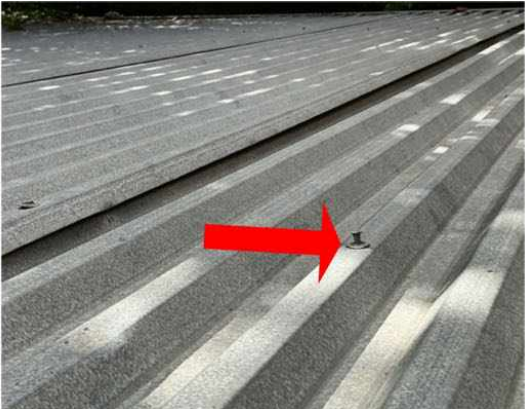
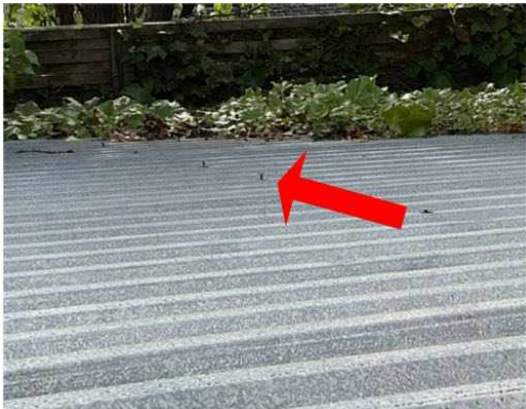
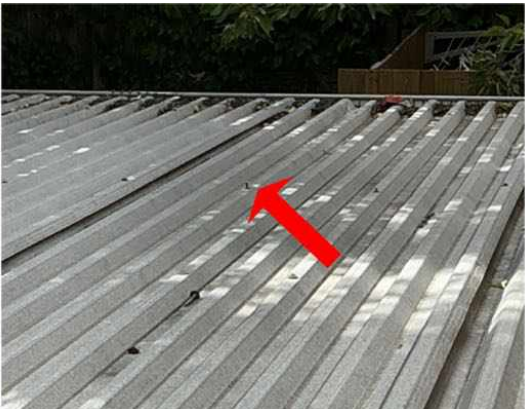
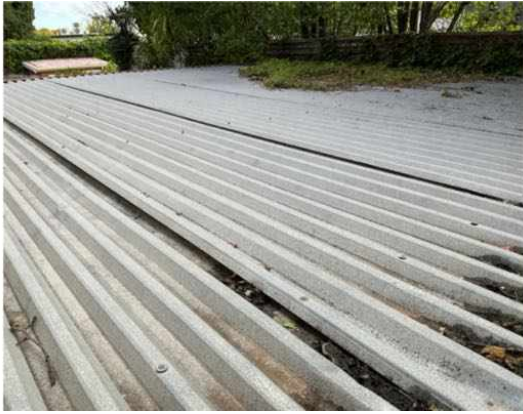
Finding 3.03

Building: Main Building
Location: Carport
Finding: Roof - Loose fixings
Information: Upon inspection of the carport roof covering, it was noted that some fixings are coming loose. It is suspected that this defect has developed as a result of a lack of adequate maintenance, but may also have been caused by inappropriate fixings being used in the construction process.

Loose roof fixings detracts from the weather tightness of the roof covering, making the internal roofing structure susceptible to water penetration and subsequent damage. If left unaddressed, it is likely that secondary damage to associated building elements will develop, potentially necessitating remedial works to these structures.

A plumbing contractor should be appointed to advise on rectification options and on the cost of repair. It is advised that remedial works be performed as soon as possible to prevent any further damage.

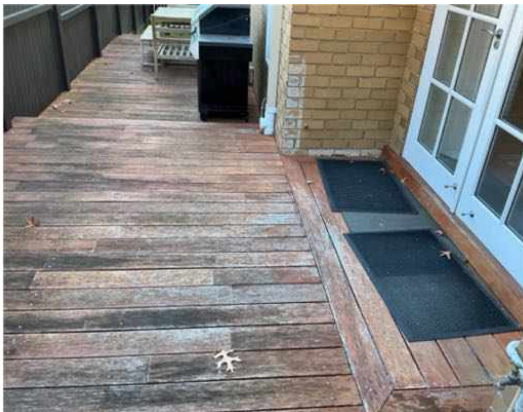
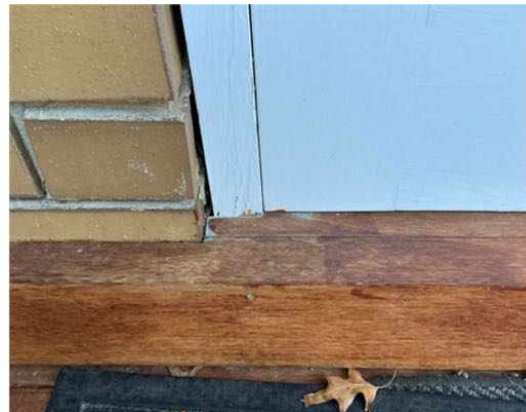
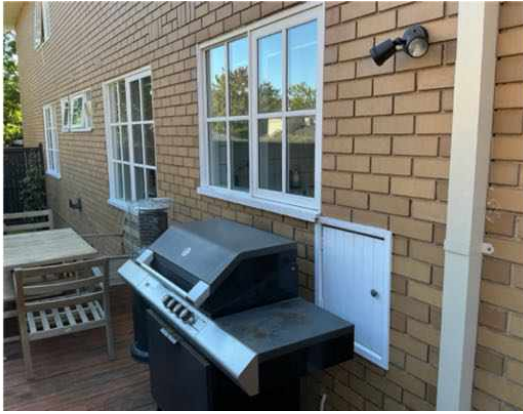
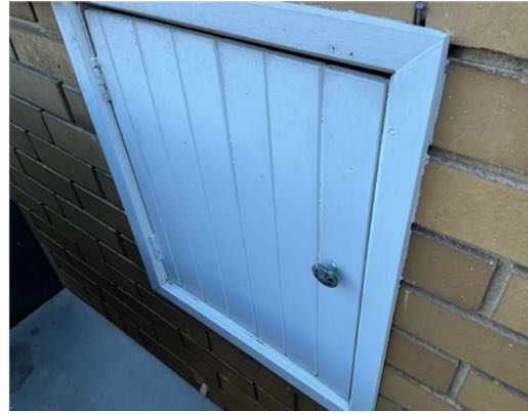
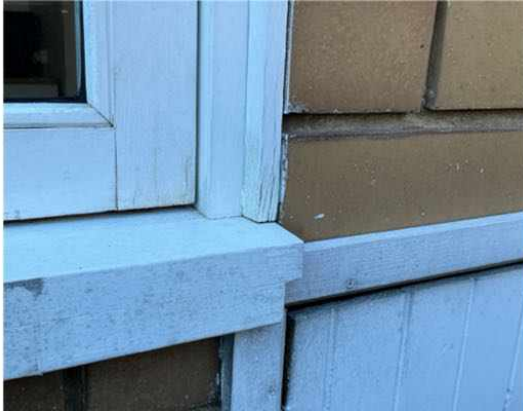
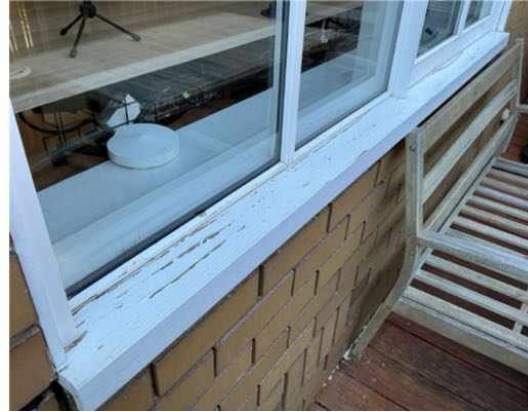
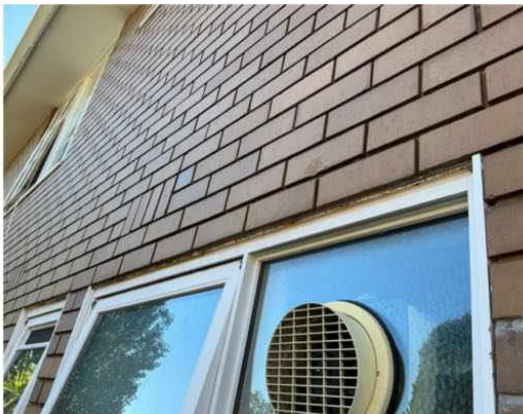
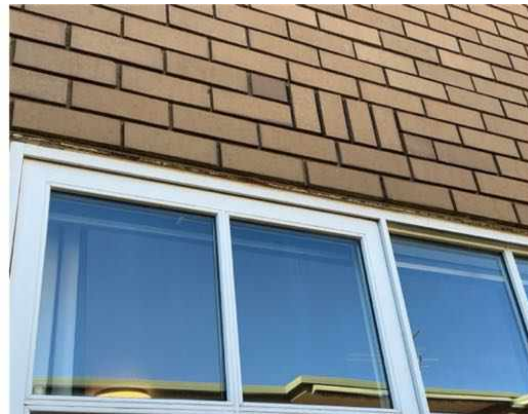
Finding 3.04

Building:	Main Building
Location:	Exterior walls - rear
Finding:	External painting deteriorated
Information:	Parts of the external paintwork has been neglected and requires attention to prepare and re-paint.

Whilst incomplete or missing paint finish is generally an appearance defect, it can also lead to the development of secondary building defects over time. Incomplete areas of paint finish expose the area to moisture, potentially accelerating the deterioration of underlying building materials.

Degraded paint finishes should be sanded back, filled, leveled and painted, as applicable. Where inadequate or missing paint protection has led to the deterioration of the associated building element, repair and/or replacement of this building element may be required.

A painting contractor should be appointed as soon as possible to perform necessary works to aid the appearance of the affected area and to ensure the area is protected against further deterioration. Alternatively, the homeowner following manufacturer instructions may perform these works.

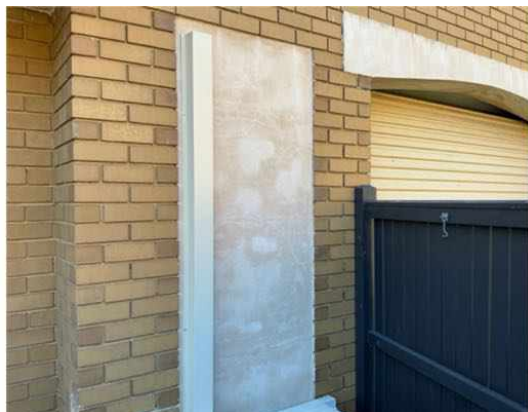
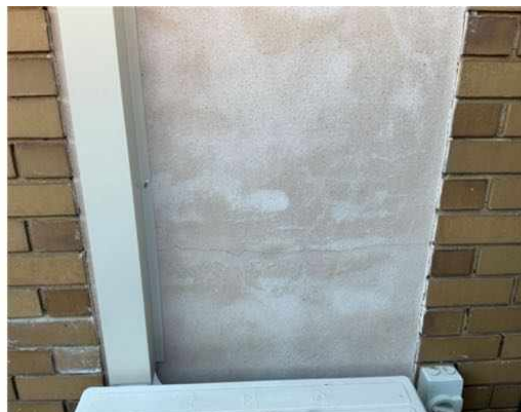
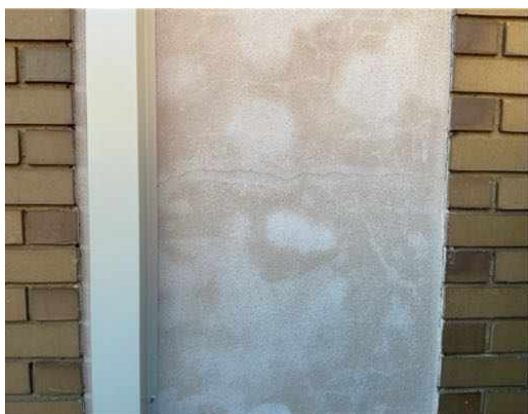
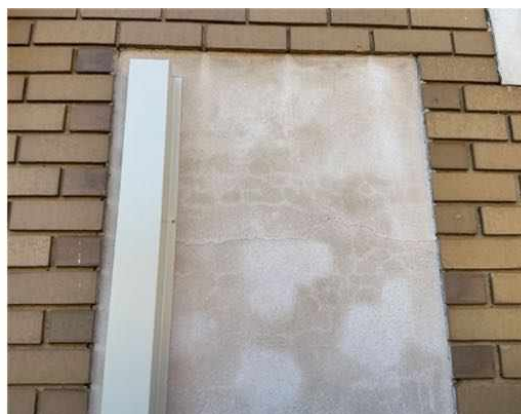
Finding 3.05

Building:	Main Building
Location:	Exterior walls - rear
Finding:	Render Cracks and deterioration
Information:	It has been observed that cracking and deterioration to the external rendered surfaces has occurred to these parts of the building.

Noticeable cracks are a common occurrence in external render and are a likely result of age expected building movement, general expansion, and/or contraction of building materials in different weather conditions. Noticeable cracks in render may develop if left unattended. Recommend engaging a renderer to repair to make more aesthetic and to reduce the risk of further deterioration at the owners discretion.

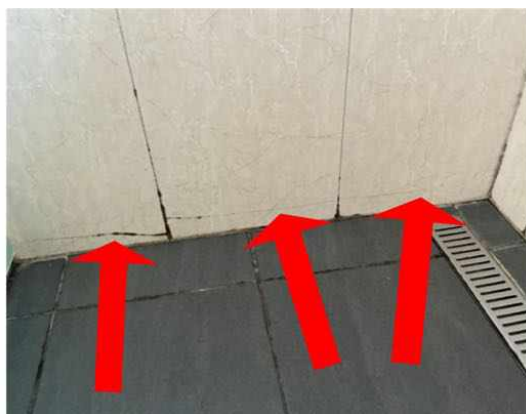
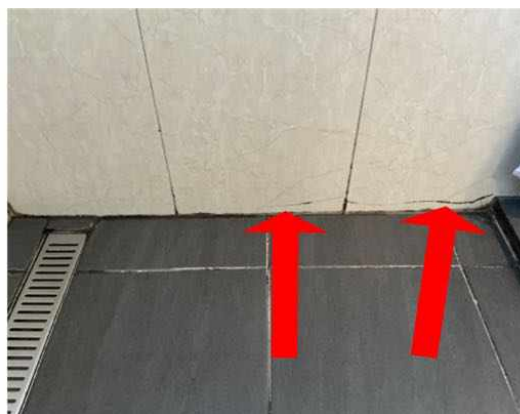
Finding 3.06

Building:	Main Building
Location:	Bathroom
Finding:	Bathroom Cracked tiles
Information:	Cracked tiles was evident to the bathroom shower at the time of inspection. It is suspected that this cracking has occurred as a result of minor settlement of the building or accidental impact damage.

Cracked tiles to the household detract from the overall appearance of the affected areas and there is a risk of water ingress through cracked tile surfaces which may lead to underlying substrate damage.

While not considered a matter of urgency, replacement of cracked tiles is recommended as soon as possible. A tiling contractor may be appointed to perform these works. Where cracks become more numerous, contact a licensed building inspector for further investigation.

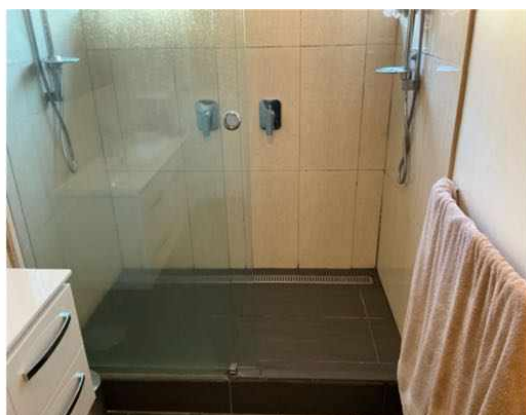
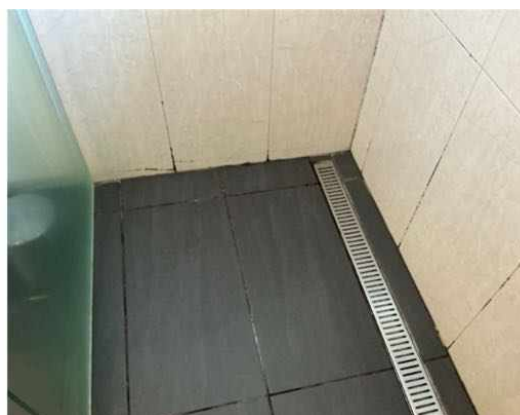
Finding 3.07

Building:	Main Building
Location:	Bathroom
Finding:	Bathroom Sealant and grouting - Missing or damaged
Information:	It was noted on inspection that sealant or grout is degraded to the tiled shower alcove and or other areas of the bathroom.

Different materials and floor areas move at different rates, generally causing cracking to grout or sealant at this point. A flexible sealant is required to allow for expected expansion and contraction, while keeping the joint water tight and protective of all associated building materials.

Flexible and mould resistant materials should be applied to affected areas to prevent any subsequent water damage that is likely to occur. Regular maintenance and replacement of damage or missing or damaged sealant and grout is highly recommended to the wet areas, as this is a regular wear and tear defect. Sealant and grouting in areas that come into regular contact with water should be maintained for the long term care of your property.

A sealant specialist or tiling contractor should be appointed to complete these works as soon as possible

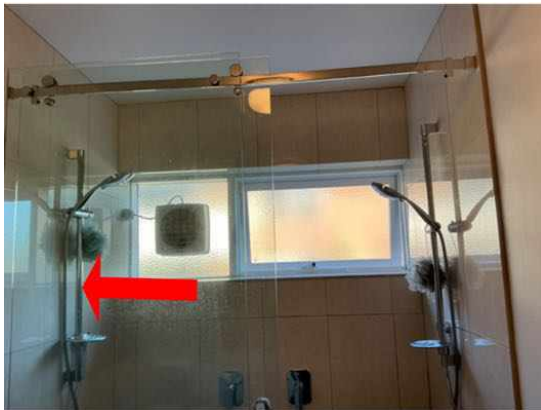
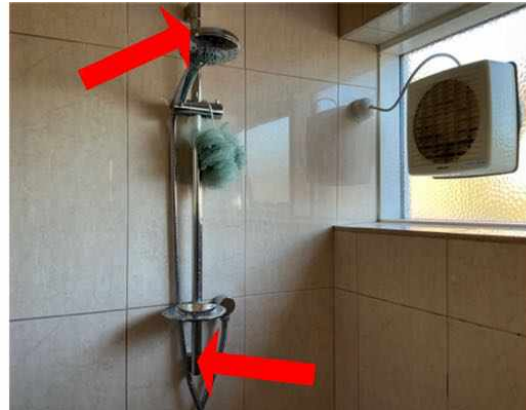
Finding 3.08

Finding: Shower head is loose

Information: The left hand shower head is loose and requires tightening. This can often happen over time with deterioration or lack of maintenance. Recommend engaging a plumber to repair/replace the shower head to reduce the risk of further deterioration as soon as possible.

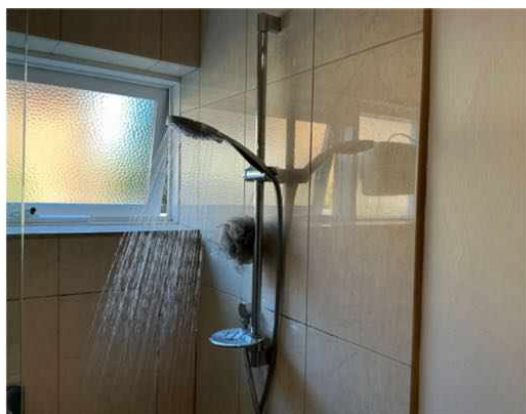
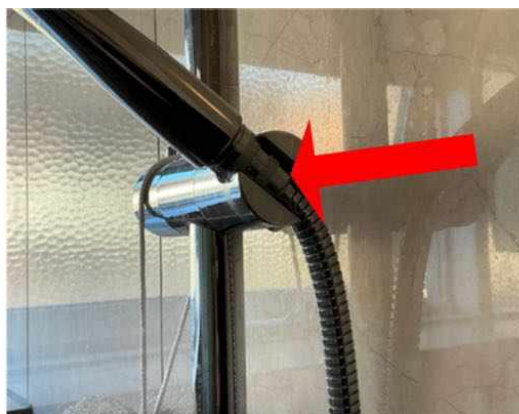
Finding 3.09

Finding: Shower head is dripping/leaking

Information: The right hand shower head to the bathroom is loose and dripping/leaking. This can often happen over time with deterioration or if the shower head is loose and needs tightening. Recommend engaging a plumber to repair/replace the shower head to reduce the risk of further deterioration and water leaks as soon as possible.

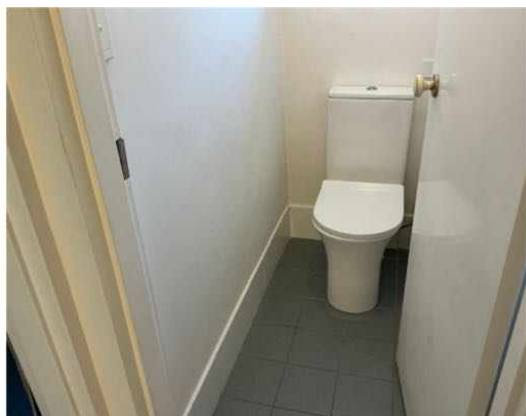
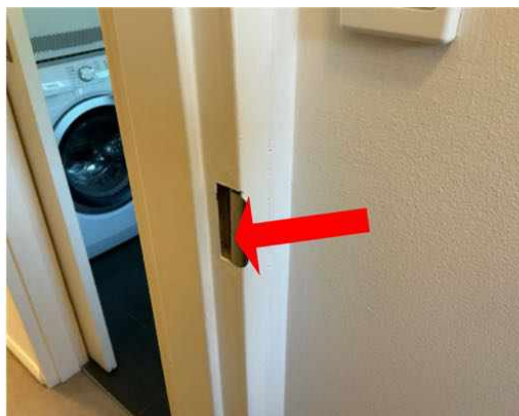
Finding 3.10

Building: Main Building
 Location: Toilet (WC)
 Finding: Door striker plate loose
 Information: The door striker plate to the toilet was found to be loose and needs adjustment at the time of inspection.

Repair is advised to improve the operational state of the associated door.

A qualified carpenter or general handyman should be appointed to repair at the client's discretion.

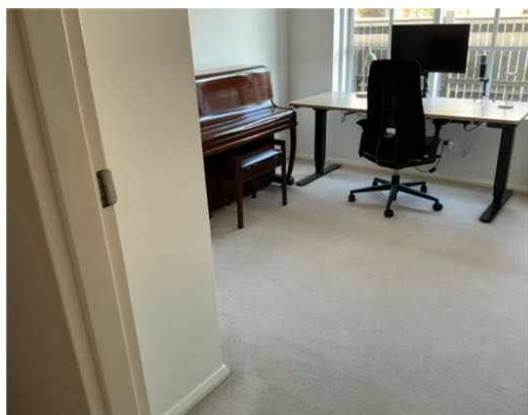
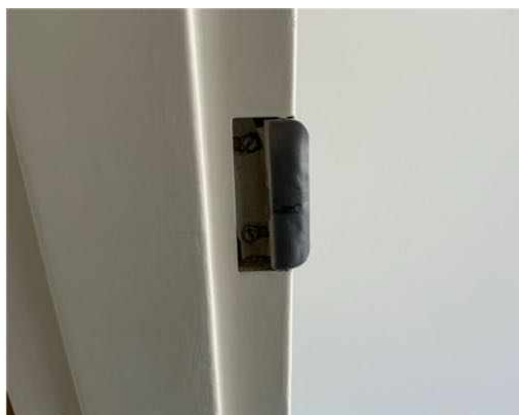
Finding 3.11

Building: Main Building
 Location: Bedroom 1
 Finding: Door striker plate loose
 Information: The door striker plate to bedroom 1 was found to be loose and needs adjustment at the time of inspection.

Repair is advised to improve the operational state of the associated door.

A qualified carpenter or general handyman should be appointed to repair at the client's

discretion.

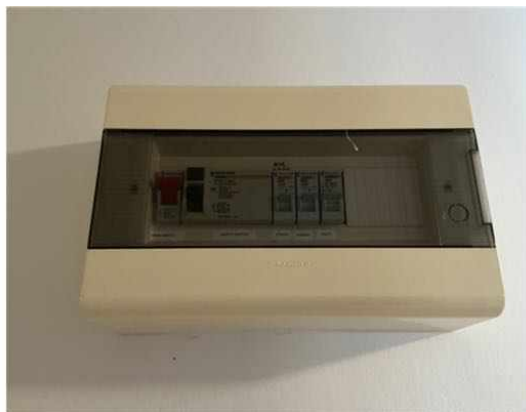
Building:	Main Building
Location:	All External Areas
Finding:	No Termite Management System - no evidence of a chemical installation
Information:	The application of a post-construction chemical termite barrier is highly recommended for all properties, particularly if live termite activity has been found on the site previously. Such barriers are highly effective in preventing termite attack on any timber building elements throughout the property.

A durable notice should be placed in the switchboard unit to indicate current termite barriers. At the time of inspection, it appeared as though no termite management system has been installed, with no evidence to suggest preventative works taking place.

The client may consider gaining further advice from a pest controller as to the costs and procedures involved with this application. It is recommended that obtaining such advice be a short-term priority.

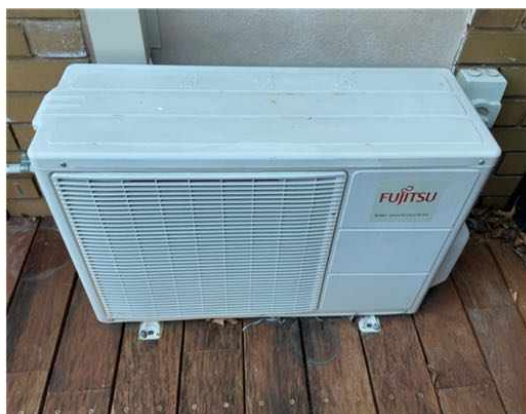
Finding 6.02

Building:	Main Building
Location:	Yard
Finding:	Air conditioning unit overflow -Not plumbed for drainage
Information:	The overflow to the air conditioning unit is not plumbed or connected to suitable drainage, which has resulted in the surrounding area becoming excessively damp. These damp conditions can lead to secondary defects such as rot, rust or corrosion of associated building elements, the formation of fungal decay, or even the creation of potential slip hazards. When coupled with poor site drainage, pooling of water may also attract termite activity to this area. It is highly recommended that a qualified plumber be appointed to install adequate drainage to the overflow. These works will ensure that the area remains dry and free of any secondary defects.

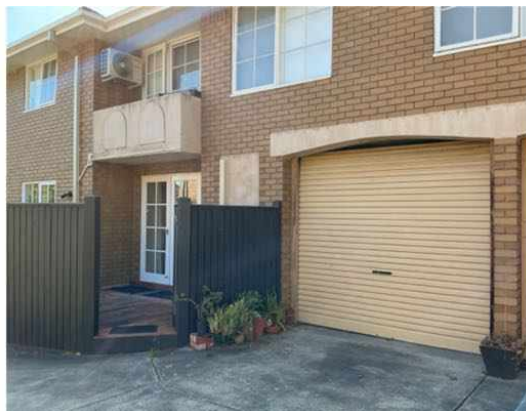
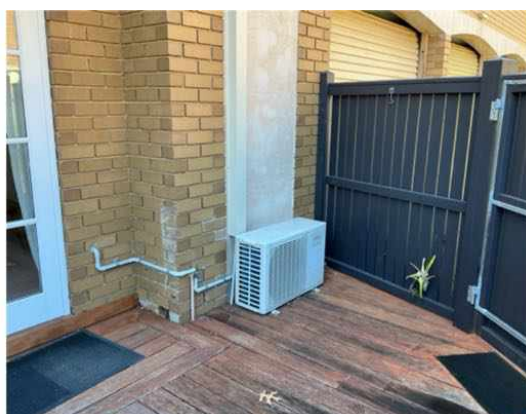
Finding 6.03

Building:	Main Building
Location:	Various parts of the building
Finding:	Bridging attachments to buildings
Information:	Bridging occurs when items against a building provide a concealed entry point for termites into the building or by passing around a termite management system.

a clear gap of not less than 25mm from building, bridging occurs. Attachments to buildings such as hot water services, downpipes, verandahs, decks, steps, fences, service conduits and the like provide the opportunity for concealed entry.

Building attachments of this nature need to be frequently inspected for termite activity by a qualified inspector.

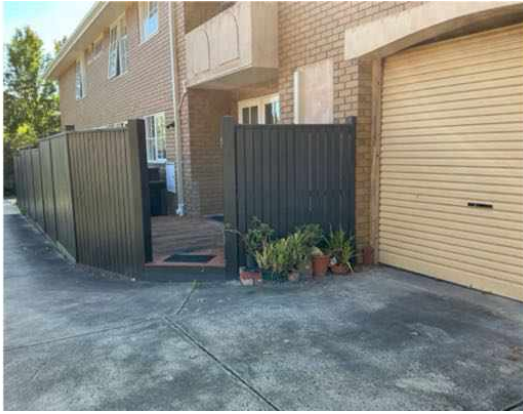
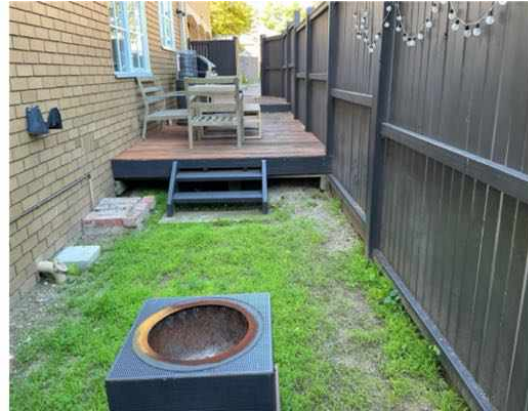
Finding 6.04

Building:	Main Building
Location:	Various parts of the building
Finding:	In ground contact
Information:	Any timbers in direct ground contact provide opportunity for concealed termite entry and are likely to be subject to premature rot and decay as the soil retains moisture or damp conditions against the timbers.

Remove untreated timber that is in direct contact with external grounds. Consider replacement with more durable materials i.e. treated timber or non timber elements. Frequent pest inspections are advised to readily identify any termite activity in these areas.

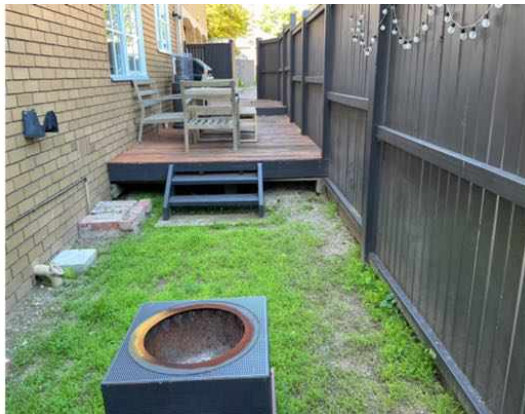
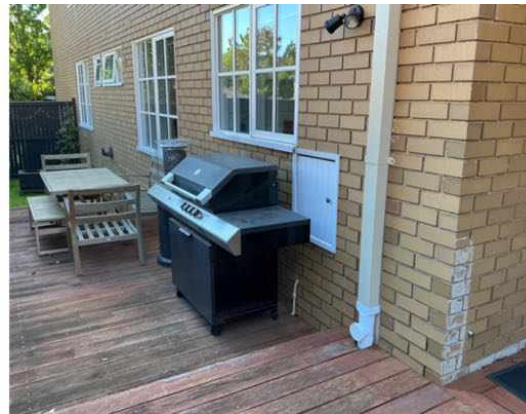
Noted Item

Building: Main Building
Location: All External Areas
Finding: Additional Photos - Obstructions and Limitations
Information: These photographs are an indication of the obstructions and limitations which impeded full inspection of the property at the time of inspection. These obstructions can hide an array of defects and should be removed to allow full inspection to be carried out. A re-inspection is recommended once the areas are made accessible.

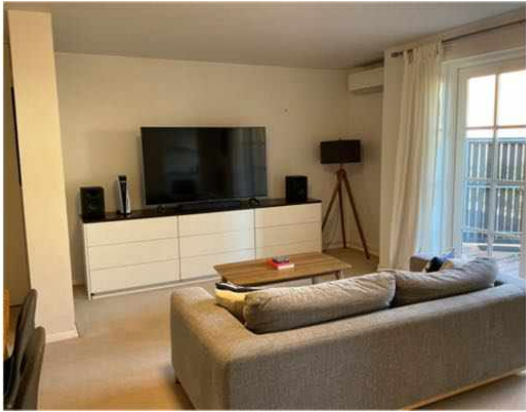
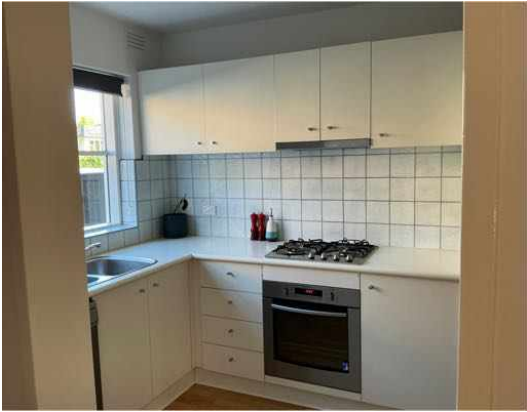
Noted Item

Building: Main Building
Location: All Internal Areas
Finding: Additional Photos - Obstructions and Limitations
Information: These photographs are an indication of the obstructions and limitations which impeded full inspection of the property at the time of inspection. These obstructions can hide an array of defects and should be removed to allow full inspection to be carried out. A re-inspection is recommended once the areas are made accessible.
