# Building and Timber Pest Inspection Report

Inspection Date: Wed, 28 Jan 2026

Property Address: 25 Mariners Way, Hastings VIC 3915,  
Australia

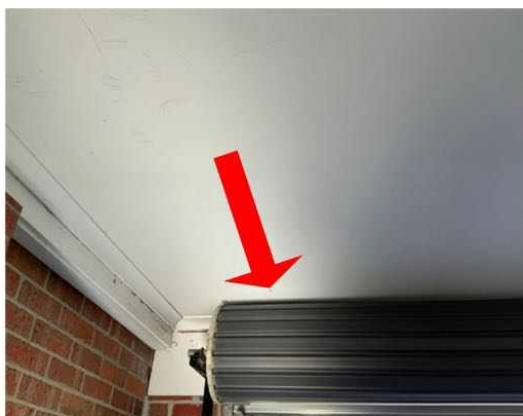
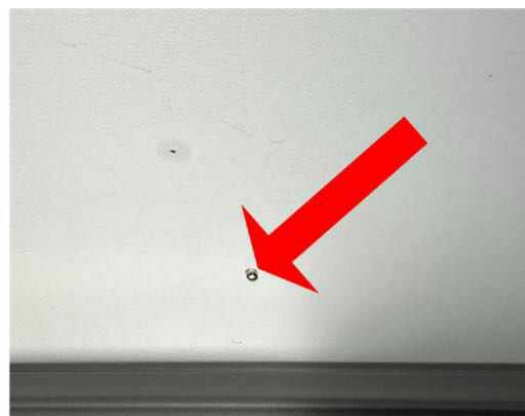
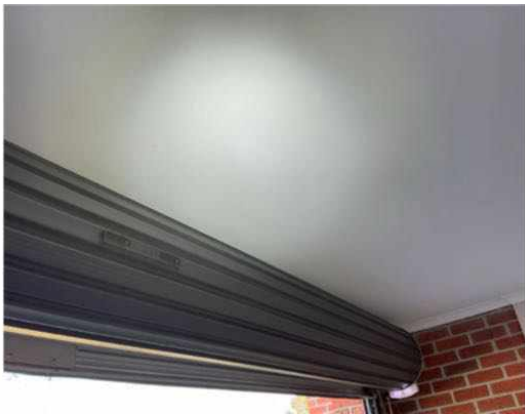
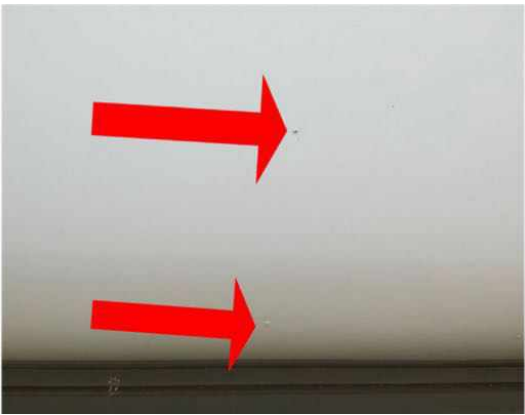
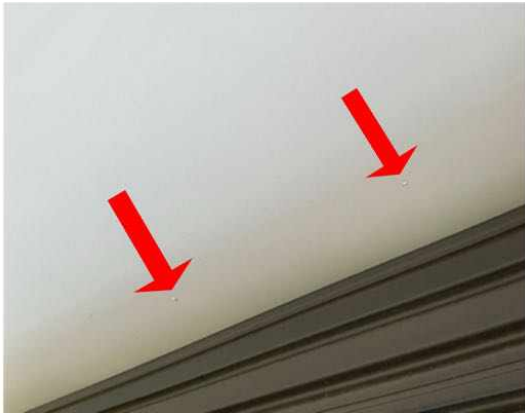
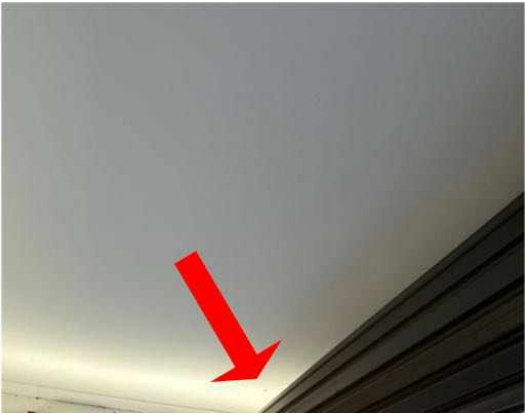
Building: Main Building  
Location: Garage  
Finding: Ceiling -fixings popping/coming loose  
Information: Sections of the garage ceiling were found to have fixings popping/coming loose at the time of inspection. Popped fixings to the fixed ceiling structure generally indicates that the building materials/fixings (e.g. nails or glue) have become loose and require reattachment. This is quite a common defect in garages of this age. It is suspected that internal plaster is used where wet board plasterboard should be used and it gets affected by the moisture and condensation in the air. There is normally no insulation in the ceiling allowing the moisture to accelerate the deterioration.

Where sagging is evident repairs such as re-gluing or replacing of ceiling sheets, may be required. Such works may be performed by relevant tradespeople, such as plasterers and painters.

The appropriate action should be taken by the client as soon as possible to ensure that any potential further damage is limited.

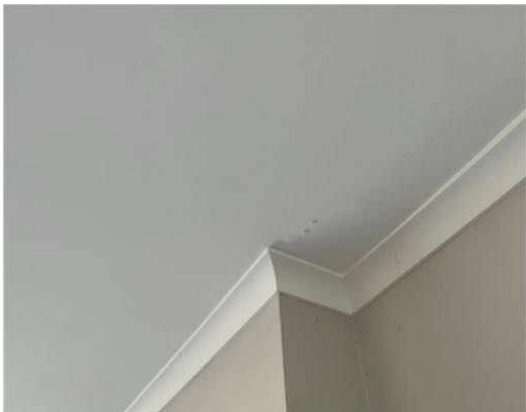
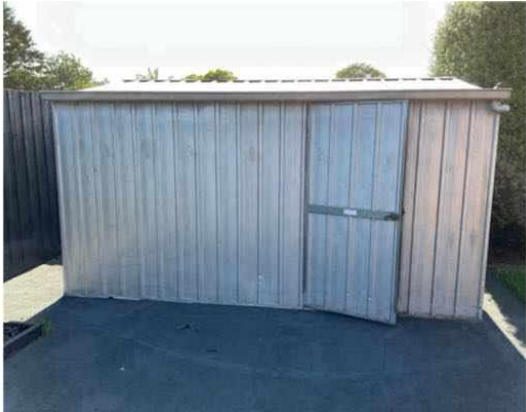
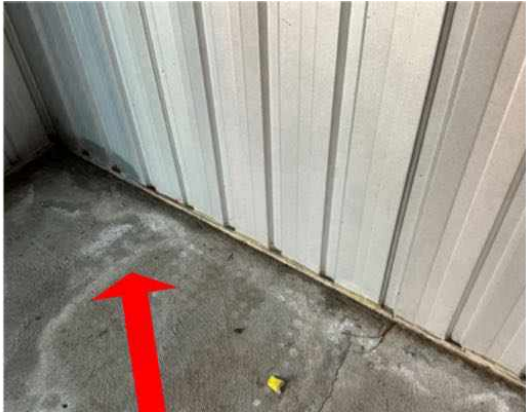
**Finding 3.02**

Building: Main Building  
Location: Yard - Back  
Finding: Water ingress to shed  
Information: The current site grading directs surface water run-off towards the shed rather than away from it which is causing rust and corrosion to the base of the shed. Ongoing moisture ingress may lead to deterioration and increased risk of corrosion and potential damage to stored items. It is recommended that a suitably qualified contractor be engaged to re-grade the surrounding ground to direct water away from the shed or improve surface drainage with spoon drains or aggie drains and assess and repair any damage caused by water ingress at the owners discretion.

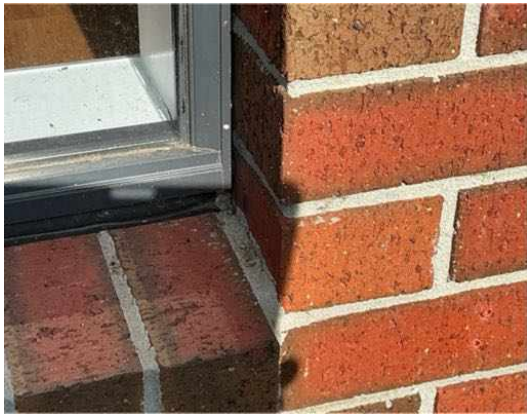
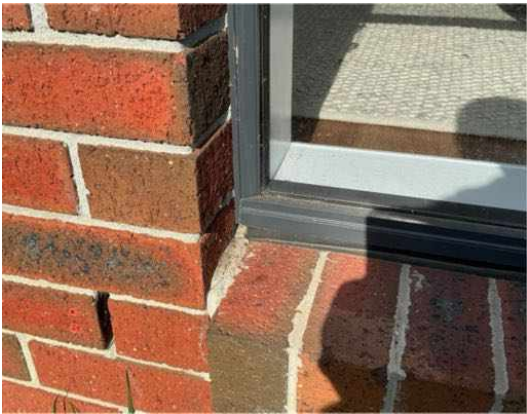
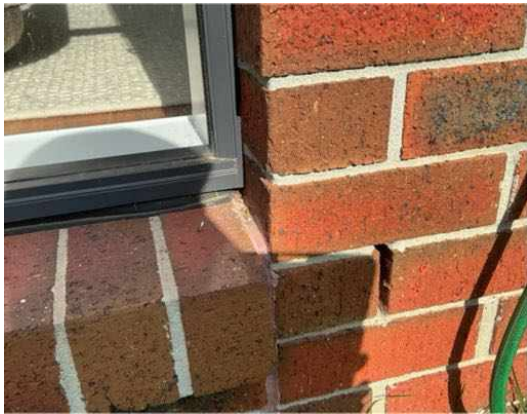
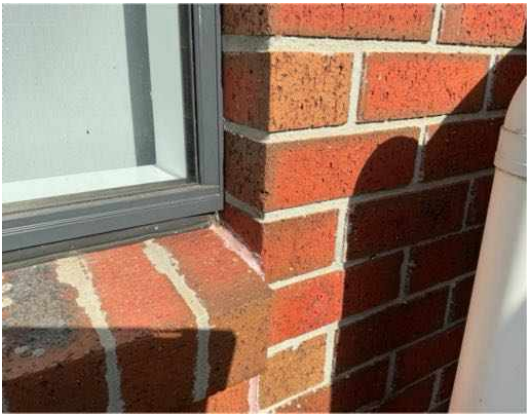
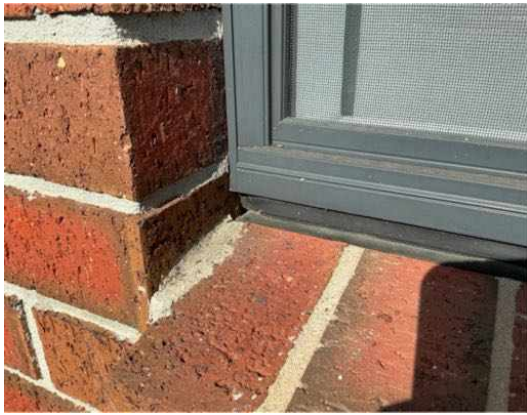
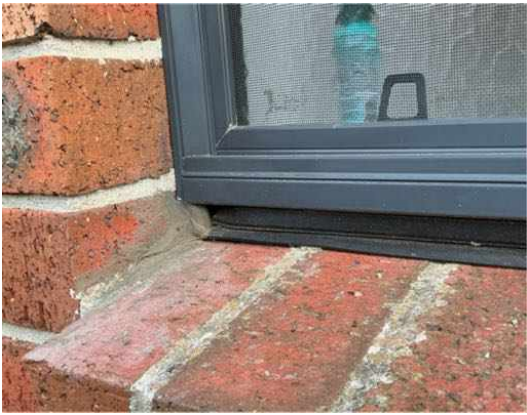
**Finding 3.03**

Building: Main Building  
Location: Various parts of the building  
Finding: A few gaps to the exterior walls/windows  
Information: A few gaps were noticed to some of the exterior walls/windows to the building. These gaps can let in water, drafts, and pests. Overtime moisture ingress may cause damage to internal walls, mould growth, or structural issues. Gaps also reduce the energy efficiency of the property. Recommend engaging a caulker to seal gaps with an exterior grade flexible sealant that is UV and weather resistant to reduce the risk of pest/water penetration to the building as soon as possible.

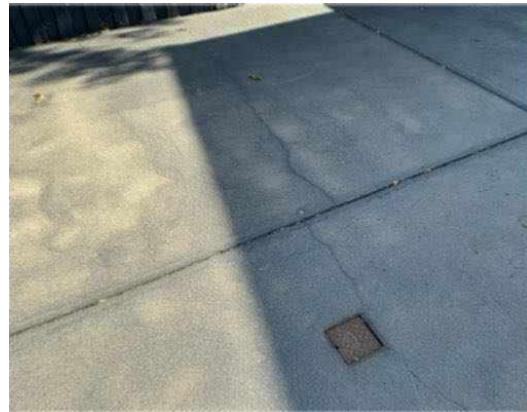
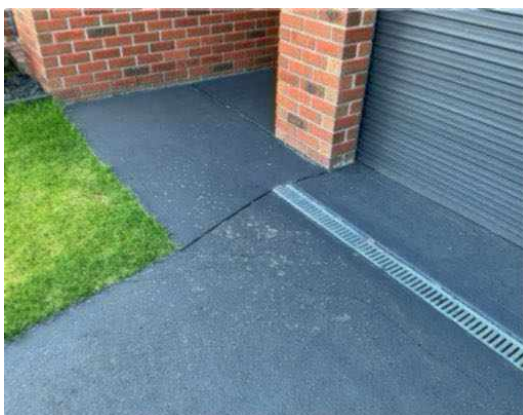
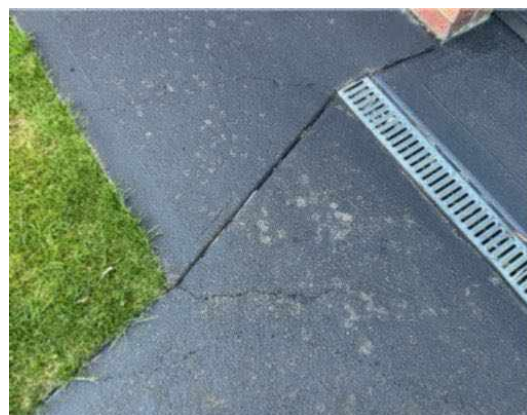
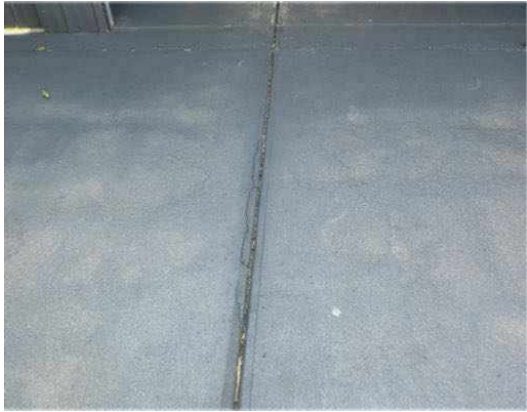
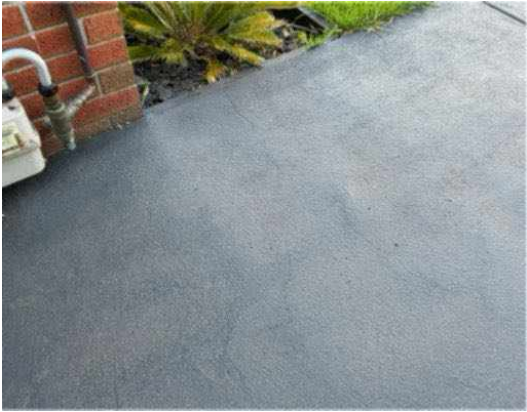
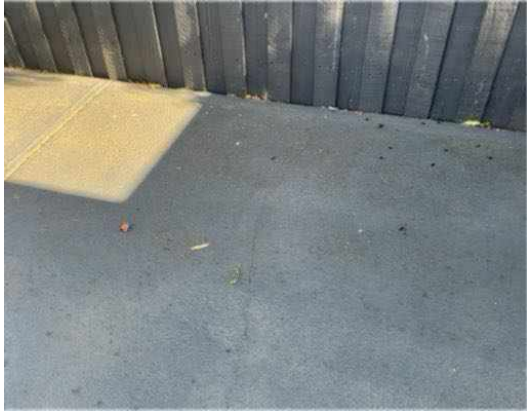
Finding 3.04

Building: Main Building  
Location: Driveway and pathways  
Finding: Driveway/pathway Cracking  
Information: Cracks were identified in the driveway and pathways external concrete paving. Although cracks are quite noticeable, they are often only considered to be an appearance defect, and usually do not indicate any structural damage.

Generally the cause of the cracks in existing concrete paving such as driveways and pathways is indicative of the expansion and contraction of the concrete. Such causes are generally due to environmental factors, such as moisture levels, weather conditions, root systems of nearby trees or the soil types on which they are laid.

Cracks may also be due to poor original installation of the concrete. Factors such as poor compaction of the sub surface and/or inadequate reinforcing of the slab may create cracking and other secondary defects.

Monitoring of all cracking should be conducted frequently. Always contact a building inspector should cracks widen, lengthen, or become more numerous.

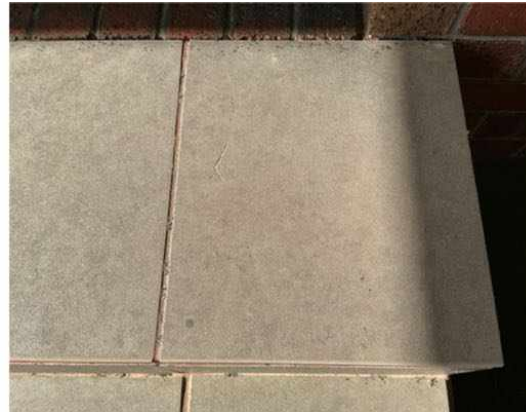
### Finding 3.05

Finding: Cracked tile

Information: A cracked tile was evident to the rear steps at the time of inspection. It is suspected that this cracking has occurred as a result of minor settlement or shrinkage of the building but could also be to poor installation of the tiles in the first place.

Cracked tiles to the household detract from the overall appearance of the affected areas however it is unlikely to create or lead to any secondary defects.

While not considered a matter of urgency, replacement of cracked tiles is

recommended at the clients discretion. A tiling contractor may be appointed to perform these works. Where cracks become more numerous, contact a licensed building inspector for further investigation.

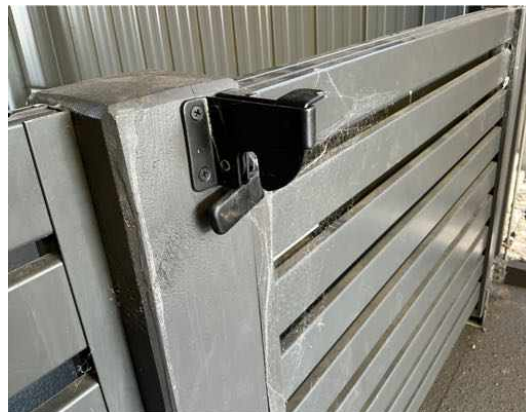
### Finding 3.06

Building: Main Building  
 Location: Yard - Back  
 Finding: Gate latch needs adjustment  
 Information: The latch to the side gate was found to be binding and needs adjustment.

Repair is advised to improve the operational state of the associated gate.

A qualified carpenter or general handyman should be appointed to repair at the client's discretion.

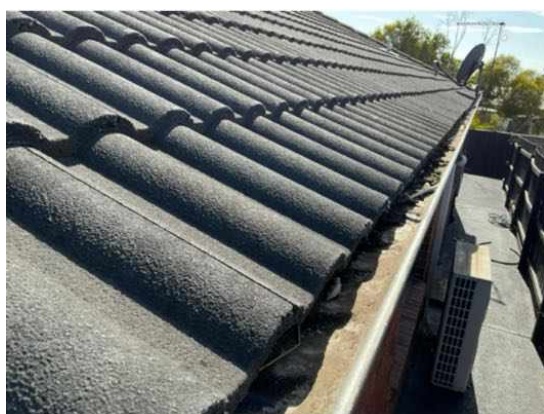
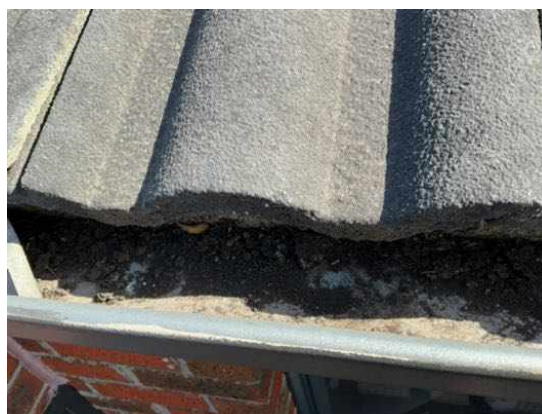
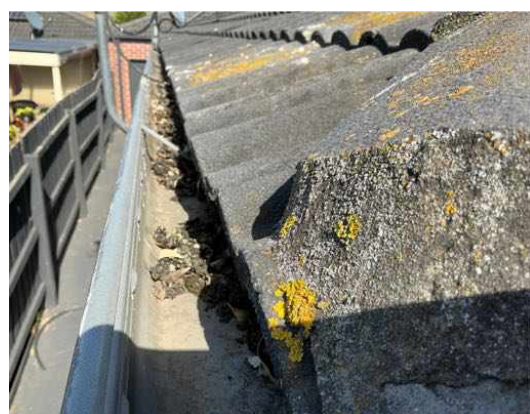
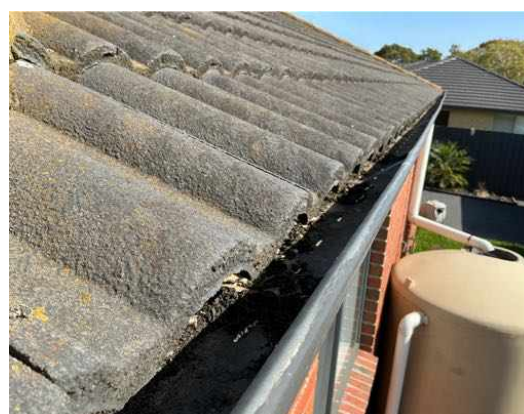
### Finding 3.07

Building: Main Building  
 Location: Roof Exterior  
 Finding: Gutters -Partially Blocked with debris  
 Information: It was noticed on inspection that some of the gutters were partially blocked with debris. Roof plumbing structures, such as guttering and downpipes, should be free of

Blocked gutters are likely to lead to high levels of moisture in the affected areas. Such moisture will not only cause rust and decay of the associated building materials, but can also provide conditions that are conducive to termite and timber pest activity. Blockages in gutters should therefore be removed immediately to ensure dry conditions are maintained.

Consult a Licensed Plumber for further specific advice on remedial works that may be required. In the interim, it is highly advised that blocked gutters be removed by the homeowner or a general handyperson as a matter of urgency.

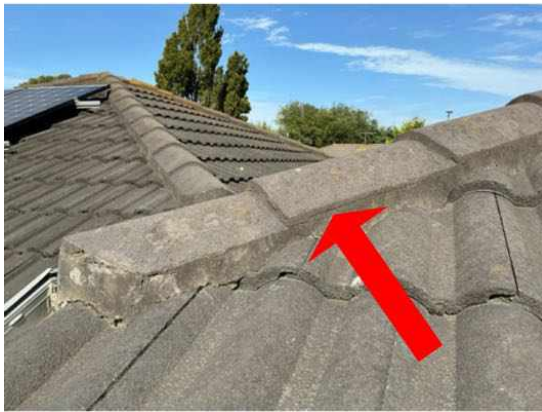
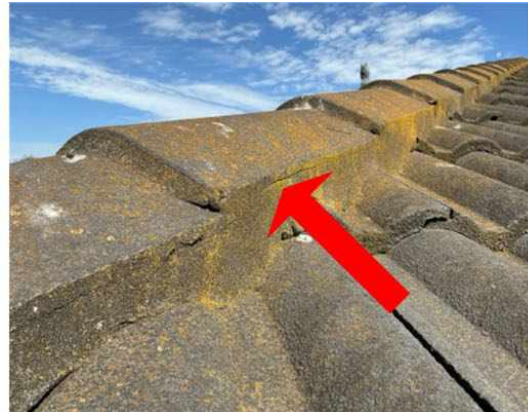
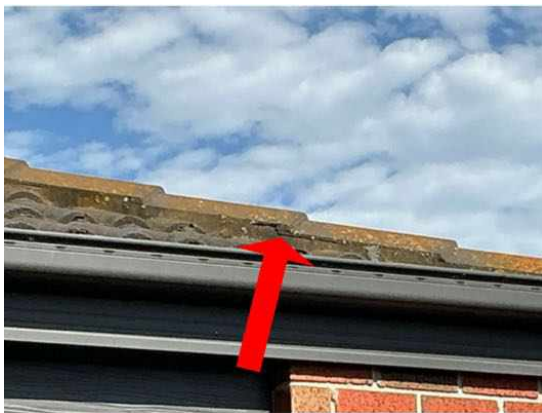
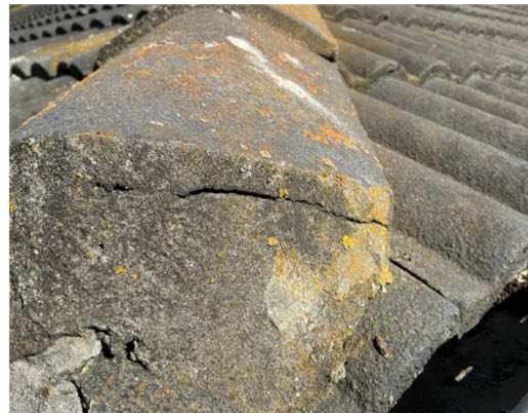
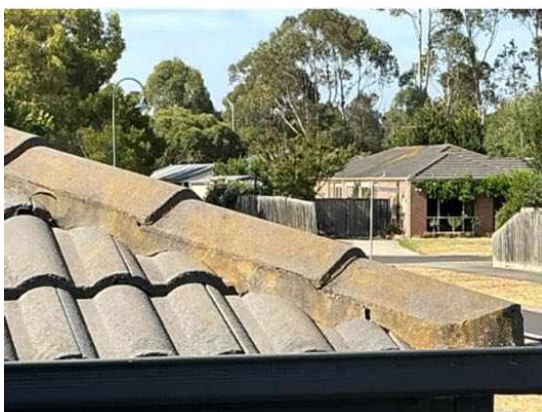
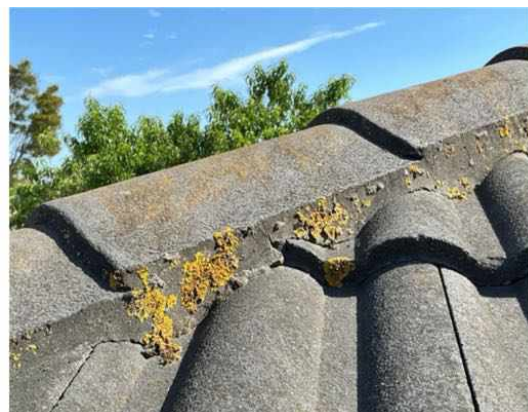
### Finding 3.08

Building:	Main Building
Location:	Roof Exterior
Finding:	Roof tile mortar deterioration and cracking
Information:	Cracking and deterioration was observed in the ridge and hip tile mortar bedding. The mortar has separated in several areas, with visible gaps forming between ridge tiles

and the underlying bedding. This condition indicates age-related degradation and exposure to the elements, which has caused the mortar to become brittle and lose its bonding integrity.

Compromised mortar may lead to further deterioration, potentially allowing water ingress and structural damage to the roof structure below.

Recommend engaging a qualified roofing contractor to carry out repointing or full re-bedding of affected ridge and hip tiles as necessary. All deteriorated mortar should be removed and replaced with new flexible roof bedding compound in accordance with current Australian Standards (AS 2050).

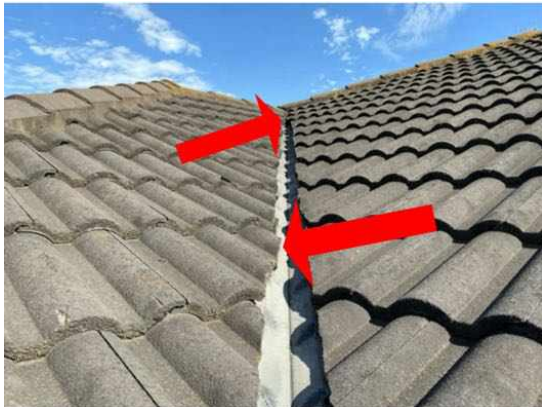
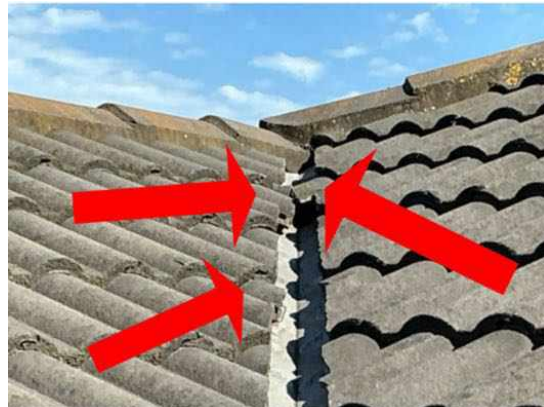
### Finding 3.09

Building:	Main Building
Location:	Roof Exterior
Finding:	Roof tiles not sitting correctly
Information:	Some of the roof tiles are not sitting correctly. This can happen with deterioration overtime or could be from poor workmanship. Recommend engaging a roof tiler to rectify to reduce the risk of water penetration to the building as soon as possible.

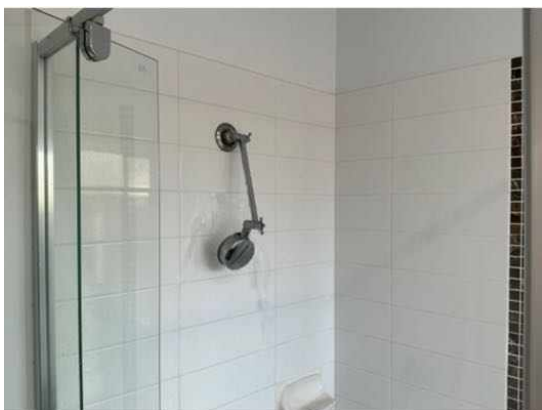
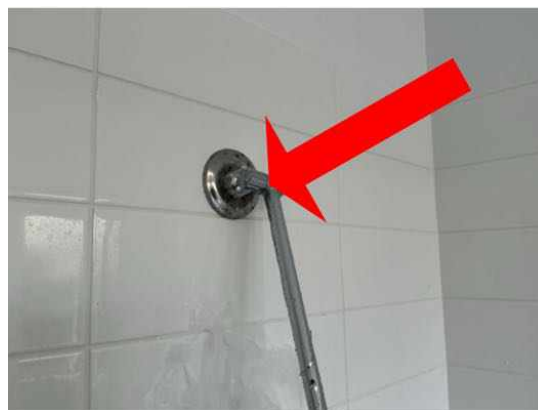
### Finding 3.10

Building:	Main Building
Location:	Bathroom
Finding:	Shower head is loose/leaking
Information:	The shower head to the bathroom is loose/leaking. Recommend engaging a plumber to repair/replace the shower head to make more operational at the owners discretion.

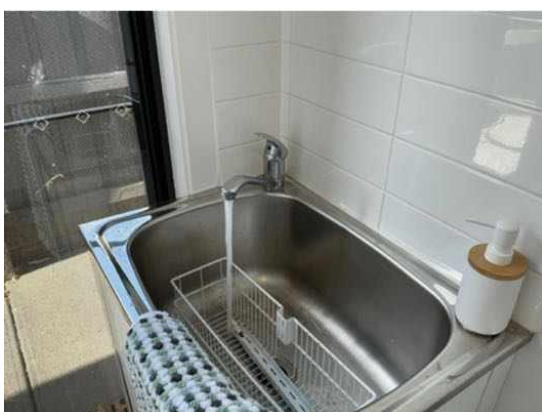
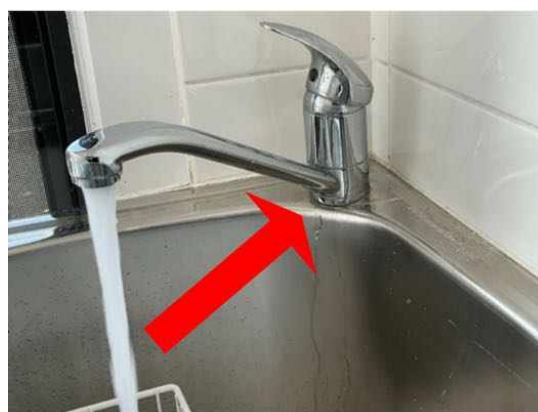
### Finding 3.11

Building:	Main Building
Location:	Laundry
Finding:	Tap - Leaking laundry
Information:	The tap in the laundry was found to be leaking at the time of inspection. This is a common defect that is consistent with general ageing of the building element. However, it may be indicative of substandard plumbing workmanship if the tap is relatively new.

While this defect only seems minor, if left unmanaged, it is likely to result in the development of rust, water damage and/or extensive water usage and can attract termites and other pests.

It is advised that a handyman or licensed plumber be appointed to perform remedial works on the affected tap. Such works should be performed prior to the development of secondary defects to ensure adequate functionality of all associated building elements.

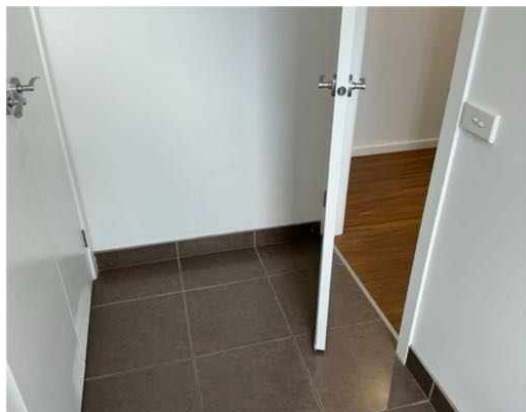
### Finding 3.12

Building:	Main Building
Location:	Laundry

Finding: Door stop- missing  
 Information: The laundry doorstop is missing and is unable to stop the door handle from damaging the wall. Although some building elements may seem irrelevant or unnecessary, all building elements play a key role in the operation and function of the overall structure and its performance.

Re-installation or replacement of the door stop is advised as soon as possible to prevent any subsequent damage to the door or associated structures. A general handyman may be appointed to perform these works at client discretion.

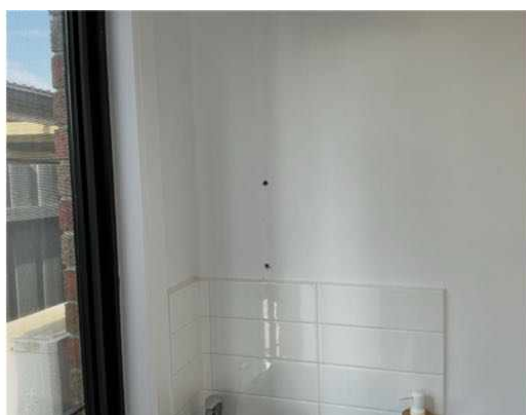
### Finding 3.13

Building: Main Building  
 Location: Laundry  
 Finding: Hole in plaster  
 Information: There is some holes in the plaster to the laundry walls. Recommend engaging a plasterer/painter to repair to make more aesthetic at the owners discretion.

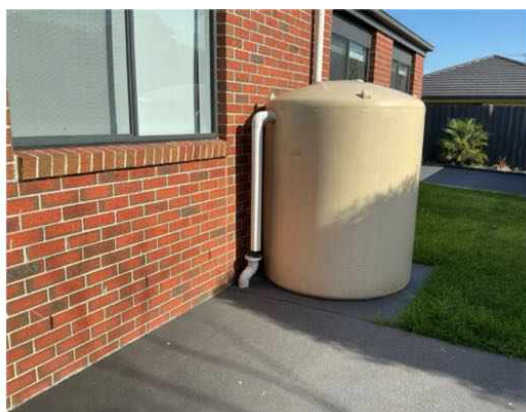
Where plumbing doesn't drain adequately, the area at the base perimeter can become excessively damp, potentially creating an environment that is susceptible to rust and corrosion of surrounding building elements, as well as attracting termites and other pests.

It is highly recommended that a plumber be appointed to further inspect the area and to install adequate drainage equipment immediately where necessary.

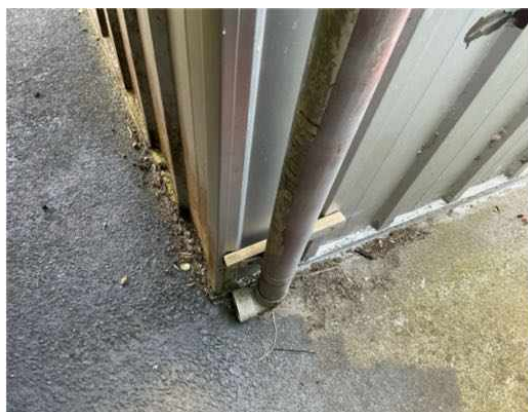
#### Finding 6.02

Building:	Main Building
Location:	Shed
Finding:	downpipe not connected to stormwater
Information:	The shed down pipe is not connected to stormwater. This disconnection negatively impacts the functional capacity of the plumbing.

Where plumbing doesn't drain adequately, the area at the base perimeter can become excessively damp, potentially creating an environment that is susceptible to rust and corrosion of surrounding building elements, as well as attracting termites and other pests.

It is highly recommended that a plumber be appointed to further inspect the area and to install adequate drainage equipment immediately where necessary.

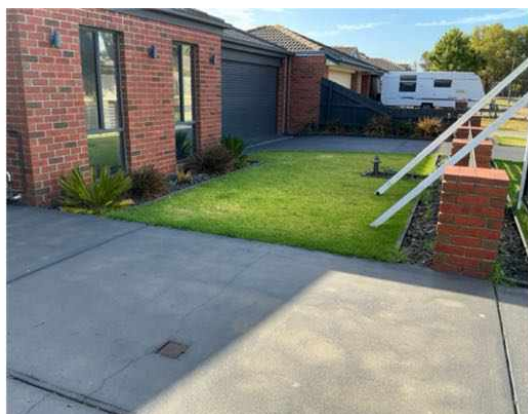
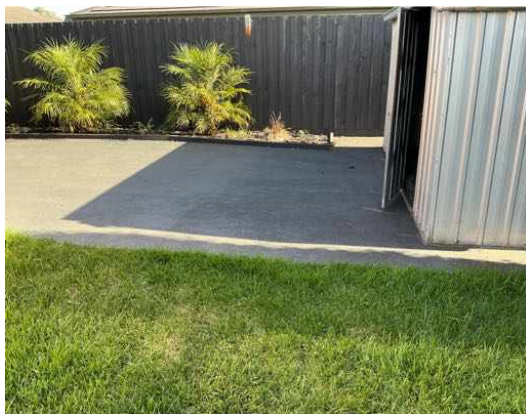
**Finding 6.03**

Building: Main Building  
 Location: Yards  
 Finding: Site drainage - poor/inadequate  
 Information: The site drainage to parts of the yards was found to be inadequate at the time of inspection, creating potential for subsequent water damage to associated building elements. Excessive moisture will attract termites.

It is important that water does not lie against the base of walls; surrounding paths and ground levels should be sloped to drain water away from walls. Downpipes should not discharge stormwater onto lower walls or plinths. Stormwater should be carried away by large, regularly cleaned drains. Ground levels may need to be lowered to expose a buried DPC.

Where site drainage is inadequate, installation of an Agricultural (Aggie) Drain may be required. A qualified plumber should be appointed to further inspect the property and perform any remedial works as necessary. Water damage and secondary defects are likely to occur if left unmanaged.

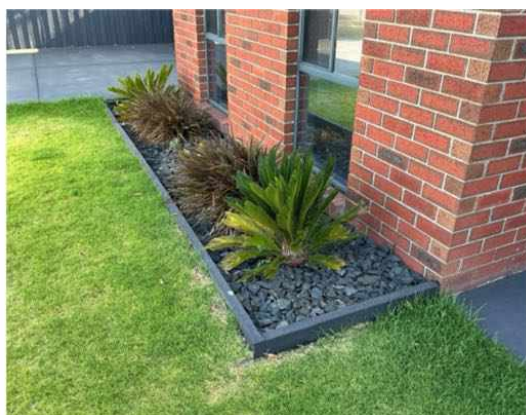
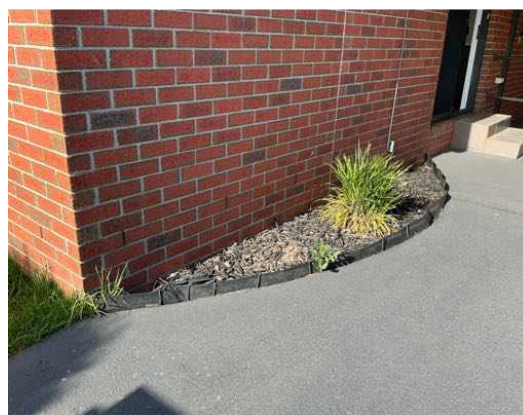
### Finding 6.04

Building:	Main Building
Location:	Yards
Finding:	Garden Beds Conditions Conducive to Termites
Information:	Garden beds were found to be evident in close proximity to the building. Garden beds immediately adjacent to the perimeter of the building block the visual inspection of these areas, providing a concealed termite entry point.

These garden beds can include untreated timber, and with a combination of moisture from watering hosing can make conditions conducive to termite activity and termite ingress.

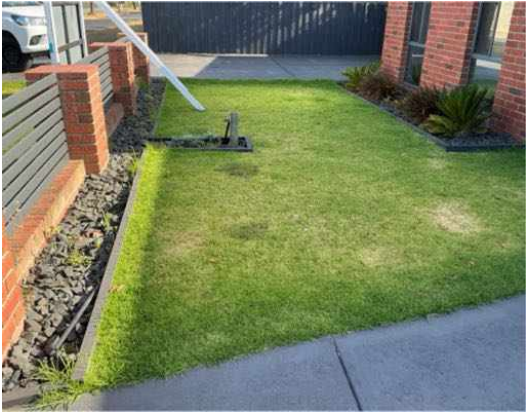
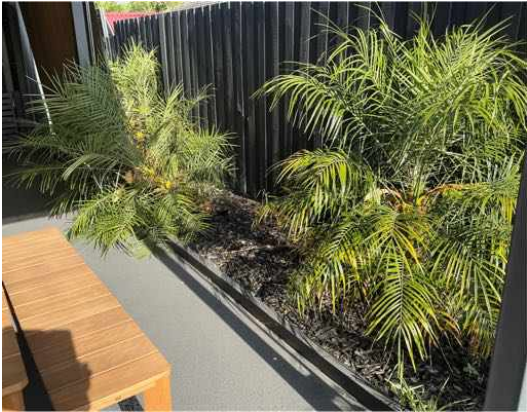
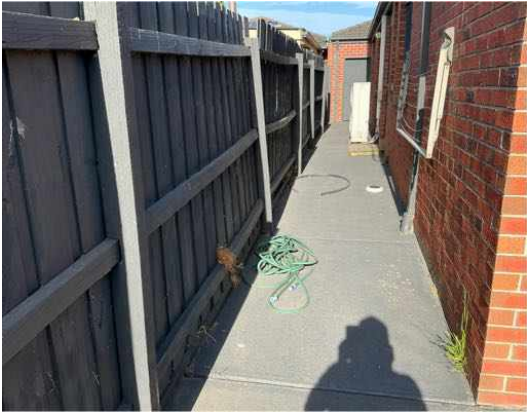
and are likely to be subject to premature rot and decay as the soil retains moisture or damp conditions against the timbers.

Remove untreated timber that is in direct contact with external grounds. Consider replacement with more durable materials i.e. treated timber or non timber elements. Frequent pest inspections are advised to readily identify any termite activity in these areas.

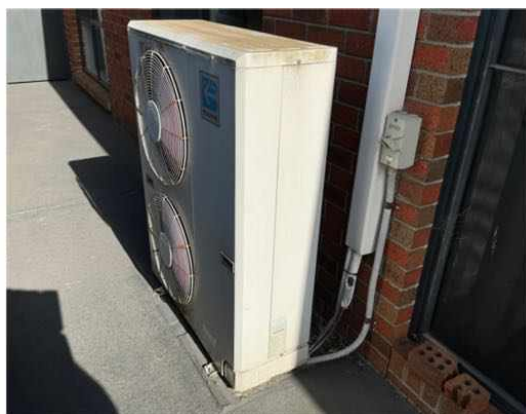
### Finding 6.07

Building:	Main Building
Location:	Yard - Back
Finding:	Air conditioning unit overflow -Not plumbed for drainage
Information:	The overflow to the air conditioning unit is not plumbed or connected to suitable drainage, which has resulted in the surrounding area becoming excessively damp. These damp conditions can lead to secondary defects such as rot, rust or corrosion of associated building elements, the formation of fungal decay, or even the creation of potential slip hazards. When coupled with poor site drainage, pooling of water may also attract termite activity to this area. It is highly recommended that a qualified plumber be appointed to install adequate drainage to the overflow. These works will ensure that the area remains dry and free of any secondary defects.

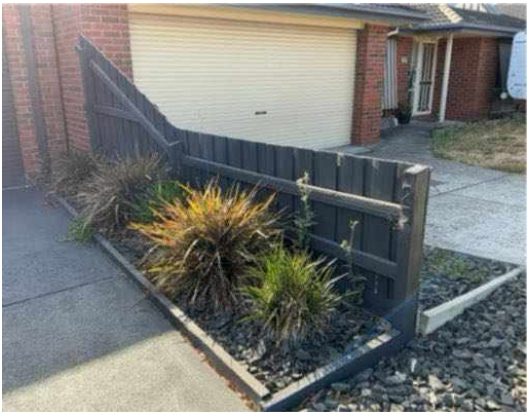
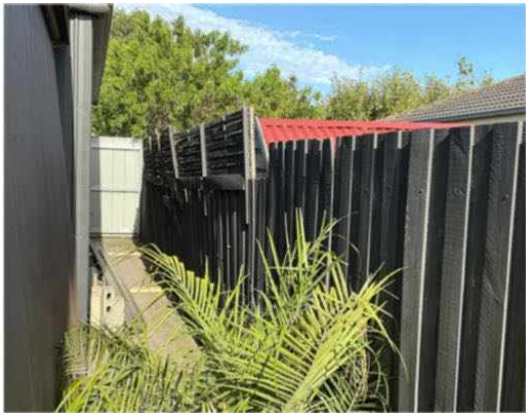
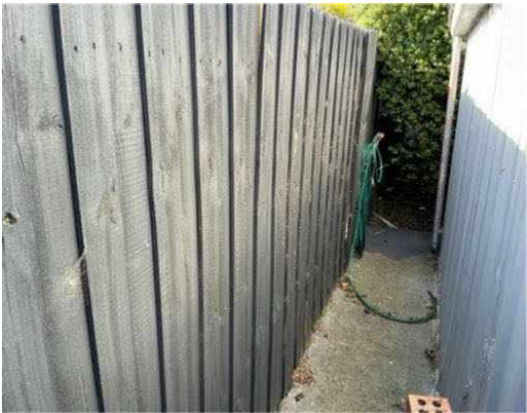
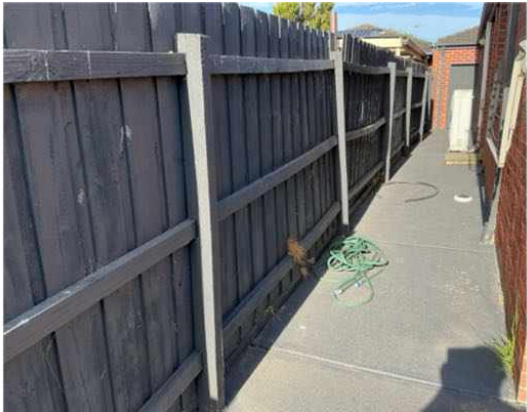
### Finding 7.01

Building:	Main Building
Location:	Yards
Finding:	Fencing - wood rot-fungal decay
Information:	It was noted at the time of inspection that sections of the fencing to the property have

deteriorated and have fungal decay/wood rot present. Typically fencing deteriorates due to age and or wear, rot and or rust which is generally expected for a structure of this age, due to prolonged exposure to weather conditions. Sometimes inadequate installation or maintenance can be to blame.

If left unattended, it is likely that further damage will occur. It is suspected that repair of several elements of the fencing may be required however replacement may be a consideration of the client also.

A licensed fencing contractor should be appointed to provide further advice and perform rectification works as necessary.

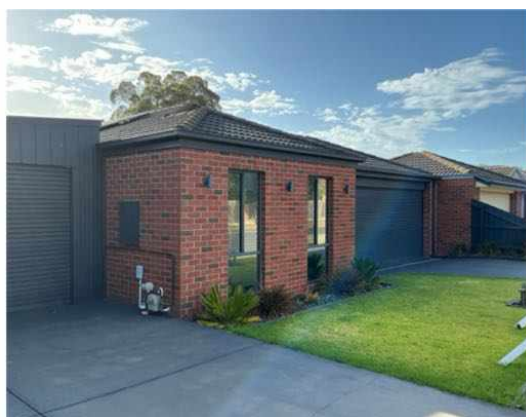
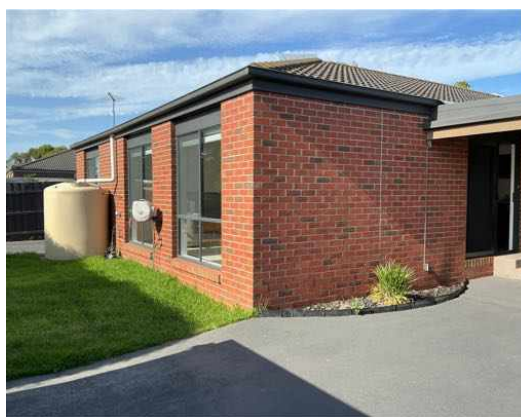
Building: Main Building  
Location: All External Areas  
Finding: Additional Photos - Obstructions and Limitations  
Information: These photographs are an indication of the obstructions and limitations which impeded full inspection of the property at the time of inspection. These obstructions can hide an array of defects and should be removed to allow full inspection to be carried out. A re-inspection is recommended once the areas are made accessible.

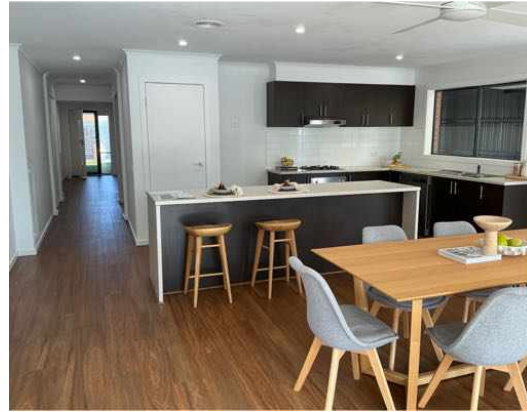
Building: Main Building  
Location: All Internal Areas  
Finding: Additional Photos - Obstructions and Limitations  
Information: These photographs are an indication of the obstructions and limitations which impeded full inspection of the property at the time of inspection. These obstructions can hide an array of defects and should be removed to allow full inspection to be carried out. A re-inspection is recommended once the areas are made accessible.

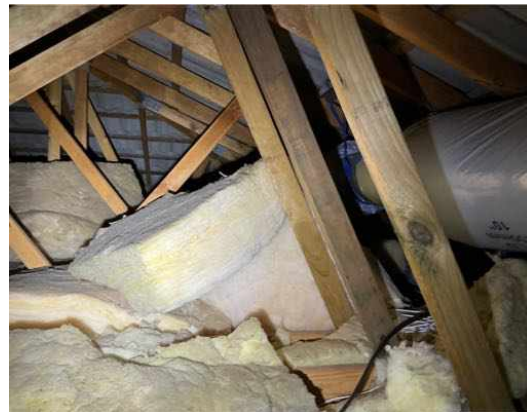
Building:	Main Building
Location:	Roof Void
Finding:	Obstructions and Limitations -roof cavity
Information:	These photographs are an indication of the obstructions and limitations which impeded full inspection of the roof cavity at the time of inspection. These obstructions can hide an array of defects and should be removed to allow full inspection to be carried out. A re-inspection is recommended once the areas are made accessible.
