# Building and Timber Pest Inspection Report

Inspection Date: Tue, 10 Mar 2026

Property Address: 44 Beverley Ave, Unanderra NSW 2526,  
Australia

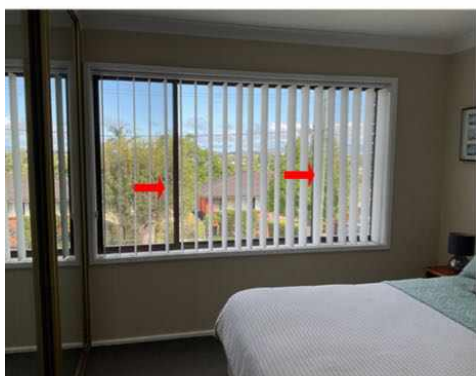
Building:	Building 1
Location:	Many upper windows
Finding:	Window opening restrictors missing.
Information:	The Building Code of Australia rules require all openable windows (where the internal floor is more than 2m above the ground outside) in residential rooms to be fitted with a suitable screen or restrictor. Windows located 1.7m above the floor level do not require protection.

Window restrictors are required where people who are vulnerable to the risk of falling have access to windows. This means all windows above ground level which do not have another fall prevention safety measure in place, such as a balcony or balustrade should have a restrictor.

These need to be added urgently for the safety of all persons.

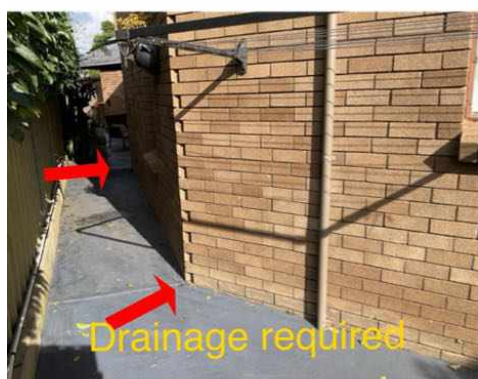
Rising damp is generally managed by the installation of a damp proof course during construction. A Damp Proof Course (DPC) is an impermeable barrier at the base of the wall above ground level. However, many 19th Century buildings have no damp course installed, or the materials have failed. The DPC may have been omitted as a consequence of poor workmanship, or it may have been bridged where materials built up against the side of the house allow moisture ingress above the DPC level.

The first step in addressing rising damp is to diagnose the cause. The identified cause should be addressed first before addressing the appearance and other defects which have resulted from the rising damp. If the original cause is not resolved, further cases of damp are likely to ensue, resulting in secondary defects.

Consultation with a qualified plumber is advised immediately to identify the cause of the damp and perform remedial works as required.

It is recommended to get advice and quotes before purchase.

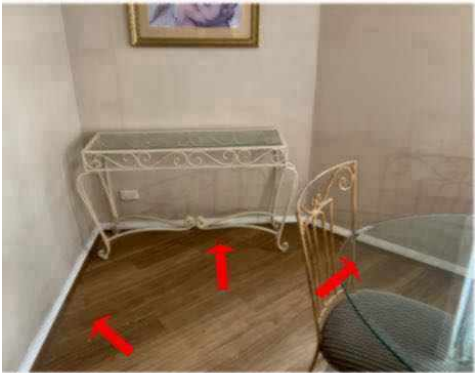
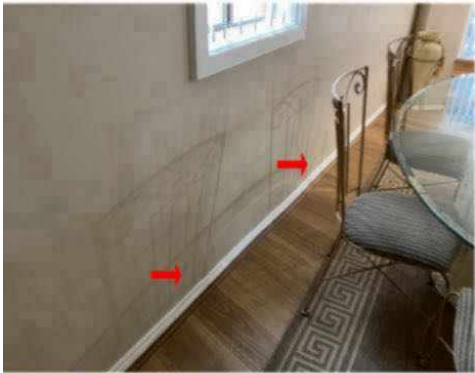
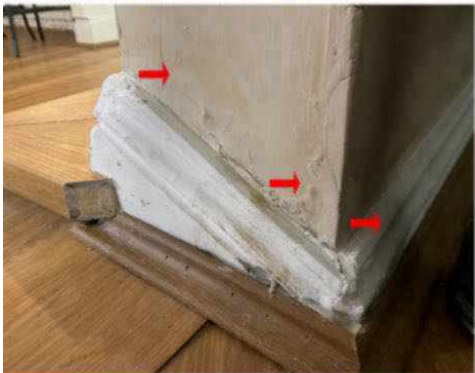
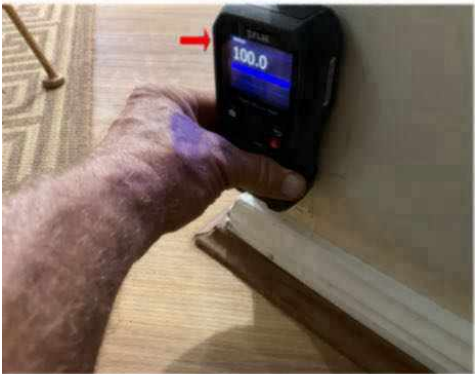
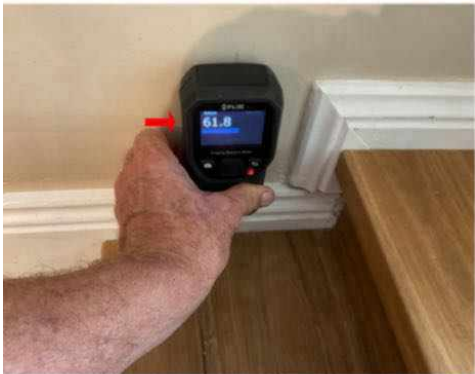
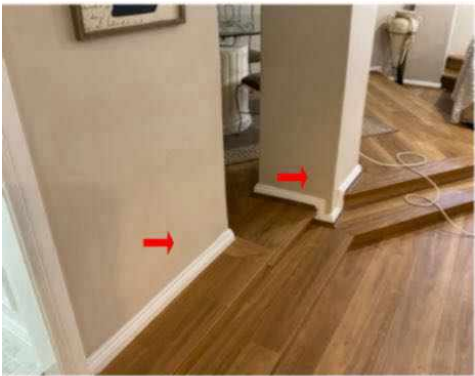
Finding 3.02

Building: Building 1  
Location: Entry, kitchen, dining room  
Finding: Evidence of excessive moisture was present at the time of inspection  
Information: Excessive moisture was found in these pictured areas. Maximum readings of 100 were found in the dining room and medium readings in the other pictured areas.

This can attract termites and produce conditions that promote termite attack, fungal growth and wood decay. Excessive moisture is generally caused by deteriorated, inadequate or missing roof drainage, rising damp, damaged external sealant, leaking plumbing pipes or fixtures, poorly plumbed HWS overflows or condenser units and poor site drainage. It is highly recommended that all plumbing and drainage fixtures and fittings be maintained regularly in order to prevent excessive moisture being present in the internal property. See rising damp defect at top of this report.

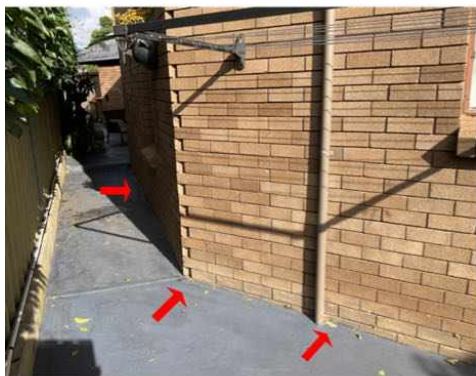
### Finding 3.03

Building:	Building 1
Location:	Rear Walls
Finding:	Site drainage - Inadequate
Information:	The site drainage in this rear area was found to be inadequate at the time of inspection, creating potential for subsequent water damage to associated building elements.

No drainage was found in this area and it is thought rainwater is ingressing the rear wall causing the rising damp found in internal areas.

It is important that water does not lie against the base of walls; surrounding paths and ground levels should be sloped to drain water away from walls. Downpipes should not discharge stormwater onto lower walls or plinths. Stormwater should be carried away by large, regularly cleaned drains. Ground levels may need to be lowered to expose a buried DPC.

Where site drainage is inadequate, installation of an Agricultural (Aggie) Drain may be required. A qualified plumber should be appointed to further inspect the property and perform any remedial works as necessary. Secondary defects are likely to occur if left unmanaged.

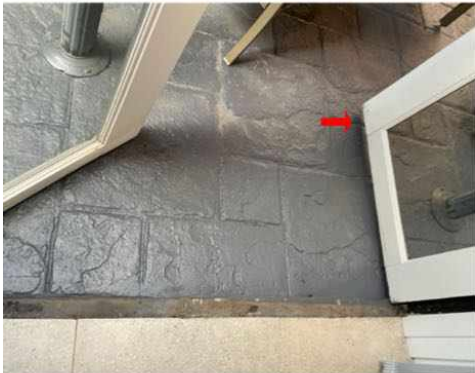
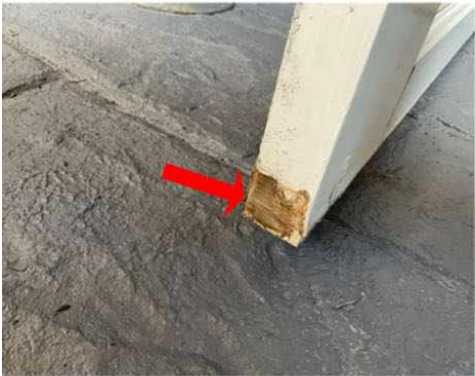
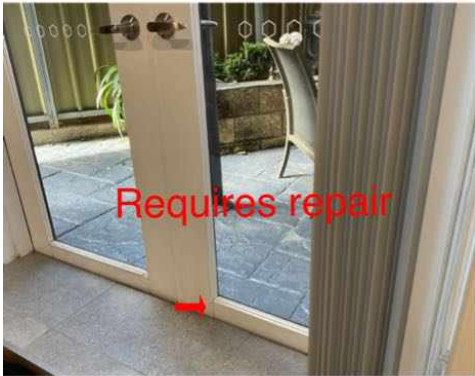
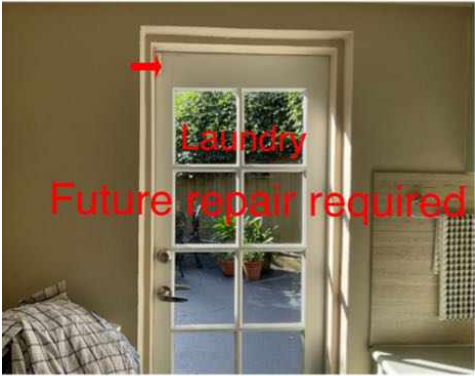
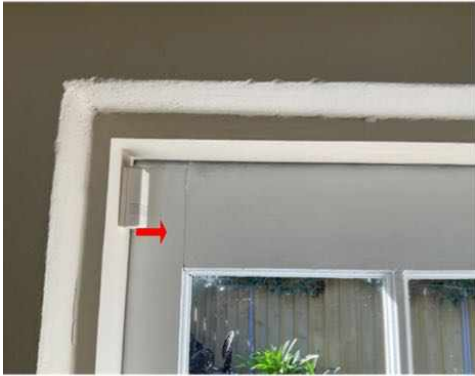
### Finding 3.04

Building:	Building 1
Location:	Many doors
Finding:	Doors - Binding/jamming and one damaged
Information:	Binding and/or jamming of these doors is evident during standard operation. This defect inhibits the functionality of the affected doors as well as creating potential for secondary defects to associated building elements, such as damage to the floor covering or the adjoining door jamb.

A door that binds to flooring or to the associated door frame may have several causes, ranging from minor defects, such as poor installation of the door or deteriorated hinges, through to major structural issues, such as damage to subfloor structures.

Two doors are starting to come apart at joints. One lounge room door needs urgent repair. The left front door and the laundry door may need repair/ replacement in the next 1-2 years.

For these apparent minor causes, a qualified carpenter should be appointed to perform minor rectification works at client discretion.

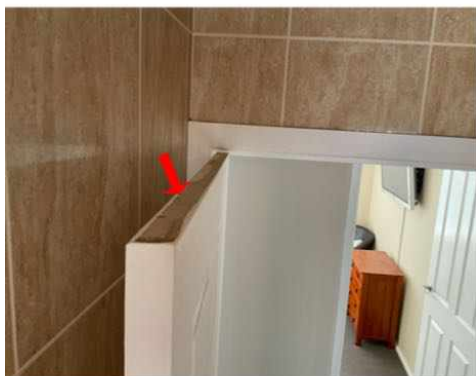
NSW Guide to Standards and Tolerances 9.6 states that “door leaves are defective if they do not have all sides, top and bottom edges sealed/painted

Whilst incomplete or missing paint finish is generally an appearance defect, it can also lead to the development of secondary building defects over time. Incomplete areas of paint finish expose the area to moisture, potentially accelerating the deterioration of underlying building materials.

Incomplete paint finishes should be sanded back, filled, leveled and painted, as applicable. Where inadequate or missing paint protection has led to the deterioration of the associated building element, repair and/or replacement of this building element may be required.

A painting contractor should be appointed as soon as possible to perform necessary works to aid the appearance of the affected area and to ensure the area is protected against further deterioration. Alternatively, the homeowner following manufacturer instructions may perform these works.

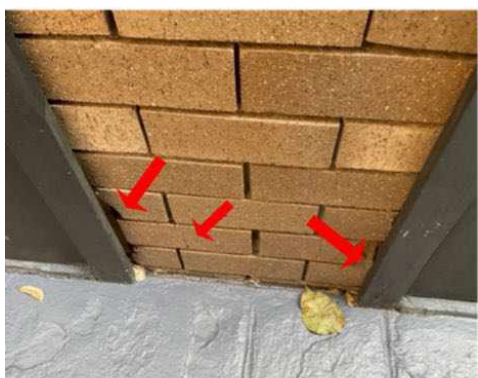
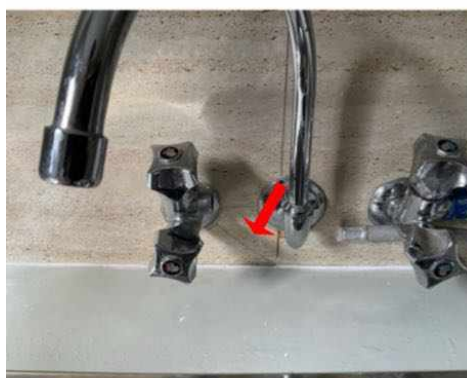
### Finding 3.07

Building: Building 1  
 Location: Pictured external areas  
 Finding: Building elements - Damaged  
 Information: Evidence of minor missing or damaged areas was identified at the time of the inspection. These include -

1. Some damaged bricks in the rear walls and small damaged areas of mortar was found in other areas not yet affecting these walls but require annual monitoring.
2. One cracked tile was found above the laundry tub.

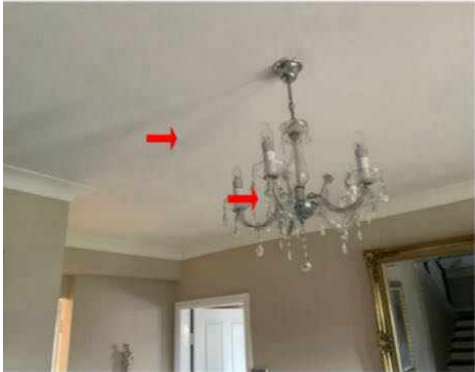
### Finding 3.08

Building: Building 1  
 Location: East bedroom and foyer  
 Finding: Ceilings - Water stained  
 Information: Water staining to ceiling linings in these 2 areas was evident at the time of inspection. Water staining indicates that surfaces have been exposed to excessive moisture over time. The minerals and other elements in the water lead to staining, which may graduate to corrosion and deterioration if left unmanaged.

While mostly an appearance defect, water staining can be indicative of more serious defects, which may be currently concealed by interior ceilings.

The owner advised the gutters were leaking last year and had them replaced in 2025. See attached receipt.

No moisture has found in these areas after 10 readings were taken.

Where water staining is active, a licensed plumber must be consulted to identify the cause of the staining and to provide advice on any reparation works that may be required. Replacement of any damaged structures is advised.

Conversely, where water staining appears to be inactive, affected building materials may be repaired or replaced at client discretion.

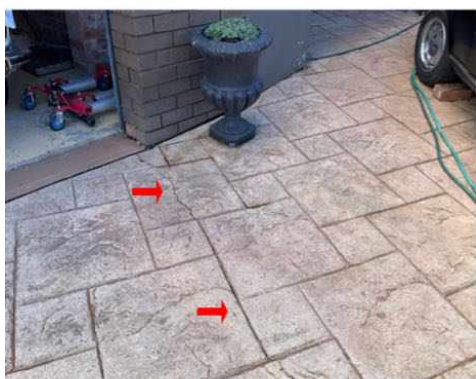
### Finding 3.09

Building:	Building 1
Location:	Yard - front and back
Finding:	Crack in concrete slabs - Category 1
Information:	Small cracks coded as Category 1 was identified in the property slabs. A Category 1 crack is described as a fine but noticeable crack, with the slab at an otherwise reasonable level. To be considered Category 1, the approximate width of the crack is less than 1.0mm, or a less than 10mm change in offset when a 3m straight edge is placed over the defect.

Category 1 cracks should be monitored for a period of 12 months. At the end of the monitoring period, identified cracks that are rated greater than Category 2 are considered defects, and require rectification.

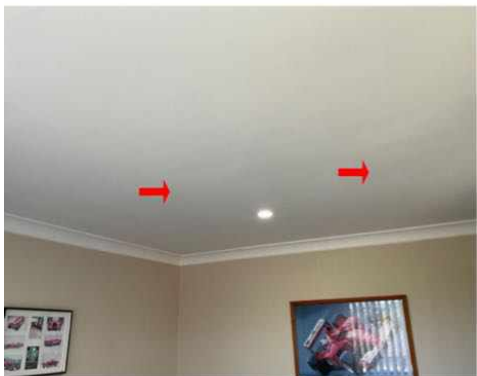
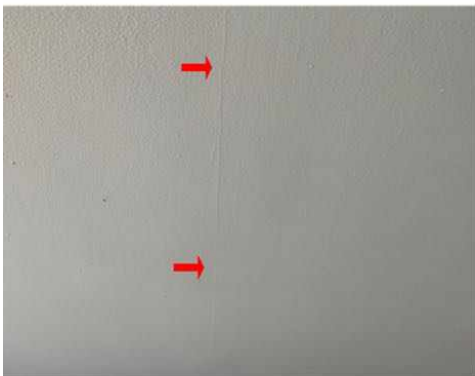
### Finding 3.10

Building:	Building 1
Location:	Lounge Room & bedroom - upstairs
Finding:	Cracking - Damage Category 0 - Hairline (less than 1mm)
Information:	Hairline cracks are very minor in nature and generally are only ever an appearance defect. While such cracking may be noticeable in some cases, it is quite common and does not indicate any structural damage.

Cracking of this nature can generally be repaired with minor sanding, filling and/or repainting. Such works should be performed by a qualified painter or a general handyman.

Monitoring of all cracking should be conducted frequently. Always contact a building inspector should cracks widen, lengthen, or become more numerous.

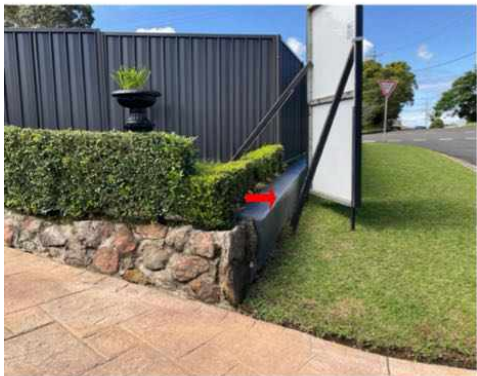
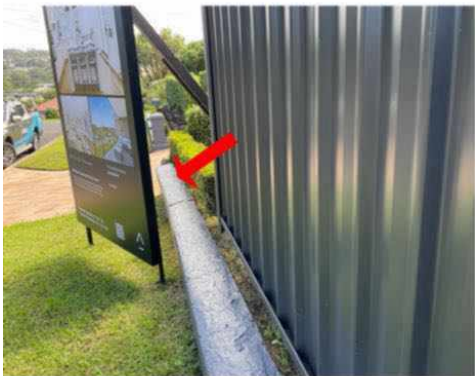
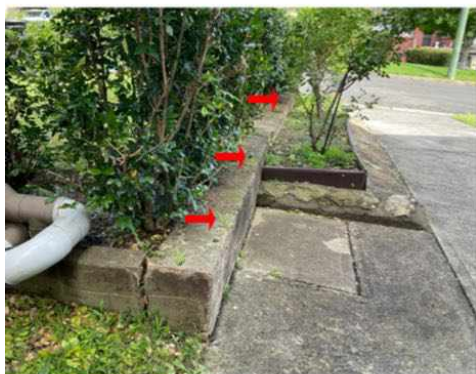
**Finding 3.11**

Building: Building 1  
Location: Pictured fences  
Finding: Fences and small retaining walls - leaning  
Information: Evidence of damage to the pictured fences/ small walls was identified at the time of the inspection. The likely cause of these low areas leaning is not enough concrete used in the footings. If left unmanaged this fences/walls may deteriorate further. It is suggest a fencing contractor be engaged for rectification when convenient.

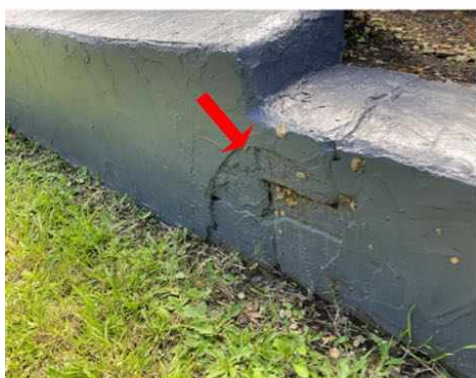
### Finding 3.12

Building:	Building 1
Location:	Yard - front
Finding:	Render (external) cracking.
Information:	It has been observed that cracking to some external rendered surfaces. The degree of damage is described as "slight" noticeable cracks which are easily filled. Cracking of this size are generally less than 5mm in width.

Always contact your building inspector should cracks widen, lengthen, or become more numerous.

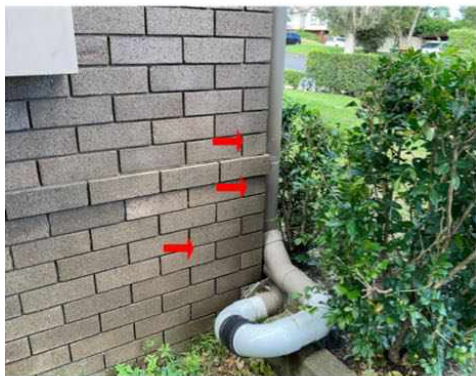
### Finding 3.13

Building:	Building 1
Location:	Exterior front left wall
Finding:	Step cracking to brickwork (minor under 1mm)
Information:	Step cracking was identified to the brickwork in this area at the time of inspection. Step cracking, which is similar to other forms of cracking, has a variety of possible causes. However, the most common is the subsidence of adjacent footings.

Step cracking is a relatively common defect, and is most likely to occur adjacent to windows, doors and other openings. Mortar failure in the gaps between affected

bricks indicates the stresses and tensions affecting the wall.

Where step cracking is extensive or severe, the client is advised to consult a structural engineer. This very minor step cracking can be used as a warning sign to address factors causing stress to the wall, which can include the effect of surrounding trees, water leaks, soil erosion, or even the presence of reactive soils in the surrounding area.

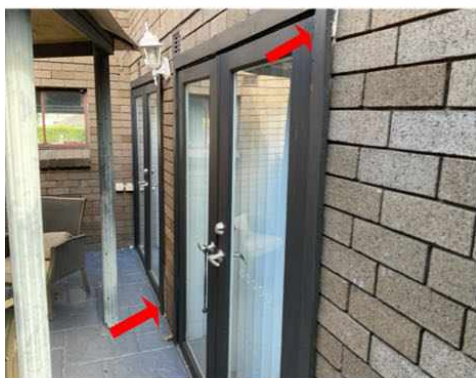
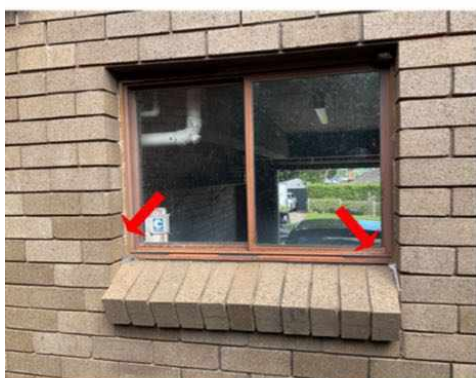
### Finding 3.14

Building:	Building 1
Location:	Window and door corner areas
Finding:	Sealant (external) - Missing.
Information:	It was noted on inspection that areas of external sealant was missing to small areas of the external walls.

Flexible sealants should be applied to these affected areas to prevent any subsequent water damage that is likely to occur.

A sealant specialist or skilled handy person should be appointed to complete these works as soon as possible

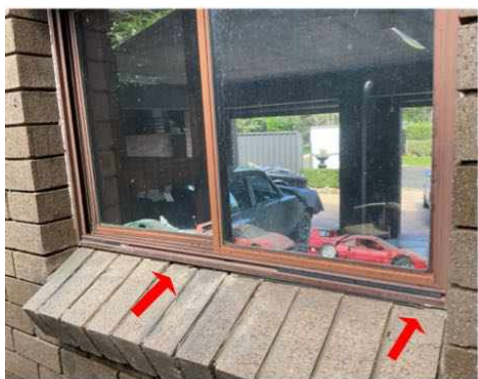
Building:	Building 1
Location:	Exterior walls
Finding:	Window seals - deteriorated
Information:	The window seals have deteriorated and are in a generally poor condition. Due to frequent exposure to weather conditions and subsequent moisture, deterioration of window seals is expected in a property of this condition and age.

Where window seals have deteriorated, the window is no longer weather-tight; rain penetration and subsequent water damage is therefore likely to ensue. Insulation of the area against external weather conditions will also be compromised.

It is recommended that all deteriorated window seals be replaced by a general handyman or sealant expert to prevent any further damage and to restore the window to a fully functional level.

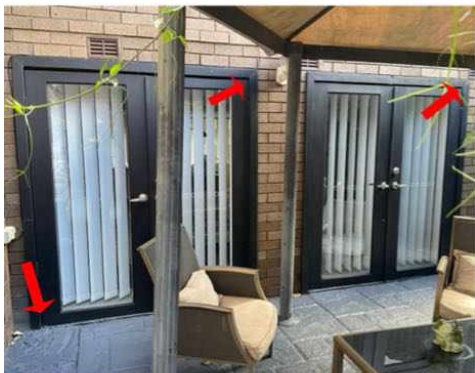
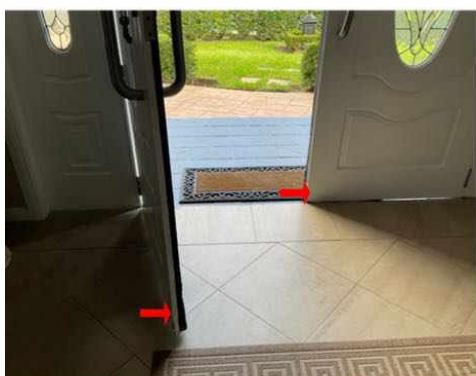
### Finding 3.17

Finding: Wood rot

Information: The building shows evidence of wood rot. Wood rot, also known as Fungal Decay, occurs when timbers and other cellulose building materials are exposed to damp conditions on an ongoing basis. This could be the result of exposure to weathering over a prolonged period of time, or the attraction of excessive moisture from other abutting building materials.

Early intervention and regular maintenance, particularly of exterior timbers, will prolong the useful life of these building elements. Prior to any works being performed, the cause of the moisture that has created the visible wood rot should be identified and addressed in a suitable manner. Replacement of affected timbers may then be a necessary step in protecting surrounding building elements from such deterioration.

A qualified carpenter or registered builder may also be required to replace affected building materials.

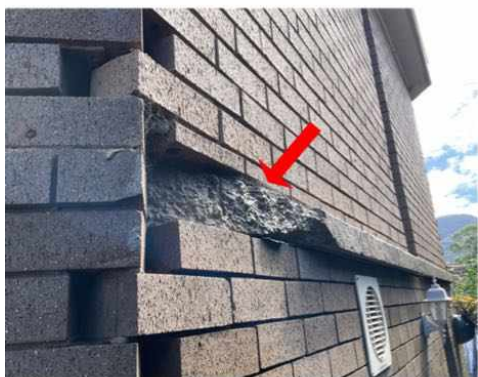
Building:	Building 1
Location:	Rear wall areas
Finding:	Concrete spalling
Information:	This area has suffered Concrete Spalling. This is the breakdown of concrete via natural

weathering and/or chemical reaction that results in sections of cement chipping off the main body – often resulting in fractured, compromised concrete. Spalling looks like pitted and scarring and breaks off in flecks which can expose rebar.

A concreting contractor can provide advice on repairs of this damaged concrete when convenient.

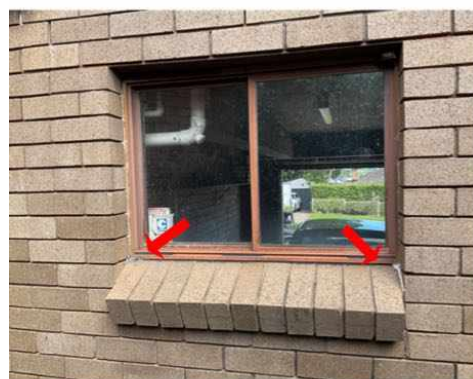
Finding: Sealant (external) - missing and attractive to termites

Information: It was noted on inspection that areas of external sealant was missing to small areas of the external walls. A flexible sealant or flashing is required to protect the associated building materials from rainwater ingress. Any moisture ingress into the property is very attractive to termites. Flexible sealants or flashing should be applied to these affected areas to prevent termite activity.

A sealant specialist or skilled handy person should be appointed to complete these works as soon as possible.

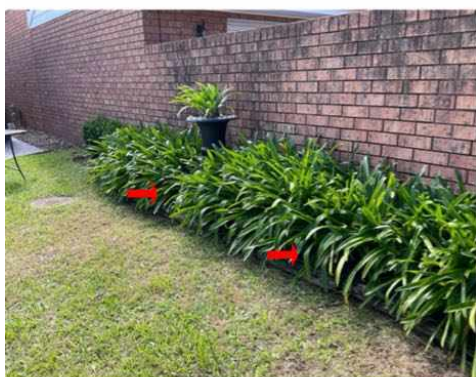
Finding: Timber in contact with the ground  
 Information: Any timbers in direct ground contact provide opportunity for concealed termite entry and are likely to be subject to premature rot and decay as the soil retains moisture or damp conditions against the timbers.

Removal of all waste timber that is in direct contact with ground is highly advised. This timber is promoting mould and wood rot and is very attractive to termites.

Frequent pest inspections are advised to readily identify any termite activity in these areas.
