## Building Inspection Report

Inspection Date: Wed, 25 Feb 2026

Property Address: 38 Stanton St, Doncaster VIC 3108,  
Australia

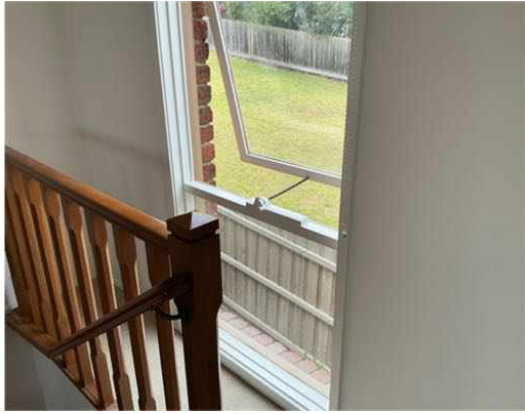
#### Defects 1.02

Building:	Main Building
Location:	Upstairs
Finding:	Windows not restricted opening
Information:	Second story windows in buildings constructed after 2013 must be fitted with devices to restrict the window opening more than 12.5cm to prevent falls. Even if this property was constructed prior to this date it is a safety hazard not to have restricting devices installed.

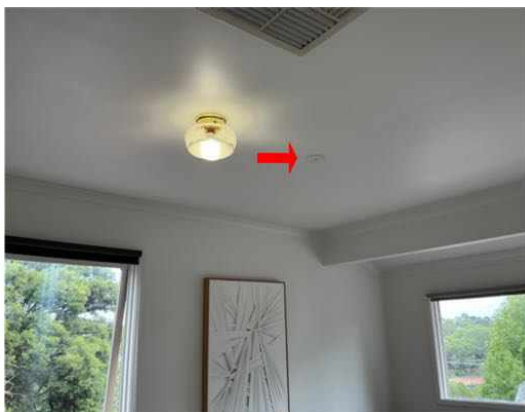
### Defects 1.03

Building:	Main Building
Location:	All Areas
Finding:	Smoke Detectors and Alarms
Information:	Reporting on Smoke Detectors or Alarms, including hard wired smoke detection systems and their legislative requirements, is outside the Scope of this Report.

Please note that this defect is highlighted as a caution only. We suspect, based on our experience in the building industry, that the absence of smoke detectors, or their poor condition, should be addressed as a matter of urgency to improve occupant safety.

Always ensure sufficient working and suitable smoke detectors are installed prior to occupying any building. Additionally, it is advised that all smoke detectors be tested by the homeowner on a monthly basis.

Please refer to AS3786 and state based legislation, which may also apply.

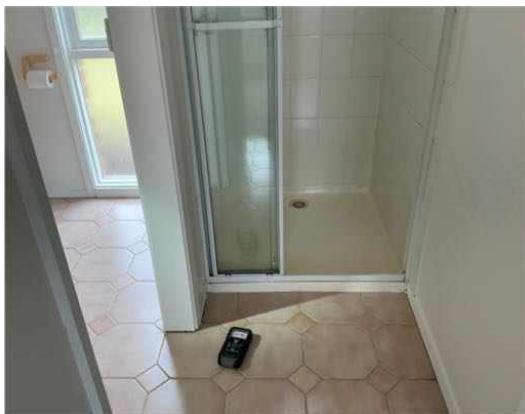
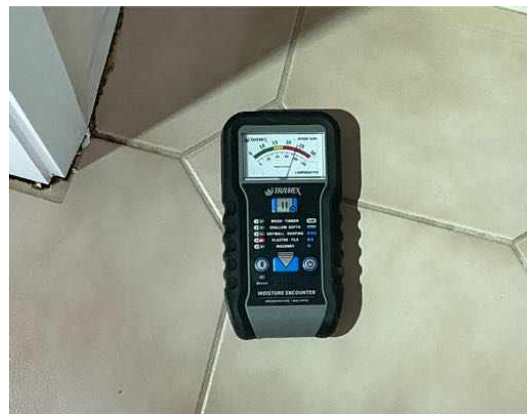
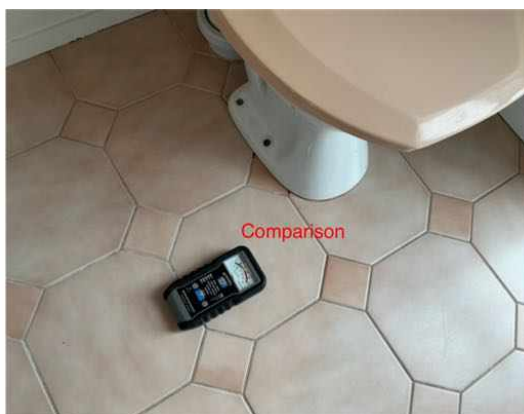
### Defects 2.01

Building: Main Building  
Location: Upstairs bathroom  
Finding: Shower - Leaking  
Information: Leaking was evident to the shower area at the time of inspection as shown in photos with the moisture meter. It is suspected that the leaking has occurred as a result of general ageing of the building elements.

Leaking from the shower base, where left unattended, is likely to lead to water damage to adjoining flooring and walls. Leaking can lead to water damage and necessitate extensive remedial works being required. Active water leaks may also create an environment that is susceptible to the formation and development of mould.

1/The leaking upstairs shower which will need the tiling and waterproofing to be replaced, this is considered a major defect for rectification.

Appointment of a tiling contractor is required to replace the shower the bathroom waterproofing and tiling. Such works should be performed as soon as possible to ensure that no further damage occurs.

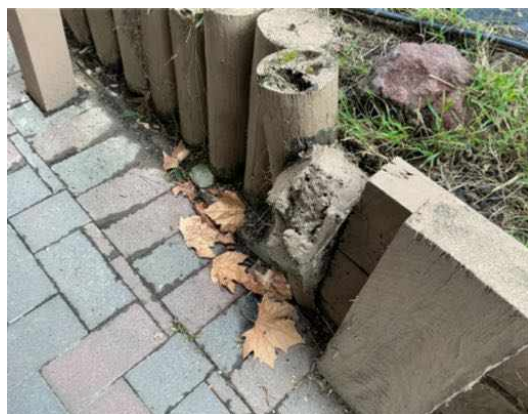
**Defects 3.01**

Building: Main Building  
Location: All Areas  
Finding: Retaining wall - Defective  
Information: The retaining wall in this are was found to be defective at the time of inspection. Generally, defective retaining walls are caused by poor original design or material use. However, deteriorated retaining walls may also be a result of substandard construction, poor site drainage or unmanaged stormwater flows.

If left unmanaged, the retaining wall may become a safety hazard if it continues to destabilise. Where retaining walls further rot and decay, an environment is created that is conducive to termite and pest infestation.

Significant repair and replacement should be expected. Where retaining walls are considered structural walls, a structural engineer / surveyor should be consulted regarding required remedial works. Otherwise, a landscaper or retaining wall installer may be appointed to repair or replace the wall, at the discretion of the client.

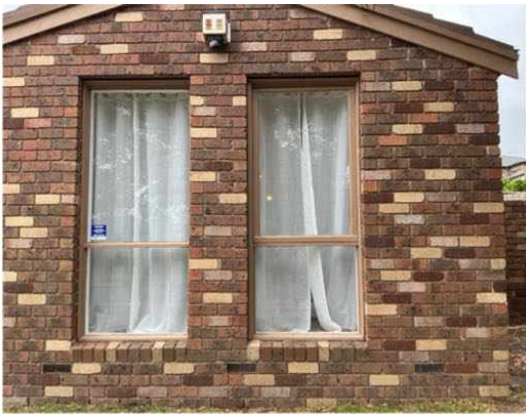
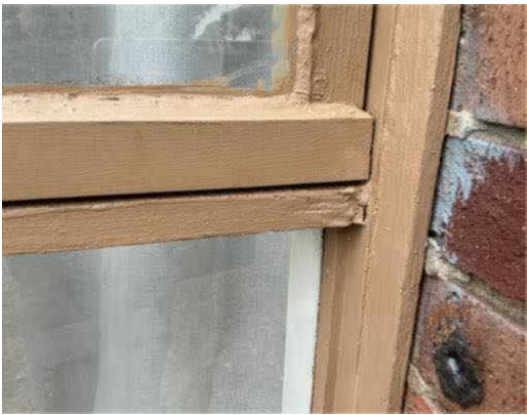
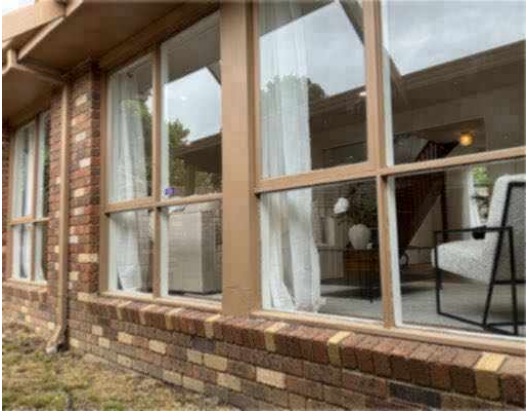
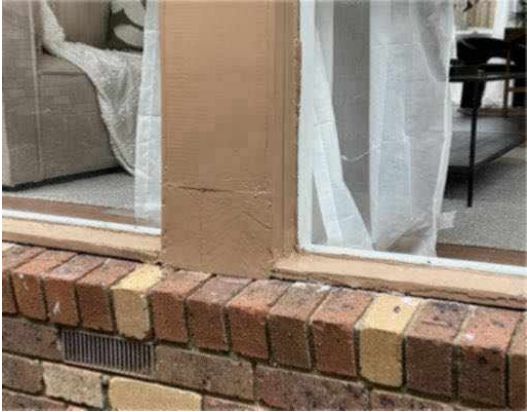
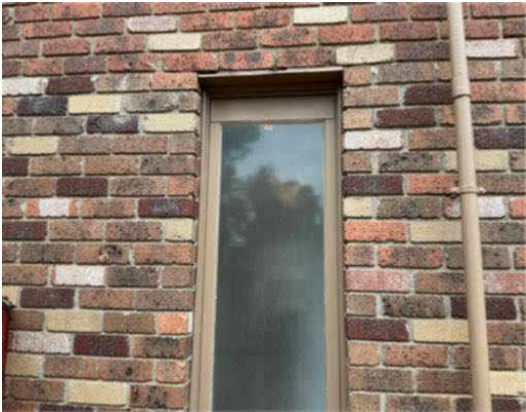
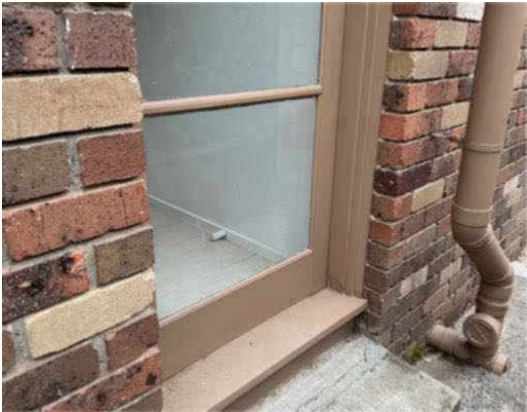
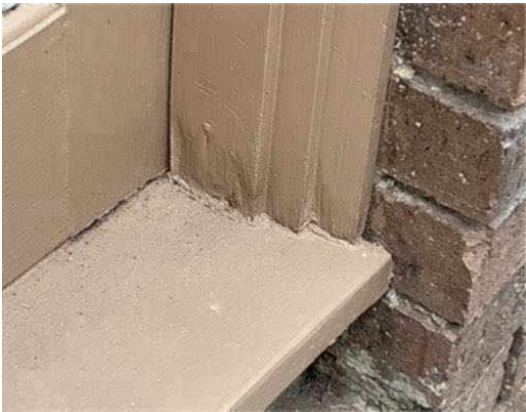
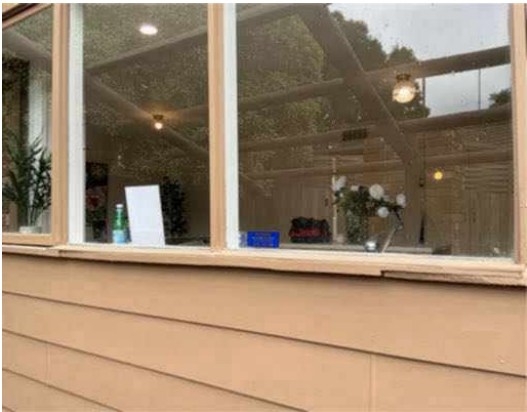
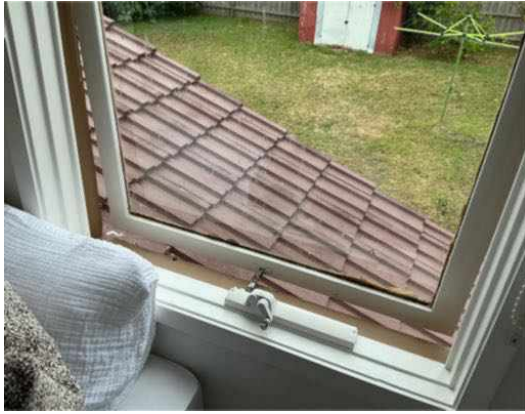
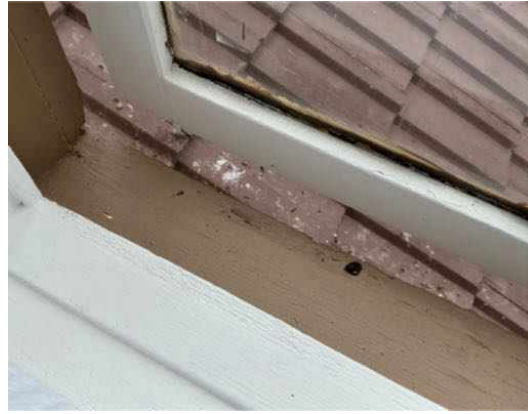
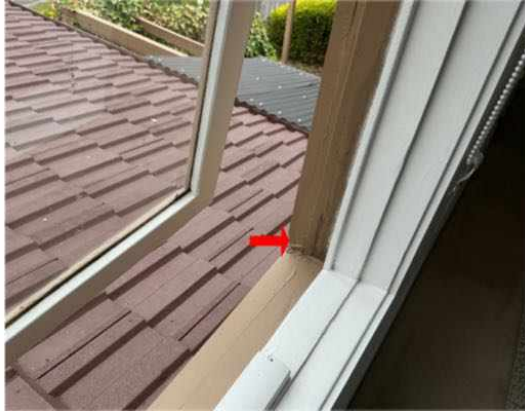
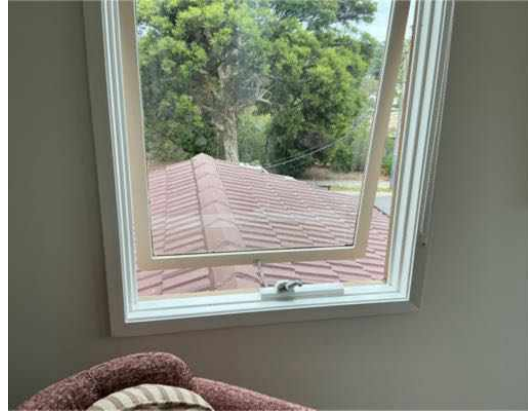
### Defects 3.02

Building:	Main Building
Location:	Windows and external doors
Finding:	Windows - Wood rot most windows
Information:	Wood rot was found to be affecting external windows. Wood rot, also known as Fungal Decay, occurs when timbers and other cellulose building materials are exposed to damp conditions on an ongoing basis.

It is likely that this wood rot has developed as a result of frequent exposure to rain and other weather conditions. It is suspected that failure to maintain the window frames over a prolonged period has resulted in them deteriorating at an accelerated rate, increasing their susceptibility to the development of wood rot. Leaks in roof plumbing or associated pipework may have also contributed to the formation of the wood rot in this area.

2/The windows with extensive woodrot, many of these will need to be repaired or replaced, these works may prove costly, purchasers should be prepared to meet these costs.

Early intervention and regular maintenance will prolong the useful life of these building elements. Prior to any works being performed, any associated pipework or roof plumbing should be inspected by a licensed plumber for faults or leaks.

Repair and/or replacement of affected window frames may be a necessary step in protecting surrounding building elements from such deterioration. Remedial works should be performed by a qualified carpenter or registered builder as soon as possible to prevent any further damage.

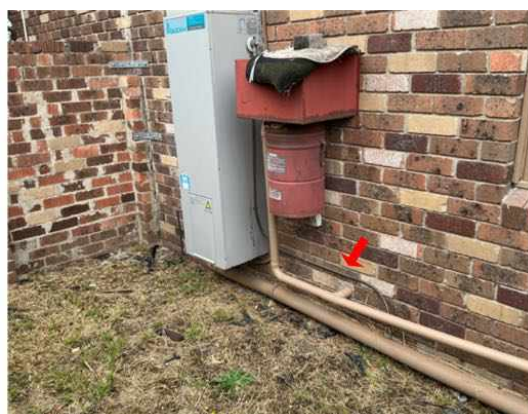
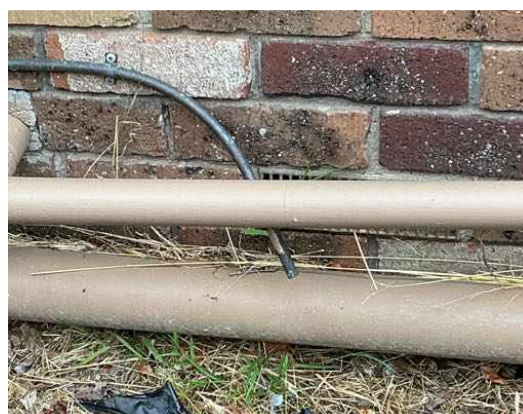
Finding: HWS Overflow - Not Connected  
 Information: The Hot Water System (HWS) overflow was found to be disconnected from storm water drainage and is creating excessive moisture in the surrounding area.

These damp conditions can lead to secondary defects such as rot, rust or corrosion of associated building elements, the formation of fungal decay, or even the creation of potential slip hazards. When coupled with poor site drainage, pooling of water may also attract termite activity to this area.

It is highly recommended that a licensed plumber be appointed to connect the HWS overflow in order to prevent such an environment from being created. These minor works should be carried out as soon as possible.

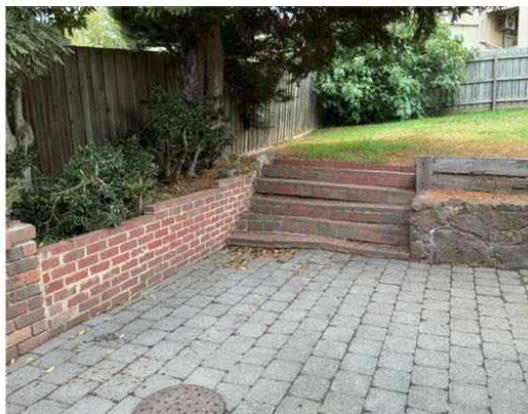
### Defects 3.05

Building: Main Building  
 Location: Rear Elevation  
 Finding: Subsidence - Local trees and vegetation  
 Information: Trees and other vegetation can have a significant local effect on drying of soils. Over a number of years, especially during drought conditions, adjacent trees and vegetation may draw excessive moisture from the soils. The opposite may also occur, where swelling of the soil results when the trees decline or are removed.

As the cumulative moisture deficient is reversed, the surface level around the tree will rise and expand laterally. This is often damaging to buildings and landscaping unless the foundations have been strengthened or designed to cope with the effect.

Subsidence can have complex and varying causes, which will influence the required remedial works.

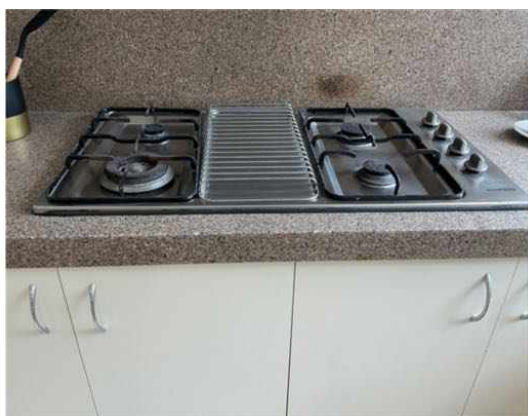
### Defects 3.06

Building:	Main Building
Location:	Kitchen
Finding:	Building element - Not operating igniters to stove top
Information:	Non-operational items should be addressed to ensure that the full function of the building structure is available. Where some building elements are not operating as intended, it is possible that secondary building defects could arise due to their non-operation.

Repair and/or replacement of the faulty building element is recommended. It is highly recommended that the relevant tradesperson be engaged to perform any necessary works.

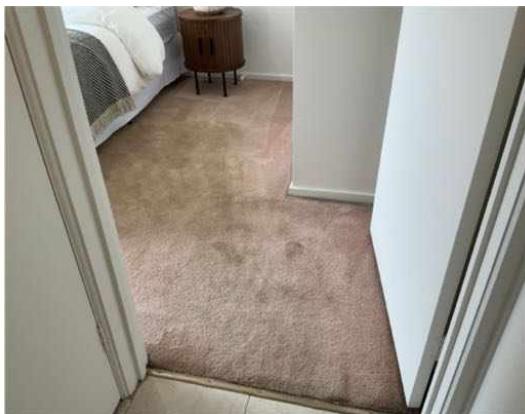
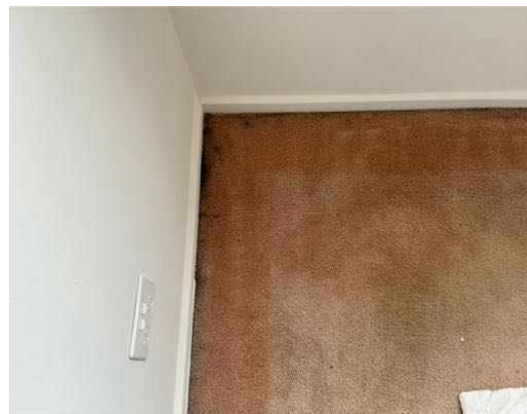
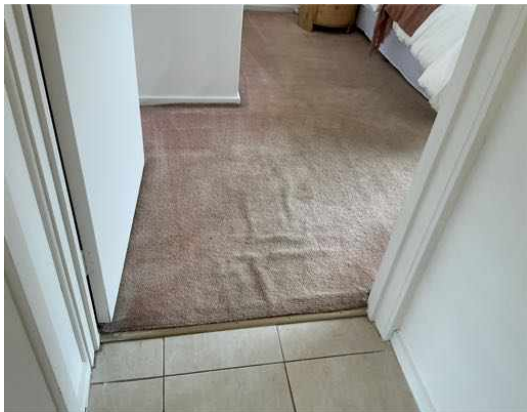
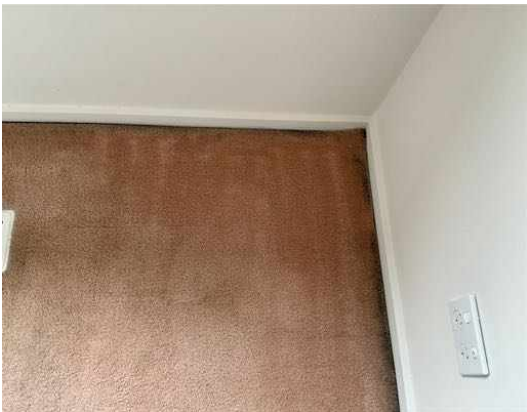
### Defects 3.08

Building:	Main Building
Location:	Downstairs Carpet
Finding:	Carpet - Deteriorated
Information:	Sections of the carpet floor covering throughout were worn and stained, these carpets may be replaced at the clients convenience.

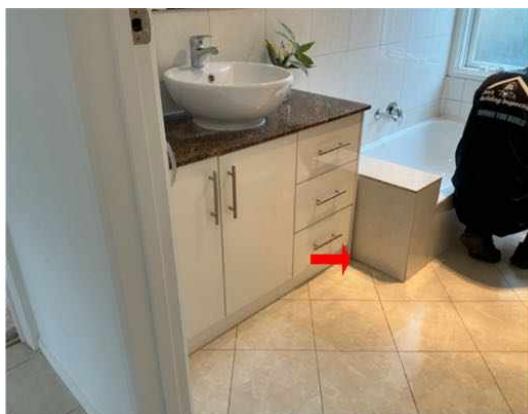
### Defects 3.10

Building:	Main Building
Location:	Bathroom
Finding:	Building element - Swollen
Information:	Swollen building elements generally indicate that the building materials have been affected by excessive moisture over a prolonged period of time, and have swollen as a result. The formation and development of mould/fungi or mildew is also a likely consequence of excessive moisture, which may pose major respiratory issues for occupants, particularly the elderly, the very young and those with existing illnesses and could be potential health safety hazards. In these cases an appropriately qualified inspector/tester should also be contacted for advice and/or technical assistance.

The structural integrity of swollen building elements can not be guaranteed, and further damage is likely to develop if left unmanaged. Excessive moisture is likely to lead to the development of secondary damage to any associated building elements, which may necessitate major reparation works if prolonged.

Rectification of the cause of the water leak should be addressed prior to any remedial works to the swollen building elements. A licensed plumber should be appointed immediately to identify the cause of the leak and provide advice on remedial works as necessary. Repair and/or replacement of swollen building elements should be conducted as a matter of urgency by a registered builder or qualified carpenter.

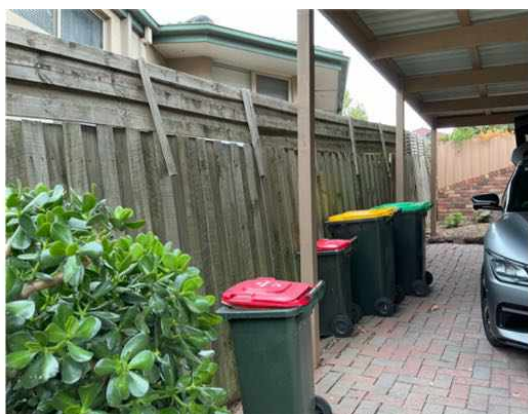
### Defects 3.11

Finding: Fencing - Deteriorated

Information: It was noted at the time of inspection that sections of the fencing throughout the property have deteriorated. Typically fencing deteriorates due to age and or wear, rot and or rust which is generally expected for a structure of this age, due to prolonged exposure to weather conditions. Sometimes inadequate installation or maintenance can be to blame.

If left unattended, it is likely that further damage will occur. It is suspected that repair of several elements of the fencing may be required however replacement may be a consideration of the client also.

A licensed fencing contractor should be appointed to provide further advice and perform rectification works as necessary.

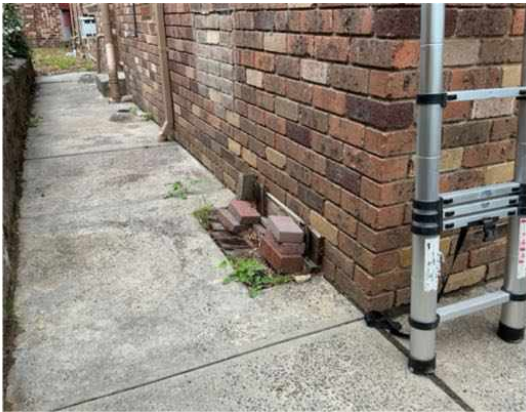
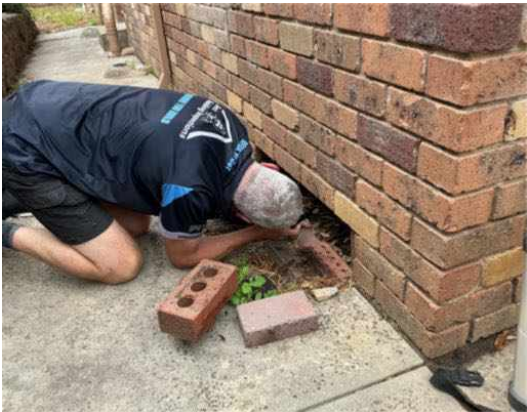
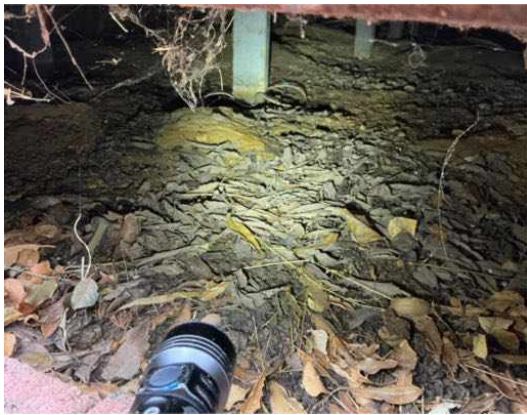
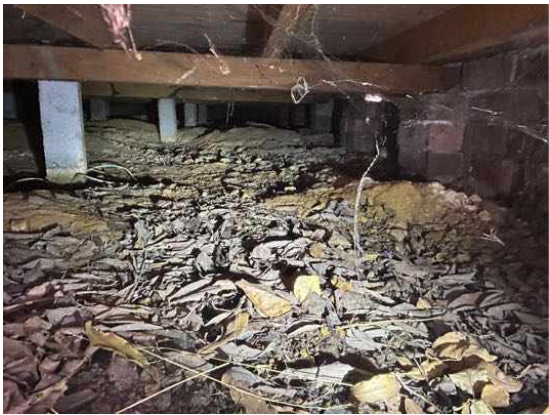
**Noted Item**

Building: Main Building  
Location: Subfloor  
Finding: Subfloor access limitations  
Information: No access to the subfloor was present due to facts including but not limited to access hatch size or placement, for this reason access to the subfloor was not possible.

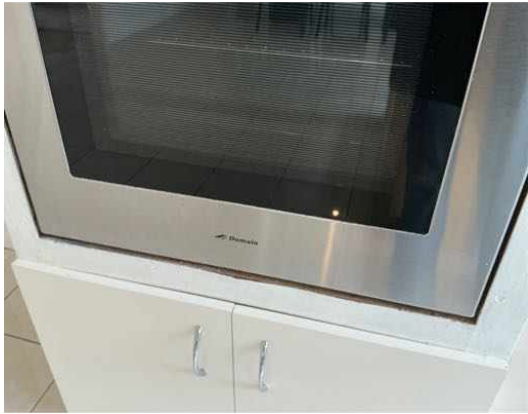
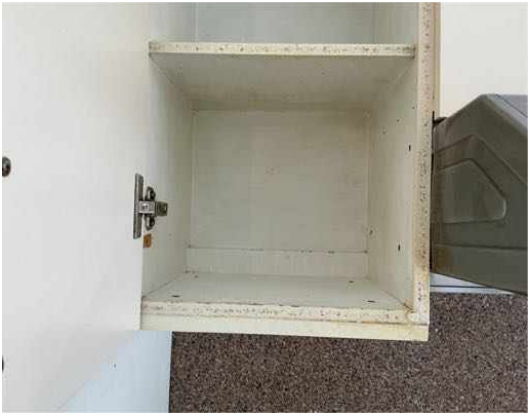
Noted Item

Building: Main Building  
Location: All Areas  
Finding: Deteriorated elements  
Information: It was identified that some items around the home have suffered from environmental effects and wear and tear with replacement required.

Secondary defects are likely if the issue is not addressed.

Elements such as bolts and structural brackets may require the services of a builder where replacement is required other wise a carpenter or handy man can attend to the more general replacement requirements such as loose hinges, door handles, fixtures etc.
