Building and Timber Pest Inspection Report

Inspection Date: Mon, 12 Jan 2026

Property Address: 947 Centaur Rd, Hamilton Valley NSW
2641, Australia

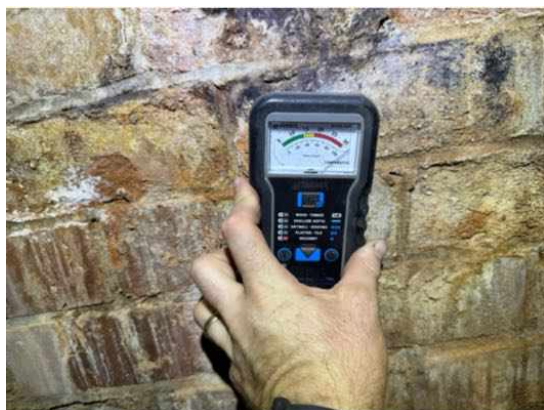
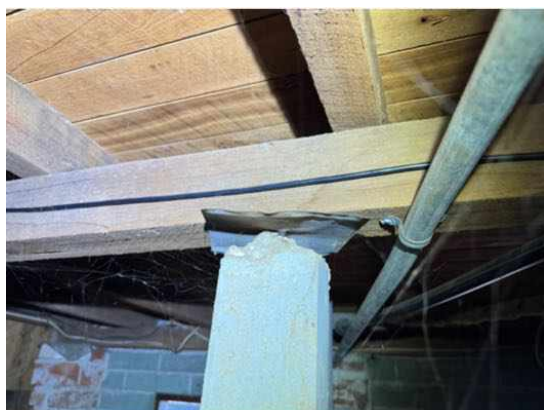
Finding 3.01

Building: Main Building
Location: Carport, Subfloor
Finding: Brickwork & Concrete Piers - Deterioration (Fretting) & Rising Damp
Information: Deterioration (fretting), was evident in some areas of the carport brickwork and some concrete piers. High moisture (Rising damp) was also evident in these areas.

Recommend engaging a damp proofing specialist in the short term, to provide further advice and remedial works. The client should monitor the fretting. Should further deterioration occur, a structural engineer should be engaged to provide further advice. Further deterioration is likely to occur, if neglected.

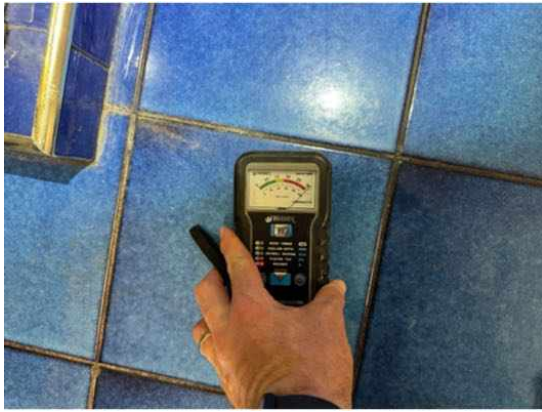
Finding 3.02

Building:	Main Building
Location:	Bathroom Floor
Finding:	Bathroom - High Moisture In Floor
Information:	<p>Evidence of high moisture was identified at, but not limited to the bathroom floor. Causes of high moisture in the flooring could be attributed to water pooling in the area, associated leaking and/or insufficient use of preventative measures such as bath mats.</p> <p>Preventative measures such as using a bath mat should be taken by the client. Should further excessive moisture in the flooring become apparent, a licensed tiling contractor and/or licensed plumber should be engaged for further evaluation and remedial works where necessary.</p>

High moisture was identified at, but not limited to the bathroom floor. Recommend engaging a licensed plumber to provide further advice and remedial works where necessary.

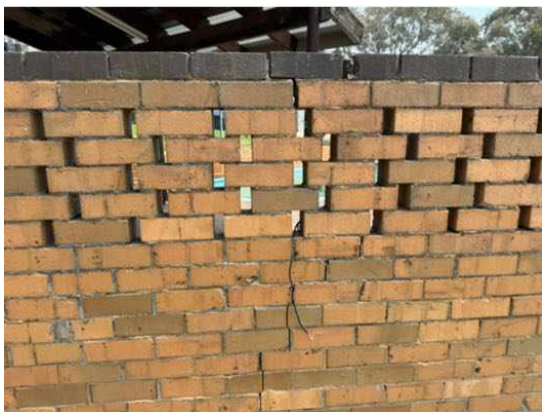
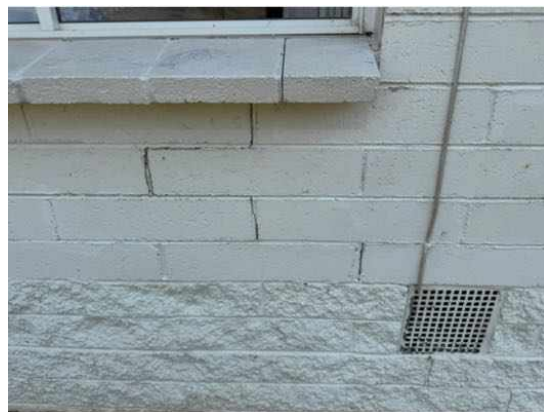
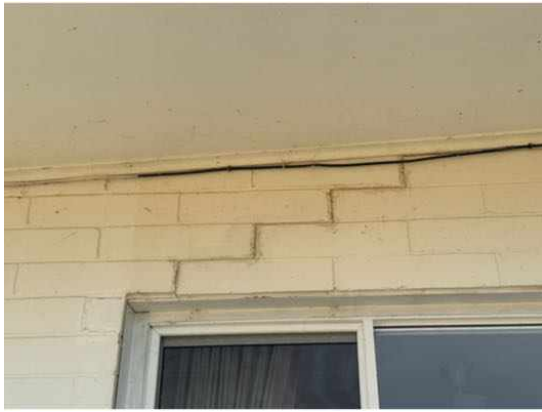
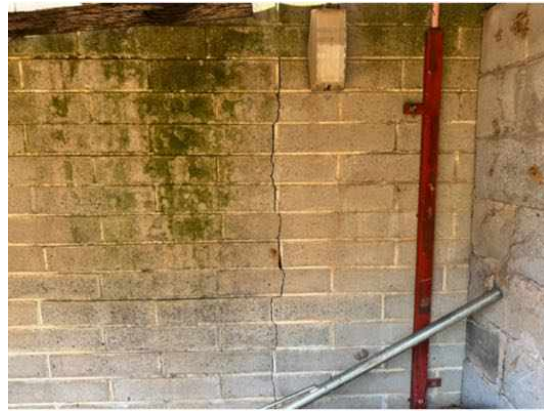
Finding 3.03

Building:	Main Building
Location:	Carport, Pool Fence, External Brickwork
Finding:	Brickwork - Step cracking
Information:	Step cracking was identified to areas of the carport, pool fence & main building brickwork. Step cracking, has a variety of possible causes. However, the most common is general movement of adjacent footings.

Step cracking is a relatively common defect, and is most likely to occur adjacent to windows, doors and other openings. The client should monitor the cracking. Should the step cracking lengthen, widen or become more numerous, the client should contact a structural engineer, to provide further advice.

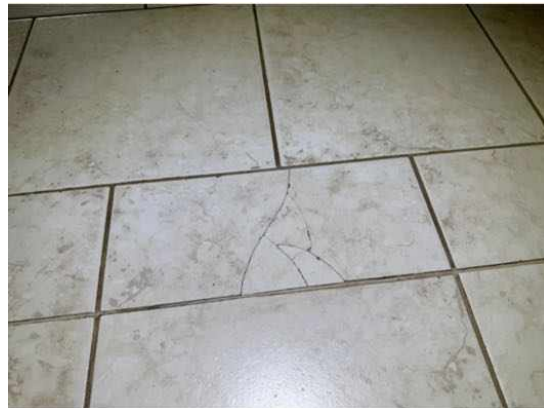
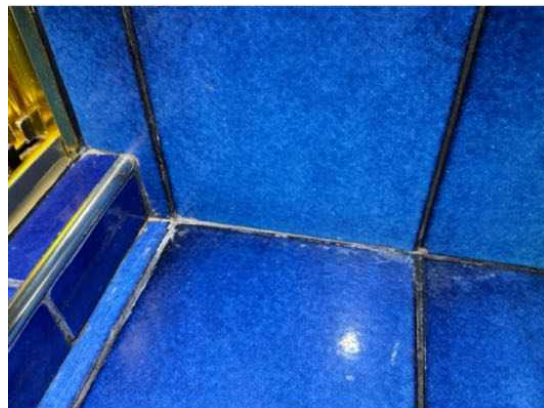
Finding 3.04

Finding: Sealant / grouting - deteriorated or missing & Cracked Tiles

Information: It appears that the sealant and grout has deteriorated in some tiled areas, a common defect in buildings of a similar age. Areas of cracked tiles were also noted. Sealant and grouting in areas that come into regular contact with water should be maintained for the long term care of your property.

Recommend engaging a licensed tiling contractor in the short term, to provide maintenance works where necessary.

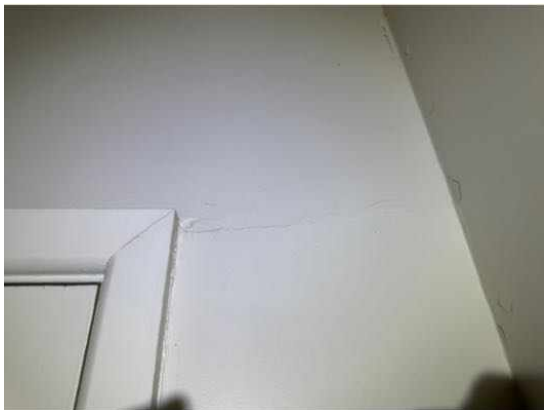
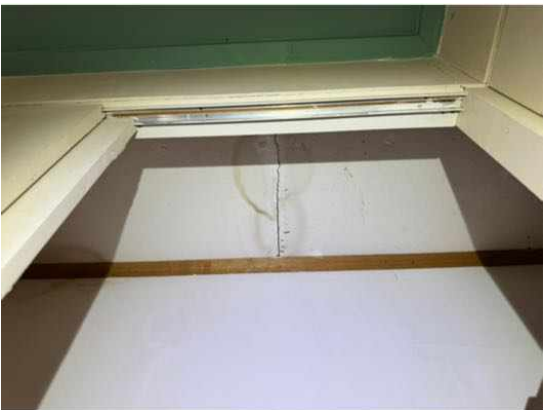
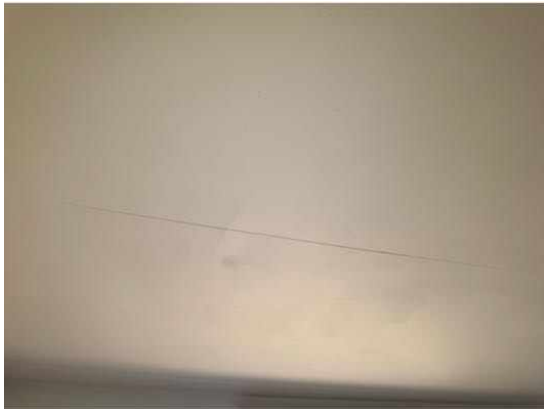
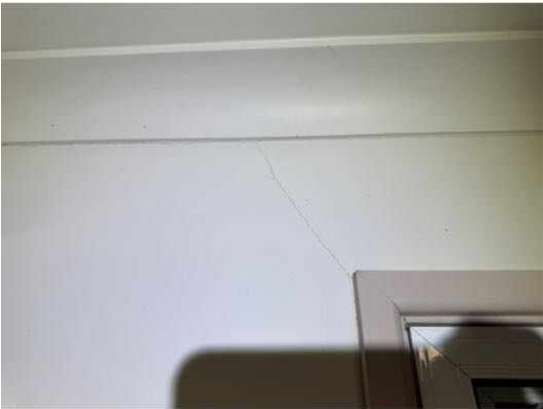
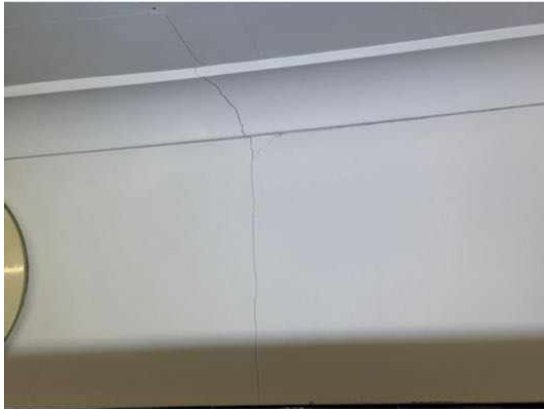
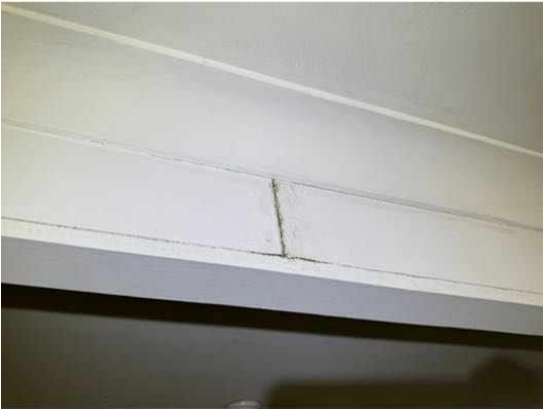
Finding 3.05

Finding: Plaster - Cracking

Information: There appears to be cracking in some areas of the ceiling and wall linings throughout the building. Cracking of this type is common in buildings of a similar age. Although this is mostly a visual defect, it is advised that the client monitor these areas.

Should cracking widen, lengthen, or become more numerous, the client should consult with a structural engineer for further evaluation.

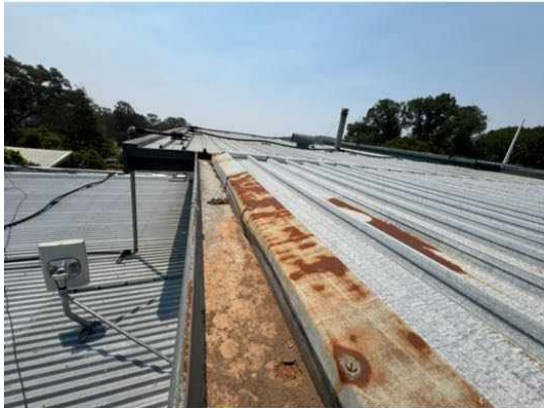
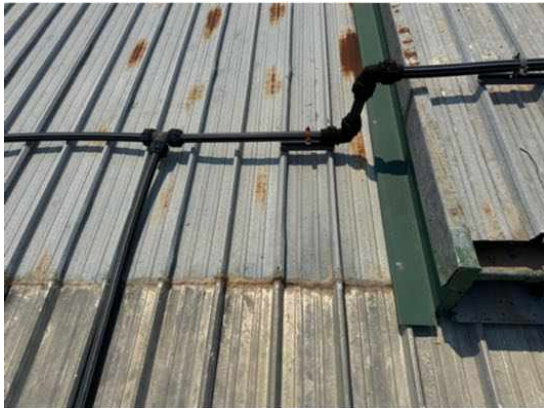
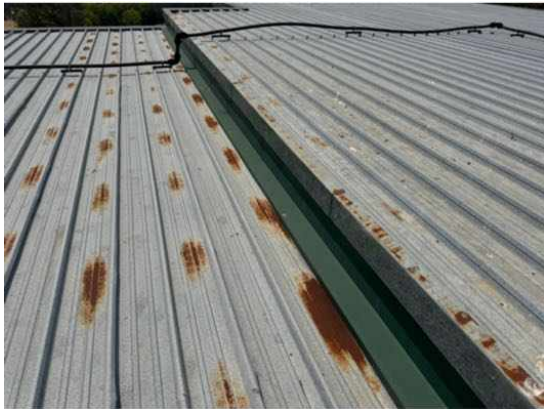
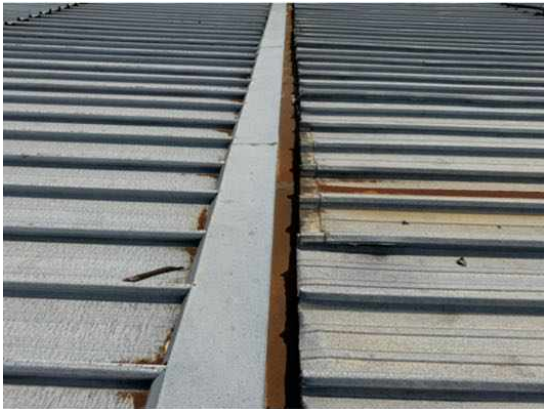
Finding 3.06

Building: Main Building
Location: Roof Exterior, Gutters
Finding: Roof Exterior & Roof Plumbing - Weathered, Rust
Information: Rust and weathering was identified to areas of the roof exterior and roof plumbing. While weathering of the roof exterior & plumbing is consistent with the age of the property, maintenance works are advised. Areas of roof sealant were also found to be weathered and should be maintained.

Where left unmanaged, rusted & weathered roof sheeting and plumbing is likely to lead to secondary defects, including water leaks. Recommend that the client consult with a licensed roofing contractor in the short term, to provide further advice on maintenance works required.

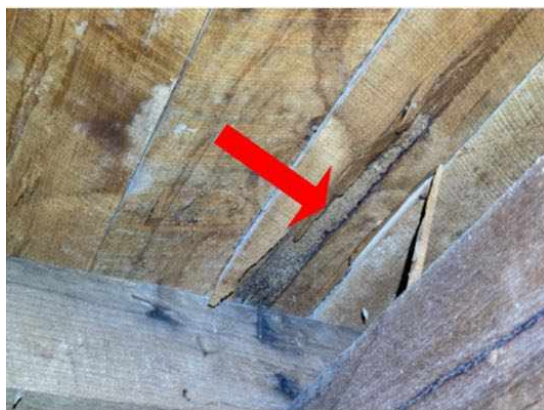
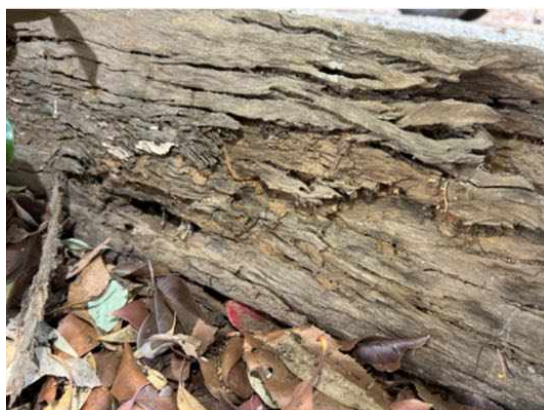
Finding 5.01

- Building: Main Building
- Location: Tree, Landscaping Timbers, Subfloor
- Finding: Evidence of termite workings & damage
- Information: Evidence of termite damage & workings were identified at, but not limited to, areas throughout the subfloor, external landscaping timbers, and a tree next to the shed.

The client should engage a licensed pest controller in the short term, to provide further advice regarding installation of a termite treatment. 6 monthly termite inspections, conducted by a qualified termite inspector, are also recommended

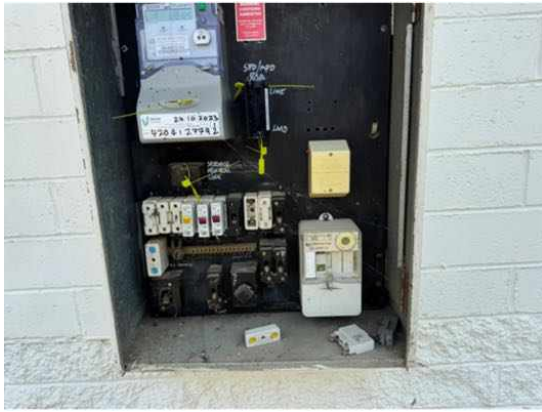
Finding 6.01

Building:	Main Building
Location:	Switchboard
Finding:	Termite Management System - no evidence of a chemical installation
Information:	The application of a termite barrier is strongly recommended, as it appears no termite management system has been installed, with no evidence or durable notice to suggest works taking place. Generally, a durable notice is placed in the meter box to indicate current termite barriers.

Such barriers are highly effective in preventing termite attack on the building and therefore should be installed. Recommend seeking further advice from a licensed pest controller.

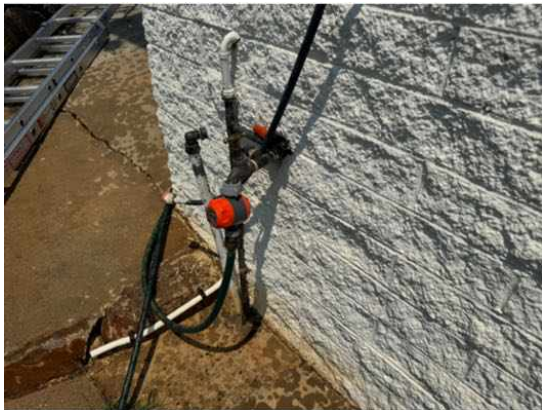
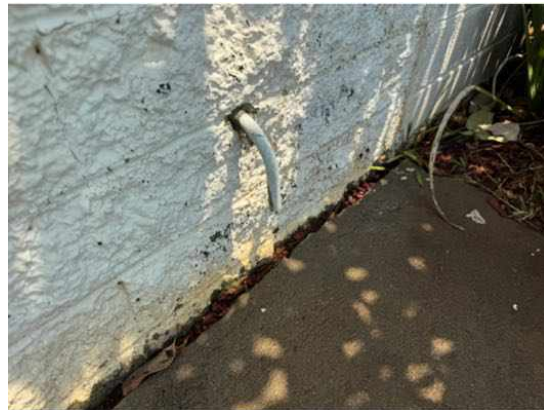
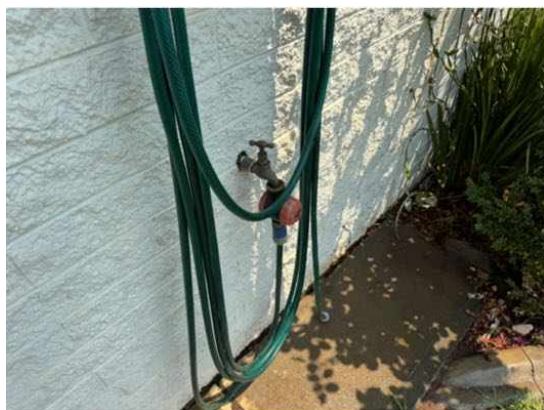
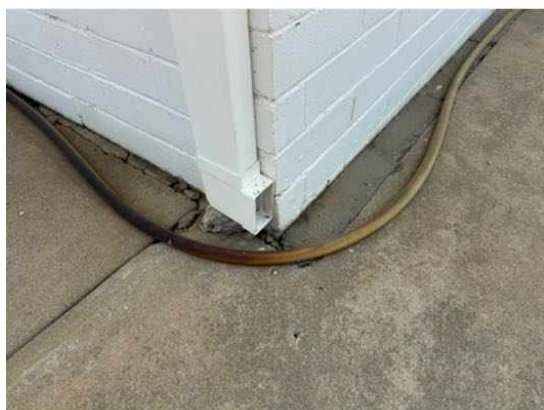
Finding 6.02

Building:	Main Building
Location:	All external areas, Downpipes
Finding:	Potential Water pooling - against property
Information:	It appears that there are potential areas around the perimeter of the property that could be susceptible to water pooling. Some down-pipes were also found to be disconnected from drainage.

Where insufficient drainage of taps, roof plumbing, and hot water system & aircon overflows are present, water pooling is likely to occur, and can create areas conducive to timber pests and potential damage to the subfloor structure overtime, if neglected.

Recommend engaging a licensed plumber to provide further advice & remedial works.

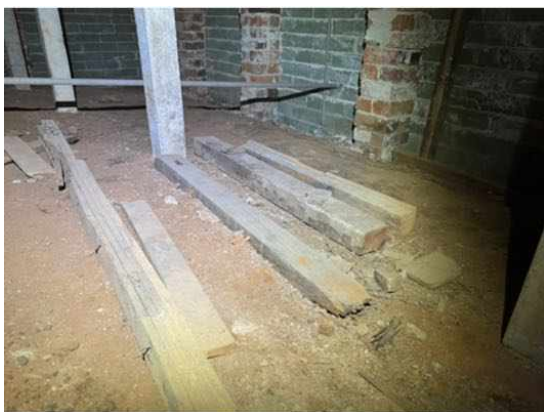
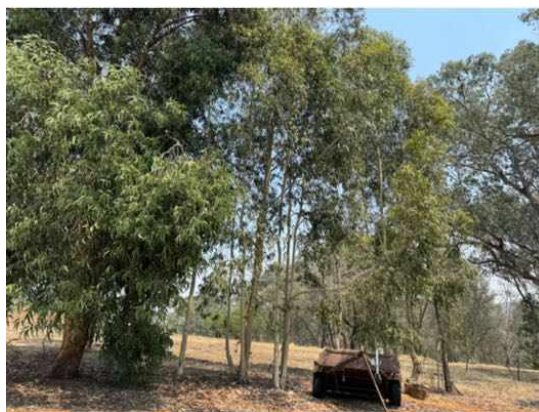
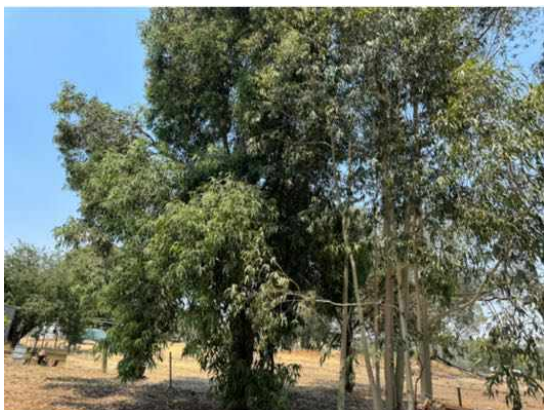
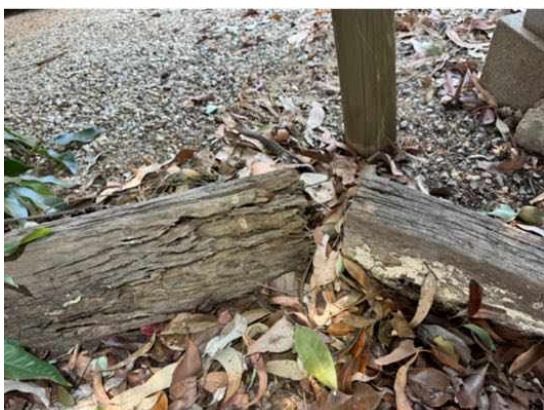
Finding 6.03

Building:	Main Building
Location:	All External Areas, Subfloor
Finding:	Timber in direct ground contact & trees - conducive to termites
Information:	Where timber materials are in direct contact with the ground and consequently moisture, they become conducive to termite activity. The timber piers, timber debris in the subfloor, tree stumps, and trees surrounding the building create an environment conducive to termite infestation.

Where feasible, any timbers in direct contact with the ground should be removed and any trees in close proximity to the building should be removed or test drilled (inspected) at least annually to reduce the risk of termite infestation & detect any early signs of termite activity.

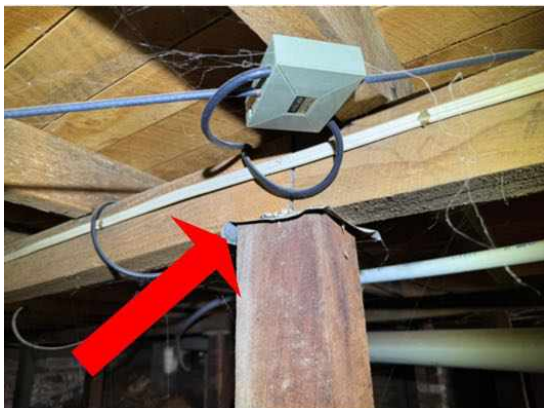
Finding 6.04

Building:	Main Building
Location:	Subfloor
Finding:	Ant caps - Inadequate
Information:	It was found that some ant caps that have been installed are inadequate. Ant caps are designed to easily identify termite or pest ingress from stumps to the adjoining bearers.

Where ant caps are inadequate, this poses as an obstruction to the inspection and frequent monitoring of these areas should be carried out in order to identify any early signs of termite workings. Recommend engaging a licensed carpenter to install adequate ant caps to the subfloor.

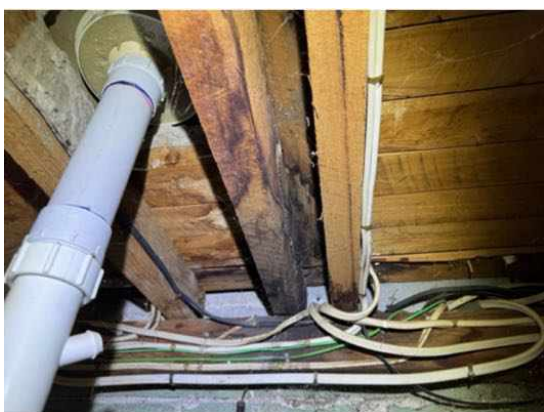
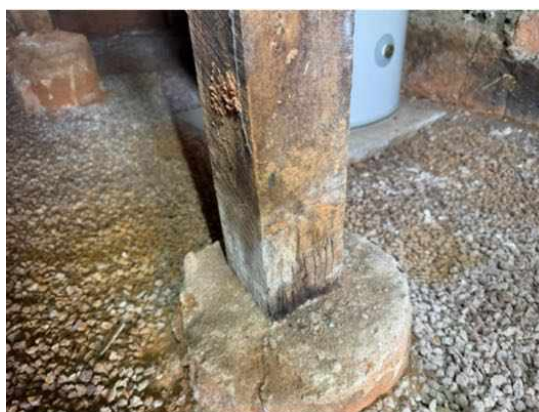
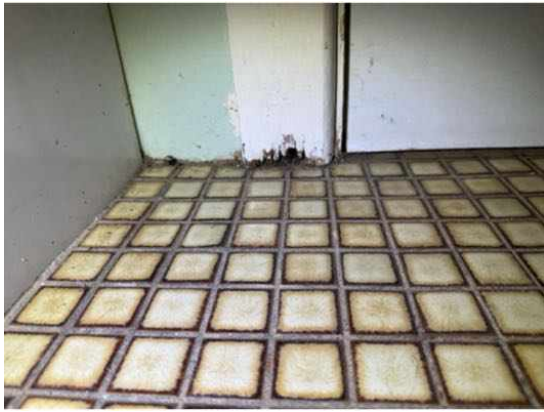
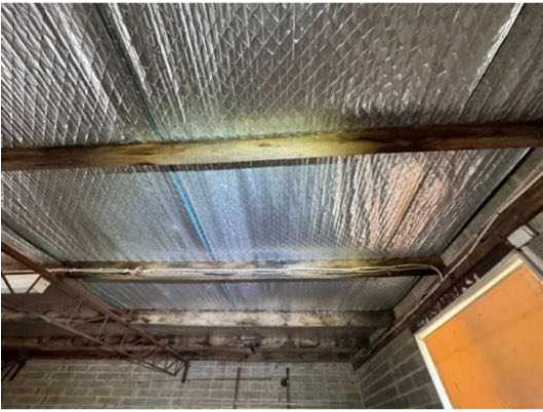
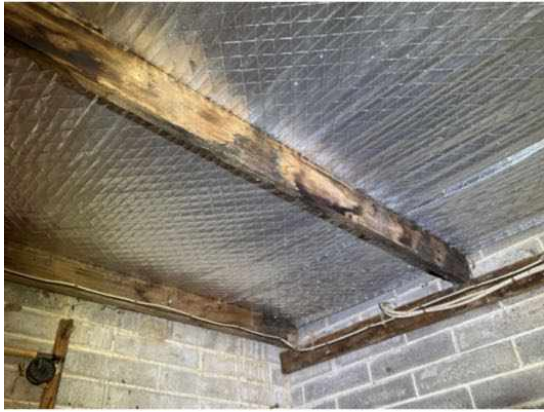
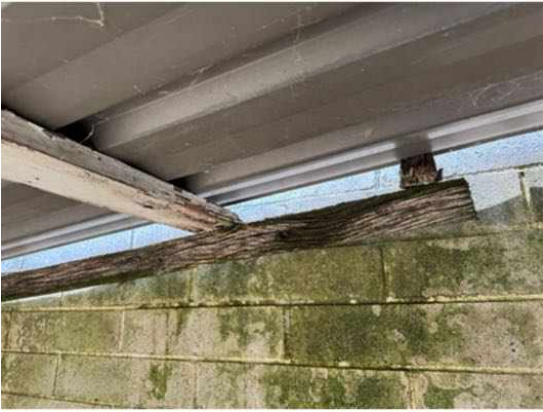
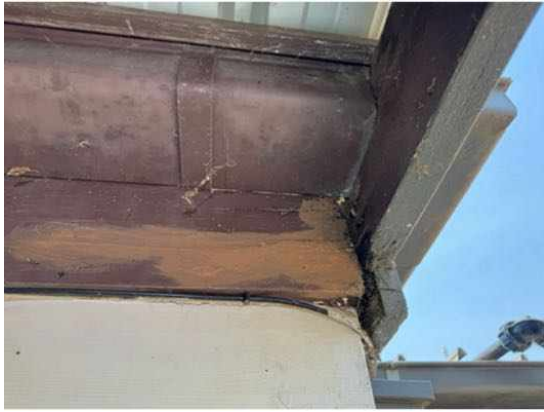
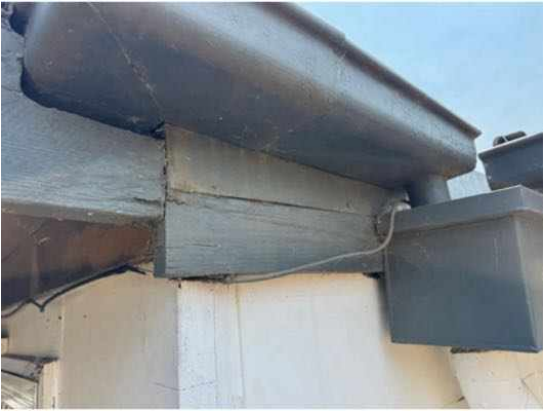
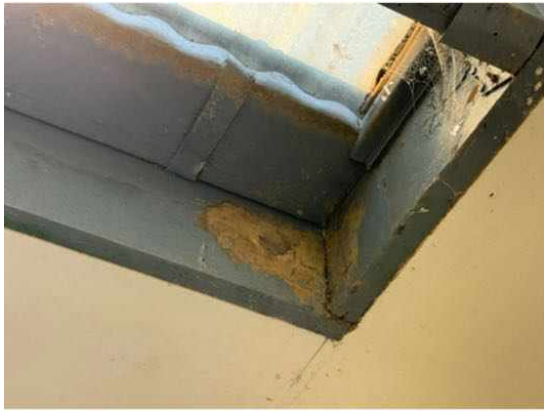
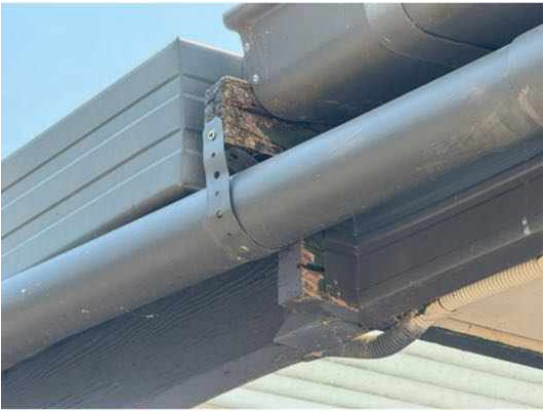
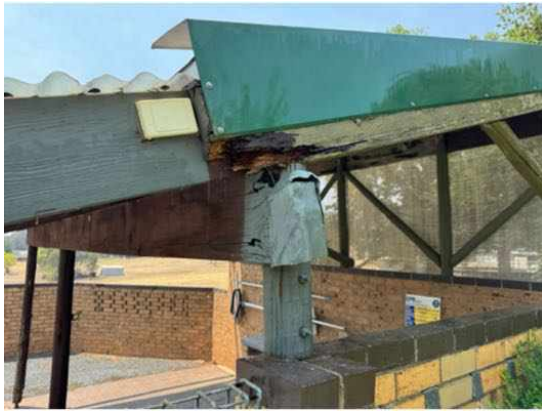
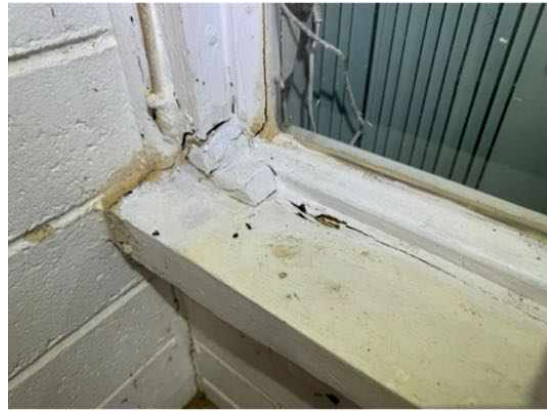
Finding 7.01

Building:	Main Building
Location:	Subfloor, Stumps, fascia's, Patio, Pool Area & Shed Framing, architraves
Finding:	Fungal decay & weathering
Information:	Areas of fungal decay (wood rot) were identified at but not limited to areas of the subfloor, timber piers, fascia's, patio and shed framing, pool area framing, some architraves and window frames.

For areas of fungal decay, the client can engage a licensed carpenter at their discretion to replace affected materials. For areas of general weathering, it is advised the client engage a licensed painter to provide maintenance works. The client should monitor the condition of the timber piers. Should further deterioration occur, a structural engineer should be engaged to provide further advice & remedial works.

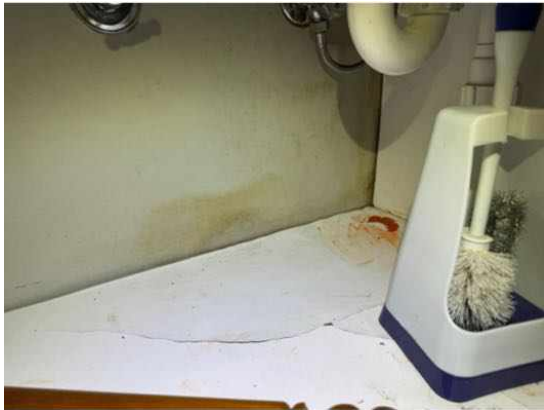
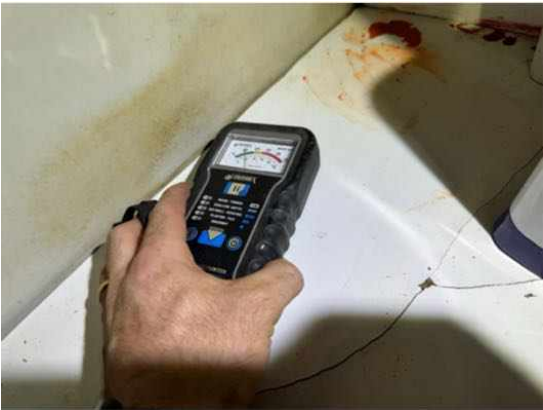
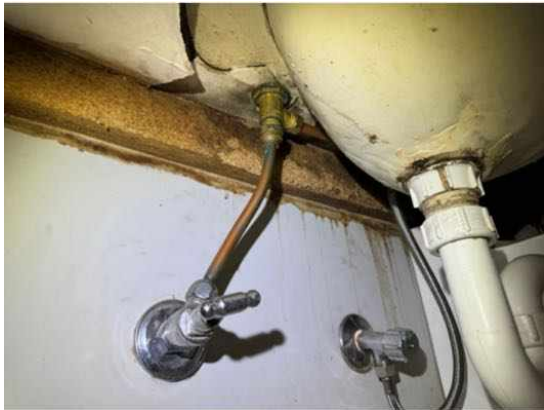
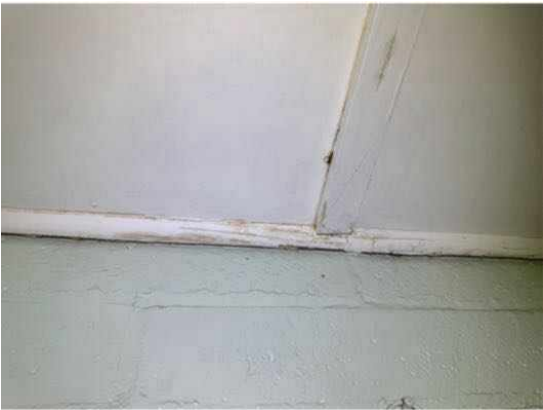
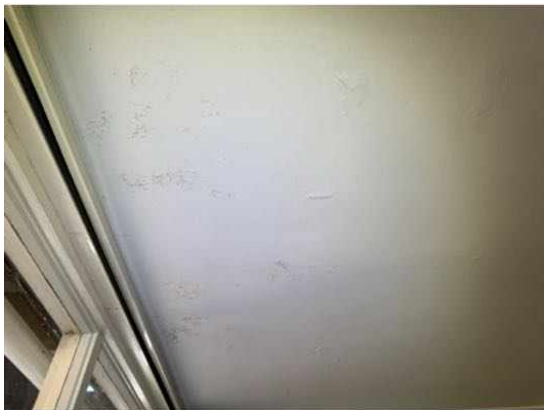
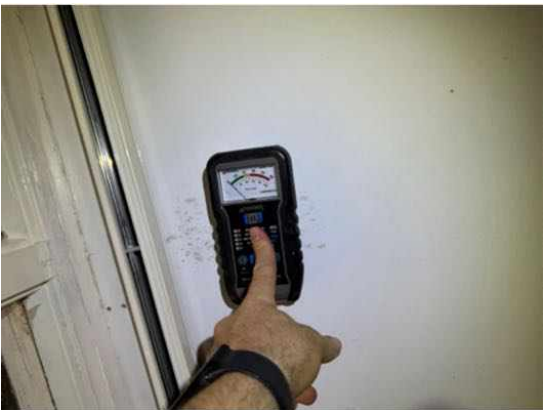
Building: Main Building
 Location: Bedroom Cupboards, Lounge Room Ceiling, Bathroom & Ensuite Vanities
 Finding: Water Staining Present
 Information: It appears that water staining was present including but not limited to, the bedroom cupboards, lounge room ceiling, and the bathroom & ensuite vanities. Potential causes of leaking include deteriorated roof cladding or damaged plumbing fittings and fixtures. No high moisture was evident in these areas at the time of inspection.

It is recommended that the client monitor these areas and engage a licensed plumber promptly, should the leak persist or return.

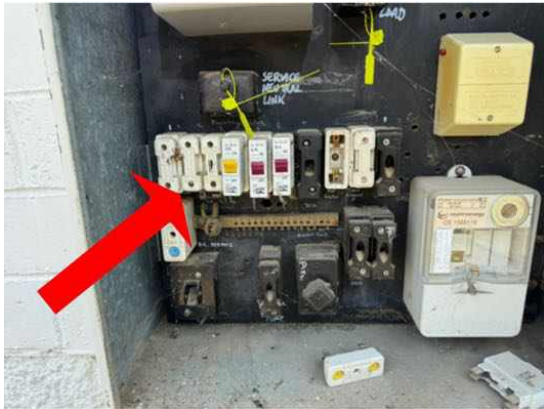
Building: Main Building
Location: Switchboard
Finding: Electrical switchboard - Old ceramic fuses
Information: It was noted that the electrical switchboard has old ceramic fuses in place. It is noted for the clients consideration that a switchboard upgrade may be required. Recommend consulting with a licensed electrician to provide further advice.

- Old ceramic fuses identified in switchboard. Recommend engaging a licensed electrician to provide further advice.
