# Building and Timber Pest Inspection Report

Inspection Date: Fri, 20 Feb 2026

Property Address: 2/40 Markham Ave, Runaway Bay QLD  
4216, Australia

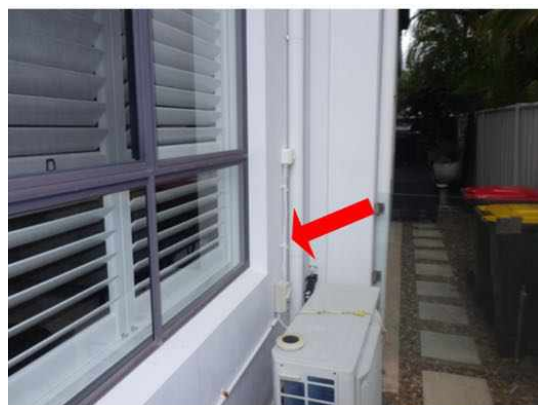
Exposed electrical cabling and/or connections represent a potential safety hazard including for fire and personal contact.

A licensed electrician should be engaged to further investigate and undertake rectification work as a matter of priority.

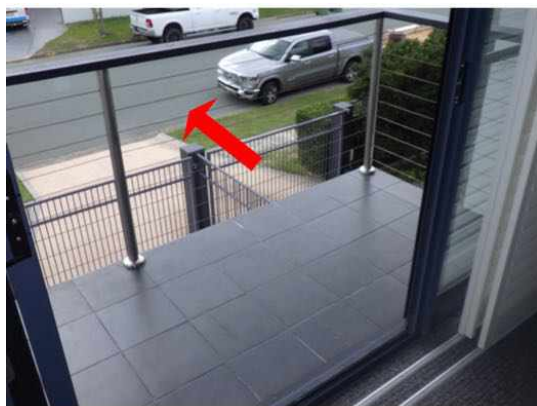
#### Finding 1.02

Building:	Main Building
Location:	Balcony > Existing
Finding:	Balustrade - Suspected Non-Compliance
Information:	The gaps between the main bedroom balcony, balustrade stainless steel wires were able to be separated upto (.155mm wide) greater than the present building regulation requirement of 125mm.

This defect creates a potential safety hazard and should be rectified as soon as possible to ensure the safety of the area and to meet present building standards and regulations.

A registered builder should be contacted to discuss possible rectification solutions.

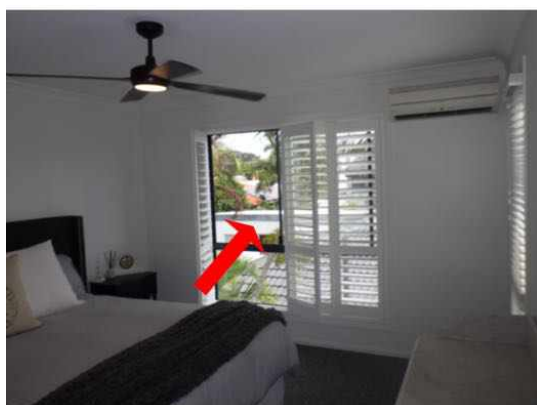
### Finding 1.03

Building:	Main Building
Location:	Bedroom 2 > Centre,Rear
Finding:	Window safety
Information:	It was noted that the window of the upper level bedroom 2 is less than 1.7m from the floor and has a fall greater than 2m on the exterior from the sill and as such is required to only open upto 125mm or have a security grill fitted.

This is noted as a safety concern and this regulation may not have been in place at the time of construction.

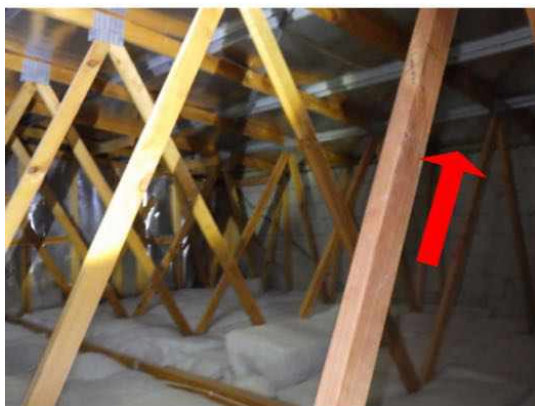
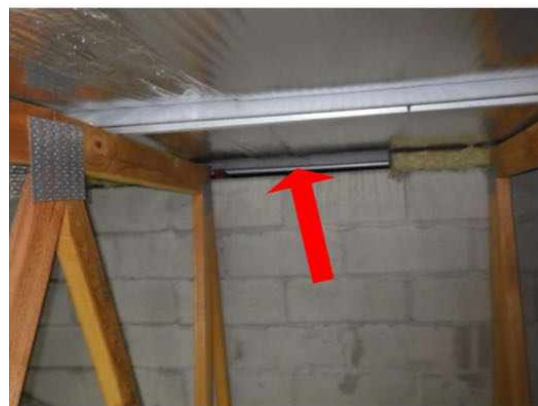
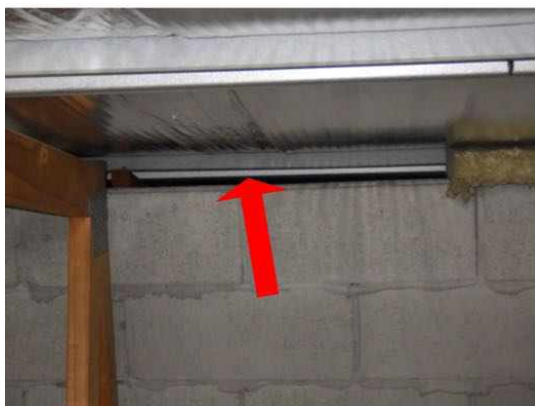
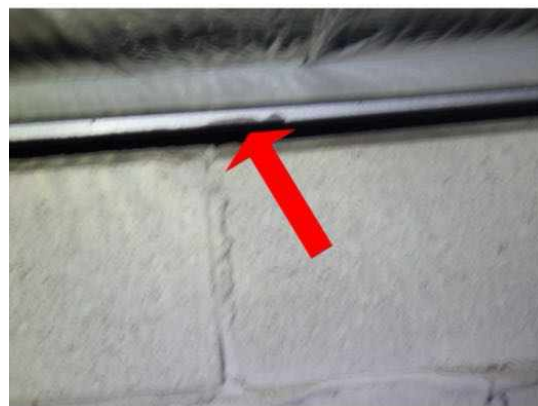
### Finding 1.04

Building: Main Building  
 Location: Attic > Centre Left  
 Finding: Rock Wool - Missing  
 Information: At the time of inspection it was observed there was a section of fire resilient- non combustible rock wool type product missing from the top of the concrete block party wall/underside of the metal roof sheeting separating the adjoining property.

It is important the area is fully sealed with an approved non combustible product, to act as a fire stop.

A licensed insulation installer should be engaged to replace the rock wool as a matter of priority.

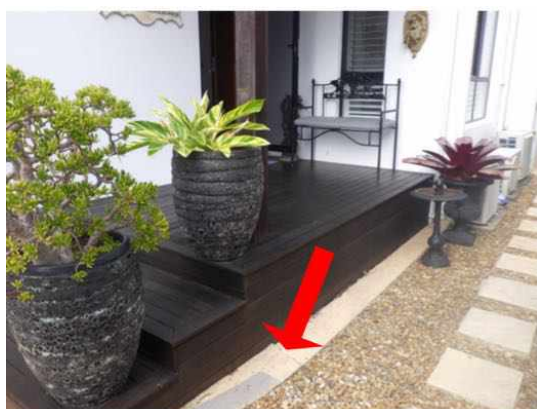
Location: External Areas > Ground Level  
 Finding: Cracking in concrete slab - Category 1  
 Information: Cracking coded as Category 1 was identified to external area concrete slab or edging. A Category 1 crack is described as a fine but noticeable crack, with the slab at an otherwise reasonable level.

To be considered Category 1, the approximate width of the crack is less than 1.0mm, or a less than 10mm change in offset when a 3m straight edge is placed over the defect.

Category 1 cracks should be monitored for a period of 12 months. At the end of the monitoring period, identified cracks that are rated greater than Category 2 are considered defects, and require rectification.

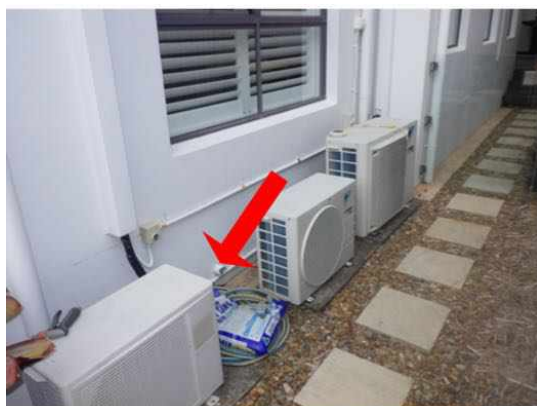
Building: Main Building  
 Location: Exterior walls - right side > Centre Right  
 Finding: Frog Flap  
 Information: At the time of inspection the frog flap was missing from the laundry area drainage pipe . Although the defect is of an appearance type nature, the missing frog flap does allow for potential pest ingress into the area.

A qualified plumber or general handyman could be engaged to replace the frog flap, at the clients discretion.

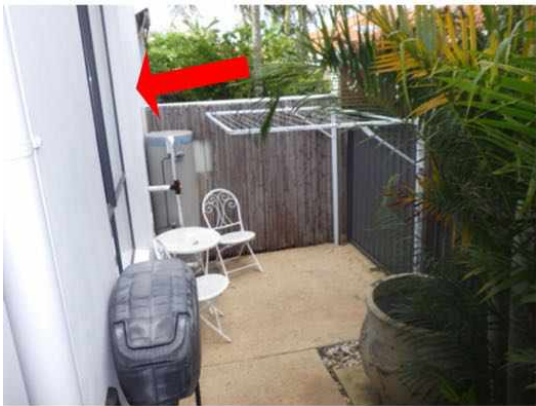
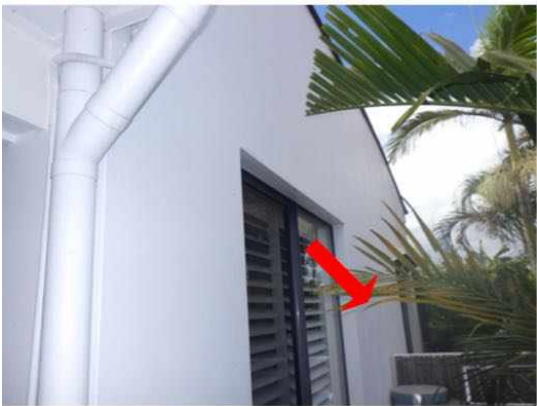
Building: Main Building  
Location: Exterior walls - rear > Centre  
Finding: Damage to Masonry Walls (Cracks)  
Information: It was observed at the time of inspection, that there is minor cracking damage to masonry wall at the rear of the property which may have been caused by movement of footings, or normal ground movement. The degree of damage falls within Category 0, described as hairline cracks, which are less than 0.1mm in width limit.

Damage of this category is not considered a defect for rectification. Always contact your building inspector should cracks widen, lengthen, or become more numerous.

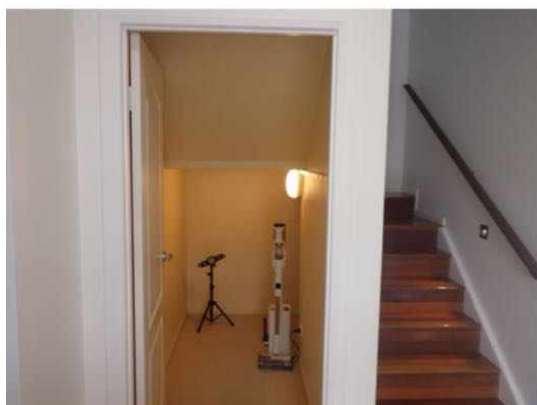
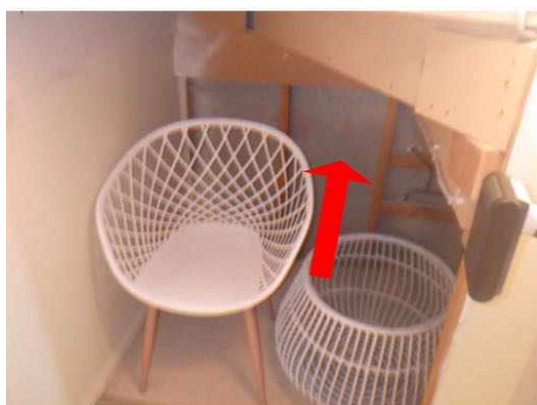
### Finding 3.06

Building: Main Building  
 Location: Under Stair Void or Storeroom > Centre Right  
 Finding: Incomplete works.  
 Information: At the time of inspection it appeared there were areas of incomplete wall linings in the understair storage cupboard..

A qualified carpenter or general handyman could be engaged to complete the work, at the clients discretion.

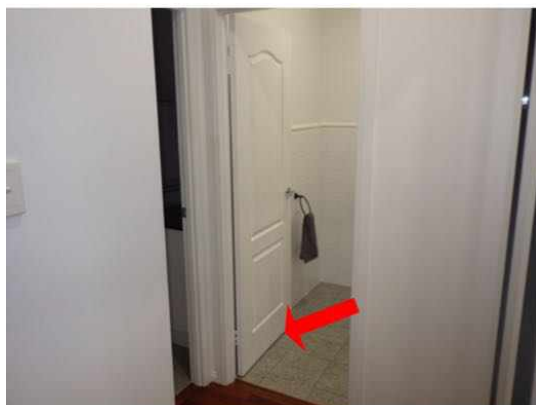
### Finding 3.07

Building: Main Building  
 Location: Powder Room > Front  
 Finding: Damaged Door  
 Information: The door leading into the powder room has suffered damage to the bottom edge.

Damage occurs generally when the building materials have aged and decayed, but in this instance the damage appears to be the result of exposure to moisture, possibly from the bottom and/or top edges of the door not being sealed with a suitable paint or sealant at the time of construction.

A qualified carpenter or general handyman could be appointed to repair/replace the door at the clients discretion.

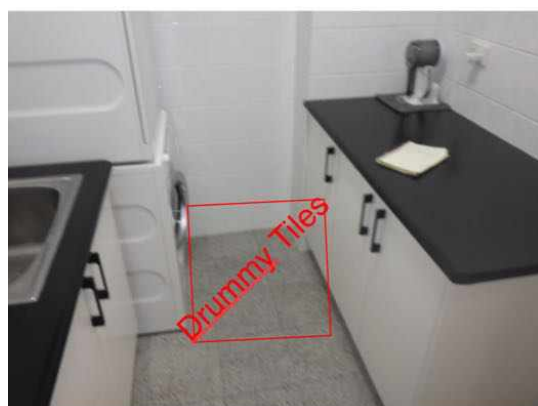
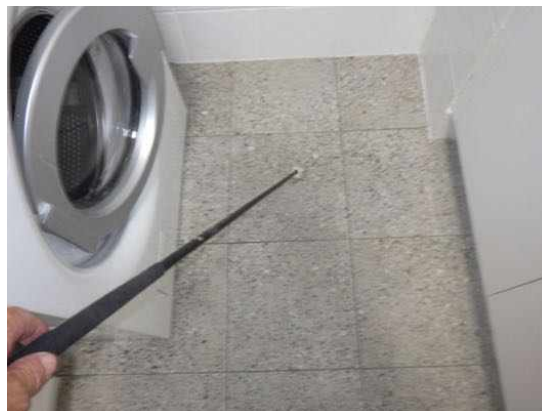
Building: Main Building  
 Location: Laundry > Centre Right  
 Finding: Tiles - Drummy  
 Information: Drummy tiled areas were identified in the laundry area floor at the time of inspection. The term 'drummy' refers to tiles that despite being in relatively good condition have a hollow sound when tapped on and may be inclined to crack from heavy impact

whether accidental or deliberate. Drummy tiled areas may be a direct result of moisture exposure or poor workmanship during the construction process.

A tiling contractor could be appointed to perform works if necessary.

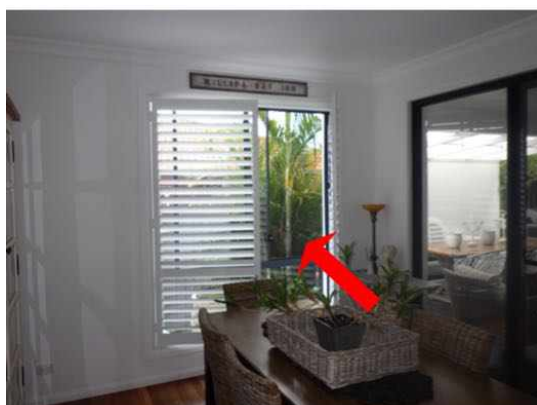
Location: Dining Room > Centre,Rear  
 Finding: Window - Stiff to Slide  
 Information: The aluminium sliding window in the dining room area was stiff to operate at the time of the inspection. Windows provide ventilation to the adjoining area and should be at a fully operational level to ensure user comfort. Restricted function of the window may also pose as a potential safety hazard if required for emergency egress from the building.

Generally, factors such as general age of the building element and a lack of maintenance are the usual causes for this type of defect.

An aluminium window service agent will be required to repair the affected windows.

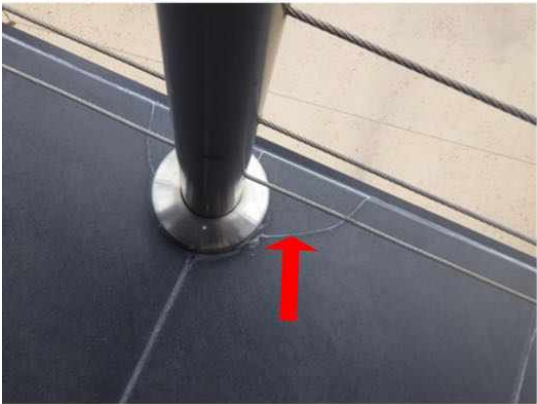
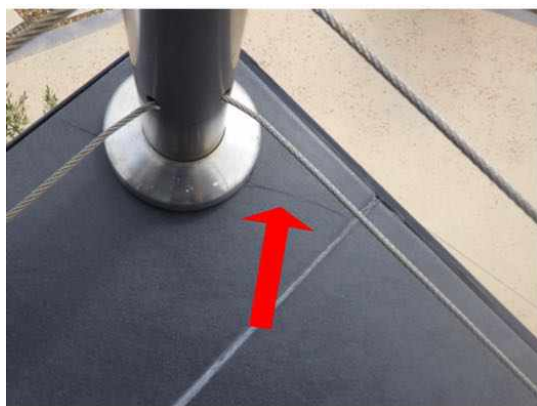
Building: Main Building  
Location: Balcony > Existing  
Finding: Tiles - Cracked  
Information: Cracked tiles to the front balcony floor area were identified at the time of inspection. Such defects are generally caused by impact or movement to associated structures e.g handrail or balustrades. Cracked or broken tiled areas may also be a direct result of poor workmanship during the construction process.

A tiling contractor should be appointed to perform repair works.

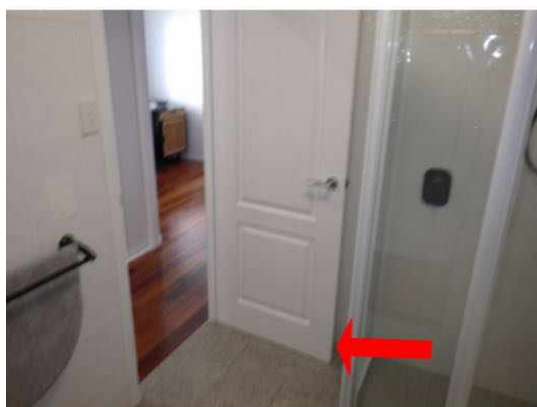
### Finding 3.14

Building: Main Building  
 Location: Bathroom > Front Left  
 Finding: Door stop - Missing  
 Information: The bathroom door stop is missing or is inadequate to stop the door handle from impacting the wall.

Re-installation or replacement of the door stop is advised to prevent any subsequent damage to the wall linings or associated structures.

A general handyman may be appointed to perform these works at client discretion.

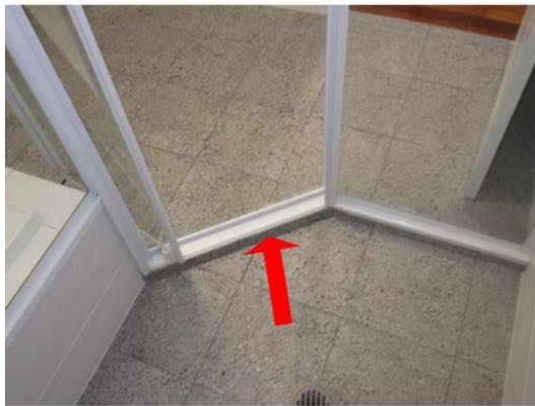
### Finding 3.15

Building: Main Building  
 Location: Bathroom > Centre Left  
 Finding: Sealant Missing  
 Information: It was noted on inspection that sealant is missing from the shower floor/hob tile intersection, it is important this area is sealed to prevent moisture from penetrating these areas.

A sealant specialist or tiling contractor should be appointed to complete these works.

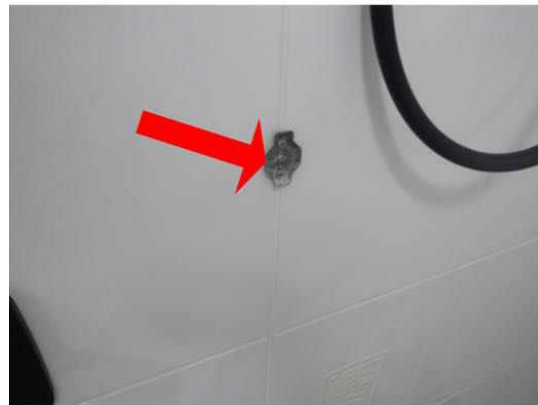
### Finding 3.16

Building: Main Building  
 Location: Bathroom > Centre Left  
 Finding: Fitting or fixture - Missing  
 Information: A fixture was missing from the bathroom shower cubicle at the time of inspection

It is assumed the missing fixture was a soap dish or similar.

A general handyman could be appointed to replace the missing fixture at discretion of the client.

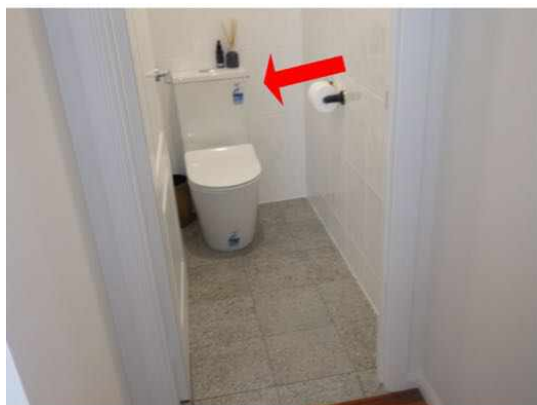
### Finding 3.17

Building: Main Building  
 Location: Toilet (WC) > Rear Right  
 Finding: Internal Wall - Holes  
 Information: Holes were identified in the WC cistern right side wall tiles. It is suspected that the holes are from a previously removed fixture or fitting.

All excessive holes, gaps or cracks should be adequately filled by a suitable sealant or filler. Such works may be conducted by a general handyman or licensed painter.

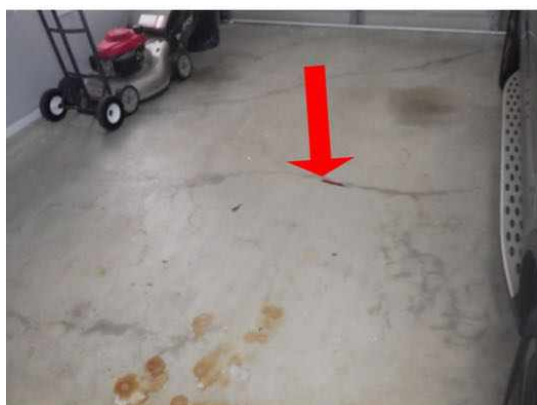
### Finding 3.18

Building:	Main Building
Location:	Garage > Ground Level
Finding:	Cracking in concrete slab - Category 1
Information:	Cracking coded as Category 1 was identified in the garage floor concrete slab (as per example photos). A Category 1 crack is described as a fine but noticeable crack, with the slab at an otherwise reasonable level.

To be considered Category 1, the approximate width of the crack is less than 1.0mm, or a less than 10mm change in offset when a 3m straight edge is placed over the defect.

Category 1 cracks should be monitored for a period of 12 months. At the end of the monitoring period, identified cracks that are rated greater than Category 2 are considered defects, and require rectification.

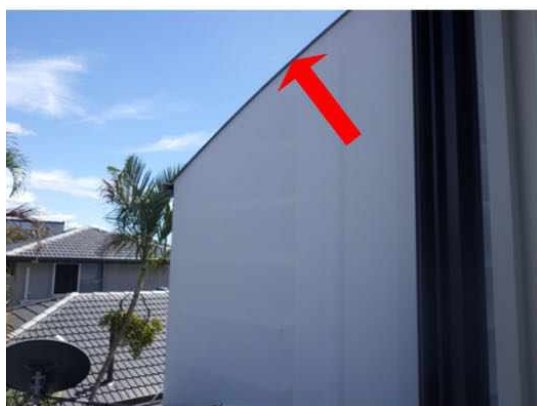
Building: Main Building  
 Location: Roof Exterior > Centre Right  
 Finding: Roof flashing  
 Information: It was suspected at the time of inspection a roof flashing or capping may be missing or has been previously removed (reasons unknown) to the upper level roof area on the right side of the property.

A roofing plumber should be appointed check all external roof areas and repair or replace any metal flashings as required.

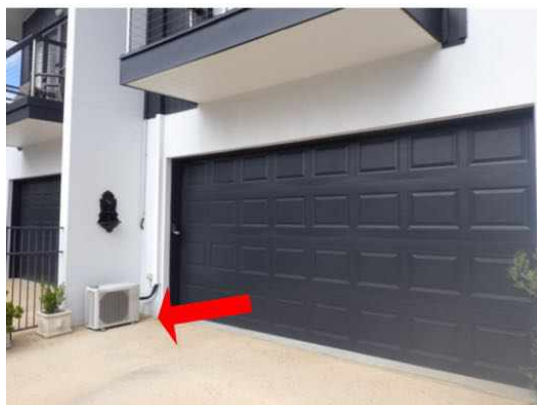
## Finding 6.02

Building: Main Building  
 Location: Exterior walls - front > Front Left  
 Finding: Overflow - Not plumbed for drainage  
 Information: The air conditioning unit overflow is not plumbed or connected to suitable drainage, which can result in the surrounding area becoming excessively damp. These damp

conditions can lead to secondary defects such as rot, rust or corrosion of associated building elements, the formation of fungal decay, or even the creation of potential slip hazards. When coupled with poor site drainage, pooling of water may also attract termite activity to this area. It is highly recommended that a qualified plumber be appointed to install adequate drainage to the overflow. These works will ensure that the area remains dry and free of any secondary defects.

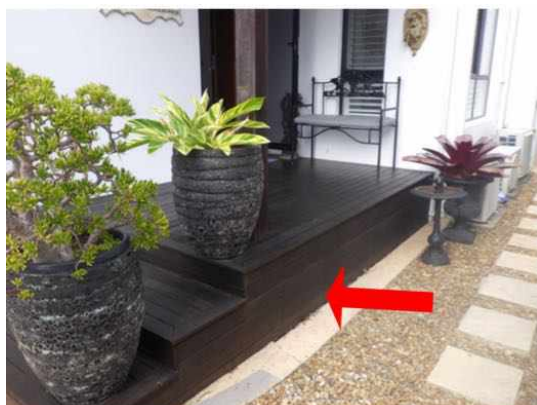
**Finding 6.03**

Building: Main Building  
 Location: Entry > Existing  
 Finding: Deck - In ground contact  
 Information: At the time of inspection it was noted the timber steps and deck area to the entry area of the property is in direct contact with the finished ground level.

Any timbers in direct ground contact provide opportunity for concealed termite entry and are likely to be subject to premature rot and decay as the soil retains moisture or damp conditions against the timbers.

Frequent pest inspections every 1 - 2 months are highly advised to readily identify any termite activity in these areas.

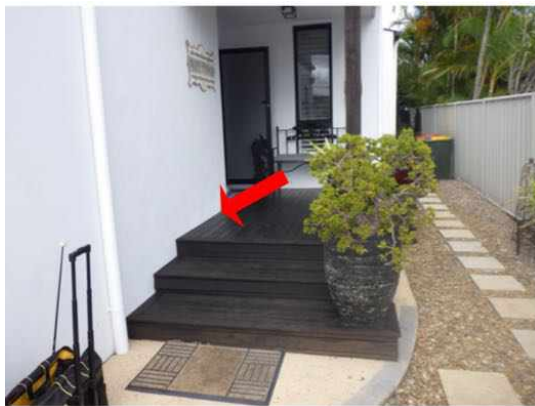
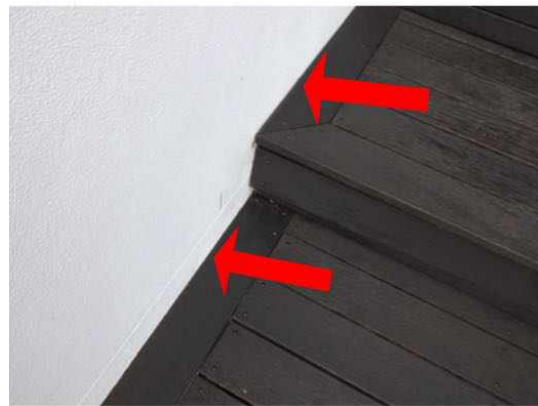
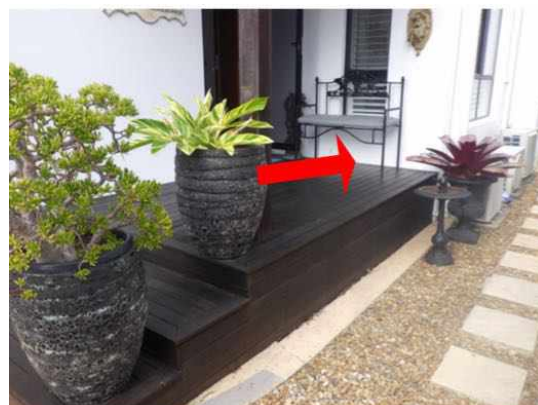
**Finding 6.04**

Building: Main Building  
 Location: Entry > Existing  
 Finding: Inspection Zone Exposure  
 Information: At the time of inspection the timber deck to the entry area at the front of the property finished tight against the exterior wall cladding.

It is highly recommended that timber termite pest inspections be carried out every 1 - 2 months to aid protection of the property against infestation.

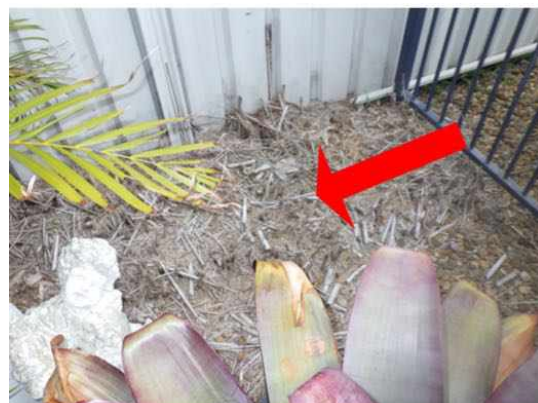
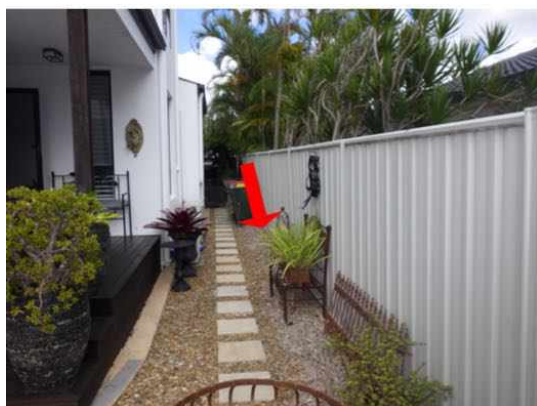
Finding: Garden Beds - Conditions Conducive to Termites

Information: Garden beds and external landscape areas were found to contain timber, stumps, debris and garden waste at the time of inspection (as per example photos). These garden beds can include untreated timber, and with a combination of moisture from watering hosing can make conditions conducive to termite activity and termite ingress. Removal of any garden debris or vegetation is highly advised. Frequent pest inspections are advised to readily identify any termite activity in these areas.

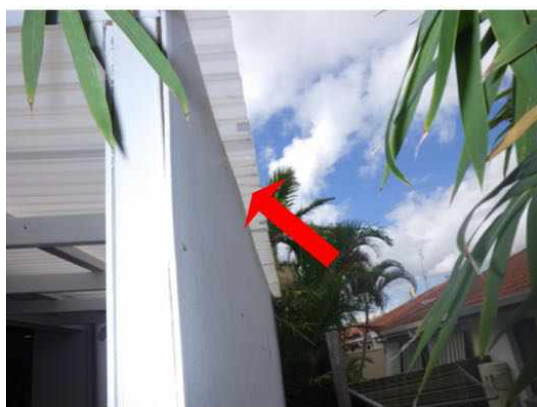
Building:	Main Building
Location:	Alfresco > Rear
Finding:	Roof Guttering Missing
Information:	At the time of inspection there was no roof guttering installed to alfresco area roof.

Although some building elements may seem irrelevant or unnecessary, all building elements play a key role in the operation and function of the overall structure and its performance. Roof areas missing gutters are likely to lead to high levels of moisture in the ground areas directly below. Such moisture will not only cause rust and decay of the associated building materials, but can also provide conditions that are conducive to termite and timber pest activity.

Installation of roof guttering and stormwater downpipes should be conducted as soon as possible to ensure that no damage or functional issues occur to associated building materials.

A qualified roof plumber should be appointed to replace the missing guttering.

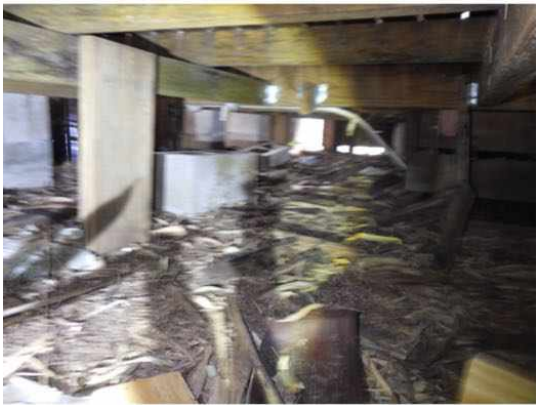
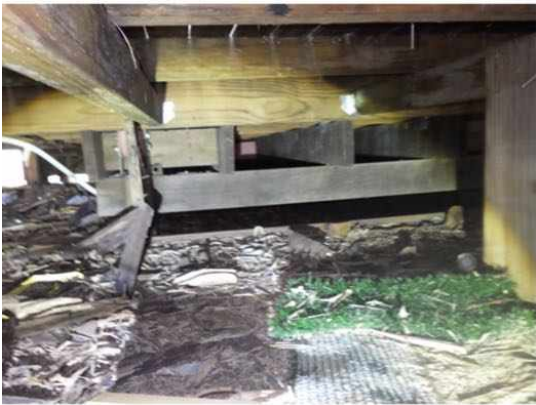
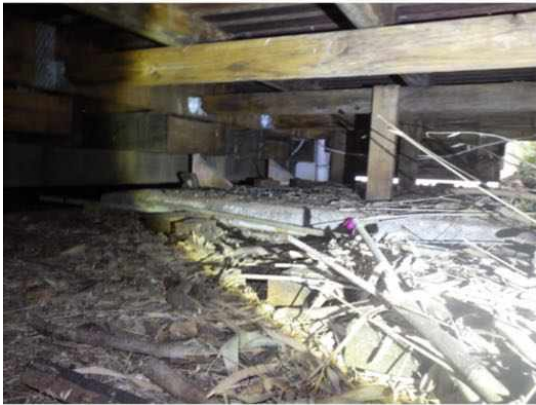
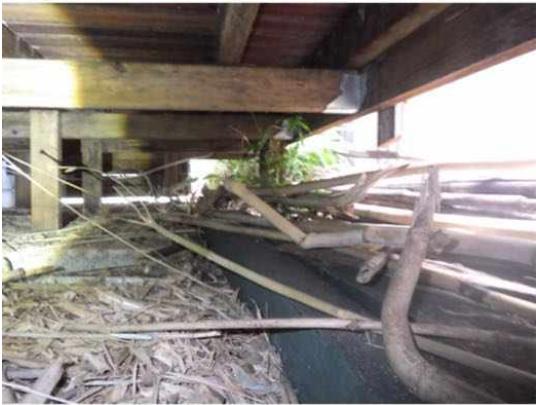
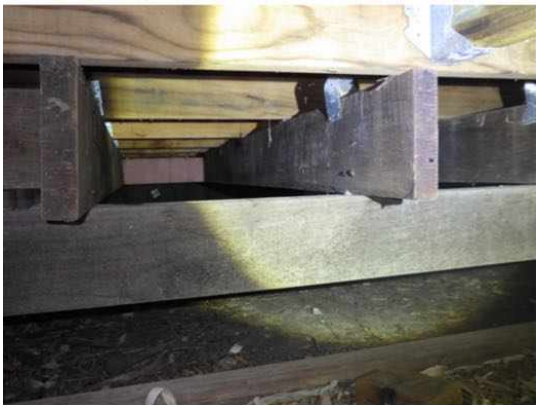
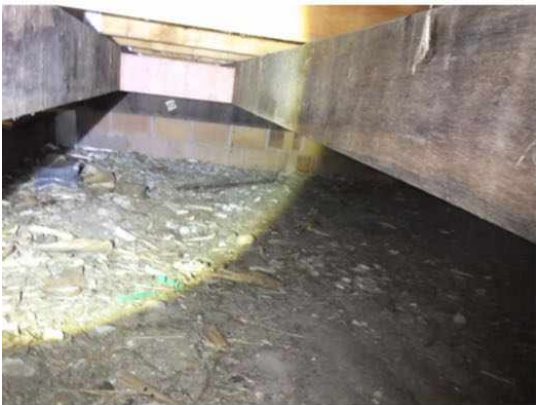
### Finding 6.10

Building:	Main Building
Location:	Deck > Existing
Finding:	Obstructions and Limitations Subfloor
Information:	These photographs are an indication of the obstructions and limitations which impeded full inspection of the Subfloor at the time of inspection. These obstructions can hide an array of defects and should be removed to allow full inspection to be carried out. A re-inspection is recommended once the areas are made accessible.
