Building and Timber Pest Inspection Report

Inspection Date: Tue, 24 Feb 2026

Property Address: 3/612 Prune St, Lavington NSW 2641,
Australia

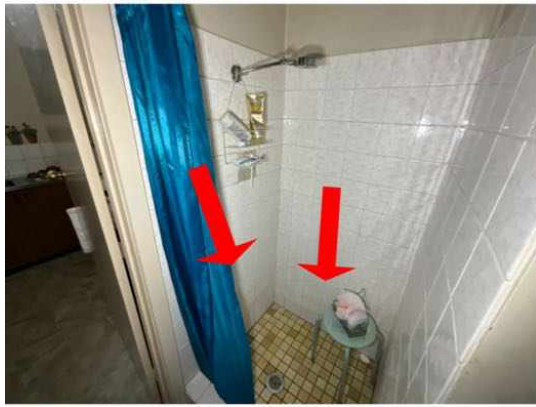
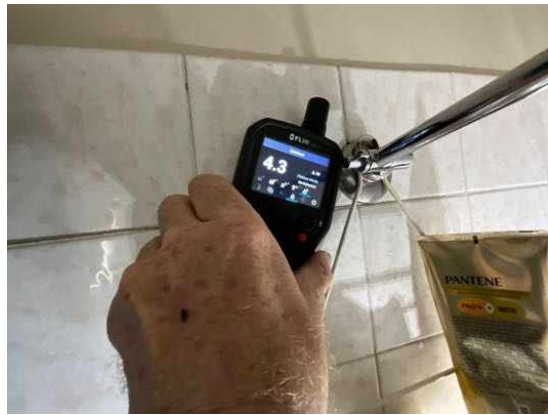
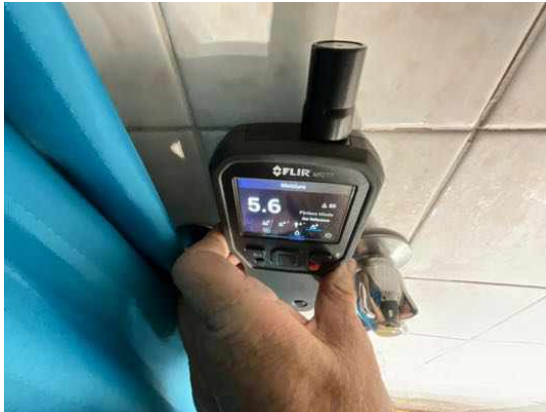
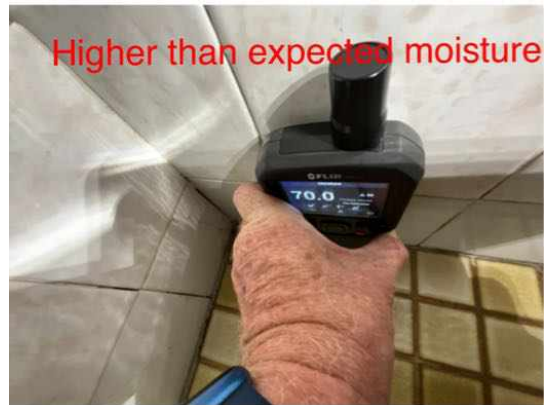
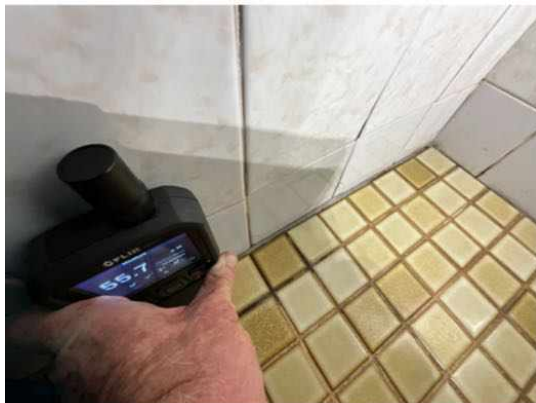
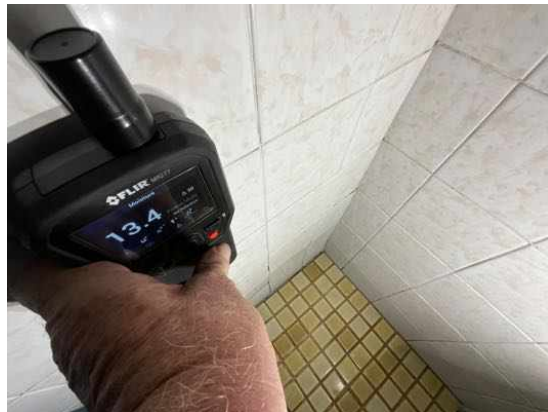
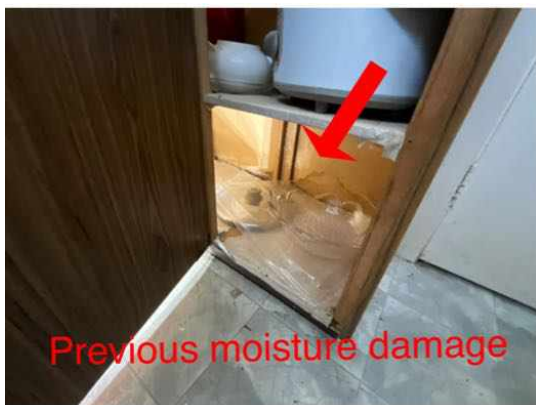
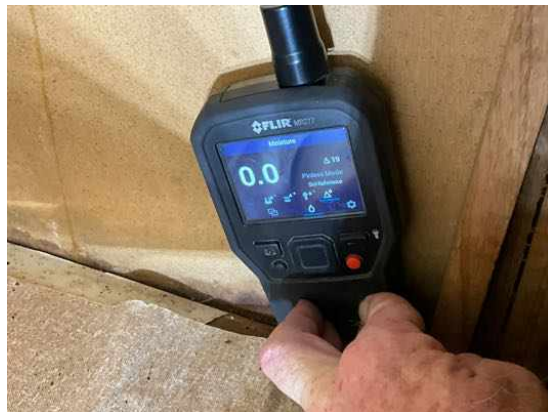
Finding 3.01

Building:	Building 1
Location:	Shower
Finding:	Shower damp- Monitor
Information:	Damp is evident to the lower 400mm of wall to the shower alcove.

This defect is quite common, and is suspected to have been caused by moisture permeating or leaching through the grouting and perhaps gaps in the sealant prior to repair.

Damp (or structural damp) refers to the presence of unwanted moisture in the structure of a building, either as the result of intrusion from outside, or condensation from within the structure. In the shower area, internal water leaks or other sources of excessive moisture are generally the cause of damp.

Monitoring the area is advised and if any visual signs of excessive moisture appear (peeling paint, mould) then consultation with a qualified plumber or bathroom specialist would be advised to identify the cause of damp and to perform remedial works as required.

Always ensure that sealant and grout is in good condition to prevent any moisture issues occurring in the future.

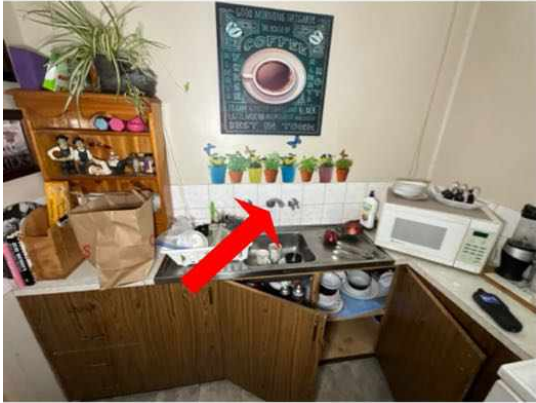
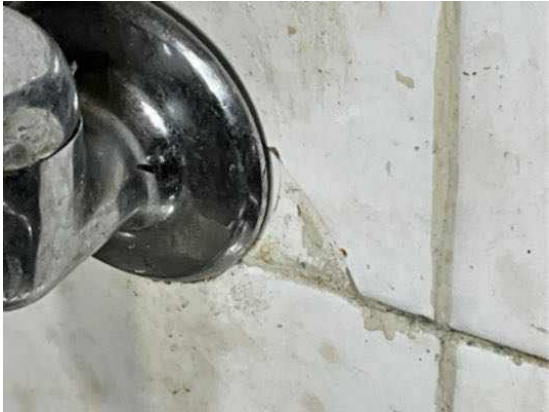
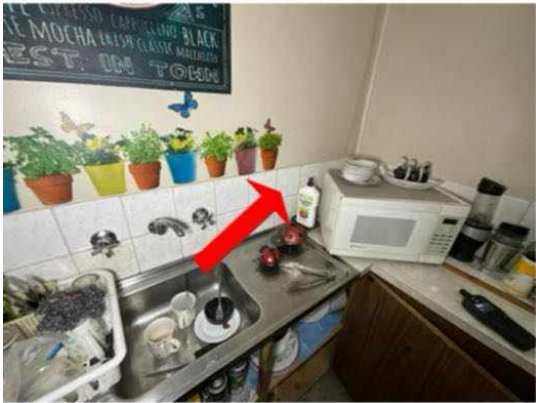
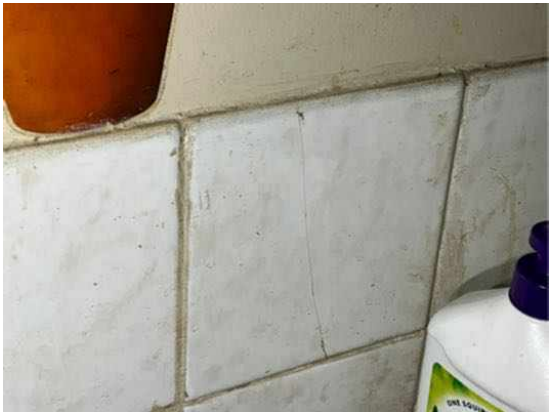
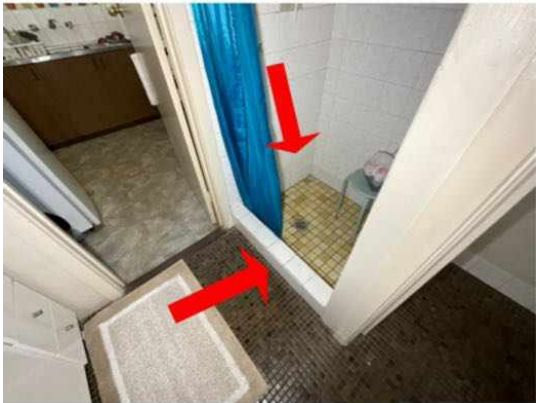
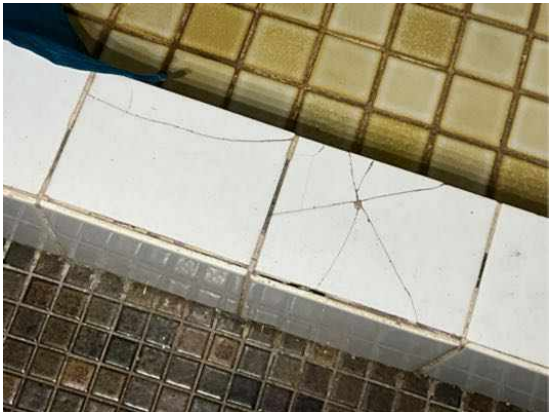
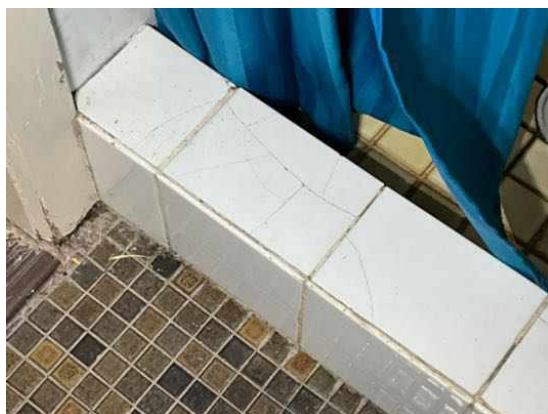
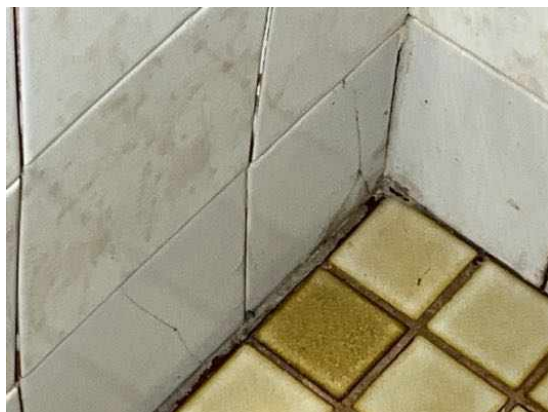
Finding 3.02

Building: Building 1
Location: Kitchen, shower
Finding: Wall Tiles- Cracked
Information: Cracked tiles within the household detract from the overall appearance of the affected areas, as well as creating potential for water penetration to adjoining building elements. If left unmanaged, water damage may occur as a result of constant water penetration over a prolonged period of time.

While not considered a matter of urgency, replacement of tiles is advised as a solution. A Tiling Contractor may be appointed to perform these works at client discretion.

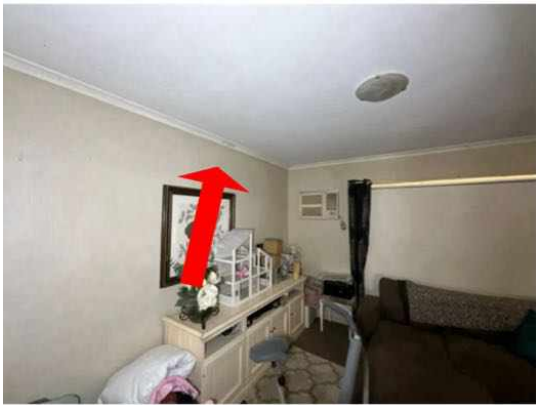
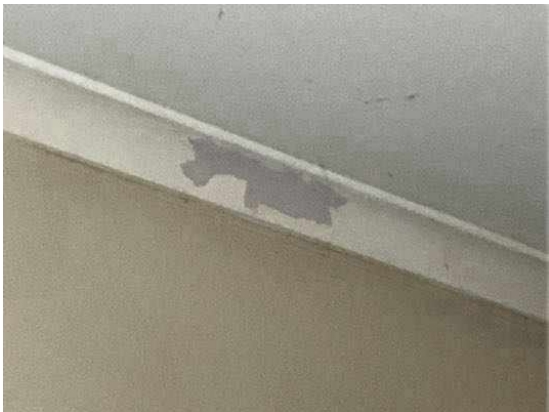
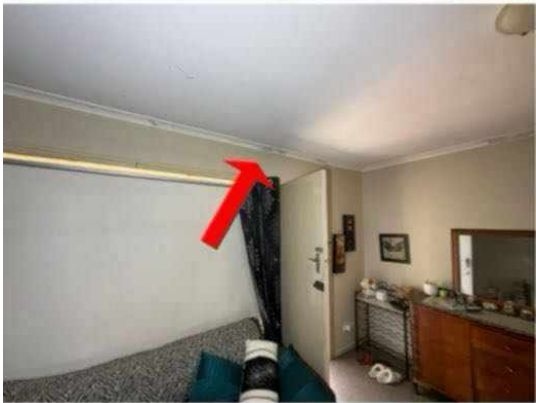
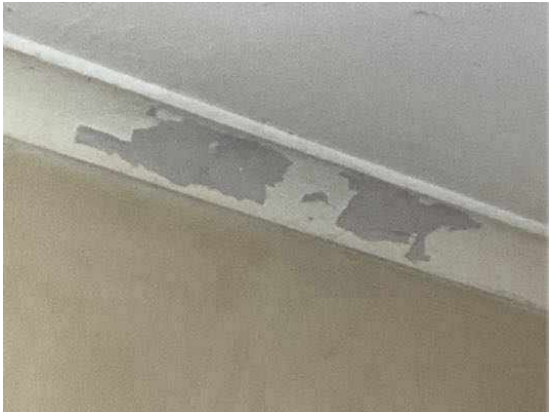
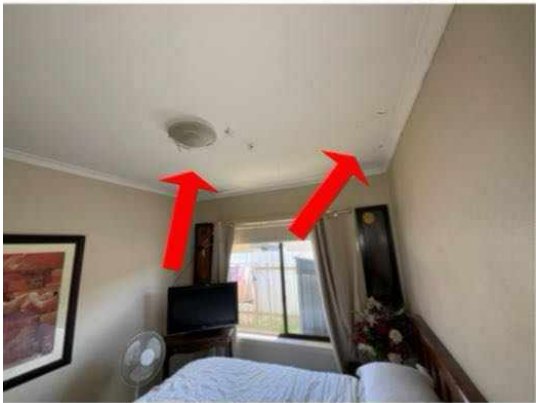
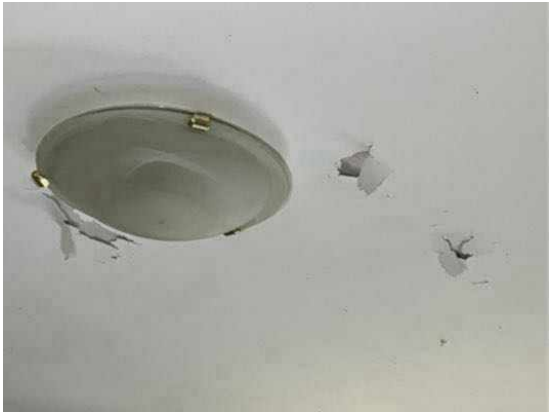
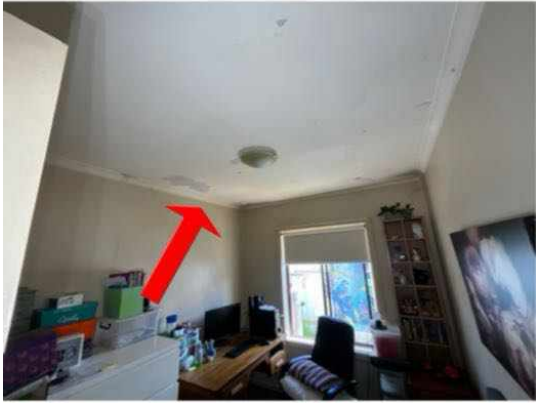
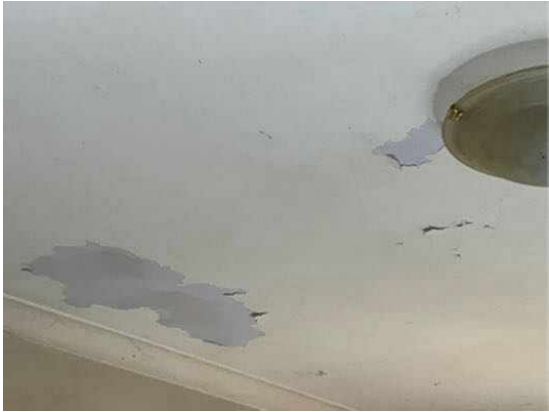
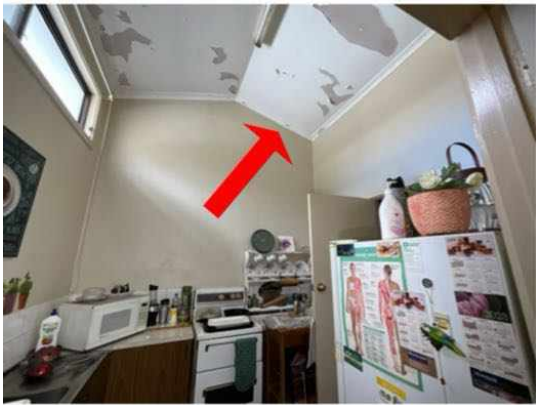
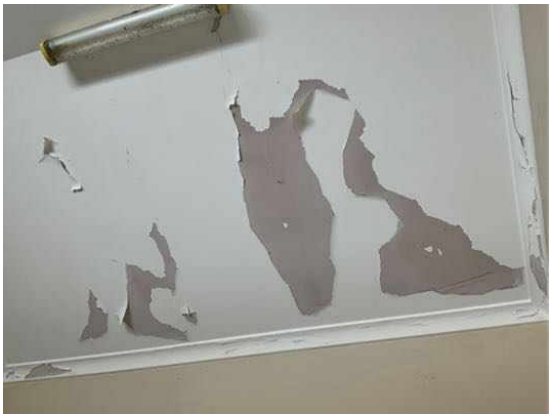
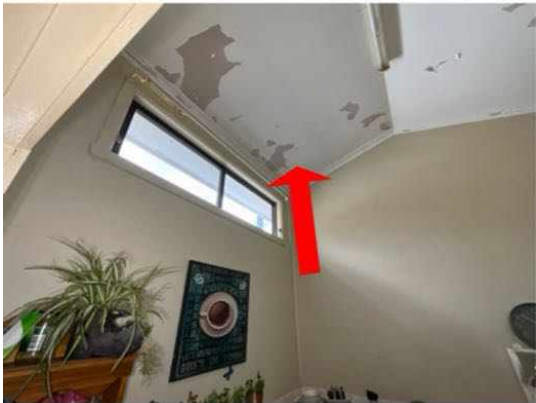
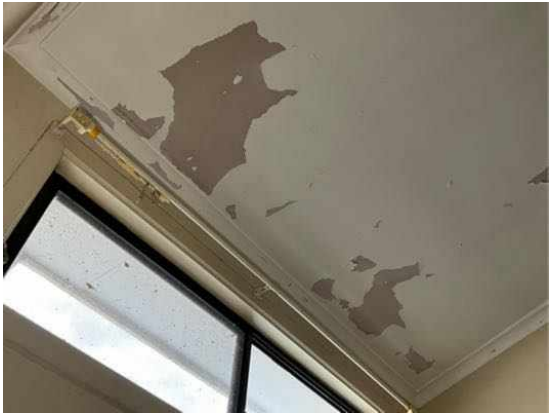
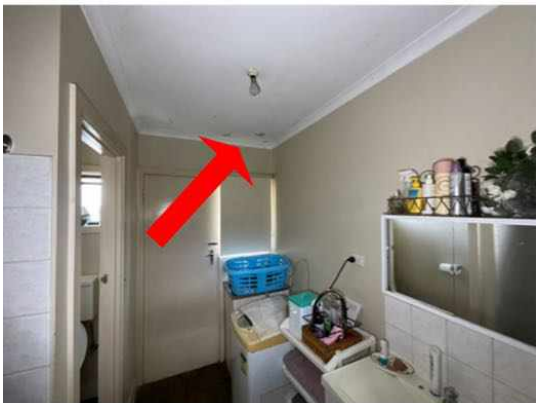
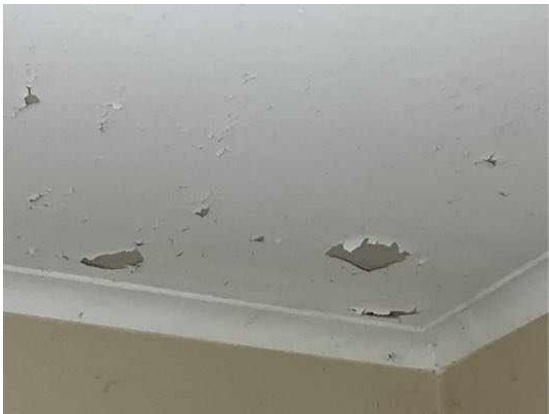
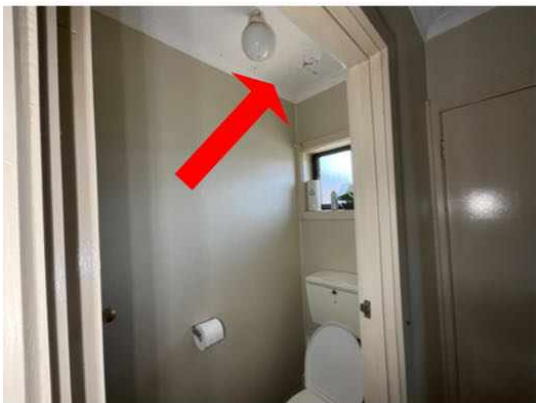
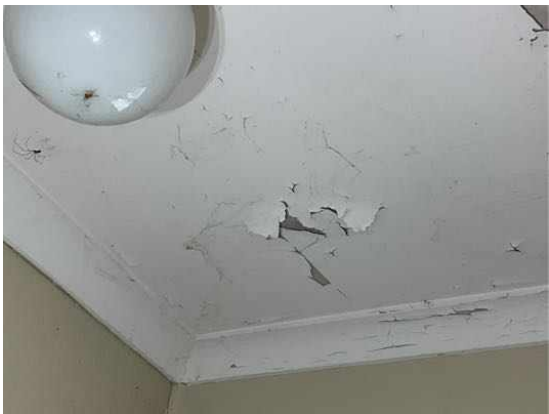
Finding 3.03

Building:	Building 1
Location:	Living Room, bed 1,2, kitchen, laundry,Wc
Finding:	Painted surface - Flaking
Information:	Sections of paint in this area was found to have deteriorated. Paint flaking is generally an indication of excessive moisture in the area, that is currently hidden by the painted surface.

The presence of excessive moisture can have major implications on associated building elements if left unattended. While only seemingly minor at this stage, the damage cannot be determined due to the paint obstructing any further inspection of the damage.

A qualified Painter should be contacted at the Owner's discretion to re-paint the ceiling.

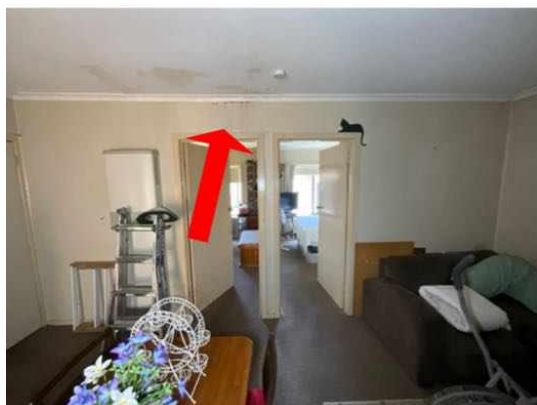
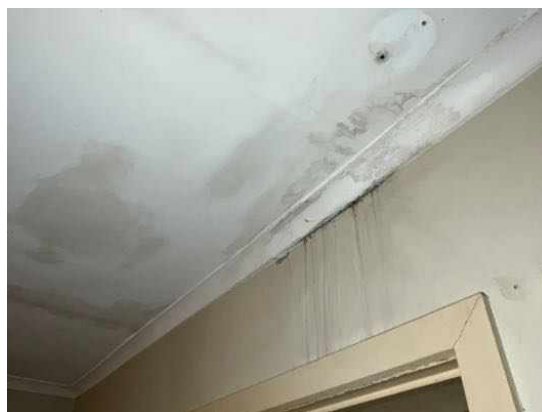
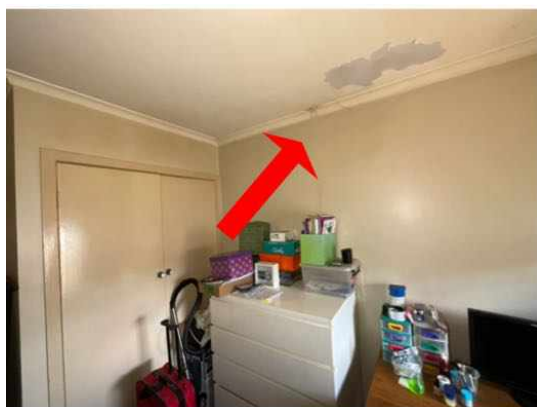
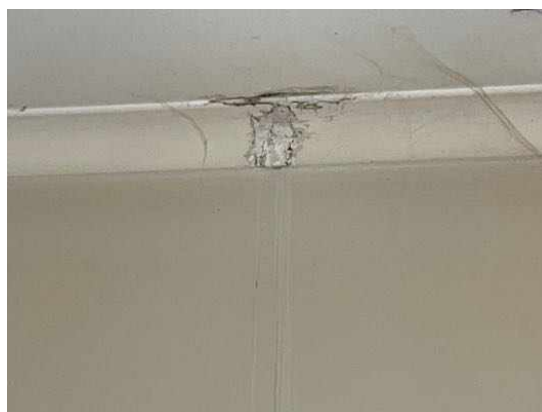
Finding 3.04

Building: Building 1
 Location: Living Room
 Finding: Ceiling - Water damaged
 Information: Water damage to the ceiling lining is generally an indication of excessive moisture being present in the roof void, usually via a leak to the roof covering.

Where water damage is evident to the ceiling, the primary requirement is to identify and rectify the source of the leak. A roofing plumber should be appointed as soon as possible to identify the leak and perform rectification works as necessary, ensuring the water damage is restricted.

Once the leak is repaired, consultation with relevant tradespeople, including plasterers and painters, is advised. Rectification works may include replacement of ceiling lining or minor repainting, depending on the extent of the damage.

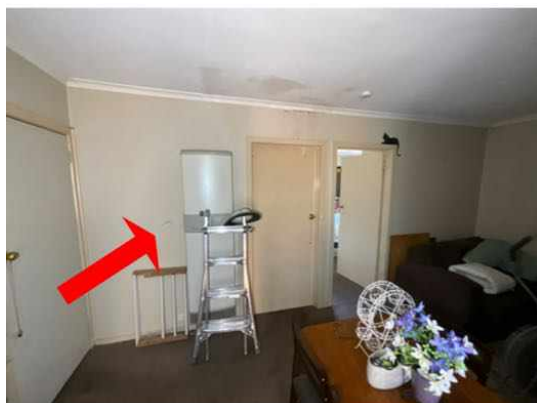
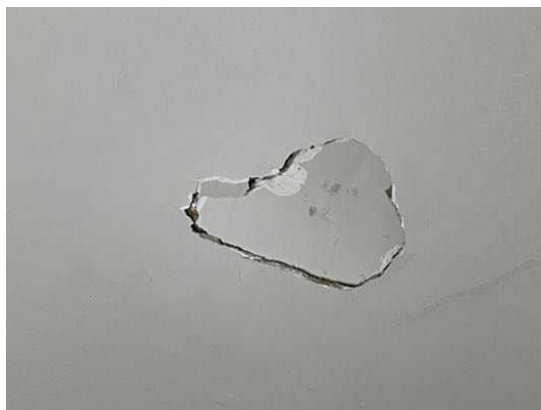
Finding 3.05

Building: Building 1
 Location: Living Room
 Finding: Impact damage
 Information: This area appears to show impact damage. This has compromised the structure. This damage has also compromised the moisture barrier.

Some attempts at repair have been initiated.

Appropriate trades should be contacted soon to restore this area to full function.

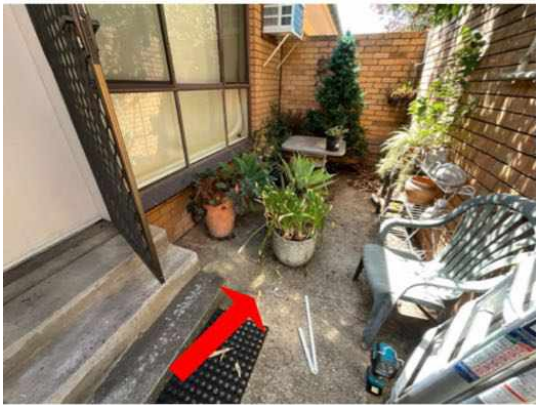
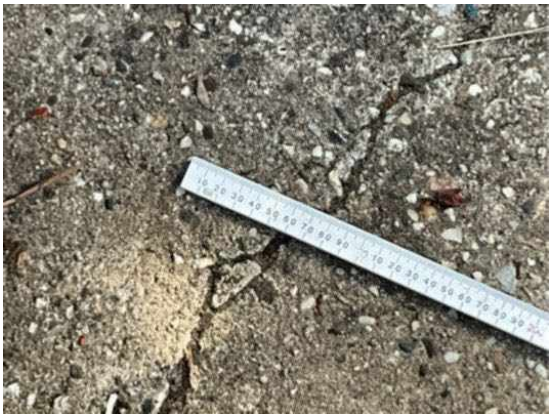
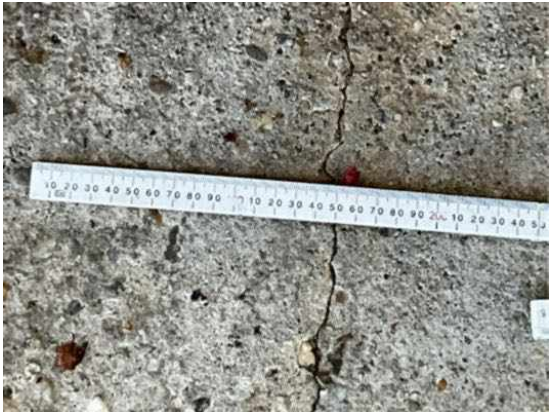
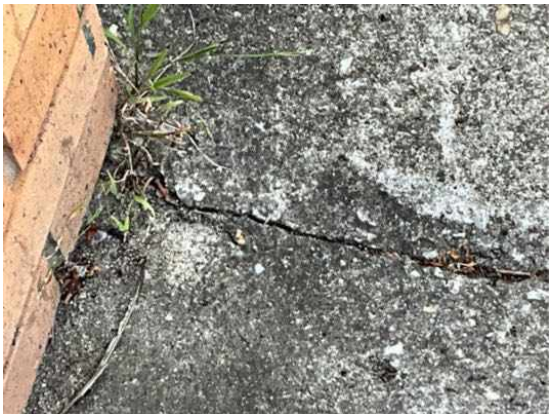
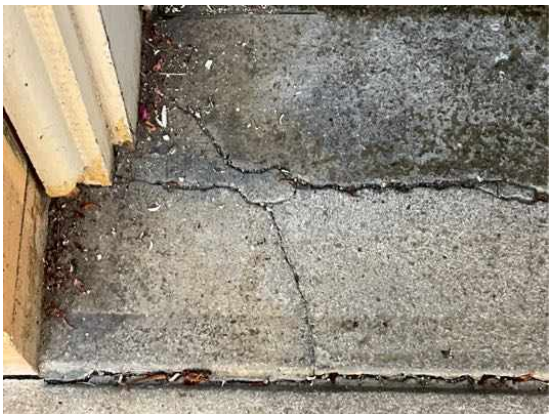
Finding 3.06

Building:	Building 1
Location:	Yard - Front, carport, entry
Finding:	Cracking - External Concrete Paving Damage Category 2 - Distinct (less than 3mm)
Information:	Distinct cracks were identified in external concrete paving. Distinct cracks are generally found in older concrete paving, and may also present as a trip hazard as consequence of an uneven or curved surface.

General age and expected deterioration of the paved areas is a common cause of this type of cracking. However, expansion and contraction of the slab may also have occurred due to environmental factors. Such factors include variable moisture and weather conditions, the presence of trees and their roots having a settling or lifting affect on the soil, or the effect of load bearing, e.g. heavy vehicles over a sustained period of time.

Cracking to this degree may also be due to poor original installation of the concrete. Factors such as poor compaction of the sub surface and/or inadequate reinforcing of the slab may create cracking and other secondary defects.

Repairs are likely to be required to prevent further cracking and to reduce hazards associated with cracking, such as tripping. Monitoring of all cracking should be conducted frequently. Always contact a building inspector should cracks widen, lengthen, or become more numerous.

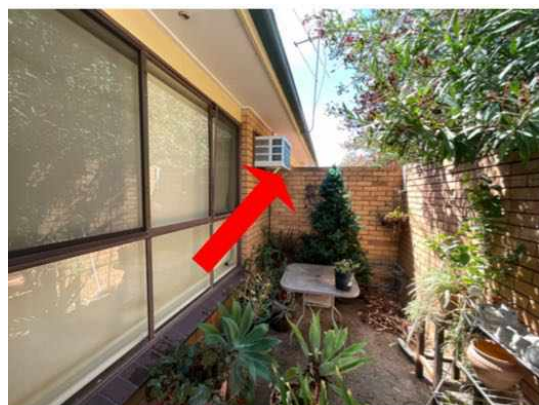
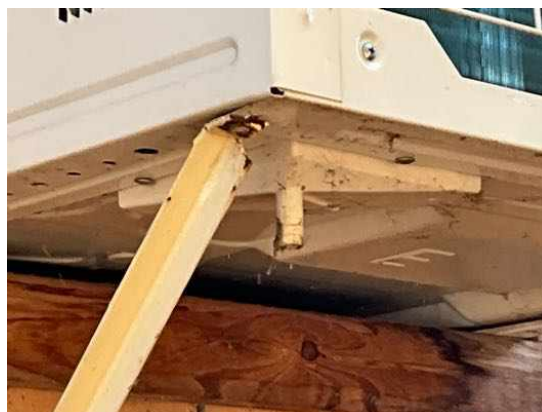
Finding 6.01

Building: Building 1
 Location: Yard - Front
 Finding: Air conditioner - Disconnected overflow
 Information: The Air Conditioner (A/C) overflow was found to be disconnected from storm water drainage and is creating excessive moisture in the surrounding area.

Such leaking creates an environment which is conducive to an array of defects, including water damage to associated building elements and the attraction of termite or timber pest infestation.

It is highly recommended that a licensed plumber be appointed to connect the A/C overflow in order to prevent such an environment from being created. These minor works should be carried out as soon as possible.

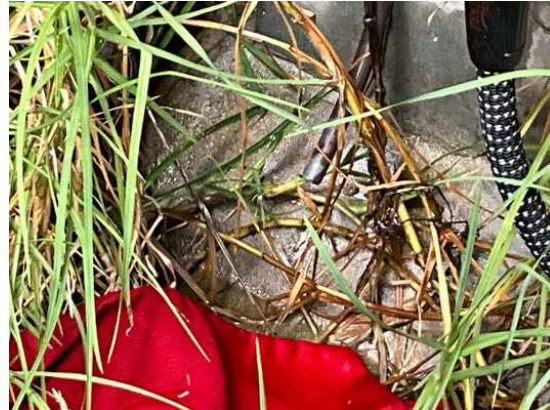
Finding 6.02

Building: Building 1
 Location: Yard - Back
 Finding: HWS Overflow - Not Connected
 Information: The Hot Water System (HWS) overflow was found to be disconnected from storm water drainage and is creating excessive moisture in the surrounding area.

These damp conditions can lead to secondary defects such as rot, rust or corrosion of associated building elements, the formation of fungal decay, or even the creation of potential slip hazards. When coupled with poor site drainage, pooling of water may also attract termite activity to this area.

It is highly recommended that a licensed plumber be appointed to connect the HWS overflow in order to prevent such an environment from being created. These minor works should be carried out as soon as possible.

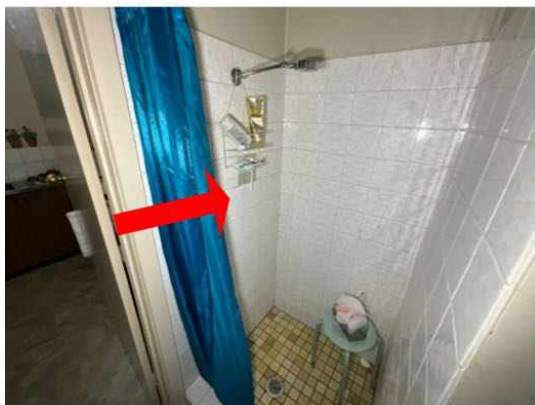
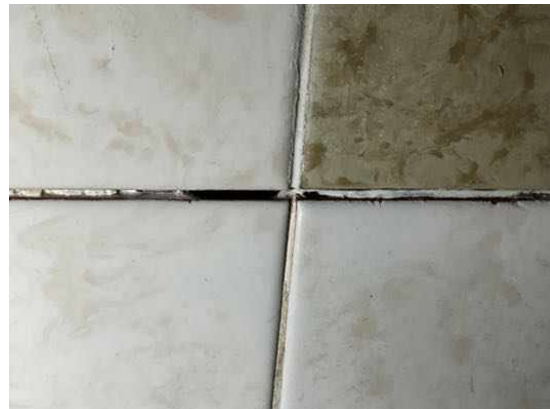
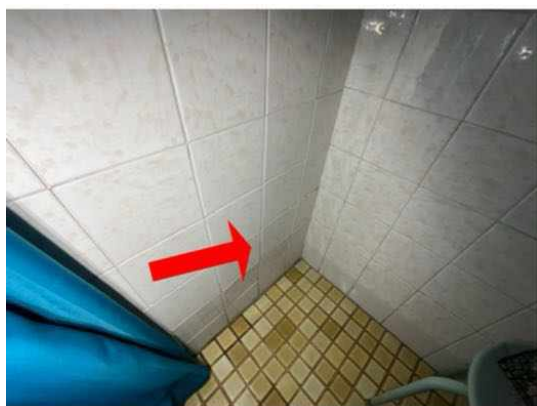
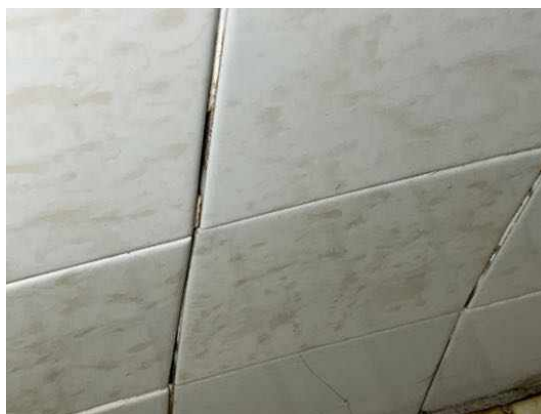
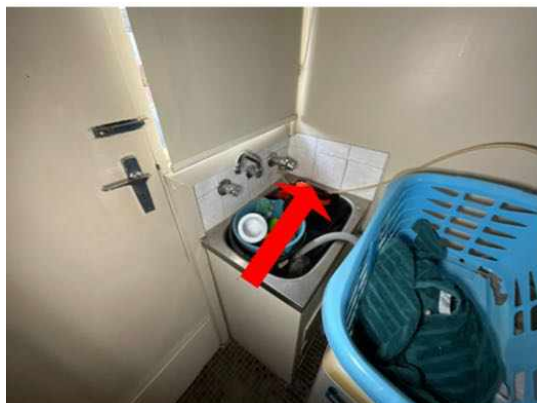
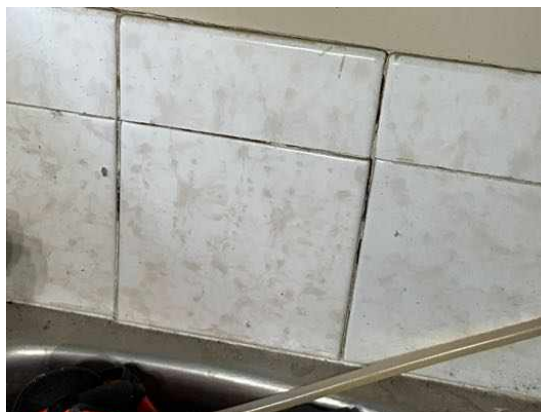
Finding 6.03

Building:	Building 1
Location:	Bathroom/ laundry
Finding:	Inadequate sealant or Grout
Information:	This area has a lack of effective Sealant or Grout. This is allowing the ingress of water to the structure inside the wall.

The presence of water encourages Termite attack, Mould and Fungal Decay.

A Tiler or General Handy person must be contacted as soon as possible to effect repairs and prevent further deterioration.

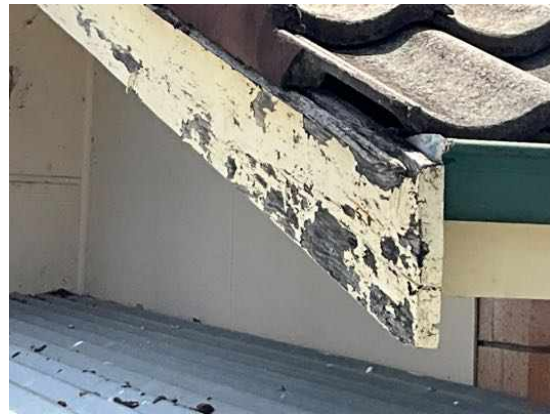
Finding 6.04

Building:	Building 1
Location:	Eaves
Finding:	Timber - exposed to weather
Information:	External timbers that are frequently exposed to harsh weather conditions require adequate protection in order to maintain their condition. Where timbers have not been painted or treated adequately, general deterioration is likely to occur at an accelerated rate.

If left unattended, replacement of these timbers is likely to be necessary in the short-term future. Adequate treatment of these timbers is required as soon as possible by a painting contractor or general handyman.

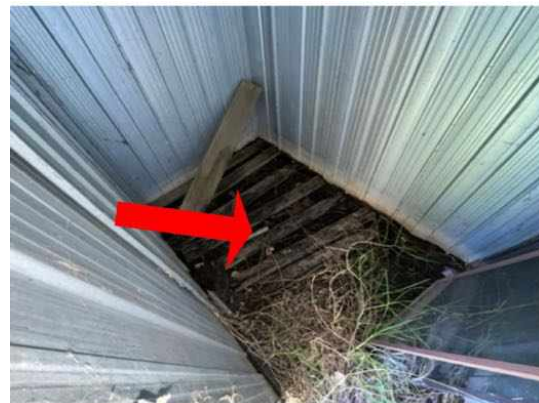
Finding 6.05

Building:	Building 1
Location:	Shed
Finding:	Untreated or non-durable timbers in a hazardous environment
Information:	To reduce the risk of timber pest attack it is essential that timber used in a hazardous environment (e.g. in direct contact with the ground or frequently exposed to damp conditions) is of sufficient durability and/or is adequately preservative treated.

Untreated timbers in direct contact with the ground are likely to develop severe wood rot and/or fungal decay if left unattended creating attraction for subterranean termites to infest the timbers from surrounding areas.

If untreated or non-durable timbers are found to be in a hazardous environment it is highly advised that replacement of these building elements be performed as soon as possible to aid the protection of the property against termite / timber pest attack.

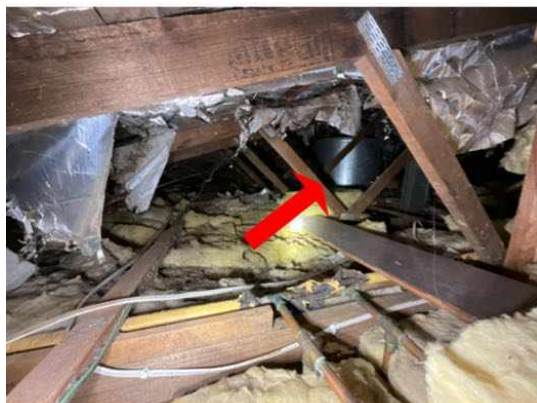
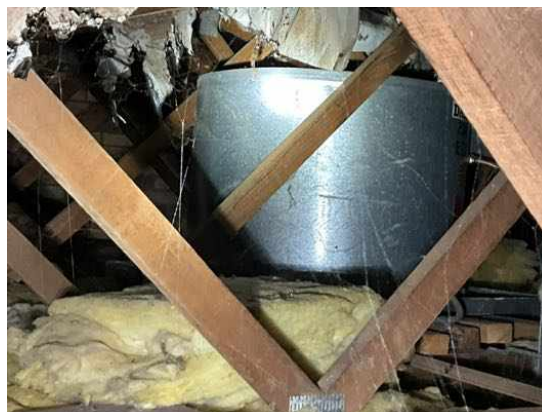
Finding 6.06

Building:	Building 1
Location:	Roof Void
Finding:	Gravity-Fed HWS - Disconnected
Information:	It was noted at the time of inspection that a disconnected gravity-fed hot water

system (HWS) remains in this area.

Despite this plumbing structure being unused, it is likely to be storing residual water, and is therefore susceptible to rust and corrosion. If allowed to continue, rust and corrosion is likely to lead to damage to adjoining building elements, and may also make the area susceptible to termite or timber pest activity.

While it is a costly exercise to remove the disused gravity-fed HWS, it is advisable in the short-term future to prevent any further damage to the area. Further consultation with a licensed plumber is required to gain further advice on removal of the structure.

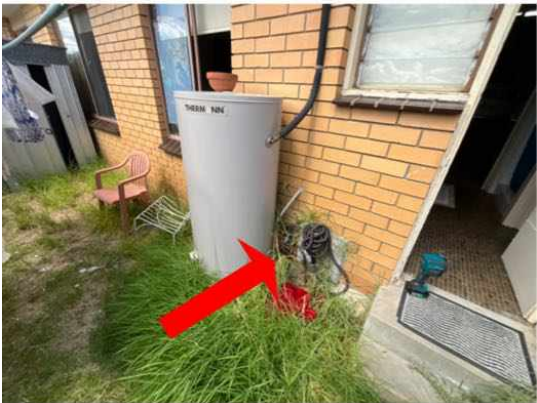
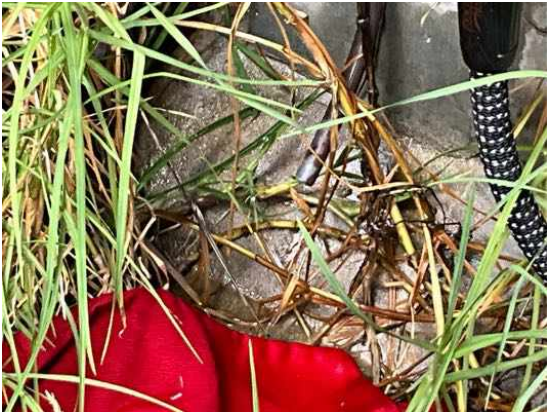
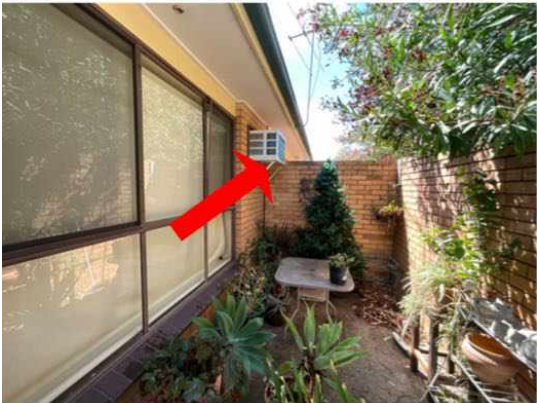
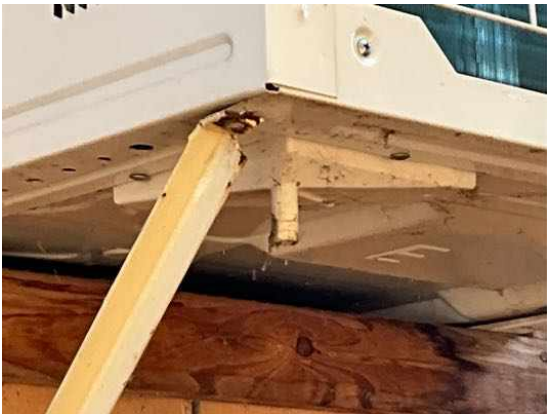
Finding 6.07

Building:	Building 1
Location:	All External Areas
Finding:	Termite Management System - no evidence of a chemical installation
Information:	The application of a post-construction chemical termite barrier is highly recommended for all properties, particularly if live termite activity has been found on the site previously. Such barriers are highly effective in preventing termite attack on any timber building elements throughout the property.

A durable notice should be placed in the switchboard unit to indicate current termite barriers. At the time of inspection, it appeared as though no termite management system has been installed, with no evidence to suggest preventative works taking place.

The client may consider gaining further advice from a pest controller as to the costs and procedures involved with this application. It is recommended that obtaining such advice be a short-term priority.

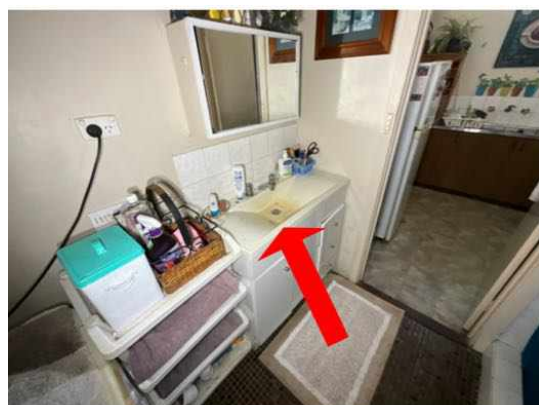
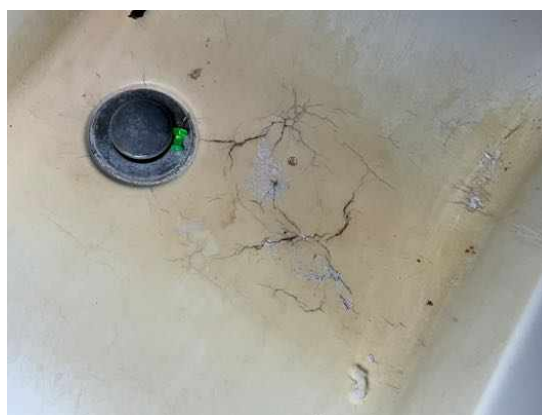
Building: Building 1
 Location: Laundry
 Finding: Vanity Basin- Cracked
 Information: Cracking was evident to the Vanity Basin at the time of inspection, which is suspected to have been caused by wear and tear over time. While the cracking appears to be minor, any further impact damage sustained by the basin may lead to additional cracking.

Consultation with a plumber regarding repair or replacement is required. Remedial works may be required to protect against any further damage.

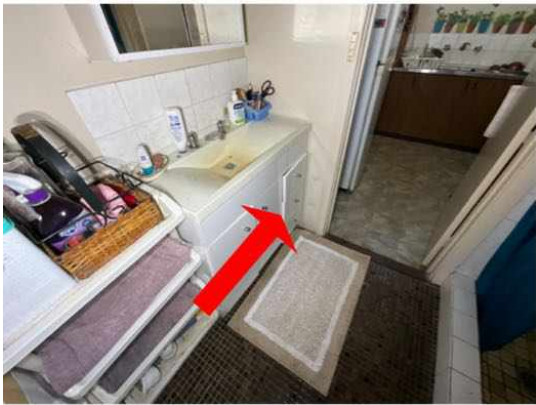
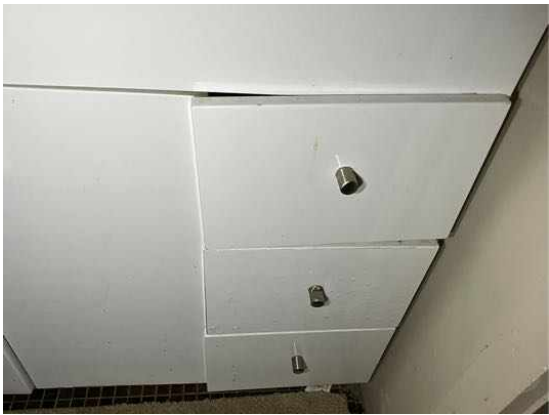
Building: Building 1
 Location: Laundry
 Finding: Cabinetry - Misaligned
 Information: The Cabinetry element at the time of inspection was found to be misaligned. The Cabinetwork was not returning all the way when closed. This is not a structural problem. The operation of sliding/ hinged mechanisms can be maintained by periodic adjustments to avoid increased damage as required.

It is recommended that a Handy Person or Cabinet maker be contacted to adjust the cabinetry and prevent any potential deterioration. This can be done at the discretion of the owner.

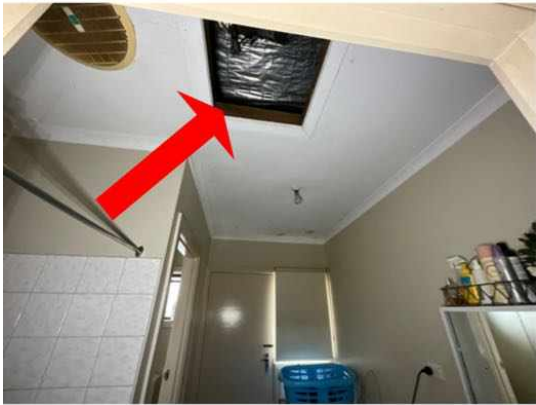
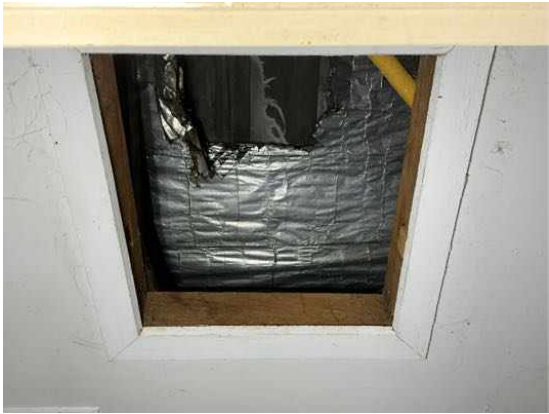
Building: Building 1
Location: Laundry
Finding: Access hatch
Information: The access hatch panel is missing. Replacement is recommended.

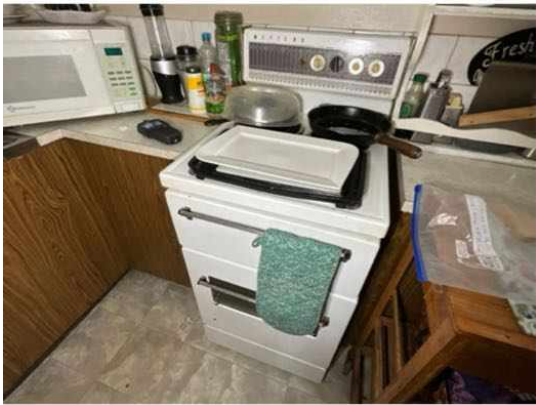
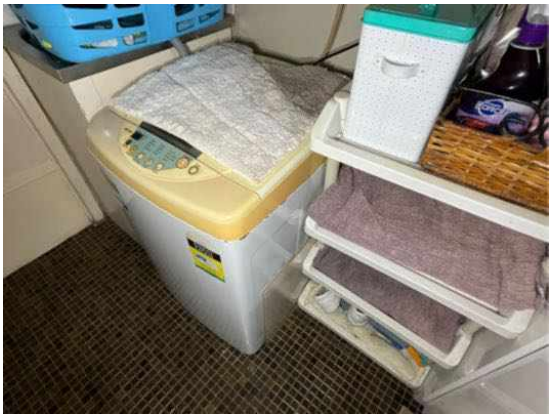
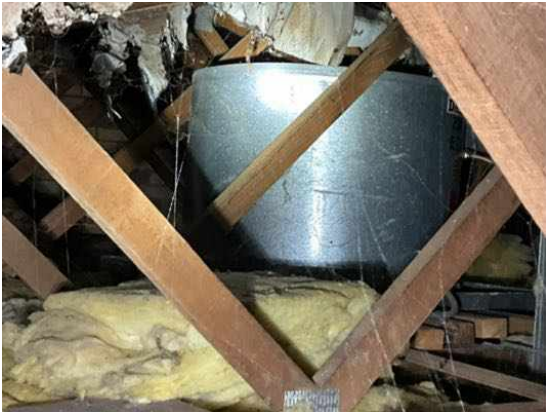
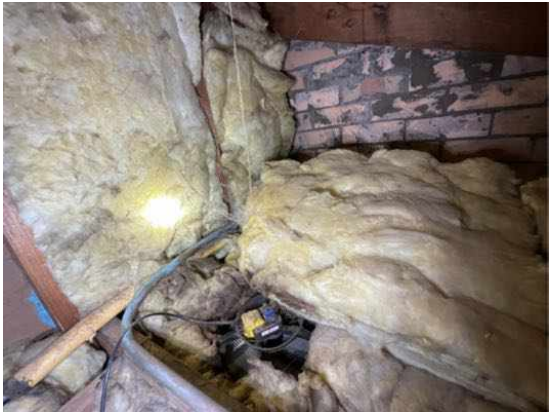
Building: Building 1
Location: All Areas
Finding: Additional Photos - Obstructions and Limitations
Information: These photographs are an indication of the obstructions and limitations which impeded full inspection of the property at the time of inspection. These obstructions can hide an array of defects and should be removed to allow full inspection to be carried out. A re-inspection is recommended once the areas are made accessible.
