## Building Inspection Report

Inspection Date: Mon, 30 Mar 2026

Property Address: 5 Sulky St, Menangle Park NSW 2563,  
Australia

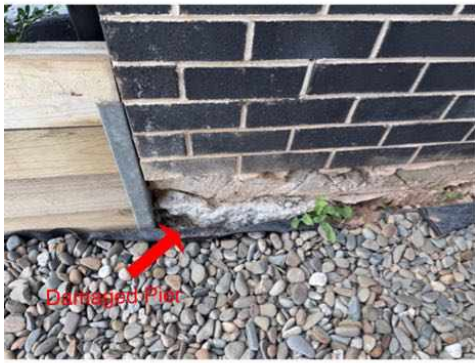
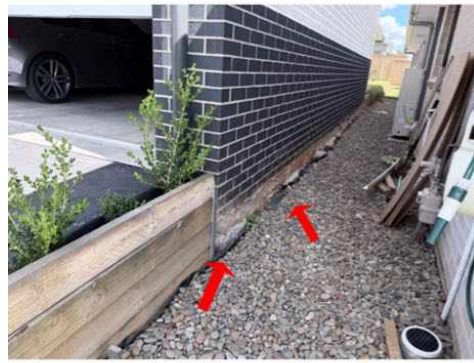
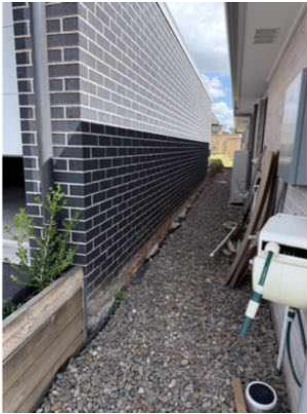
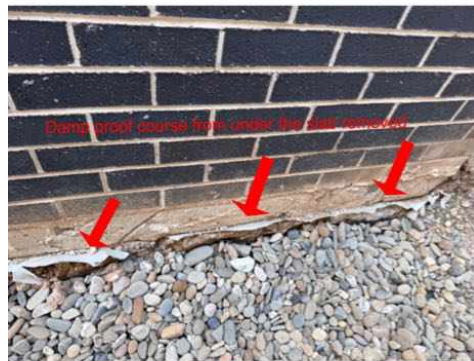
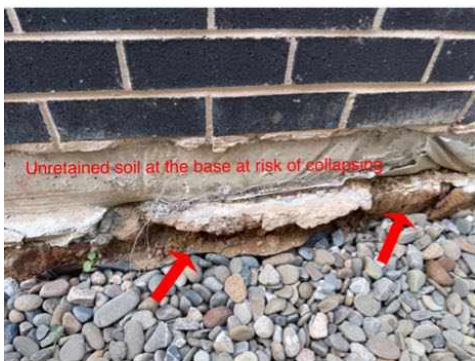
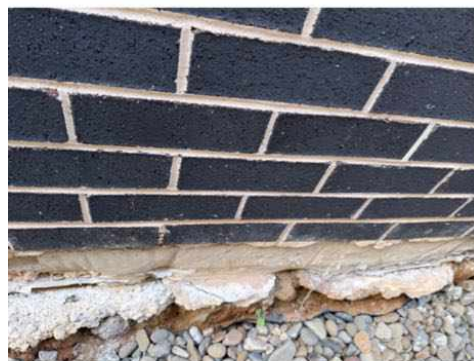
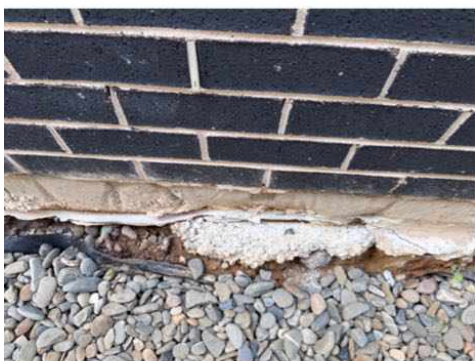
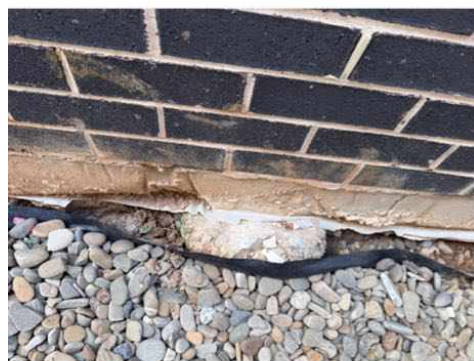
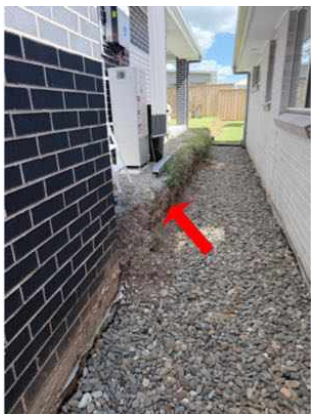
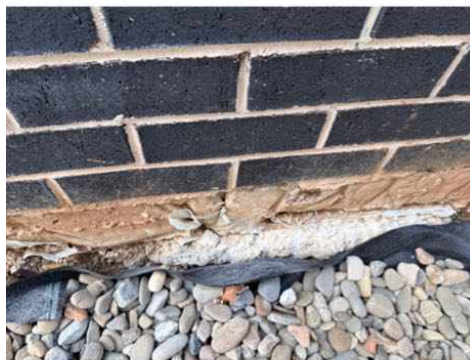
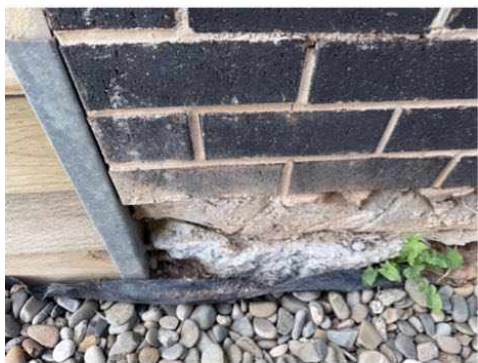
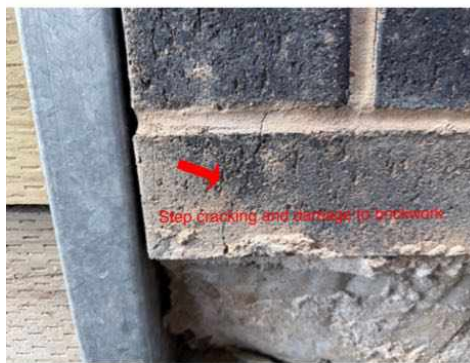
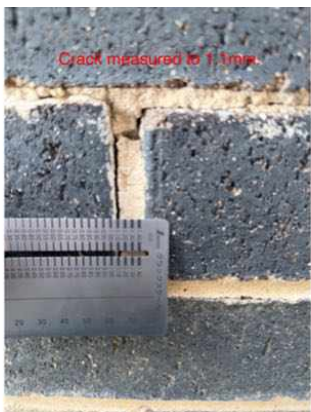
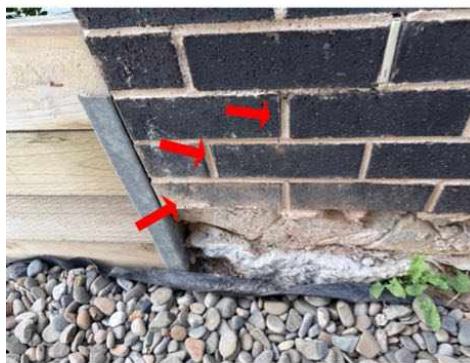
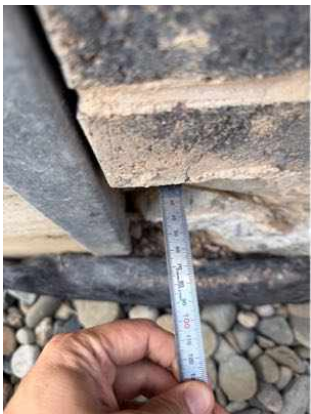
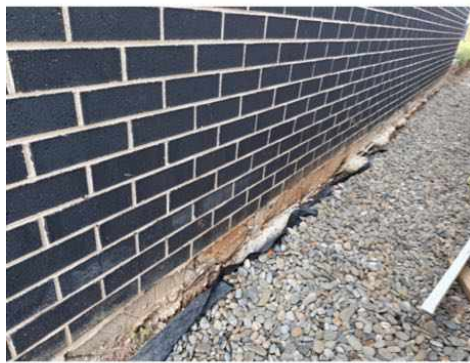
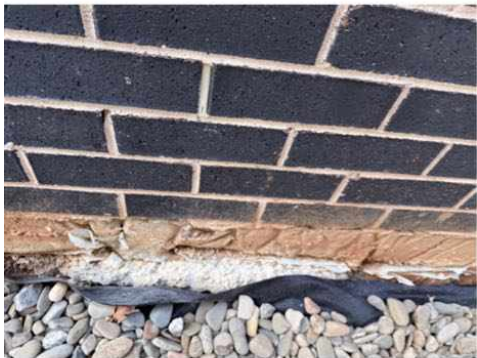
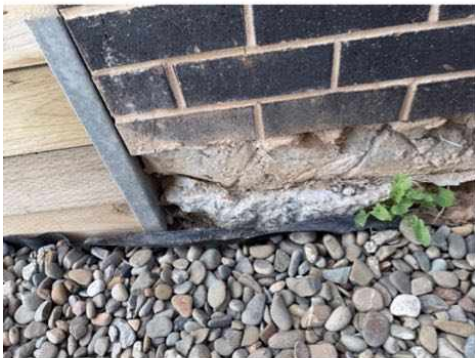
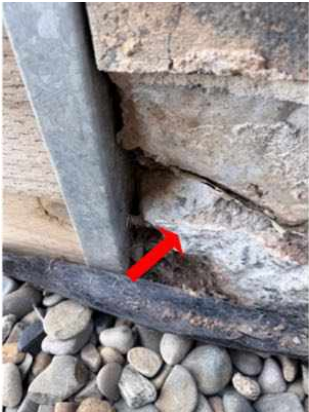
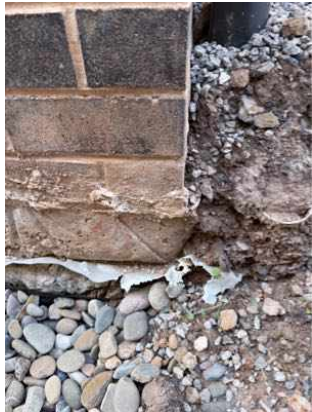
#### Defects 2.01

Building: Main Building  
Location: Exterior walls - right side  
Finding: External Foundation Damage  
Information: During the inspection, it was found that the external right side of the property has been damaged.

I observed the following damages:

1. Step cracking to brick work,
2. Crack to exceed 1mm,
3. Damp proof course to the slab edge being removed,
4. Pier to be jack hammered,
5. Land and soil at the boundary not retained.

It is found that the pier and damp proof course have been damaged causing stepped cracking to the brick wall.

Recommendation:

It is of my recommendation that the area to step crack be supported with an galvanised steel angle to support the area of brickwork.

The side of the slab foundation should be rendered and a waterproofing be applied to prevent moisture penetration and damp rise to the slab.

The exposed soil under the concrete slab should be retained to prevent any erosion and compromise the foundation of the garage slab.

Protection of the side wall is required to prevent any deterioration of the building condition.
