Building Inspection Report

Inspection Date: Mon, 30 Mar 2026

Property Address: 607 Heather Grove, Clyde North VIC 3978,
Australia

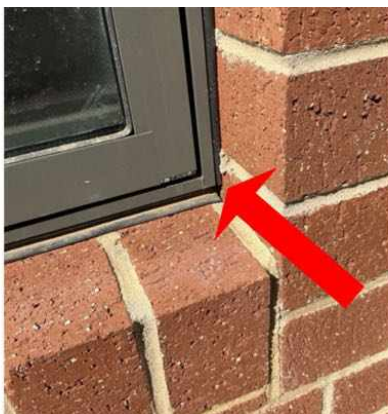
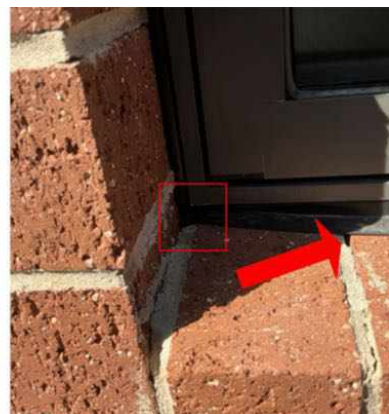
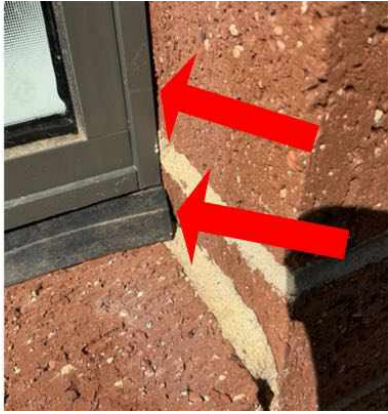
Defects 3.01

Building: Main Building
Location: All External Areas
Finding: Gaps Around External Window Frames
Information: Multiple gaps were identified between the external window frames and the adjoining brickwork across several elevations. These gaps appear to be the result of either poor or inconsistent sealant application during installation, or deterioration of the original sealant over time.

Unsealed or poorly sealed gaps can allow moisture ingress, wind-driven rain, draughts, and provide potential entry points for pests. Ongoing exposure to moisture may also contribute to internal dampness and premature deterioration of surrounding building elements.

A qualified handyman or registered builder should apply a consistent, waterproof, flexible exterior-grade sealant around all affected windows to ensure adequate weatherproofing and protection against moisture and pest entry.

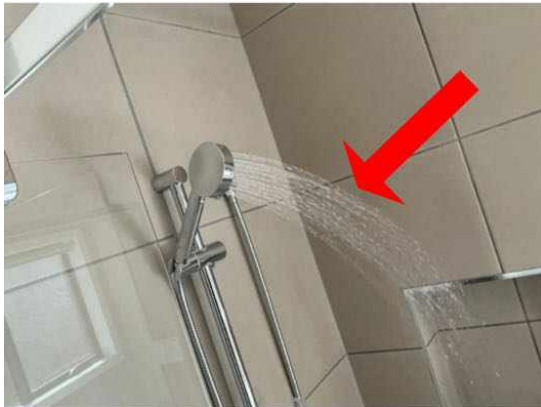
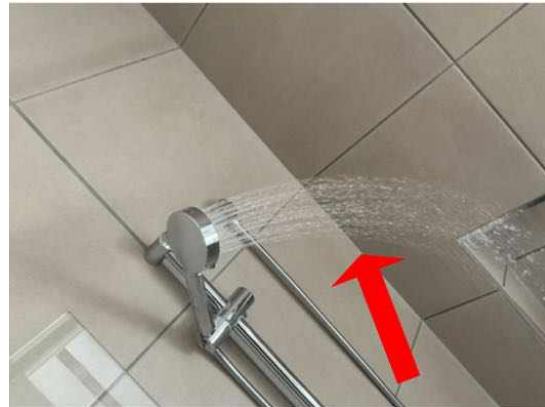
Defects 3.02

Building: Main Building
 Location: Both Showers
 Finding: Low Water Pressure to Showers
 Information:

Weak water flow was observed at both showers at the time of inspection.

This condition may be associated with low water pressure, partial blockages, or issues with fixtures or supply lines. While not a structural concern, it may impact the functionality and usability of the showers.

It is recommended that a licensed plumber be engaged to assess the cause of the reduced water flow and carry out necessary rectification to restore adequate pressure and performance.

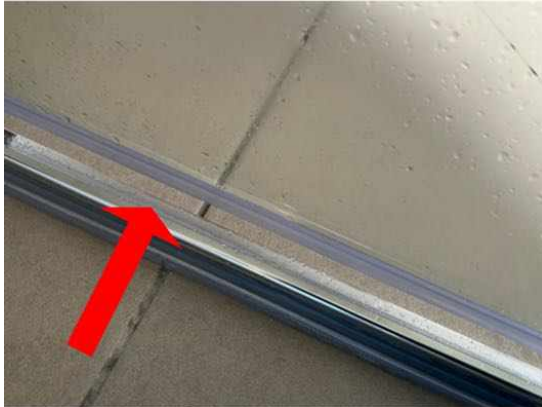
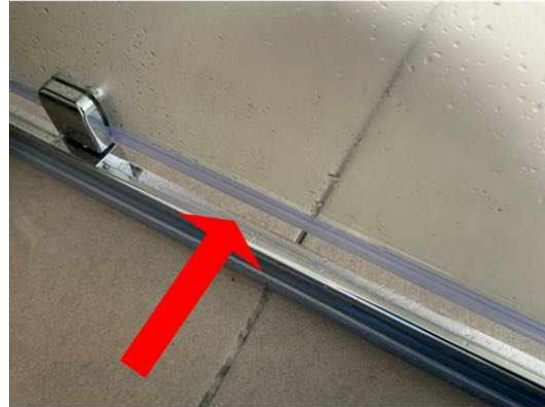
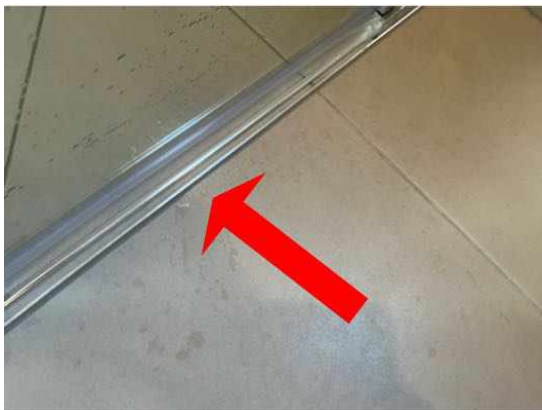
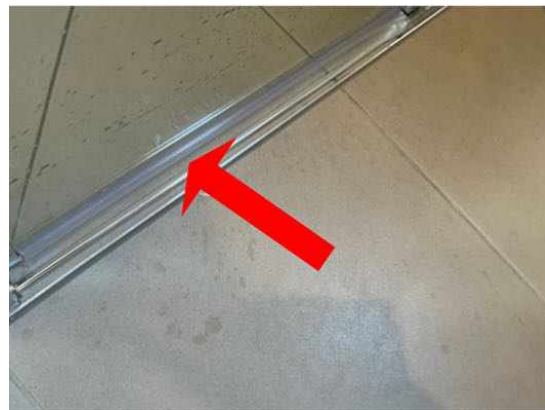
Defects 3.03

Building: Main Building
 Location: Both Showers
 Finding: Inadequate Shower Water Stops (Weather Trims)
 Information:

The shower water stops (weather trims) to both showers were observed to be insufficient in height and effectiveness, which may allow water to escape the shower

area during use.

This condition may lead to water spreading beyond the designated wet area, increasing the risk of moisture damage to adjacent flooring and building elements over time.

It is recommended that a qualified handy person or qualified bathroom specialist be engaged to upgrade the existing water stops to compliant and more effective trims to ensure adequate water containment within the shower areas.

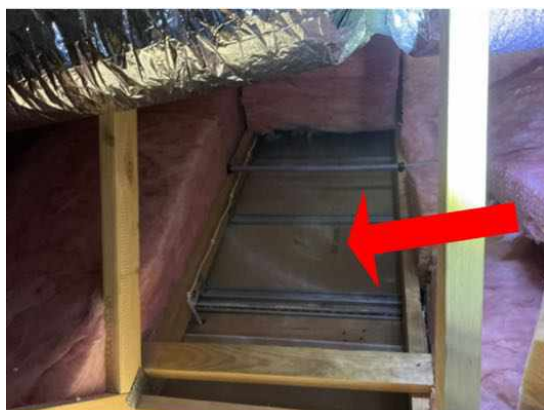
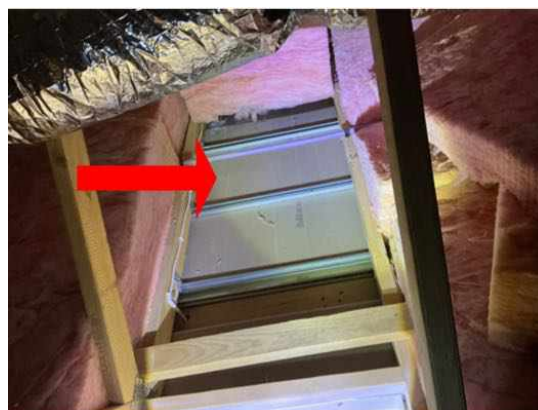
Defects 3.04

Building:	Main Building
Location:	Roof Void
Finding:	Insulation - Inadequate
Information:	Upon inspection of the roof void it was noted that there is a lack of adequate insulation.

Insufficient insulation will result in a comparatively higher cost to heat and cool a property as there is a lack of Insulation (or uneven coverage of insulation) which works as a barrier to heat transfer. This helps to keep out unwanted heat in summer and preserves warmth inside your home in winter. It can also help soundproof your home from unwanted airborne noise transfer.

The level of insulation in the property does not meet current Australian Standards. Installation of adequate insulation is required and should be conducted as soon as possible.

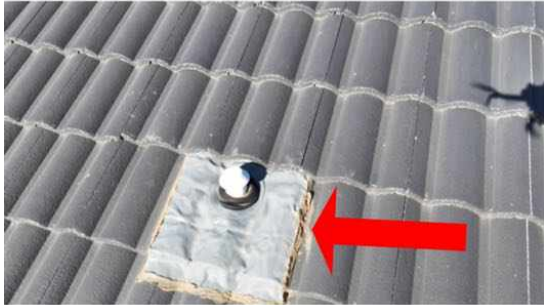
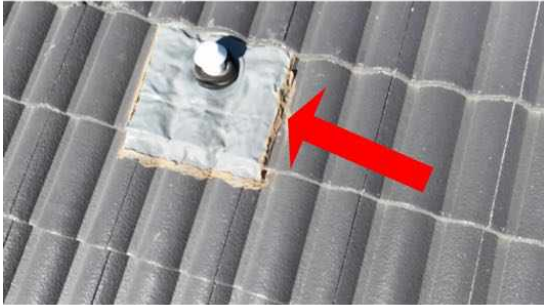
Defects 3.05

Building: Main Building
 Location: Roof Exterior
 Finding: Roof Covering – Non-Compliant Penetration Flashing Installation
 Information:

The roof penetration flashing has been installed using an improvised patching method, where a membrane/sealant material has been applied over the roof tiles rather than a properly formed and integrated flashing system. This type of installation does not align with standard roofing practices expected in new construction.

This condition presents a risk of premature failure, as the applied material may deteriorate over time and is unlikely to provide a durable and watertight seal. In a new dwelling, such installation reflects substandard workmanship and may lead to water ingress into the roof space if not rectified.

It is recommended that a qualified roof tiler be engaged to remove the existing patch and install a compliant, purpose-made penetration flashing integrated correctly with the roof tiles in accordance with manufacturer guidelines and relevant standards. Rectification should be carried out promptly as part of the builder's defect liability obligations.

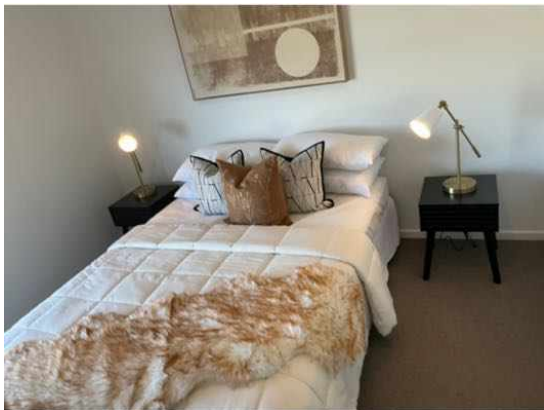
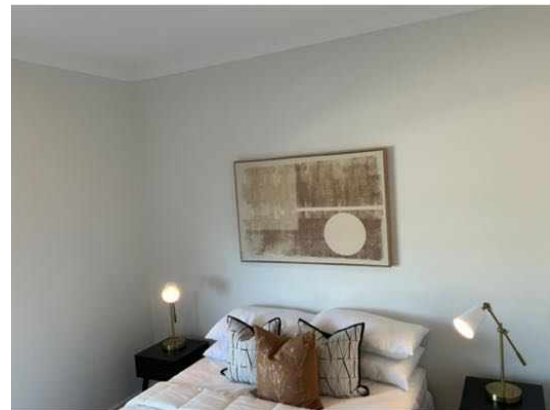
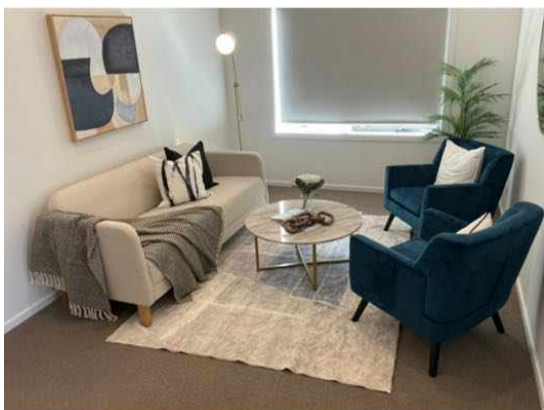
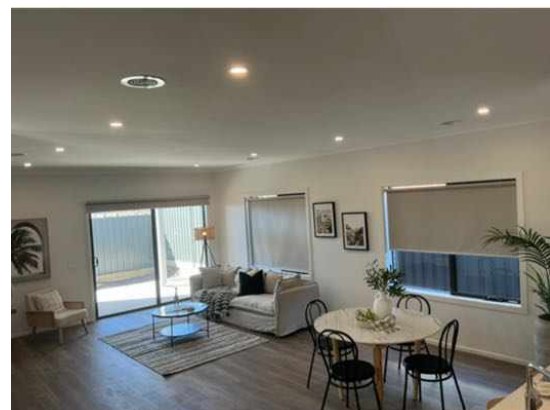
Building: Main Building
 Location: All Areas
 Finding: Obstructions and Limitations - Interior
 Information: These photographs are an indication of the obstructions and limitations which impeded the inspection of the internal areas of the property at the time of inspection. These obstructions can hide an array of defects and should be removed to allow full inspection to be carried out. A re-inspection is recommended once the areas are made accessible.

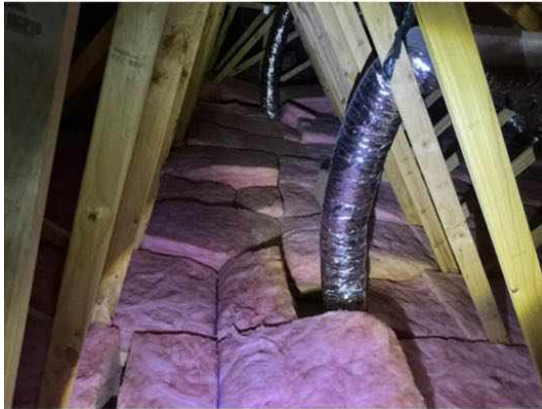
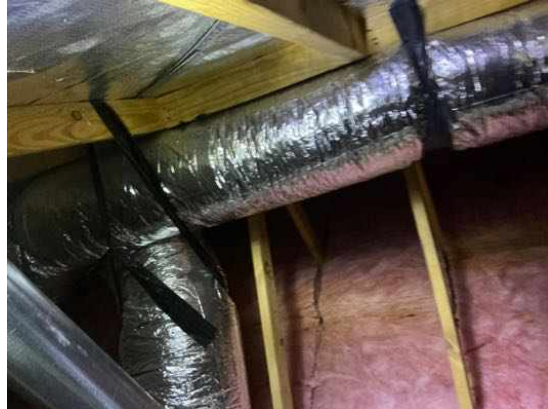
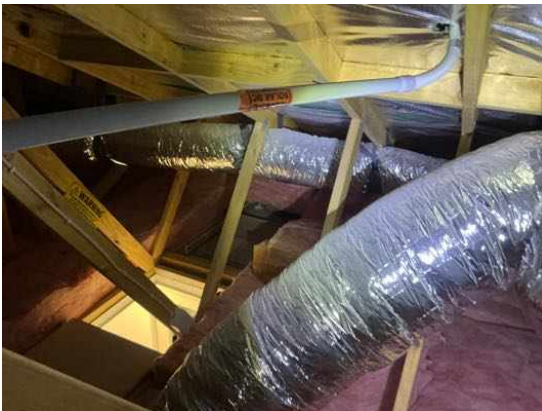
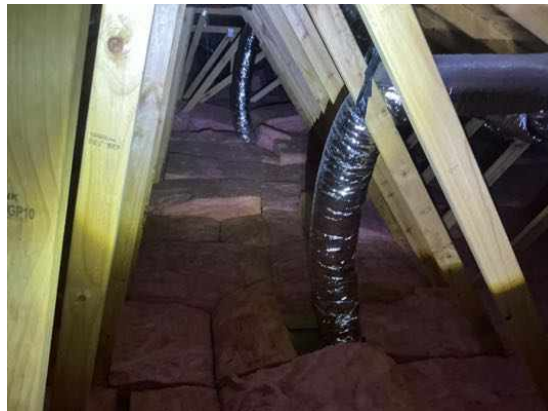
Building: Main Building
 Location: Roof Void
 Finding: Obstructions and Limitations - roof cavity
 Information: These photographs are an indication of the obstructions and limitations which impeded the inspection of the roof cavity area of the property at the time of inspection. These obstructions can hide an array of defects and should be removed to allow full inspection to be carried out. A re-inspection is recommended once the areas are made accessible.

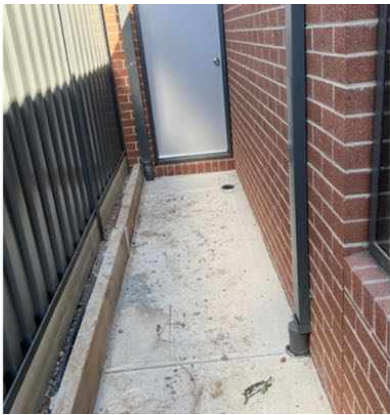
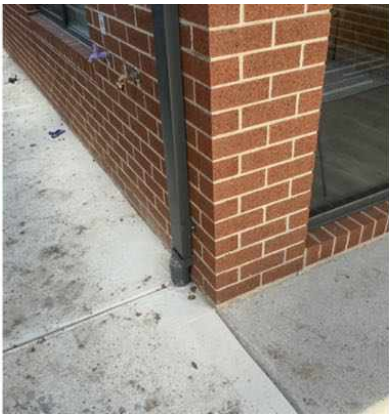
Building: Main Building
 Location: All External Areas
 Finding: Obstructions and Limitations - Exterior
 Information: These photographs are an indication of the obstructions and limitations which impeded the inspection of the external areas of the property at the time of inspection. These obstructions can hide an array of defects and should be removed to allow full inspection to be carried out. A re-inspection is recommended once the areas are made accessible.
