# Building and Timber Pest Inspection Report

Inspection Date: Fri, 30 Jan 2026

Property Address: 3 Clyde Ct, West Wodonga VIC 3690,  
Australia

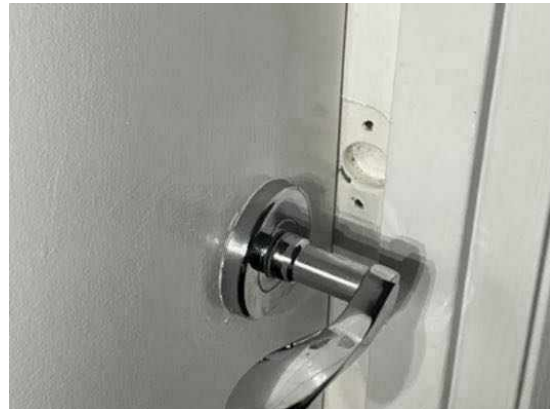
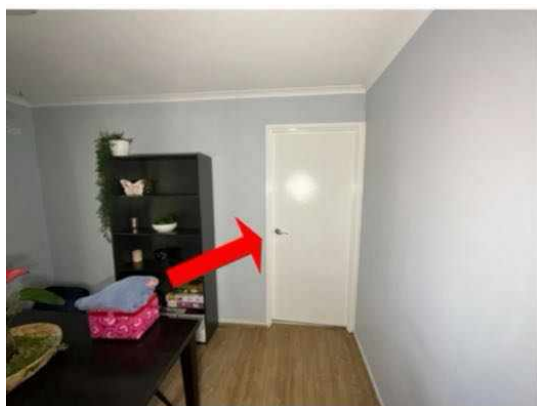
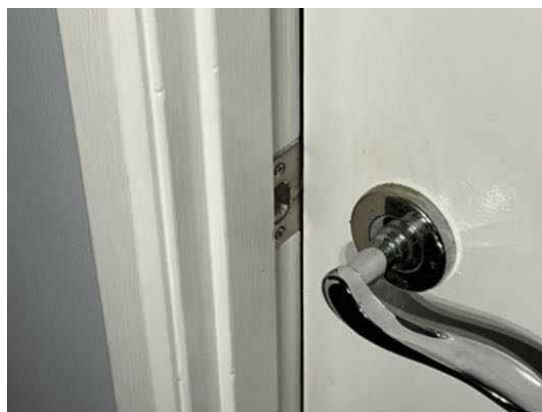
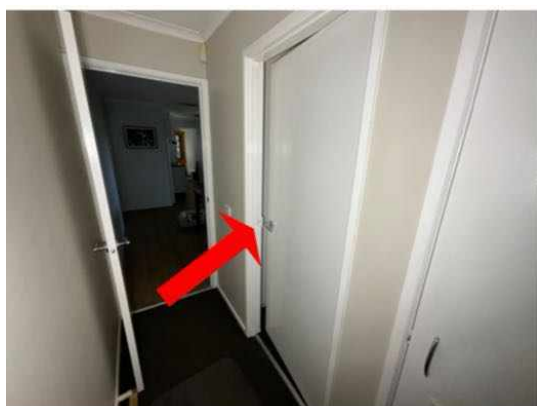
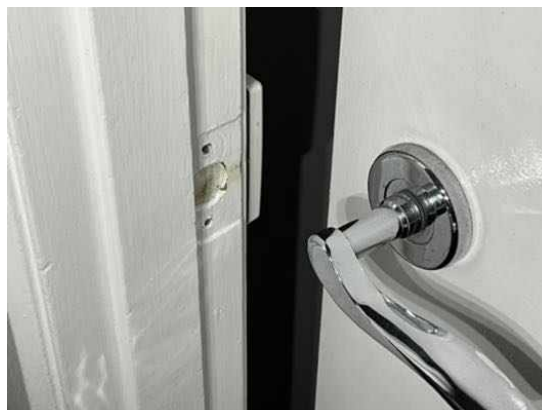
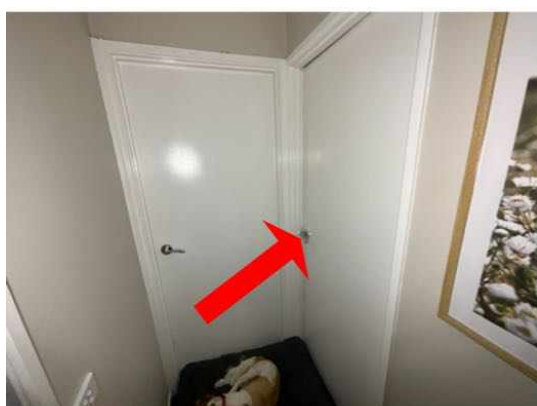
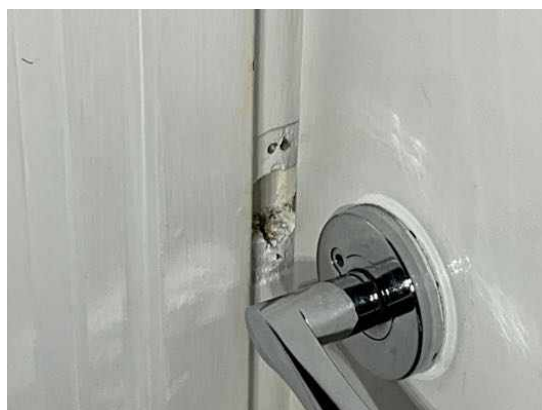
#### Finding 3.01

Building: Building 1  
Location: Study, hall, laundry, bed 2  
Finding: Door - Striker plate misaligned  
Information: The striker plate to this door appears to have become misaligned and has consequently resulted in the door's operation being compromised.

This is a common defect and is expected in a property of this age, whether being due to substandard installation or general deterioration of the door hardware.

Readjustment of the striker plate is recommended at client discretion. Works such as these can be completed by a general handyman or qualified carpenter.

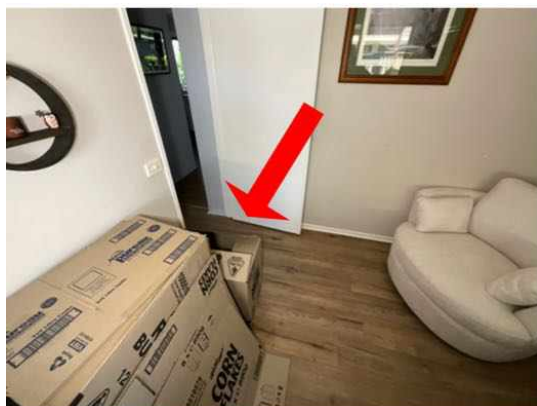
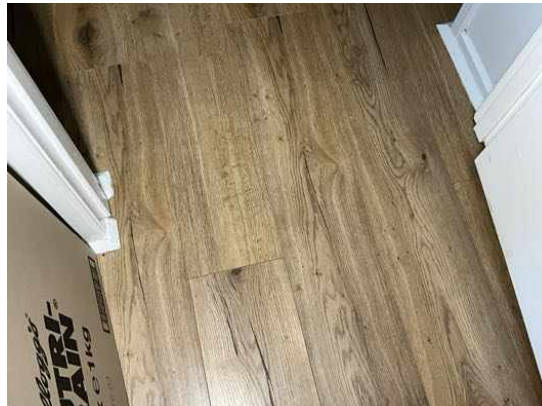
### Finding 3.02

Building:	Building 1
Location:	Study
Finding:	Floors - bouncy
Information:	The internal flooring in this area was identified as being bouncy at the time of inspection. A bouncy floor surface generally presents as a discernible change in level as they are walked across, in noisy or creaking flooring, or in consequent movement of surrounding furniture and fixtures.

Bouncy floors generally indicate that the floorboards or the subfloor structures are coming loose from the joists that they are installed on. Bouncy flooring may also be the result of gaps between flooring and stumps or joist structures, which require packing.

The client is advised to seek quotations for required repairs from a Registered Builder specialising in re-stumping. The potential resolution may range from packing gaps in subfloor structures through to replacement of subfloors stumps and refixing of flooring.

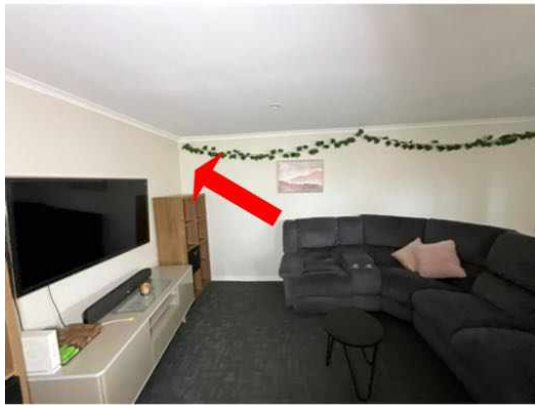
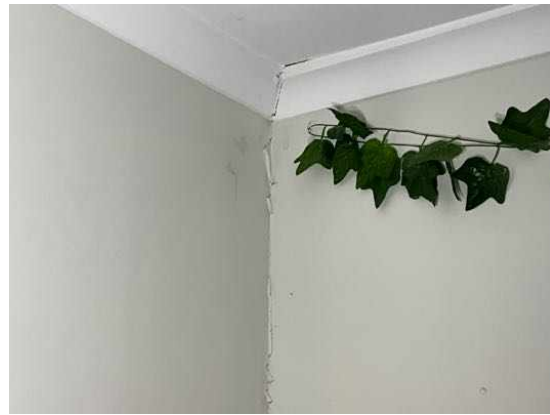
### Finding 3.03

Building:	Building 1
Location:	Bungalow
Finding:	Cracking - Damage Category 2 - Noticeable (up to 5mm)
Information:	Noticeable cracks are a common occurrence as a result of many primary defects. Such causes may include age, general wear and tear, expected building movement, general expansion/contraction of building materials in different weather conditions, and/or minor failings in the installation or application of building materials.

Noticeable cracks may result in minor sticking or jamming of associated doors and windows, which require easement. However, noticeable cracks are easily filled and repaired. A plasterer can be consulted to install an expansion joint at this point to allow for this movement during different weather conditions.

Monitoring of all cracking should be conducted frequently. Always contact a building inspector should cracks widen, lengthen, or become more numerous. Additionally, your building inspector should also be contacted if associated building elements such as doors and windows become more difficult to operate over time.

Relevant tradespeople, such as carpenters, painters and plasterers, should be appointed to perform remedial works, as deemed necessary.

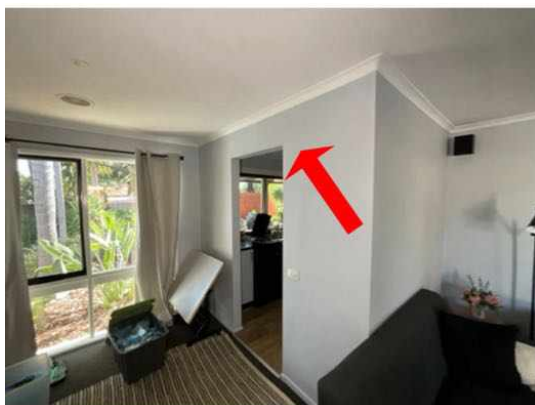
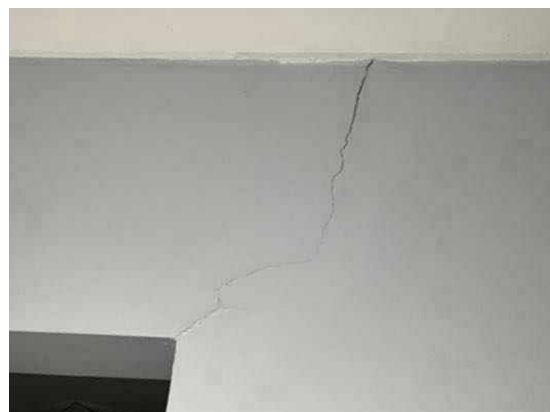
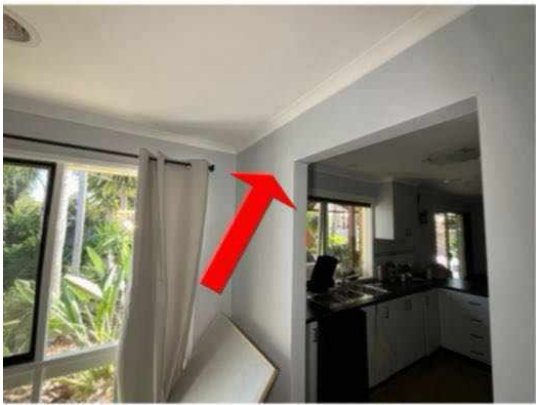
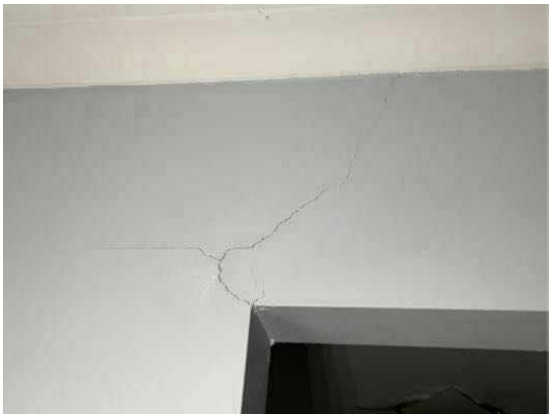
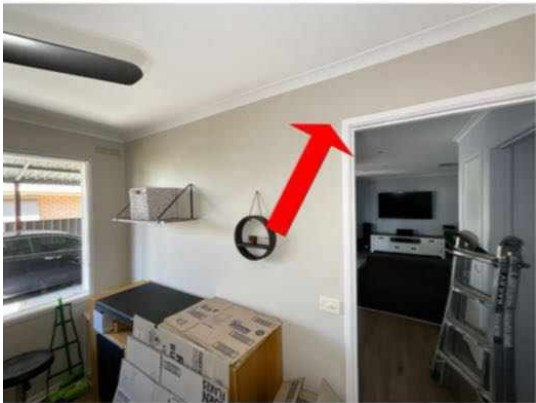
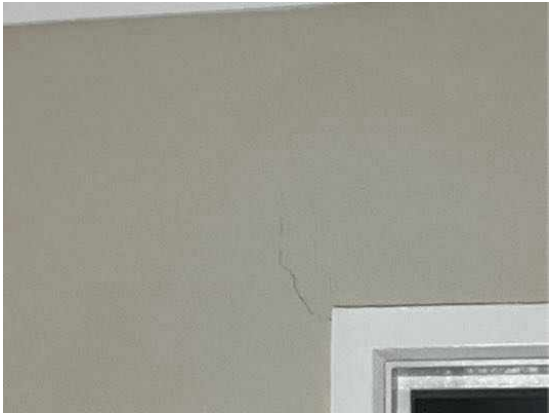
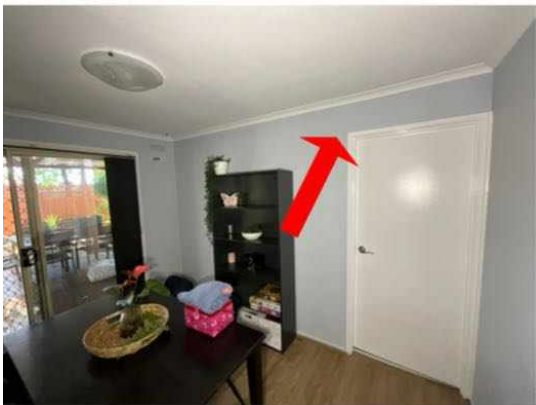
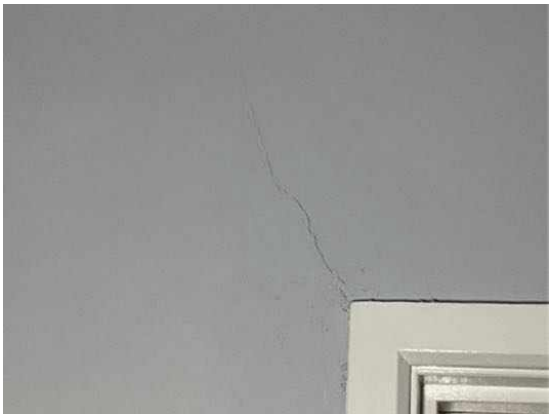
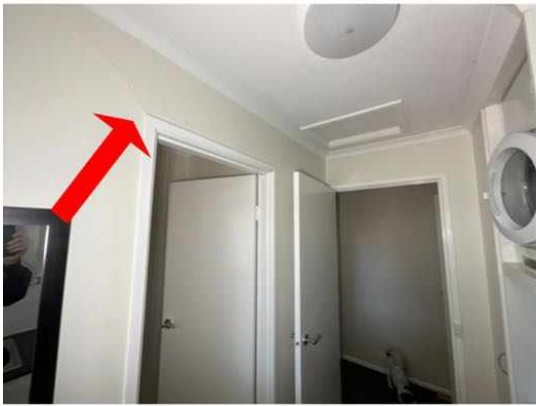
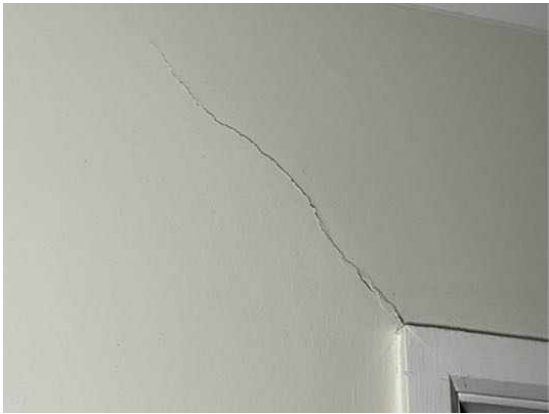
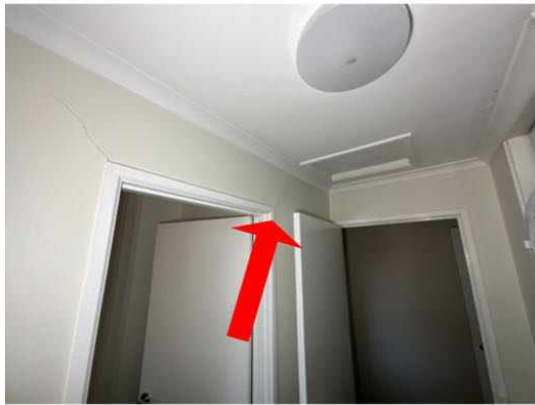
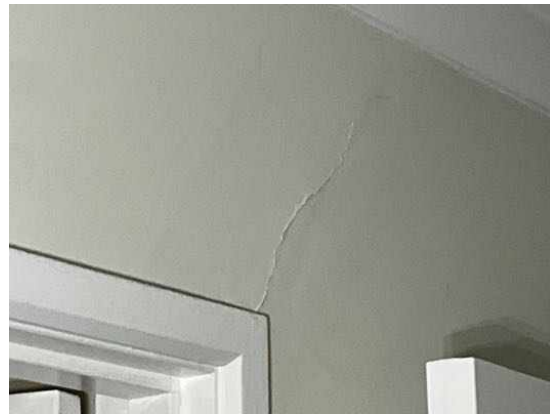
### Finding 3.04

Building:	Building 1
Location:	Dining Room, study, living, laundry
Finding:	Cracking - Damage Category 1 - Fine (up to 1mm)
Information:	Although fine cracks are quite noticeable, they are often only considered to be an appearance defect, and usually do not indicate any structural damage. Generally, the cause of a fine crack is indicative of a separation between building materials and finishes (e.g. paint, plaster, etc.) along joins.

Cracking of this nature can generally be repaired with minor sanding, filling and/or repainting. Such works should be performed by a qualified painter or a general handyman.

Monitoring of all cracking should be conducted frequently. Always contact a building inspector should cracks widen, lengthen, or become more numerous.

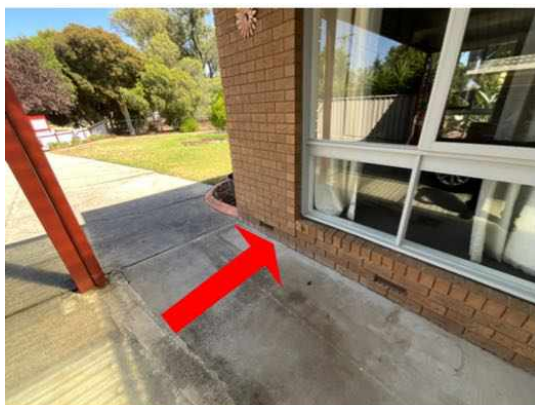
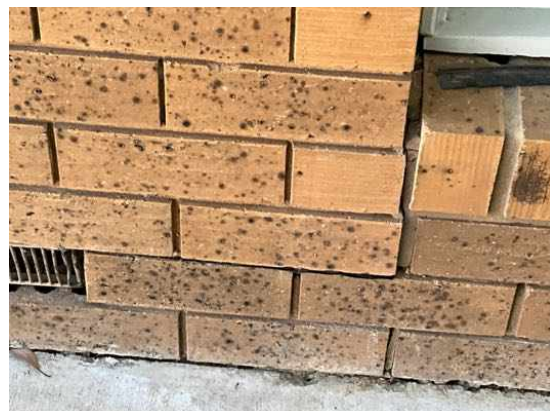
### Finding 3.05

Building: Building 1  
 Location: Carport  
 Finding: Brickwork- Step cracking  
 Information: Step cracking was identified to the brickwork in this area at the time of inspection. Step cracking, which is similar to other forms of cracking, has a variety of possible causes. However, the most common is the subsidence of adjacent footings.

Step cracking is a relatively common defect, and is most likely to occur adjacent to windows, doors and other openings. Mortar failure in the gaps between affected bricks indicates the stresses and tensions affecting the wall.

Minor step cracking can be used as a warning sign to address factors causing stress to the wall, which can include the effect of surrounding trees, water leaks, soil erosion, or even the presence of reactive soils in the surrounding area.

If cracks increase in size or number contact a Licensed builder immediately to make all needed repairs.

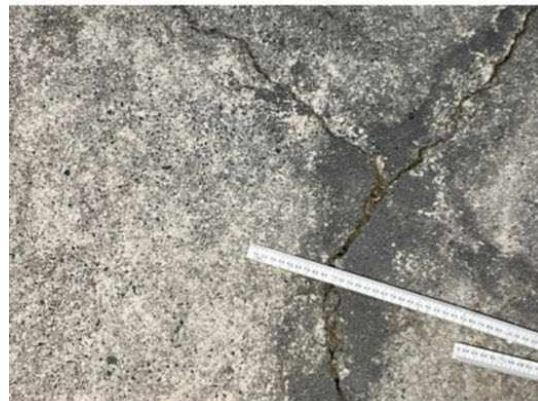
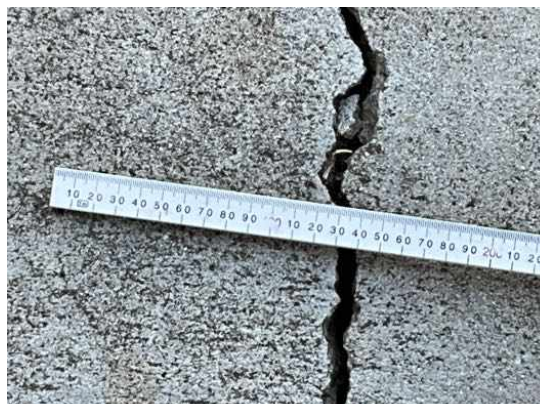
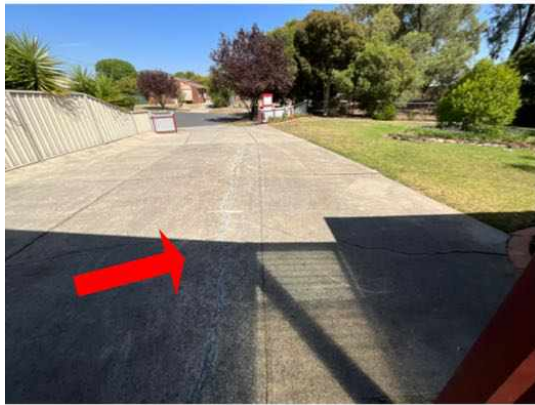
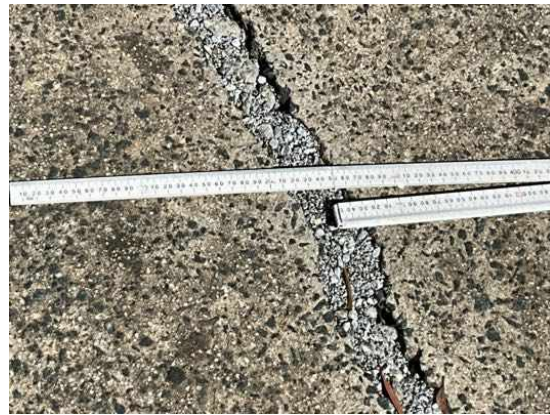
### Finding 3.06

Building: Building 1  
 Location: Garage, driveway, carport

Finding: Cracking - External Concrete Paving Damage Category 4 - Gaps in Slab (4mm - 10mm +)

Information: Gaps in the slab were identified in external concrete paving. Gaps in the slab are significant and are likely to lead to the development of safety hazards and secondary defects if left unmanaged, such as the creation of a trip hazard.

General age and expected deterioration of the paved areas is a common cause of this type of cracking. However, expansion and contraction of the slab may also have occurred due to environmental factors. Such factors include variable moisture and weather conditions, the presence of trees and their roots having a settling or lifting affect on the soil, or the effect of load bearing, e.g. heavy vehicles over a sustained period of time.

Cracking to this degree may also be due to poor original installation of the concrete. Factors such as poor compaction of the sub surface and/or inadequate reinforcing of the slab may create cracking and other secondary defects. Gaps in the concrete paving may also have a more significant structural cause, such as subsidence of soils.

Where gaps in the concrete paving are adjacent to structural elements of the building, the advice of a Structural Engineer is advisable before undertaking repairs. Significant repair and likely replacement of the concrete paving is probable.

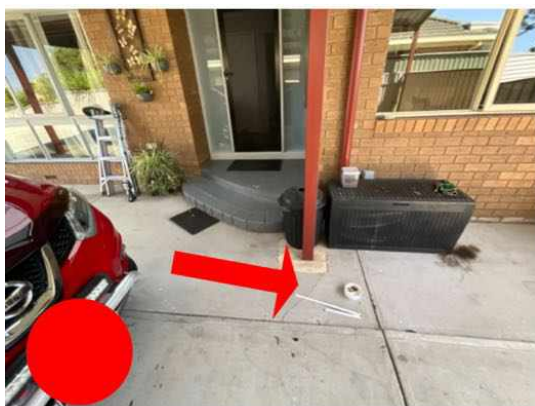
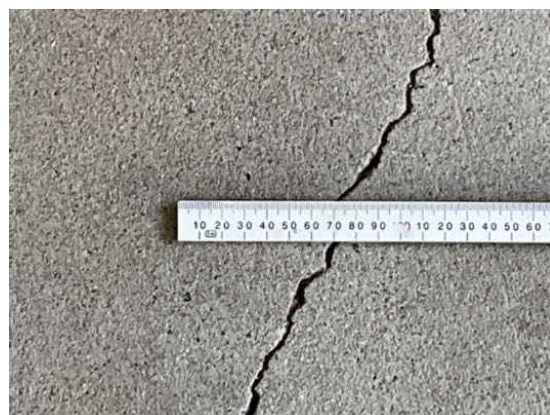
### Finding 3.07

Building:	Building 1
Location:	Carport
Finding:	Cracking - External Concrete Paving Damage Category 1 - Fine (less than 2mm)
Information:	Fine cracks were identified in external concrete paving. Although fine cracks are quite noticeable, they are often only considered to be an appearance defect, and usually do not indicate any structural damage. To be considered a Category 1 or fine crack, the crack is found to be less than 2mm in width.

Generally the cause of a hairline crack in existing concrete paving such as driveways and pathways is indicative of the expansion and contraction of the concrete. Such causes are generally due to environmental factors, such as moisture levels, weather conditions, root systems of nearby trees or the soil types on which they are laid.

Fine cracks may also be due to poor original installation of the concrete. Factors such as poor compaction of the sub surface and/or inadequate reinforcing of the slab may create cracking and other secondary defects.

Monitoring of all cracking should be conducted frequently. Always contact a building inspector should cracks widen, lengthen, or become more numerous.

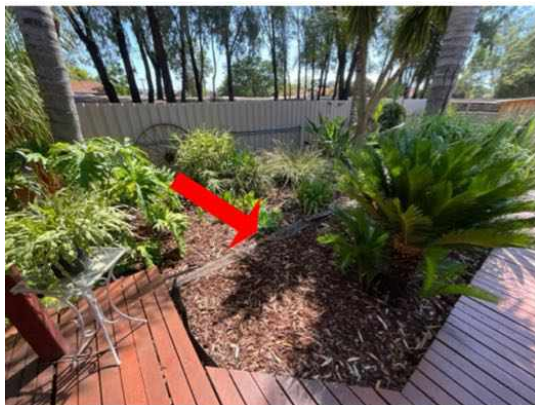
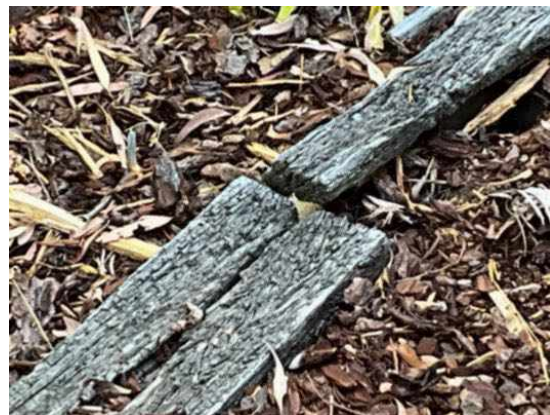
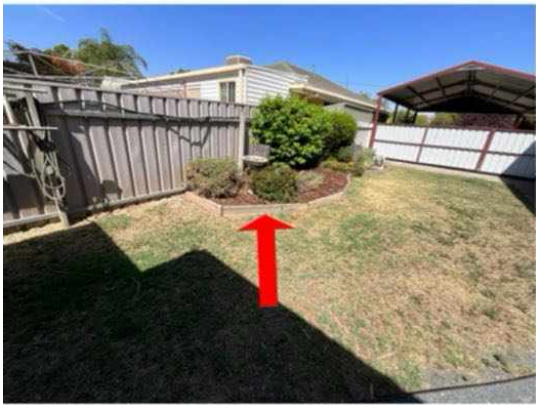
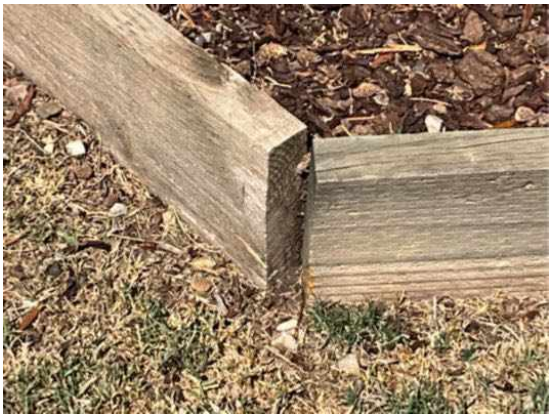
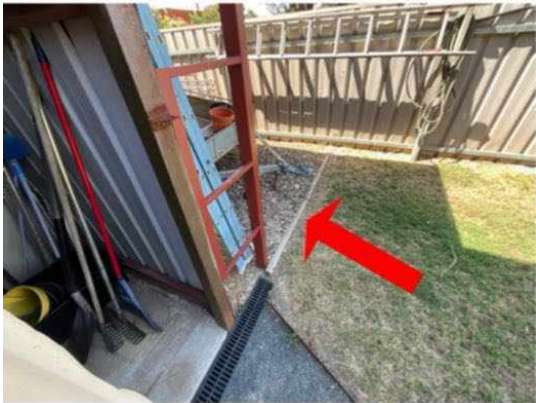
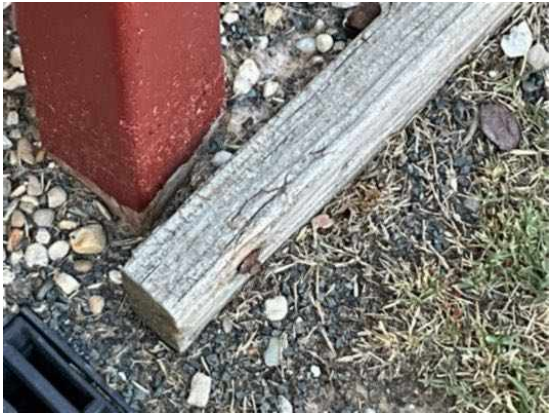
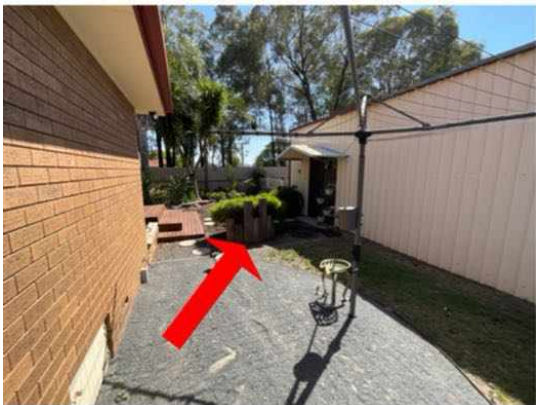
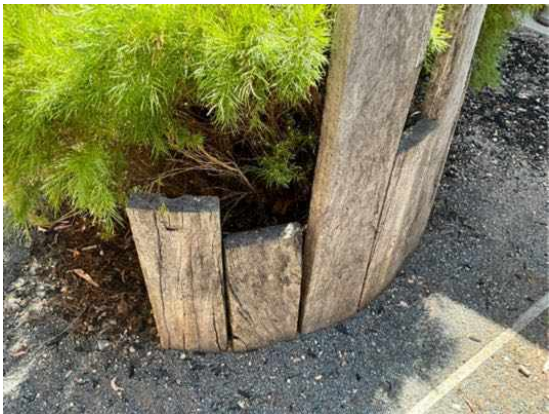
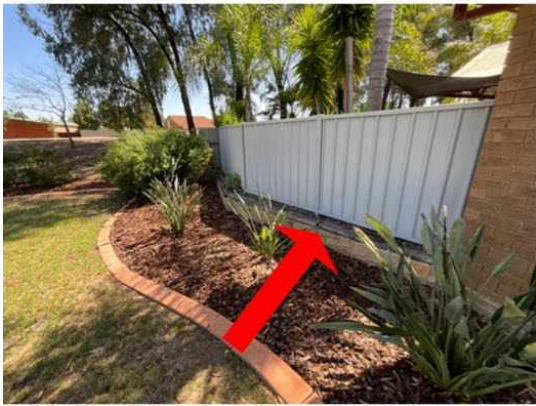
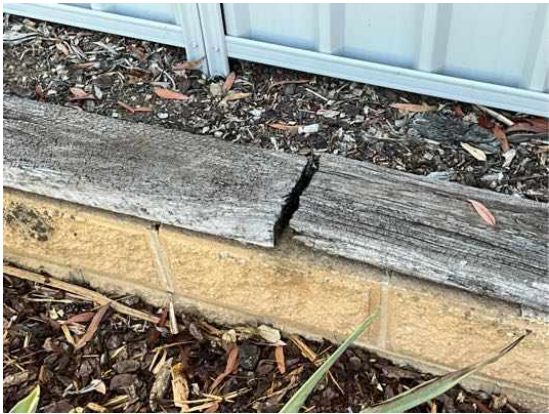
### Finding 6.01

Building:	Building 1
Location:	Yard - Back, front
Finding:	Untreated or non-durable timbers in a hazardous environment
Information:	To reduce the risk of timber pest attack it is essential that timber used in a hazardous environment (e.g. in direct contact with the ground or frequently exposed to damp conditions) is of sufficient durability and/or is adequately preservative treated.

Untreated timbers in direct contact with the ground are likely to develop severe wood rot and/or fungal decay if left unattended creating attraction for subterranean termites to infest the timbers from surrounding areas.

If untreated or non-durable timbers are found to be in a hazardous environment it is highly advised that replacement of these building elements be performed as soon as possible to aid the protection of the property against termite / timber pest attack.

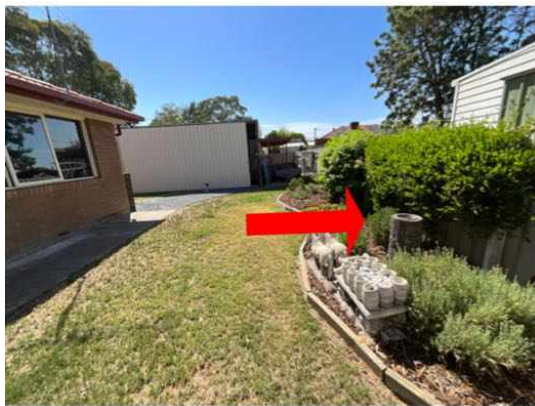
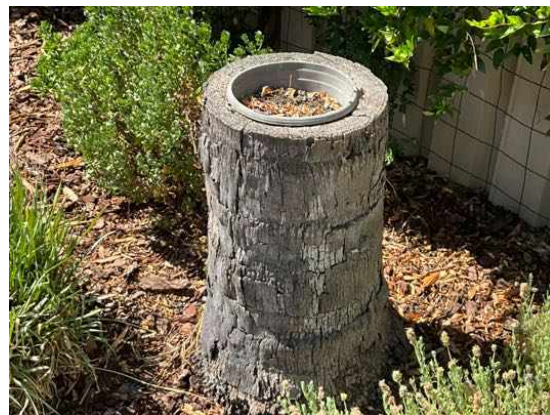
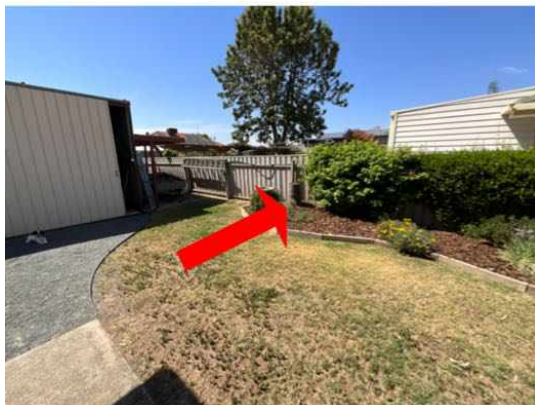
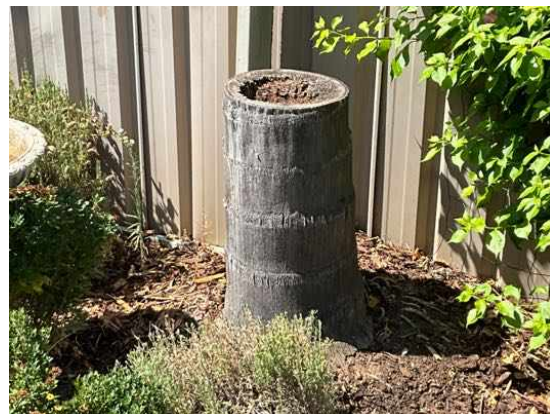
Finding 6.02

Building: Building 1  
 Location: Yard - Back  
 Finding: Tree Stump in Ground  
 Information: Any tree stumps in the yard not removed during the tree removal process provides the opportunity for Termite infestation and is likely to be subject to decay from damp conditions against the stump.

All tree stumps should be removed by professional tree removal services where possible. Meanwhile regular inspections are advised to identify any termite activity in the areas identified.

Services for tree stump removal should be contacted as soon as possible to reduce the risk of timber pest attack.

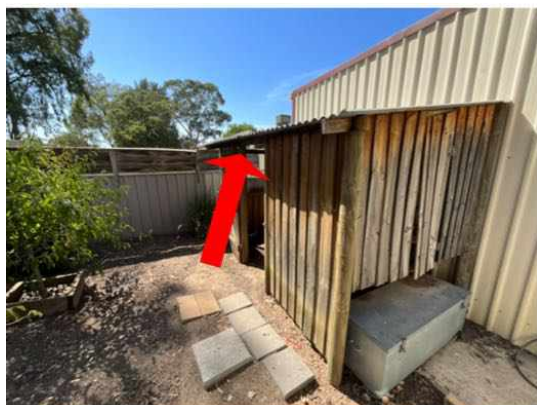
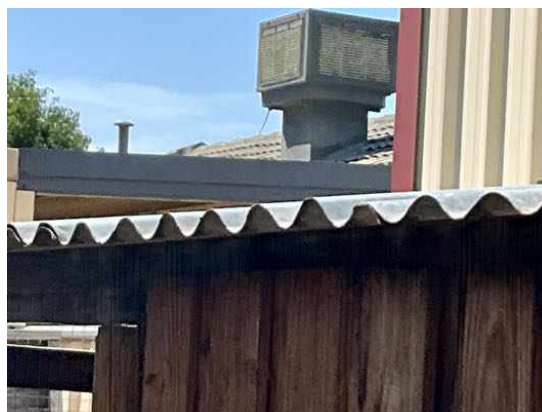
### Finding 6.03

Building: Building 1  
 Location: Chook house  
 Finding: Guttering Missing  
 Information: The Guttering in this area was missing at the time of inspection. Guttering, Downpipes and Stormwater drainage are vital to protect the integrity of the structure and to prevent an environment conducive to Timber Pest attack.

A Plumber should be contacted as soon as possible to replace and connect to drainage the missing Guttering.

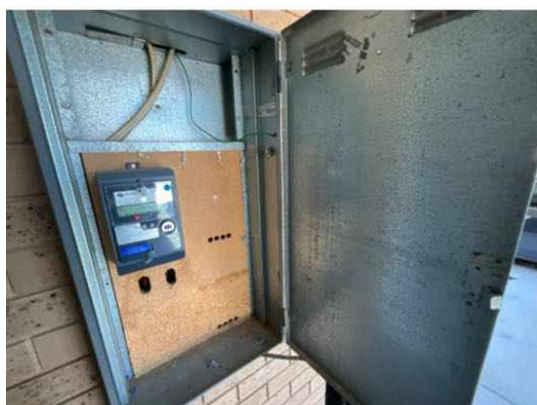
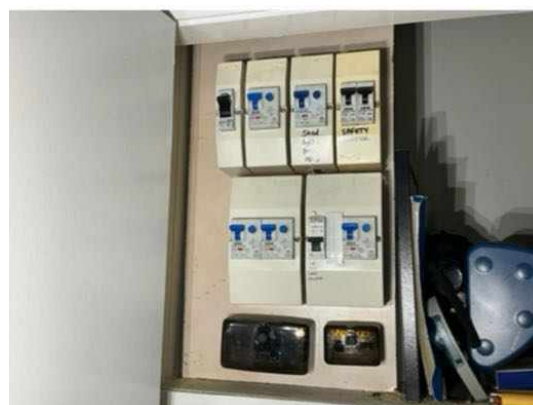
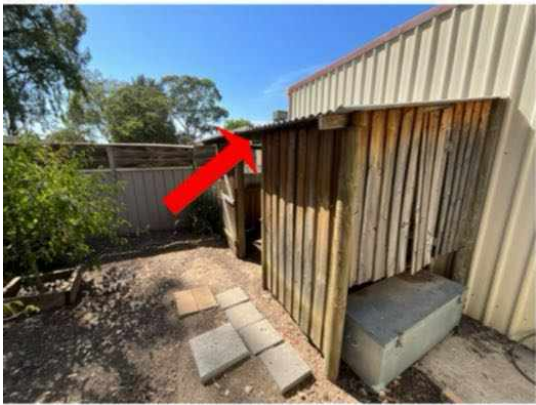
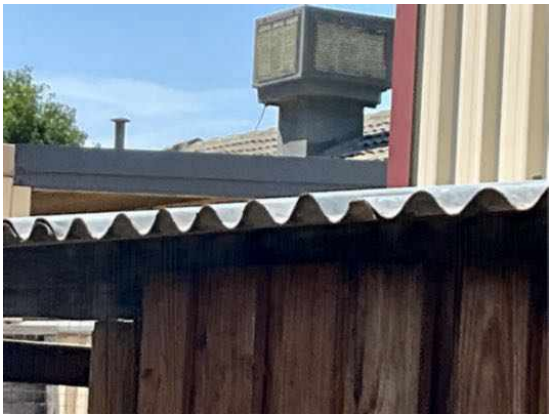
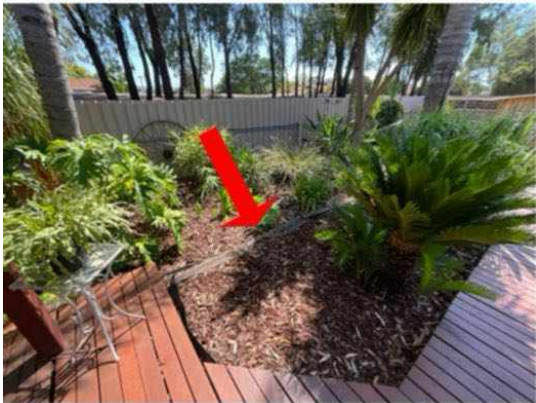
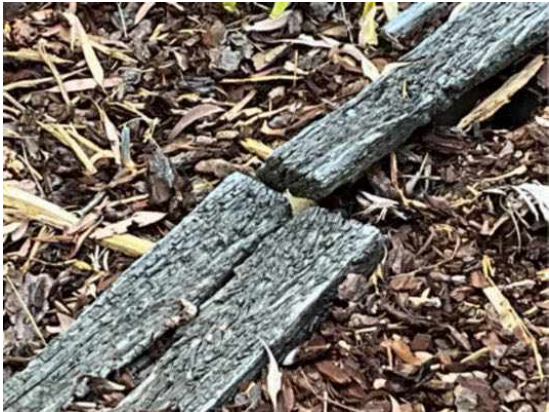
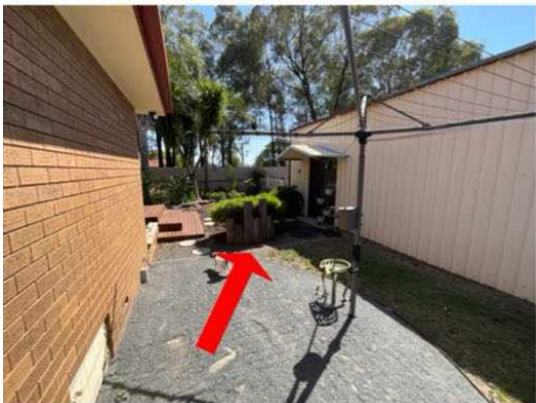
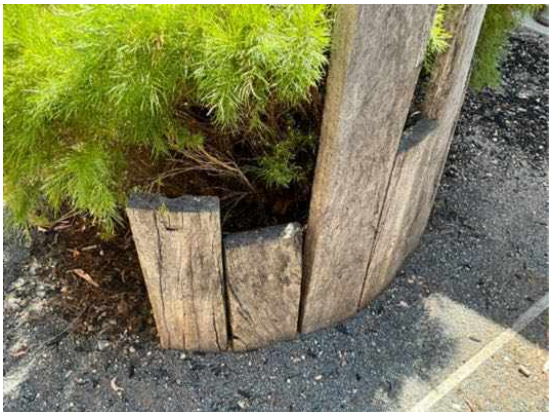
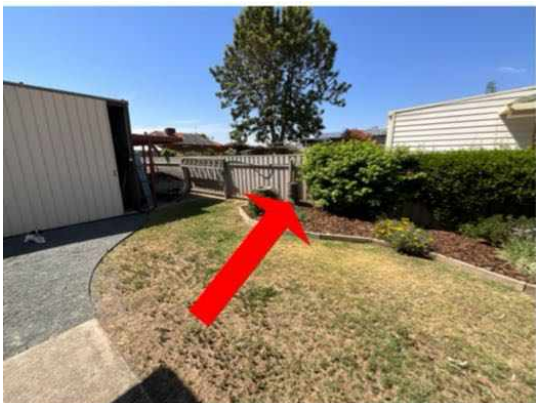
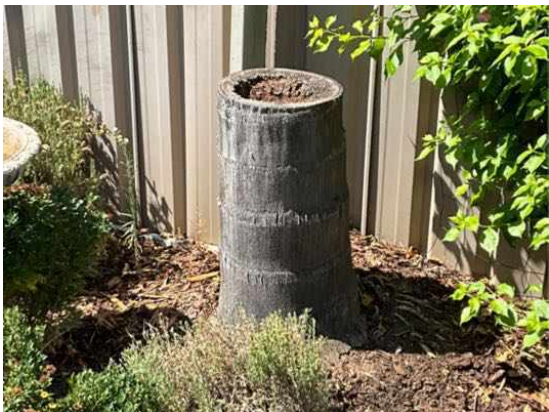
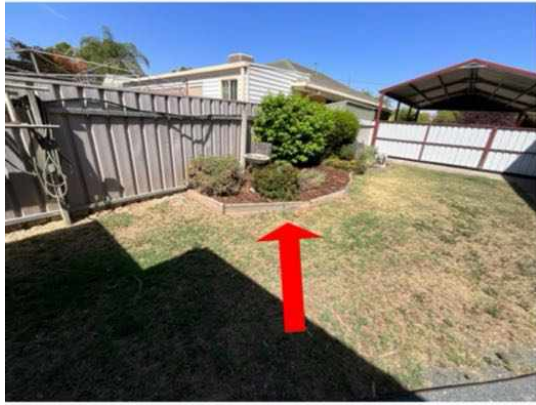
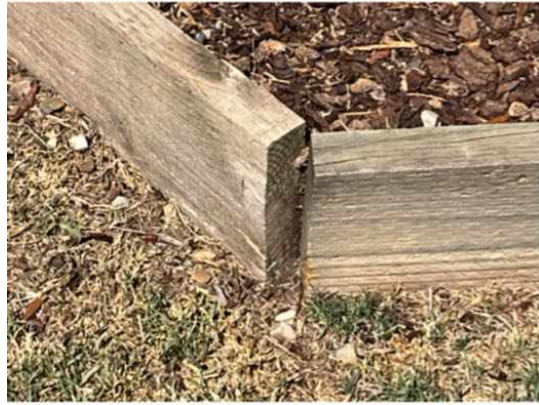
### Finding 6.04

Building:	Building 1
Location:	All External Areas
Finding:	Termite Management System - no evidence of a chemical installation
Information:	The application of a post-construction chemical termite barrier is highly recommended for all properties, particularly if live termite activity has been found on the site previously. Such barriers are highly effective in preventing termite attack on any timber building elements throughout the property.

A durable notice should be placed in the switchboard unit to indicate current termite barriers. At the time of inspection, it appeared as though no termite management system has been installed, with no evidence to suggest preventative works taking place.

The client may consider gaining further advice from a pest controller as to the costs and procedures involved with this application. It is recommended that obtaining such advice be a short-term priority.

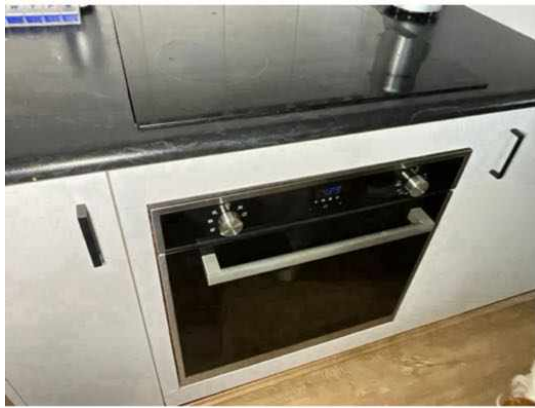
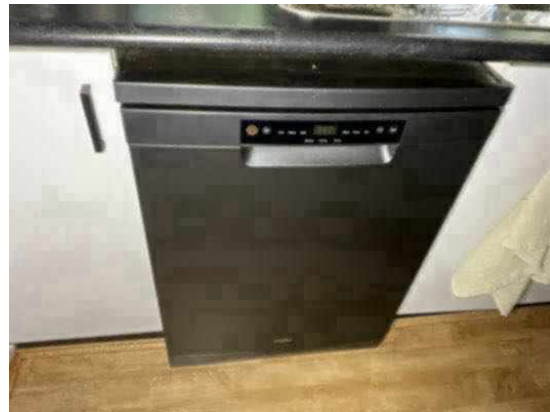
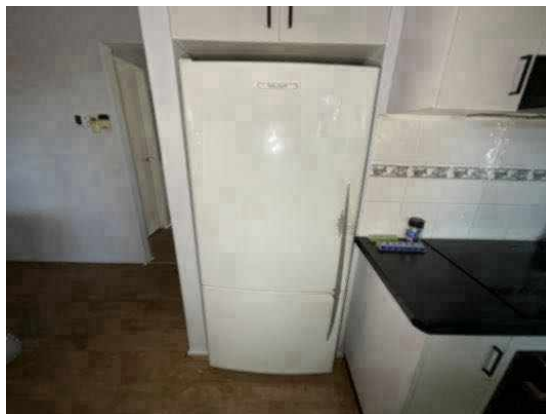
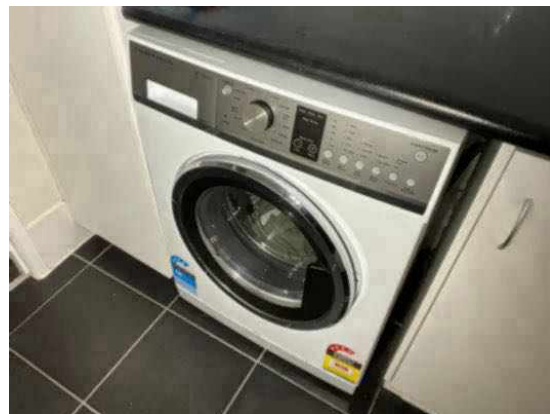
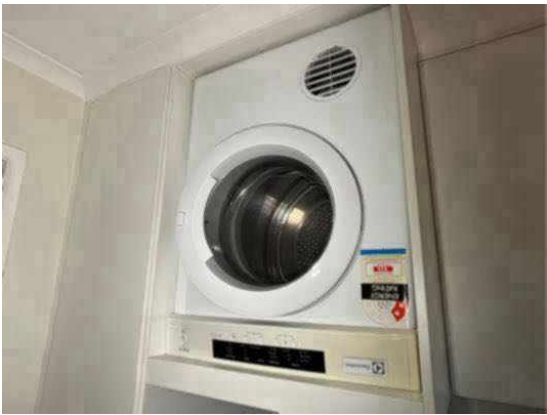
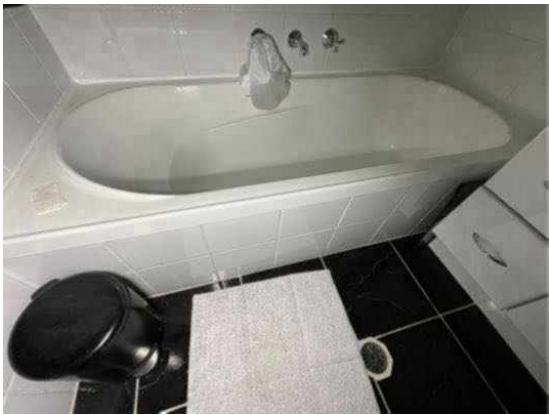
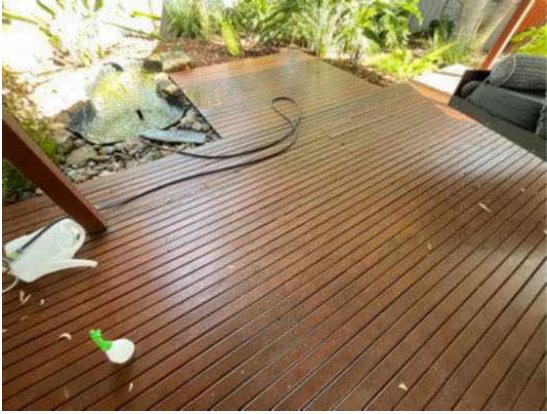
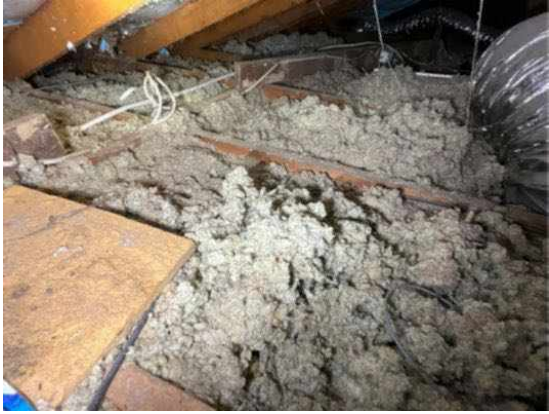
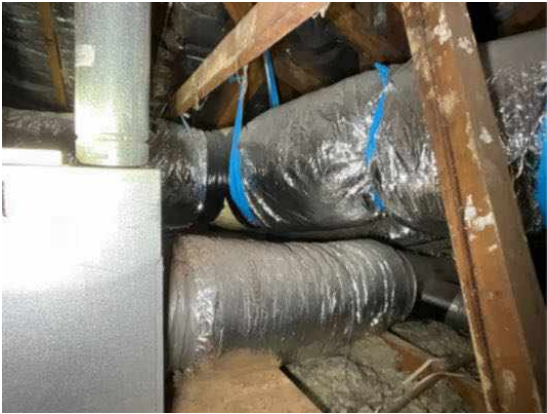
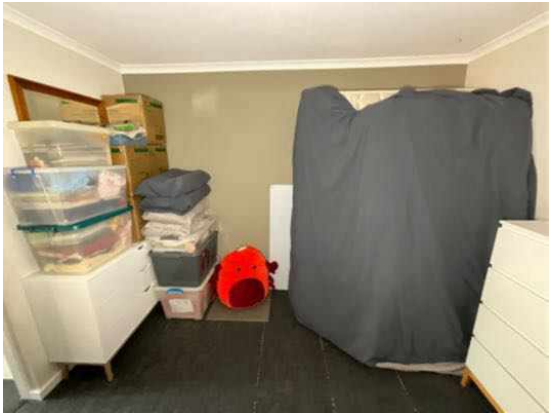
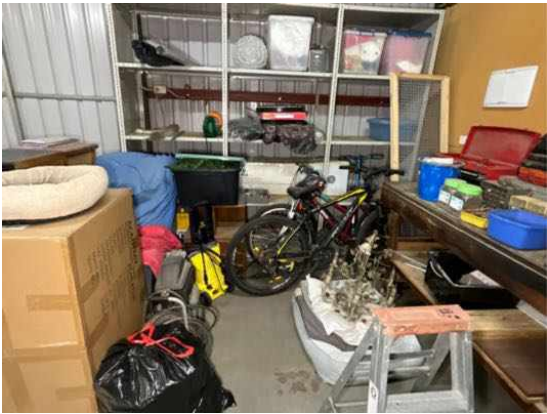
#### Noted Item

Building: Building 1  
Location: All Areas  
Finding: Additional Photos - Obstructions and Limitations  
Information: These photographs are an indication of the obstructions and limitations which impeded full inspection of the property at the time of inspection. These obstructions can hide an array of defects and should be removed to allow full inspection to be carried out. A re-inspection is recommended once the areas are made accessible.
