Building and Timber Pest Inspection Report

Inspection Date: Thu, 8 Jan 2026

Property Address: 11 Sonia Ct, West Wodonga VIC 3690,
Australia

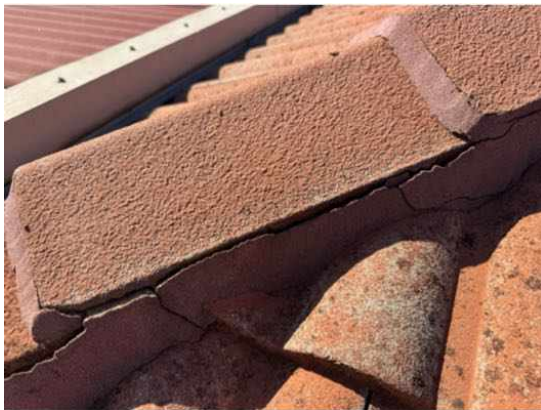
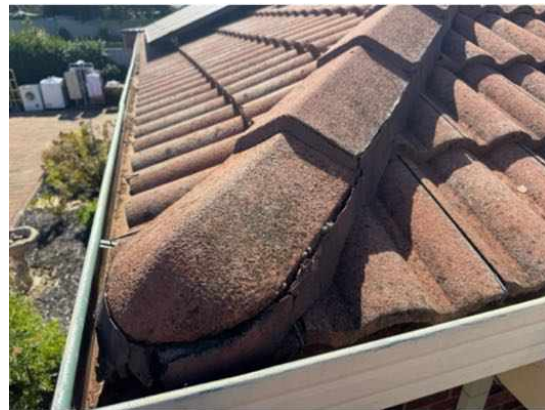
Finding 3.01

Finding: Roof Exterior - Minor Cracking

Information: Although the majority of the roof exterior appeared to be in relatively good condition, some areas of minor cracking were identified. While weathering of the roof exterior is consistent with the age of the property, the client should monitor the condition of the roof exterior.

Areas of minor cracking were identified to areas of the roof exterior. Recommend client to monitor the condition of the roof exterior. Should further deterioration occur, a licensed roofing contractor should be engaged to provide maintenance works.

Should further deterioration occur, a licensed roofing contractor should be engaged to provide maintenance works where necessary.

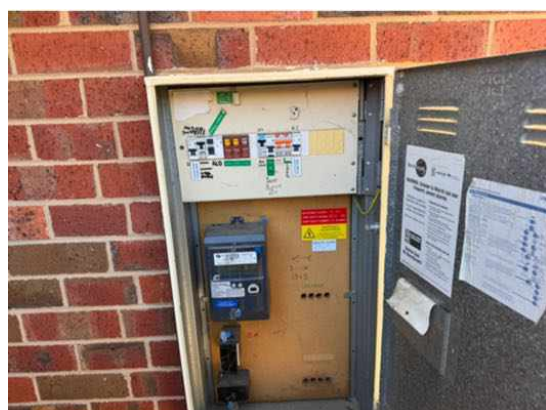
Finding 6.01

Building:	Main Building
Location:	Switchboard
Finding:	Termite Management System - no evidence of a chemical installation
Information:	The application of a termite barrier is recommended, as it appears no termite management system has been installed, with no evidence or durable notice to suggest works taking place. Generally, a durable notice is placed in the meter box to indicate current termite barriers.

Such barriers are highly effective in preventing termite attack on the building and therefore should be installed.

Installation of a termite barrier is recommended as there was no evidence of installation of a previous termite management system. 12 monthly termite inspections, conducted by a qualified termite inspector are also advised. Recommend engaging a licensed pest controller, to provide further advice.

Recommend seeking further advice from a licensed pest controller.

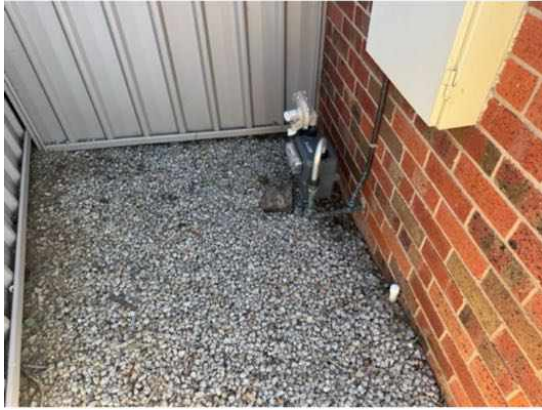
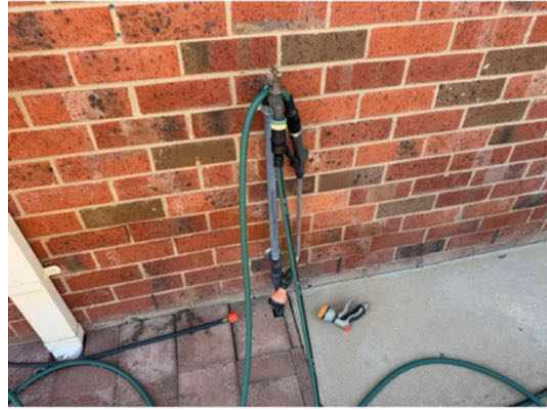
Finding 6.02

Building:	Main Building
Location:	All external areas
Finding:	Potential Water pooling - against property
Information:	Potential areas of water pooling around the perimeter of the property were identified. Where insufficient site drainage and drainage of taps is present, water pooling is likely to occur, and can create areas conducive to timber pests.

Recommend consulting with a licensed plumber and/or landscaping contractor to provide further advice.

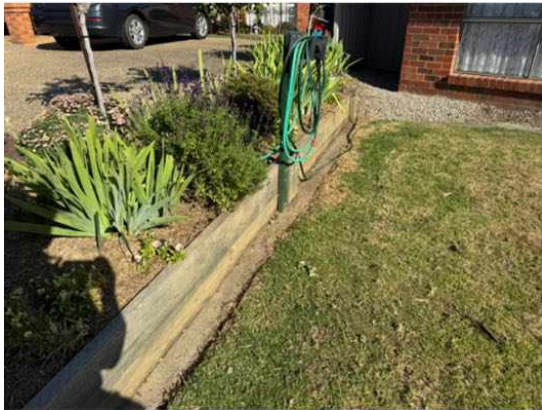
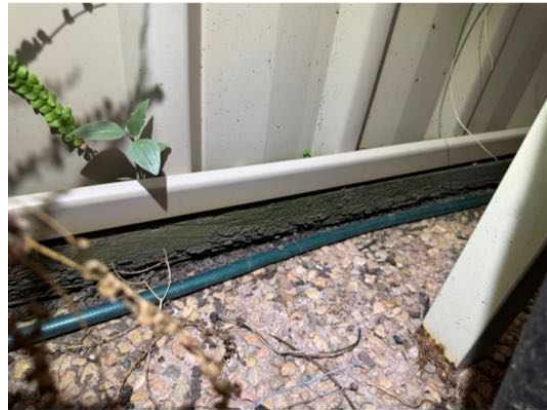
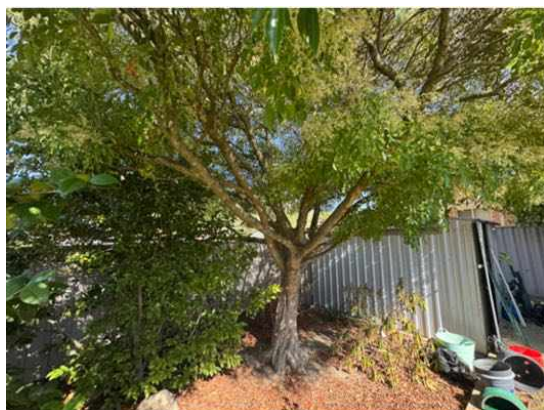
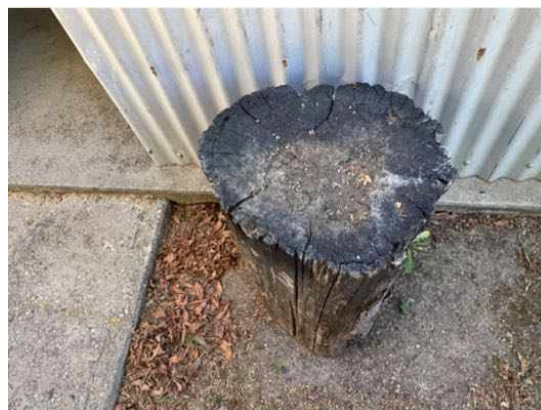
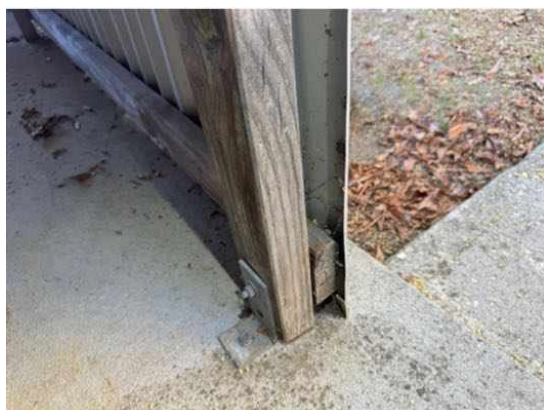
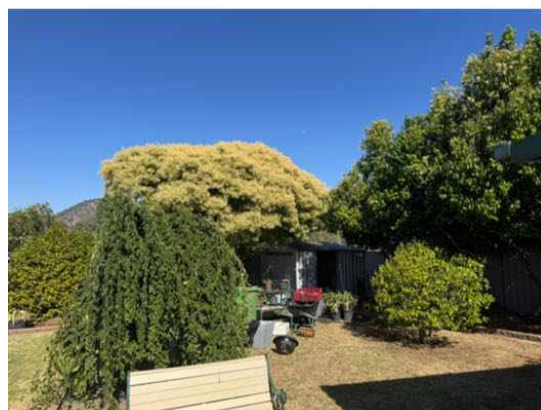
Finding 6.03

Building:	Main Building
Location:	All External Areas
Finding:	Timber in direct ground contact & trees - conducive to termites
Information:	Where timber materials are in direct contact with the ground and consequently moisture, they become conducive to termite activity. The tree stumps, landscaping timber's and trees surrounding the building create an environment conducive to termite infestation.

Where feasible, any timbers in direct contact with the ground should be removed and any trees in close proximity to the building should be removed or test drilled (inspected) at least annually to reduce the risk of termite infestation & detect any early signs of termite activity.

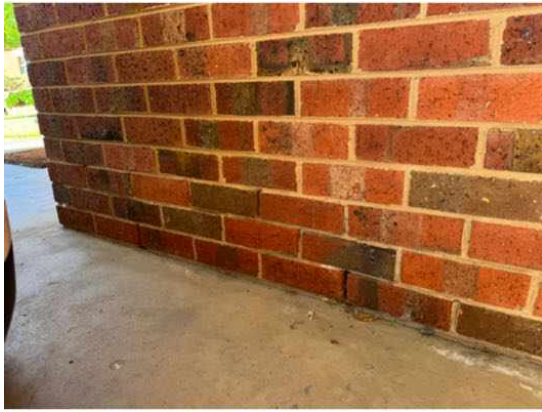
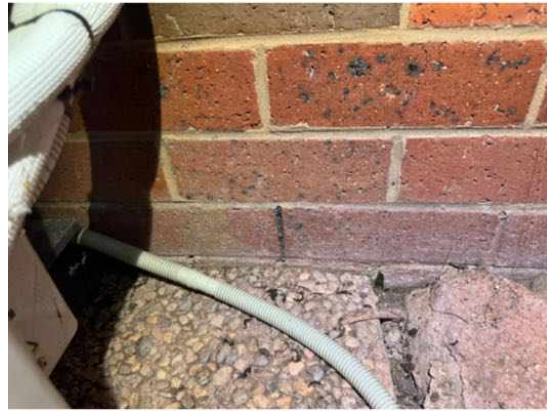
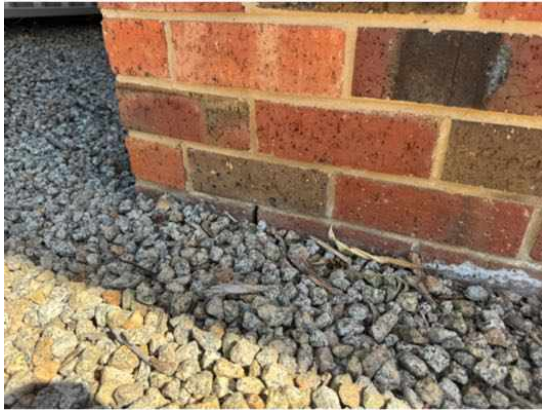
Finding 6.04

Building:	Main Building
Location:	External Areas
Finding:	Weep holes - Insufficient Clearance
Information:	It appears areas of the external ground levels were higher than or at the base of the weepholes, which can restrict moisture escape and allow termites to bypass any termite barriers. Blocked weepholes also allow for concealed termite entry into the building.

Areas where the external ground level is higher or at the base of the weep holes were identified, allowing the potential for concealed termite entry, and can restrict weep-hole drainage. Therefore these areas should be frequently inspected by a qualified termite inspector. Where feasible, it is advised that the external ground level be lowered to allow for sufficient inspection zone & ensure sufficient drainage.

Therefore these areas should be inspected frequently by a qualified termite inspector and where feasible, external ground levels should be lowered by a licensed landscaping contractor, to restore adequate weep hole drainage and inspection zones.

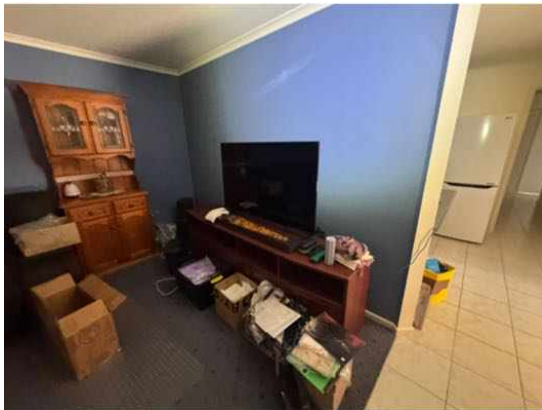
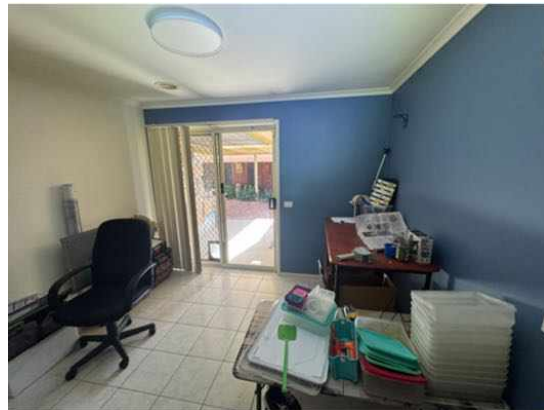
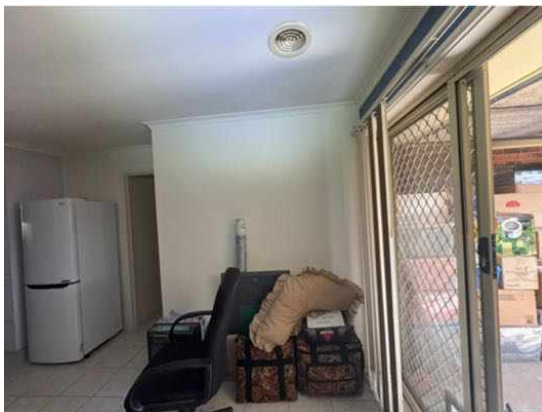
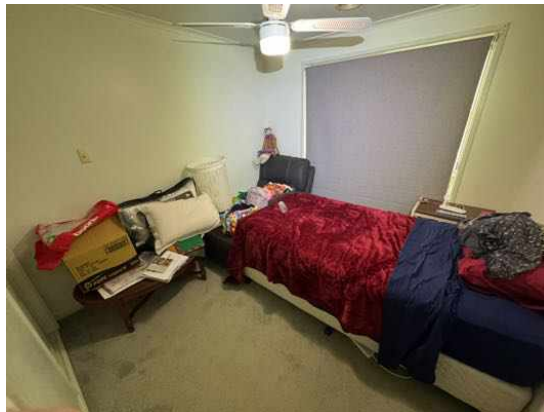
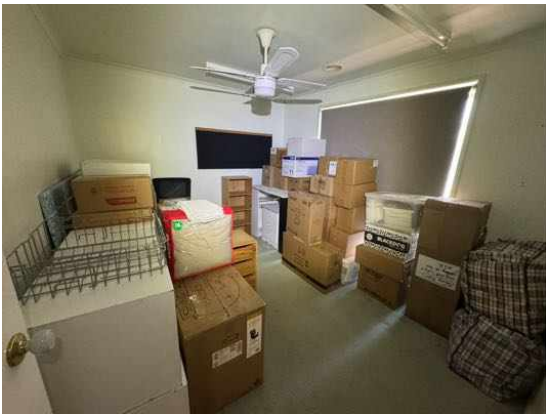
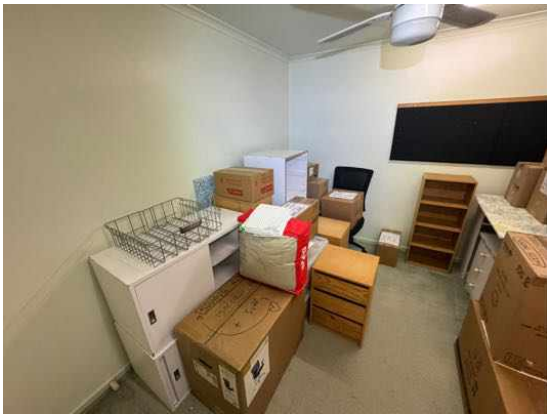
Building: Main Building
Location: All Areas
Finding: Additional Photos - Obstructions and Limitations
Information: These photographs are an indication of the obstructions and limitations which impeded full inspection of the property at the time of inspection. These obstructions can hide an array of defects and should be removed to allow full inspection to be carried out. A re-inspection is recommended once the areas are made accessible.

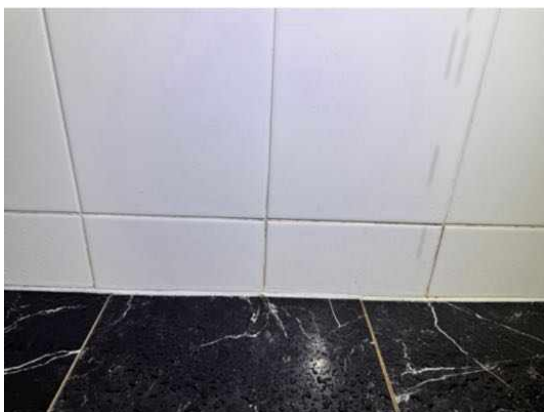
Building: Main Building
 Location: Tiled Areas
 Finding: Sealant and grouting - Monitor & General Maintenance
 Information: It appears that the sealant and grouting in the tiled areas are slightly weathered, a common defect in houses of a similar age.

It is noted for the clients information that sealant and grouting in areas that come into regular contact with water should be maintained.

Should the sealant deteriorate further, a tiling contractor should be engaged to provide maintenance works where necessary to ensure all wet areas are sufficiently sealed.

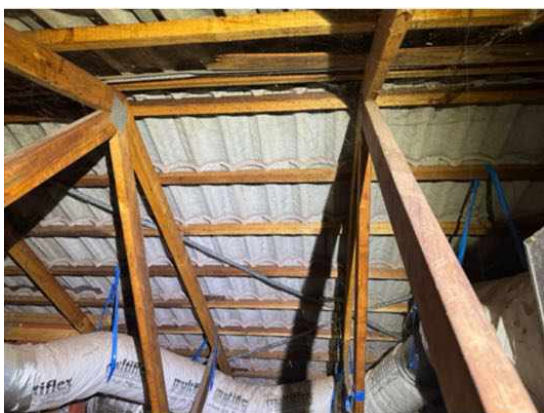
Building:	Main Building
Location:	Roof Void
Finding:	Sarking - Not Present
Information:	It is noted for your information that sarking has not been installed on the roof, which is common in buildings of a similar age. Sarking is a laminated aluminium foil which assists in insulating the property and acts as a vapour-barrier to the roof void.

The client can consult with a licensed roofing contractor at their discretion, to provide further advice.

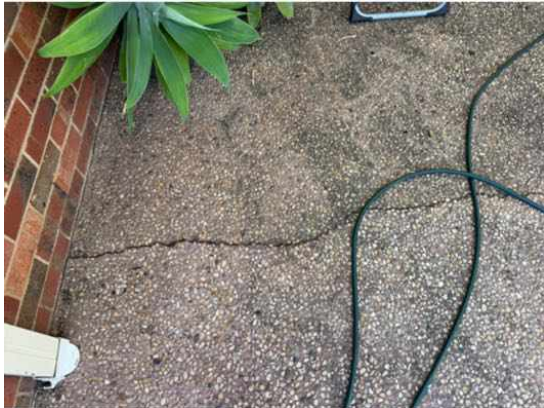
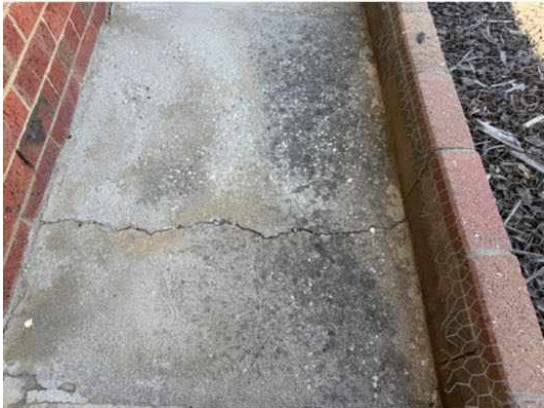
Building:	Main Building
Location:	Pavement
Finding:	Cracking - Pavement & Footpath
Information:	It was noted there is cracking in areas of the pavement and footpath. Cracks in the pavement are a common occurrence in houses of a similar age.

Recommend that the client monitor the cracking. A licensed concreter can be engaged at clients discretion, should cracks widen, lengthen, or become more numerous.

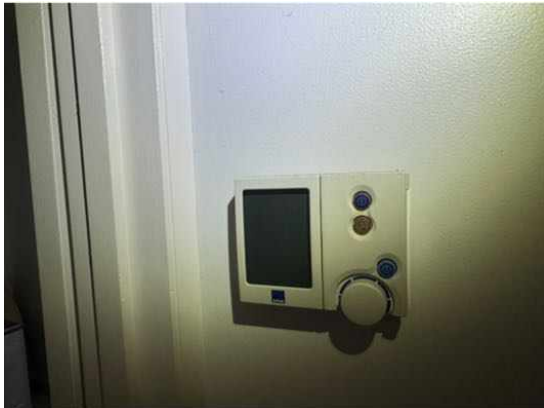
Building: Main Building
Location: Evap System
Finding: Evaporative System - Not Operating
Information: It appears that the evaporative system was not operating at the time of inspection. The client can engage a HVAC specialist at their discretion to provide further advice & maintenance works.
