# Building and Timber Pest Inspection Report

Inspection Date: Thu, 29 Jan 2026

Property Address: 3 Quail Pl, Modbury Heights SA 5092,  
Australia

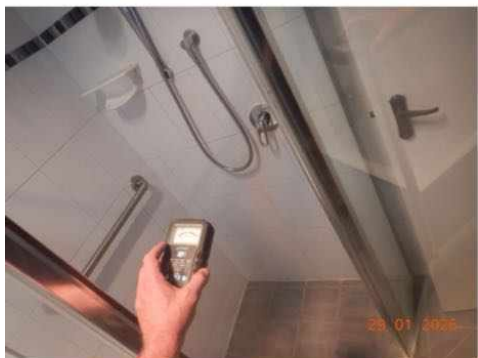
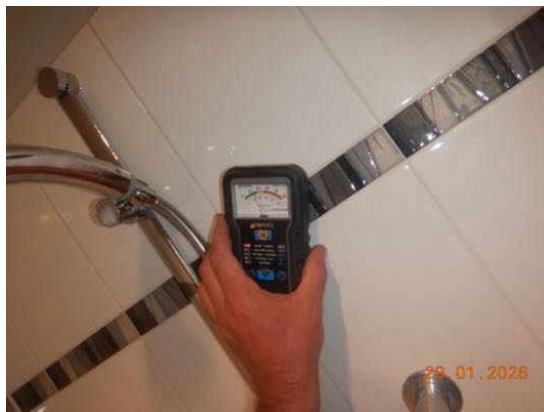
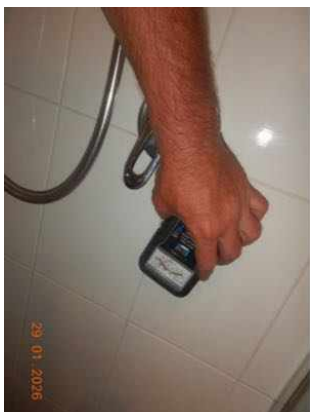
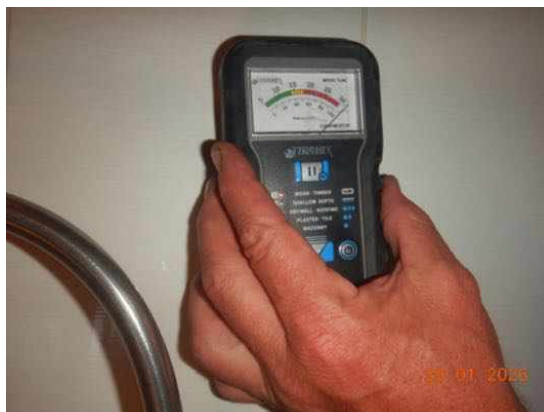
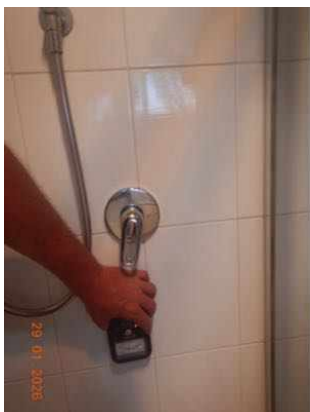
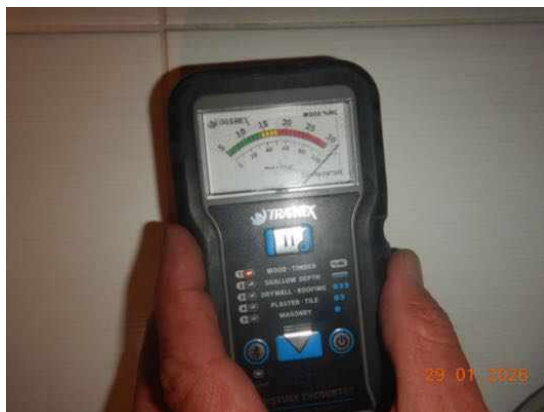
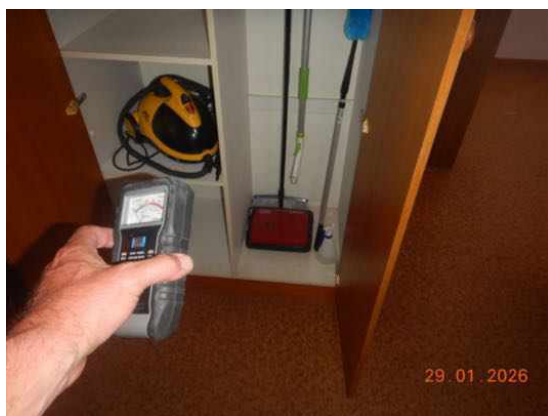
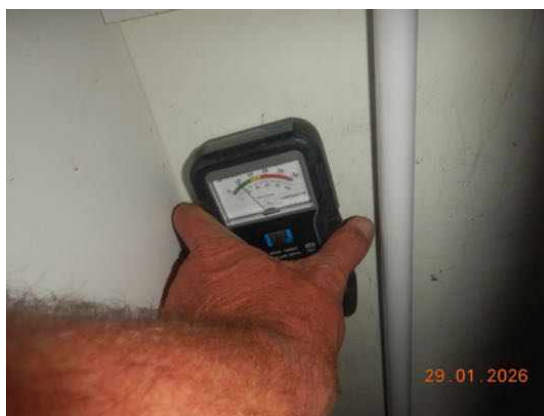
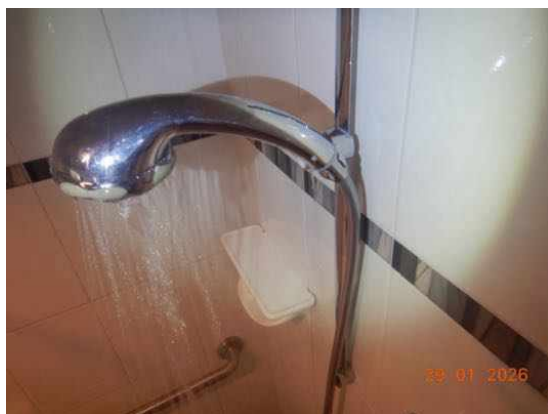
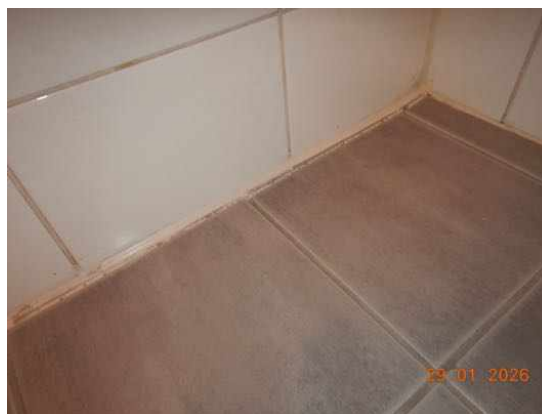
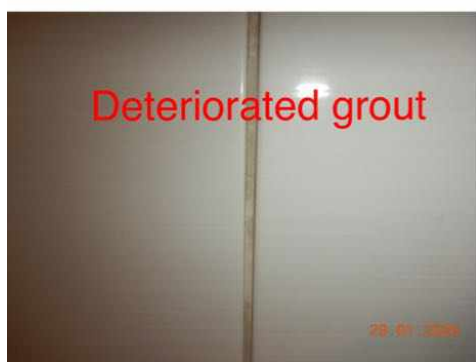
#### Finding 2.01

Building: Building 1  
Location: Bathroom  
Finding: Shower - Damp  
Information: Damp is evident to large sections of wall in the shower alcove. There is no transfer of moisture appearing on the other side of the wall however there was a cupboard there which obstructed the testing of the rear side of the wall and as such a plumber pressure test is recommended to ensure there are no leaks to pipework.

In the shower area, internal water leaks or other sources of excessive moisture are generally the cause of damp.

Unmanaged damp in the shower recess is likely to facilitate the formation and development of mould and fungi growth, decaying associated building materials and compromising their structural integrity. High moisture around timber elements also creates an environment that is conducive to termite activity. Further investigation would likely uncover currently concealed defects.

The showerhead appears to be spilling water all over the wall which could be a likely contributing factor and may require replacement of the showerhead.

Consultation with a qualified plumber is advised immediately to identify the cause of damp and to perform remedial works as required. They're also appears to be minor deterioration to the grout which requires regular maintenance and as such should be repaired by a bathroom sealant specialist.

Always ensure that sealant and grout is in good condition to prevent any moisture issues occurring in the future.

Further investigate moisture to shower alcove wall.

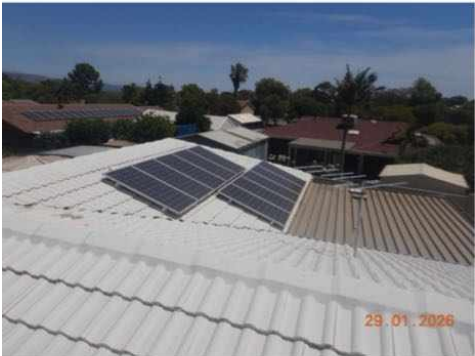
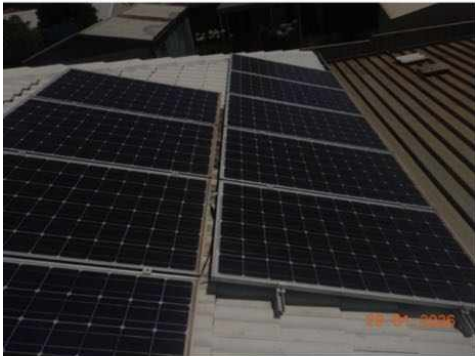
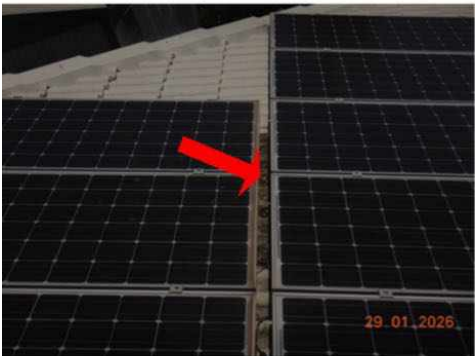
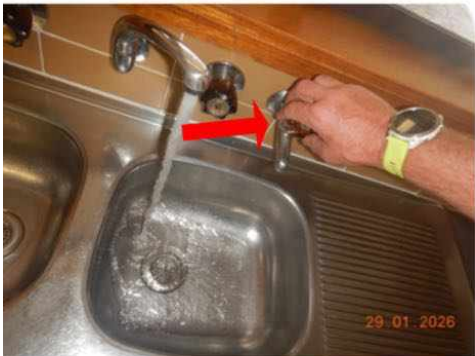
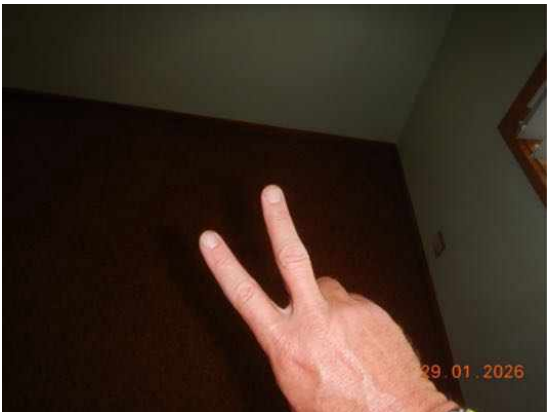
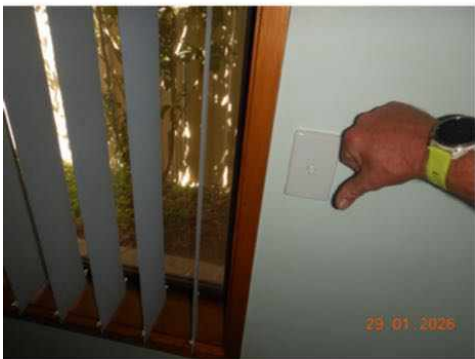
### Finding 3.01

Building:	Building 1
Location:	All Areas
Finding:	Minor defects present
Information:	There were several age and maintenance related defects evident to the dwelling at the time of inspection. These defects include but are not limited to

- Debris behind solar panels.
- Rain water tap not operating in kitchen
- Roller shutter to bedroom 2 did not operate

Appropriate licensed trades people could be appointed to make repairs at the discretion of the client.

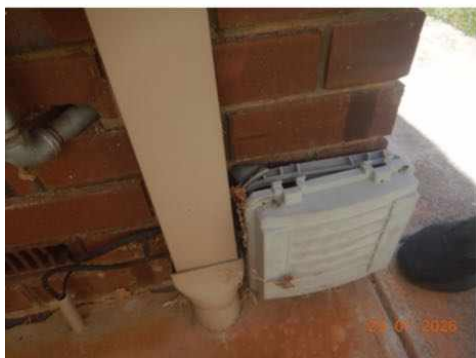
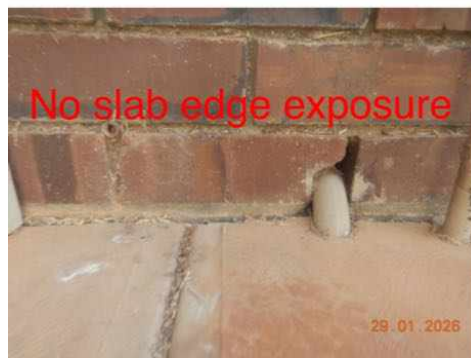
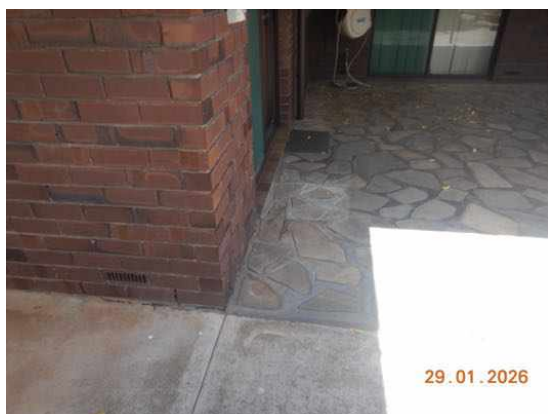
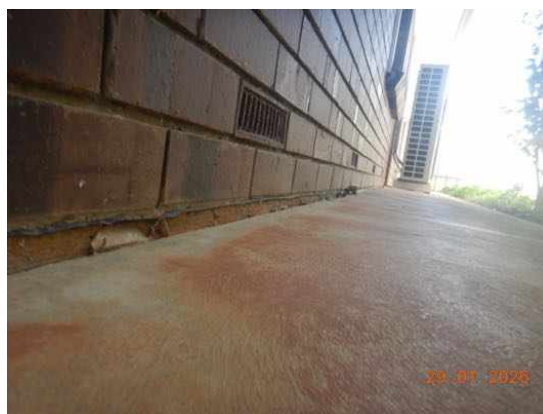
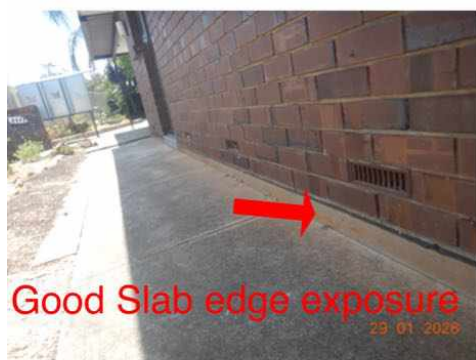
**Finding 6.01**

Building: Building 1  
Location: All External Areas  
Finding: Slab Edge - Exposure  
Information: An inspection zone of at least 75mm in relation to the exposed slab edge, between the bottom brick and the perimeter pavement, is required. This inspection zone should be maintained in order to force termites into the open where they can be detected more readily during regular inspections. The slab edge should not be concealed by anything that may prevent inspection of the area, including render, landscaping, soil, turf, paving, concrete cladding or other structures.

If the slab edge is not properly exposed there is a high risk of concealed termite attack which your inspector will likely not be able to see. Sometimes, in order to determine the type of slab, a suitably qualified person such as an architect or builder may be required to consult construction plans.

Where the slab edge cannot be properly inspected, it is highly recommended that termite or timber pest inspections be carried out every 6-12 months to aid protection of the property against infestation and termite treatment advice is followed closely.

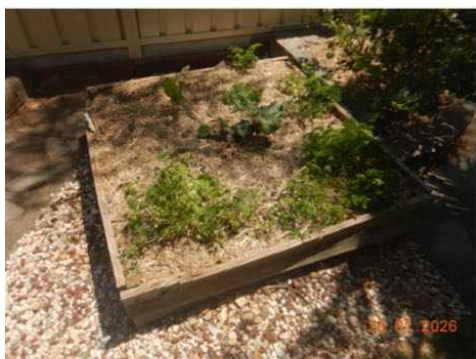
### Finding 6.02

Building:	Building 1
Location:	All External Areas
Finding:	Untreated or non-durable timbers in a hazardous environment
Information:	To reduce the risk of timber pest attack it is essential that timber used in a hazardous environment (e.g. in direct contact with the ground or frequently exposed to damp conditions) is of sufficient durability and/or is adequately preservative treated. Additionally any timber lying around or timber stumps should be removed.

Untreated timbers in direct contact with the ground are likely to develop severe wood rot and/or fungal decay if left unattended creating attraction for subterranean termites to infest the timbers from surrounding areas.

If untreated or non-durable timbers are found to be in a hazardous environment it is highly advised that replacement of these building elements be performed as soon as possible to aid the protection of the property against termite / timber pest attack. Failing this close monitoring is recommended in an attempt to identify termite infestation at an early stage.

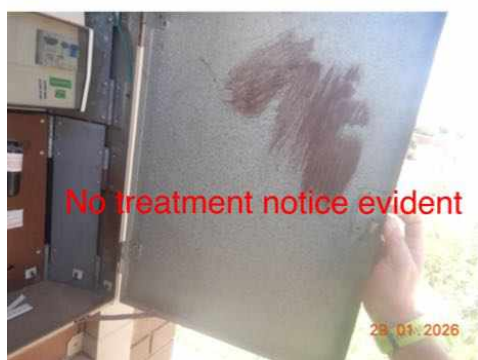
### Finding 6.03

Finding: Termite Management System - no evidence of a chemical installation  
Information: The application of a post-construction chemical termite barrier is highly recommended for all properties, particularly if live termite activity has been found on the site previously. Such barriers are highly effective in preventing termite attack on any timber building elements throughout the property.

At the time of inspection, it appeared as though no termite management system has been installed, with no evidence to suggest preventative works taking place.

A durable notice should be placed in the switchboard unit to indicate current termite barriers.

The client may consider gaining further advice from a pest controller as to the costs and procedures involved with this application. It is recommended that obtaining such advice be a short-term priority.

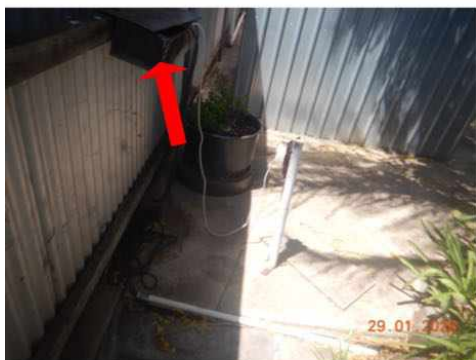
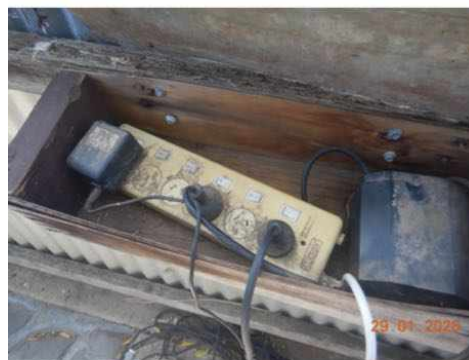
Building: Building 1  
 Location: Yard - Back  
 Finding: Electrical issues.  
 Information: Several electrical issues were noted at the time of inspection.

- Garage light not operating. Likely bulb.
- Indoor power boards present outside near fishpond

Ensure electrical is compliant to the pond area.

Appointment of a licensed electrician is highly advised to provide additional information and make repairs as required to ensure the safety of occupants.

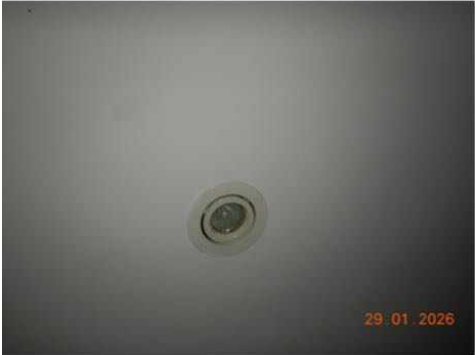
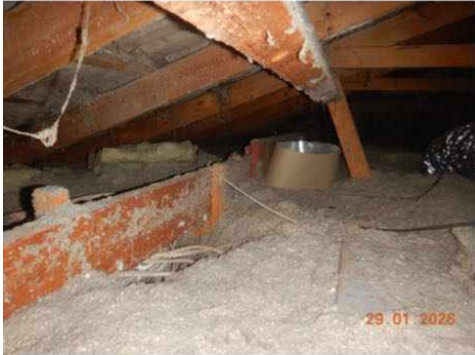
Building: Building 1  
 Location: Roof Void  
 Finding: Down-lights, Halogen  
 Information: There were several lights that appear to be halogen down lights noted throughout the dwelling.

Whilst in use, down lights create immense heat that, without these protective coverings, creates potential for ignition of any flammable objects that the down light holding may come into contact with (e.g. insulation, leaf litter).

In accordance with Australian Standards, fire-resistant protection covers are required on all down lights.

Swap halogen lights for LED's

Alternatively the lights could be swapped for LED equivalents which burn cooler and use considerably less power.

A qualified electrician should be appointed to provide further advice and quotation for replacement immediately.
