Building and Timber Pest Inspection Report

Inspection Date: Thu, 5 Feb 2026

Property Address: 43 St Pauls Way, Blacktown NSW 2148,
Australia

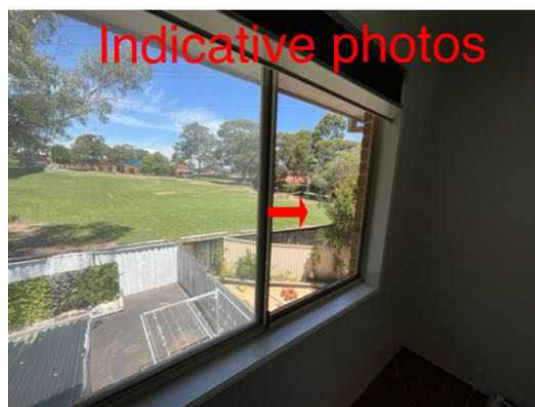
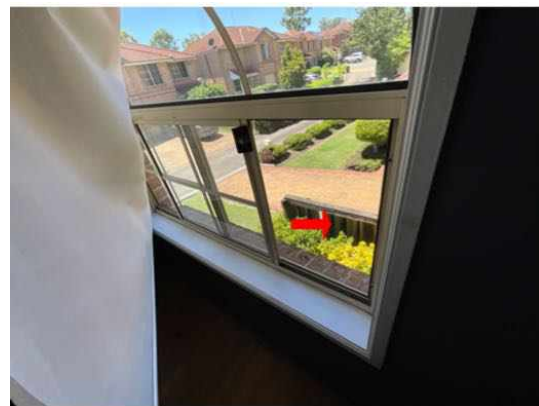
Building:	Main Building
Location:	Upstairs Windows
Finding:	Window restrictions - Missing
Information:	Window restrictors were found to be missing.

The National Construction Code (NCC) requirements apply to all openable bedroom windows in residential buildings, including hotels, motels and for all windows in early childhood centres.

Windows need to be locked at 12.5cm when the devices are engaged. The safety devices must be robust and child proof. The alternative is security screens such as bars or grills on the windows so long as they have gaps no bigger than 12.5cm. Flyscreens do not comply unless they are the reinforced security type and capable of resisting the very strong outward pressure which would prevent a child falling through. The laws apply to openable windows in a building within 1700mm of the internal floor and if the internal floor is more than 2m above the ground floor outside.

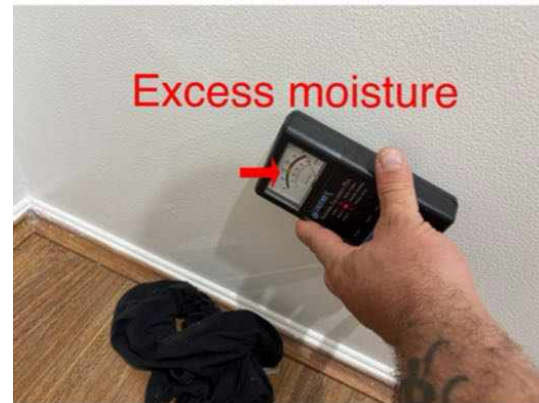
Finding 2.01

Building:	Main Building
Location:	Master
Finding:	Waterproofing damage - Suspected
Information:	Excessive moisture was detected in these areas at the time of inspection. Internal water leaks can be detrimental to surrounding building elements. The potential cause in this area is damage to the waterproofing membrane inside the shower recess.

Attracting termites, corrosion, mould, decay and water damage are potential outcomes where a minor water leak is left unattended. More serious defects may also result, such as electrical hazards, or water damage to structural building elements.

In extreme cases, structural damage may develop due to a prolonged water leak. It is highly advised that this issue be addressed immediately by a bathroom specialist as a matter of relative urgency.

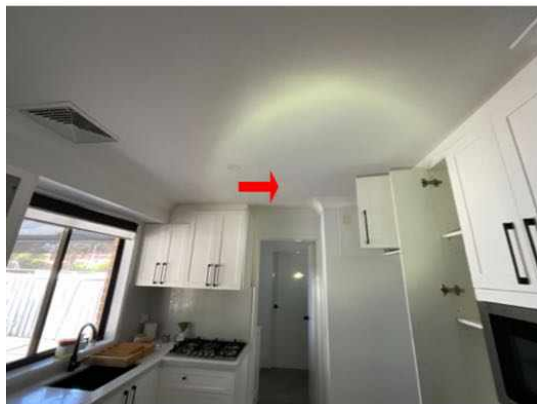
Finding 3.01

Building:	Main Building
Location:	Kitchen
Finding:	Water staining
Information:	Water staining was evident in this area at the time of inspection. Water staining indicates that surfaces have been exposed to excessive moisture over time. The minerals and other elements in the water lead to staining, which may graduate to corrosion and deterioration if left unmanaged.

While mostly an appearance defect, water staining can be indicative of more serious defects, which may be currently concealed by other building elements.

Where water staining is active, a licensed plumber must be consulted to identify the cause of the staining and to provide advice on any reparation works that may be required. Replacement of any broken or damaged structures is advised.

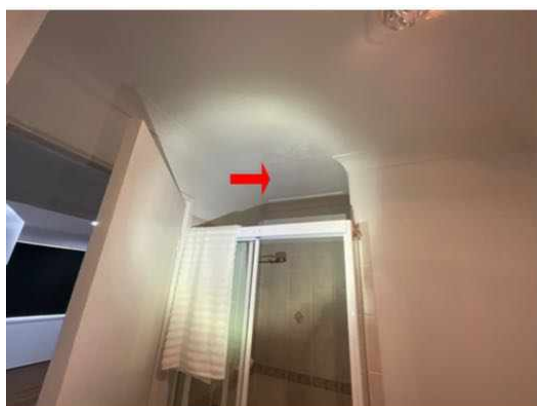
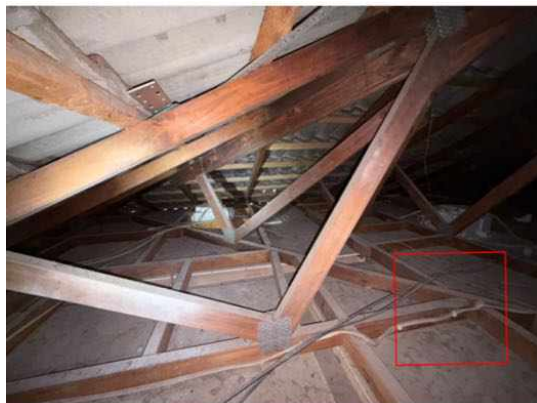
Finding 3.02

Building:	Main Building
Location:	Bathroom
Finding:	Ceiling - Water damaged
Information:	Water damage to the ceiling lining is generally an indication of excessive moisture being present in the roof void, usually via a leak to the roof covering. However since no damage was identified to the surface above in the roofvoid, it is suspected that lack of air ventilation and hence the excess moisture from regular shower use is the underlying reason.

It is highly recommended though that a roofing plumber should be appointed as soon as possible to ensure no water leaks are affecting the roof covering.

Then, consultation with relevant tradespeople, including plasterers and painters, is advised. Rectification works may include replacement of ceiling lining or minor repainting, depending on the extent of the damage.

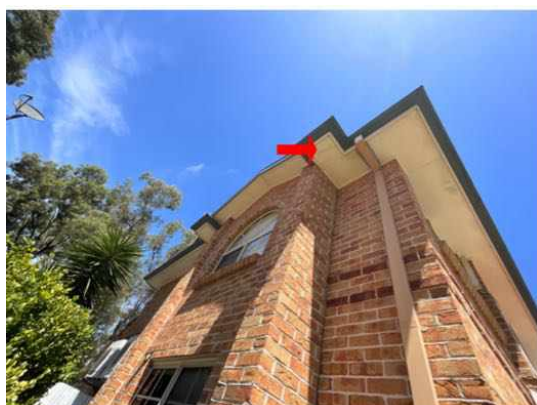
Finding 3.03

Building:	Main Building
Location:	Front right corner
Finding:	Eaves/Roof plumping -- water damages
Information:	Water damage is generally an indication of excessive moisture being present, usually via a leak. It is suspected that gutter blockages causing stormwater to backflow into the eaves causing water damages. This is additionally conducive to termite activity due to the damp conditions.

Where water damage is evident, the primary requirement is to identify and rectify the source of the leak. Gutters must be kept clear of any blockages moving forward. A roofing plumber should be appointed for further assessment if the problem persists.

Once the leak is repaired, consultation with relevant tradespeople, including carpenters, plasterers and painters, is advised.

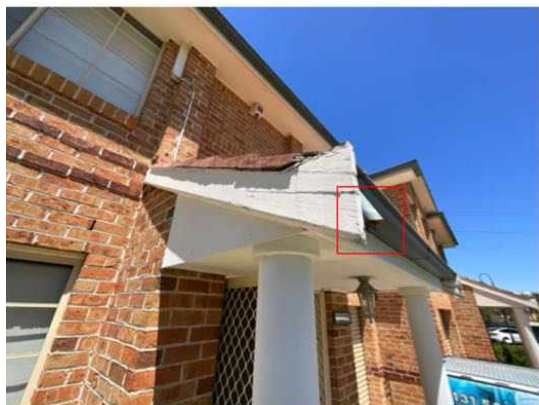
Finding 3.04

Building:	Main Building
Location:	Multiple areas
Finding:	Stormwater drain - Not connected
Information:	The roof plumbing is not adequately connected to stormwater drainage on the site.

Where roof plumbing doesn't drain adequately, the area at the base perimeter can become excessively damp, potentially creating an environment that is susceptible to rust and corrosion of surrounding building elements, as well as attracting termites and other pests.

It is highly recommended that a plumber be appointed to further inspect the area and to install adequate drainage equipment where necessary.

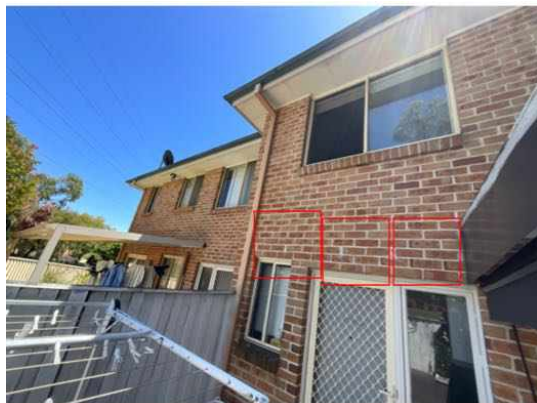
Finding 3.05

Building:	Main Building
Location:	Exterior walls - rear
Finding:	Blockage of weepholes
Information:	Weep holes in the exterior brickwork of the property are designed to allow condensation that may build up between the brickwork and subsequent timber framework to drain from within the wall hence preventing any deterioration of the timber building elements.

Build-up of moisture is likely to occur if weep holes are covered.

It is highly recommended that weep holes are left exposed in all areas throughout the external property. A general handyman must be appointed to ensure all weepholes are fully exposed.

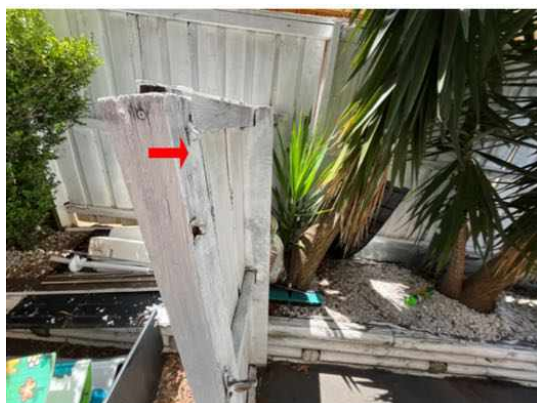
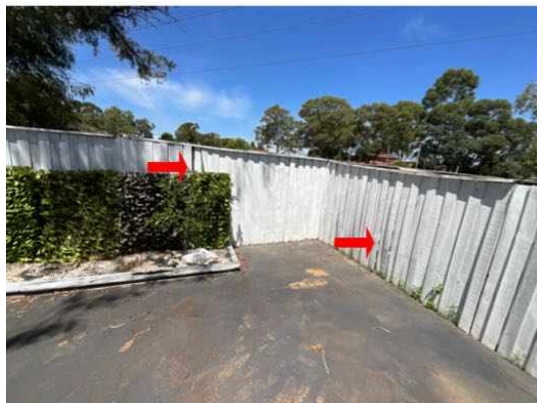
Finding 3.06

Finding: Fencing - Deteriorated

Information: It was noted at the time of inspection that sections of the fencing in this area has deteriorated. Typically fencing deteriorates due to age and or wear, rot and or rust which is generally expected for a structure of this age, due to prolonged exposure to weather conditions. Sometimes inadequate installation or maintenance can be to blame.

If left unattended, it is likely that further damage will occur. It is suspected that repair of several elements of the fencing may be required however replacement may be a consideration of the client also.

A licensed fencing contractor should be appointed to provide further advice and perform rectification works as necessary.

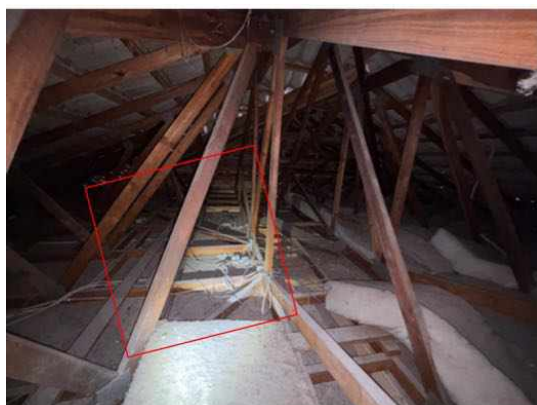
Finding 3.07

Building:	Main Building
Location:	Roof Void
Finding:	Insulation - Inadequate
Information:	Upon inspection of the roof void it was noted that there is a lack of adequate insulation.

The level of insulation in the property does not meet current Australian Standards. Installation of adequate insulation is required and should be conducted as soon as possible.

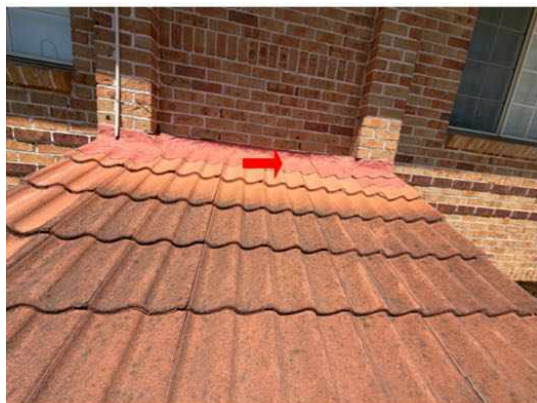
Finding 3.08

Building:	Main Building
Location:	Porch
Finding:	Roof plumbing - Flashing cracked
Information:	Water leaks generally occur when a particular area of the property is not weather or water tight. Cracks were evident to the roof flashing in this area at the time of inspection.

Regardless of the location, if left unmanaged, even minor leaks can lead to serious damage of associated building elements, potentially resulting in the need for replacement of building materials. Damage to ceilings, wood rot, mould and other hazards, such as electrical hazards, may also arise if left unmanaged.

Further inspection and repair by a roof specialist or a licensed roof plumber is advised to adequately rectify the potential leak.

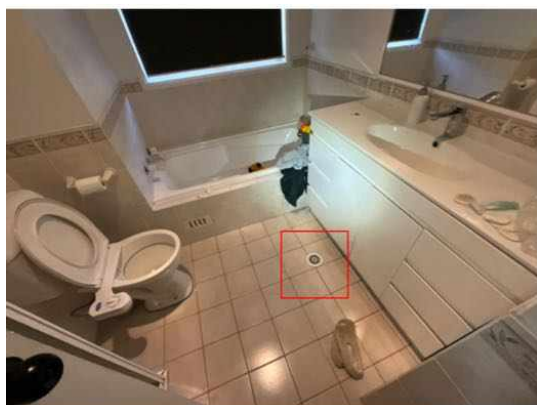
Finding 3.09

Building:	Main Building
Location:	Ensuite, bathroom
Finding:	Wet area tiles - Cracked or damaged
Information:	Cracking was evident to the tiling in this area at the time of inspection. While the cracking appears to be minor, this area is frequently exposed to water, allowing potential for water penetration into adjoining sections of walls or flooring.

If left unmanaged, water penetration to these areas may lead to subsequent water damage, which is likely necessitate repair work to affected building elements.

A bathroom specialist should be appointed to determine the integrity of the bathroom waterproofing membrane. If the membrane was found to be intact then relatively minor works to replace the cracked tiles should be carried out to ensure no further damage occurs. The re-application of silicone and grouting throughout remaining tile work is also advised, to further protect the area against water penetration.

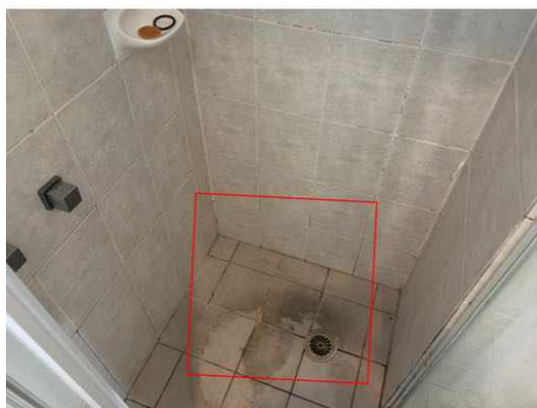
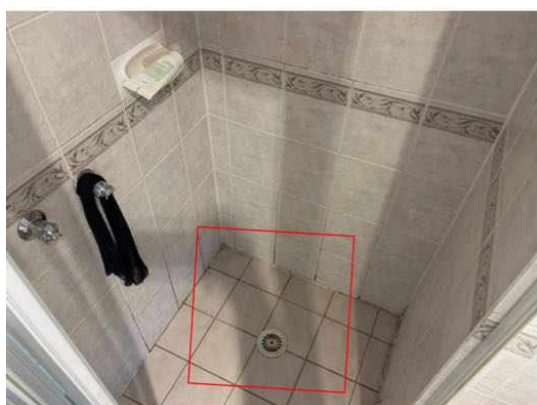
Finding 3.10

Building:	Main Building
Location:	All Wet Areas
Finding:	Sealant and grouting - Missing or damaged
Information:

It was noted on inspection that sealant or grout is degraded to this area.

Different materials and floor areas move at different rates, generally causing cracking to grout or sealant at this point. A flexible sealant is required to allow for expected expansion and contraction, while keeping the joint water tight and protective of all associated building materials.

Flexible and mould resistant materials should be applied to affected areas to prevent any subsequent water damage that is likely to occur. Regular maintenance and replacement of damage or missing or damaged sealant and grout is highly recommended to the wet areas, as this is a regular wear and tear defect. Sealant and grouting in areas that come into regular contact with water should be maintained for the long term care of your property.

A sealant specialist should be appointed to complete these works as soon as possible.

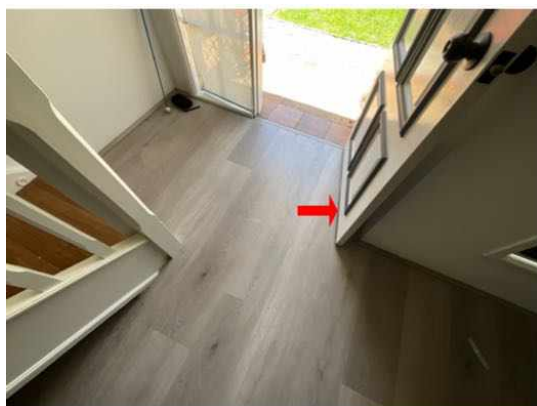
Finding 3.11

Building: Main Building
 Location: Entry
 Finding: Door - Binding/jamming
 Information:

Binding and/or jamming of this door is evident during standard operation. This defect inhibits the functionality of the affected door as well as creating potential for secondary defects to associated building elements, such as damage to the floor covering or adjacent frame.

A door that binds to flooring or to the associated door frame may have several causes, ranging from minor defects, such as poor installation of the door or deteriorated hinges.

A licensed carpenter should be appointed to perform minor rectification works at client discretion.

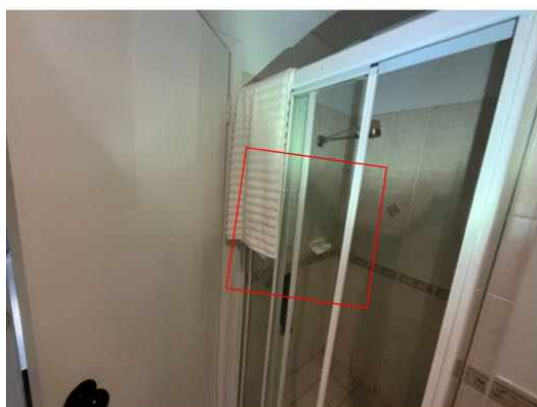
Finding 3.12

Building:	Main Building
Location:	Bathroom
Finding:	Shower door - Defective
Information:	Shower door has been removed from its position and/or defective and not operating as intended at the time of inspection.

A bathroom specialist is required to repair the shower door as soon as possible.

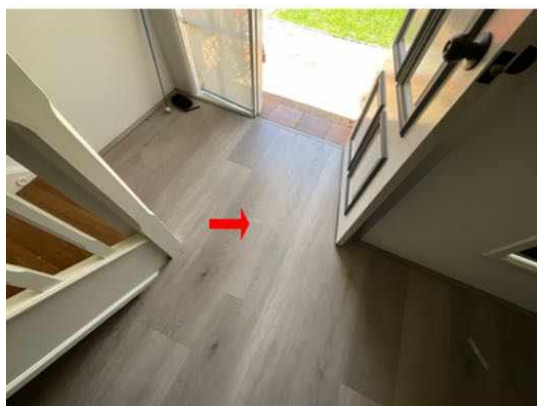
Building:	Main Building
Location:	Multiple areas of flooring
Finding:	Building element - Damaged
Information:	Breakage occurs generally when the building materials have either aged and decayed, or as a result of damage (accidental or deliberate).

Repair and/or replacement of broken elements is advised to ensure that additional secondary defects do not arise as a consequence. Such works are necessary, as all building elements play a key role in the operation and function of the overall structure and its performance.

A relevant tradesperson should be appointed to repair or replace the affected building element prior to any subsequent damage being caused.

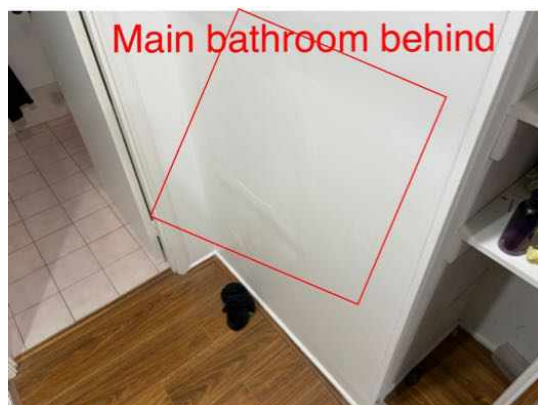
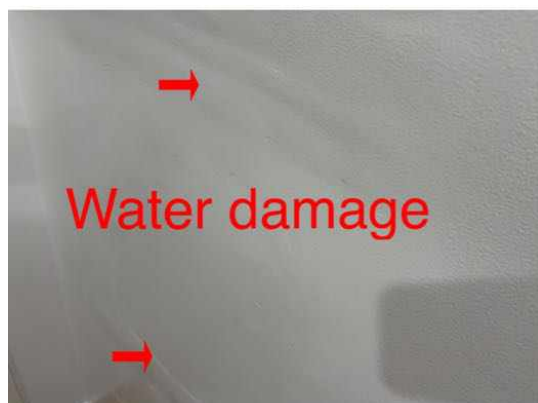
Building:	Main Building
Location:	Master
Finding:	Waterproofing damage - Suspected
Information:	Excessive moisture was detected in these areas at the time of inspection. Internal water leaks can be detrimental to surrounding building elements. The potential cause in this area is damage to the waterproofing membrane inside the shower recess.

Attracting termites, corrosion, mould, decay and water damage are potential outcomes where a minor water leak is left unattended. More serious defects may also result, such as electrical hazards, or water damage to structural building elements.

In extreme cases, structural damage may develop due to a prolonged water leak. It is highly advised that this issue be addressed immediately by a bathroom specialist as a matter of relative urgency.

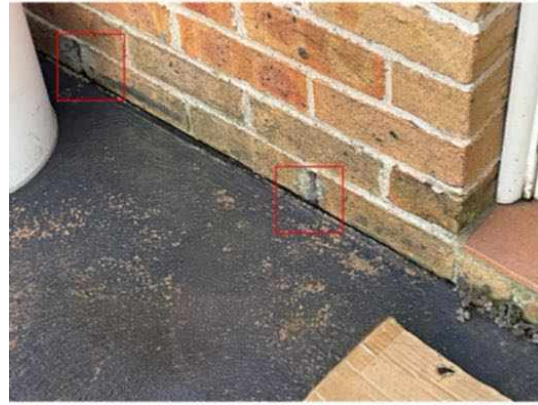
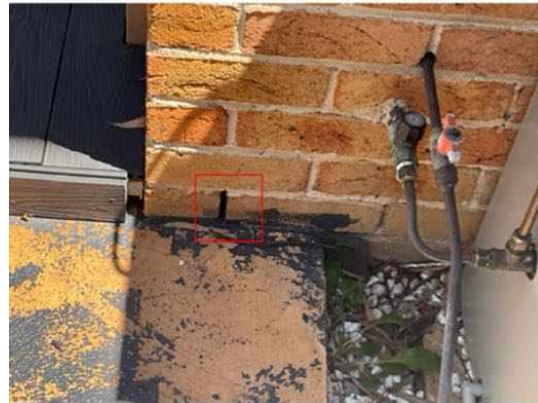
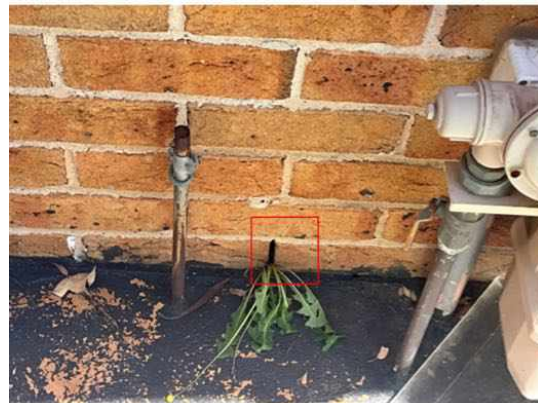
Weep holes in the exterior brickwork of the property are designed to allow condensation that may build up between the brickwork and subsequent timber framework to drain from within the wall hence preventing any deterioration of the timber building elements.

Additionally build-up of moisture is likely to occur if weep holes are covered further attracting termite activity to these areas.

It is highly recommended that weep holes are left exposed in all areas throughout the external property. Therefore if any termite activity leading into weep holes becomes easily detectable during frequent pest inspections.

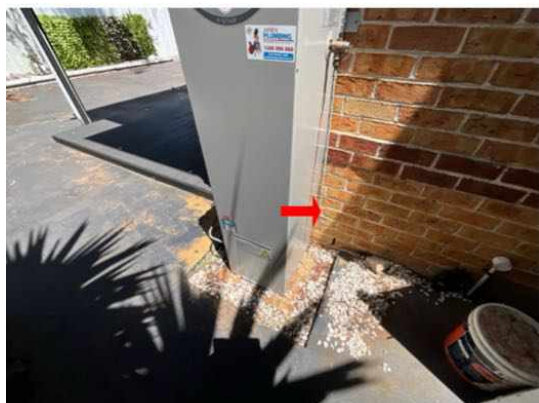
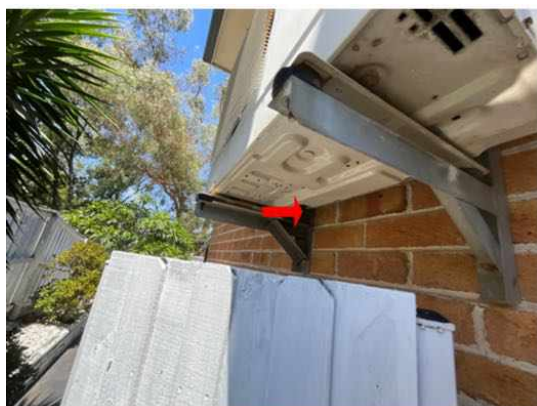
Finding 6.06

Building:	Main Building
Location:	Yard - Side
Finding:	Overflow - Not plumbed for drainage
Information:	The overflow is not plumbed or connected to suitable drainage, which can result in the surrounding area becoming excessively damp.

These damp conditions can lead to secondary defects such as rot, rust or corrosion of associated building elements, the formation of fungal decay, or even the creation of potential slip hazards. When coupled with poor site drainage, pooling of water may also attract termite activity to this area.

It is highly recommended that a licensed plumber be appointed to install adequate drainage to the overflow. These works will ensure that the area remains dry and free of any secondary defects.

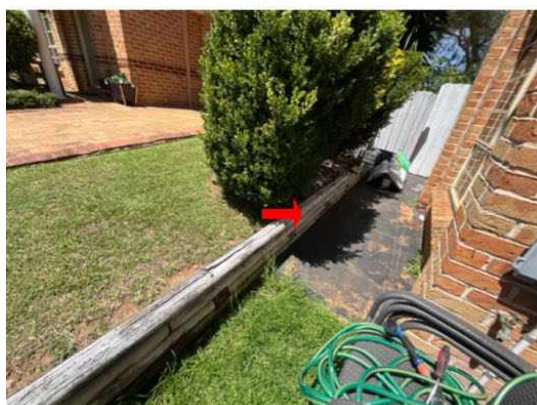
Finding 6.07

Building:	Main Building
Location:	Fencing & Landscaping
Finding:	Building materials in direct ground contact - conducive to termites
Information:	Where timber elements are in direct contact with the ground and consequently moisture or dampness they become conducive to termite activity. Whether timber is used as a building element part of a fencing structure or stored as an unused item they can provide an environment that is attractive to termite infestation.

When met with excessive moisture timber begins to decay and develop wood rot. Any timbers that are in direct contact with external grounds especially if left untreated or non-durable also provide ingress for subterranean termites into that particular element.

The removal of any such materials that may be conducive to termite activity should be removed as soon as possible to minimise the risk of termite attack.

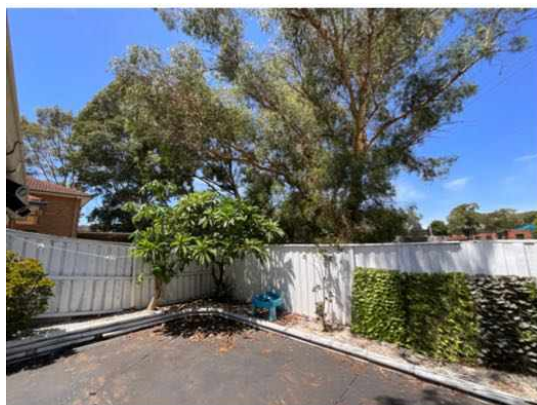
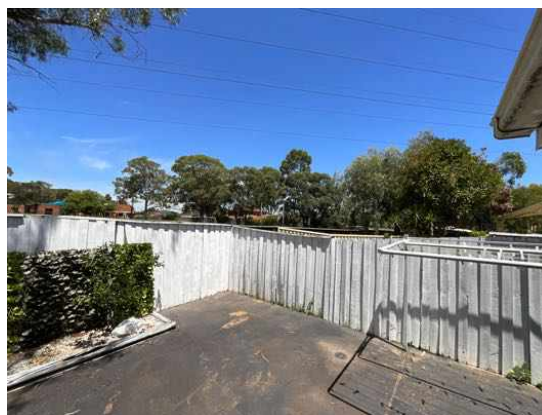
Finding 6.08

Building:	Main Building
Location:	
Finding:	Surrounding bushland - Conducive
Information:	Home and or building is situated in a high risk area for termite activity, due to close

proximity to surrounding bushland.

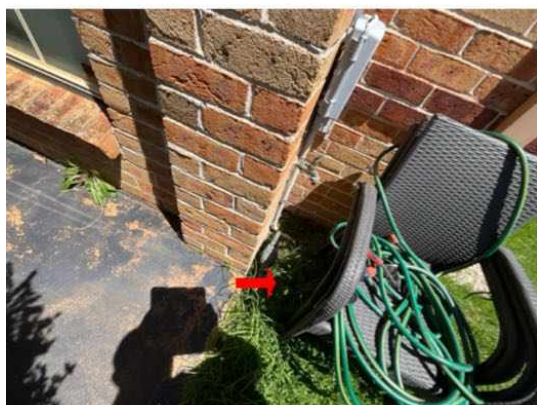
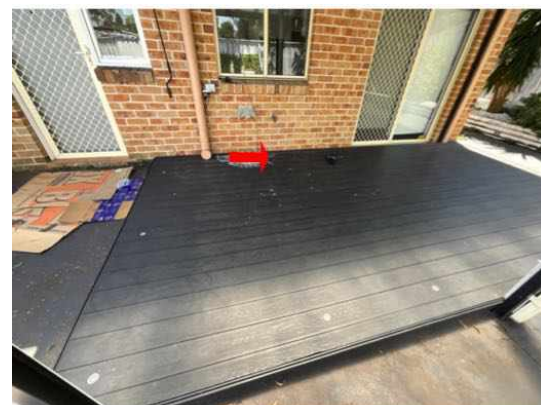
Finding 6.09

Building: Main Building
 Location: External tap
 Finding: Tap - No drain
 Information: The external tap in this area was noted to have no drain at the time of inspection.

A licensed plumber must be appointed to ensure an appropriate drain is installed.

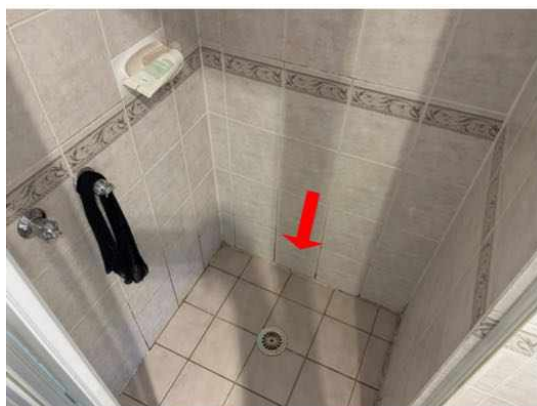
Finding 6.10

Building: Main Building
 Location: Bathroom, ensuite
 Finding: Shower damp - Sealant and grout
 Information: Damp is evident to the lower 400mm of wall to the shower alcove. This defect is quite common, and is suspected to have been caused by moisture permeating or leaching through the grouting and sealant in this area, which shows evidence of deterioration. Leaking pipes within the wall is also a possible cause however this seems unlikely in

this instance as there is no moisture build up around the taps or transferring to the other side of the wall. There appears to be no sealant around the tap spindles which may be a small contributing factor.

Damp (or structural damp) refers to the presence of unwanted moisture in the structure of a building, either as the result of intrusion from outside, or condensation from within the structure. In the shower area, internal water leaks, degraded materials or other sources of excessive moisture are generally the cause of damp.

Unmanaged damp in the shower recess is likely to facilitate the formation and development of mould and fungi growth, decaying associated building materials and compromising their structural integrity of associated elements. It is important to address damp conditions, as the World Health Organisation notes that excess moisture leads - on almost all indoor materials - to growth of microbes such as moulds, fungi and bacteria, which subsequently emit spores and other matter into the indoor air. Exposure to these contaminants is associated with a wide range of respiratory and other health-related problems. Damp conditions also create a conducive environment for termite infestation.

Consultation with a bathroom sealant specialist is advised immediately to identify the cause of damp and to perform remedial works as required.

Always ensure that sealant and grout is in good condition to prevent any moisture issues occurring in the future.

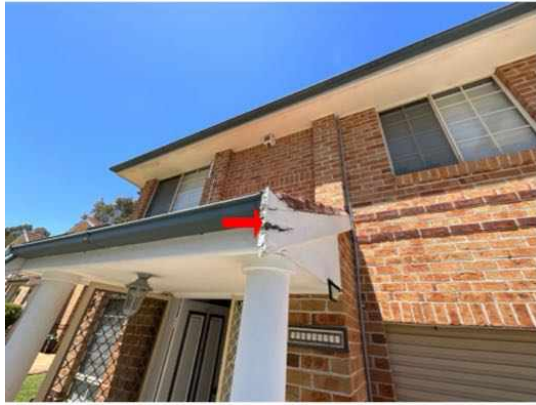
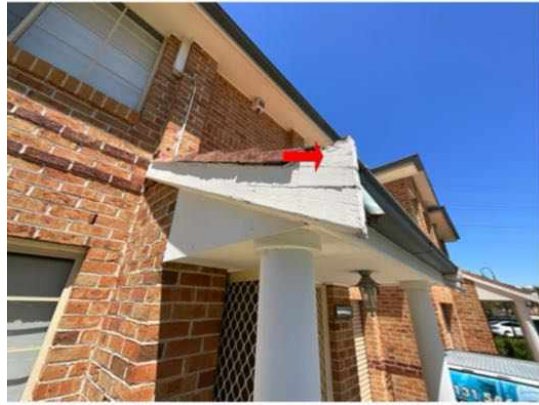
Finding 7.01

Finding: Wood rot/decay

Information: This building element shows evidence of wood rot. Wood rot, also known as Fungal Decay, occurs when timbers and other cellulose building materials are exposed to damp conditions on an ongoing basis. This could be the result of exposure to weathering over a prolonged period of time, or the attraction of excessive moisture from other abutting building materials. Contributing factors also include poor air ventilation in the area.

Wood rot is often associated with general damp problems and is evidenced by a `musty` smell or mould and mildew occurring on surfaces. If left unmanaged, damp conditions can lead to further health problems and the decay of timbers will continue.

A licensed plumber may be appointed to assess the cause of excessive moisture and to provide advice on any remedial works as required. A licensed carpenter may also be required to replace affected building materials.
