## Building Inspection Report

Inspection Date: Wed, 11 Mar 2026

Property Address: 26 James St, Plympton SA 5038, Australia

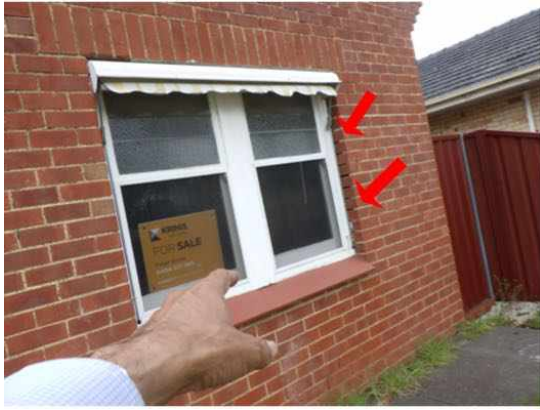
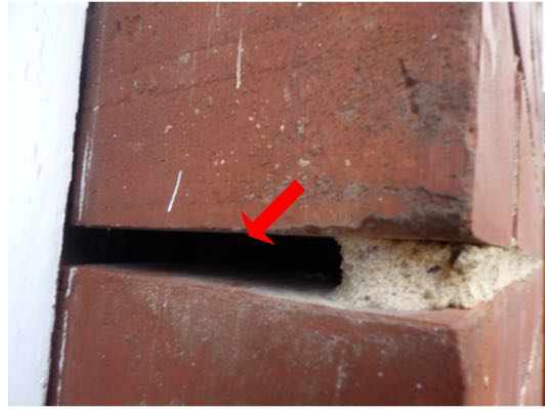
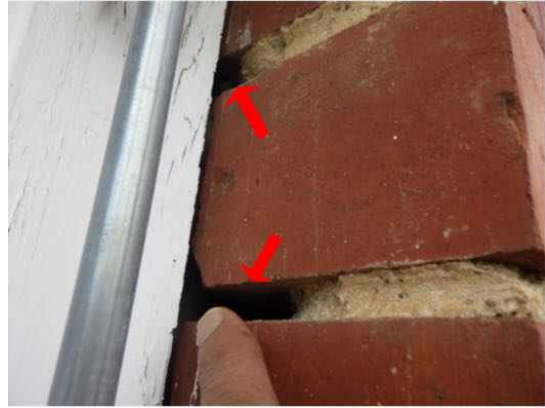
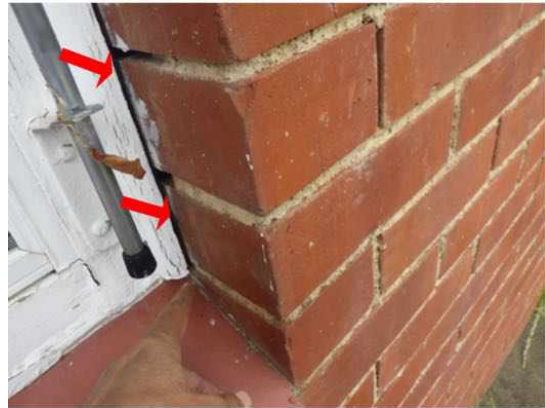
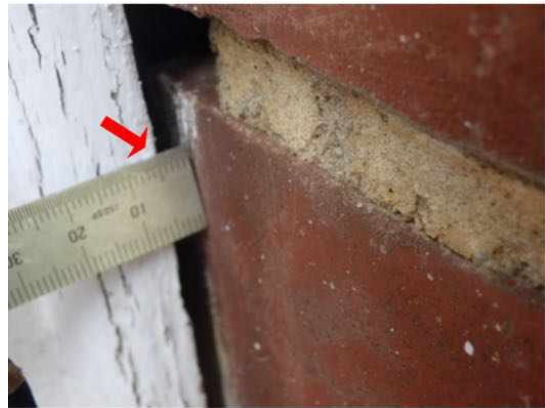
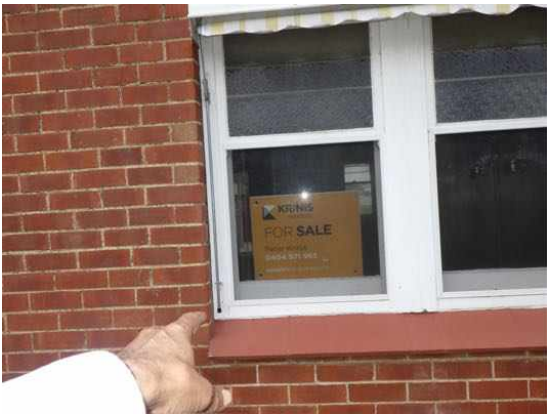
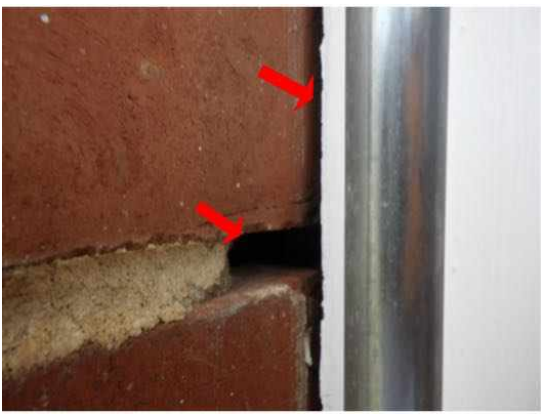
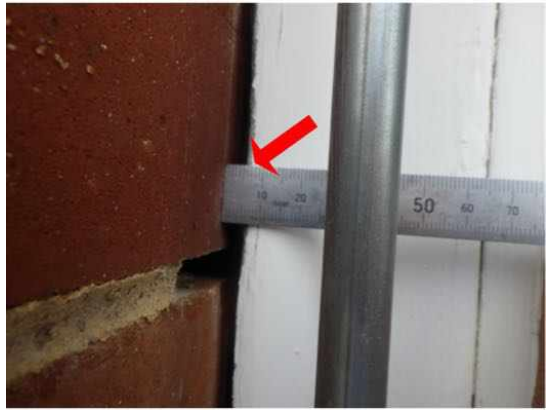
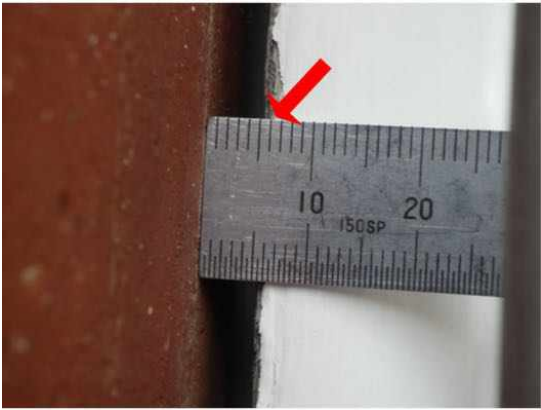
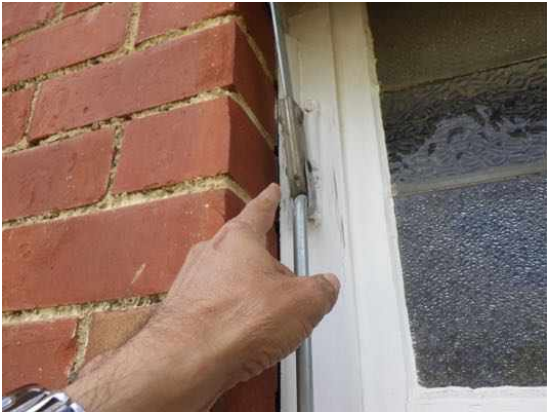
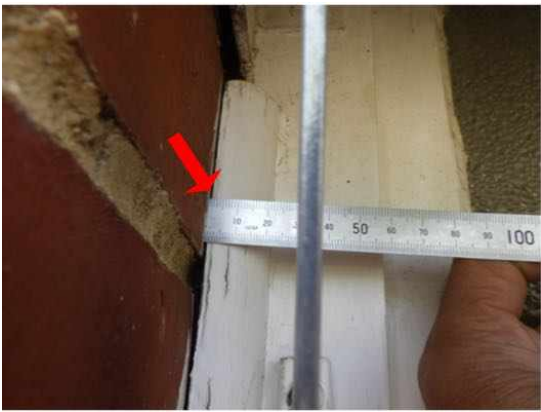
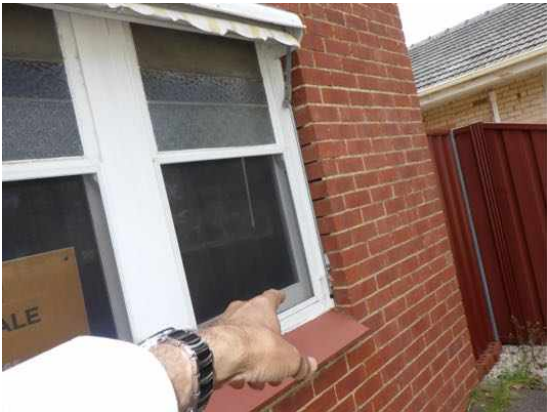
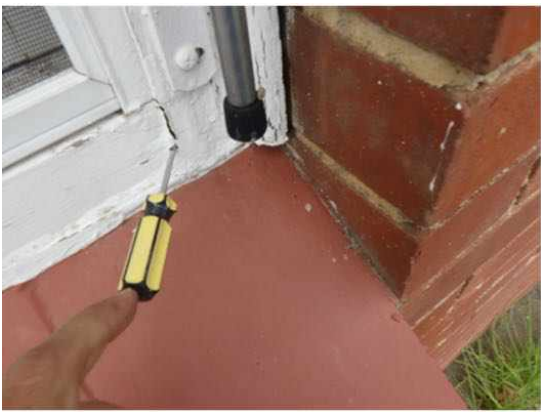
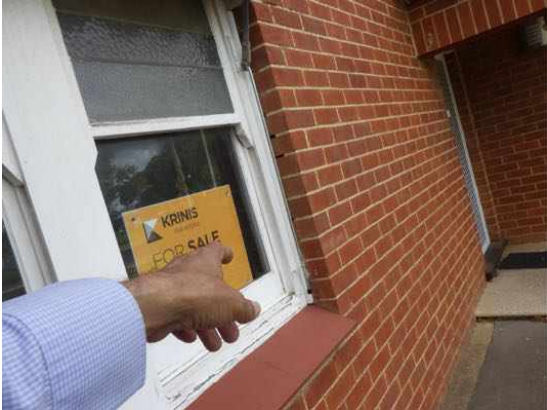
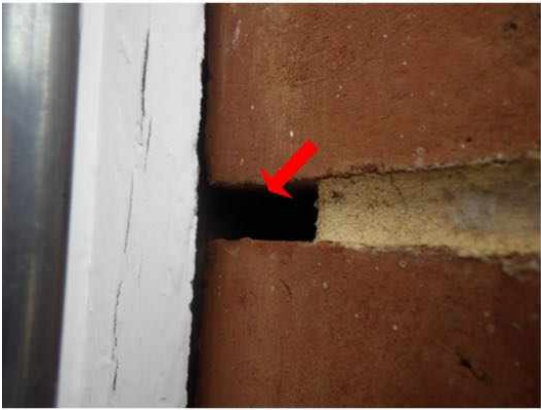
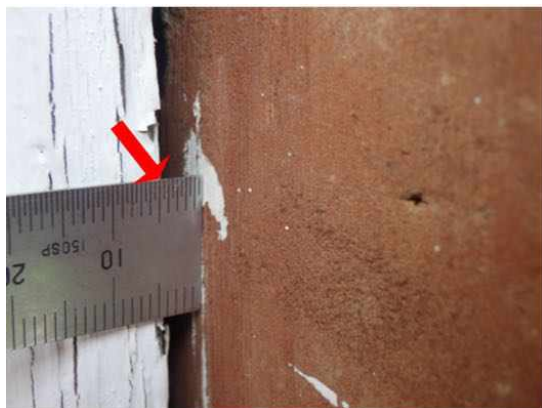
#### Defects 2.01

Building: Building 1  
Location: All External Areas  
Finding: External Walls & Window Frame Assembly - Significant Gaps Observed / Bricks Mortar Deterioration  
Information: At the time of inspection, it was noted that significant gaps are present between the external wall cladding and window frame assembly / building elements at various locations around the property. These gaps indicate poor detailing, movement, deterioration of materials, or inadequate installation and sealing.

Apart from that at the time of inspection it was also noticed evidence of mortar deterioration to few sections of bricks in this area.

Such conditions may arise due to age-related degradation, environmental exposure, or physical damage. If left unrectified, these gaps may allow water and air ingress, potentially leading to secondary defects, including moisture damage, deterioration of adjacent building elements, and reduced thermal and weatherproof performance.

Repair and/or replacement of the affected components is recommended to reinstate the integrity and performance of the building envelope. All building elements play an essential role in the operation and overall performance of the structure, and defects of this nature may adversely impact durability and habitability.

It is advised that a suitably qualified and licensed tradesperson be engaged to assess and rectify the affected areas to prevent further deterioration or consequential damage.

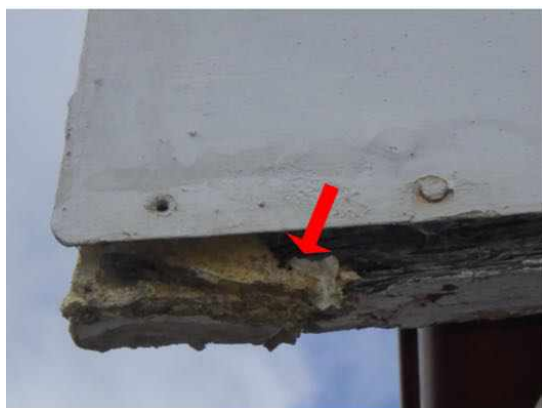
## Defects 2.02

Building:	Building 1
Location:	All External Areas
Finding:	Wood rot
Information:	This building element shows evidence of wood rot. Wood rot, also known as Fungal Decay, occurs when timbers and other cellulose building materials are exposed to damp conditions on an ongoing basis. This could be the result of exposure to weathering over a prolonged period of time, or the attraction of excessive moisture from other abutting building materials. Contributing factors also include poor air ventilation in the area.

Wood rot is often associated with general damp problems and is evidenced by a 'musty' smell or mould and mildew occurring on surfaces. If left unmanaged, damp conditions can lead to further health problems and the decay of timbers will continue.

Early intervention and regular maintenance, particularly of exterior timbers, will prolong the useful life of these building elements. Prior to any works being performed, the cause of the moisture that has created the visible wood rot should be identified and addressed in a suitable manner. Replacement of affected timbers may then be a necessary step in protecting surrounding building elements from such deterioration.

A qualified plumber may be appointed to assess the cause of excessive moisture and to provide advice on any remedial works as required. A qualified carpenter or registered builder may also be required to replace affected building materials.

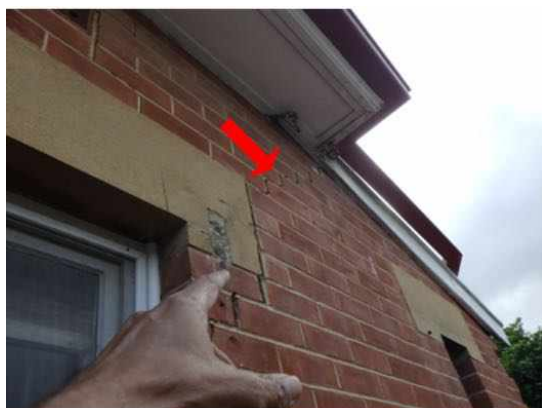
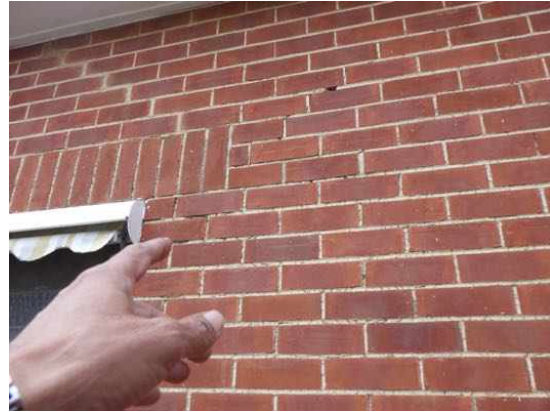
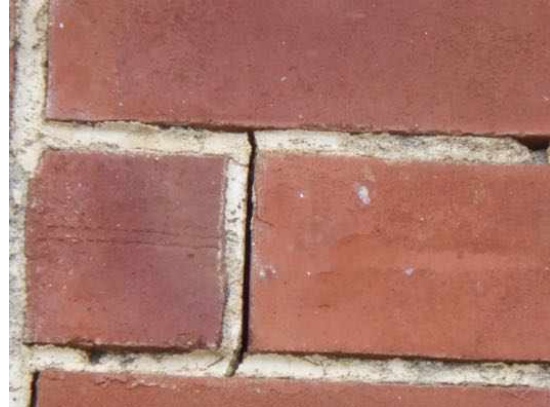
### Defects 2.03

Building: Building 1  
 Location: All External Areas  
 Finding: Brickwork cracking major and minor/ Sections of Bricks Damaged  
 Information: At the time of inspection major and minor cracking were identified to the some sections of exterior brickwork around the property. Cracks of this type are likely to have been caused by minor expected movement of building elements, but may also have a structural cause that is more significant.

Apart from that at the time of inspection it was also noticed evidence of bricks damaged in this external walls rear area / Sections of Bricks Damaged

A crack of this size may be repaired by extensive filling. Additionally, further remedial works to associated building elements, such as eave sheeting or external door frames, is likely to be required.

A qualified bricklayer should be contacted immediately to estimate and perform repair and restoration works. Consultation with a structural engineer may be required where structural instability is found to be the underlying cause of the cracking.

Always contact a building inspector should cracks widen, lengthen, or become more numerous.

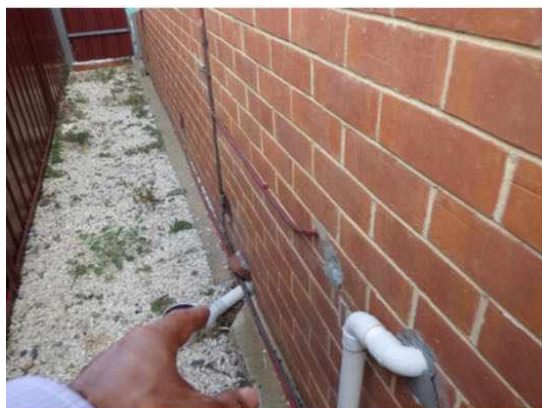
## Defects 2.04

Building:	Building 1
Location:	All External Areas
Finding:	External walls - Holes at lower base
Information:	At the time of inspection significant holes were identified around pipe penetrations in this wall section at lower base. It is suspected that the installation of this pipework was completed to a substandard level of workmanship or is incomplete.

Gaps and holes around pipework makes the area susceptible to insect and vermin ingress, as well as allowing water penetration to the cavity wall. As such, associated building elements are likely to deteriorate at an accelerated rate, and major implications are expected if holes around the pipework are left unmanaged.

All excessive holes, gaps or cracks should be adequately filled by a suitable sealant or trimmings as soon as possible to prevent any further damage. Such works may be conducted by a general handyperson or licensed plumber.

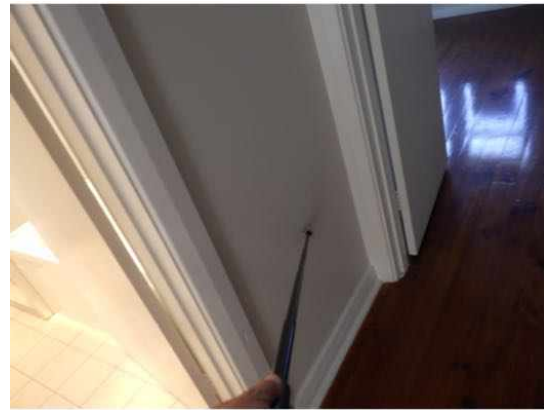
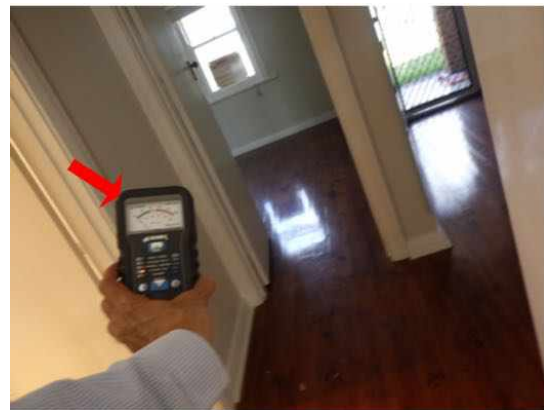
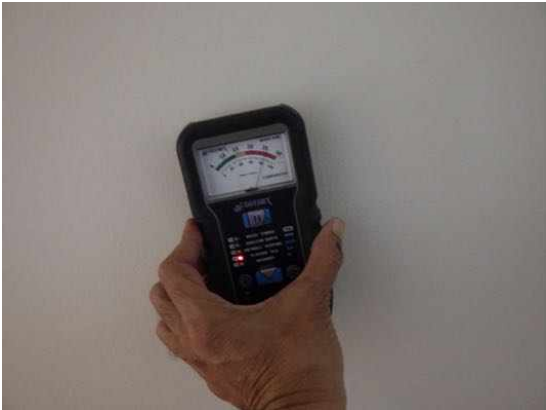
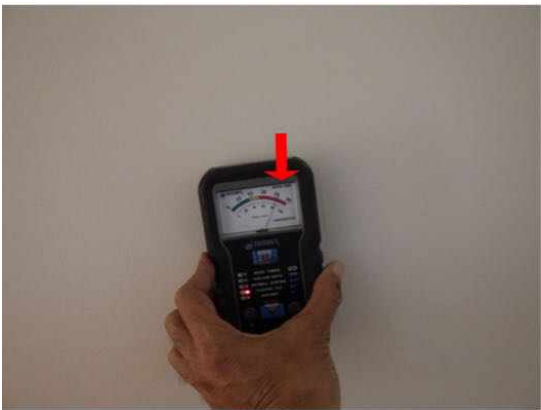
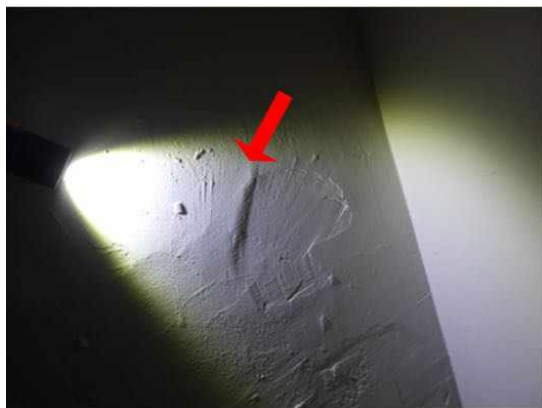
## Defects 2.05

Building:	Building 1
Location:	All Internal Areas
Finding:	Internal walls - Damp adjacent to bathroom
Information:	At the time of inspection it was noticed that high moisture readings were noted in these internal walls adjacent to bathroom.

Apart from that at the time of inspection it was noticed that no high moisture readings were noted in this bathroom - shower alcove and bathtub area.

Damp (or structural damp) refers to the presence of unwanted moisture in the structure of a building, either as the result of intrusion from outside, or condensation from within the structure. Generally, structural damp is caused by rain penetration, rising damp, and leaks from plumbing pipes.

Unmanaged damp facilitates the formation and development of mould, fungi growth and wood rot, decaying associated building materials and compromising their structural integrity. Damage to finishes is also likely to occur, including lifting, bubbling,

peeling and staining of paint, plaster and wallpaper.

The first step in addressing damp is to diagnose the cause. The identified cause should be addressed first prior to repairing the appearance and other defects which have resulted from the rising damp. If the original cause is not resolved, further cases of damp are likely to ensue, resulting in secondary defects.

Consultation with a qualified plumber is advised immediately to identify the cause of damp and perform remedial works as required. Where excessive mould growth is present, further inspection by a specialist environmental health inspector should also be considered.

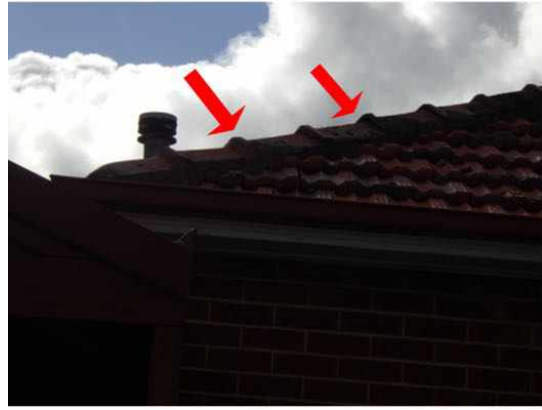
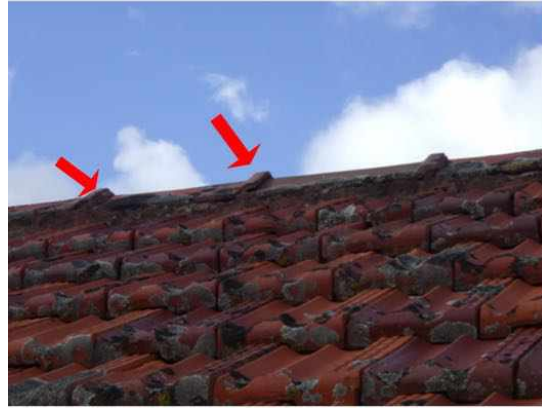
### Defects 3.01

Building:	Building 1
Location:	All External Areas
Finding:	Mortar - Deterioration
Information:	At the time of inspection it was noticed that evidence of mortar deterioration to few roof tiles around the property.

Mortar, or 'bedding', is the material which fills joints and intersections between tiles and other building elements on the exterior roof covering, such as gable ends, hip capping and valleys. Upon inspection of the exterior roof, it was noted that sections of the mortar show varying levels of deterioration.

Mortar generally deteriorates as a result of frequent exposure to weather conditions over a prolonged period of time. Mortar that is deteriorating may allow water ingress into the roof void, putting associated building elements and roofing structures at risk of water damage. Deteriorated mortar also detracts from the functionality of roof tiles and other roofing elements, potentially decreasing weather tightness and roof drainage.

Mortar deterioration can be attended to by a handyperson where areas of deterioration are localised and easily accessible. Otherwise, consultation with a roofing contractor is advised where greater works are required.

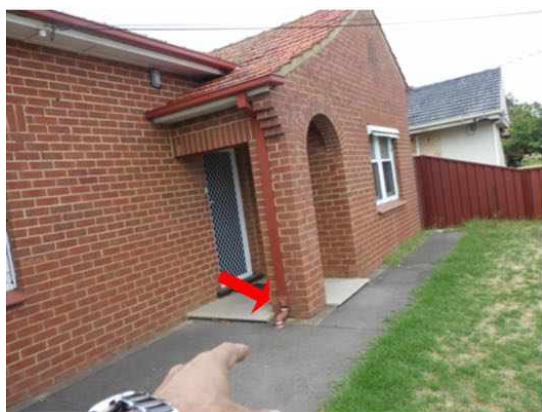
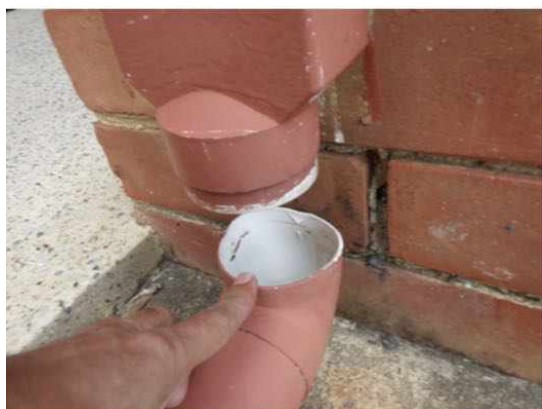
**Defects 3.03**

Finding: Site drainage - Inadequate  
 Information: The site drainage in this entry area was found to be inadequate at the time of inspection, creating potential for subsequent water damage to associated building elements.

It is important that water does not lie against the base of walls; surrounding paths and ground levels should be sloped to drain water away from walls. Downpipes should not discharge stormwater onto lower walls or plinths. Stormwater should be carried away by large, regularly cleaned drains. Ground levels may need to be lowered to expose a buried DPC.

Where site drainage is inadequate, installation of an Agricultural (Aggie) Drain may be required. A qualified plumber should be appointed to further inspect the property and perform any remedial works as necessary. Water damage and secondary defects are likely to occur if left unmanaged.

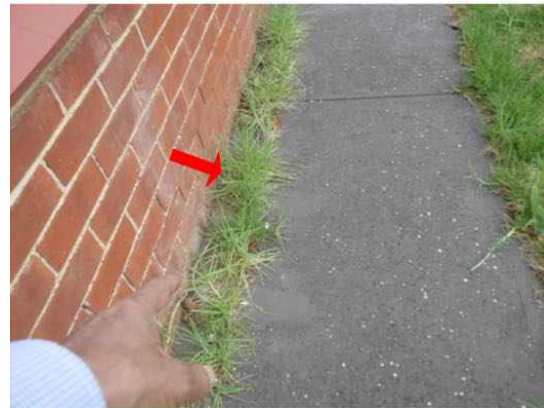
### Defects 3.04

Building: Building 1  
 Location: All External Areas  
 Finding: Bridging - Vegetation  
 Information: Where vegetation obstructs inspection of building elements, also known as bridging as it provides a bridging point for the access of termites, full inspection can not be

achieved. Consequently moisture or dampness may be present and the areas becomes conducive to termite activity. Plants against or very close to buildings provide cover, shade and can provide an environment that is attractive to termite infestation.

The removal and replanting of species that do not provide "cover" or cutting back of existing vegetation will assist greatly in preventing Bridging from occurring.

The removal of any such materials that may be conducive to termite activity should be carried out as soon as possible and arrange re inspection to minimize the risk of termite attack.

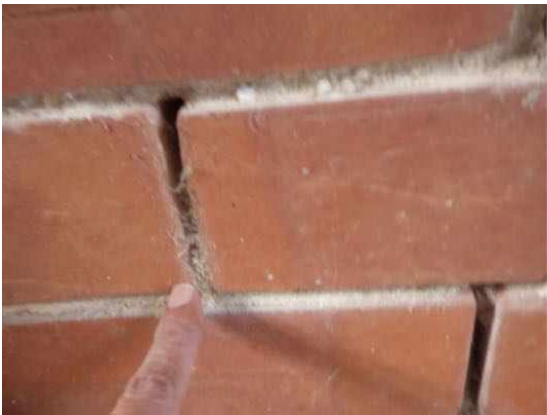
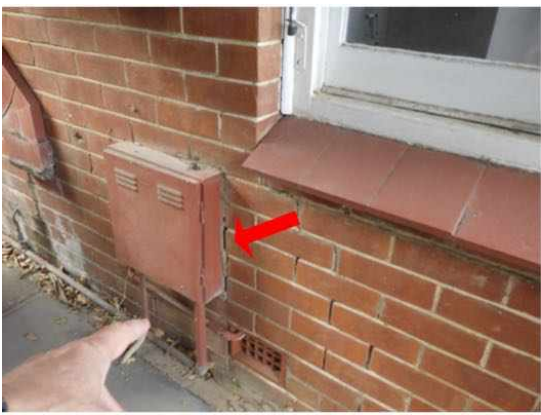
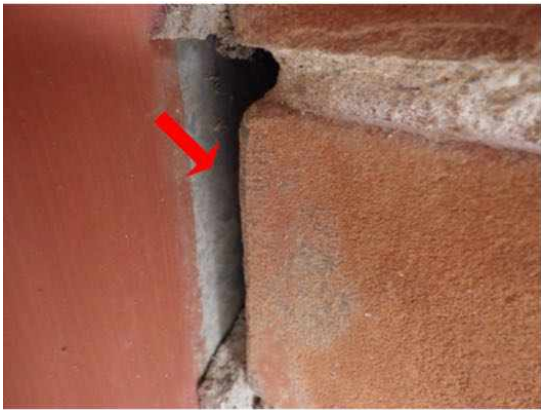
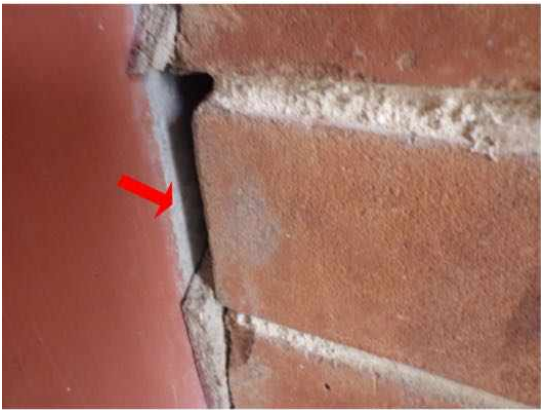
### Defects 3.07

Finding: Brickwork - Deteriorated mortar

Information: Mortar, or 'bedding', is the material which fills joins and intersections between bricks in masonry walls and structures. Sections of mortar in this brickwork were identified as having deteriorated, which is generally expected for a property of this age and condition.

Mortar may deteriorate as a result of age of building materials, minor movement of bricks, or frequent exposure to weathering. Mortar should be replaced to ensure that

bricks remain in their intended location and to prevent gaps, which would allow water or moisture ingress and secondary damage as a result.

Mortar deterioration can be addressed by a bricklayer where areas of deterioration are localised and easily accessible. Alternatively, appointment of a registered builder is advised, to repoint large areas of decaying mortar. Where secondary structural defects have become evident, consultation with a structural engineer may be required.

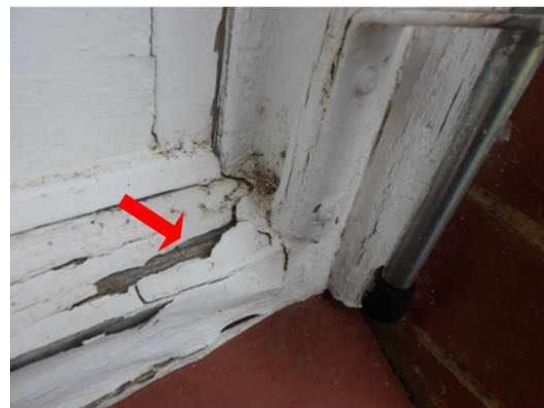
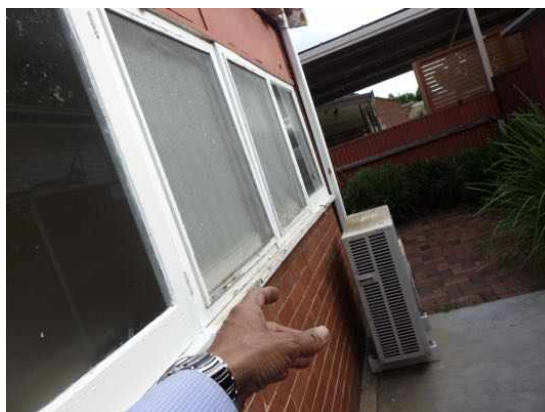
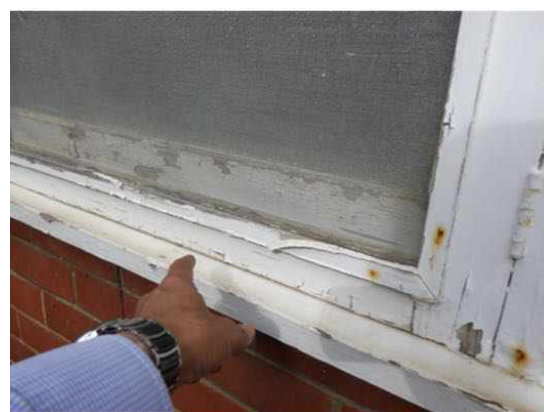
**Defects 3.08**

Building: Building 1  
Location: All External Areas

Finding: External painting deteriorated  
Information: Much of the external paintwork including but not limited to windows, fascias, guttering, veranda and other external fitments have been neglected and require attention to prepare and re-paint.

Whilst incomplete or missing paint finish is generally an appearance defect, it can also lead to the development of secondary building defects over time. Incomplete areas of paint finish expose the area to moisture, potentially accelerating the deterioration of underlying building materials.

Degraded paint finishes should be sanded back, filled, leveled and painted, as applicable. Where inadequate or missing paint protection has led to the deterioration of the associated building element, repair and/or replacement of this building element may be required.

A painting contractor should be appointed as soon as possible to perform necessary works to aid the appearance of the affected area and to ensure the area is protected against further deterioration. Alternatively, the homeowner following manufacturer instructions may perform these works.

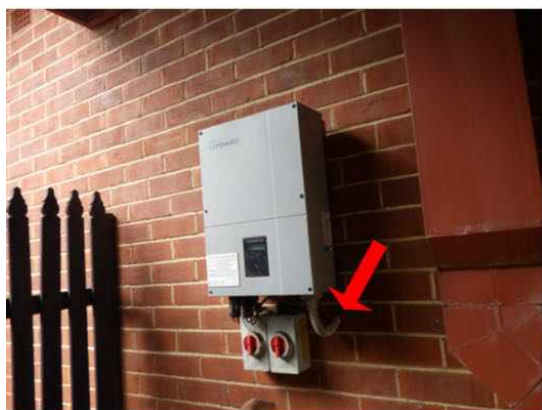
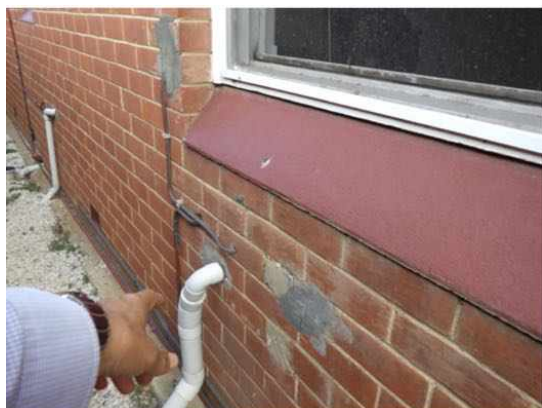
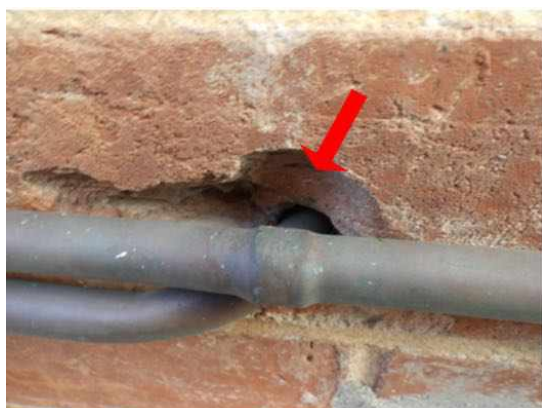
### Defects 3.09

Gaps and holes around pipework makes the area susceptible to insect and vermin ingress, as well as allowing water penetration to the cavity wall. As such, associated building elements are likely to deteriorate at an accelerated rate, and major implications are expected if holes around the pipework are left unmanaged.

All excessive holes, gaps or cracks should be adequately filled by a suitable sealant or trimmings as soon as possible to prevent any further damage. Such works may be conducted by a general handyperson or licensed plumber.

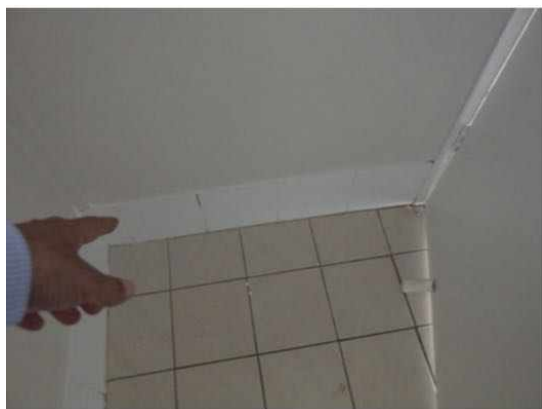
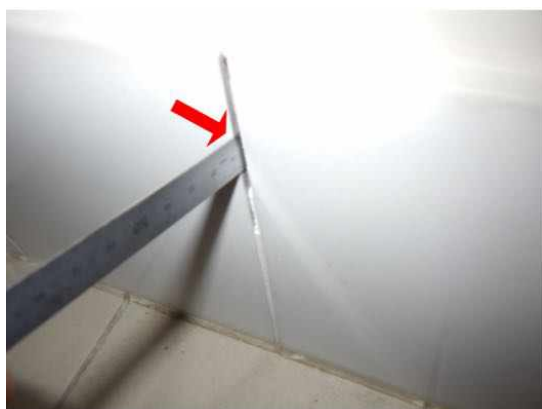
### Defects 3.10

Building:	Building 1
Location:	All Internal Areas
Finding:	Grout - Missing/ Deteriorated
Information:	Grout is missing/ deteriorated in this toilet area. Grout is used to protect gaps and crevices in building materials to ensure that they are water-tight and prevent water penetration to the associated structures.

Where grout is missing, a tiling contractor should be appointed immediately to apply grout and re-apply any silicone where necessary. Failure to do so is likely to lead to water damage to the surrounding area.

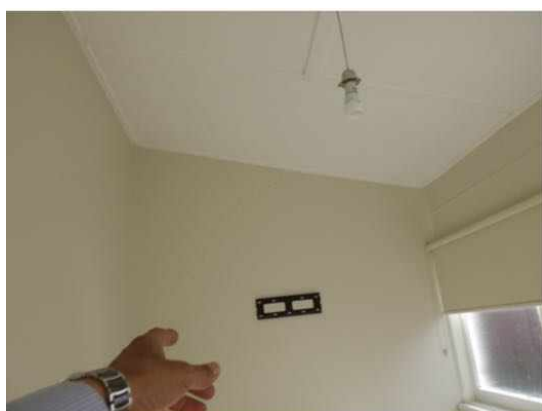
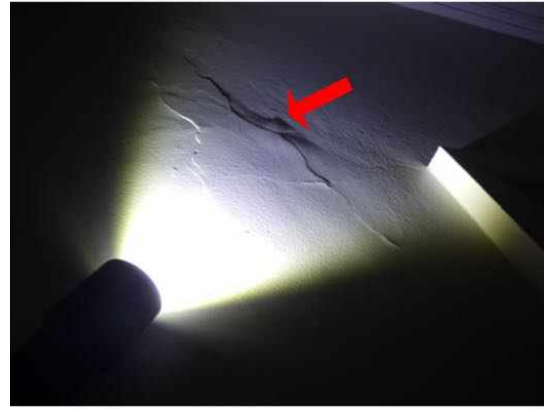
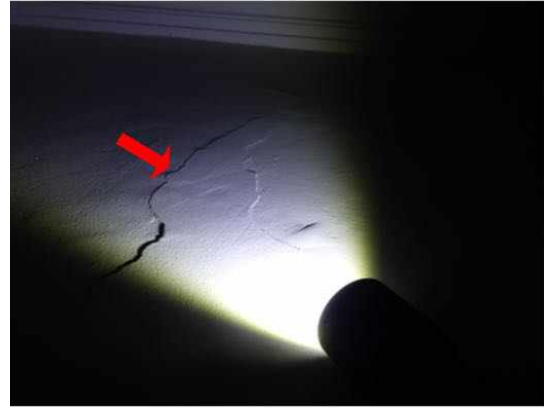
### Defects 3.12

The most common causes of plaster failure are physical damage and moisture damage. Moisture causes plaster to swell and shrink as the humidity of the air changes, or as a consequence of leaks, which can be enough to create drumminess or cracking.

Drummy plaster generally needs chemical re-adhesion or to be screwed back to the substrate, with minor consequent patching and painting required.

Ensure that the general environment is free of moisture and humidity to aid in the prevention of drummy plaster and plaster damage. Appointment of a qualified plasterer is advised in order to complete remedial works as necessary.

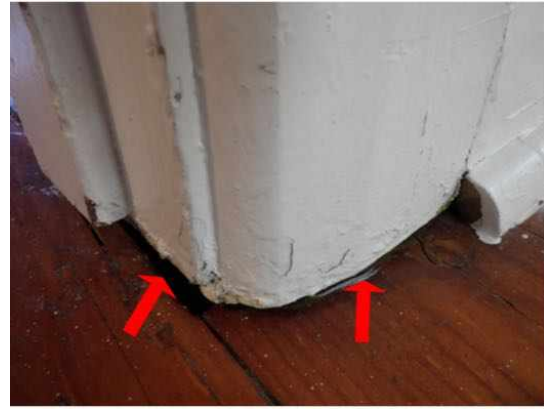
### Defects 3.13

Building:	Building 1
Location:	All Internal Areas
Finding:	Timber flooring - Gaps to edges
Information:	Considerable gaps were noticeable around door jambs and edges of flooring. These gaps serve the purpose of allowing the flooring material to expand and contract, which is expected due to moisture levels and humidity.

While purposeful, these gaps make the adjoining building elements prone to water penetration, creating potential for the development of secondary damage.

While beading is used in most places to cover this gap around smaller corners, it is recommended that these gaps be filled with a coloured caulking compound. Such works should be performed by a qualified carpenter or general handyman, and should be completed at the discretion of the client.

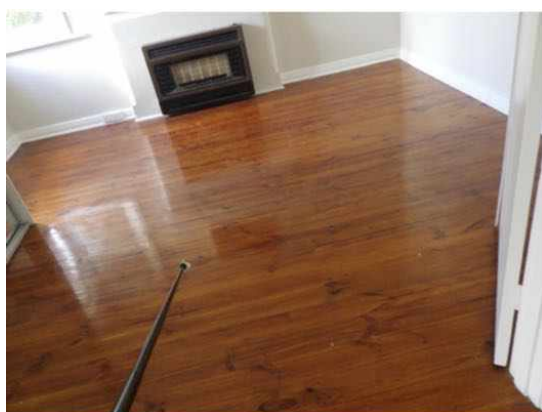
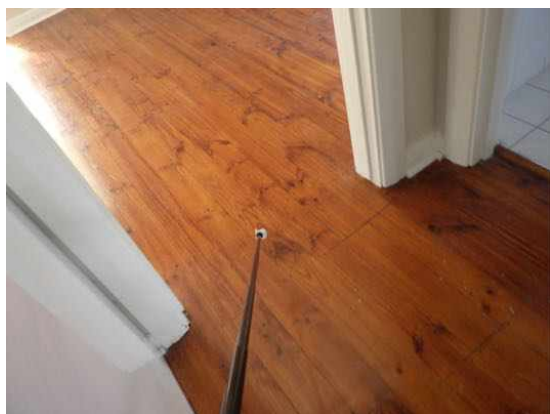
### Defects 3.16

Bouncy floors generally indicate that the floorboards or the subfloor structures are coming loose from the joists that they are installed on. Bouncy flooring may also be the result of gaps between flooring and stumps or joist structures, which require packing.

The client is advised to seek quotations for required repairs from a Registered Builder specialising in re-stumping. The potential resolution may range from packing gaps in subfloor structures through to replacement of subfloors stumps and refixing of flooring.

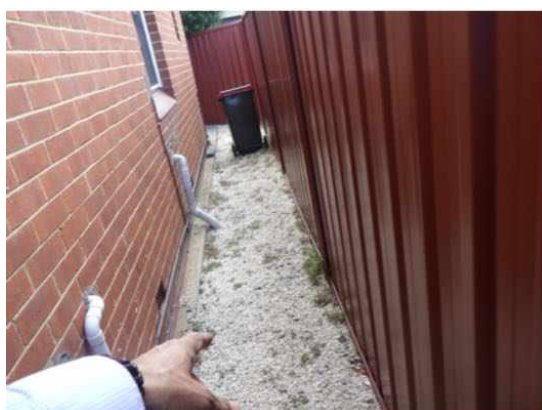
### Defects 3.17

Building:	Building 1
Location:	All External Areas
Finding:	External Paving – Missing Sections / Not Installed
Information:	At the time of inspection, it was observed that several sections of external paving were missing or not installed around the perimeter of the property. This condition has resulted in exposure of the concrete slab edge, thereby compromising the intended protection to the slab and adjoining building elements.

Exposed slab edges may increase the risk of moisture penetration, deterioration of structural and non-structural elements, termite or pest ingress, and ongoing maintenance issues. This condition is considered a defect and a maintenance concern that requires attention.

It is recommended that a suitably qualified and licensed contractor be engaged to install the missing external paving sections and reinstate adequate protection to the slab edge. All works should be carried out in accordance with relevant Australian Standards, the National Construction Code (NCC), and accepted building practices.

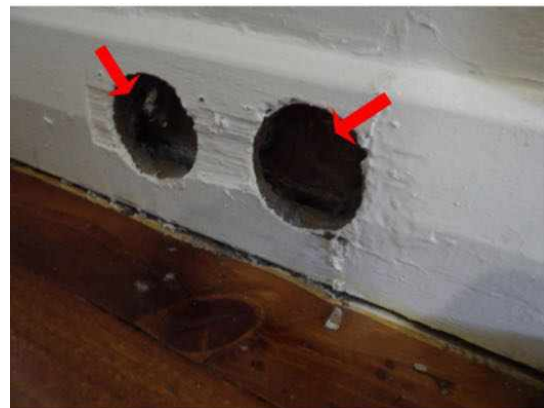
### Defects 3.19

Building:	Building 1
Location:	All Internal Areas
Finding:	Surface - Holes
Information:	Holes in surfaces are generally indicative of impact damage, whether accidental or deliberate, or a failing of the surface material.

Where holes are apparent in the surface of a building material, the surface is no longer sealed against water penetration or further impact damage, which may lead to additional damage to the surrounding surface.

Repair or replacement of the affected building element is recommended as soon as possible to ensure that any secondary defects are minimised. A qualified carpenter or general handyperson should be appointed to perform these works.

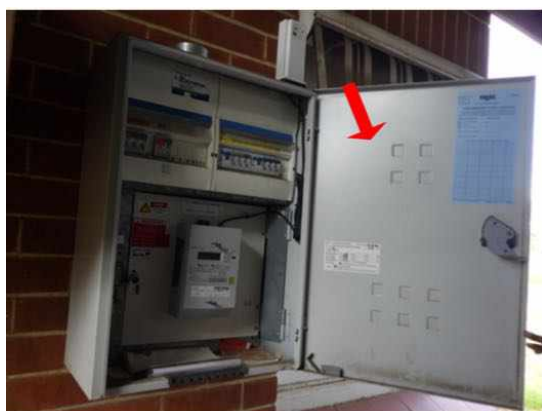
A durable notice should be placed in the switchboard unit to indicate current termite barriers. At the time of inspection, it appeared as though no termite management system has been installed, with no evidence to suggest preventative works taking place.

The client may consider gaining further advice from a pest controller as to the costs and procedures involved with this application. It is recommended that obtaining such advice be a short-term priority.

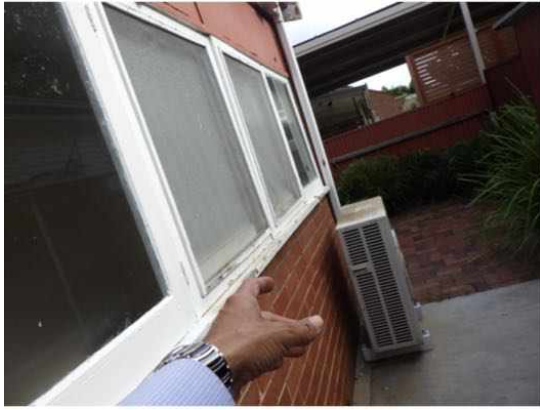
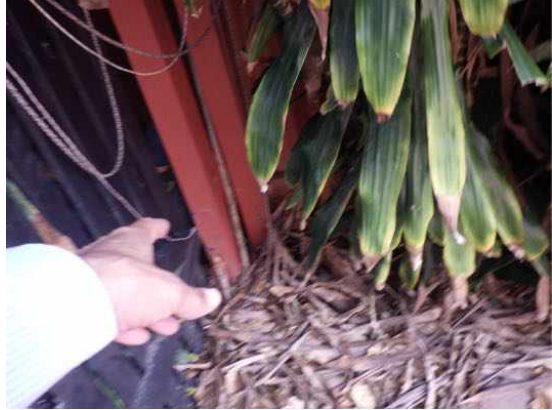
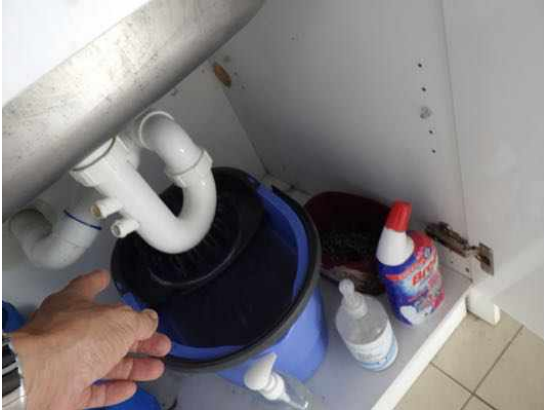
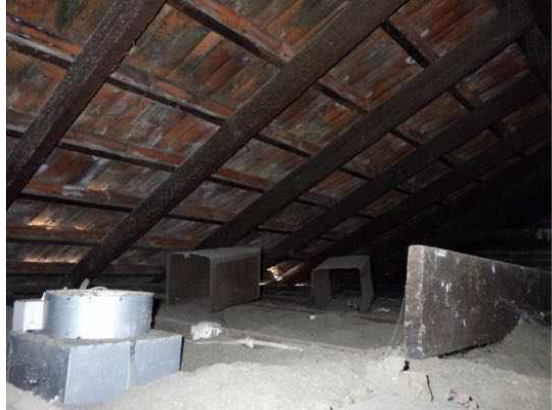
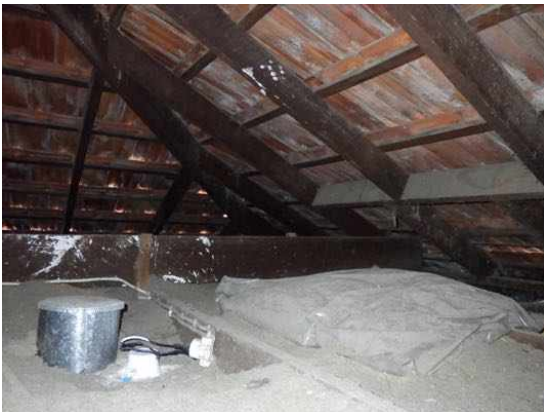
### Noted Item

Building:	Building 1
Location:	All Areas
Finding:	Additional Photos - Obstructions and Limitations
Information:	These photographs are an indication of the obstructions and limitations which impeded full inspection of the property at the time of inspection. These obstructions can hide an array of defects and should be removed to allow full inspection to be carried out. A re-inspection is recommended once the areas are made accessible.
