Building and Timber Pest Inspection Report

Inspection Date: Mon, 19 Jan 2026

Property Address: 276 Rainbow St, Coogee NSW 2034,
Australia

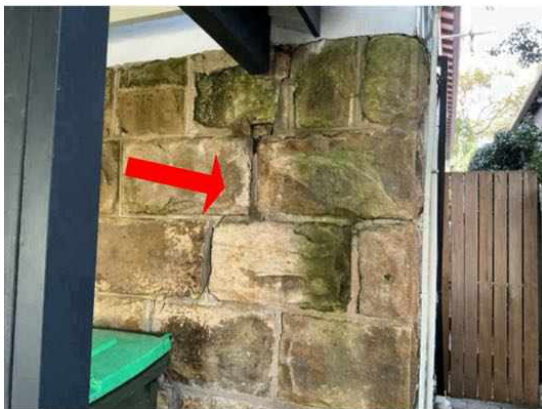
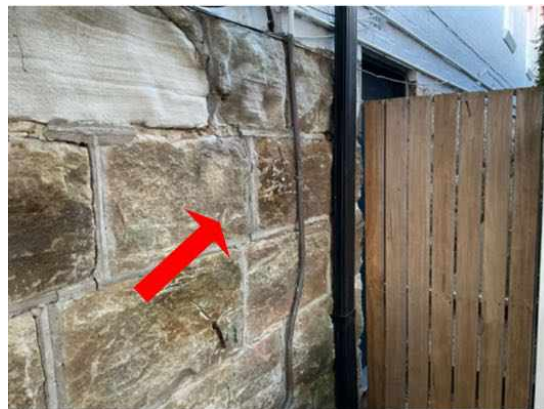
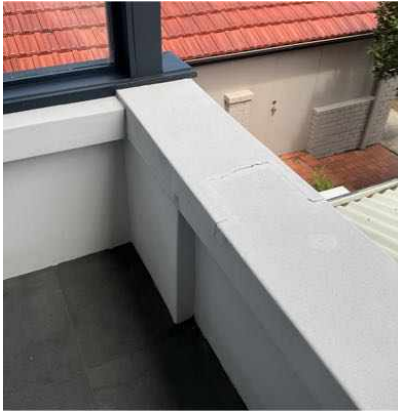
Finding 3.01

Building: Main Building
Location: Exterior walls - front
Finding: Fine Cracking – Stone Foundation
Information: Fine cracking was observed in the stone foundation at the front of the property. The cracking may indicate minor settlement, and there is some evidence that the foundation may have dropped slightly in this area. At the time of inspection, no associated secondary defects were noted internally or externally.

It is highly recommended to consult further with a licensed builder or engineer to further assess the extent of movement and determine whether the cracking is ongoing or if it has stabilised. This will assist in identifying whether any remedial work is necessary to prevent future structural issues.

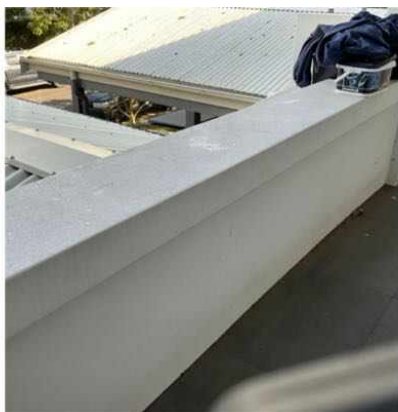
Finding 3.02

Building:	Main Building
Location:	Front Elevation
Finding:	Balustrade - Suspected Non-Compliance
Information:	The balustrade was measured and found to less than the present building regulation requirement of 1000mm high.

Some changes to the building regulations are made to ensure the safety of all inhabitants and balustrades are definitely one of those crucial regulations.

This defect creates a potential safety hazard and should be rectified as soon as possible to ensure the safety of the area and to meet present building standards and regulations.

A registered builder should be contacted to discuss possible rectification solutions.

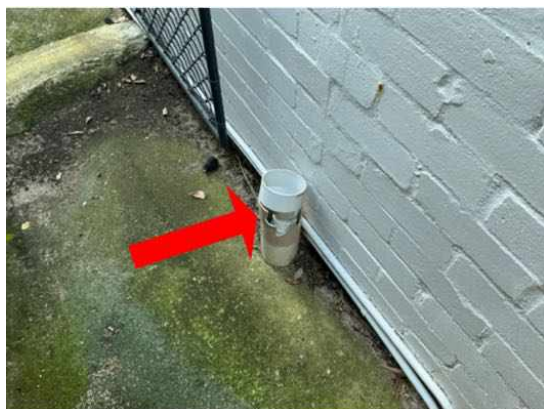
Finding 3.03

Location: Exterior walls - right side
 Finding: Plumbing element - Missing
 Information: A grA grill or cover is missing from the sewer vent. Without this cover, debris may enter the sewer and cause blockages.

It is important to replace any missing building elements as soon as possible to prevent potential damage or functional issues with the plumbing.

A plumber should be hired promptly to replace the missing cover.

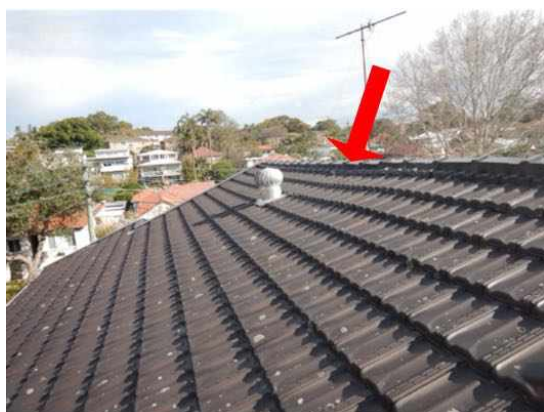
Finding 3.04

Building: Main Building
 Location: Roof Exterior
 Finding: Sagging Roof Line
 Information: The roofing structure was found to be sagging in a sections at the time of inspection.

Sagging roof structures are likely to create strain on associated building elements, creating potential for secondary damage including the deterioration of roof coverings.

Although it does appear to be causing any structural issues, and there is no indications of cracking or movement on the interior side of the roof, it is recommend appointing a builder to further inspect the area and determine if repairs are required.

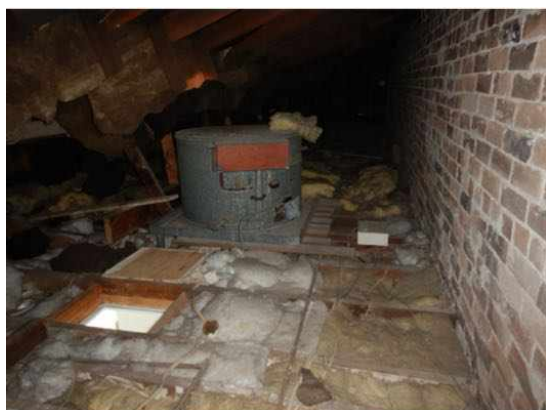
Finding 3.05

Building:	Main Building
Location:	Roof Void
Finding:	Gravity-Fed HWS - Disconnected
Information:	It was noted at the time of inspection that a disconnected gravity-fed hot water system (HWS) remains in this area.

Despite this plumbing structure being unused, the HWS can rust and may also make the area susceptible to termite or timber pest activity. However, if the structure is not causing any issues it can remain in place until a renovation take place on the roof area.

Further consultation with a licensed plumber is required to gain further advice on removal of the structure.

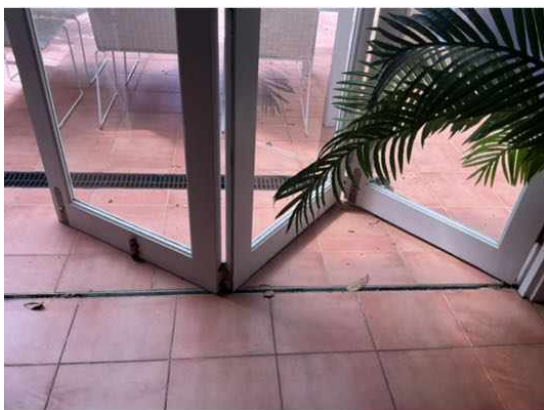
Finding 3.06

Building:	Main Building
Location:	Rear Elevation
Finding:	Door - Stiff to slide
Information:	The door in this area was jammed and difficult to slide along the associated tracks at the time of the inspection. Restricted function of the affected door may pose as a potential safety hazard if required for emergency egress from the building.

Generally, factors such as general age of the building element and a lack of maintenance are the usual causes for this type of defect.

Replacement of door hardware or tracks may be required, as well as minor repairs and cleaning. A registered builder or general handy person will be required to repair the affected doors.

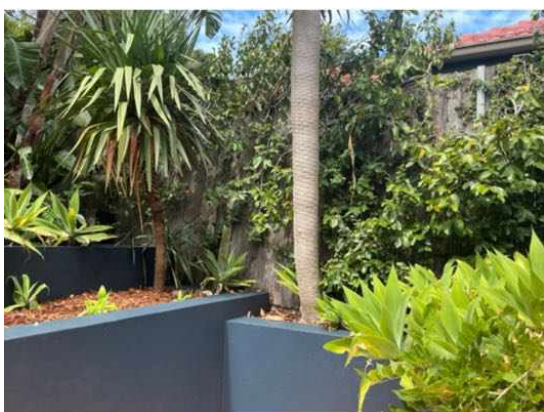
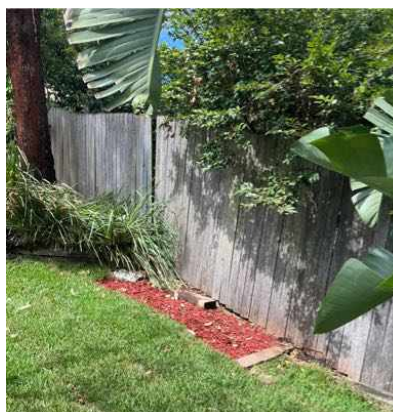
Finding 3.07

Finding: Fencing - Deteriorated

Information: It was noted at the time of inspection that sections of the fencing throughout the property have deteriorated. Typically fencing deteriorates due to age and or wear, rot and or rust, and due to prolonged exposure to weather conditions. Sometimes inadequate installation or maintenance can be to blame.

If left unattended, it is likely that further damage will occur. It is suspected that repair of several elements of the fencing may be required however replacement may be a consideration of the client also.

A licensed fencing contractor should be appointed to provide further advice and perform rectification works as necessary.

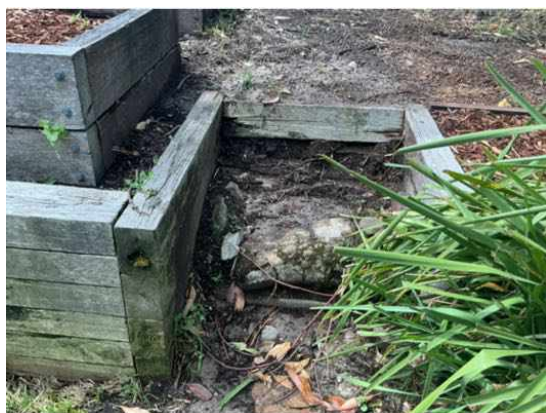
Finding 3.08

Finding: Steps deteriorated

Information: The external and steps in this area is out of level and uneven. Uneven steps is likely to

indicate minor defects such as expected movement and is common for properties of this age. Where uneven steps create a trip hazard, personal injury may ensue if due caution is not taken by all persons within this area. Repair of the area can be carried out to prevent further issues. Further consultation with a builder is advised.

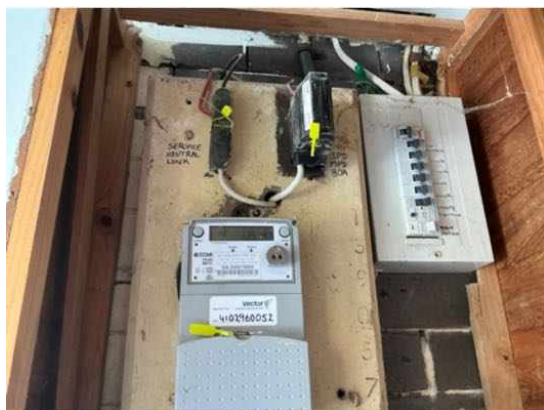
Finding 6.01

Building:	Main Building
Location:	Exterior walls - front
Finding:	Termite Management System No Evidence of Installation
Information:	The application of a post-construction termite barrier is highly recommended for all properties. Such barriers are highly effective in preventing termite attack on any timber building elements throughout the property.

A durable notice should be placed in the switchboard unit to indicate current termite barriers. At the time of inspection, it appeared as though no termite management system has been installed, with no evidence to suggest preventative works taking place.

The client may consider gaining further advice from a pest controller as to the costs and procedures involved with this application. It is recommended that obtaining such advice be a short-term priority.

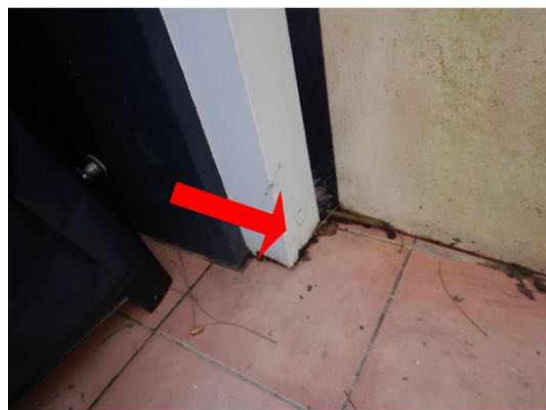
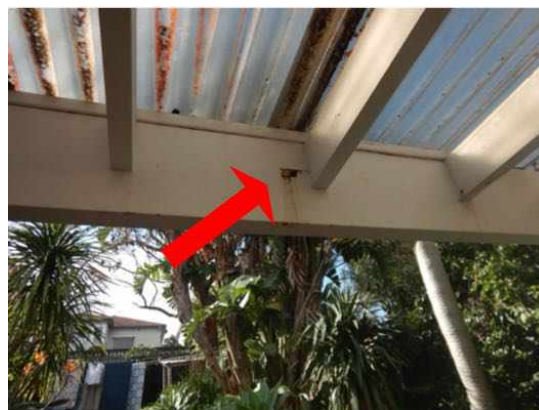
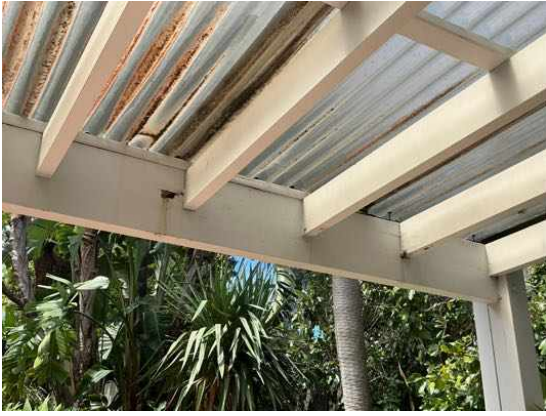
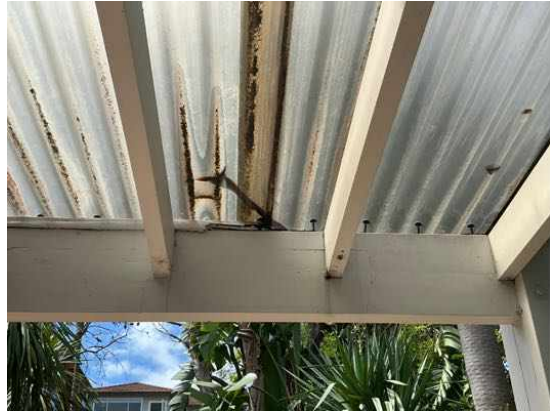
Finding 7.01

Finding: Structure - Wood rot

Information: The pergola structure is showing signs of deterioration and wood rot (fungal decay) of the timbers. It is suspected that this defect has developed as a result of a lack of maintenance on external timber and ongoing exposure to weather.

Damp conditions could cause the timbers to fail, resulting in the structures failing to bear the load (or weight) of the building as originally intended. Without repairs and maintenance, including potential replacement of affected elements, it is likely that structural issues will result, as well as an array of minor defects.

Where wood rot is present to any structural timber, rectification or replacement of the affected timber building element is required. The adequate timeframe for such works are dependent on the severity of the rot. Where rot has developed to become widespread, replacement of sections of the structure may be required. Consultation with a structural engineer or registered builder specialising is highly advised.

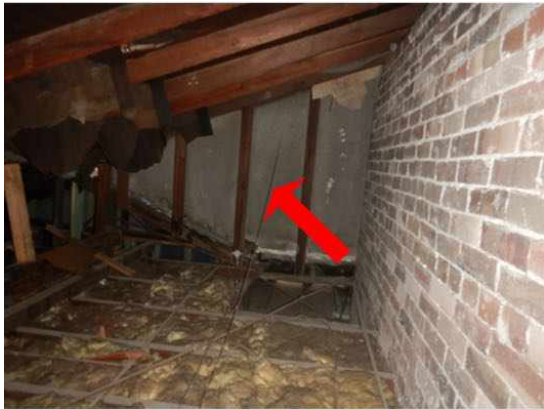
Noted Item

Building:	Main Building
Location:	Roof Void
Finding:	Asbestos Containing Material Suspected
Information:	Reporting on Asbestos is outside the Scope of this Report. This suspected defect is highlighted as a caution only. We suspect, based on our experience in the building industry, that there is a higher risk of the identified building element and other possible areas of the house containing asbestos.

As Asbestos Reporting is outside the scope of this report, we advise that you consider a separate Asbestos Inspection and Condition Audit, which can include the taking of samples for definitive confirmation of the presence of Asbestos.

In the interim, the client is advised to act with caution, especially when considering any damage to building materials general wear and tear renovations extensions demolition and general maintenance activities due to the suspected presence of Asbestos.
