Building and Timber Pest Inspection Report

Inspection Date: Thu, 19 Mar 2026

Property Address: 5/436 Malabar Rd, Maroubra NSW 2035,
Australia

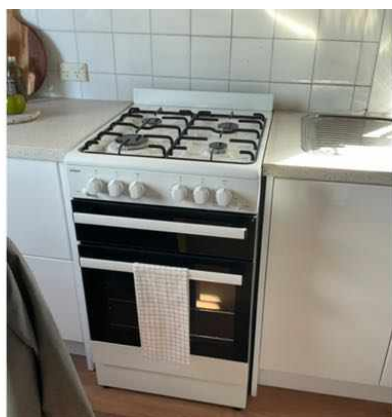
Building:	Main Building
Location:	Kitchen
Finding:	Unsecured Oven Installation
Information:	The electric oven located beneath the gas cooktop in the kitchen island was found to be unsecured.

During a light pull, the oven moved forward freely, presenting a potential safety hazard, especially if weight is applied to the open door. According to AS 4349.1–2007 Appendix C (C2.2 and C2.3), appliances should be properly installed to prevent movement or dislodgement.

This defect is considered a major safety concern due to the risk of injury or damage. Immediate rectification is recommended by a licensed kitchen installer or qualified tradesperson to properly secure the appliance in accordance with manufacturer installation instructions. Rectification should occur within 24–48 hours to eliminate the risk.

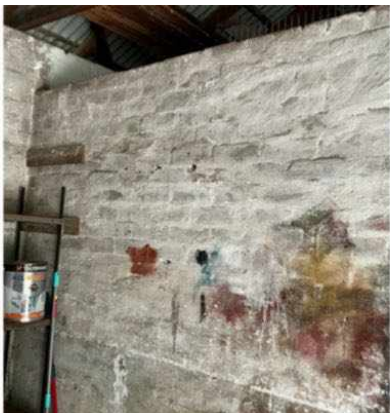
Finding 2.01

Building:	Main Building
Location:	Garage
Finding:	Brickwork - Step cracking - Strata - Requires further investigation
Information:	External garage brickwork displayed stepped cracking and uneven floor with associated moisture-related deterioration and surface breakdown. The cracking pattern suggests movement within the masonry, potentially related to footing

settlement and/or prolonged moisture ingress. This condition is beyond normal cosmetic deterioration and may lead to further cracking, moisture penetration, and localised structural degradation if left unaddressed. Further assessment and repair by a suitably qualified structural engineer and remedial masonry/waterproofing contractor is recommended.

As the affected wall appears to form part of the external garage structure within a strata complex, responsibility for investigation and repair may rest with the Owners Corporation, subject to confirmation against the strata plan and by-laws.

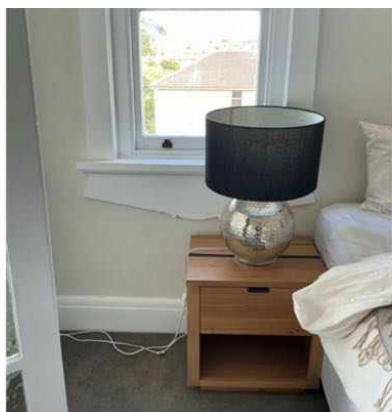
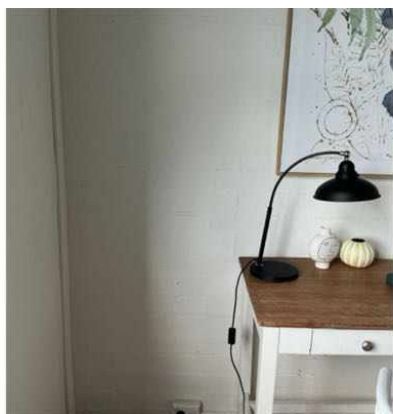
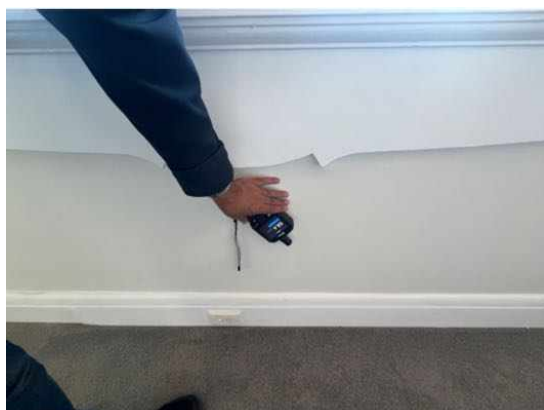
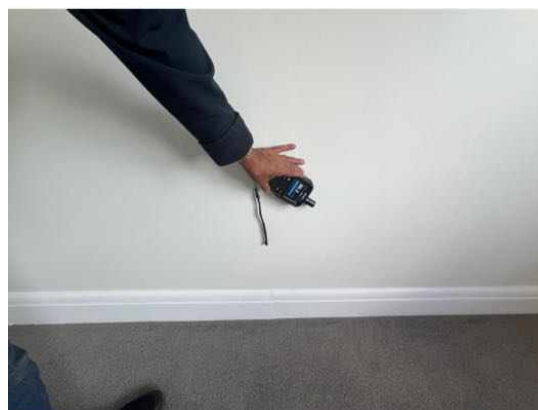
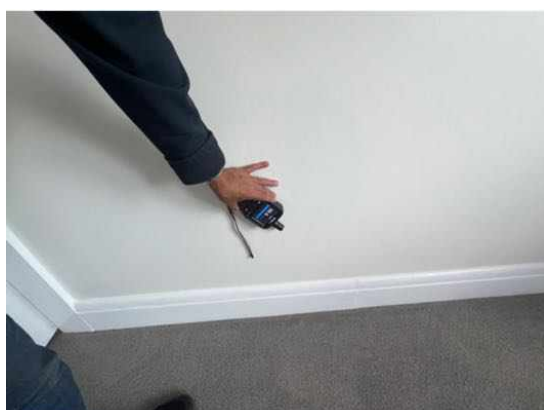
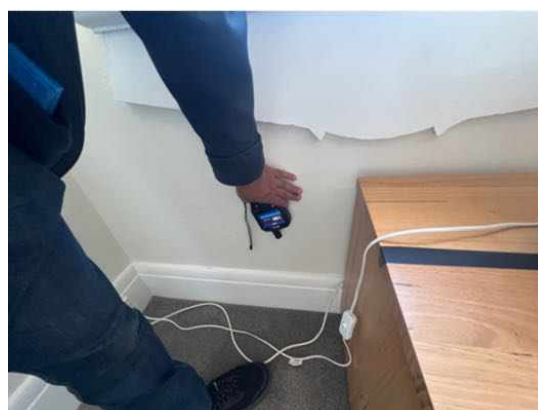
Finding 3.01

Building:	Main Building
Location:	All Internal Areas- External parameter wall
Finding:	Damp (Elevated moisture related deterioration (Paint bubbling) also present to some areas
Information:	Damp (or structural damp) refers to the presence of unwanted moisture in the structure of a building, either as the result of intrusion from outside, or condensation from within the structure. Generally, structural damp is caused by rain penetration, rising damp, and leaks from plumbing pipes.

Consultation with a qualified plumber is advised immediately to identify the cause of damp and perform remedial works as required. Where excessive mould growth is present, further inspection by a specialist environmental health inspector should also be considered.

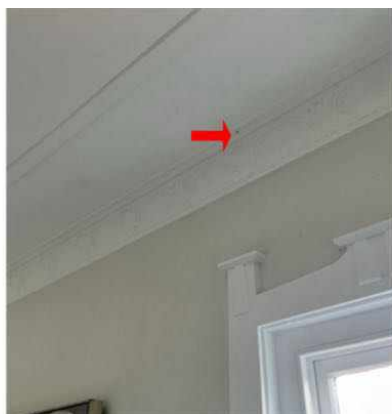
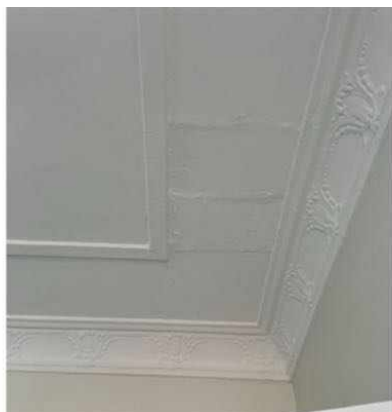
Finding 3.02

Building:	Main Building
Location:	All Internal Areas - Ceiling
Finding:	Painted surface - Bubbling/Elevated moisture and moisture related deterioration to some areas - Requires further investigation (Possible waterproofing)
Information:	Sections of paint in this area was found to have bubbled and deteriorated. Paint bubbling is generally an indication of excessive moisture in the area, that is currently hidden by the painted surface. The ceiling also exhibited elevated moisture in multiple locations. The exact cause of moisture ingress couldn't be confirmed during a visual inspection however waterproofing risk could not be ruled out.

The presence of excessive moisture can have major implications on associated

building elements if left unattended. The ceiling remains serviceable however, the damage cannot be determined due to the paint obstructing any further inspection of the damage.

It is highly advised that the affected paint be cleaned to allow a further, more invasive inspection by a licensed plumber. Failure to act on this defect may necessitate major works in the future.

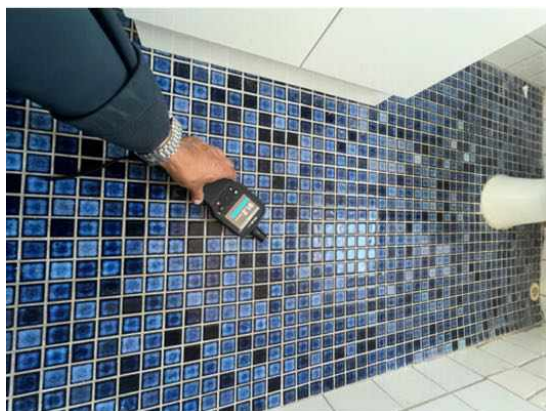
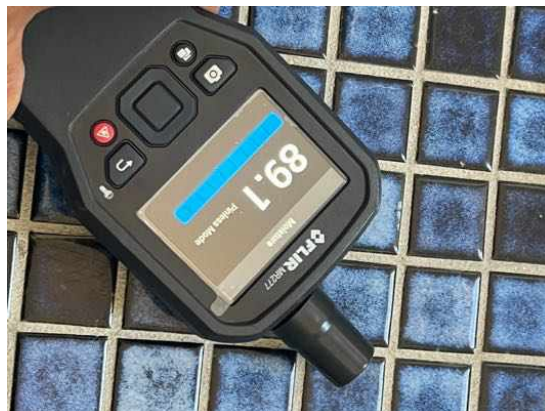
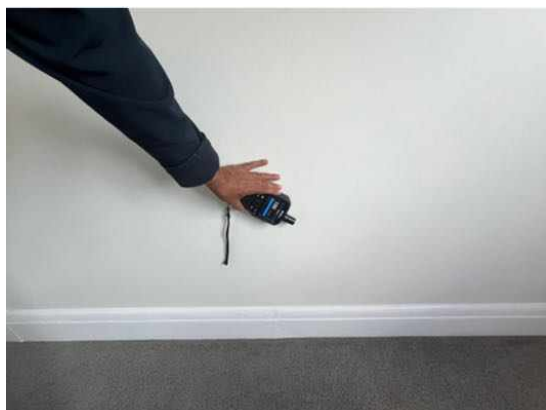
Finding 3.03

Building:	Main Building
Location:	Bathroom
Finding:	Elevated Moisture Bathroom & Back of shower (Possible waterproofing, requires further investigation)
Information:	Elevated moisture levels were detected to tiled surfaces in bathroom/shower areas. This may be due to porous or missing grout, cracked tiles or recent use, however the possibility of waterproofing membrane failure or plumbing leaks cannot be excluded. Persistent moisture ingress can lead to concealed damage, including timber rot and mould growth. Further investigation by a licensed plumber and/or waterproofing contractor is recommended as soon as possible. The back of shower area also

showed elevated moisture but no visible deterioration was evident at the time of inspection.

Failure to investigate further could result in significant works and costs in the future.

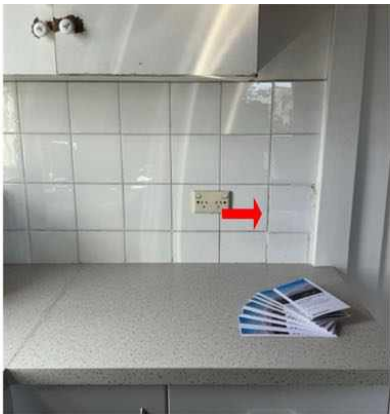
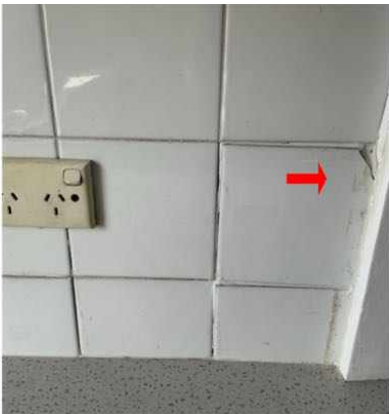
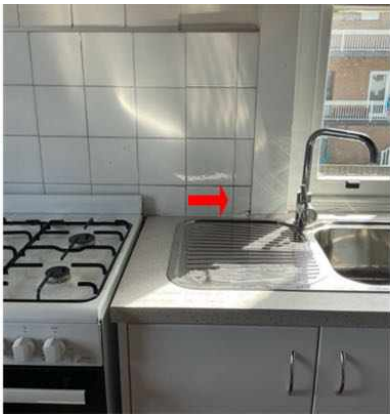
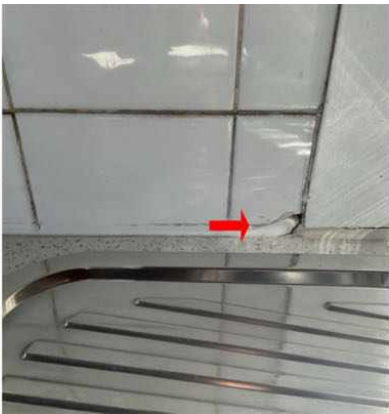
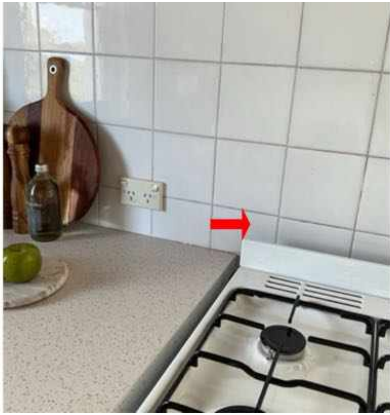
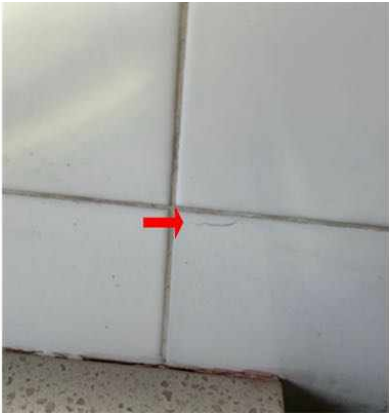
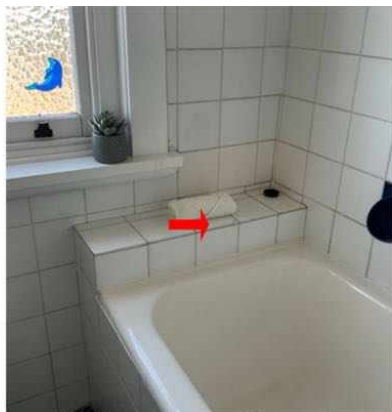
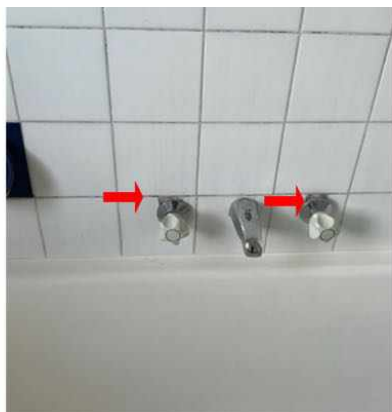
Finding 3.04

Building:	Main Building
Location:	All Internal Areas - Kitchen, Bathroom
Finding:	Tiles - Cracked or damaged
Information:	Cracking was evident to the tiling in this area at the time of inspection. While the cracking appears to be minor, this area is frequently exposed to water, allowing

If left unmanaged, water penetration to these areas may lead to subsequent water damage, which is likely necessitate repair work to affected building elements.

A tiling contractor should be appointed to ensure that no further water damage occurs. The re-application of silicone and grouting throughout remaining tile work is also advised, to further protect the area against water penetration.

Where water penetration has led to water damage, appointment of a relevant tradesperson may be required to repair damaged building elements.

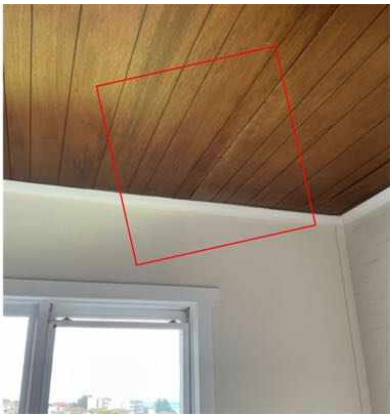
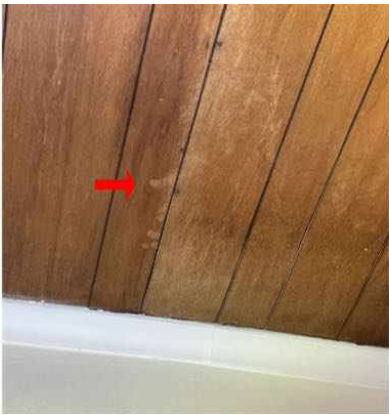
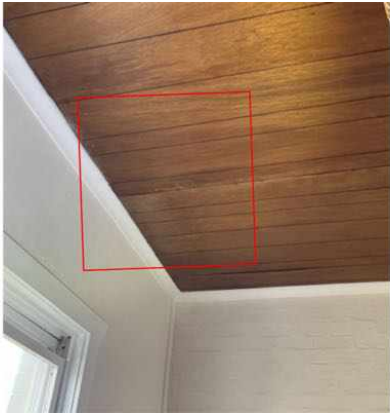
Finding 3.05

Building:	Main Building
Location:	All Internal Areas - Front stepped sitting
Finding:	Ceiling - Water damaged
Information:	Water damage to the ceiling lining is generally an indication of excessive moisture being present in the roof void, usually via a leak to the roof covering.

Where water damage is evident to the ceiling, the primary requirement is to identify and rectify the source of the leak. A roofing plumber should be appointed as soon as possible to identify the leak and perform rectification works as necessary, ensuring the water damage is restricted.

Once the leak is repaired, consultation with relevant tradespeople, including plasterers and painters, is advised. Rectification works may include replacement of ceiling lining or minor repainting, depending on the extent of the damage.

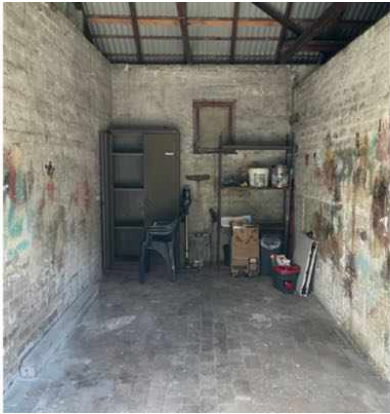
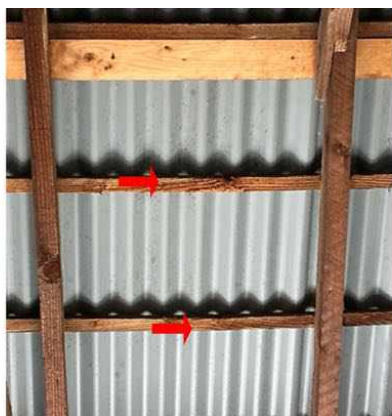
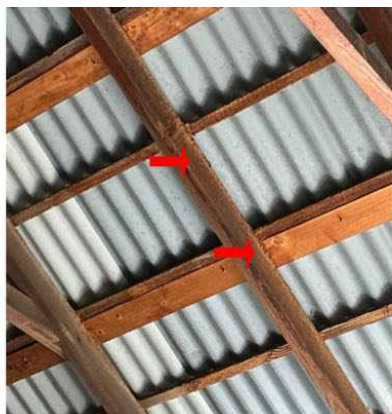
Finding 3.06

Building: Main Building
Location: Garage
Finding: Timber Delignification
Information: A section of roof framing timber was found to be deteriorated. The condition is consistent with delignification, a chemical breakdown of lignin caused by prolonged exposure to heat and moisture in the roof void. The affected timber should be assessed by a qualified carpenter for potential reinforcement or replacement. A further invasive inspection by a strata appointed licensed timber pest technician is also recommended.

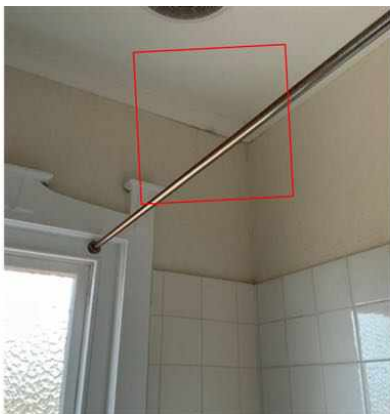
Finding 3.07

Finding: Water staining

Information: Water staining was evident in this area at the time of inspection. Water staining indicates that surfaces have been exposed to excessive moisture over time. The minerals and other elements in the water lead to staining, which may graduate to corrosion and deterioration if left unmanaged.

While mostly an appearance defect, water staining can be indicative of more serious defects, which may be currently concealed by other building elements.

Where water staining is active, a licensed plumber must be consulted to identify the cause of the staining and to provide advice on any reparation works that may be required. Replacement of any broken or damaged structures is advised.

Conversely, where water staining is old and inactive, affected building materials may be repaired or replaced at client discretion. A qualified carpenter or registered builder may be appointed to perform these works.

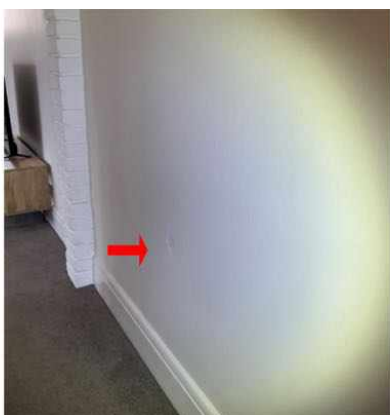
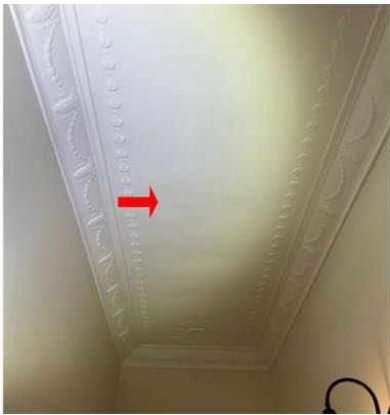
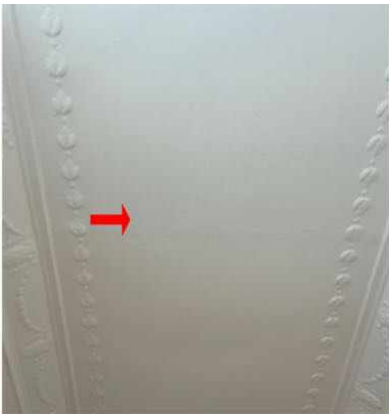
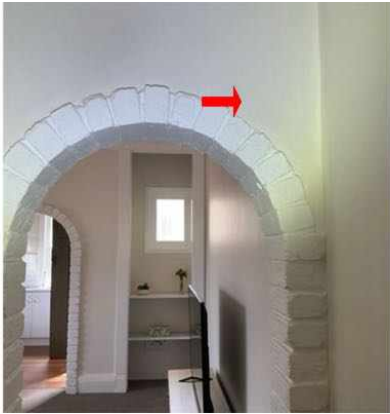
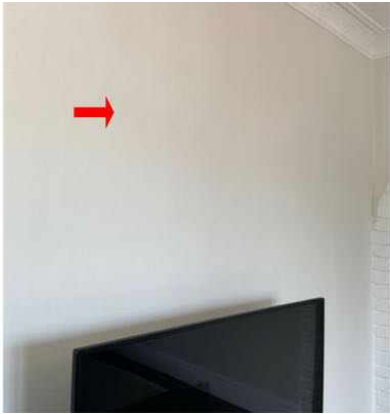
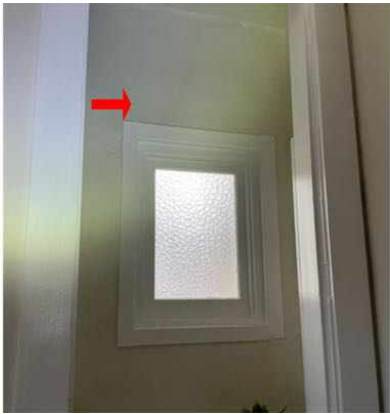
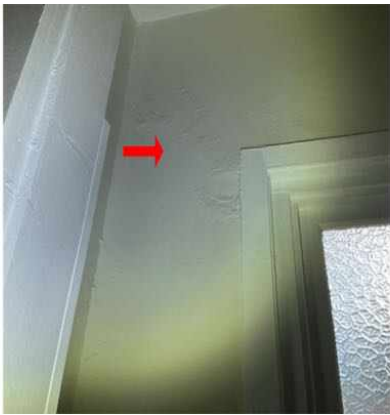
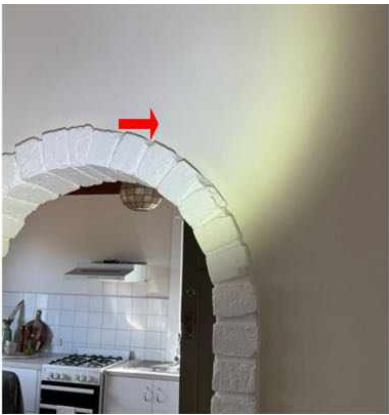
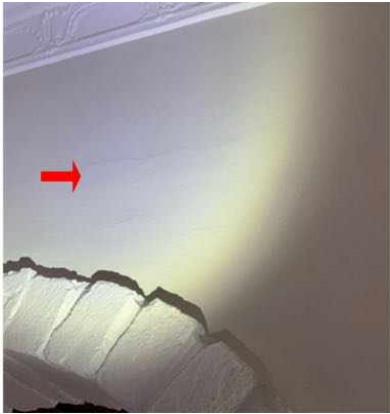
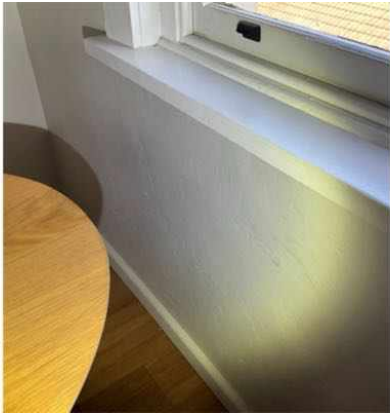
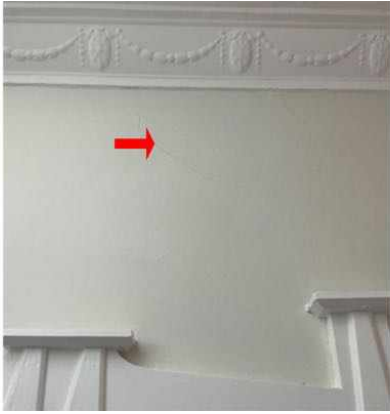
Finding 3.08

Building:	Main Building
Location:	All Internal Areas
Finding:	Paint finish and hairline cracking to some areas
Information:	The paint finish in this area was identified as being incomplete at the time of inspection including some hairline minor cracking.

Whilst incomplete or missing paint and minor cracking and imperfections in finish is generally an appearance defect, it can also lead to the development of secondary building defects over time. Incomplete areas of paint finish expose the area to moisture, potentially accelerating the deterioration of underlying building materials.

Incomplete paint finishes should be sanded back, filled, leveled and painted, as applicable. Where inadequate or missing paint protection has led to the deterioration of the associated building element, repair and/or replacement of this building element may be required.

A painting contractor should be appointed as soon as possible to perform necessary works to aid the appearance of the affected area and to ensure the area is protected against further deterioration. Alternatively, the homeowner following manufacturer instructions may perform these works.

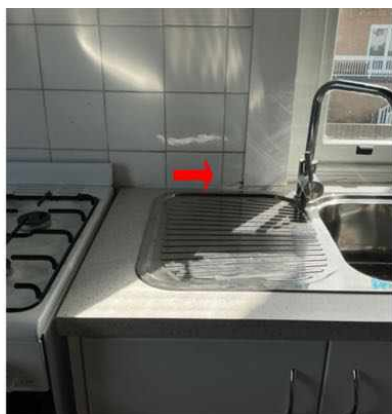
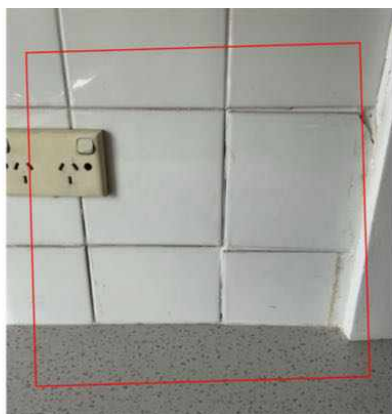
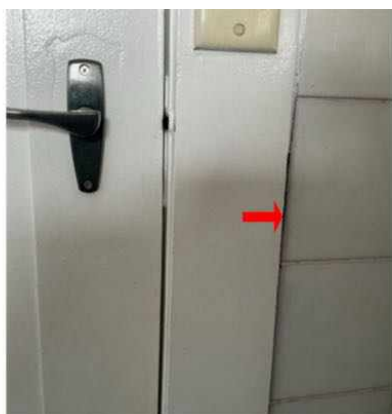
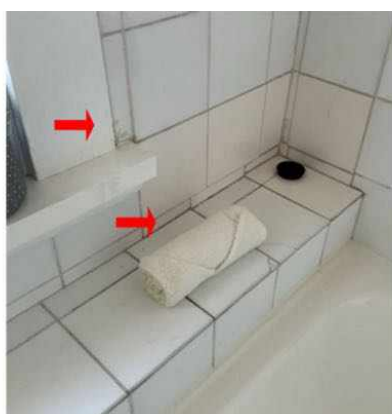
Finding 3.09

Building: Main Building
Location: All Internal Areas - Bathroom , Kitchen
Finding: Sealant and grouting - Missing or degraded to some areas
Information: It was noted on inspection that sealant or grout is degraded. There is also evidence of poor workmanship and excessive use of sealant. Silicone should never be used as a first line of defence against waterproofing. Further inspection by a licensed waterproofing contractor is highly recommended

Different materials and floor areas move at different rates, generally causing cracking to grout or sealant at this point. A flexible sealant is required to allow for expected expansion and contraction, while keeping the joint water tight and protective of all associated building materials.

There appears to be excessive mould to the sealant and grout which will likely require scraping out and replacement.

Flexible and mould resistant materials should be applied to affected areas to prevent any subsequent water damage that is likely to occur. Regular maintenance and replacement of damage or missing or damaged sealant and grout is highly recommended to the wet areas, as this is a regular wear and tear defect. Sealant and grouting in areas that come into regular contact with water should be maintained for the long term care of your property.

A sealant specialist or tiling contractor should be appointed to complete these works as soon as possible

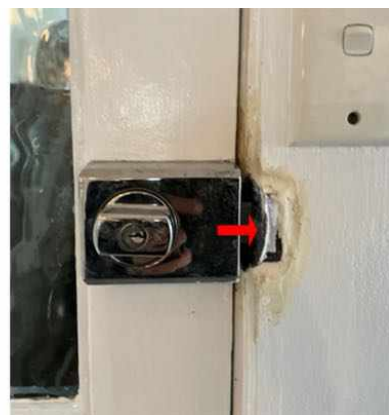
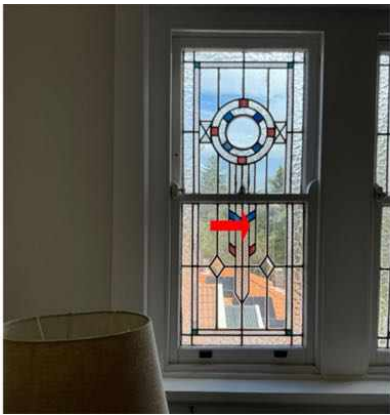
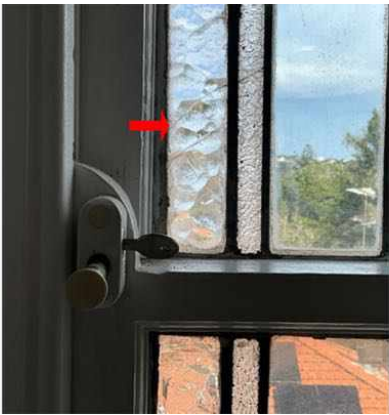
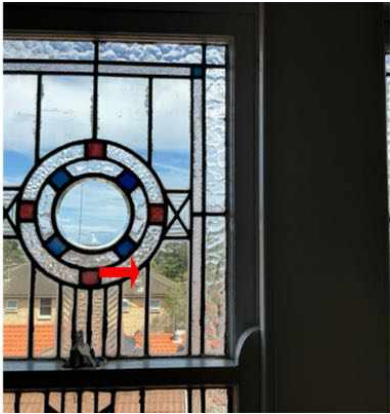
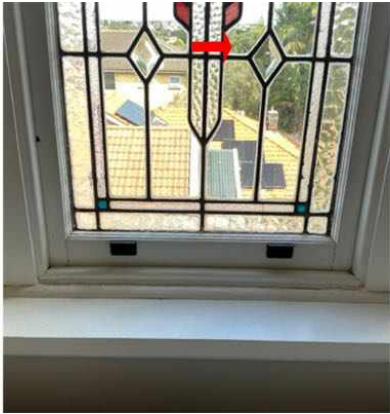
Building:	Main Building
Location:	All Internal Areas
Finding:	Building element - Damaged - excess silicone use front door , window glass cracked lounge
Information:	Breakage occurs generally when the building materials have either aged and decayed, or as a result of damage (accidental or deliberate).

Repair and/or replacement of broken elements is advised to ensure that additional secondary defects do not arise as a consequence. Such works are necessary, as all building elements play a key role in the operation and function of the overall structure and its performance.

A relevant tradesperson should be appointed to repair or replace the affected building element prior to any subsequent damage being caused.

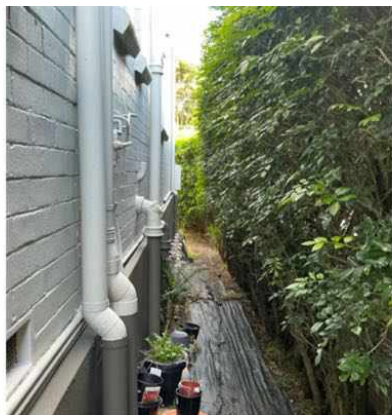
Finding 6.01

Building: Main Building
Location: All External Areas
Finding: Trees within 50m
Information: Trees within 50m of the property can be conducive to termite activity. It is recommended an invasive inspection of all trees within 50m to the property be carried out by a qualified pest control expert.
