## Building Inspection Report

Inspection Date: Thu, 9 Apr 2026

Property Address: 6 Elijah St, Morphett Vale SA 5162,  
Australia

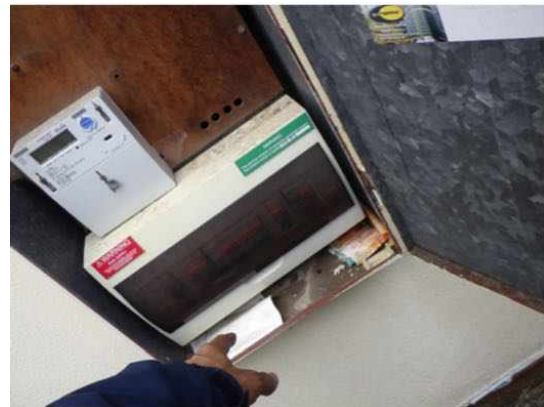
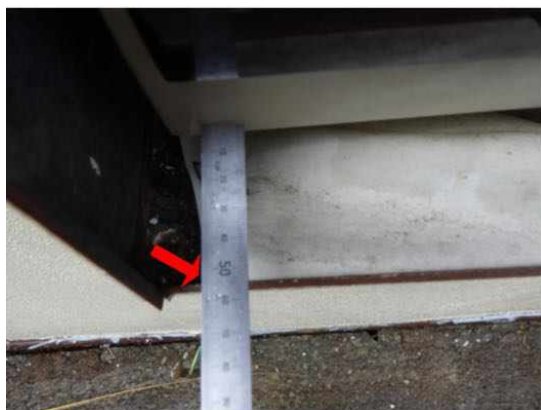
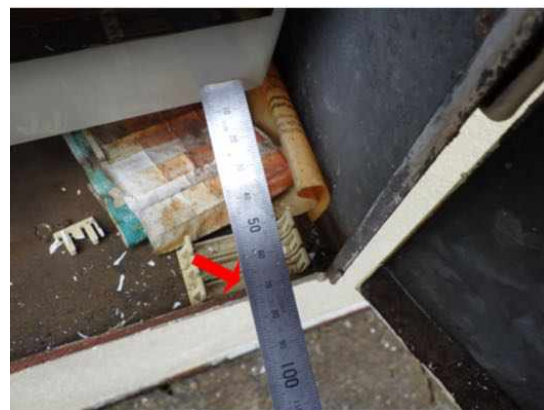
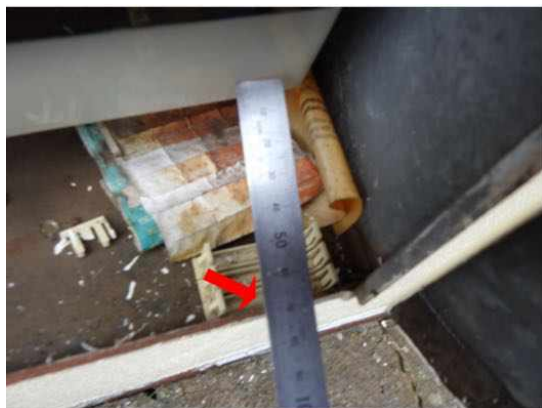
#### Defects 1.01

| Finding: | Electrical Backing Board - Broken/ Loose from its original fixing |
| Information: | The electrical backing board in this area was found to be broken/ loose from its original fixing at the time of inspection. Breakage occurs generally when the building materials have aged and decayed, but may also be indicative of impact damage to the building element (accidental or deliberate). |

Left unmanaged, the fitting is unlikely to cause further damage to surrounding building elements. However, the broken fitting does expose electrical works, and may create a safety hazard if there is potential contact with persons in the area.

Repair and/or replacement of the broken fitting is advised. A Licensed electrician should be appointed to repair/replace the fitting immediately.

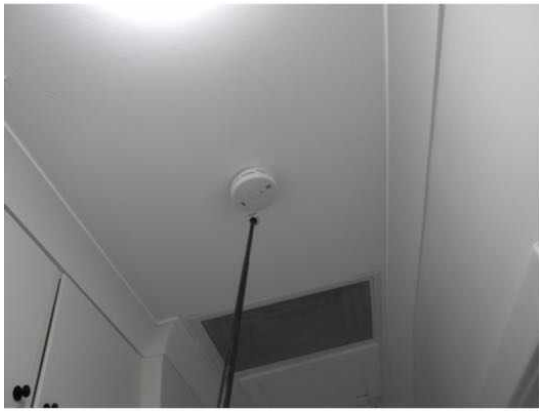
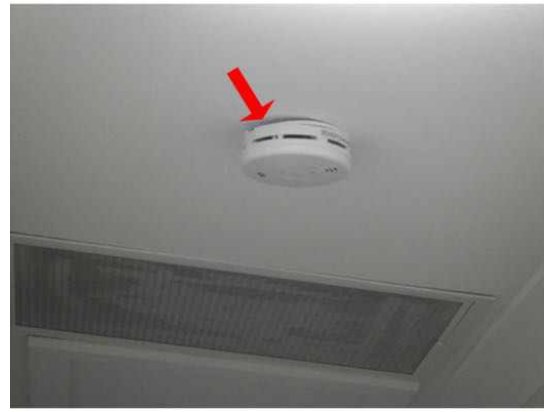
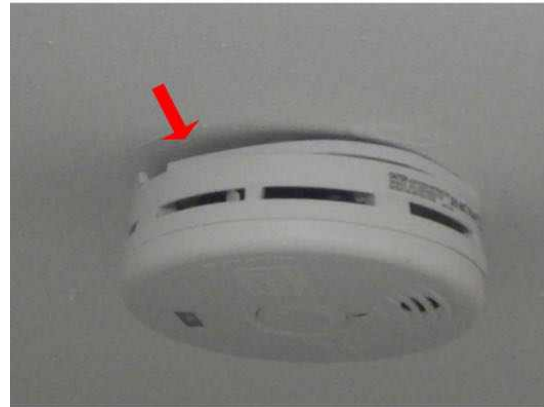
## Defects 1.02

| Finding: | Smoke Detectors and Alarms - Loose from its original fixing |
| Information: | At the time of inspection it was noticed that Smoke Detectors and Alarms - Loose from its original fixing and creating a potential safety hazards for the persons coming in contact in this area. |

Please note that this defect is highlighted as a caution only. We suspect, based on our experience in the building industry, that the absence of smoke detectors, or their poor condition, should be addressed as a matter of urgency to improve occupant safety.

Always ensure sufficient working and suitable smoke detectors are installed prior to occupying any building. Additionally, it is advised that all smoke detectors be tested by the homeowner on a monthly basis.

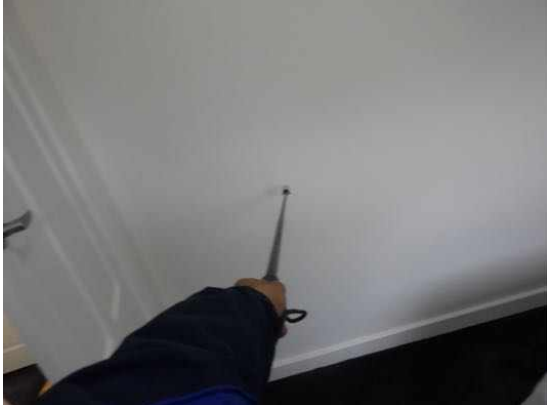
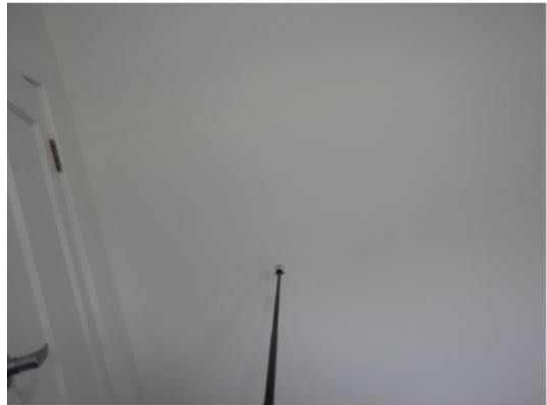
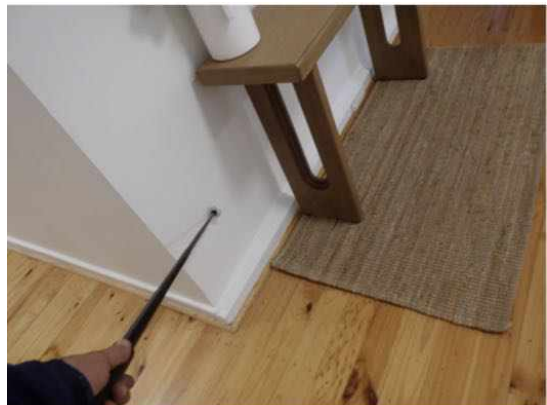
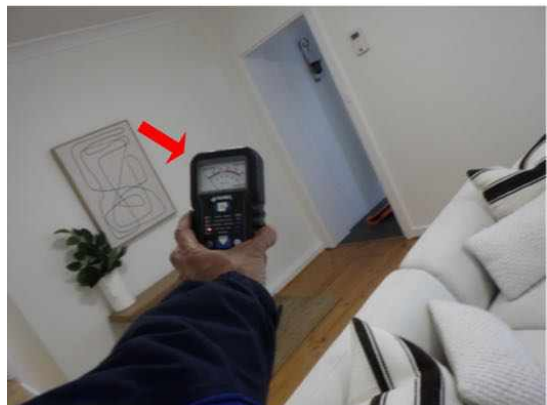
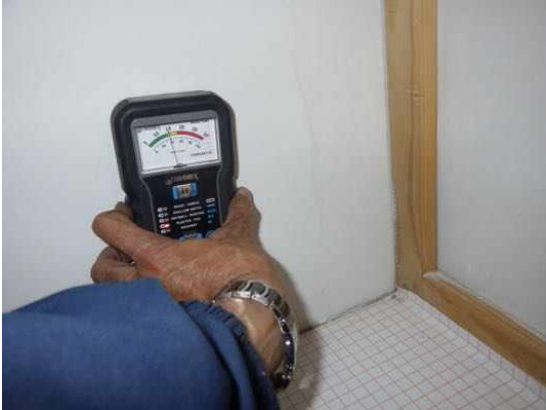
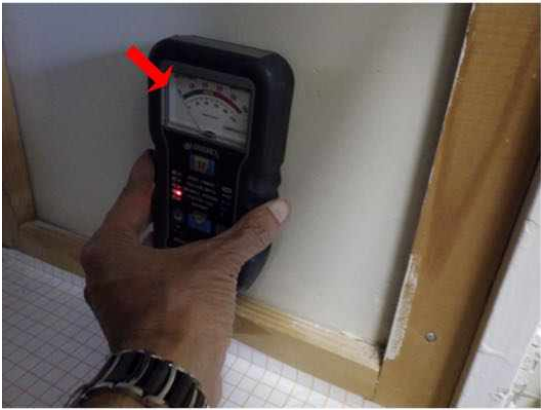
### Defects 2.01

Building: Building 1  
Location: All Internal Areas  
Finding: Internal walls - Damp  
Information: At the time of inspection it was noticed that high moisture reading to few sections of internal walls around the property.

structure of a building, either as the result of intrusion from outside, or condensation from within the structure. Generally, structural damp is caused by rain penetration, rising damp, and leaks from plumbing pipes.

Unmanaged damp facilitates the formation and development of mould, fungi growth and wood rot, decaying associated building materials and compromising their structural integrity. Damage to finishes is also likely to occur, including lifting, bubbling, peeling and staining of paint, plaster and wallpaper.

The first step in addressing damp is to diagnose the cause. The identified cause should be addressed first prior to repairing the appearance and other defects which have resulted from the rising damp. If the original cause is not resolved, further cases of damp are likely to ensue, resulting in secondary defects.

Consultation with a qualified plumber is advised immediately to identify the cause of damp and perform remedial works as required. Where excessive mould growth is present, further inspection by a specialist environmental health inspector should also be considered.

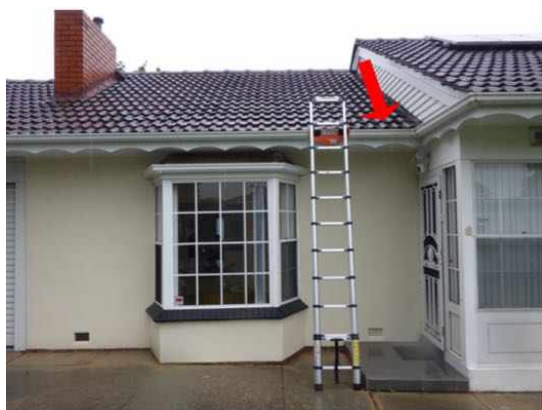
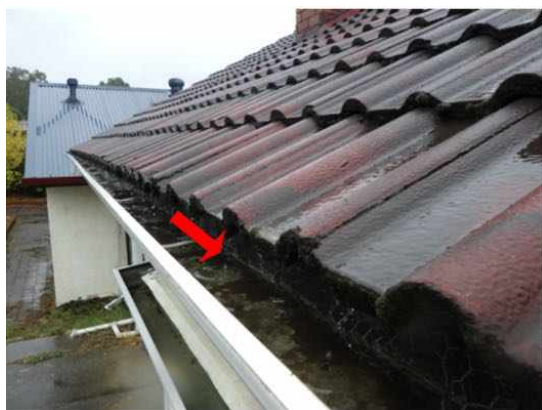
### Defects 3.01

Blocked gutters are likely to lead to high levels of moisture in the affected areas. Such moisture will not only cause rust and decay of the associated building materials, but can also provide conditions that are conducive to termite and timber pest activity. Blockages in gutters should therefore be removed immediately to ensure dry conditions are maintained.

Consult a Licensed Plumber for further specific advice on remedial works that may be required. In the interim, it is highly advised that blocked gutters be removed by the homeowner or a general handyperson as a matter of urgency.

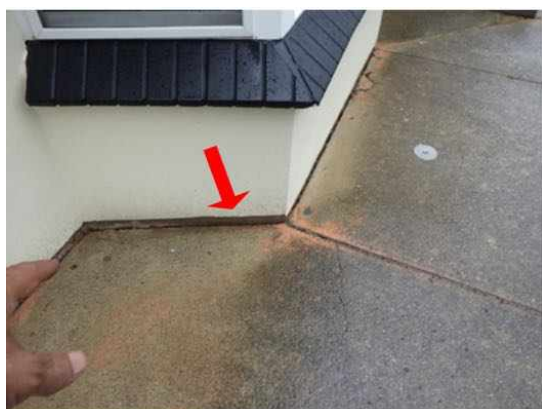
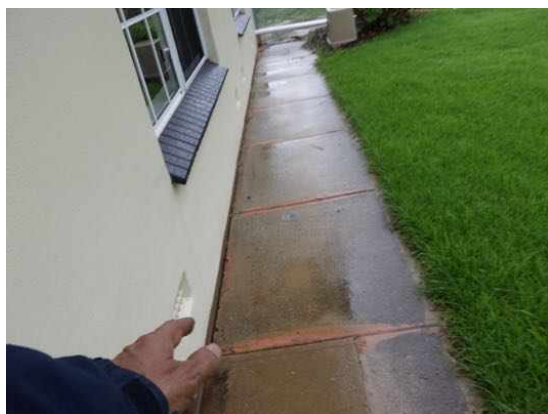
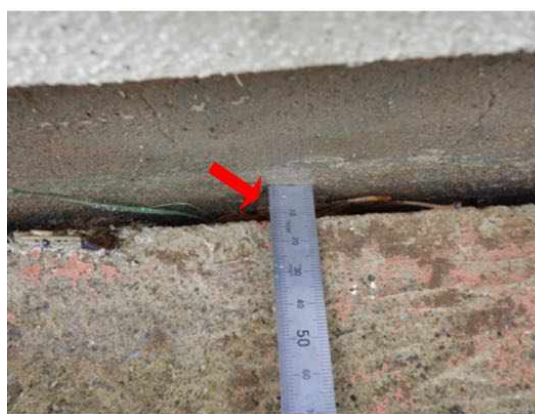
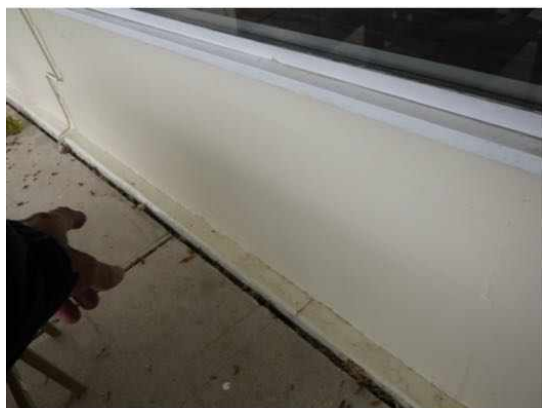
## Defects 3.02

| Information: | Gaps in the external concrete paving were identified at the time of inspection. Gaps in the slab are significant and are likely to lead to the development of secondary defects if left unmanaged, such as the creation of a trip hazard and water entry points. |

With reactive clay soils, it is extremely important to ensure that all stormwater flows including roof and ground flows, contained and continually maintained. High moisture also creates an environment that is conducive to termite attack.

A licensed Plumber should be appointed immediately to ensure that the stormwater pipework is intact and adequate, and all gaps to concrete, driveways and paths should be sealed by a licensed builder or a general handy person to keep moisture from entering.

A licensed concretor may be required to replace pavements that are beyond repair.

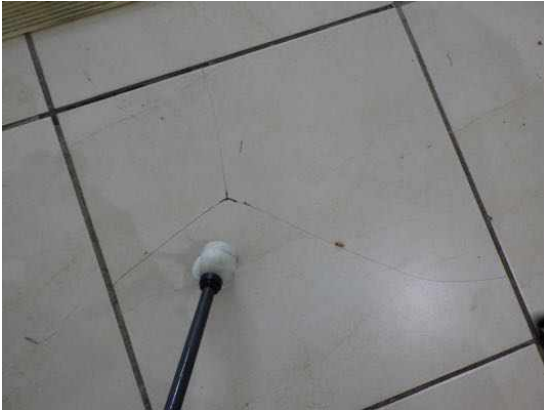
### Defects 3.03

| Finding: | Tiles - Cracked or damaged |
| Information: | Cracking was evident to the tiling in this entry & kitchen area at the time of inspection. While the cracking appears to be minor, this area is frequently exposed to water, allowing potential for water penetration into adjoining sections of walls or flooring. |

If left unmanaged, water penetration to these areas may lead to subsequent water damage, which is likely necessitate repair work to affected building elements.

A tiling contractor should be appointed to ensure that no further water damage occurs. The re-application of silicone and grouting throughout remaining tile work is also advised, to further protect the area against water penetration.

Where water penetration has led to water damage, appointment of a relevant tradesperson may be required to repair damaged building elements.

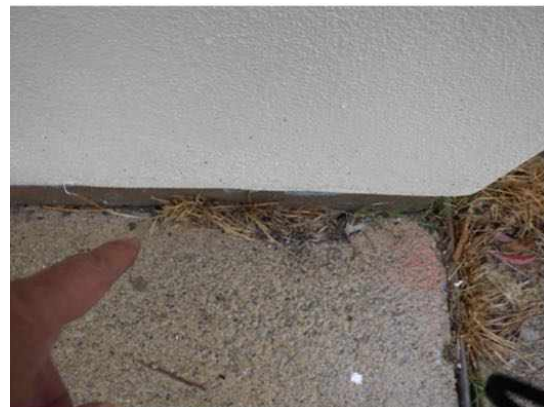
Defects 3.04

Building: Building 1  
 Location: All External Areas  
 Finding: Bridging - Vegetation  
 Information: Where vegetation obstructs inspection of building elements, also known as bridging as it provides a bridging point for the access of termites, full inspection can not be achieved. Consequently moisture or dampness may be present and the areas becomes conducive to termite activity. Plants against or very close to buildings provide cover, shade and can provide an environment that is attractive to termite infestation.

The removal and replanting of species that do not provide "cover" or cutting back of existing vegetation will assist greatly in preventing Bridging from occurring.

The removal of any such materials that may be conducive to termite activity should be carried out as soon as possible and arrange re inspection to minimize the risk of termite attack.

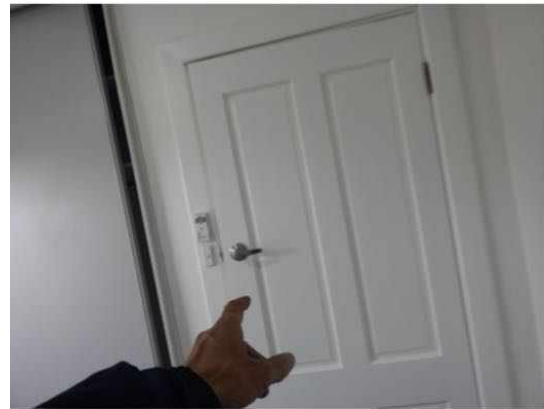
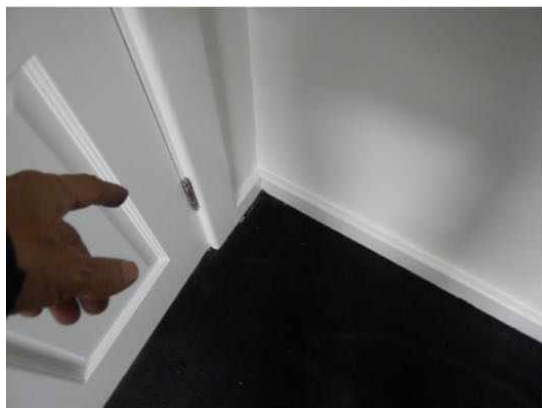
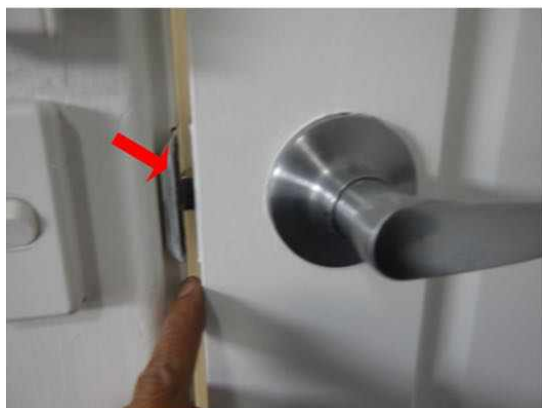
### Defects 3.05

Building: Building 1  
 Location: All Internal Areas  
 Finding: Door - Binding/jamming  
 Information: Binding and/or jamming of this bedroom door is evident during standard operation.

This defect inhibits the functionality of the affected door as well as creating potential for secondary defects to associated building elements, such as damage to the floor covering.

A door that binds to flooring or to the associated door frame may have several causes, ranging from minor defects, such as poor installation of the door or deteriorated hinges, through to major structural issues, such as damage to subfloor structures.

Where door binding/jamming appears to indicate major structural issues, a registered builder specialising in re-stumping should be appointed to provide an estimate on the cost of rectification.

For minor causes, a qualified carpenter or general handyman should be appointed to perform minor rectification works at client discretion.

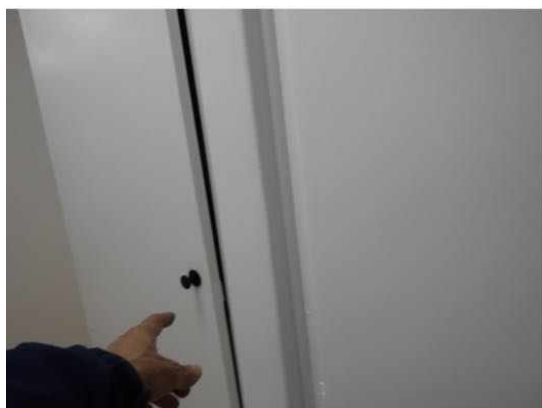
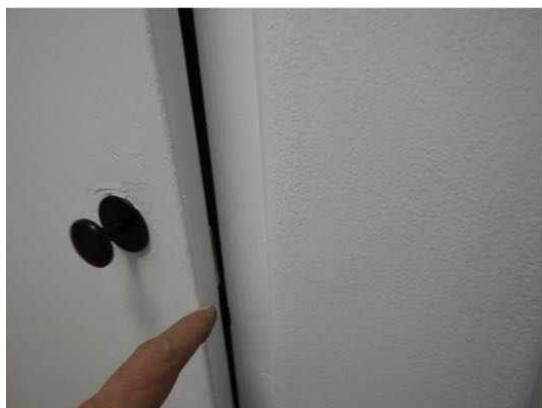
### Defects 3.06

| Information: | It was noted that the cabinet door in this area was not latching during operation at the time of inspection. Whilst detracting from the functionality of this building element, this minor defect may also be a security risk, and may therefore have serious implications if left unattended. |

It is suspected that this defect has occurred due to minor issues with the associated hinges. Such damage is identified as general wear and tear, which is expected for building elements of this age.

A qualified carpenter or general handyperson may be appointed to perform rectification works as necessary, at client discretion. If left unattended, further functional impairment is likely to occur.

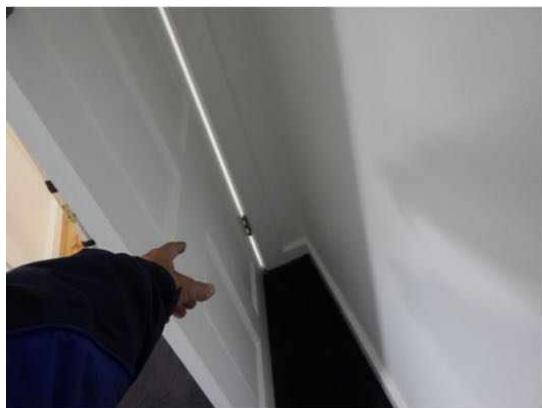
### Defects 3.07

| Finding: | Door stop - Missing |
| Information: | The door stop is missing or is inadequate to stop the door handle from damaging the wall. Although some building elements may seem irrelevant or unnecessary, all building elements play a key role in the operation and function of the overall structure and its performance. |

Re-installation or replacement of the door stop is advised as soon as possible to prevent any subsequent damage to the door or associated structures. A general handyman may be appointed to perform these works at client discretion.

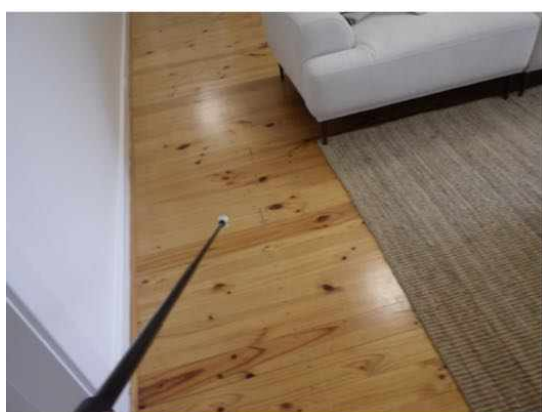
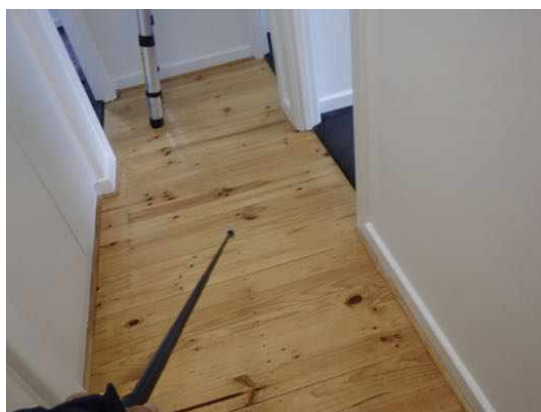
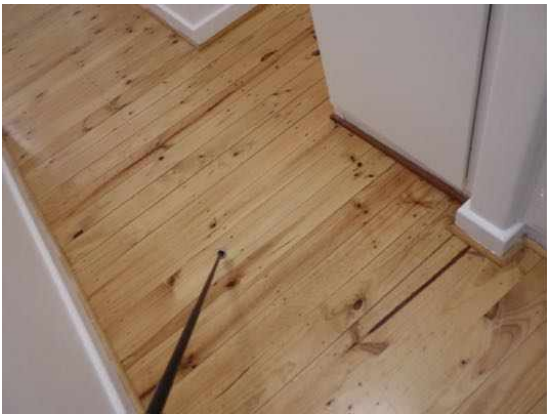
### Defects 3.08

Bouncy floors generally indicate that the floorboards or the subfloor structures are coming loose from the joists that they are installed on. Bouncy flooring may also be the result of gaps between flooring and stumps or joist structures, which require packing.

The client is advised to seek quotations for required repairs from a Registered Builder specialising in re-stumping. The potential resolution may range from packing gaps in subfloor structures through to replacement of subfloors stumps and refixing of flooring.

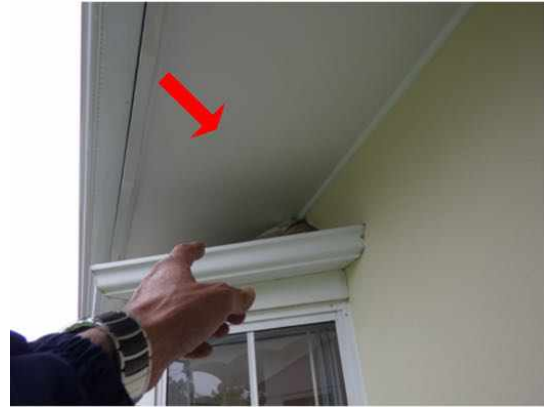
Building: Building 1  
Location: All External Areas  
Finding: Asbestos - Suspected ACM Identified on Site  
Information: Reporting on Asbestos is outside the Scope of this Report. This suspected defect is highlighted as a caution only. We suspect, based on our experience in the building industry, that there is a higher risk of the identified building element containing asbestos.

As Asbestos Reporting is outside the scope of this report, we advise that you consider a separate Asbestos Inspection and Condition Audit, which can include the taking of samples for definitive confirmation of the presence of Asbestos.

In the interim, the client is advised to act with caution, especially when considering any damage to building materials general wear and tear renovations extensions demolition and general maintenance activities due to the suspected presence of Asbestos.
