Building and Timber Pest Inspection Report

Inspection Date: Thu, 8 Jan 2026

Property Address: 33 Paynters Pocket Ave, Palmwoods QLD
4555, Australia

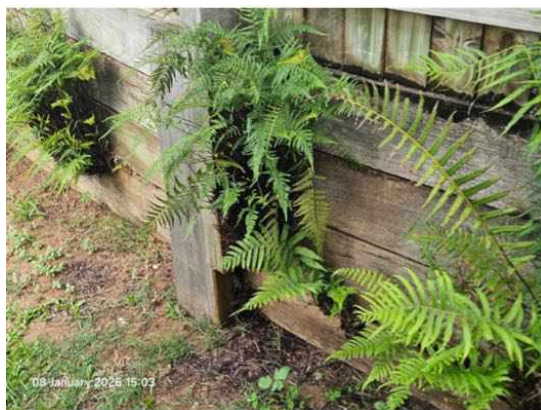
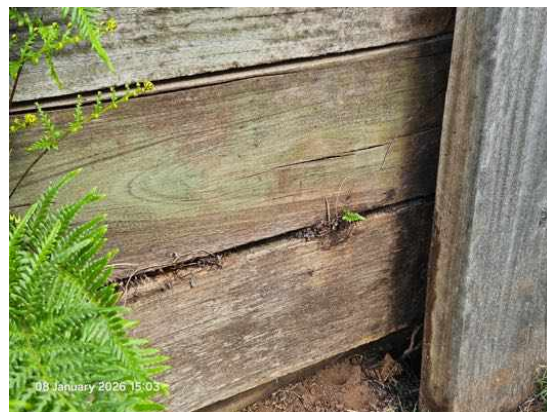
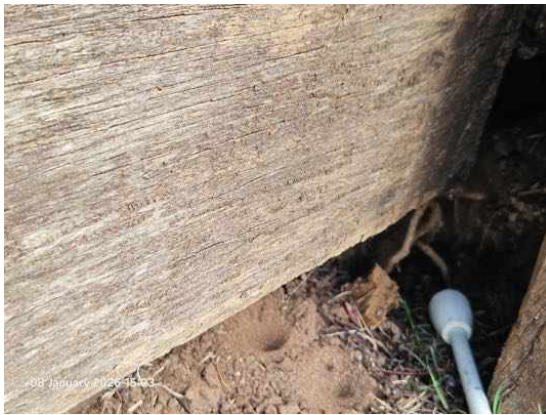
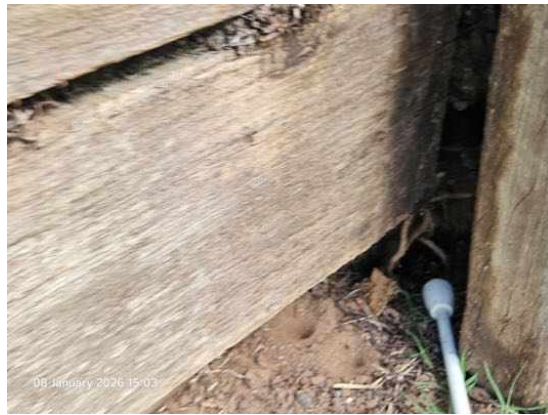
Finding 2.01

Building: Yard
Location: Right boundary
Finding: Retaining wall - Defective
Information: The retaining wall at the right boundary was found to be defective at the time of inspection. Generally, defective retaining walls are caused by poor original design or material use. However, deteriorated retaining walls may also be a result of substandard construction, poor site drainage or unmanaged stormwater flows.

If left unmanaged, the retaining wall may become a safety hazard if it continues to destabilise. Where retaining walls further rot and decay, an environment is created that is conducive to termite and pest infestation.

Significant repair and replacement may be required in the short term. Where retaining walls are considered structural walls, a structural engineer / surveyor should be consulted regarding required remedial works. Otherwise, a landscaper or retaining wall installer may be appointed to repair or replace the wall, at the discretion of the client.

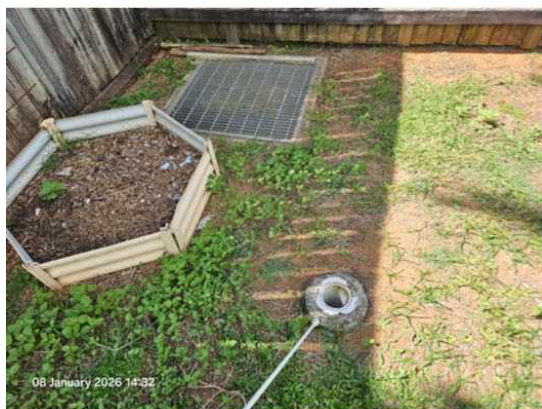
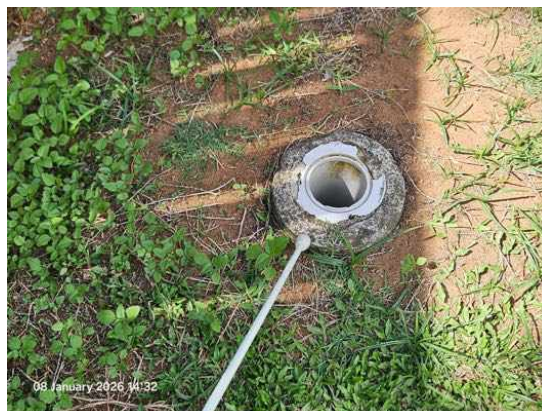
Finding 3.01

Building: Yard
 Location: Rear
 Finding: Sewer access cap - Broken
 Information: During the inspection it was noted that the cap to the sewer clear out in the rear yard was broken.

A licensed plumber could be engaged to exchange it.

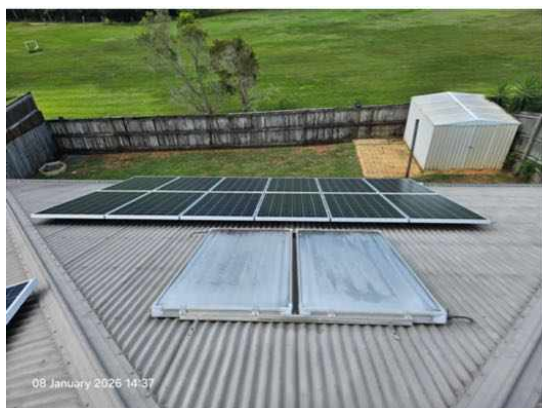
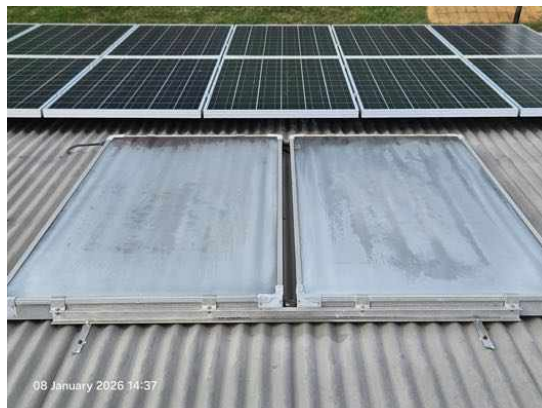
Finding 3.02

Building: Main Building
 Location: As shown
 Finding: Solar hot water unit - panel dirty.
 Information: The solar hot water unit shows evidence of general deterioration. The solar panels are in need of cleaning to maintain optimal operational efficiency.

A suitably qualified contractor could be engaged to effect any maintenance required.

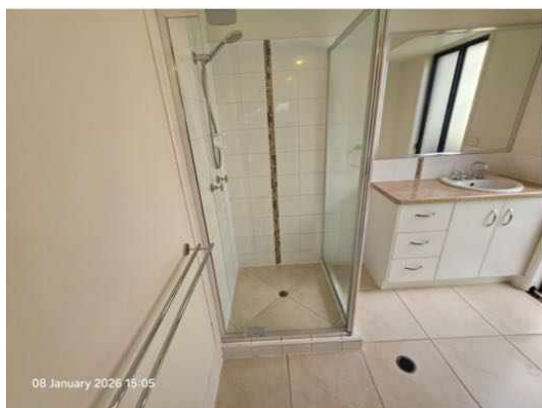
Finding 3.03

Building: Main Building
Location: Ensuite - Master
Finding: Elevated moisture present - ensuite shower
Information: Elevated moisture was noted in the tiled wall surfaces of the ensuite shower.

The levels varied at differing points throughout the recess. This could possibly be due to deteriorated grout and silicone sealants and / or plumbing fittings and fixtures. The grouts and sealants can break down over time and become porous, allowing moisture to enter the wall sheet surface behind the tiles. Some scouring and wear was noted in the grout joints.

Elevated moisture can attract timber pests and vermin, and produce conditions that promote timber pest attack, fungal growth and wood decay.

The moisture readings in the ensuite shower recess are limited to the lower courses of tiles, which can usually indicate grout and silicone degradation.

It is recommended that the moisture levels in these areas be monitored over time and the grout and silicone could be renewed to possibly eliminate any further moisture penetration.

A licensed tiler and / or sealant specialist could be engaged to renew these elements.

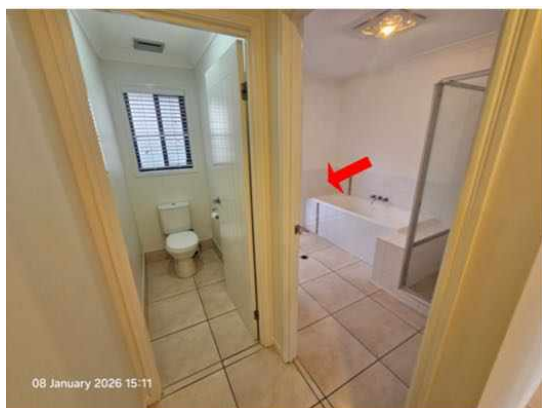
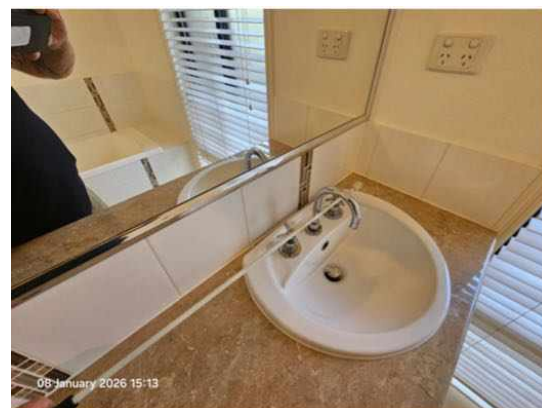
Finding 3.05

Building: Main Building
 Location: Bathroom
 Finding: Tapware - service required
 Information: On the day of inspection the taps of the bathroom vanity basin were shown to be stiff to operate and will require servicing.

It would be beneficial to have a licensed plumber inspect the taps and repair or replace accordingly.

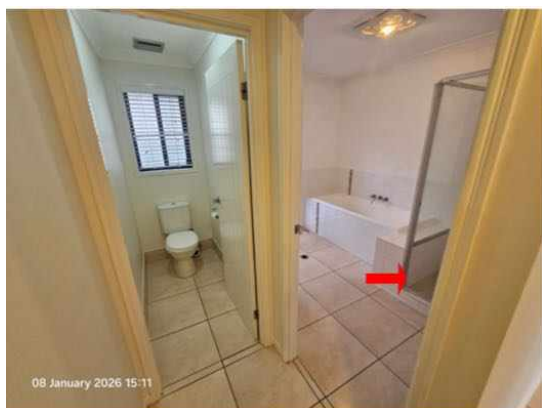
Finding 3.06

Building: Main Building
 Location: Bathroom
 Finding: Tiles - Drummy
 Information: Drummy tiles were identified in the shower recess at the time of inspection. Please see the attached photos for locations.

The term 'drummy' refers to tiles that have become detached from their fixing, despite otherwise being in relatively good condition. Such defects are generally caused by physical or moisture damage to the area. Drummy tiled areas may also be a direct result of poor workmanship during the construction process.

Tiled areas may swell and shrink with changes in air humidity if the area has sustained moisture damage. Any exposure to moisture is capable of causing tiled areas to become drummy and/or cracked over a prolonged period of time. Drummy tiled areas generally require removal and replacement of affected tiles.

Specialist trades are available for these types of services. A licensed builder may be required to undertake works if damage is extensive or if secondary building defects have resulted. Otherwise, it is advised that a tiling contractor or a tile adhesive injection service may be appointed to perform works as necessary.

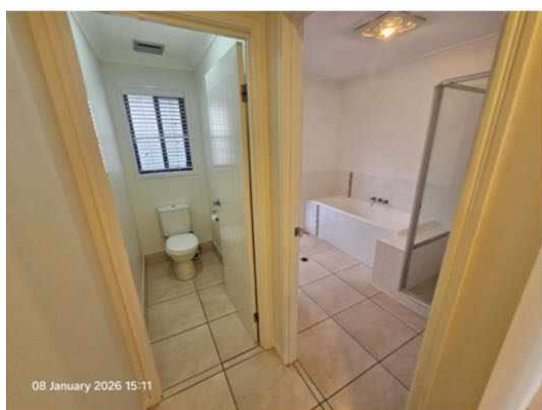
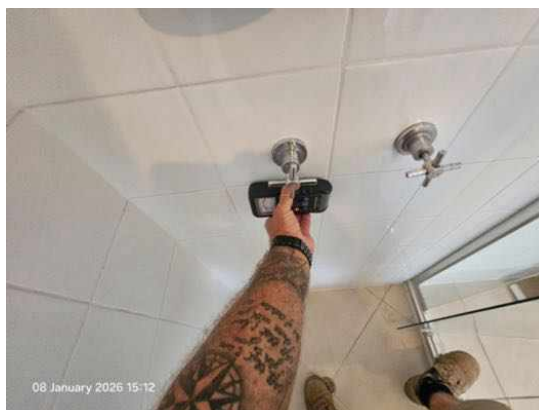
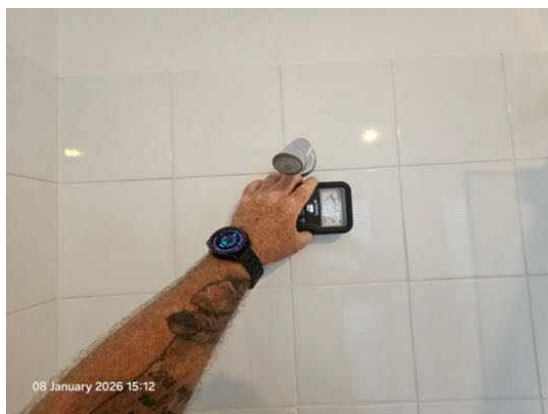
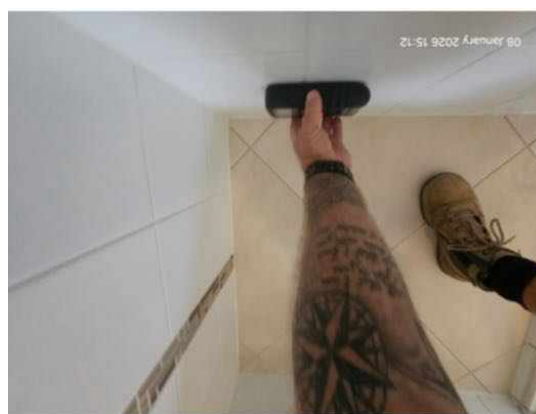
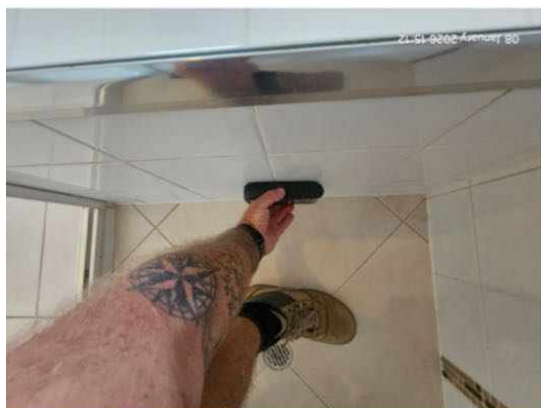
Finding 3.07

Building:	Main Building
Location:	Bathroom
Finding:	No moisture detected in bathroom
Information:	On the day of inspection the shower in the bathroom was measured for moisture using a "Tramex" moisture meter. During this inspection no moisture was detected in these areas and the tiled / sheeted surfaces appear to be in good order.

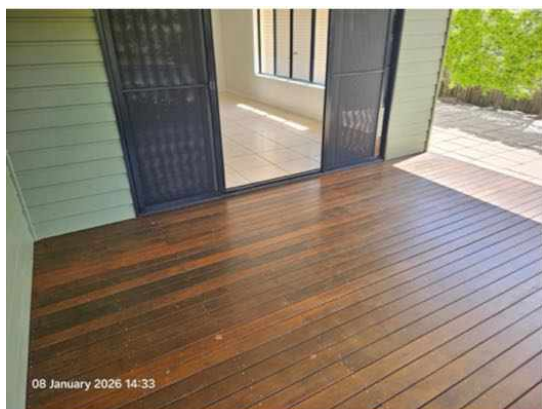
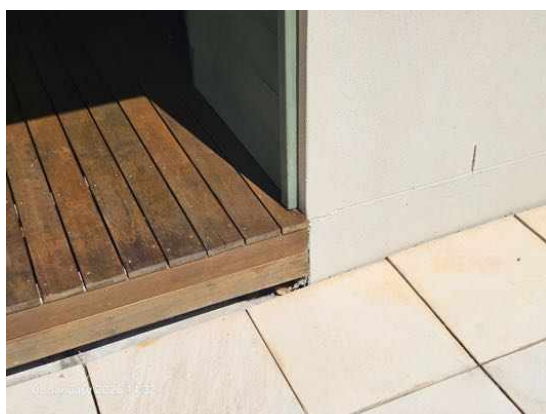
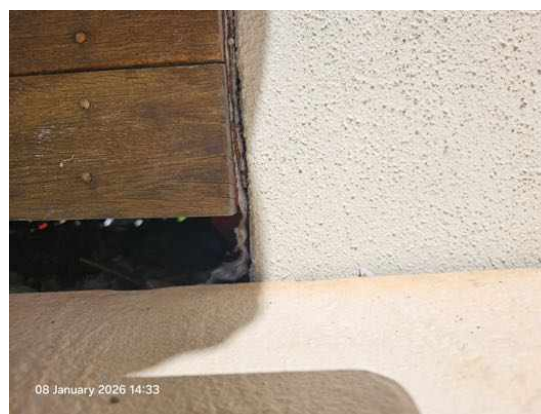
Finding 6.01

Where the slab edge cannot be properly inspected, there is a high risk of termite attack. It is usually recommended that termite or timber pest inspections be carried out every 6-12 months to aid protection of the property against infestation.

If the deck or structure is close to the ground and cannot be inspected visually from under the structure, more regular inspection should be considered.

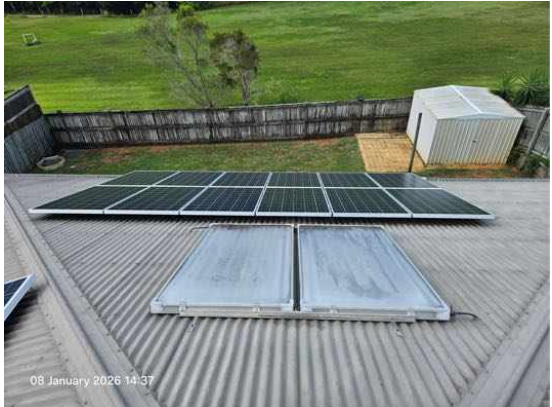
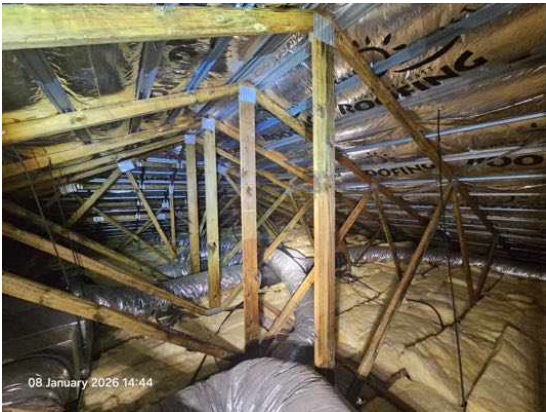
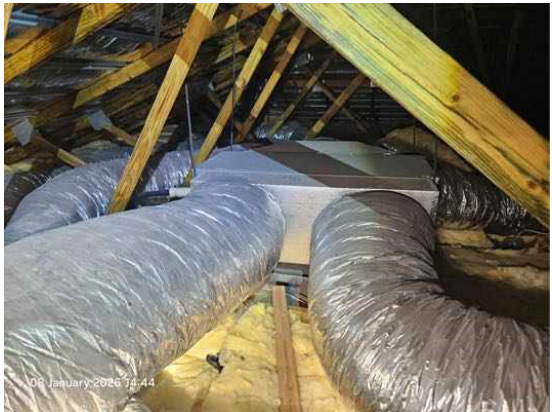
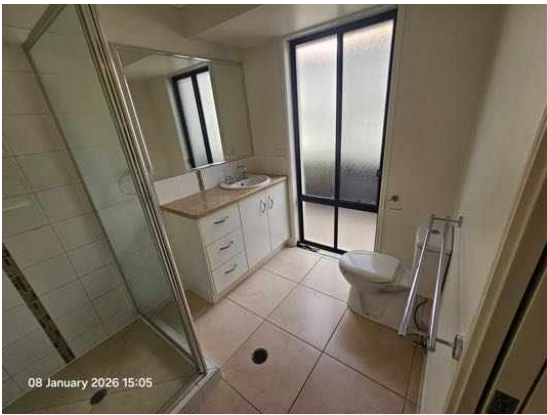
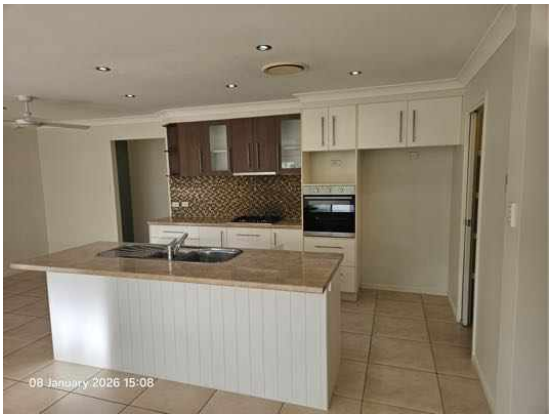
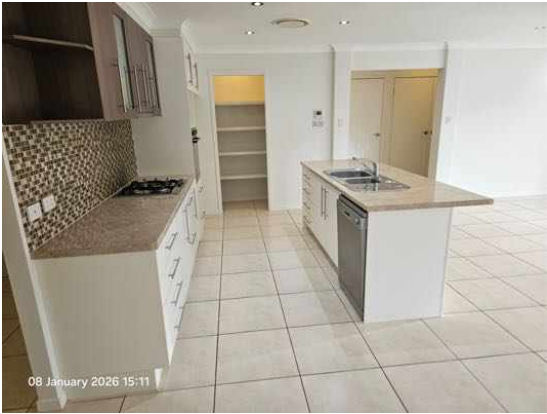
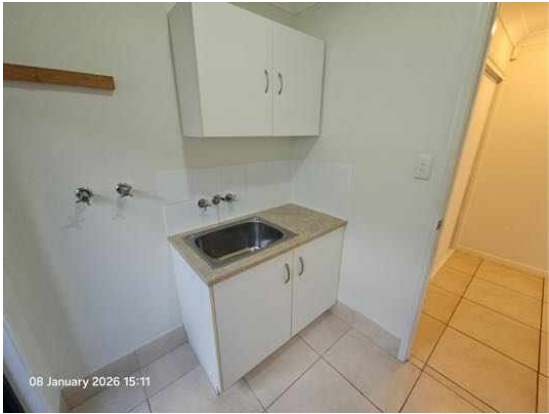
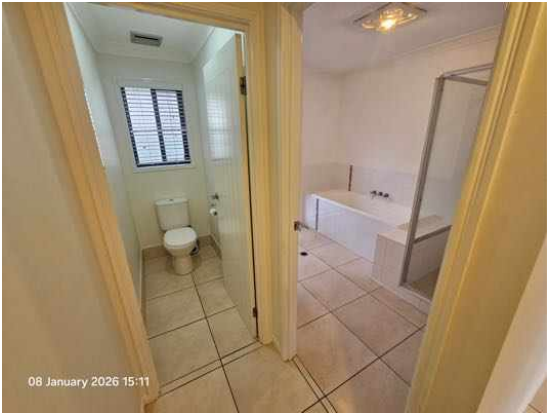
Building: Main Building
 Location: All Areas
 Finding: Additional Photos - Obstructions and Limitations
 Information: These photographs are an indication of the obstructions and limitations which impeded full inspection of the property at the time of inspection. These obstructions can prevent full inspections of the areas shown.

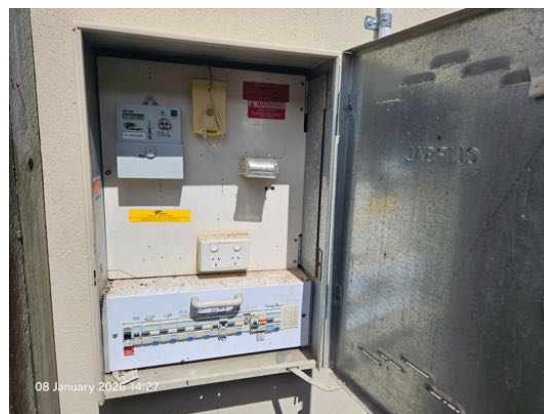
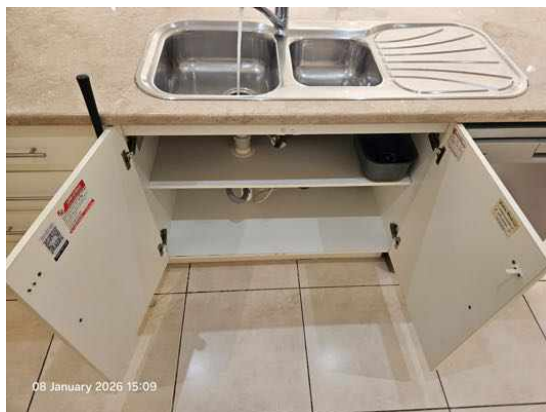
Building:	Main Building
Location:	Meter box, kitchen cupboard
Finding:	Durable pest inspection notice - not assessable
Information:	On the day of inspection it was noted that the durable timber pest inspection / treatment notice was missing, not visible or out of date. These notices / stickers are to verify the timber pest inspection dates, the inspector, the currency and type of timber pest system / barrier in place or being used in and around the property.

Annual, or more regular, inspections are crucial in maintaining and managing the properties timber pest risk profile. By not having regular inspections of the property raises the properties risk of undetected defects and damage. Without regular inspection at intervals of not greater than annually the buildings risk profile will categorised as high. Properties with trees within 50m and with gardens close to the building are at greater risk and will have a high risk profile.

It is recommend that a licensed timber pest controller be contacted to assess the properties needs and provide costings for an annual inspection programme.

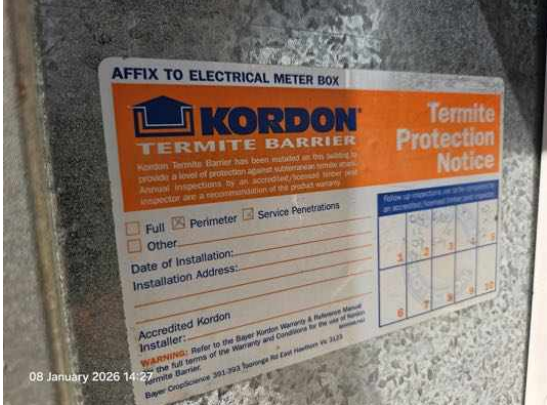
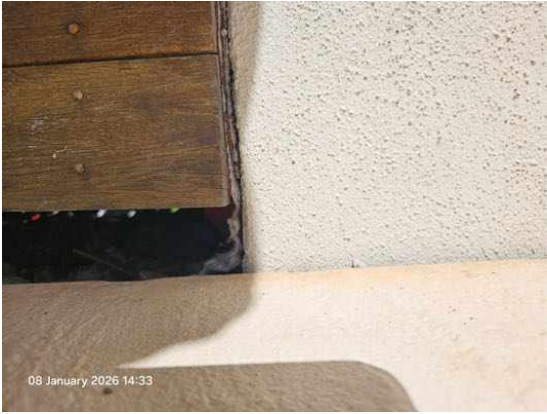
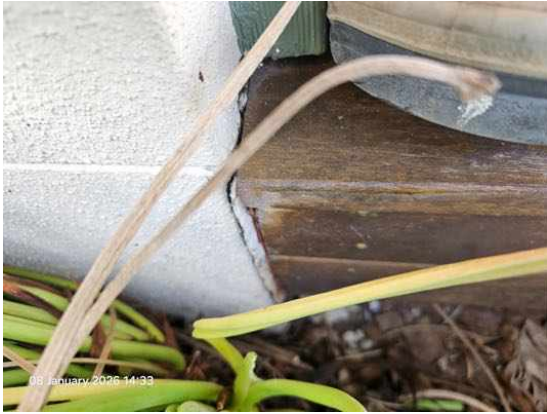
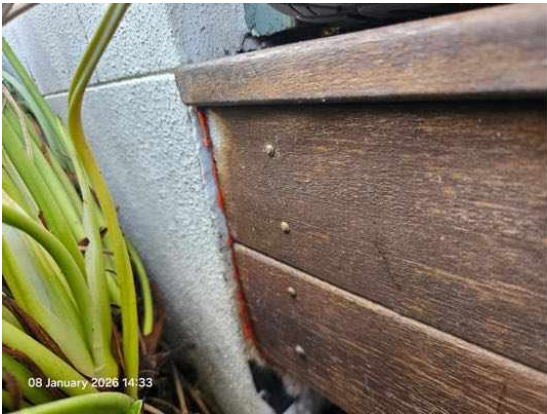
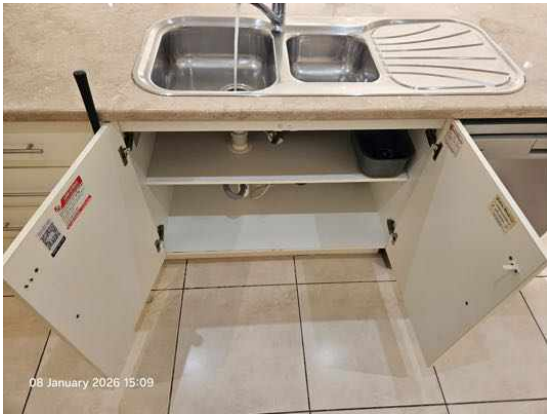
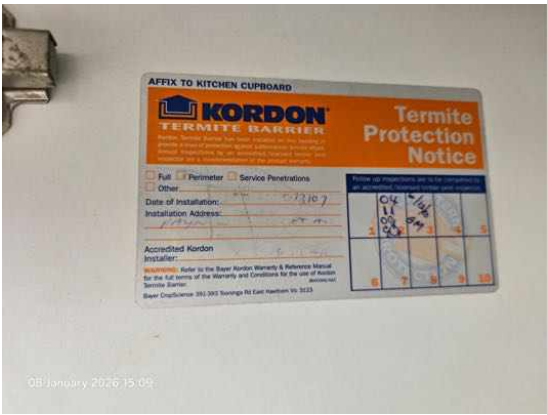
The building employs a physical barrier system to the perimeter and slab penetrations. In order for a barrier system to be effective, the property must have regular inspections at intervals of not greater than 12 months. Depending on the risk profile attributed to the property, these inspections may be recommended at lesser time periods.
