# Building and Timber Pest Inspection Report

Inspection Date: Tue, 31 Mar 2026

Property Address: 14 Selwyn Ave, Cambridge Gardens NSW  
2747, Australia

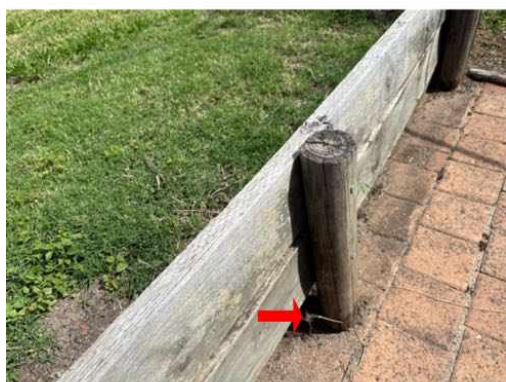
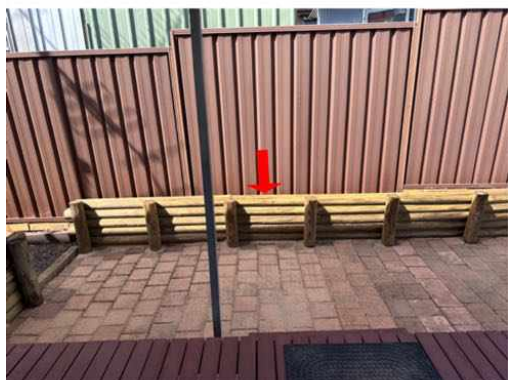
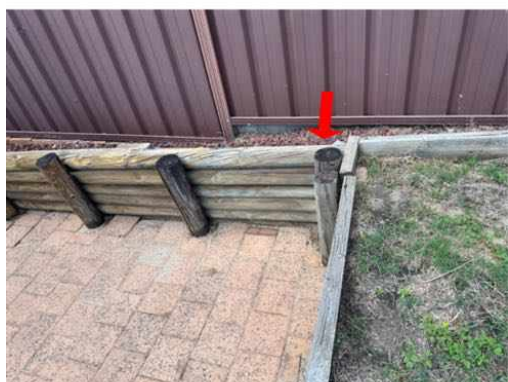
Building: Yard  
Location: Yard - Back > Rear Left  
Finding: Retaining wall - Defective  
Information: The retaining wall in this area was found to be defective at the time of inspection. Generally, defective retaining walls are caused by poor original design or material use. However, deteriorated retaining walls may also be a result of substandard construction, poor site drainage or unmanaged stormwater flows.

If left unmanaged, the retaining wall may become a safety hazard if it continues to destabilise. Where retaining walls further rot and decay, an environment is created that is conducive to termite and pest infestation.

Significant repair and replacement should be expected. Where retaining walls are considered structural walls, a structural engineer / surveyor should be consulted regarding required remedial works. Otherwise, a landscaper or retaining wall installer may be appointed to repair or replace the wall, at the discretion of the client.

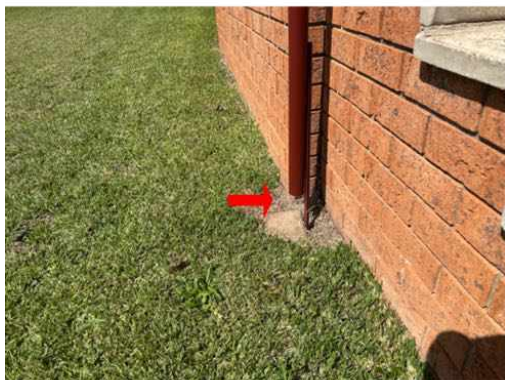
### Finding 3.02

Building:	Main Building
Location:	Front Elevation > Centre
Finding:	Roof plumbing - Missing
Information:	Some sections of the roof are not adequately drained via gutters and downpipes. Gutters and downpipes that are not installed adequately are likely to result in excessively damp conditions against the exterior surfaces and around the base perimeter of the building.

Excessive moisture creates an environment which accelerates the deterioration of building elements in the area, as well as being conducive to termite and pest infestation. Such an environment is likely to necessitate repair and/or replacement of building elements, which are prone to sustaining wood rot, rust or corrosion.

A roofing plumber should be appointed as soon as possible to install relevant roof plumbing materials. Depending on the extent of the damage, repair and/or replacement of damaged building elements may be required.

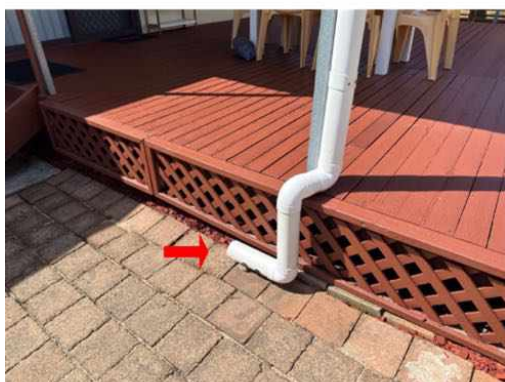
### Finding 3.03

Building:	Main Building
Location:	Deck > Rear Left
Finding:	Roof plumbing - Missing
Information:	Some sections of the roof are not adequately drained via gutters and downpipes. Gutters and downpipes that are not installed adequately are likely to result in excessively damp conditions against the exterior surfaces and around the base perimeter of the building.

Excessive moisture creates an environment which accelerates the deterioration of building elements in the area, as well as being conducive to termite and pest infestation. Such an environment is likely to necessitate repair and/or replacement of building elements, which are prone to sustaining wood rot, rust or corrosion.

A roofing plumber should be appointed as soon as possible to install relevant roof plumbing materials. Depending on the extent of the damage, repair and/or replacement of damaged building elements may be required.

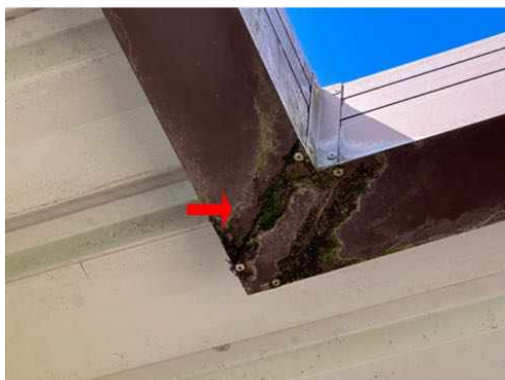
**Finding 3.04**

Building: Main Building  
 Location: Roof Exterior > Centre,Rear  
 Finding: Roof plumbing - leaking.  
 Information: Some sections of the roof are not adequately drained via gutters and downpipes. Gutters and downpipes that are not installed adequately are likely to result in excessively damp conditions against the exterior surfaces and around the base perimeter of the building.

Excessive moisture creates an environment which accelerates the deterioration of building elements in the area, as well as being conducive to termite and pest infestation. Such an environment is likely to necessitate repair and/or replacement of

building elements, which are prone to sustaining wood rot, rust or corrosion.

A roofing plumber should be appointed as soon as possible to install relevant roof plumbing materials. Depending on the extent of the damage, repair and/or replacement of damaged building elements may be required.

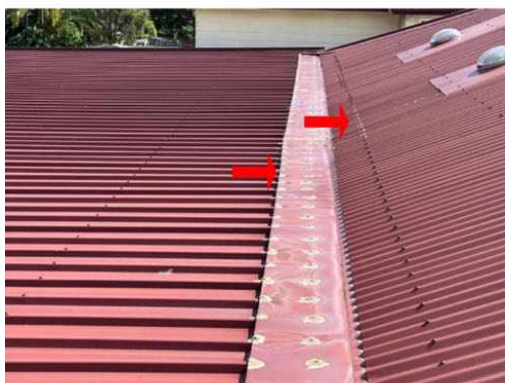
### Finding 3.05

Building:	Main Building
Location:	Roof Exterior > Centre,Rear
Finding:	Roof sheets - Excessive silicone work
Information:	The silicone repair work performed to the roofing colorbond appears to have been completed to an unsatisfactory standard. Excess silicone was evident in many sections of the colorbond area providing a blemish on the appearance as well as detracting from the drainage of the area.

It was also noted that some of the sheets have been creased or dented, this may over time provide areas for the Colorbond to develop areas of rust. The sheets may be replaced by a roofing contractor at the client discretion.

While weather-tight the excess silicone should be removed in order to increase roof drainage and to prevent accelerated deterioration of the roof sheets. A roofing contractor may be appointed to perform these works at client discretion.

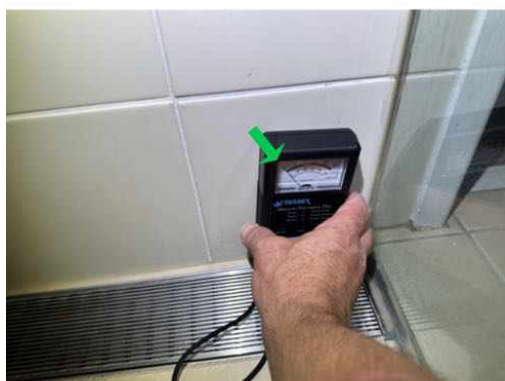
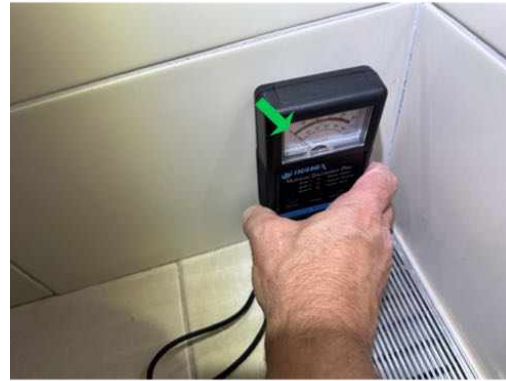
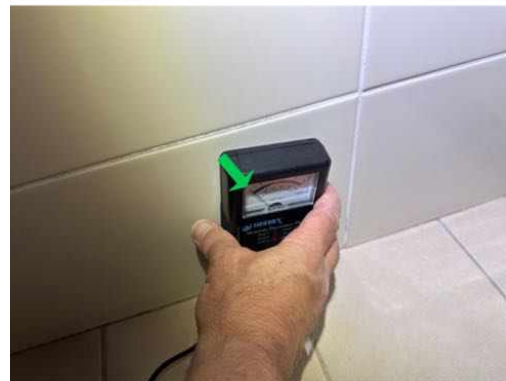
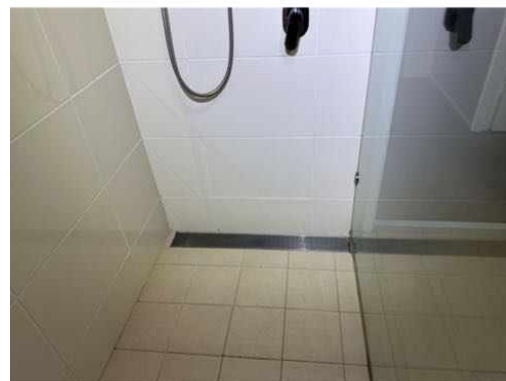
### Finding 3.06

Building: Main Building  
Location: Bathroom > Centre Left  
Finding: Moisture meter: used in Shower area.  
Information: A moisture meter was used during the inspection and isolated spots of excessive moisture was detected to accessible walls inside the property at the time of inspection.

It was noted on inspection that sealant or grout is in fair condition to most of the tiled shower alcove.

Different materials and floor areas move at different rates, generally causing cracking to grout or sealant at this point. A flexible sealant is required to allow for expected expansion and contraction, while keeping the joint water tight and protective of all associated building materials.

A moisture meter was used on all accessible walls during the inspection and excessive moisture was detected to bathroom shower walls inside the property. All areas with high moisture should be investigated by way of an invasive inspection by either a plumber and/or pest controller. High moisture levels also increase the likelihood of termite attack and may also be conducive to borer activity, wood decay, mould and deterioration of the building elements.

Flexible and mould resistant materials should be applied to affected areas to prevent any subsequent water damage that is likely to occur. Regular maintenance and replacement of damage or missing or damaged sealant and grout is highly recommended to the wet areas, as this is a regular wear and tear defect. Sealant and grouting in areas that come into regular contact with water should be maintained for the long term care of your property.

Monitoring the area is advised and if any visual signs of excessive moisture appear (peeling paint, mould) then consultation with a qualified plumber or bathroom specialist would be advised to identify the cause of damp and to perform remedial works as required.

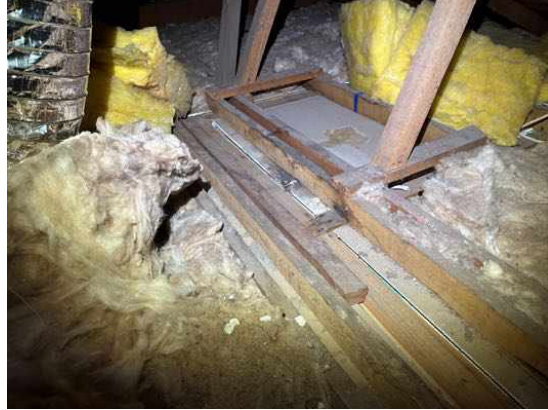
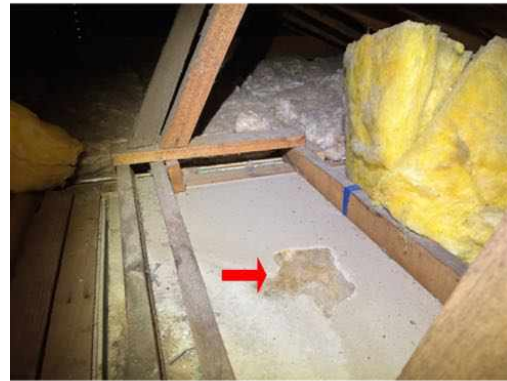
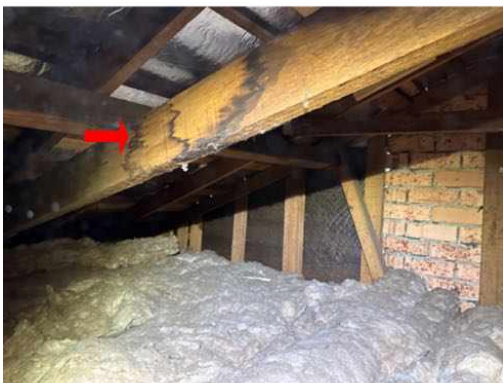
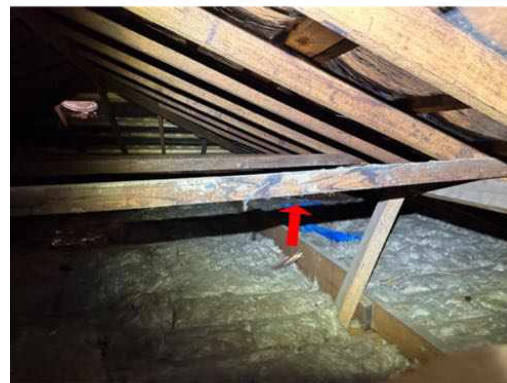
### Finding 3.07

Building: Main Building  
 Location: Roof Void > Centre  
 Finding: Water leak - Inactive  
 Information: Water leaks generally occur when a particular area of the property is not weather- or water-tight. While the damage in this area appears to be from an old inactive water leak, possibly from the original tiled roof that has been replaced with Colorbond, the area should be monitored frequently for the recurrence of any dampness.

Repair and / or replacement of previously affected building elements is at client discretion. Consider a further invasive inspection: removal of obstructions around the damaged area may reveal further damage which has been concealed. A more

significant or major defect may be identified at this time.

Where recurrence of an active water leak is identified, a qualified plumber should be appointed immediately to rectify the leak and advise on any further preventative works as necessary.

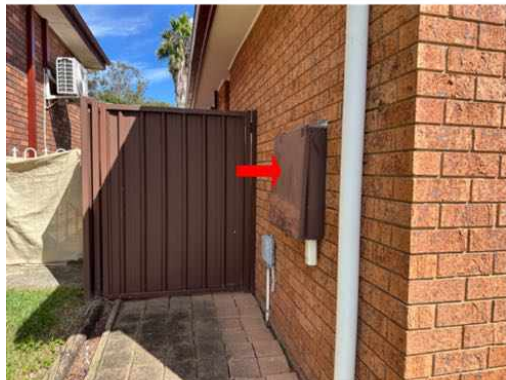
Building:	Main Building
Location:	Electrical circuit box > Front Left
Finding:	Termite Management System - no evidence of a chemical installation
Information:	The application of a post-construction chemical termite barrier is highly recommended for all properties, particularly if live termite activity has been found on the site previously. Such barriers are highly effective in preventing termite attack on any timber building elements throughout the property.

A durable notice should be placed in the switchboard unit to indicate current termite barriers. At the time of inspection, it appeared as though no termite management system has been installed, with no evidence to suggest preventative works taking place.

At the time of inspection, it appeared as though no termite management system has been installed, with no evidence to suggest preventative works taking place. The client should consider gaining further advice from a pest controller as to the costs and procedures involved with this application. It is recommended that obtaining such advice be a short-term priority.

The client may consider gaining further advice from a pest controller as to the costs and procedures involved with this application. It is recommended that obtaining such advice be a short-term priority.

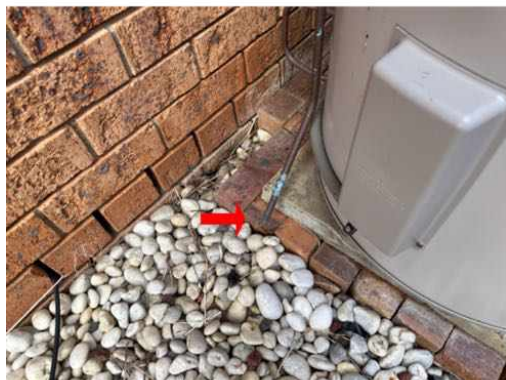
### Finding 6.02

Building:	Main Building
Location:	Exterior walls - left side > Rear Left
Finding:	HWS Overflow - Not Connected
Information:	The Hot Water System (HWS) overflow was found to be disconnected from storm water drainage and is creating excessive moisture in the surrounding area.

These damp conditions can lead to secondary defects such as rot, rust or corrosion of associated building elements, the formation of fungal decay, or even the creation of potential slip hazards. When coupled with poor site drainage, pooling of water may

also attract termite activity to this area.

It is highly recommended that a licensed plumber be appointed to connect the HWS overflow in order to prevent such an environment from being created. These minor works should be carried out as soon as possible.

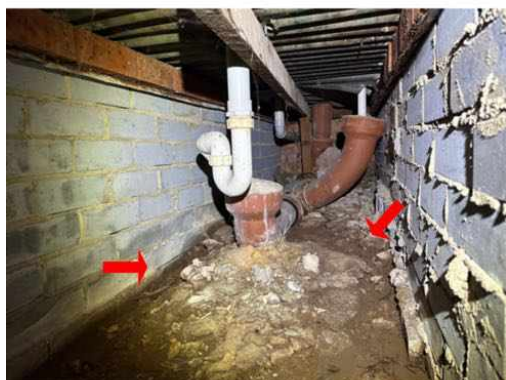
### Finding 6.03

Building:	Main Building
Location:	Subfloor > All Areas
Finding:	Subfloor: Damp.
Information:	At the time of inspection there appeared to be sections of the subfloor area with excessive moisture which can lead to secondary defect of other building materials. A well drained sub floor can aid in preventing secondary damage such as wood rot and pest activity, as well as preventing the development of mould and mildew (which can lead to respiratory safety hazards for occupants). This should be investigated as soon as possible by a plumber for leaking pipes or to improve site drainage.

Ventilation can be restricted by a variety of minor defects, including obstructions in the subfloor space, a lack of vents or a low clearance.

A well ventilated subfloor aids in maintaining dry conditions,

The initial step in improving ventilation is to ensure that the subfloor area is free of any debris or stored items. Where ventilation is still inadequate, it is advised to ensure that all vents are clear of blockages, and additional vents may be installed.

The client may also consider mechanical ventilation (powered fans) to improve subfloor airflow. Remedial works should be conducted as a matter of urgency to protect against the development of potentially harmful subfloor conditions.

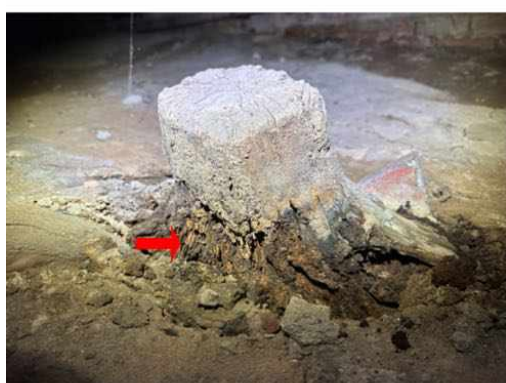
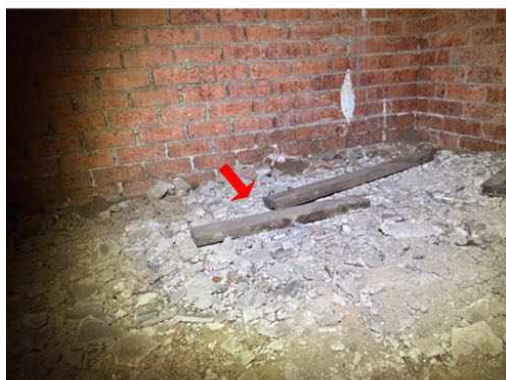
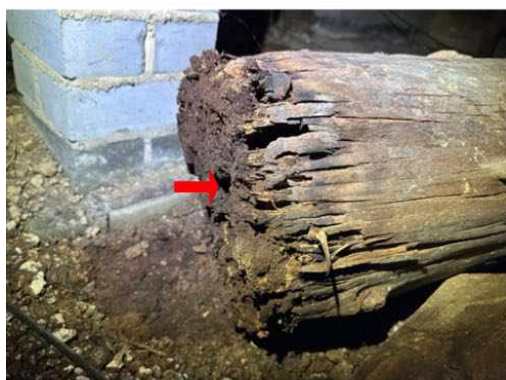
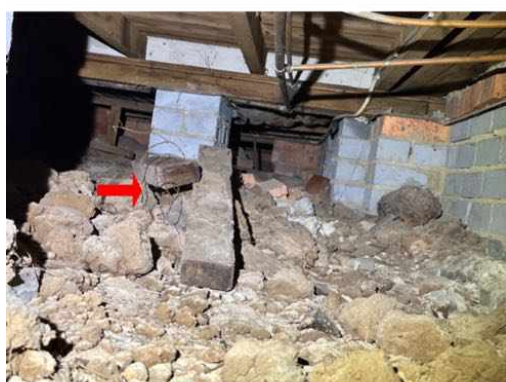
### Finding 6.04

Information: An array of debris was found in the subfloor area at the time of inspection. Debris in this area restricts subfloor ventilation and creates potential for concealed pest entry. Stored timbers and other materials may also make the area susceptible to termite activity and wood rot.

A clear and empty subfloor will be better ventilated and easier to maintain in a dry condition. The removal of any timber debris is vital in minimising the risk of termite or wood borer activity.

Debris in the subfloor should be removed as soon as possible. Depending on the location and amount of debris and stored items, the homeowner may elect to undertake this task. Alternatively there are a large number of rubbish removal subcontractors that could undertake these works.

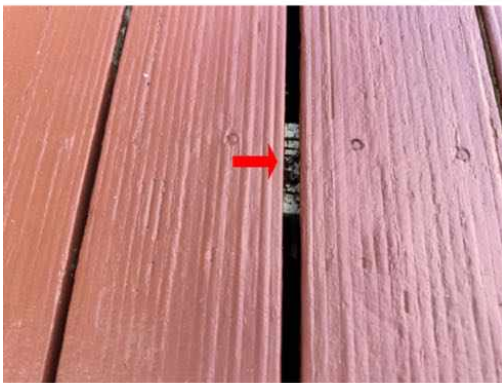
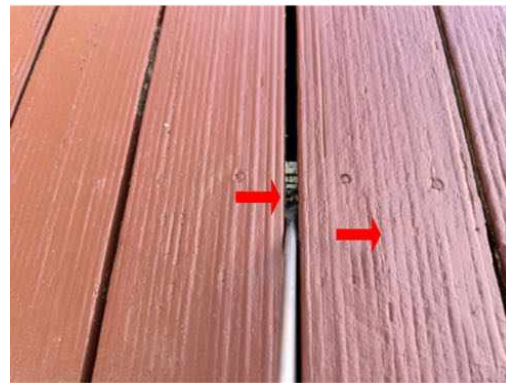
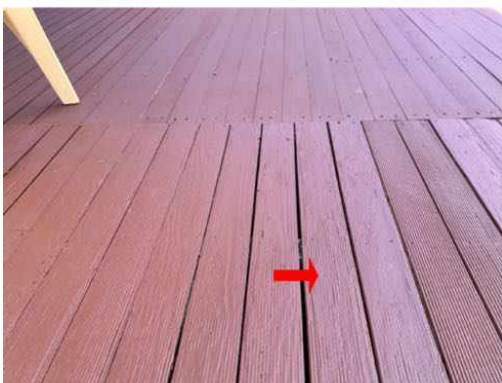
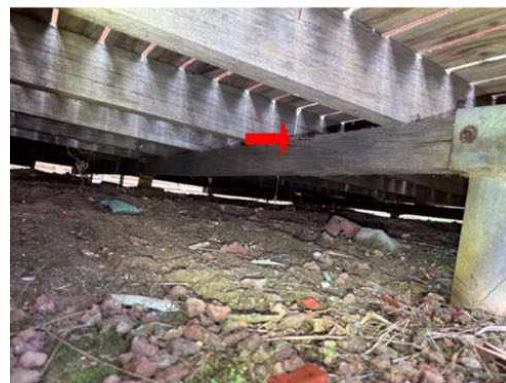
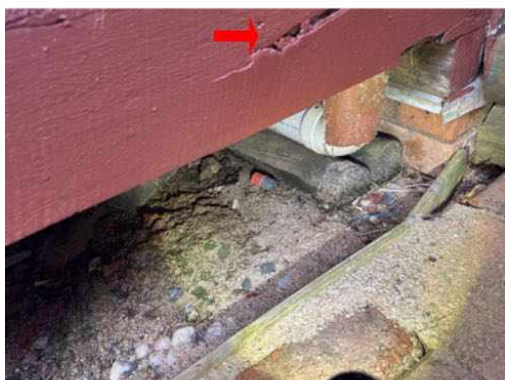
Building: Main Building  
Location: Deck > Rear Left  
Finding: Fungal decay - present (localised)

Information: Fungal decay also known as wood decay or wood rot generally refers to the deterioration of timber elements when in contact with excessive levels of moisture for a prolonged period of time.

The development of fungal decay is accelerated by temperatures in the range of 5degreeC to 40degreeC as well as the presence of oxygen. Generally fungal decay develops on timber elements that are in use in an external environment which are exposed to rain penetration.

In this case although the affected timber element is in a decaying state the extent of any visible damage appears to be localised to a specific area and is yet to spread to other parts of the building element or affect adjoining structures. It is highly recommended that the deck to be inspected by a licensed contractor or engineer to determine the structural load capacity of the affected timber and the need for replacement or repair of any timber deemed necessary.

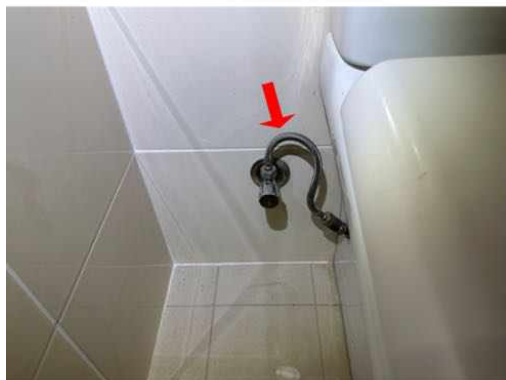
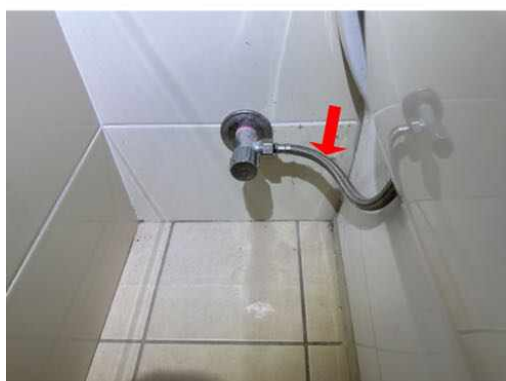
## Noted Item

Building: Main Building  
 Location: All Areas > All Areas  
 Finding: Pipe: Flexible Braided pipes.  
 Information: Braided Stainless Steel Flexi connector hose are popular in modern home fit outs because they can be bent into shape. They started to be installed in the early two thousands and their use is now extremely widespread in contemporary construction and renovations.

It is recommended that the Flexi pipes to be replaced at the owners discretion to avoid an “escape water incident” which may lead to water damage to other building elements in the home.

This work can be undertaken by a licensed plumber, general handy person at the owners discretion.

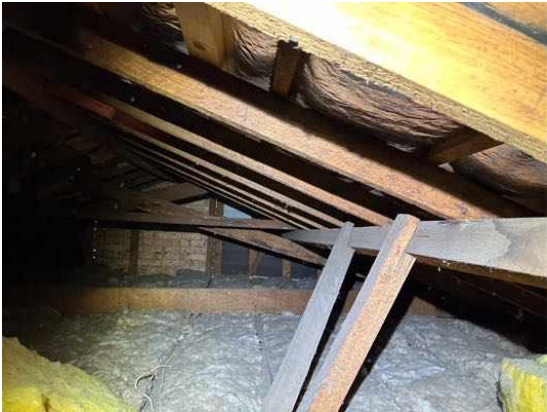
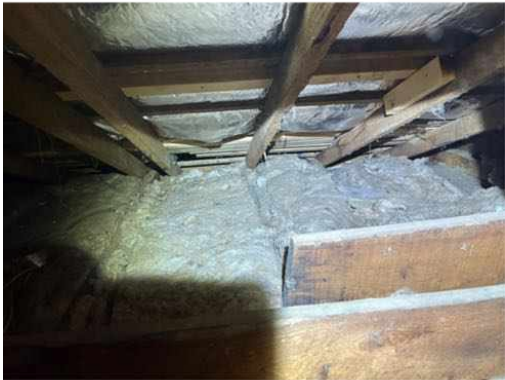
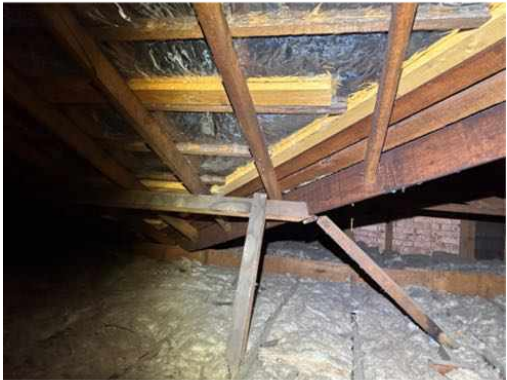
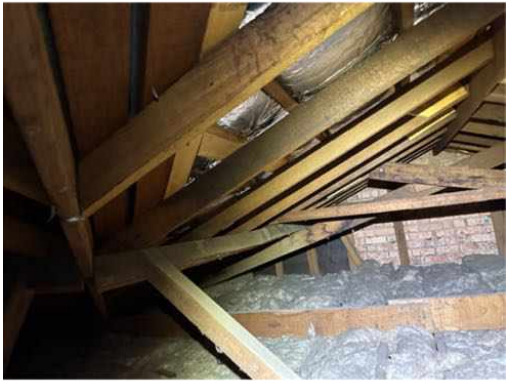
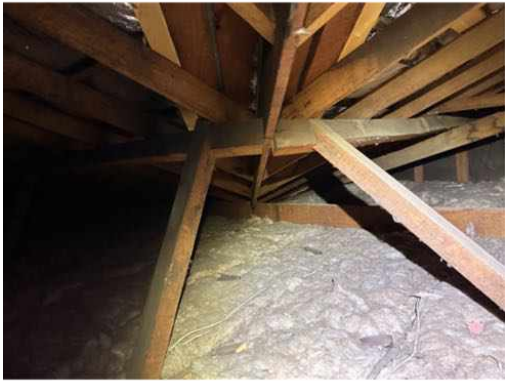
Noted Item

Building: Main Building  
Location: All Areas > All Areas  
Finding: Roof void: limited access.  
Information: Limited access to the roof void was present due to facts including but not limited to access hatch size or placement, insulation, areas of low pitched roof, for this reason inspection to the roof void was minimal and a range of defect's from minor to major may not be visible at the time of inspection.
