Building and Timber Pest Inspection Report

Inspection Date: Fri, 6 Feb 2026

Property Address: 802/187 Kent Street, Sydney NSW 2000

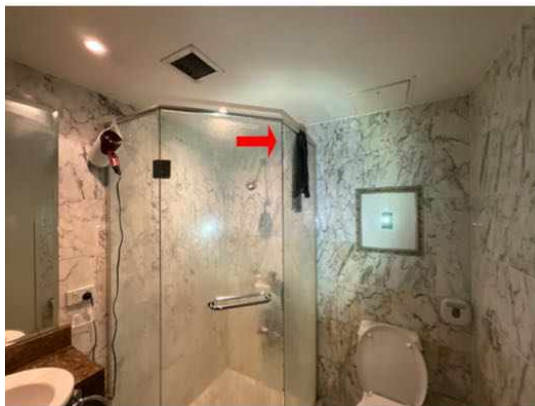
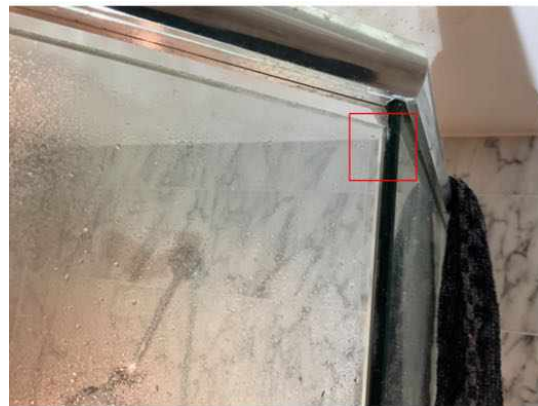
Finding 1.01

Building: Main Building
 Location: Bathroom
 Finding: Shower doors - Binding/Jamming
 Information:

Binding and/or jamming of shower doors were evident during standard operation at the time of inspection. This defect is a potential safety hazard if the shower screen breaks due to impact or jamming force.

It appears this is due to poor initial installation of the shower components.

The shower door was found to be jamming against the adjacent glass panel, requiring urgent and relatively minor repairs to ensure any cracking or breakage to the glass is prevented.

A licensed glazier is required immediately for repairs and to ensure the safety of the area.

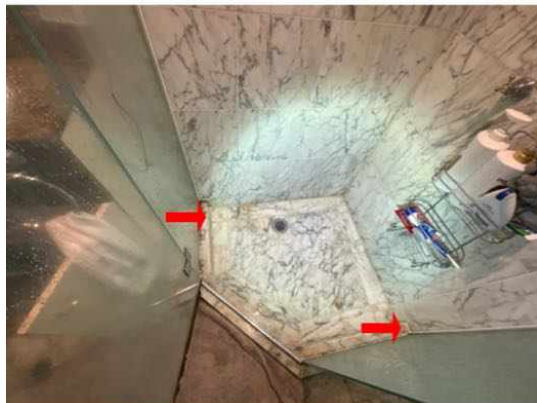
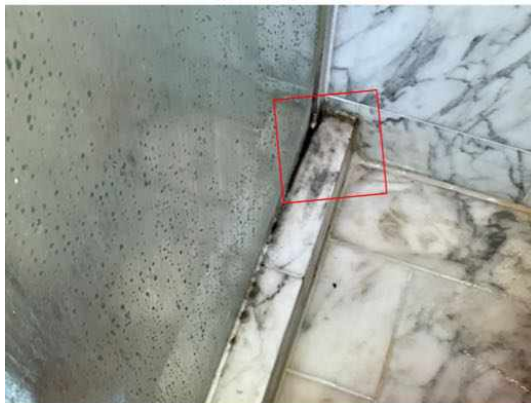
Finding 3.01

Building: Main Building
 Location: Bathroom
 Finding: Sealant and grouting - Mould
 Information:

There appears to be excessive mould to the sealant and grout which will likely require scraping out and replacement. Flexible and mould resistant materials should be applied to affected areas to prevent any subsequent water damage that is likely to

occur. Regular maintenance and replacement of damage or missing or damaged sealant and grout is highly recommended to the wet areas, as this is a regular wear and tear defect. Sealant and grouting in areas that come into regular contact with water should be maintained for the long term care of your property. A sealant specialist or tiling contractor should be appointed to complete these works as soon as possible.

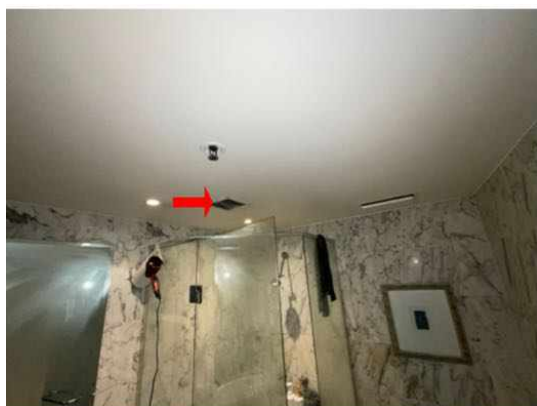
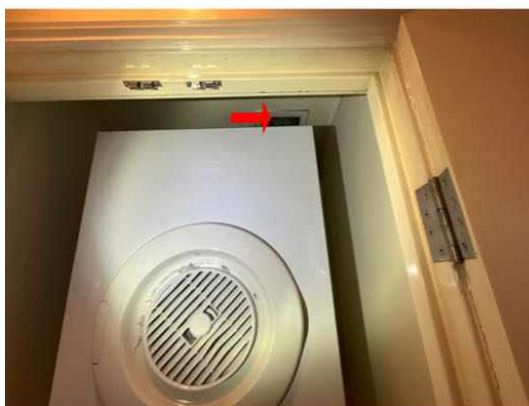
Finding 3.02

Building:	Main Building
Location:	Bathroom, laundry
Finding:	Exhaust fan - Not operating
Information:	The exhaust fan in this area appears to be damaged or blocked and is not operating as intended. If left unmanaged, a lack of general maintenance is likely to lead to the development of more significant defects, such as water damage to surrounding building materials from inadequate ventilation. If left unattended for a prolonged period of time, poor ventilation in this area may also be conducive to the development of mould.

Where no secondary damage has developed, the Homeowner may undertake minor cleaning of the area and consider replacement of the exhaust fan. Alternatively, consultation with a Licensed Electrician is required to check for any secondary or concealed damage and consider repair or replacement.

Please be advised that a cabinet maker or qualified carpenter may also be required if water damage has occurred and that an additional specialist mould inspection may be required if severe mould has resulted.

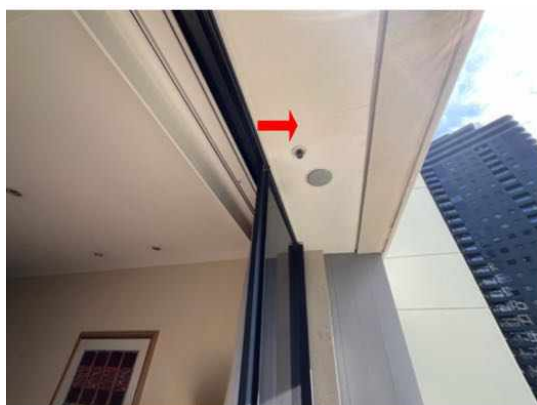
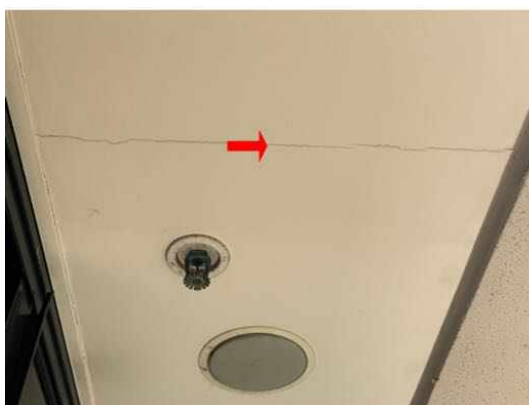
Finding 3.03

Building:	Main Building
Location:	Balcony
Finding:	Cracking - Damage Category 1 - Fine (up to 1mm)
Information:	Although fine cracks are quite noticeable, they are often only considered to be an appearance defect, and usually do not indicate any structural damage. Generally, the cause of a fine crack is indicative of a separation between building materials and finishes (e.g. paint, plaster, etc.) along joins.

Cracking of this nature can generally be repaired with minor sanding, filling and/or repainting. Such works should be performed by a qualified painter or a general handyman.

Monitoring of all cracking should be conducted frequently. Always contact a building inspector should cracks widen, lengthen, or become more numerous.
