Building Inspection Report

Inspection Date: Tue, 13 Jan 2026

Property Address: 1/2 Waterloo Pl, Richmond VIC 3121,
Australia

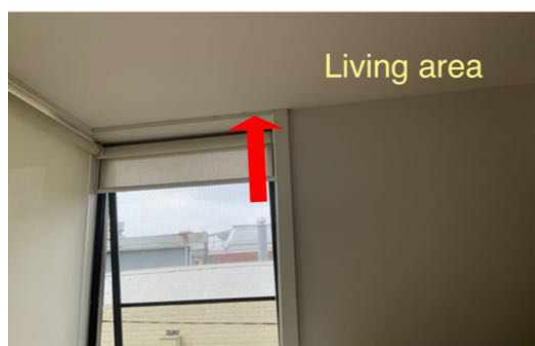
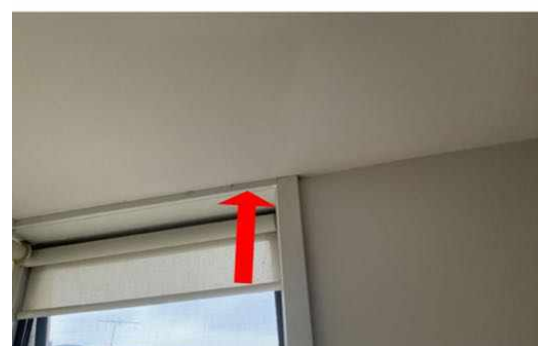
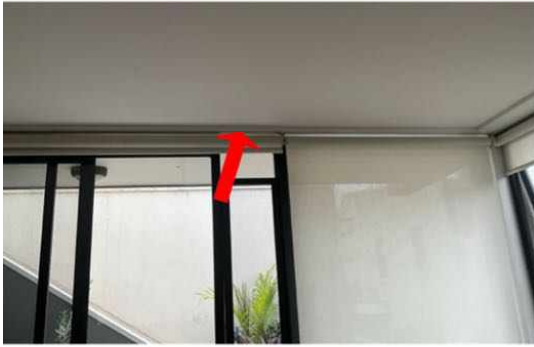
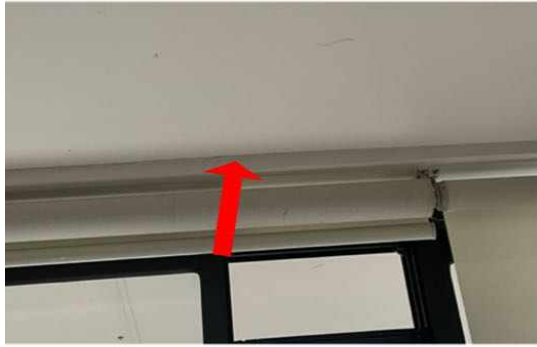
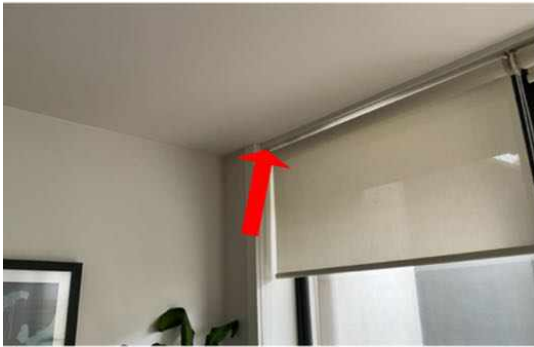
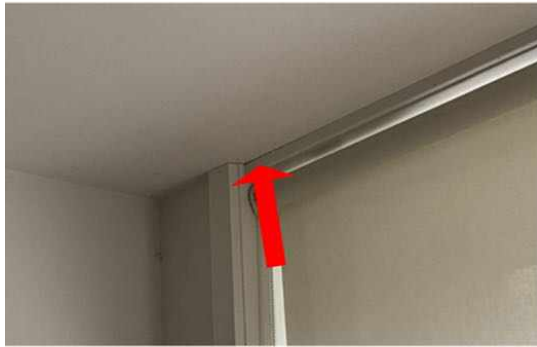
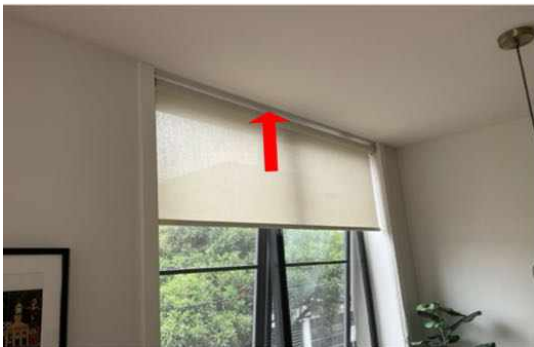
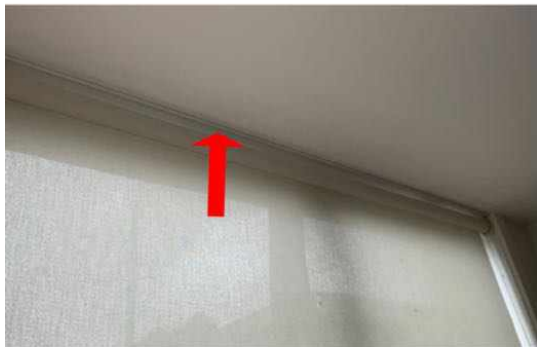
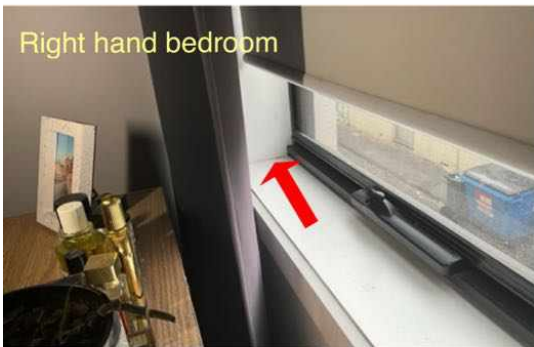
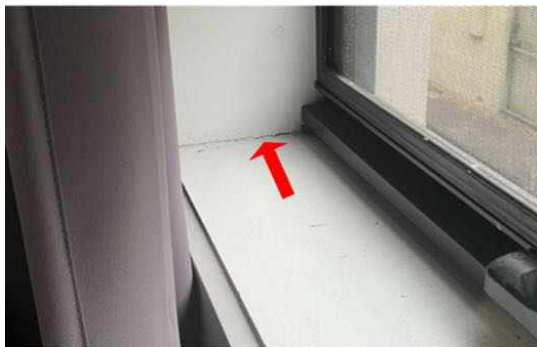
Defects 3.01

Location: All Areas

Finding: Cracking - fine

Information: Some fine cracking was noted throughout the property.

Although fine cracks are quite noticeable, they are often only considered to be an appearance defect, and usually do not indicate any structural damage. Generally, the cause of a fine crack is indicative of a separation between building materials and finishes (e.g. paint, plaster, etc.) along joins.

Note: photos included are indicative of fine cracking noted at the the time of inspection. Other fine cracks may be present but not recorded here.

Cracking of this nature can generally be repaired with minor sanding, filling and/or repainting. Such works should be performed by a qualified painter or a general handyman.

Monitoring of all cracking should be conducted frequently. Always contact a building inspector should cracks widen, lengthen, or become more numerous.

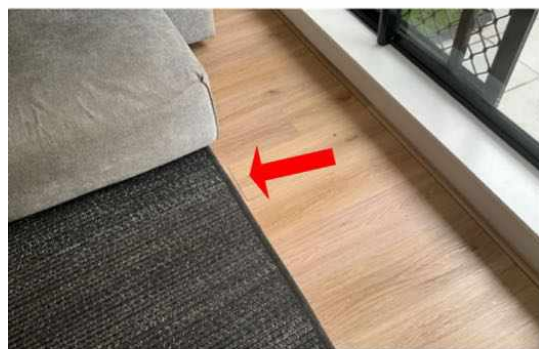
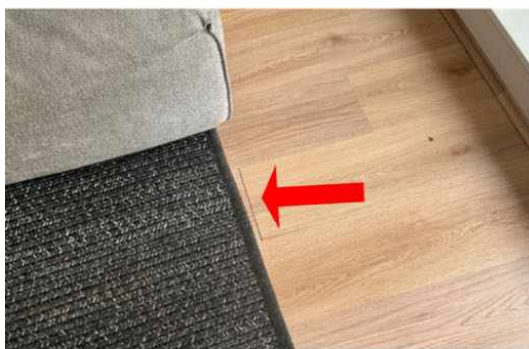
Defects 3.02

Building:
 Location: Living Room
 Finding: Gaps between floating floorboards
 Information: At the time of inspection, the flooring in the living area has small gaps between the boards. This generally occurs due to shrinkage of the boards which can result from installation issues, moisture imbalance within the boards, failure to acclimatise the boards prior to installation, natural variation within the timbers or movement of the boards.

The flooring should be monitored for a period of time to see if any changes occur. Should the gaps widen, consultation with a flooring specialist should be undertaken to determine the best course of action. This may involve filling the gaps or replacing the boards in this area.

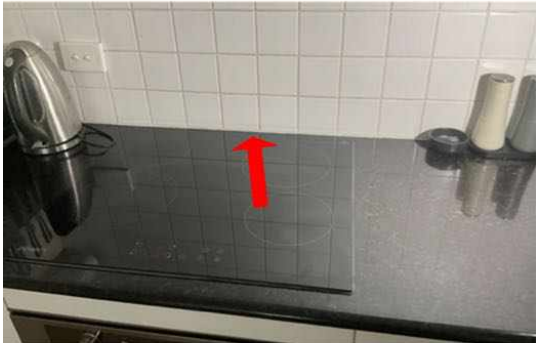
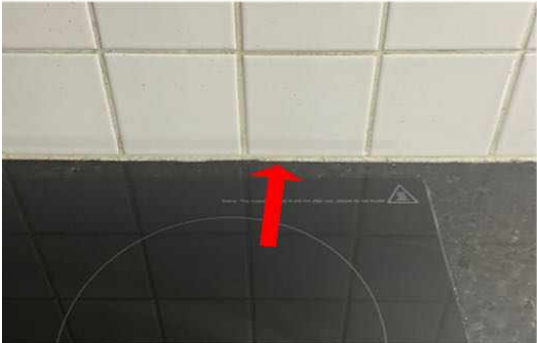
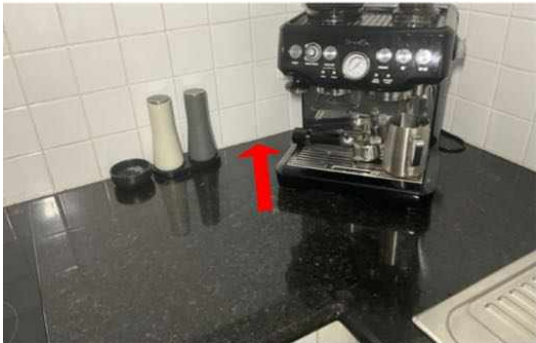
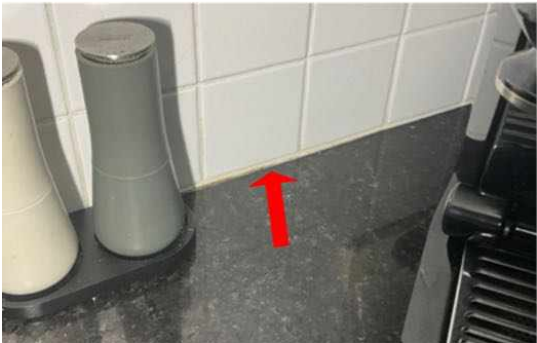
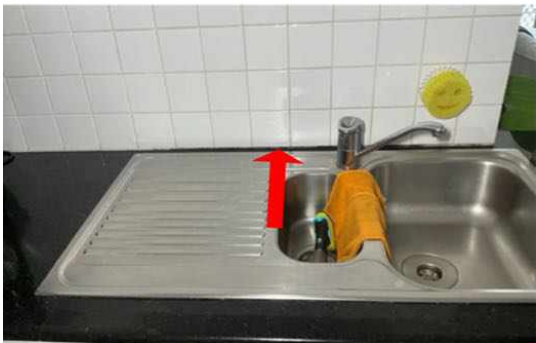
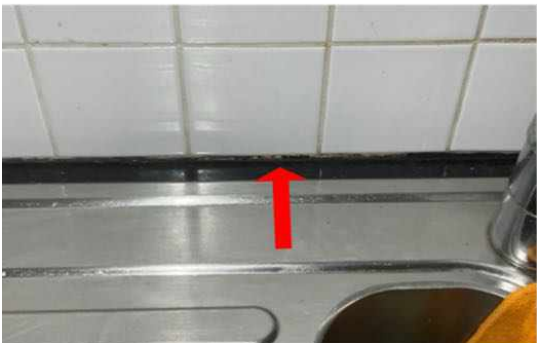
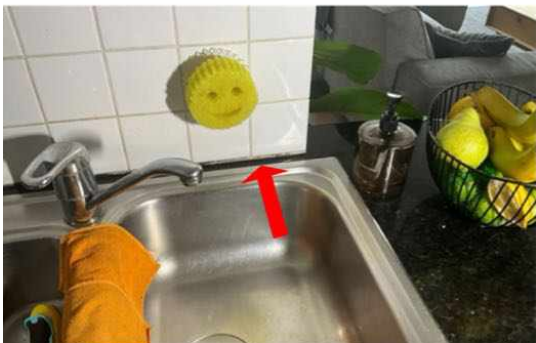
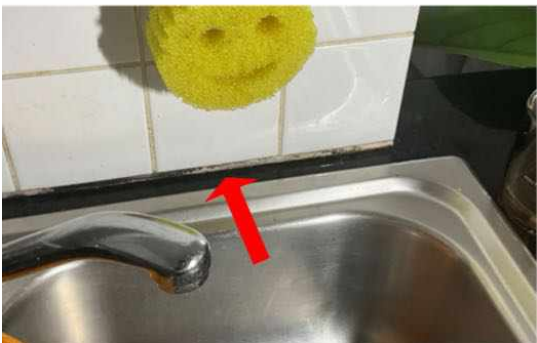
Defects 3.03

Building:
 Location: Kitchen
 Finding: Sealant - Degraded and mouldy in areas of kitchen
 Information: Sealant is degraded in this area.

Failure to do so is likely to lead to further deterioration of the sealant which in turn can lead to water damage to the surrounding area.

Where sealant is damaged or mouldy, a tiling contractor should be appointed immediately to re-apply any silicone where necessary.

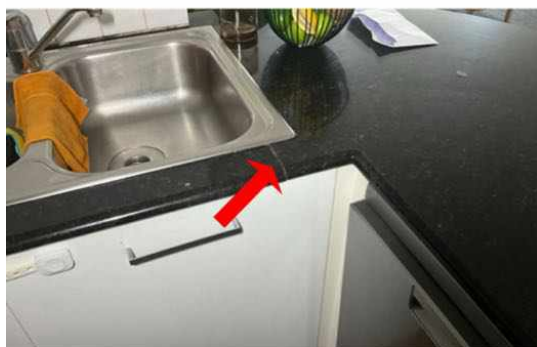
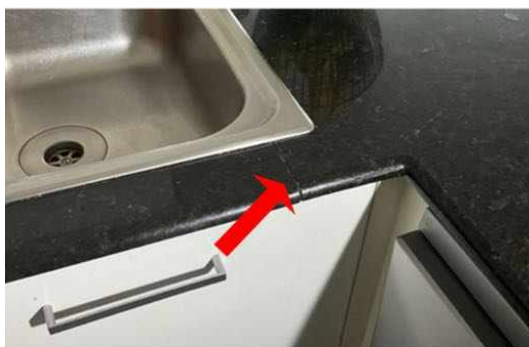
Defects 3.04

Building:
 Location: Kitchen
 Finding: Join not sealed effectively within the kitchen benchtop
 Information: At the time of inspection, the join within the bench top surface was slightly open and not sealed effectively. This has the potential to allow water ingress into the gap and cause secondary damage to the cabinets underneath.

It is highly recommended that the benchtop be sealed to prevent water ingress.

A competent handyman or kitchen benchtop specialist may be engaged to perform this task.

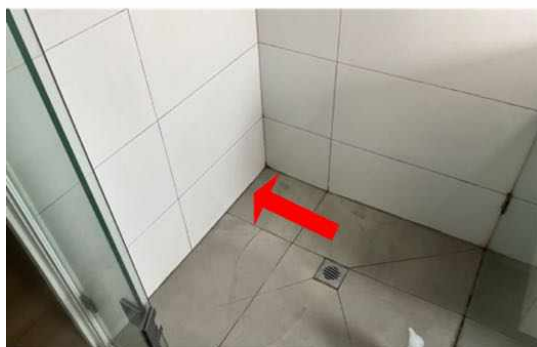
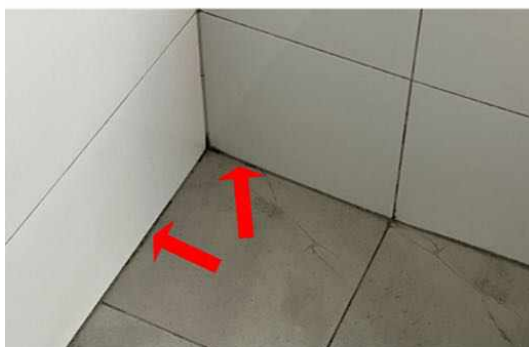
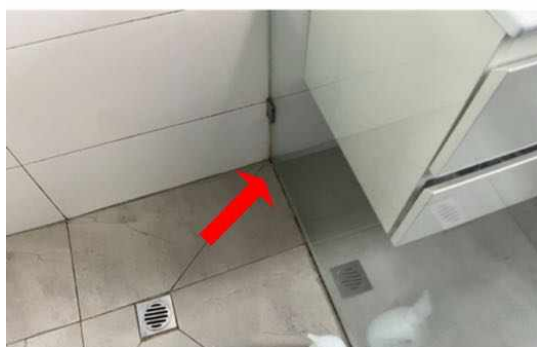
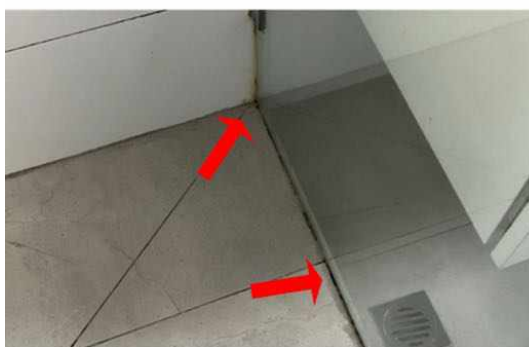
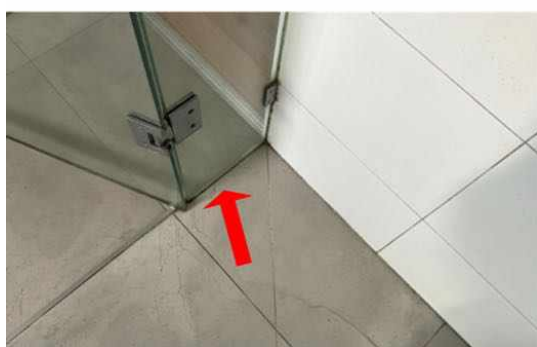
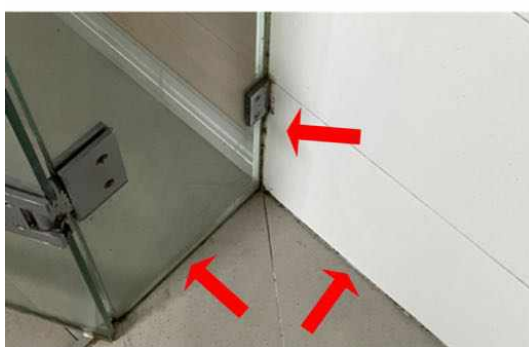
Defects 3.05

Building:
 Location: Bathroom
 Finding: Sealant / Grout - Degraded and mouldy within the shower
 Information: Sealant / Grout is degraded in this area. Sealant and grout is used to protect gaps and crevices in building materials to ensure that they are water-tight and prevent water penetration to the associated structures.

Failure to do so is likely to lead to further deterioration of the sealant and grout which in turn can lead to water damage to the surrounding area.

Excessive mould can also lead to respiratory issues .

Where sealant or grout is damaged or mouldy , a tiling contractor should be appointed immediately to scrape out and re-apply where necessary.

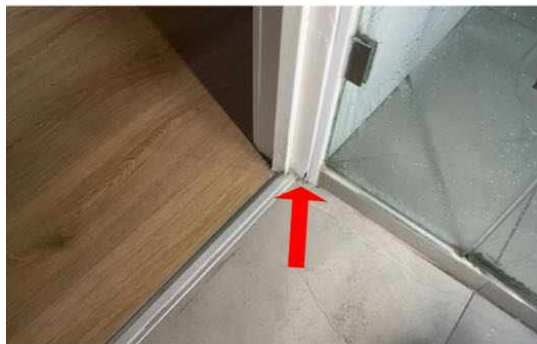
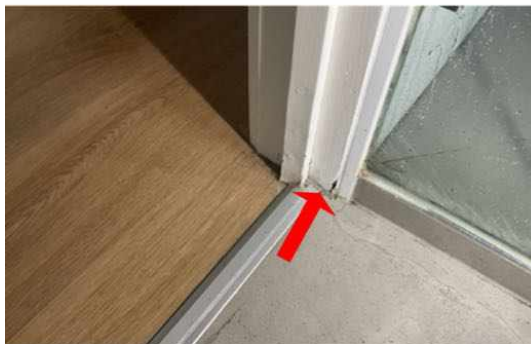
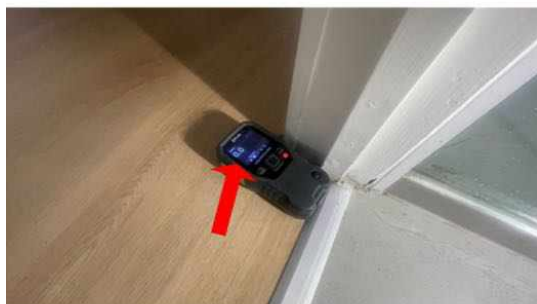
Defects 3.06

Location: Bathroom

Finding: Moisture damage to the door frame in this bathroom.

Information: Evidence of moisture damage was identified to the door frame in this bathroom.

It is suspected that this has occurred as a result of moisture from a leak around the shower screen. No current moisture was noted to the area when tested with a moisture meter.

The first step to repair this defect is to re-dash seal around the shower screen . Once this has been completed, a licensed carpenter or competent handyman may be

engaged to inspect the moisture damaged areas and repair or replace any items where necessary.

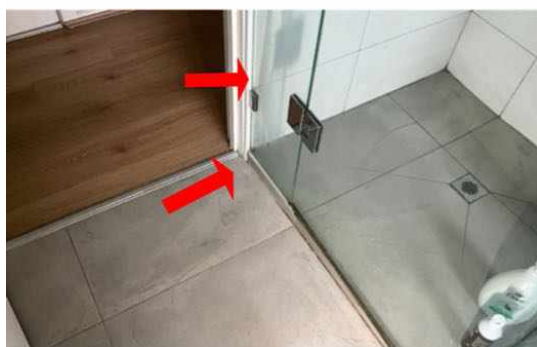
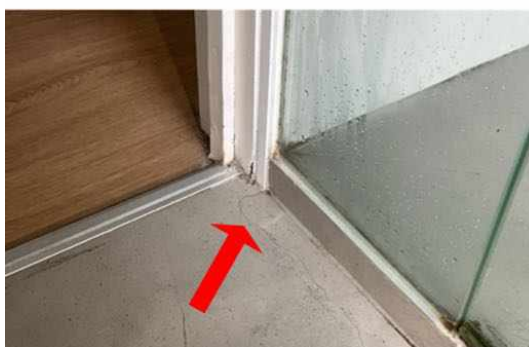
Defects 3.07

Building:
 Location: Bathroom
 Finding: Shower screen seal - Leaking
 Information: Leaking was evident to the shower screen where it meets the wall at the time of inspection. It is suspected that the leaking has occurred as a result of the screen not being sealed correctly in this area.

Leaking from the shower , where left unattended, can lead to water damage and necessitate extensive remedial works being required. Active water leaks may also create an environment that is susceptible to the formation and development of mould.

Please note: slight moisture damage was observed to the door frame next to the shower. No current moisture was noted within the area when tested with a moisture meter.

Appointment of a tiling contractor or competent handyman is required to repair / replace the sealant. Such works should be performed immediately to ensure that no further damage occurs.

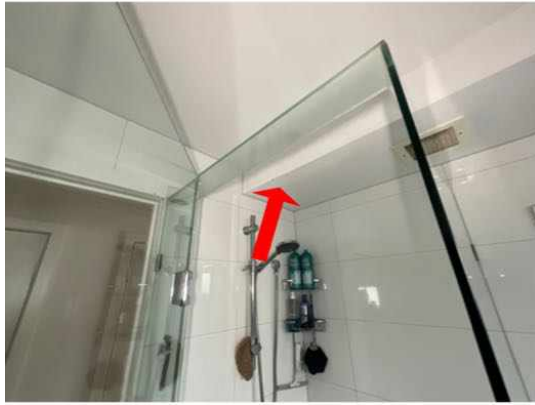
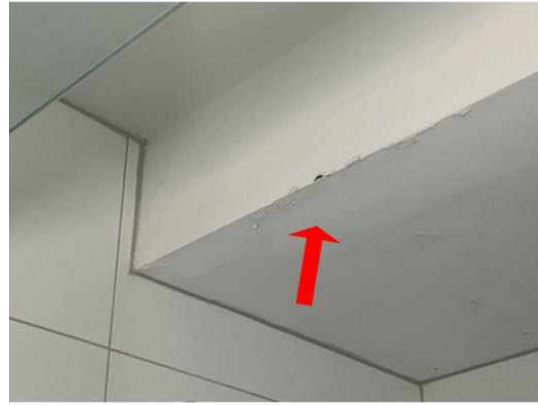
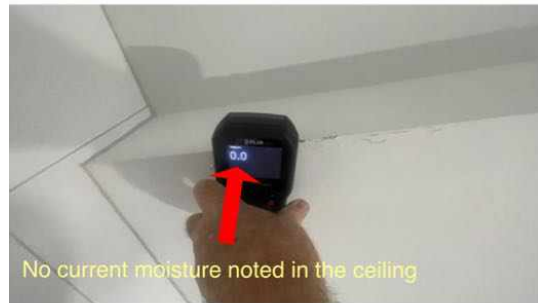
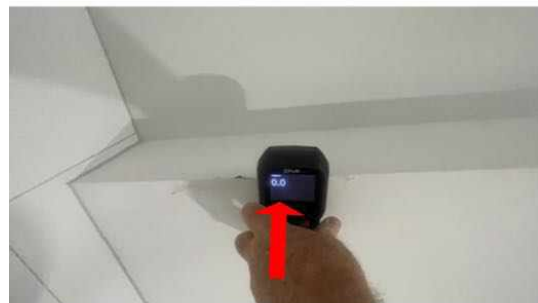
Defects 3.08

Building:	
Location:	Bathroom
Finding:	Peeling paint on ceiling within bathroom - poor ventilation
Information:	At the time of inspection, there appeared to be peeling paint to the ceiling of the bathroom. This is suspected to be due to poor ventilation within the bathroom area. There was a ceiling exhaust fan in place however it appeared to be dirty and may not be very effective. No moisture was noted in the area when tested with a moisture meter.

It is recommended that improved ventilation be looked at for the bathroom area. Cleaning of the current exhaust fan may improve its efficiency.

Should this not work, a licenced plumber or ventilation specialist may be engaged to ascertain the extent of the issue and rectify via the introduction of a new exhaust fan.

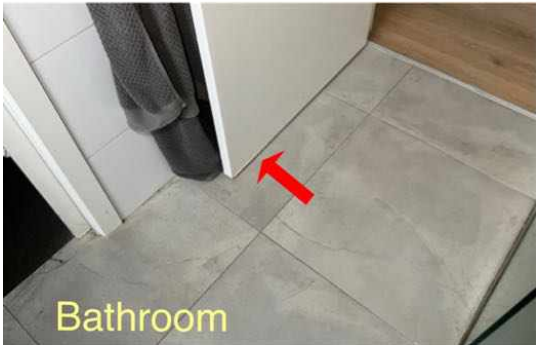
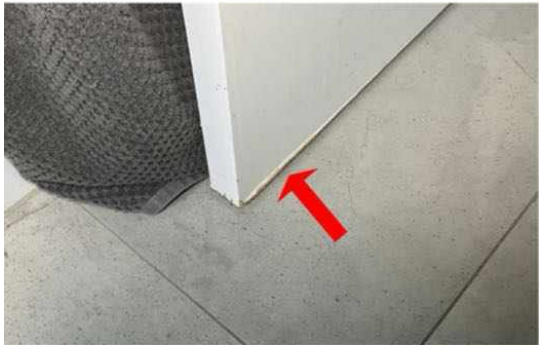
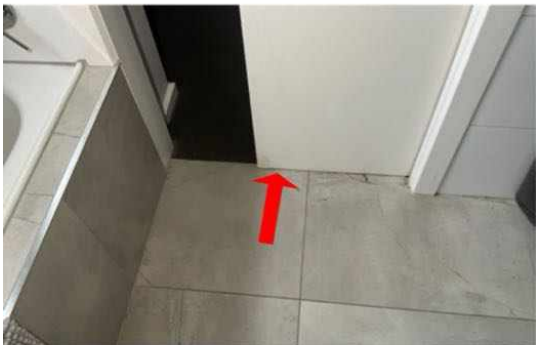
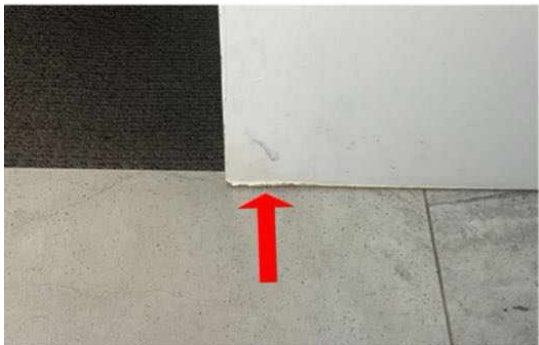
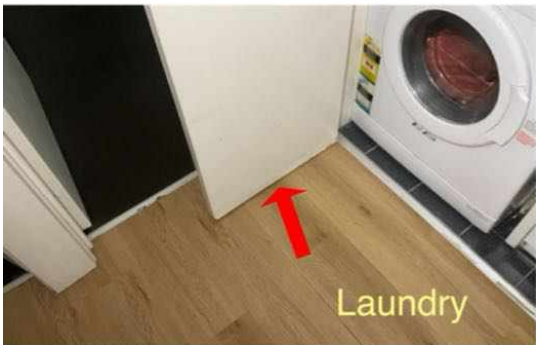
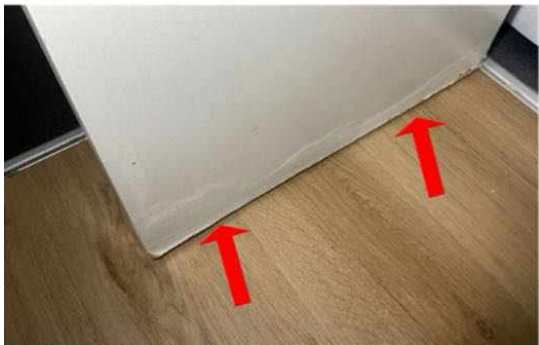
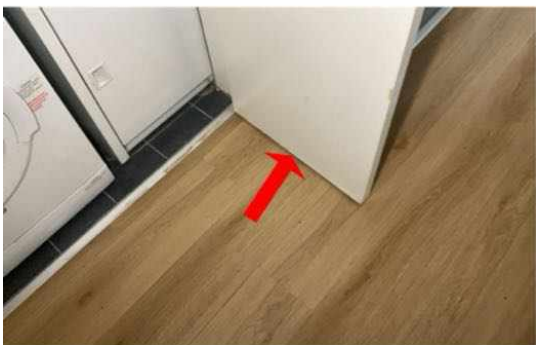
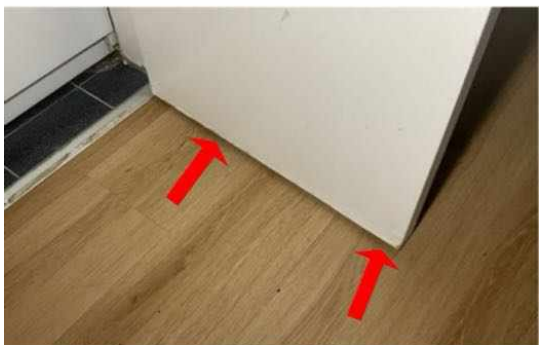
Defects 3.09

Location: All Areas

Finding: Doors showing signs of moisture damage to the base

Information: At the time of inspection there appeared to be some moisture damage at the base of the doors in the bathroom and laundry.

Doors should be sealed on all faces including top and bottom to prevent moisture seeping into the door structure and potentially causing secondary damage.

A suitably qualified handyman or painter should be engaged to remove the door, repair any damage, paint the door including top and bottom and rehang them.

If the door cannot be repaired, a new door may be required.

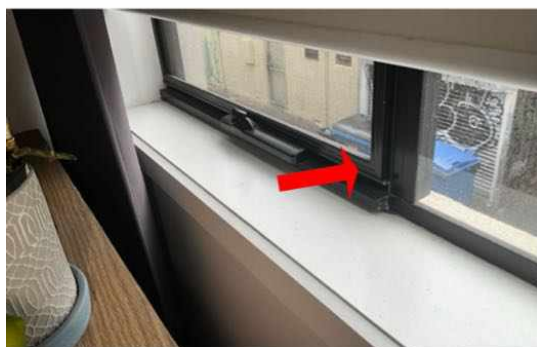
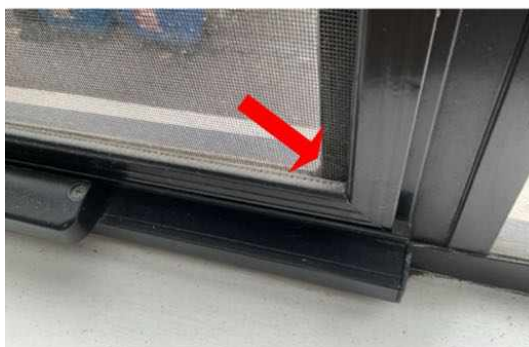
Defects 3.10

Building:	
Location:	Bedroom
Finding:	Aluminium Window - Sticking slightly when opened
Information:	At the time of the inspection, the window in this area was sticking slightly when opened. Windows provide ventilation to the adjoining area and should be at a fully operational level to ensure user comfort. Restricted function of the window may also create potential for secondary defects to the associated building elements, such as damage to the window frames as well as a potential safety hazard if required for emergency egress from the building.

The most usual causes of sticking with aluminium windows is slight misalignment of window within frame, buckling of the frame, or stiffness from lack of use. Easement may be required, which may involve slight adjustment to the window frames. It will almost always include ensuring the areas are cleaned and free of any debris that may be detrimental to their operational state.

A competent handyman can be engaged where necessary to address this issue.

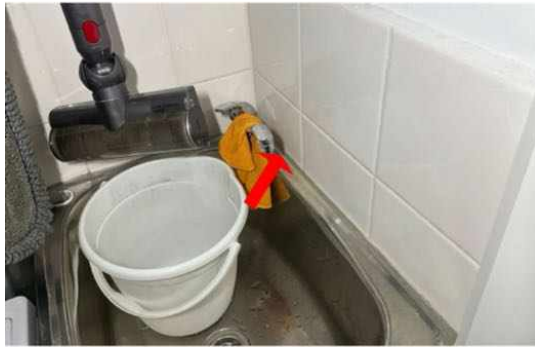
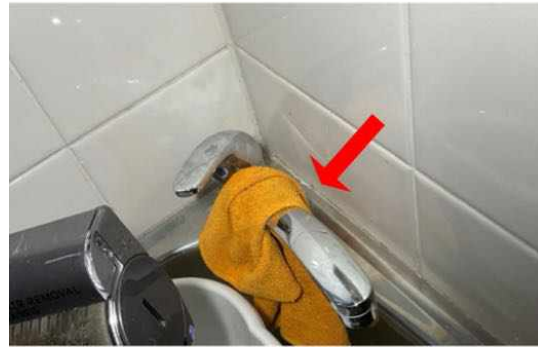
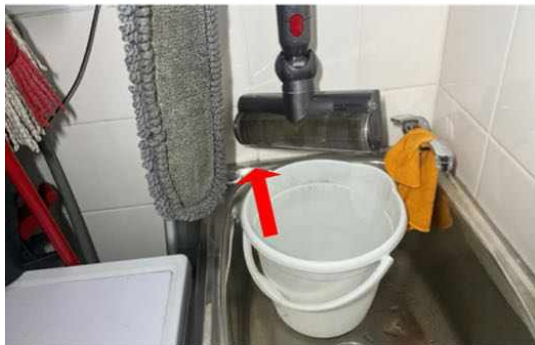
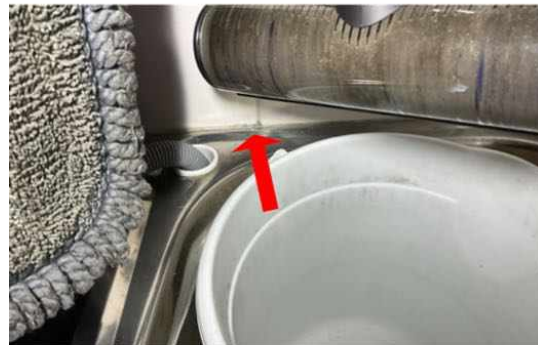
Defects 3.11

Building:	
Location:	Laundry
Finding:	Sealant - Degraded in this area
Information:	Sealant is deteriorated in this area.

Failure to do so can lead to water damage to the surrounding area.

Where Sealant is damaged or missing, a tiling contractor should be appointed immediately to re-apply any silicone where necessary.

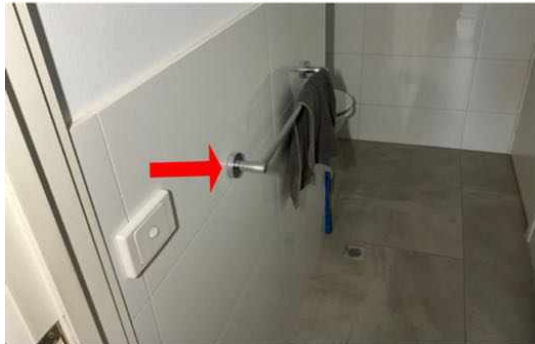
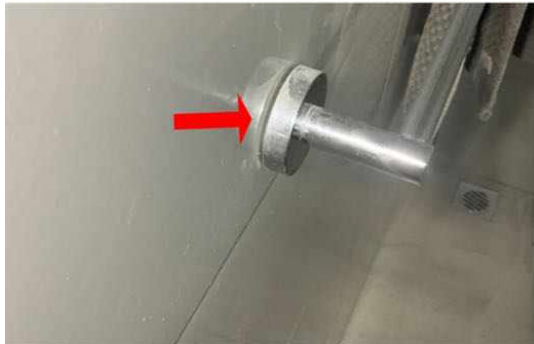
Defects 3.13

Location: Powder Room

Finding: Towel rail loose

Information: At the time of inspection , the towel rail to the powder room was loose and requires tightening.

A competent handyman can perform this task.

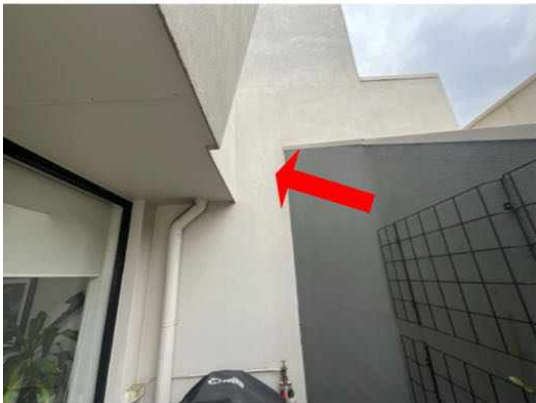
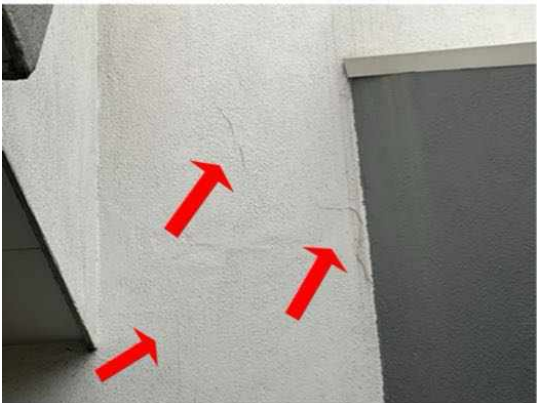
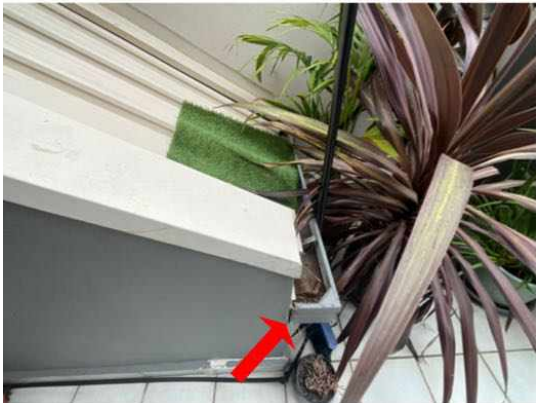
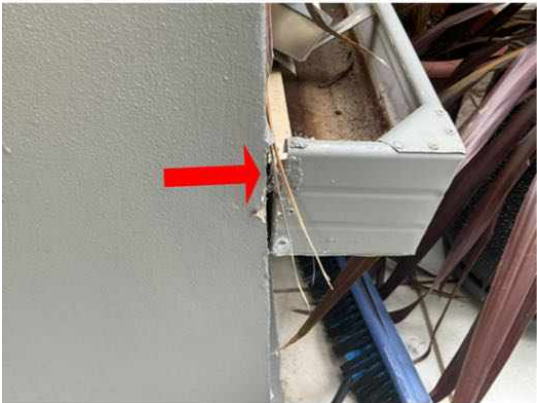
Defects 3.14

Location: Exterior walls - right side

Finding: Additional photos - suspected owners corporation minor defects

Information: - Minor cracking to the rendered wall

- Gutter slightly coming loose from wall

Please note: it is suspected that these items would be covered by the owners corporation. Your own enquiries should be made to determine whether this is the case
