Building and Timber Pest Inspection Report

Inspection Date: Tue, 24 Mar 2026

Property Address: 138 Donald Dr, Curra QLD 4570, Australia

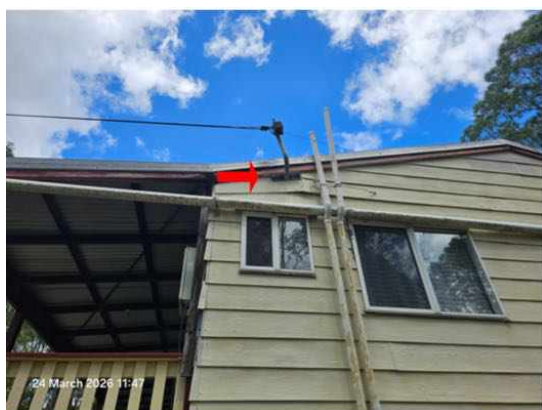
Building: Main Building
 Location: As shown
 Finding: Overhead electrical connection - bracket loose
 Information: During the inspection of the building exterior, it was noted that the steel post / bracket securing the overhead electrical connection appears to be unstable. It will require an assessment by a licensed electrician and a licensed builder. This has the potential to become an electrical safety hazard.

It is advisable to consult an electrician for a best practice solution.

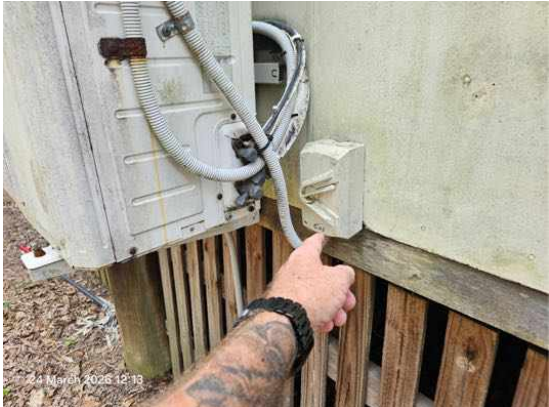
Finding 2.02

Building: Main Building
 Location: Right side
 Finding: Air conditioner - electrical issue, service recommended
 Information: During the inspection, the appliances are turned on to observe functionality. Appliances are not tested for serviceability, this is out of scope for this type of inspection. When the unit was turned on at the wall isolator switch, it tripped the safety switch. A licensed air conditioner technician and a licensed electrician should be engaged to assess the electrical service.

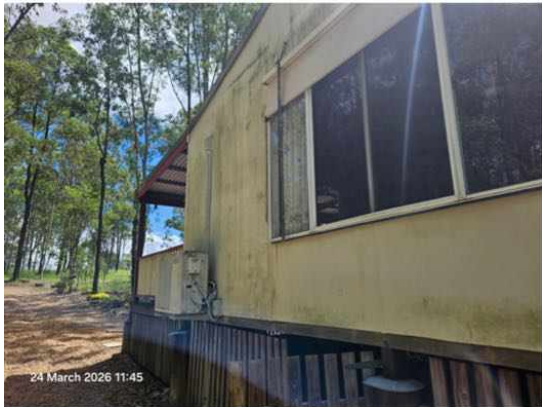
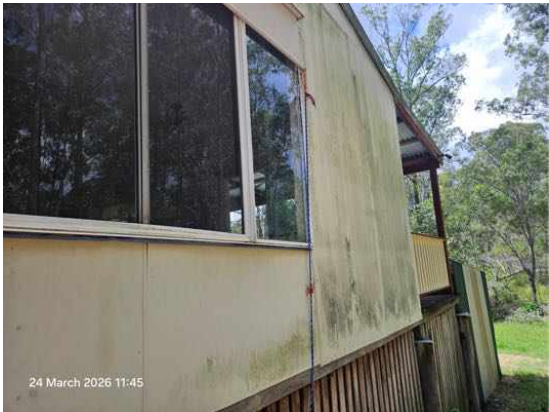
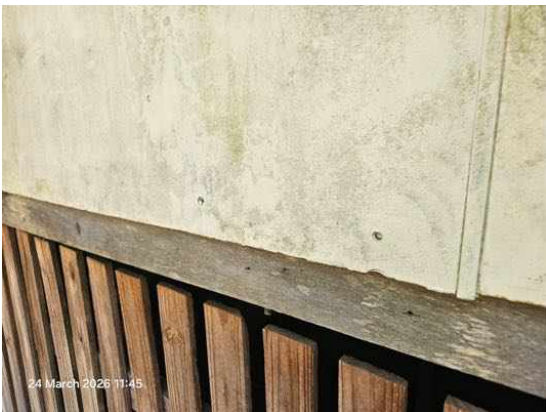
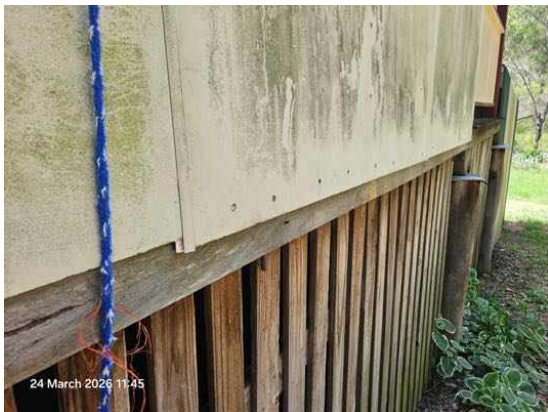
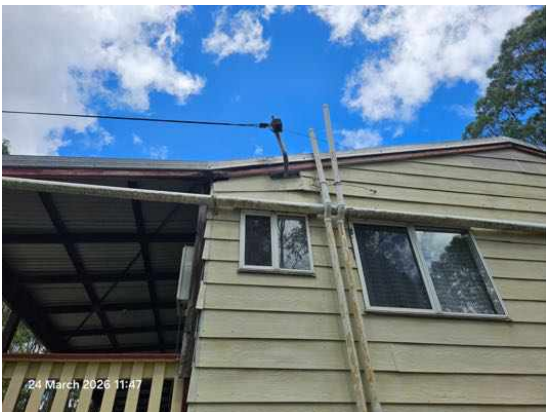
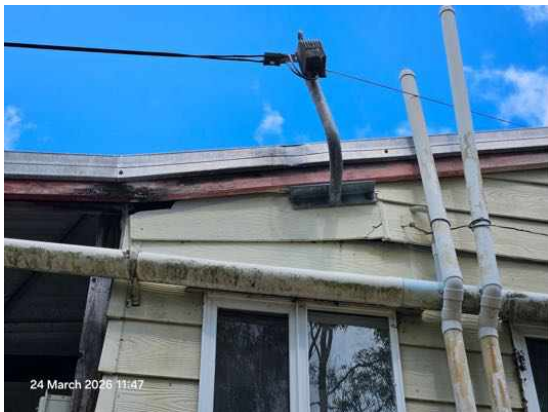
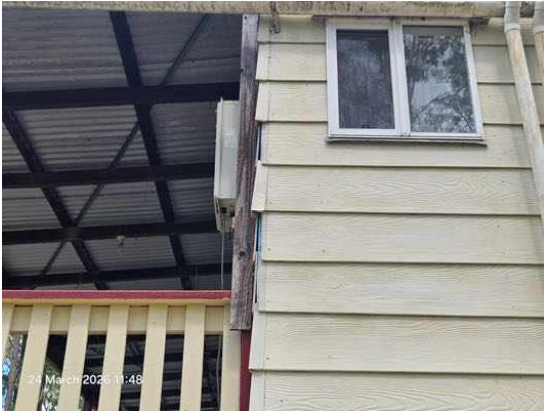
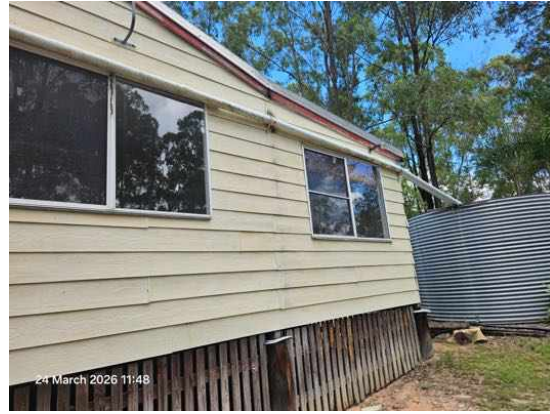
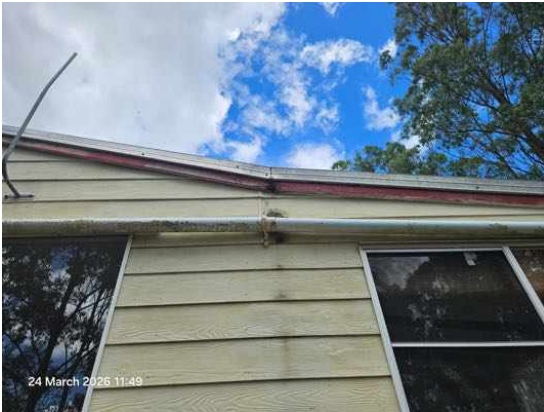
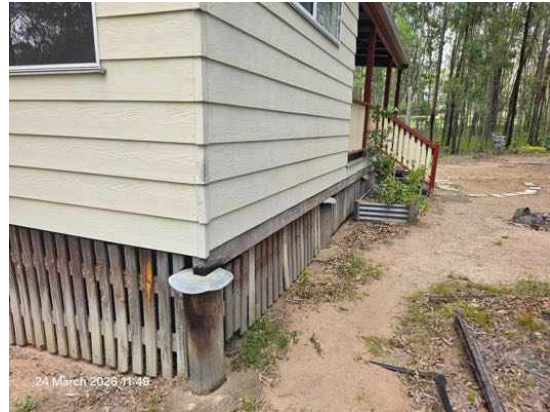
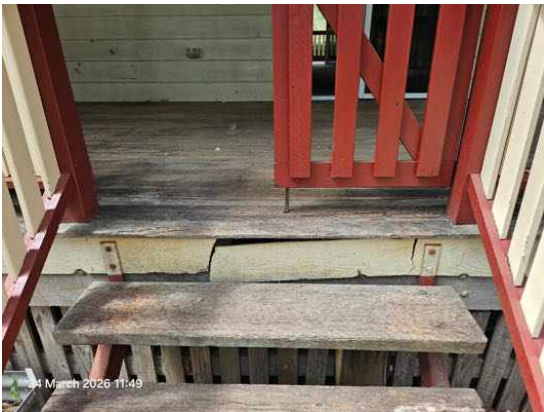
Building: Main Building
Location: All External Areas
Finding: Damaged cladding
Information: The images shown here are an indicative set of photographs of the damaged areas of fibre cement sheet and hardieplank cladding of the homes external walls.

The services of a licensed carpenter or suitably qualified handy person could be sought to repair the walls.

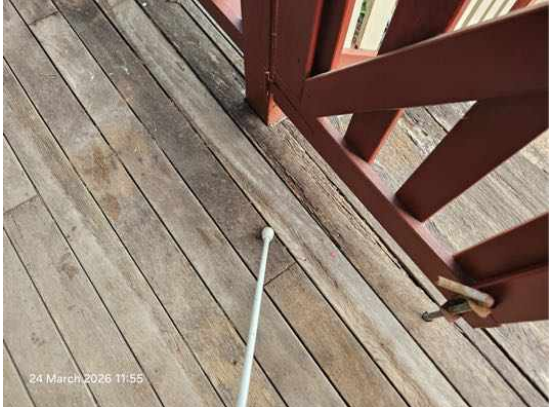
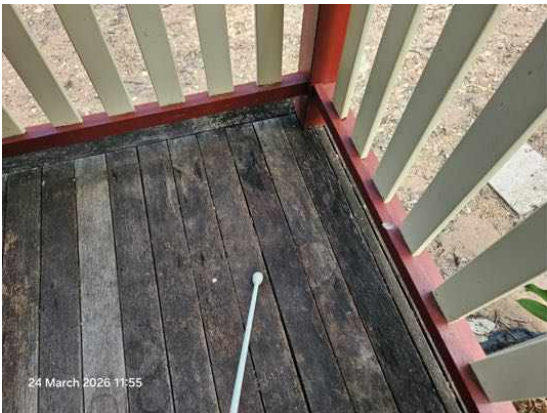
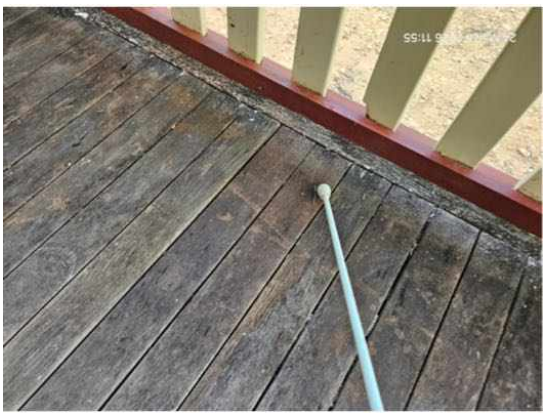
Finding 3.03

Building:	Main Building
Location:	Deck
Finding:	Decking and steps - deteriorating
Information:	During the inspection it was noted that many of the decking boards and some of the step treads are showing signs of deterioration and early stage wood rot. This will happen over time to timber building elements continually exposed to weather and the elements.

Over time at the clients discretion, the boards could be replaced as required. This could be done by the client, a licensed carpenter or a general handyman.

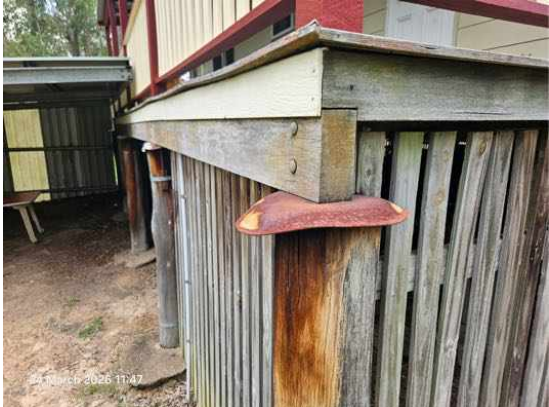
Finding 3.04

Building: Main Building
 Location: All External Areas
 Finding: Ant caps, timber pest barrier
 Information: On the day of inspection it was observed that the ant caps to the timber stumps of the sub floor are rusted. These components are an integral part of the timber pest management system and should be maintained in good order.

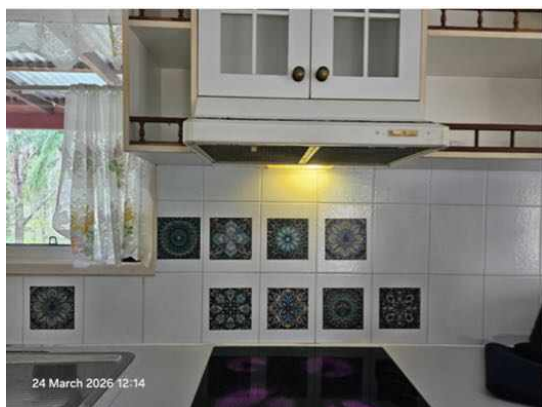
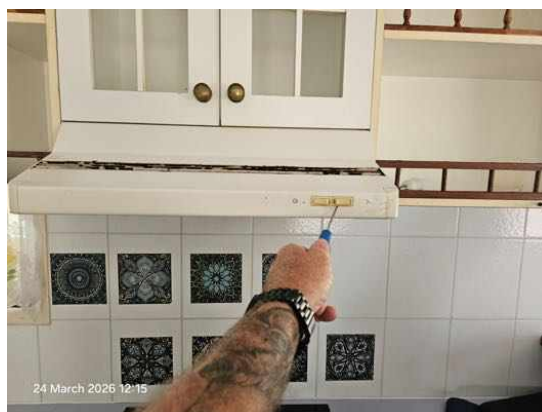
Finding 3.05

Building: Main Building
 Location: Kitchen
 Finding: Rangehood - faulty
 Information: The range hood appears to be faulty. The fan did not turn on.

A licensed electrician or licensed appliance repair technician could be appointed to replace the unit.

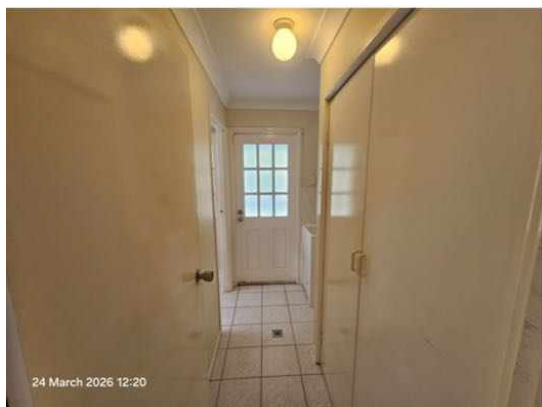
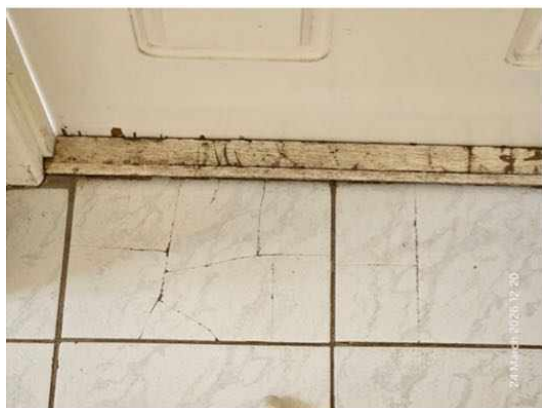
Finding 3.07

Building: Main Building
 Location: Laundry
 Finding: Cracked ceramic tiles
 Information: Cracking in the ceramic tiles of the laundry was evident in this area at the time of inspection.

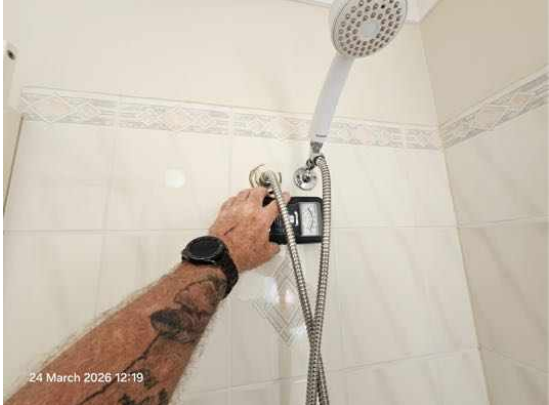
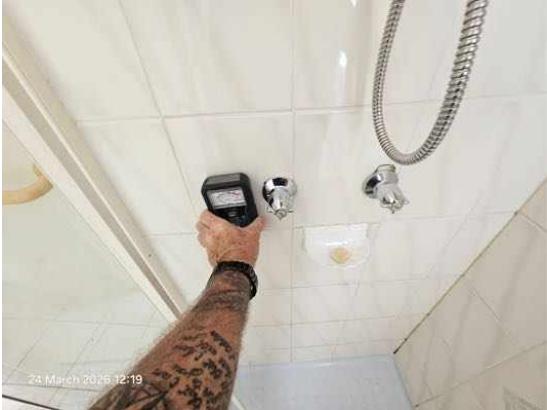
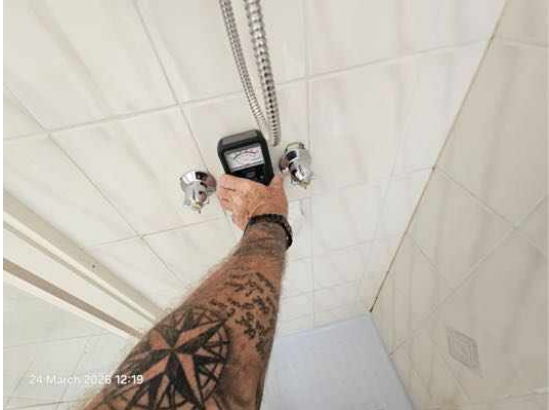
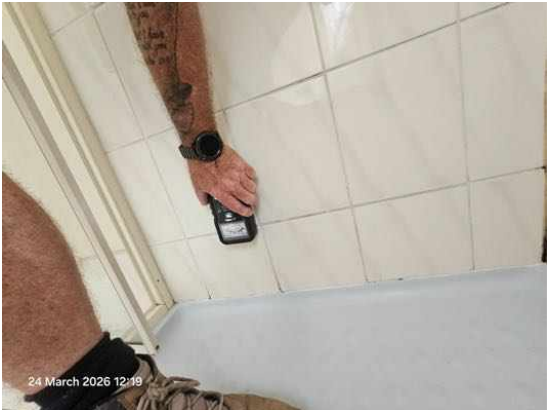
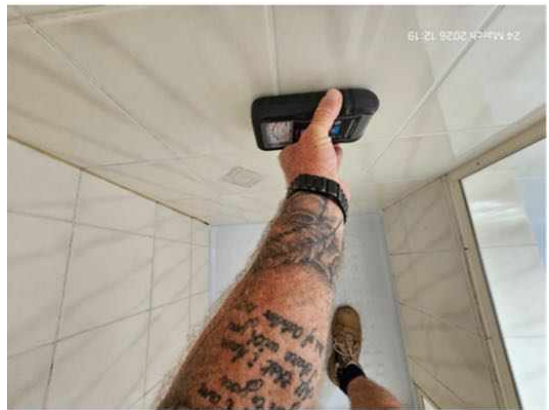
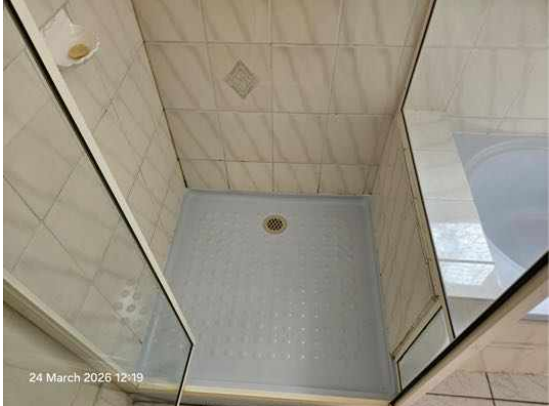
Finding 3.08

Building: Main Building
 Location: Bathroom
 Finding: No moisture detected in bathroom / ensuite
 Information: On the day of inspection the shower in the bathroom was measured for moisture using a "Tramex" moisture meter. During this inspection no moisture was detected in these areas and the tiled / sheeted surfaces appear to be in fair to good order.

The sealants require renewal and at the tap connections, the silicone is deteriorated and a cracked tile was noted above the cold tap.

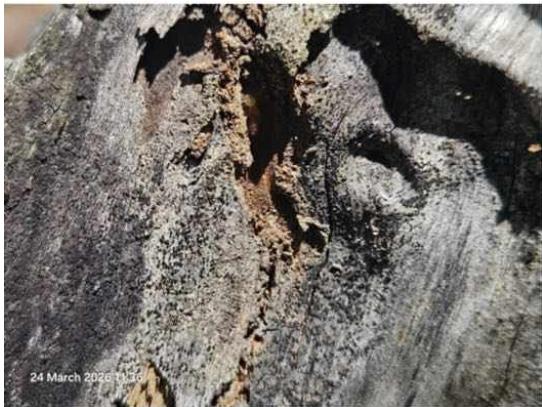
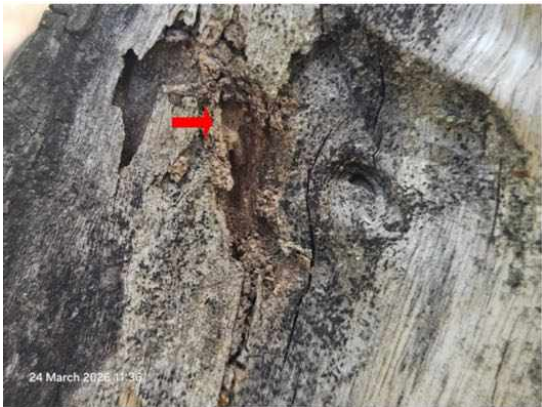
Building: Yard
Location: As shown
Finding: Termite damage - active presence
Information: During the inspection of the yard termite activity was observed. As shown in the photographs, active termites are seen in the tree stump.

It is highly recommended that a pest controller be engaged to carry out the required program to eliminate this activity.

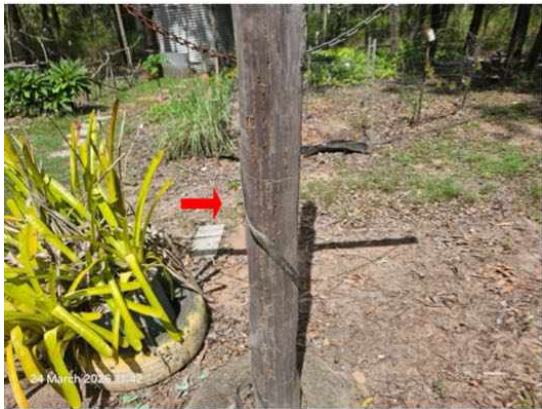
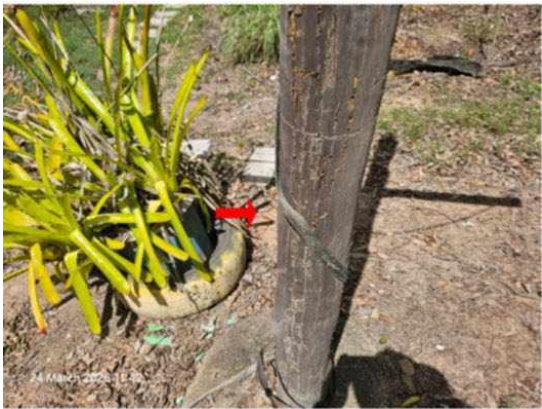
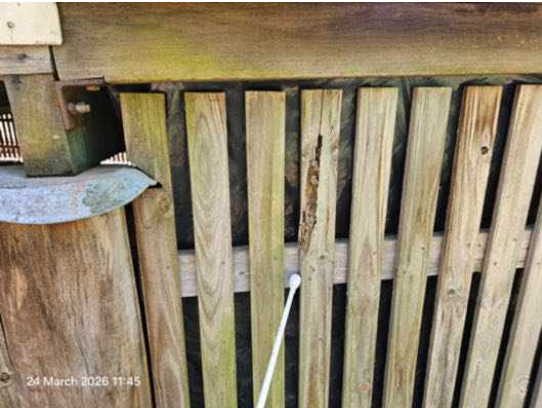
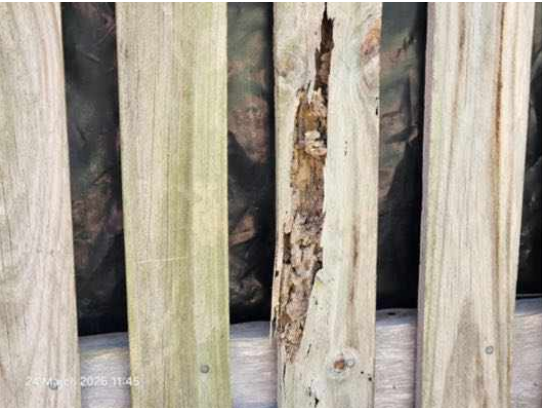
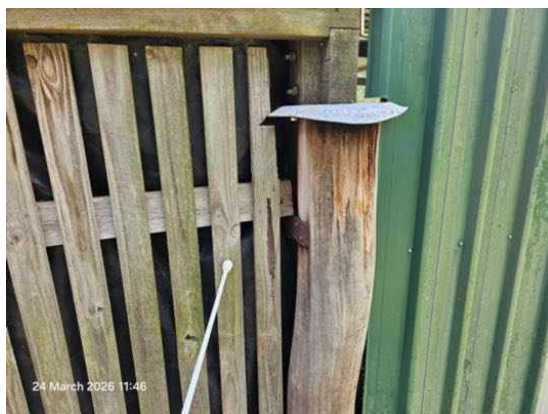
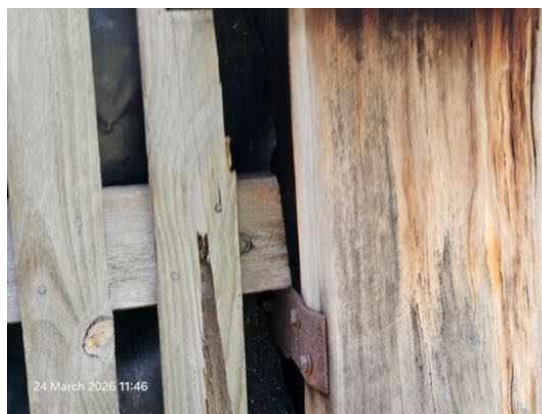
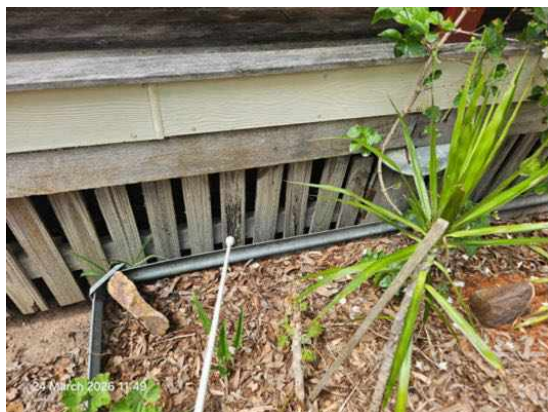
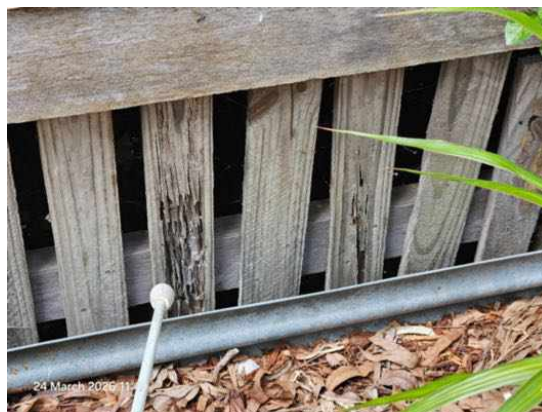
Finding 5.01

Building: Yard
 Location: As shown
 Finding: Evidence of previous inactive termite damage
 Information: On the day of inspection an area of minor inactive termite damage were noted. The damage is localised and appears to be confined to the pole beside the driveway and the slats of the subfloor.

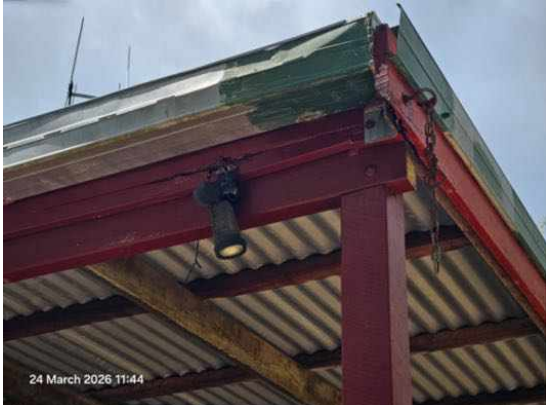
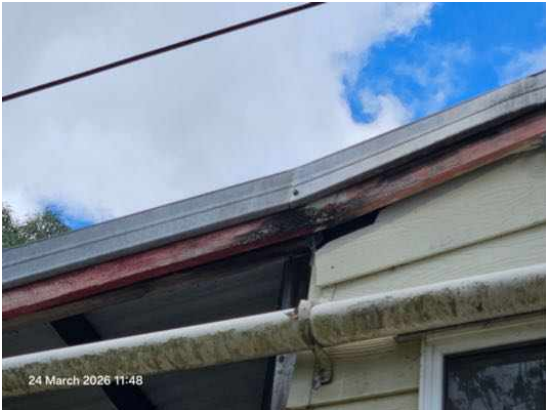
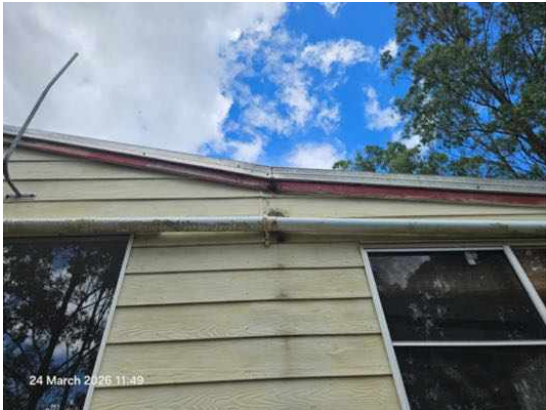
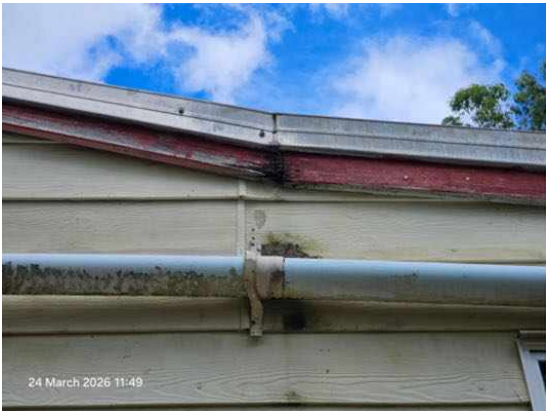
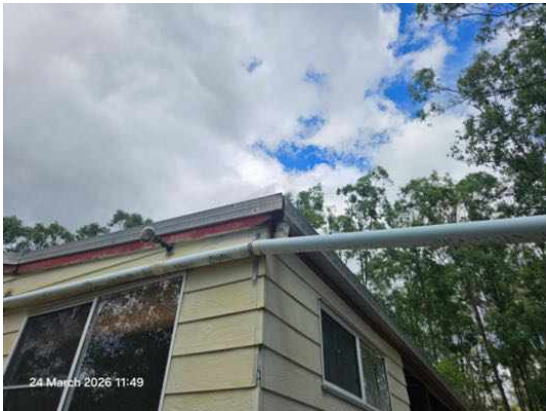
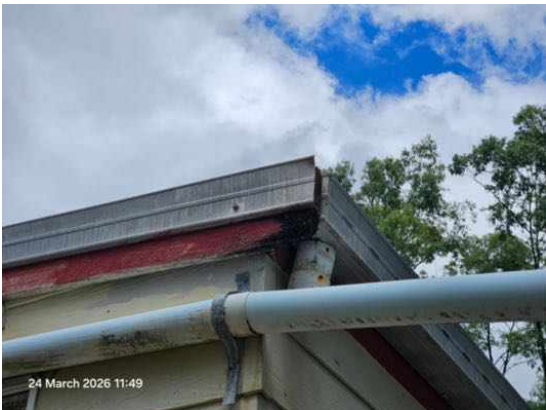
Finding 6.01

Building:	Main Building
Location:	Fascia's
Finding:	Wood rot / fungal decay
Information:	The timber components show evidence of wood rot beginning in various sections of the timber.

Wood rot, also known as Fungal Decay, occurs when timbers and other cellulose building materials are exposed to damp conditions on an ongoing basis. This could be the result of exposure to weathering over a prolonged period of time, or the attraction of excessive moisture from other abutting building materials.

Early intervention and regular maintenance, particularly of exterior timbers, will prolong the useful life of these building elements. Prior to any works being performed, the cause of the moisture that has created the visible wood rot should be identified and addressed in a suitable manner. Replacement of affected timbers may then be a necessary step in protecting surrounding building elements from such deterioration.

A licensed carpenter or licensed builder should be consulted to advise on a solution for the affected building materials.

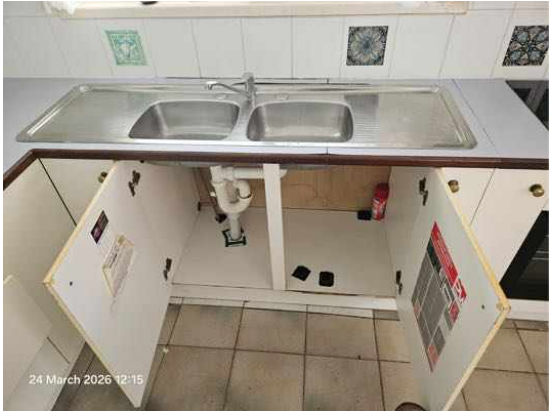
Building: Main Building
 Location: Meter box, kitchen cupboard
 Finding: Durable pest inspection notice - out of date
 Information: On the day of inspection it was noted that the durable pest inspection / treatment notice was missing, not visible or out of date. These notices / stickers are to verify the timber pest inspection dates, the inspector, the currency and type of timber pest system / barrier in place or being used in and around the property.

There has been an annual inspection programme is in place previously. It was out of date on the day of inspection and will fall due 12 months from this inspection.

It is recommend that the inspector of the day or a licensed timber pest controller be contacted to assess the properties needs and provide costings for an annual inspection programme.

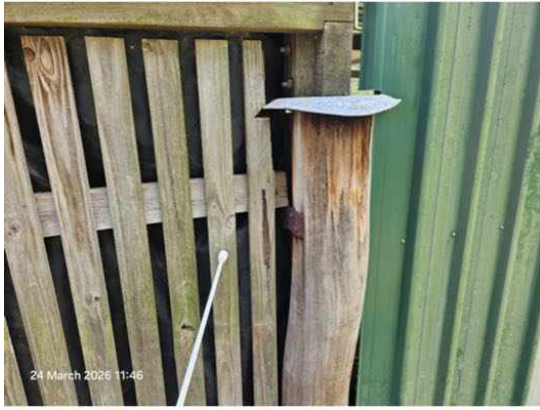
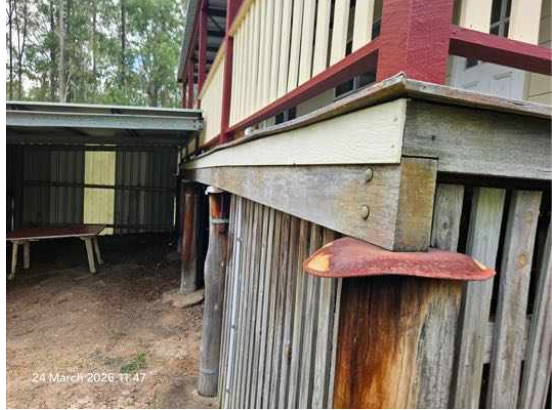
The building employs a physical barrier system to the subfloor in the form of ant caps and has had a chemical barrier applied in 2022. It may prudent to have a licensed pest controller re-assess the barrier for currency.

In order for a barrier system to be effective, the property must have regular inspections at intervals of not greater than 12 months. Depending on the risk profile attributed to the property, these inspections may be recommended at lesser time periods.
