Building and Timber Pest Inspection Report

Inspection Date: Mon, 16 Mar 2026

Property Address: 17 Bandicoot Dr, Woodcroft NSW 2767,
Australia

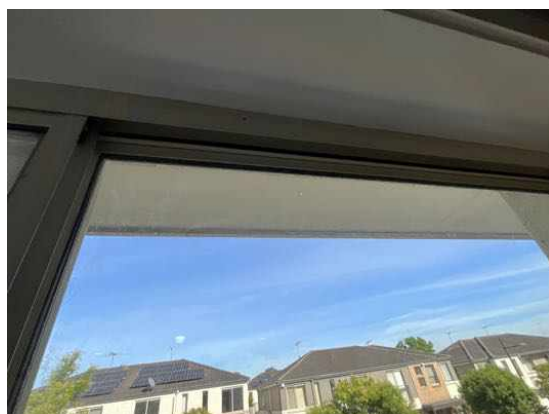
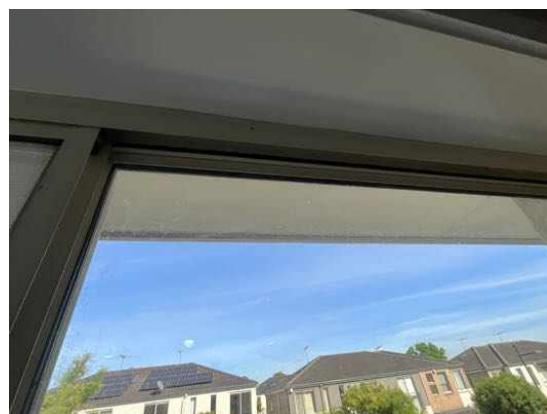
Finding 1.01

Building:	Main Building
Location:	All Areas
Finding:	Window child lock missing
Information:	The window in question lacks a child lock mechanism, which poses a potential safety risk to young occupants in the premises. As per Australian Standards windows accessible to children should be equipped with appropriate child safety locks to prevent accidental opening, reducing the risk of falls and ensuring compliance with safety regulations.

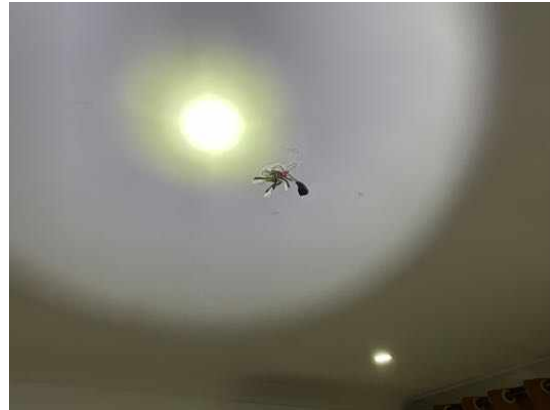
Finding 1.02

Building:	Main Building
Location:	Bedroom - Master
Finding:	Poor workmanship
Information:	The structure exhibits signs of poor workmanship, evident in various aspects of construction and finishing.

Risk: Poor workmanship poses a range of risks, including compromised structural integrity, potential safety hazards, and a decreased lifespan of the structure. It may also lead to aesthetic and functional issues.

Resolution: A qualified contractor or construction professional should be consulted to assess and address the poor workmanship. They can implement corrective measures to ensure structural soundness, safety, and overall quality of the construction.

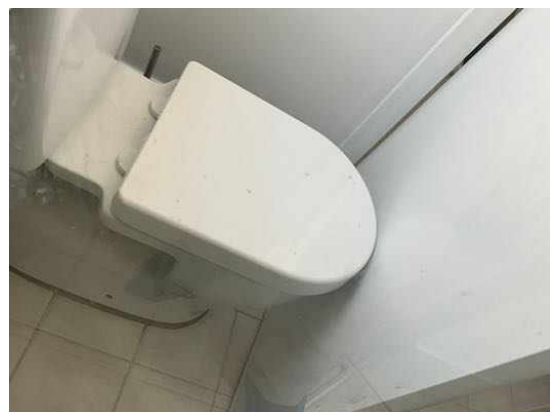
Finding 1.03

Information: A safety hazard was identified in the bathroom of the property. The issue pertains to the door, which, when fully opened, makes contact with the adjacent toilet. This situation poses an immediate risk to the safety and well-being of occupants due to the potential for accidents and injuries.

Collision between the door and the toilet can cause injury to individuals using the bathroom.

The repeated contact between the door and the toilet can also result in damage to both fixtures, leading to costly repairs or replacements.

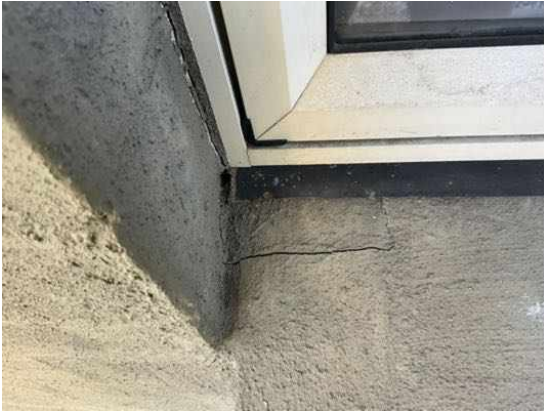
Building: Main Building
 Location: All Areas
 Finding: Brickwork - Cracking [Fine]
 Information: Although fine cracks are quite noticeable, they are often only considered to be an appearance defect and usually do not indicate any structural damage. Generally, the

cause of a fine crack is indicative of a separation between brickwork and mortar throughout the structure, but single bricks may also show cracks of this nature.

Cracking of this nature can generally be repaired with minor filling and should be conducted by a qualified bricklayer.

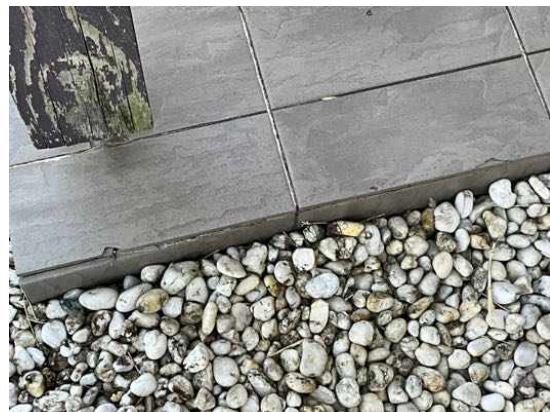
Finding 3.02

Building: Main Building
 Location: Front porch
 Finding: Tile - Floor Tile Damaged
 Information: A floor tile is visibly damaged, showing a chipped/broken section on the surface.

The damaged tile presents a trip hazard, may lead to cuts if stepped on barefoot, and can allow moisture ingress into the substrate, which may cause further deterioration or loosening of adjacent tiles. It also affects the overall appearance of the floor.

A licensed tiler should be engaged to remove the damaged tile and install a matching replacement. If spare tiles are unavailable, additional remedial work may be required to blend the repair with surrounding finishes.

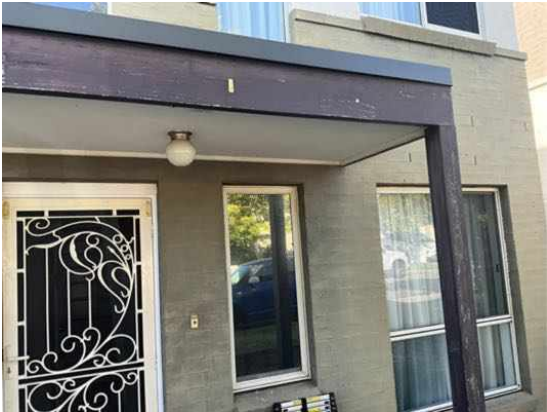
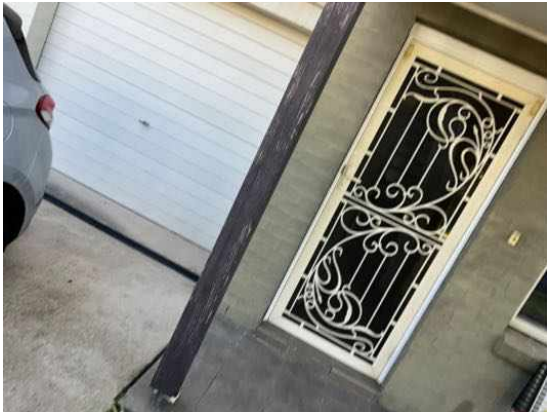
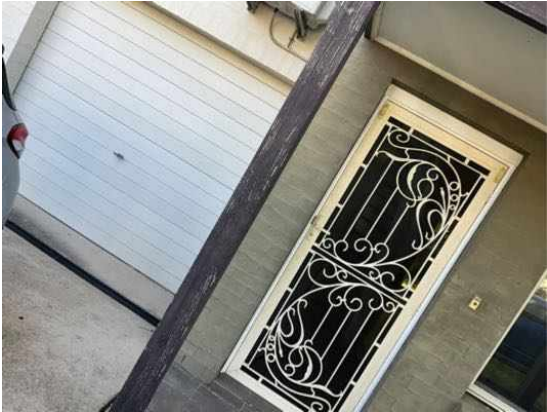
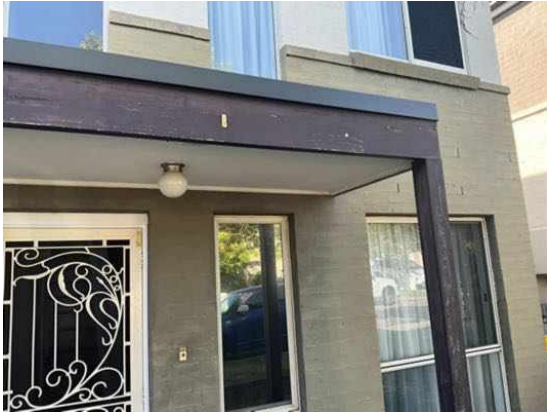
Finding 3.03

Building: Main Building
 Location: Front porch
 Finding: Timber - exposed to weather

External timbers that are frequently exposed to harsh weather conditions require adequate protection in order to maintain their condition. Where timbers have not been painted or treated adequately, general deterioration is likely to occur at an accelerated rate.

If left unattended, replacement of these timbers is likely to be necessary in the short-term future. Adequate treatment of these timbers is required as soon as possible by a painting contractor or general handyman.

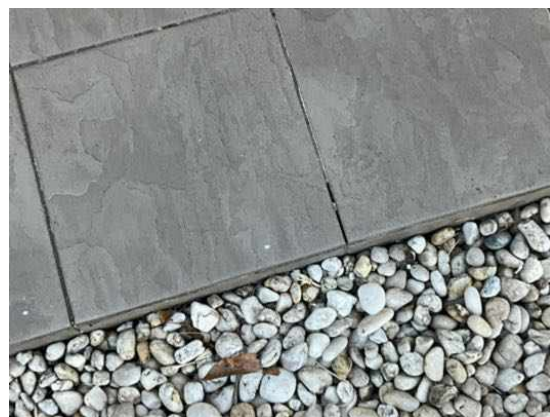
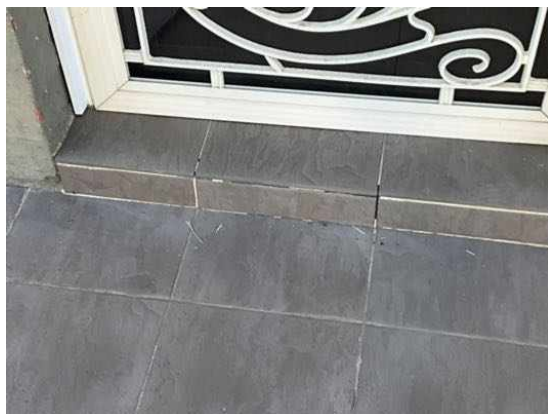
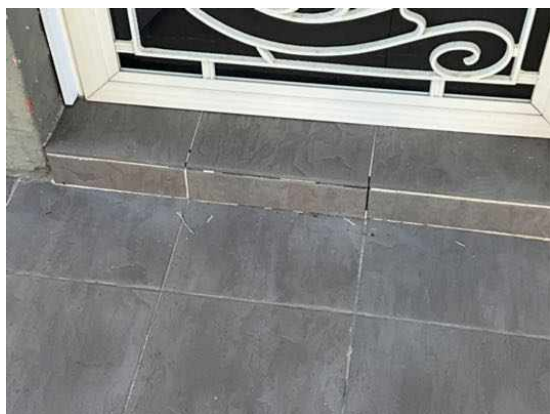
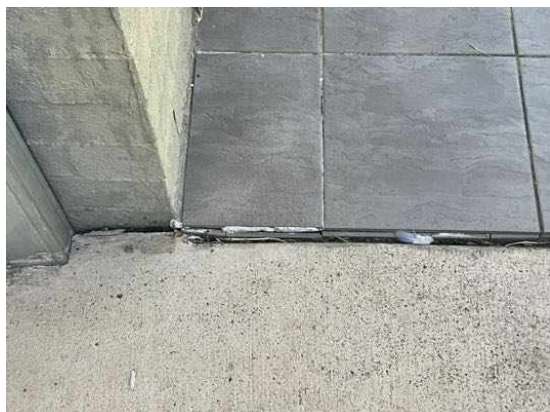
Finding 3.04

Location: Front porch
Finding: Grouting - Missing or damaged
Information: It was noted on inspection that sealant or grout is Missing or damaged. A flexible sealant is required to allow for expected expansion and contraction, while keeping the joint water tight and protective of all associated building materials.

Flexible and mould resistant materials should be applied to affected areas to prevent any subsequent water damage that is likely to occur. Regular maintenance and replacement of damage or missing or damaged sealant and grout is highly recommended , as this is a regular wear and tear defect.

A sealant specialist or tiling contractor should be appointed to complete these works as soon as possible

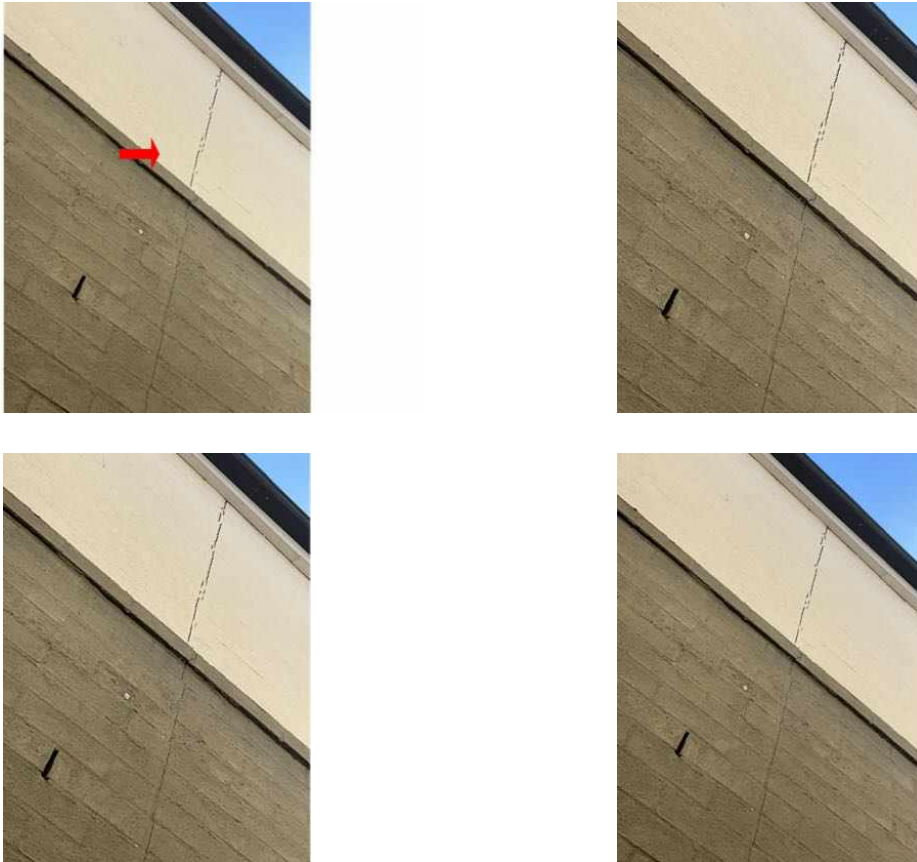
Finding 3.05

Building: Main Building
 Location: Exterior walls - right side
 Finding: Expansion Joint – Sealant Deterioration
 Information: The vertical expansion joint between the cladding and brickwork is observed with an open gap and missing or deteriorated sealant. Expansion joints are designed to allow thermal and structural movement between materials; however, the current joint condition may compromise weatherproofing.

Minor – If left unsealed, water penetration may occur behind the wall, causing dampness, efflorescence, or damage to internal materials over time.

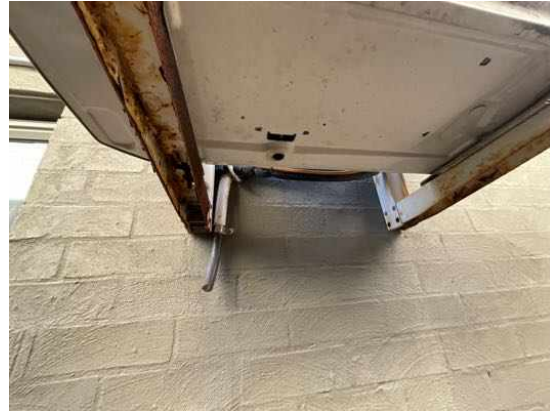
Finding 3.06

Building:	Main Building
Location:	Exterior walls - right side
Finding:	Air conditioner - Disconnected overflow
Information:	The Air Conditioner (A/C) overflow was found to be disconnected from storm water drainage and is creating excessive moisture in the surrounding area.

Such leaking creates an environment which is conducive to an array of defects, including water damage to associated building elements and the attraction of termite or timber pest infestation.

It is highly recommended that a licensed plumber be appointed to connect the A/C overflow in order to prevent such an environment from being created. These minor works should be carried out as soon as possible.

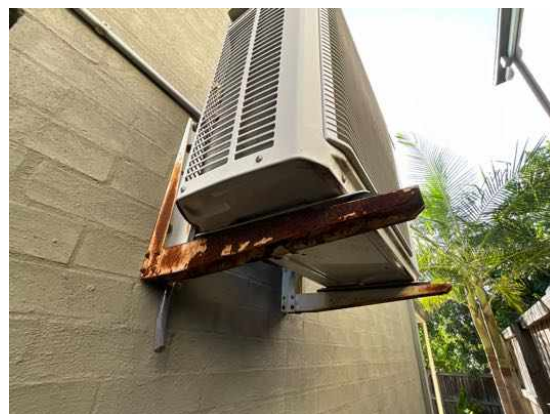
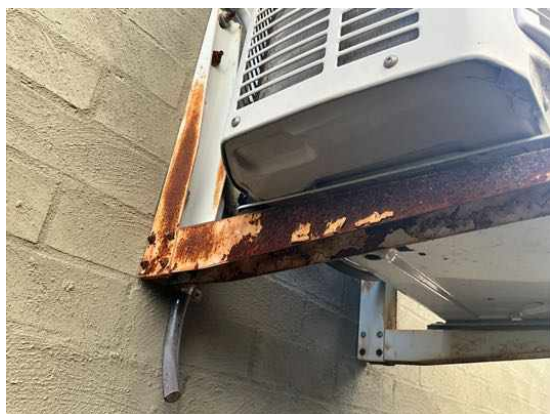
Finding 3.07

Building:	Main Building
Location:	Exterior walls - right side
Finding:	Building element - Rusted or corroded
Information:	This building element shows evidence of rusting and corrosion, which is likely to have developed as a result of excessive exposure to moisture and or inadequate coatings.

As surface rust provides no protection to the underlying iron, the deteriorating condition is likely to worsen if not addressed in the short-term future.

Rusting and corrosion should be managed by ideally removing or limiting the affected surface from exposure to moisture. A registered builder may be appointed to replace any building elements that have been severely affected by rust or water damage.

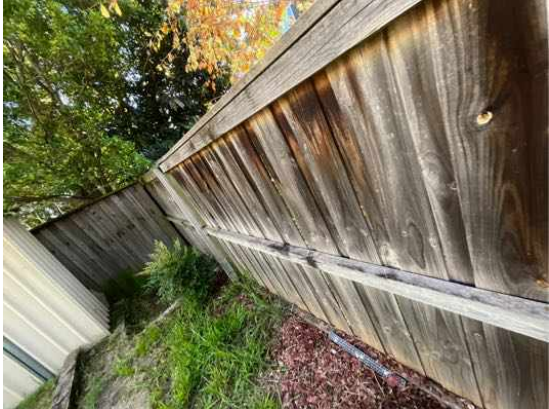
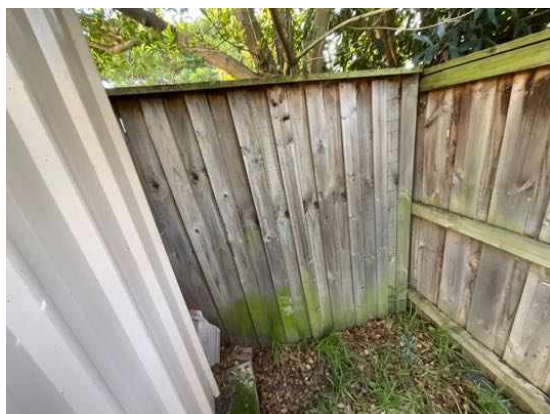
Finding 3.08

Building:	Main Building
Location:	All Areas
Finding:	Deteriorated fence
Information:	The fence along the property boundary has deteriorated significantly, showing signs of rot, rust, and structural weakness. Several sections are leaning or have become detached, compromising the integrity of the fence and its ability to perform its intended function.

1. **Safety Hazard:** The unstable fence may collapse, posing a risk of injury to residents, visitors, and passersby.
2. **Security Concern:** The compromised fence may allow unauthorized access to the property, increasing the risk of theft, vandalism, or trespassing.
3. **Property Damage:** Falling sections of the fence could damage nearby structures, plants, or other property features.

- **Licensed Fencing Contractor:** A professional fencing contractor should be hired to assess the extent of the damage and either repair or replace the deteriorated sections.
- **Handyman Services:** For minor repairs, a qualified handyman could be engaged to reinforce or repair specific sections of the fence.
- **Landscaper (if the fence is part of a larger garden feature):** If the fence is integrated into the landscape design, a landscaper with experience in fencing could be involved in the repair or replacement process.

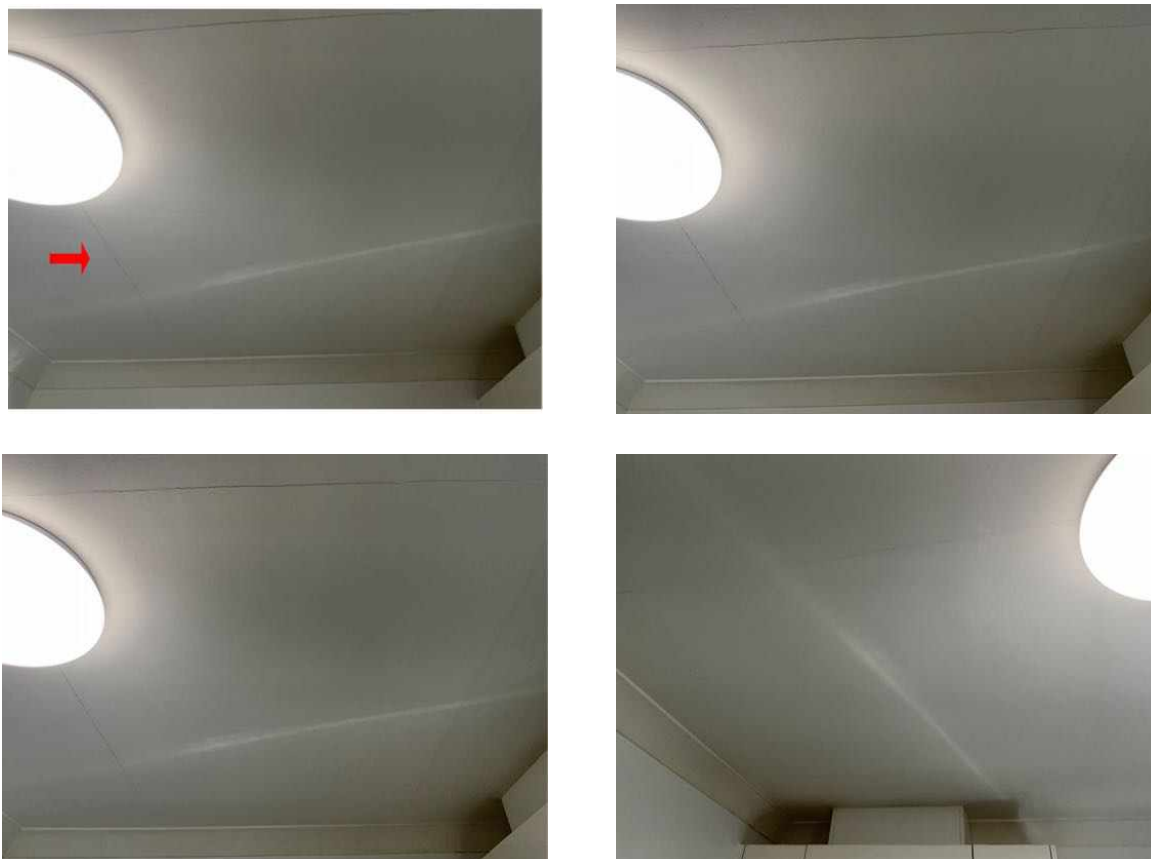
Finding: Gyprock - Fine Cracking

Information: Fine cracks were observed in the plasterboard wall. These cracks are likely due to minor building movement or settlement and are generally considered cosmetic in nature.

- A licensed plasterer or painter can fill the cracks with a flexible compound and repaint the affected area.

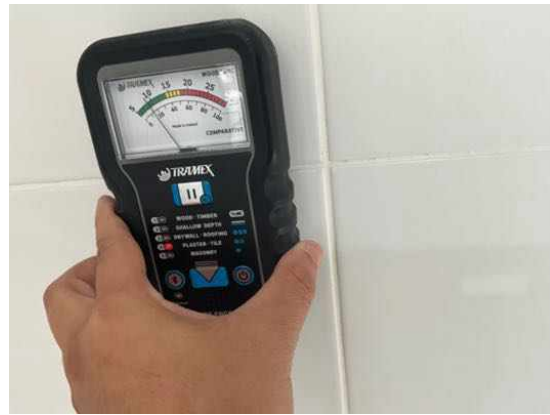
Building:	Main Building
Location:	Bathroom
Finding:	Shower - Damp
Information:	Damp is evident to the lower 300mm of wall to the shower alcove. This defect is quite common, and is suspected to have been caused by moisture permeating through the grouting in this area, which shows evidence of deterioration. Leaking pipes within the adjoining wall is also a possible cause.

Damp (or structural damp) refers to the presence of unwanted moisture in the structure of a building, either as the result of intrusion from outside, or condensation from within the structure. In the shower area, internal water leaks or other sources of excessive moisture are generally the cause of damp.

Unmanaged damp in the shower recess is likely to facilitate the formation and development of mould and fungi growth, decaying associated building materials and compromising their structural integrity. It is important to address damp conditions, as the World Health Organisation notes that excess moisture leads - on almost all indoor materials - to growth of microbes such as moulds, fungi and bacteria, which subsequently emit spores and other matter into the indoor air. Exposure to these contaminants is associated with a wide range of respiratory and other health-related problems.

Consultation with a qualified plumber or bathroom specialist is advised immediately to identify the cause of damp and to perform remedial works as required. Where excessive mould growth is present, further inspection by a specialist environmental health inspector should also be considered.

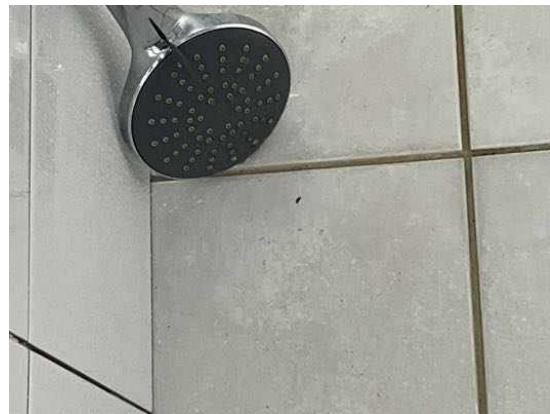
Finding 3.15

Building: Main Building
 Location: Bathroom
 Finding: Leaking plumbing fitting
 Information: Leaking plumbing fitting identified, posing the risk of water damage and increased water bills.

Potential structural damage, mold growth, and wastage of water resources.

Engage a licensed plumber to inspect and repair the leaking plumbing fitting, ensuring a proper seal and preventing any further water-related issues.

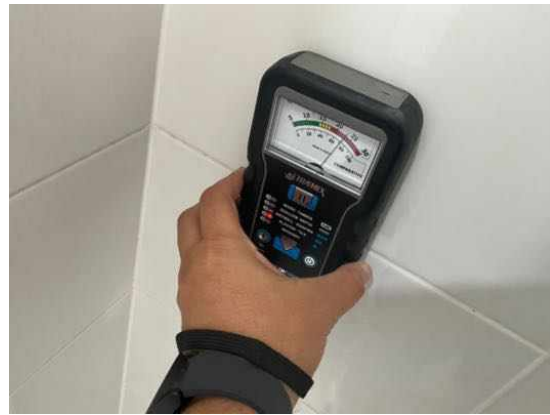
The prolonged presence of moisture can lead to mold growth, deteriorate the structure, and create an environment conducive to health hazards. Additionally, it may compromise the adhesive holding the tiles, leading to their detachment.

A licensed plumber or a qualified contractor specializing in water damage remediation should investigate the source of the moisture, fix any leaks, and address the damage. Additionally, replacing affected tiles and ensuring proper waterproofing are crucial to preventing future issues.

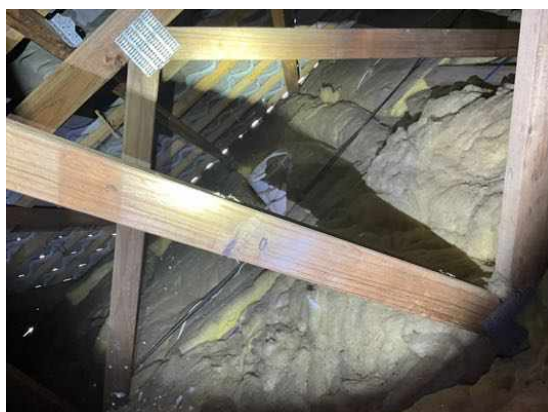
Finding 3.18

This condition may lead to excessive condensation within the roof void, increasing the

It is recommended that the exhaust fan be modified by a licensed HVAC contractor or qualified builder, ensuring it is properly ducted to discharge externally in accordance with manufacturer specifications, the National Construction Code (NCC), and applicable Australian Standards.

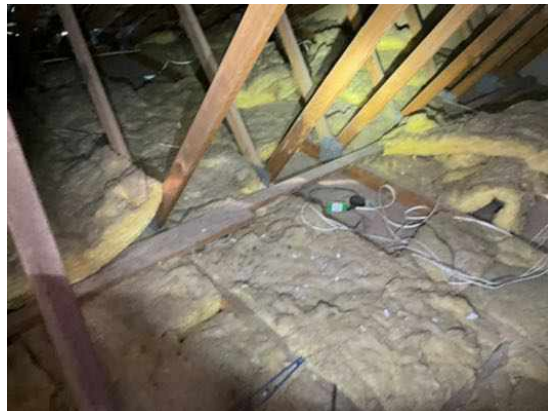
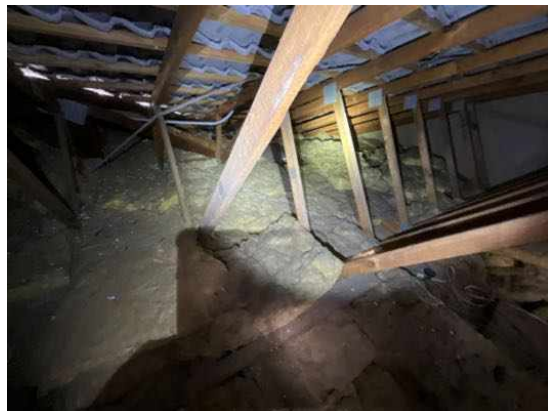
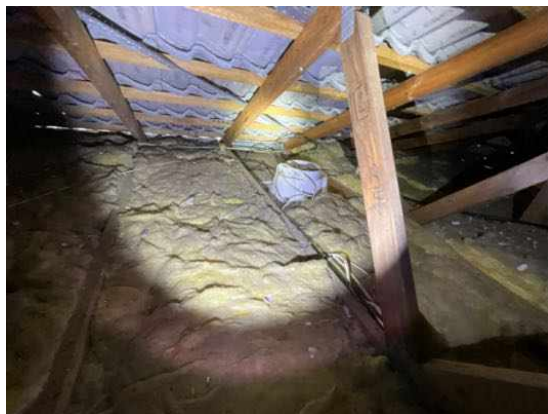
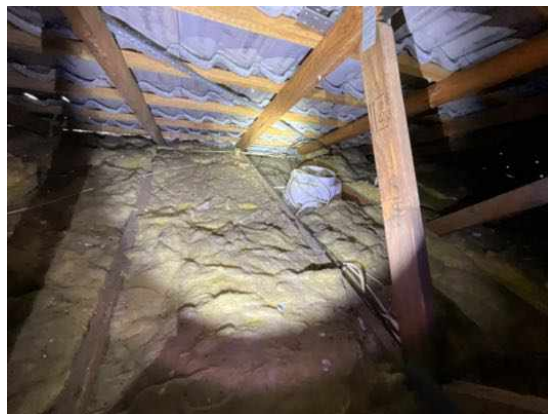
Finding 3.19

Building:	Main Building
Location:	Roof Void
Finding:	Sarking - Missing
Information:	Sarking is missing under the roof sheeting. Sarking acts as an insulator that helps with noise reduction and protects against water penetration. Sarking plays a key role in the operation and function of the overall roofing structure and its performance.

Although not a requirement at the time of construction, replacement of any missing building element is advisable (although this can be quite expensive to do after the time of construction). Where sarking is missing, regular inspections of the roof tiles for cracking and potential moisture penetration is required.

Sarking may be retrospectively fitted by a registered builder at the discretion of the client.

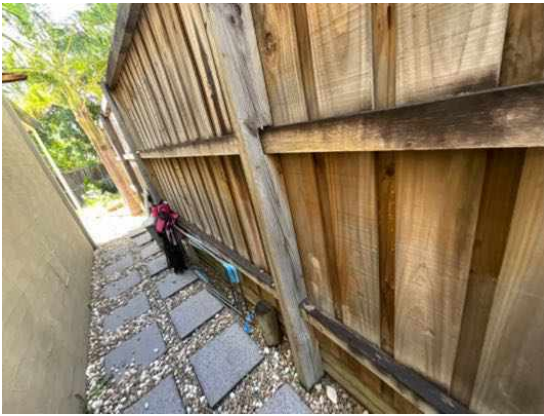
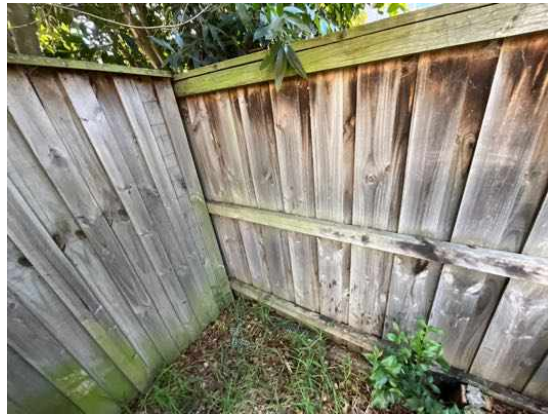
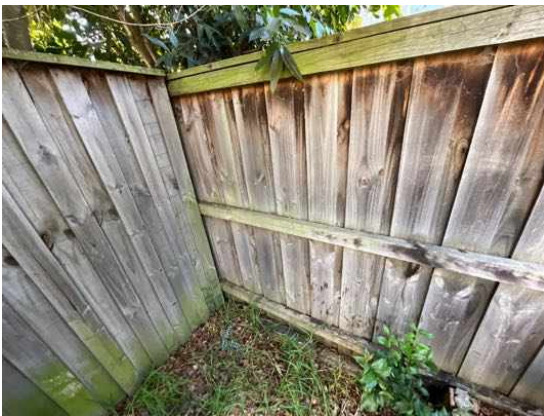
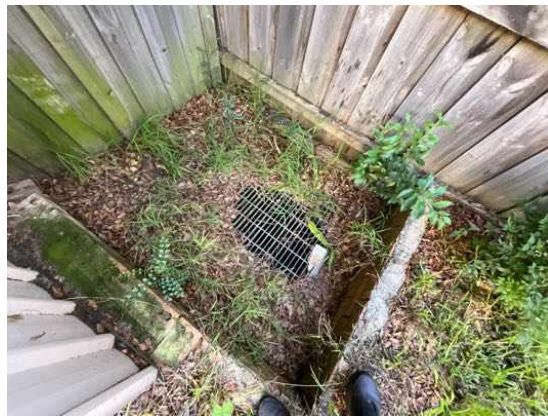
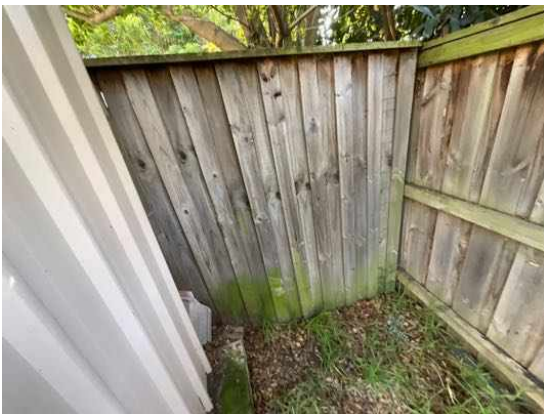
Finding 6.02

Building: Main Building
Location: All Areas
Finding: Timber on ground / conducive conditions to termite damage
Information: Timber on the ground is indeed conducive to termite damage. Termites are known to thrive in moist environments, and wood in contact with soil or moisture is more susceptible to infestation.

To prevent this, it's important to keep timber elevated and away from direct ground contact. Regular inspections and proper termite control measures are also essential to protect your wooden structures from termite damage.

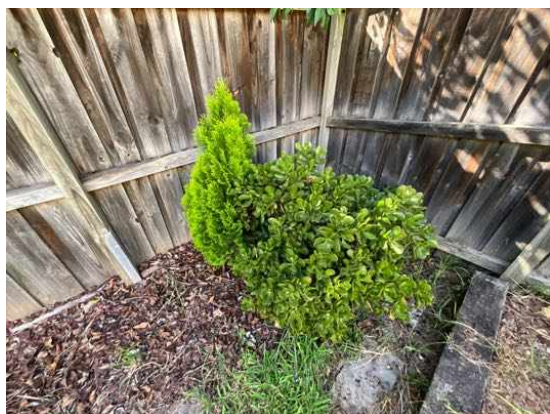
Finding 6.03

Building:	Main Building
Location:	All Areas
Finding:	vegetation around a property can increase the risk of termite infestation
Information:	The presence of vegetation around a property can increase the risk of termite infestation, as it provides a conducive environment for them. To address this, consider maintaining a clear space between the vegetation and your home. If you suspect a termite issue, it's advisable to consult with a licensed pest control professional for inspection and treatment.

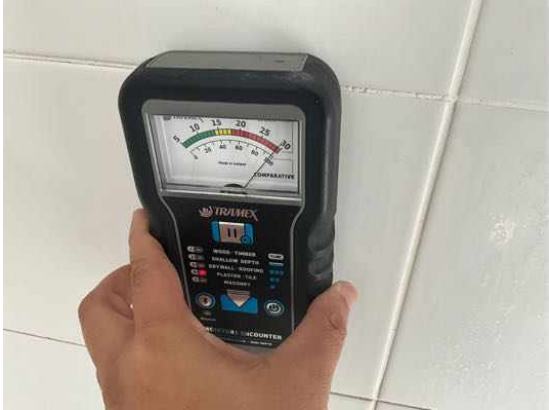
The prolonged presence of moisture can lead to mold growth, deteriorate the structure, and create an environment conducive to health hazards. Additionally, it may compromise the adhesive holding the tiles, leading to their detachment.

A licensed plumber or a qualified contractor specializing in water damage remediation should investigate the source of the moisture, fix any leaks, and address the damage. Additionally, replacing affected tiles and ensuring proper waterproofing are crucial to preventing future issues.

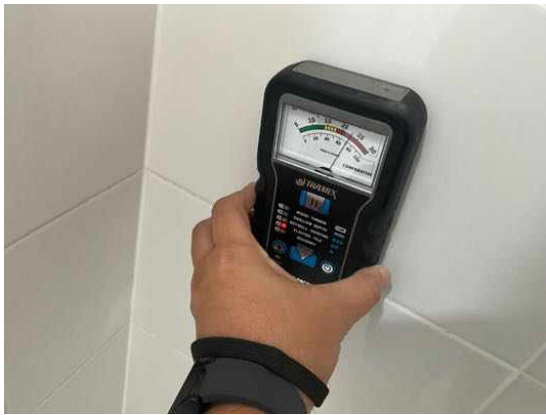
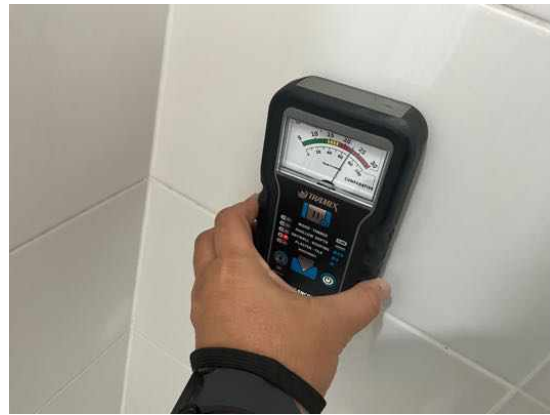
Finding 6.10

Building:	Main Building
Location:	Ensuite
Finding:	Excessive moisture - Conducive to Timber pest
Information:	Excessive moisture can attract termites and produce conditions that promote fungal growth and wood decay.

Prior to any remedial works being performed a qualified plumber should be appointed to further inspect the property and to identify the cause of the excessive moisture. Works to remove affected building elements may then be necessary and should be performed by an appropriate tradesperson.
