Building Inspection Report

Inspection Date: Mon, 30 Mar 2026

Property Address: 2 Paxton Link, Pakenham VIC 3810,
Australia

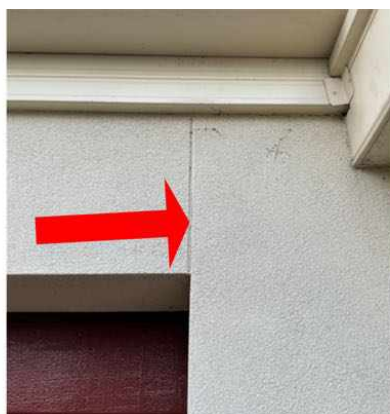
Defects 3.01

When these joints are covered by rigid finishes such as render, the ability of the structure to move freely is reduced. This can lead to cracking in the render or adjacent building elements over time, and may also contribute to moisture ingress if movement causes gaps or fractures in the render.

It is recommended that the rendered-over section be carefully removed to expose the expansion joint, and the joint reinstated with an appropriate flexible sealant or control joint system to ensure it continues to function as intended.

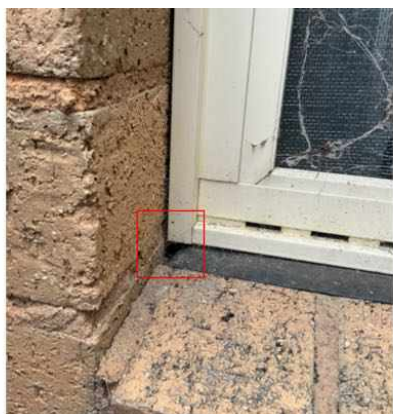
Defects 3.03

Building: Main Building
 Location: All External Areas
 Finding: Window seals - deteriorated
 Information: The window seals have deteriorated and are in a generally poor condition. Due to frequent exposure to weather conditions and subsequent moisture, deterioration of

window seals is expected in a property of this condition and age.

Where window seals have deteriorated, the window is no longer weather-tight; rain penetration and subsequent water damage is therefore likely to ensue. Insulation of the area against external weather conditions will also be compromised.

It is recommended that all deteriorated window seals be replaced by a general handyman or sealant expert to prevent any further damage and to restore the window to a fully functional level.

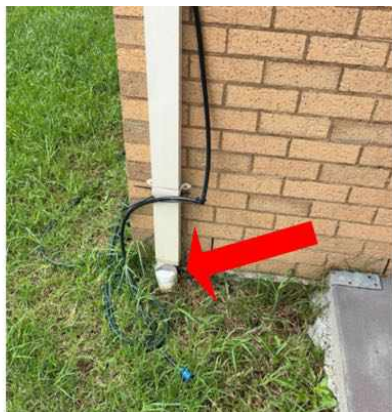
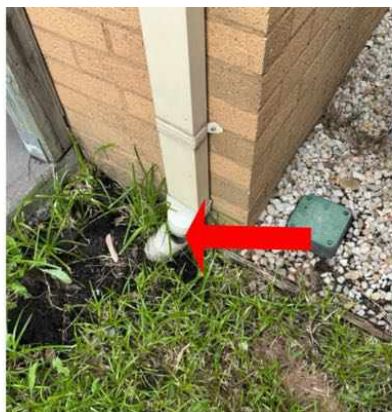
Defects 3.04

Building:	Main Building
Location:	All External Areas
Finding:	Broken Downpipe Connections
Information:

Two downpipes were observed to be broken at their connections to the stormwater system at the time of inspection.

This condition can result in uncontrolled discharge of rainwater at the base of the structure, leading to excessive moisture accumulation, increased risk of termite activity, and potential deterioration of footings and surrounding building elements.

It is recommended that a licensed plumber be engaged as a matter of urgency to repair or replace the damaged downpipe connections and ensure proper discharge of stormwater away from the structure.

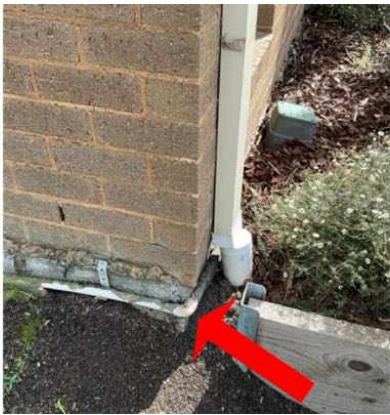
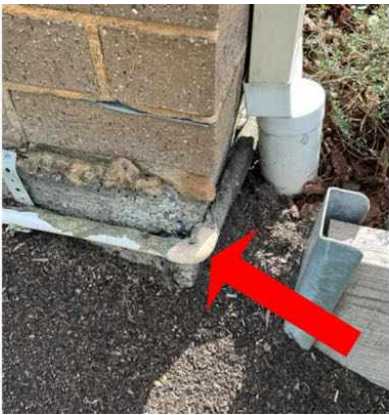
Defects 3.05

Building:	Main Building
Location:	Front Elevation
Finding:	Exposed Termite Reticulation Pipework
Information:	The termite reticulation system pipework was observed to be exposed above ground level at the base of the external wall, whereas such systems are required to be installed below ground level for proper function and protection.

This condition compromises the effectiveness of the termite management system, as exposed pipework may be damaged, tampered with, or fail to deliver adequate chemical distribution to the surrounding soil. It also increases the risk of deterioration due to environmental exposure.

It is recommended that a licensed pest control specialist reconfigure and reinstall the reticulation pipework in accordance with manufacturer guidelines, ensuring it is properly buried and protected to maintain system integrity and effectiveness.

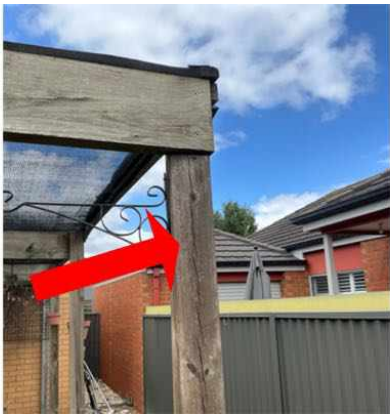
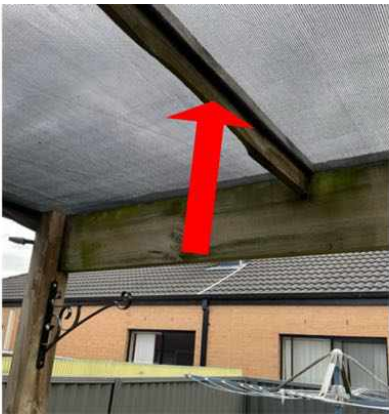
Defects 3.06

Building: Main Building
Location: Pergola
Finding: Weathering to Pergola Structure – Side Yard
Information:

The pergola structure in the side yard is showing signs of weathering and surface deterioration.

This condition indicates ongoing exposure to environmental elements, which may lead to accelerated timber degradation, reduced durability, and potential structural issues over time if left unprotected.

It is recommended that a qualified painter or maintenance contractor apply a suitable UV-resistant and weatherproof protective coating (stain or paint) to the pergola structure as soon as possible to preserve and protect the material.

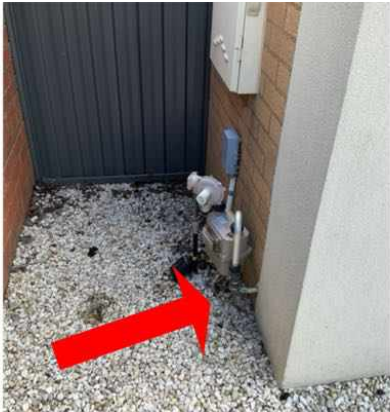
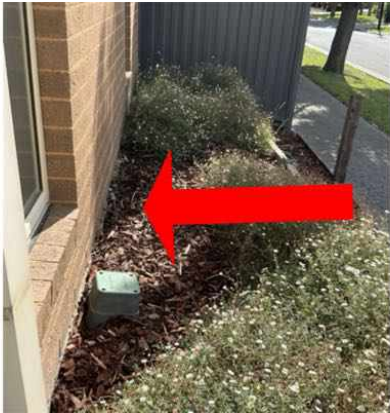
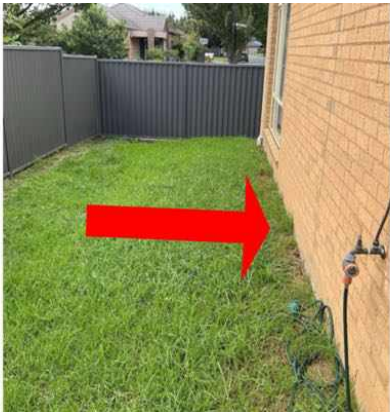
Defects 3.07

Building: Main Building
Location: All External Areas
Finding: Site drainage - Inadequate
Information:

The site drainage in all yards was found to be inadequate at the time of inspection, creating potential for subsequent water damage to associated building elements.

It is important that water does not lie against the base of walls; surrounding paths and ground levels should be sloped to drain water away from walls. Downpipes should not discharge stormwater onto lower walls or plinths. Stormwater should be carried away by large, regularly cleaned drains. Ground levels may need to be lowered to expose a buried DPC.

Where site drainage is inadequate, installation of an Agricultural (Aggie) Drain may be required. A qualified plumber should be appointed to further inspect the property and perform any remedial works as necessary. Water damage and secondary defects are likely to occur if left unmanaged.

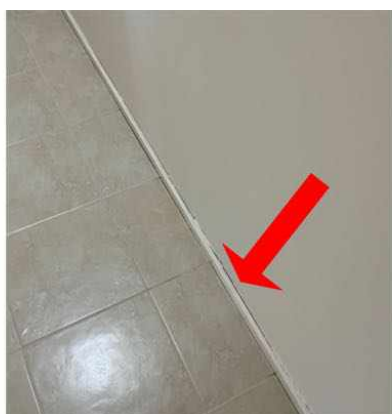
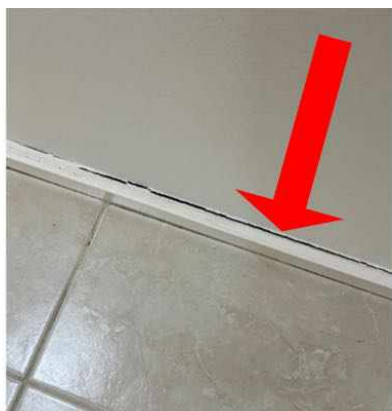
Defects 3.08

Building:	Main Building
Location:	Hallway
Finding:	Gaps and Separation to Skirting Boards – Hallway
Information:	The skirting boards in the hallway were observed to be splitting and forming small gaps at the time of inspection.

This condition is commonly associated with minor building movement and material shrinkage, which can result in loosening of fixings and visible separation over time.

It is recommended that a qualified carpenter re-secure the affected skirting boards, apply a suitable flexible sealant to fill the gaps, and carry out repainting as required to restore a neat and durable finish.

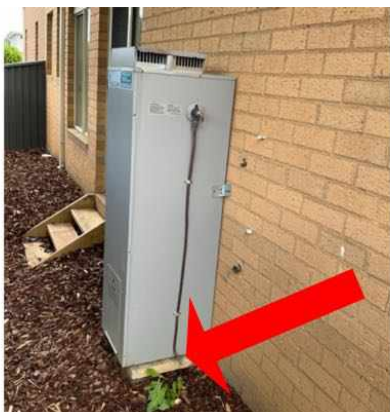
Defects 3.10

Building: Main Building
Location: Yard - Side
Finding: HWS Overflow - Not Connected
Information: The Hot Water System (HWS) overflow was found to be disconnected from storm

water drainage and is creating excessive moisture in the surrounding area.

These damp conditions can lead to secondary defects such as rot, rust or corrosion of associated building elements, the formation of fungal decay, or even the creation of potential slip hazards. When coupled with poor site drainage, pooling of water may also attract termite activity to this area.

It is highly recommended that a licensed plumber be appointed to connect the HWS overflow in order to prevent such an environment from being created. These minor works should be carried out as soon as possible.

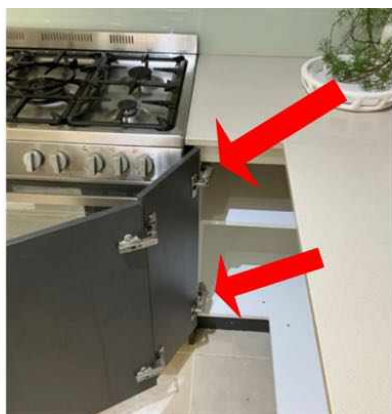
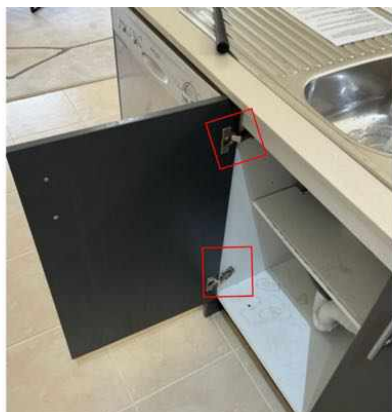
Defects 3.11

Building:	Main Building
Location:	Kitchen
Finding:	Loose and Unstable Kitchen cupboard Hinges
Information:	Upon visual inspection, it was observed that the kitchen cupboards exhibited signs of instability and looseness. The hinge was found to be improperly tightened, resulting in a wobbly and shaky doors. This condition may hinder the smooth operation of the drawer and could potentially lead to further wear or damage over time.

It is recommended that a handyman or qualified cabinet maker be engaged to assess and secure the hinge properly to restore full functionality and ensure the longevity of the cupboards .

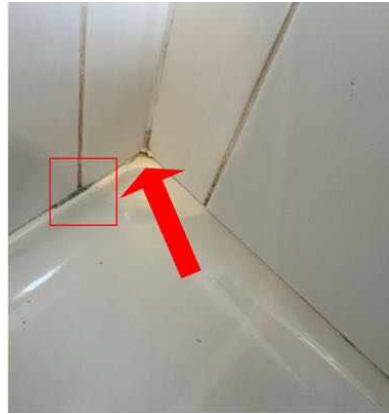
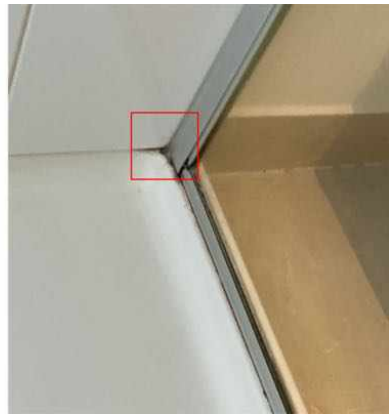
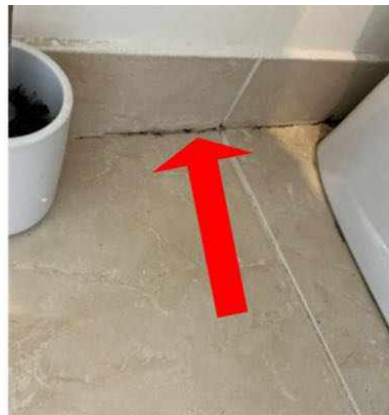
Defects 3.12

Building:	Main Building
Location:	Ensuite - Master
Finding:	Sealant and grouting - Minor deterioration
Information:	It was noted on inspection that sealant or grout is degraded to the tiled shower alcove and other areas of the bathroom.

Different materials and floor areas move at different rates, generally causing cracking to grout or sealant at this point. A flexible sealant is required to allow for expected expansion and contraction, while keeping the joint water tight and protective of all associated building materials.

Minor signs of mould were also observed in the bathroom.

Flexible and mould resistant materials should be applied to affected areas to prevent any subsequent water damage that is likely to occur. Regular maintenance and replacement of damage or missing or damaged sealant and grout is highly recommended to the wet areas, as this is a regular wear and tear defect. Sealant and grouting in areas that come into regular contact with water should be maintained for the long term care of your property.

A sealant specialist or tiling contractor should be appointed to complete these works as soon as possible

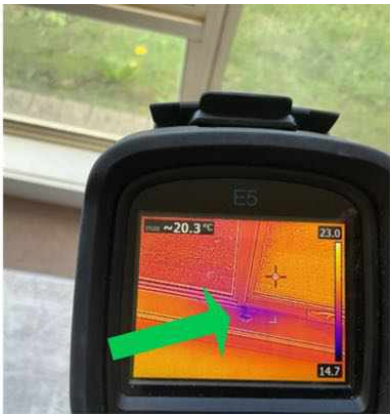
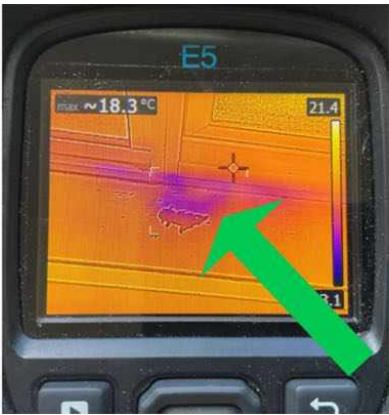
Defects 3.13

Building:	Main Building
Location:	Bedroom - Master
Finding:	Water Ingress and Moisture Damage – Master Bedroom Window - urgent rectification require
Information:	The window in the master bedroom shows signs of water damage to the windowsill, with elevated moisture readings recorded at the time of inspection. This condition is consistent with water ingress, likely due to gaps, failed sealant, or inadequate sealing around the window frame.

Ongoing moisture ingress can lead to deterioration of the window frame and surrounding building elements, as well as potential mould growth if not addressed promptly. The elevated moisture levels indicate that the issue may still be active or recurring.

It is recommended that a registered builder be engaged to carry out a detailed assessment of the window assembly, identify the source of water ingress, and undertake necessary rectification works. This should include resealing the window perimeter and ensuring the assembly is fully watertight to prevent further moisture penetration.

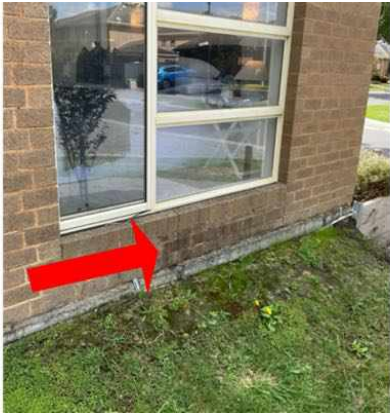
Defects 3.14

Building: Main Building
 Location: Exterior walls - front
 Finding: Water Runoff Staining to External Wall Below Window
 Information:

Significant water staining and evidence of prolonged runoff were observed to the external brickwork at the front elevation below the master bedroom window, indicating repeated exposure to rainwater in this area.

This condition suggests inadequate protection from direct rainfall and/or poor water shedding around the window assembly, which may lead to ongoing saturation of the wall, increased risk of moisture ingress into the building envelope, and potential deterioration of materials over time.

It is recommended that a registered builder assess this area and implement appropriate measures to control water exposure, which may include installation of a suitable awning or weather protection above the window, ensuring the window and surrounding penetrations are fully sealed and watertight, and cleaning of the affected brickwork. Rectification should be carried out promptly to prevent further moisture-related issues.

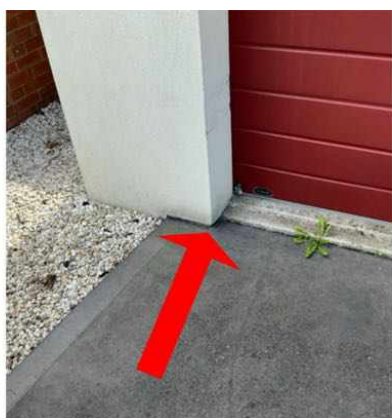
Defects 3.15

Building:	Main Building
Location:	Driveway
Finding:	Minor Subsidence to Driveway
Information:	The driveway was observed to have minor subsidence, with sections having dropped by a few millimetres at the time of inspection.

This condition may be associated with ground movement or inadequate subgrade support and, if progressive, could lead to further settlement, surface cracking, and drainage issues.

It is recommended that a qualified concreter be consulted to assess rectification options. The area should also be monitored over time to determine whether any ongoing movement is occurring.

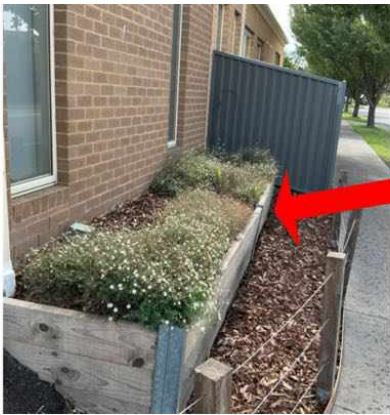
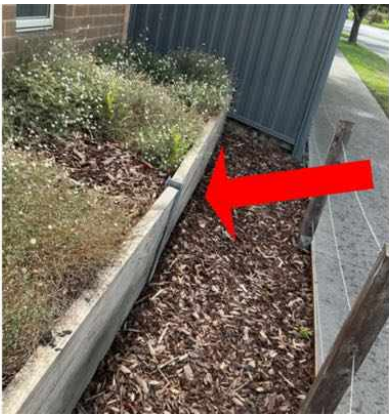
Defects 3.16

Building:	Main Building
Location:	Retaining wall
Finding:	Out-of-Alignment Retaining Wall – Right-Hand Side
Information:	The retaining wall located on the external right-hand side of the property appears to be out of alignment, with visible signs of slight movement or shifting.

This condition may indicate that the wall is not adequately resisting lateral soil pressure, which could lead to further displacement or localised failure over time. Although the wall is less than one metre in height and not considered a structural retaining wall, continued movement may still affect stability and surrounding areas.

It is recommended that a qualified carpenter assess the retaining wall and carry out appropriate rectification works, which may include re-straightening, additional support, or reinforcement to improve stability and prevent further movement.

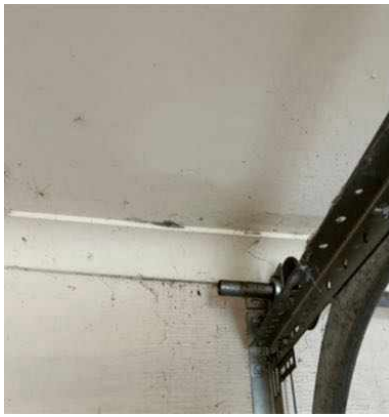
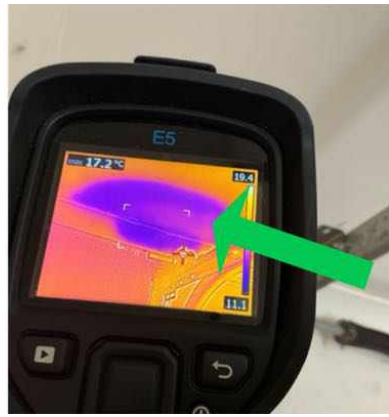
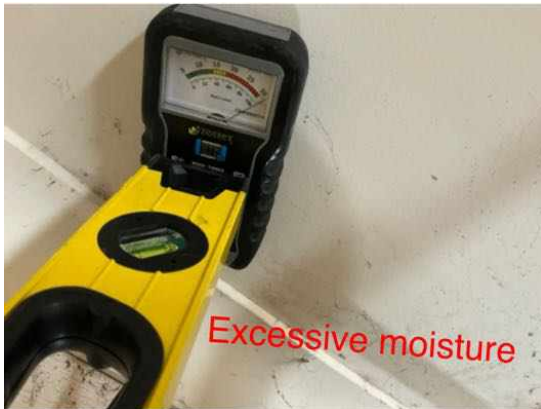
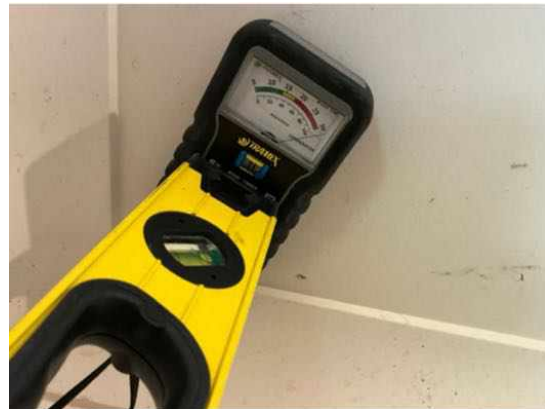
Defects 3.17

Building: Main Building
Location: Garage
Finding: Active Water Leaks to Garage Ceiling - urgent rectification required
Information: Two active leaks were identified in the garage ceiling at the time of inspection, with visible signs of water ingress and mould. Excessive moisture readings were recorded, and thermal imaging confirmed the presence of active water leaks in the affected areas.

This condition indicates ongoing moisture intrusion, which may lead to deterioration of ceiling materials, potential mould growth, and damage to surrounding structural elements if not addressed promptly.

It is recommended that a licensed plumber be engaged immediately, as a matter of urgency, to investigate the source of the leaks and carry out necessary repairs to prevent further water ingress and associated damage.

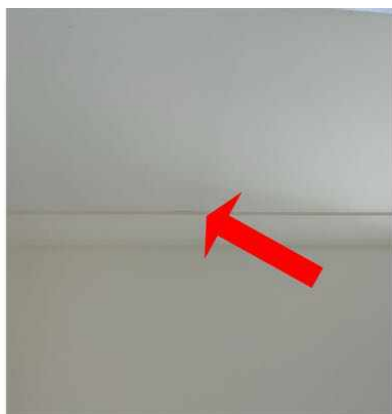
Defects 3.18

Building: Main Building
 Location: Living Room
 Finding: Minor Sag to Cornice – Living Room
 Information:

A minor sag was observed to the cornice in the living room at the time of inspection.

This condition may indicate inadequate fixing, minor movement, or deterioration of the adhesive or substrate, and may worsen over time if not addressed.

It is recommended that a qualified plasterer inspect the affected cornice, re-secure or reinstate it as required, and ensure a firm and uniform finish.

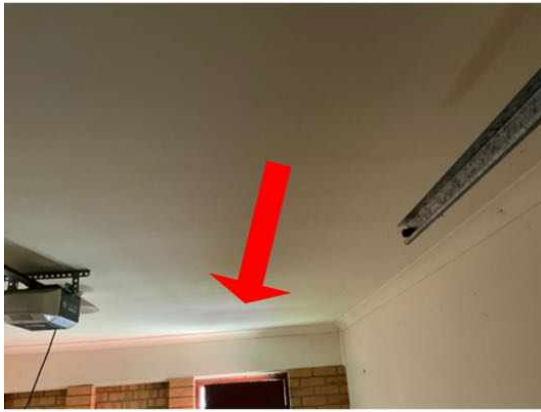
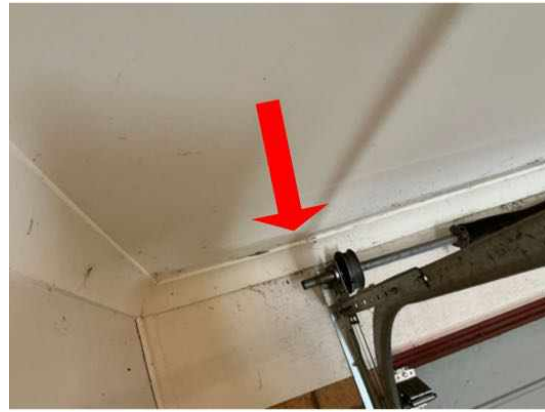
Defects 3.19

Information: Sections of the ceiling were found to be sagging at the time of inspection. Sagging to the fixed ceiling structure generally indicates that the building materials have swollen, due to contact with water, or that fixings (e.g. nails or glue) have become loose and require reattachment. This is a very common defect in carports due to their lack of insulation and or their susceptibility to moisture. Condensation builds up in the roof and rests on the plasterboard softening it somewhat which makes it more likely to sag and release from its fixing points.

Where minor sagging is evident, comparatively minor works, such as re-gluing of ceiling sheets, may be required. Such works may be performed by relevant tradespeople, such as plasterers and painters. Where excessive moisture has caused the roofing structure to swell and sag, the source of the water leak should primarily be identified prior to any remedial works being performed.

While damage is minimal at this stage a licensed plasterboard contractor should be appointed to repair the ceiling. Insulating the area could be considered by the client once repaired.

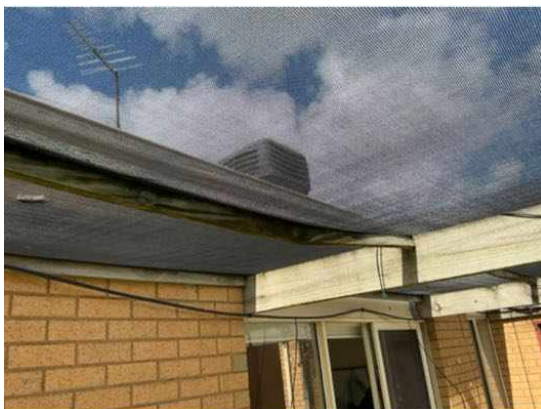
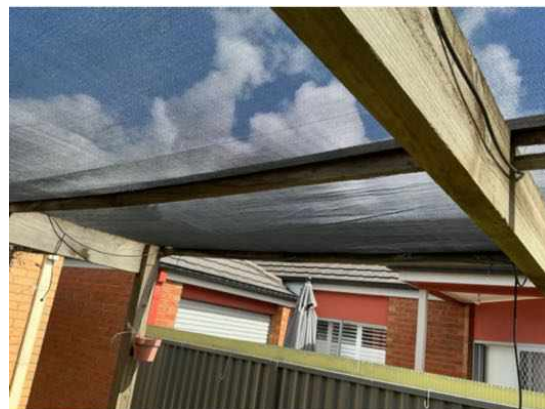
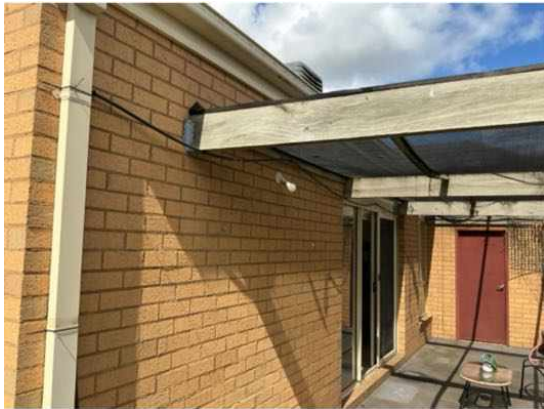
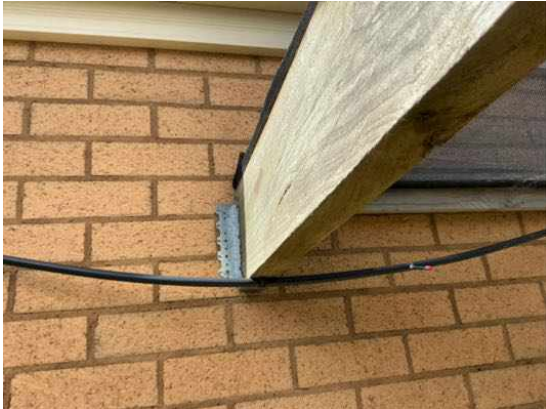
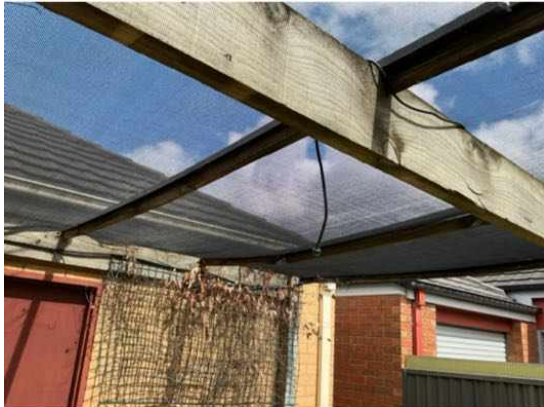
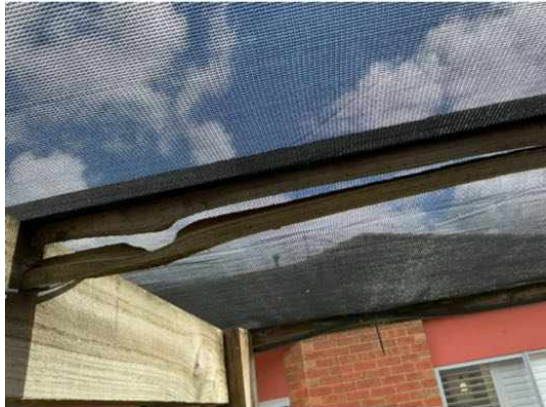
Defects 3.20

Information: The additional pergola structure that has been affixed to the side yard area of the dwelling does not appear to comply with contemporary building practices and current Australian Standards. While the structure does not currently appear to be unsafe, compliance with such standards ensures the structural integrity of the main dwelling and abutting addition.

As building standards have not been followed, this area provides a heightened risk of the development of building defects. The structural integrity of the area may have been compromised, which creates potential for the development or presence of major safety issues.

It is highly recommended that any planned repair, remodeling or demolition works be carried out by registered builders. Such works may be necessary in the short-term future to ensure the safety and functionality of the area.

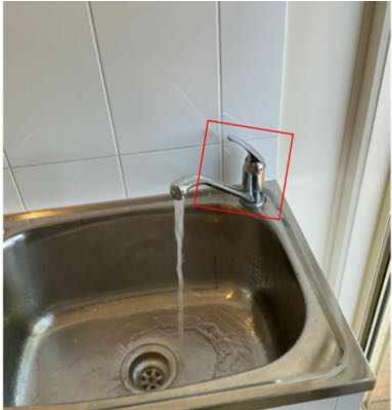
Defects 3.21

Building: Main Building
 Location: Laundry
 Finding: Tap - Loose
 Information: The tap in laundry room area has deteriorated with age, and is consequently loose. This tap being loose creates potential for water leaks and subsequent water damage to the surrounding area.

Where taps or spouts are loose, a qualified plumber should be appointed to re-fix the plumbing fitting.

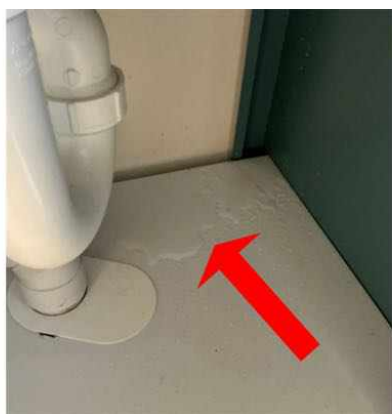
Defects 3.22

Building:	Main Building
Location:	Laundry
Finding:	Tap - Leaking
Information:	The tap in the laundry sink was found to be leaking at the time of inspection. This is a common defect that is consistent with general ageing of the building element. However, it may be indicative of substandard plumbing workmanship if the tap is relatively new.

While this defect only seems minor, if left unmanaged, it is likely to result in the development of rust, water damage and/or extensive water usage.

It is advised that a licensed plumber be appointed to perform remedial works on the affected tap. Such works should be performed prior to the development of secondary defects to ensure adequate functionality of all associated building elements.

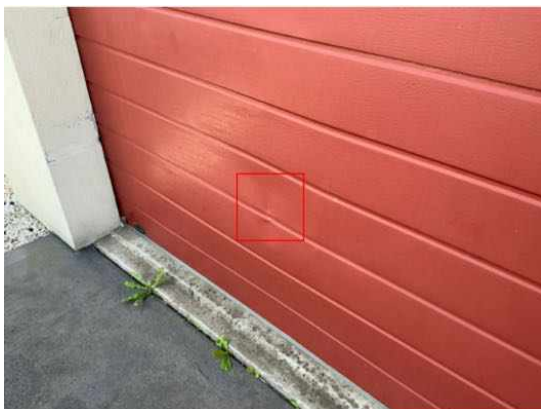
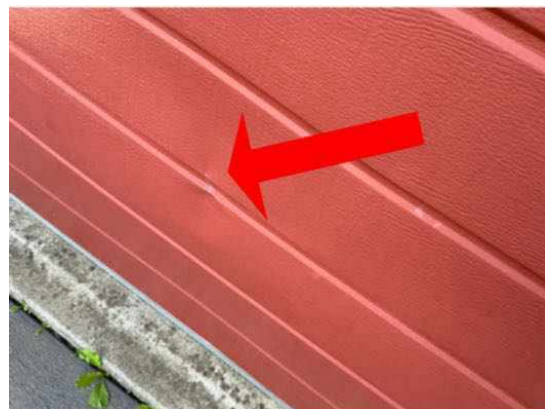
Defects 3.24

Building:	Main Building
Location:	Garage
Finding:	Garage door - Superficial markings
Information:	The garage roller door has a number of marks and dents likely to have resulted from impact damage be it accidental or deliberate impact at sometime.

Garage roller doors can fail when the building materials have aged but may be indicative of impact damage (accidental or deliberate). While superficial markings detract from the aesthetics of the building element, the functionality has not been hindered in any way.

Repair and/or replacement of the two garage doors would improve the condition of the garage but certainly not an urgent item

A qualified roller door installer or supplier should be engaged to check out the operation and overall condition of the doors to determine if repair is an option otherwise replacement may need to be considered.

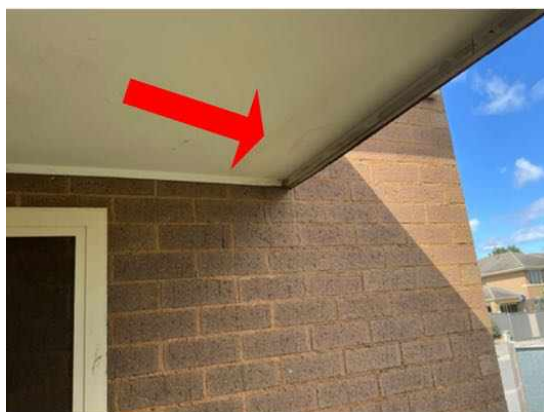
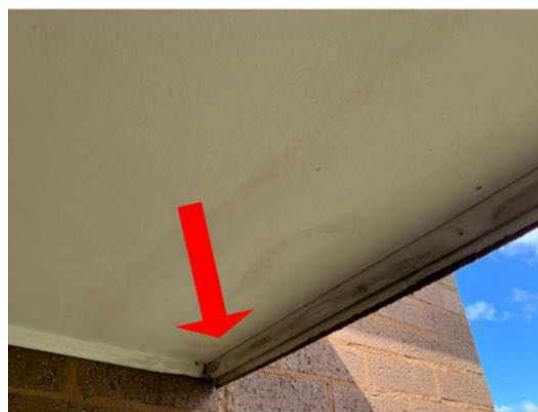
Defects 3.25

Building:	Main Building
Location:	Porch

Finding: Ceiling - Water stained

Conversely, where water staining is old and inactive, affected building materials may be repaired or replaced at client discretion.

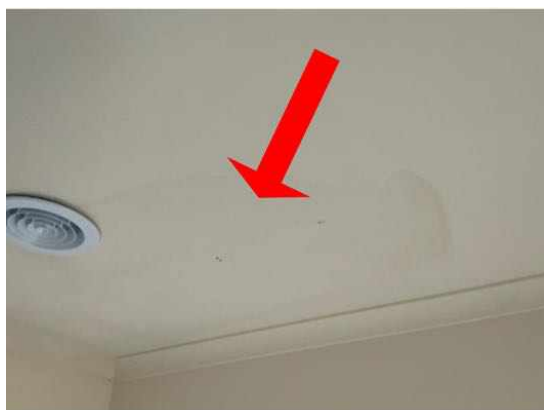
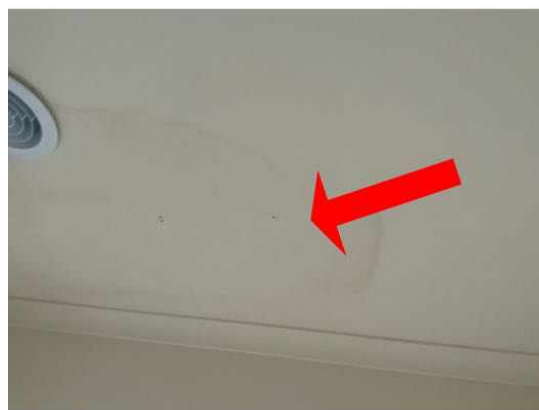
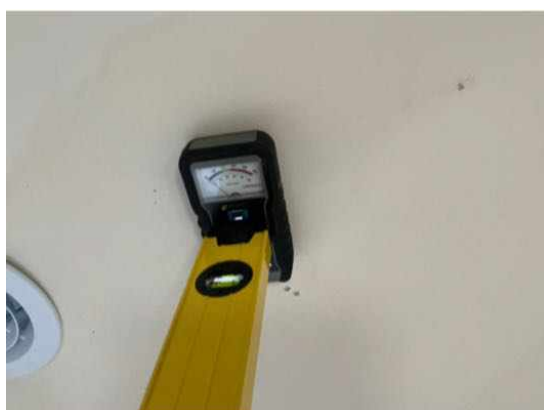
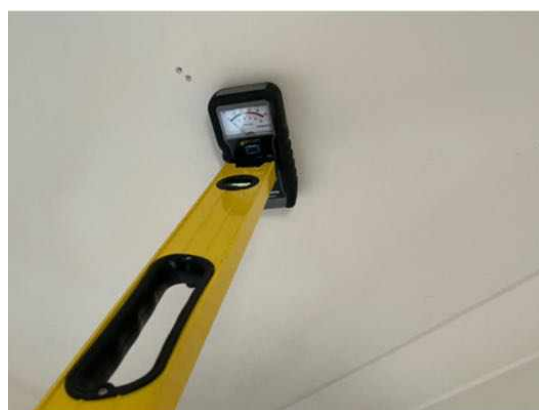
Defects 3.26

Finding: Ceiling - Water stained

Conversely, where water staining is old and inactive, affected building materials may be repaired or replaced at client discretion.

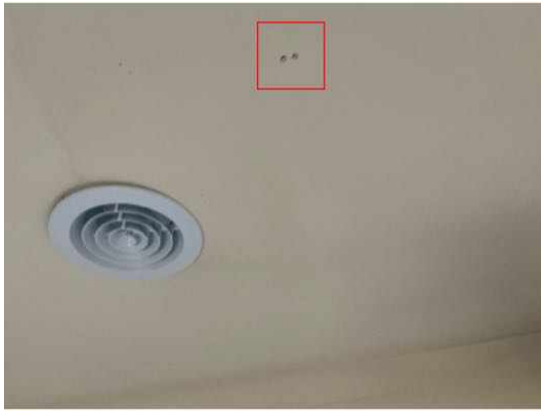
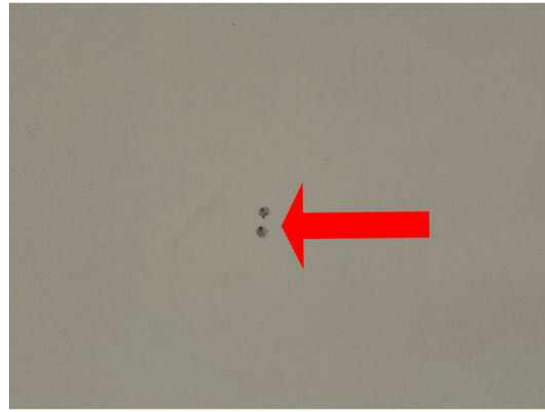
Defects 3.27

Building: Main Building
Location: Bedroom 3
Finding: Localised Plasterboard Fixing Movement
Information:

It is recommended that a qualified plasterer attend to the affected areas and carry out minor repair works, including patching, setting, sanding, and repainting to restore the ceiling finish.

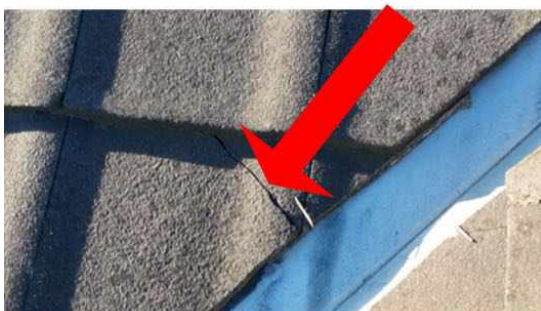
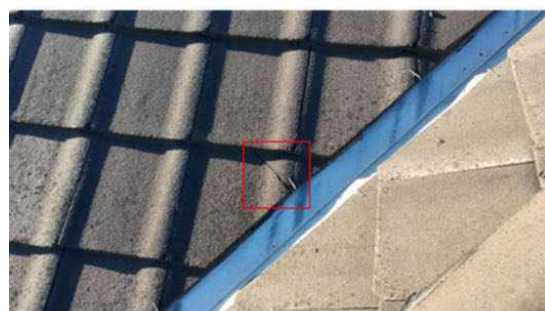
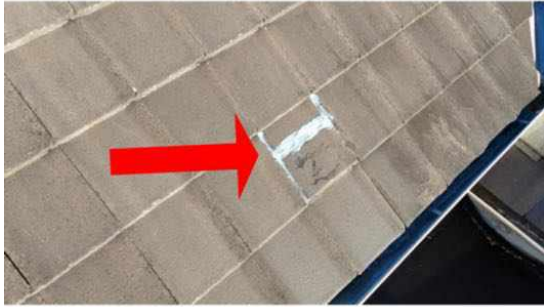
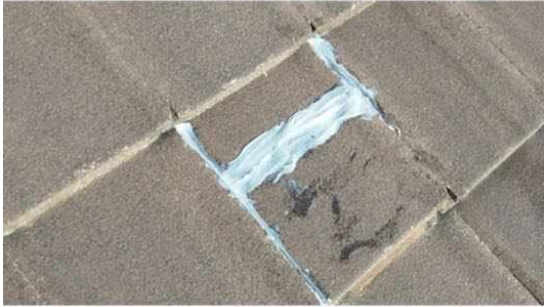
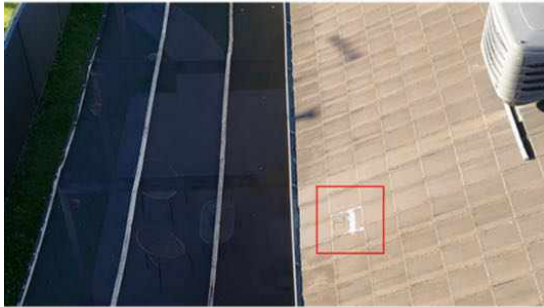
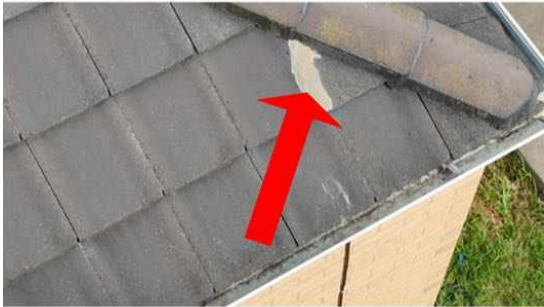
Defects 3.30

Finding: Roof tiles - Broken

Replacement of broken tiles or temporarily siliconed tiles is required and should be performed by a roofing contractor as a matter of urgency

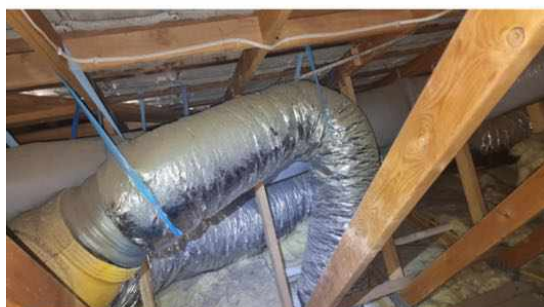
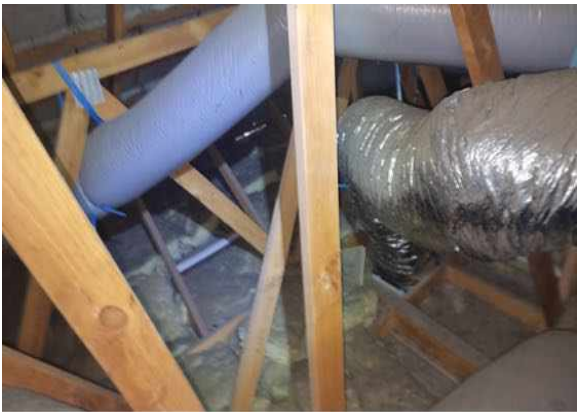
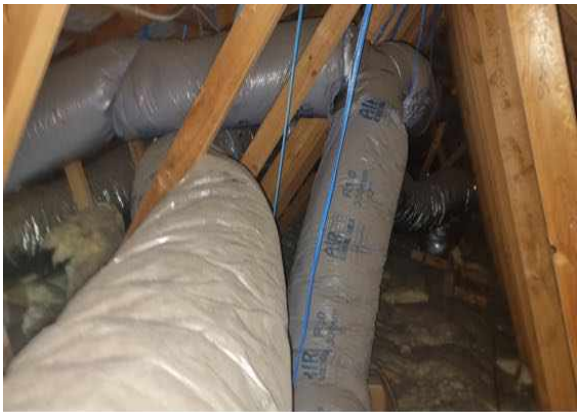
Noted Item

Building: Main Building
Location: Roof Void
Finding: Obstructions and Limitations - roof cavity
Information: These photographs are an indication of the obstructions and limitations which impeded the inspection of the roof cavity area of the property at the time of inspection. Large portions of the roof space were not accessed or inspected at the time of inspection due to significant obstructions and limitations, including extensive ducting and restricted clearance in multiple areas.

It is recommended that, where required, obstructions be cleared and safe access be provided to allow for a more comprehensive inspection of the roof space by a suitably qualified professional.
