# Building and Timber Pest Inspection Report

Inspection Date: Wed, 14 Jan 2026

Property Address: 4/114 Rooty Hill Rd N, Rooty Hill NSW  
2766, Australia

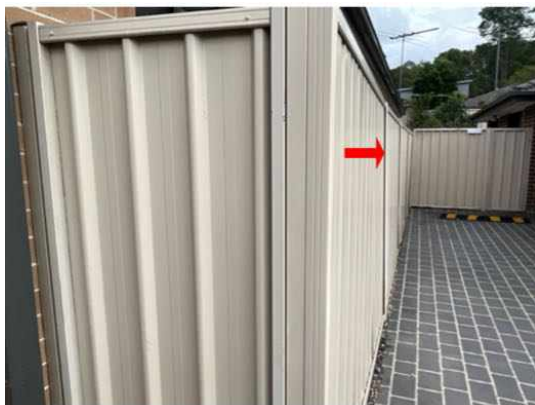
#### Finding 3.01

Location: Fencing

Finding: Fencing - Deteriorated

Information: It was noted at the time of inspection that sections of the fencing in this area has deteriorated. Typically fencing deteriorates due to age and or wear, rot and or rust which is generally expected for a structure of this age, due to prolonged exposure to weather conditions. Sometimes inadequate installation or maintenance can be to blame.

If left unattended, it is likely that further damage will occur. It is suspected that repair of several elements of the fencing may be required however replacement may be a consideration of the client also.

A licensed fencing contractor should be appointed to provide further advice and perform rectification works as necessary.

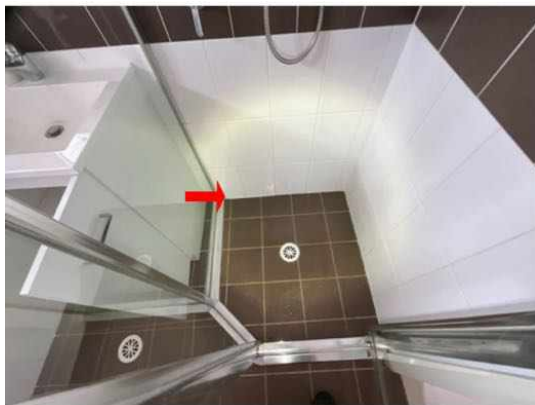
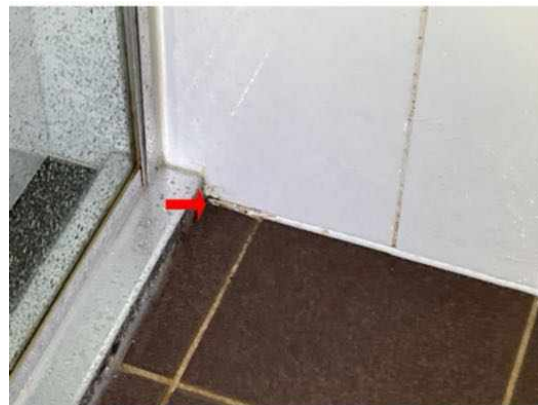
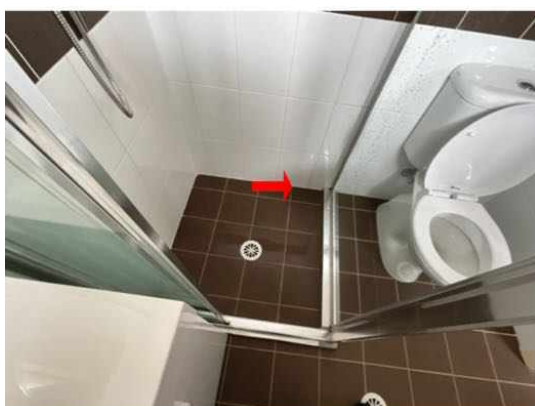
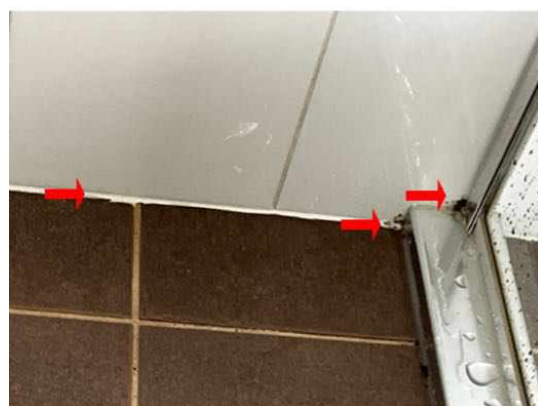
#### Finding 3.02

Location: Bathroom, ensuite

Finding: Sealant and grouting - Missing or damaged

It was noted on inspection that sealant or grout is degraded to this area.

Different materials and floor areas move at different rates, generally causing cracking to grout or sealant at this point. A flexible sealant is required to allow for expected expansion and contraction, while keeping the joint water tight and protective of all associated building materials.

Flexible and mould resistant materials should be applied to affected areas to prevent any subsequent water damage that is likely to occur. Regular maintenance and replacement of damage or missing or damaged sealant and grout is highly recommended to the wet areas, as this is a regular wear and tear defect. Sealant and grouting in areas that come into regular contact with water should be maintained for the long term care of your property.

A sealant specialist should be appointed to complete these works as soon as possible.

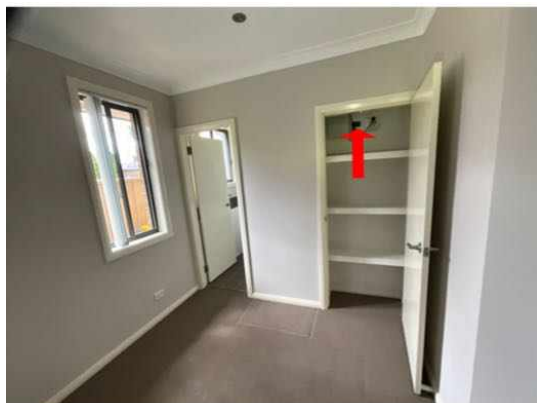
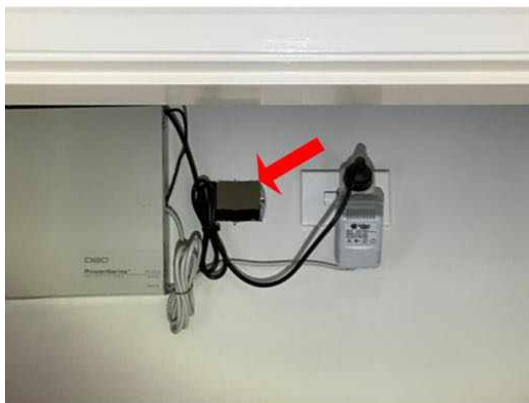
### Finding 3.03

Building: Main Building  
 Location: Bedroom - Master  
 Finding: Incomplete or substandard works

Information: The works to this area appear to be incomplete or have been completed to a substandard level.

Works that have not been completed to a satisfactory level create potential for the development of building defects and may impede on the safety and integrity of the overall structure.

It is highly recommended that the relevant trades be appointed to complete these works and ensure the safety of the area and the longevity of all associated building elements.

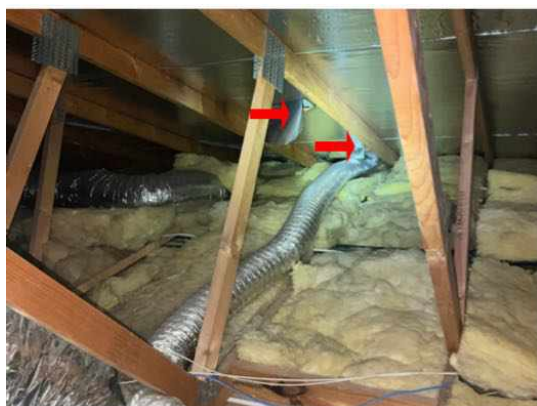
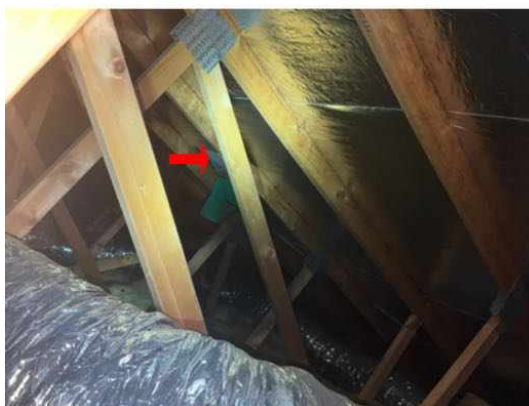
### Finding 3.04

Location: Roof Void

Finding: Sarking - Damaged

Where sarking is damaged, both insulation and moisture protection of the property are inhibited. This creates a loss of energy and thus negatively impacts the energy efficiency of the property, allowing potential for moisture ingress from condensation or leaking roof tiles.

It is important to repair any holes or damaged sections of sarking to ensure that the building material is fully functional. A registered builder or qualified carpenter should be consulted to provide further advice on this defect and to perform rectification works at client discretion.

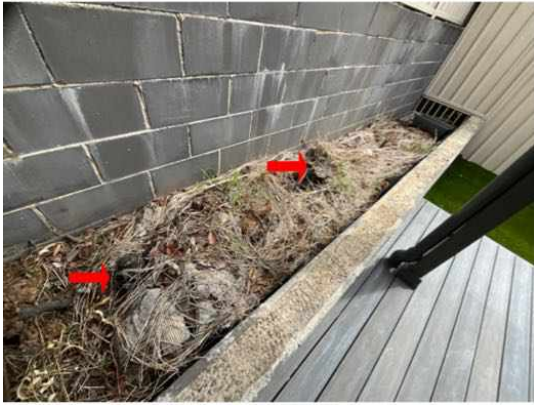
### Finding 6.01

Building: Main Building  
 Location: Yard  
 Finding: Tree stump - Remove  
 Information: Old tree stumps were found around the property. Attached photos are examples of these.

Any tree stumps in ground contact provide opportunity for concealed termite infestation and are likely to be subject to decay as the soil retains moisture or damp conditions against the tree stump.

All tree stumps should be removed where possible. Frequent pest inspections are advised to readily identify any termite activity in these areas.

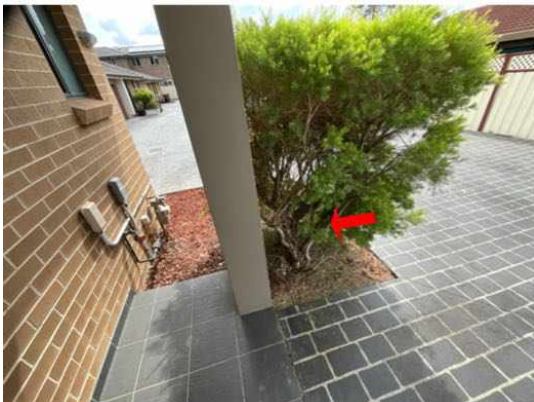
### Finding 6.02

Building:	Main Building
Location:	Vegetation
Finding:	Vegetation - Abutting property
Information:	Vegetation against external wall may have an invasive root system. If there are weak points in the brick work or concrete slab, it is possible for the roots to gain entry into these areas. Once the roots have gained entry, it is possible for termites to gain concealed entry via these roots. It is recommended to remove the vegetation and root system where possible.

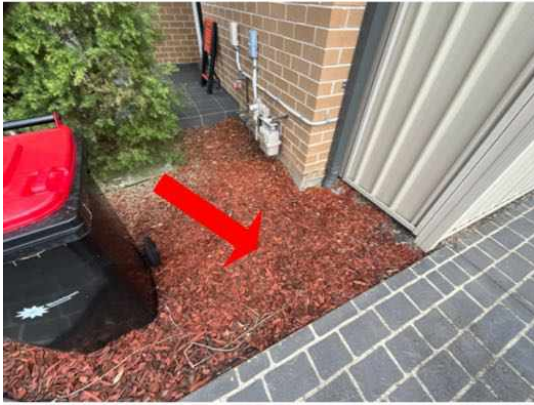
### Finding 6.03

Building:	Main Building
Location:	Garden beds
Finding:	Garden Beds
Information:	Garden beds were found to be evident in the garden area. These garden beds can include untreated timber, and with a combination of moisture from watering hosing can make conditions conducive to termite activity and termite ingress.

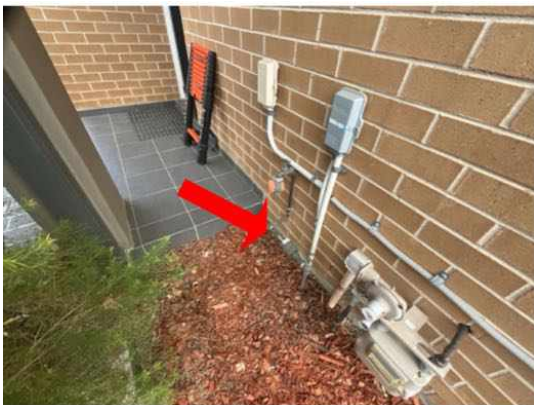
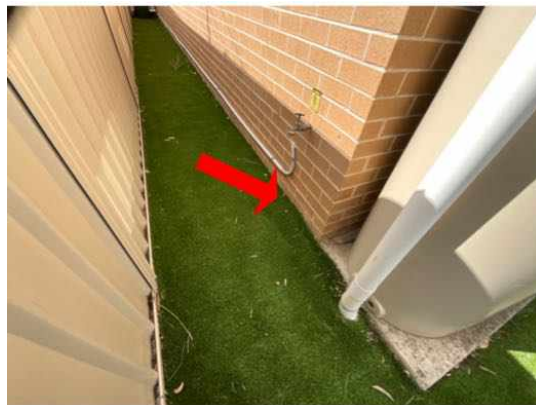
### Finding 6.04

Building: Main Building  
 Location: External tap  
 Finding: Tap - No drain  
 Information: The external tap in this area was noted to have no drain at the time of inspection.

This keeps the surrounding surfaces damp while using the tap, which becomes conducive to termite activity.

A licensed plumber must be appointed to ensure an appropriate drain is installed.

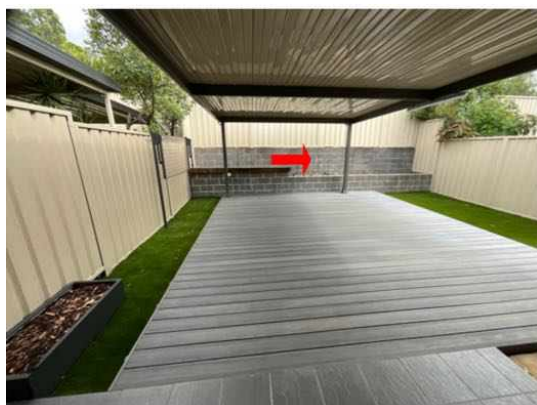
Building: Main Building  
 Location: Retaining walls  
 Finding: Retaining walls  
 Information: At the time of inspection the retaining walls were checked and no defects were observed other than those which May have been mentioned earlier in this report.

AS4349.1-2007 requires all retaining walls in excess of 700mm to be inspected by a licensed and practicing structural engineer.

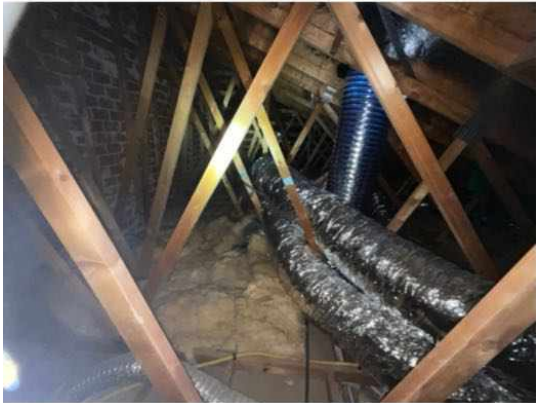
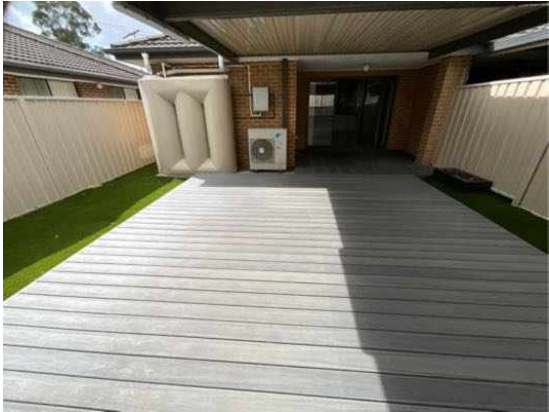
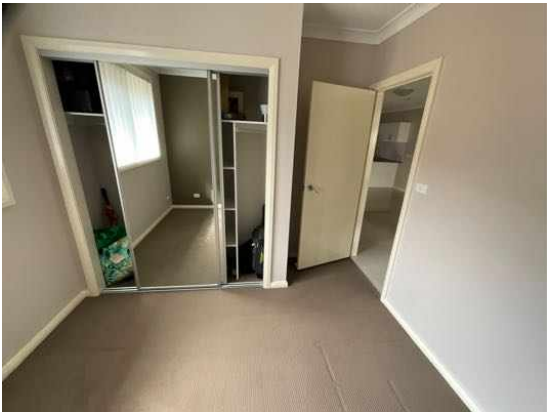
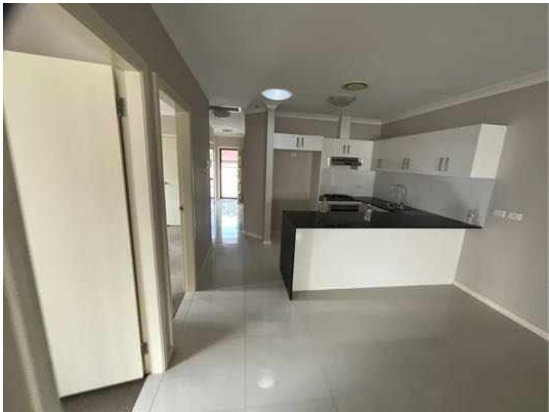
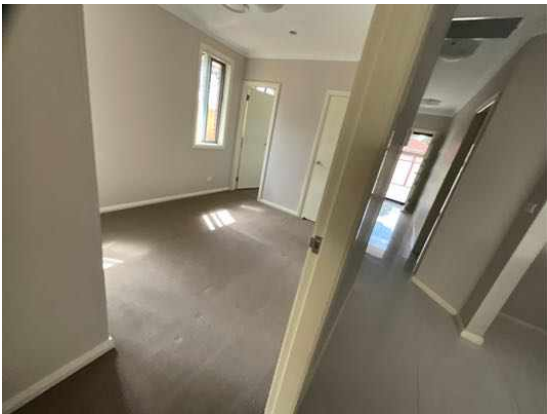
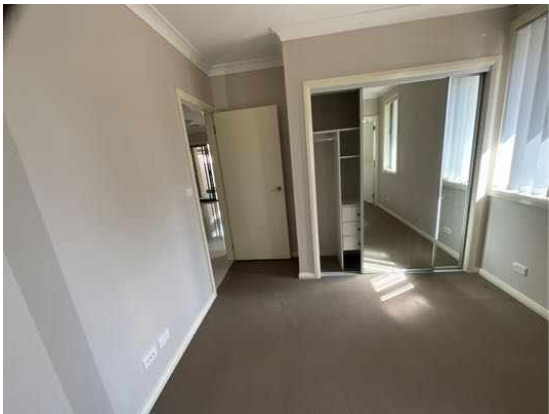
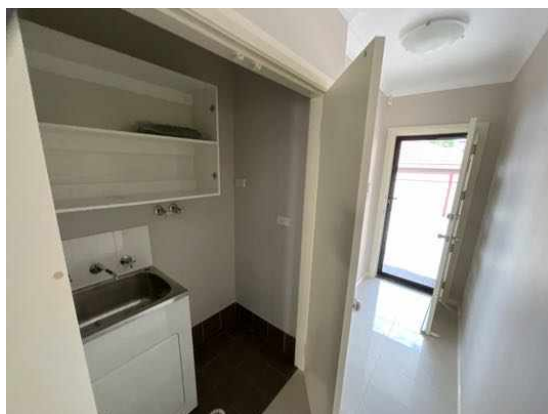
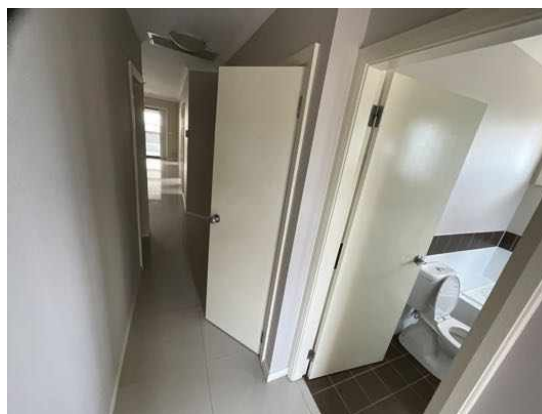
Location: All Areas  
Finding: Additional Photos - Obstructions and Limitations  
Information:

These photographs are an indication of the obstructions and limitations which impeded full inspection of the property at the time of inspection. These obstructions can hide an array of defects and should be removed to allow full inspection to be carried out. A re-inspection is recommended once the areas are made accessible.
