Building and Timber Pest Inspection Report

Inspection Date: Mon, 23 Mar 2026

Property Address: 77 Strickland Road East Bendigo

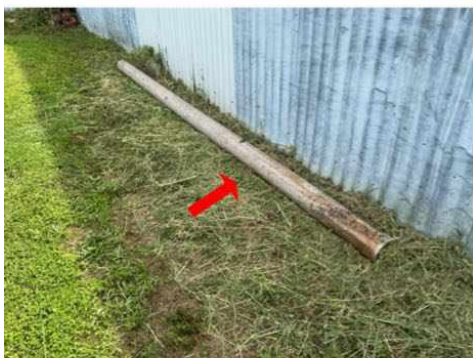
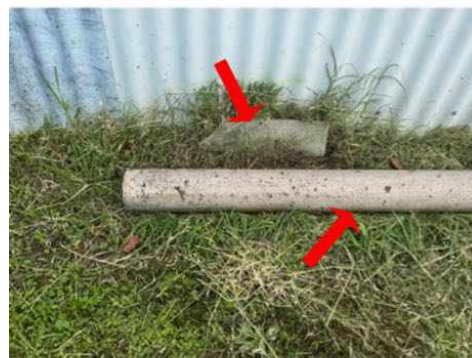
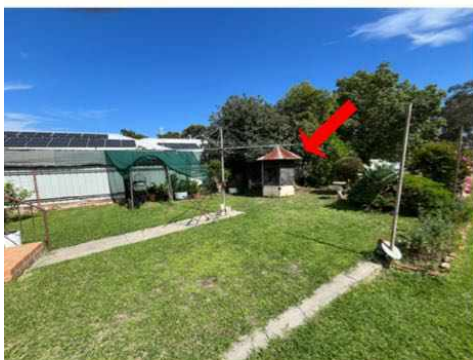
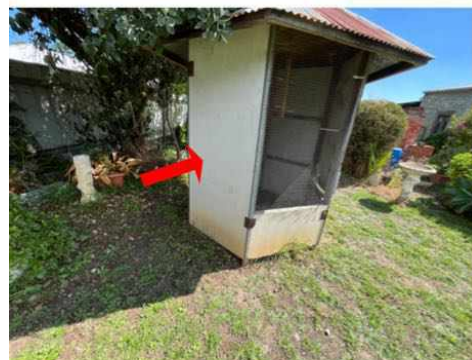
Finding 1.01

Building:	Main Building
Location:	Yard - Back
Finding:	Asbestos - Suspected ACM Identified on Site
Information:	Reporting on Asbestos is outside the Scope of this Report. This suspected defect is highlighted as a caution only. We suspect, based on our experience in the building industry, that there is a higher risk of the identified building element containing asbestos.

As Asbestos Reporting is outside the scope of this report, we advise that you consider a separate Asbestos Inspection and Condition Audit, which can include the taking of samples for definitive confirmation of the presence of Asbestos.

In the interim, the client is advised to act with caution, especially when considering any damage to building materials general wear and tear renovations extensions demolition and general maintenance activities due to the suspected presence of Asbestos.

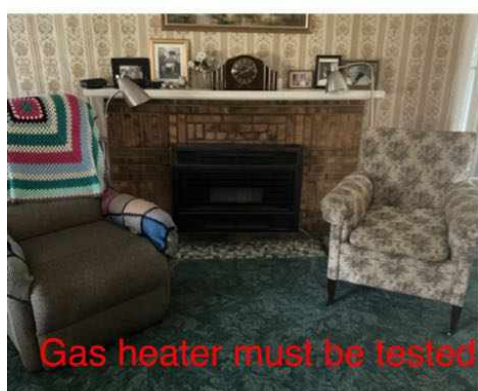
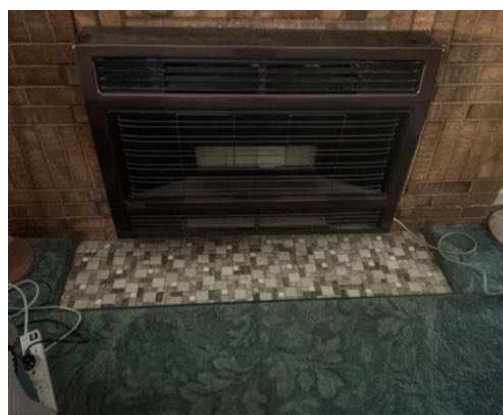
Finding 1.02

Building: Main Building
 Location: Lounge Room
 Finding: Gas Appliances - Need to be serviced
 Information: All gas appliances need to be serviced.

Apart from being inefficient, the current gas heater may be unsafe if omitting carbon monoxide.

It is unlikely that these gas appliances have ever been or recently serviced and there may be in poor or dangerous condition

A licensed gas plumber needs to be engaged to service lol the gas ppliances as soon as possible.

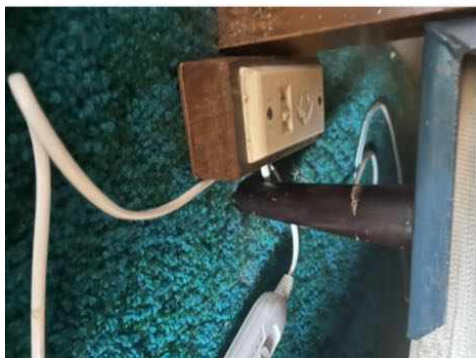
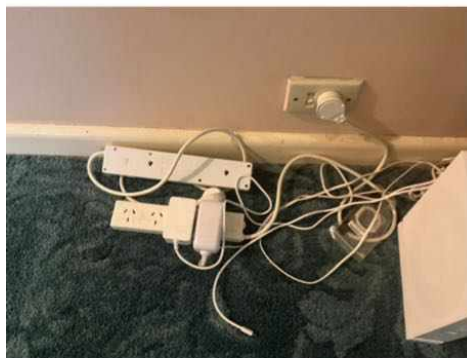
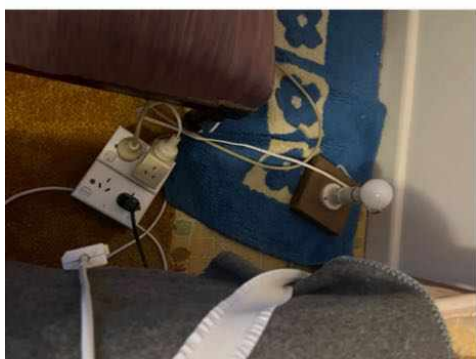
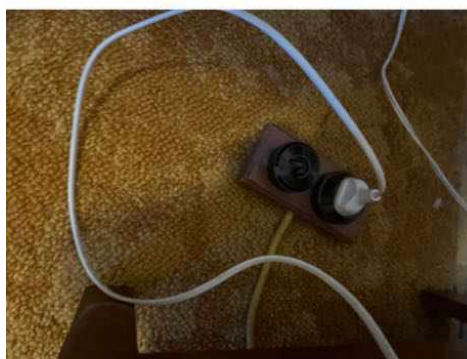
Finding 1.03

Building: Main Building
 Location: All Areas
 Finding: Plumbing and Electrical
 Information: The electrical outlets throughout the house need to be checked. Suspected non compliance.

It is highly recommended that the client makes immediate arranges to have the all areas, checked by a licensed gas plumber to ensure that the appliances are working safely and efficiently.

We recommend all other installations be checked also.

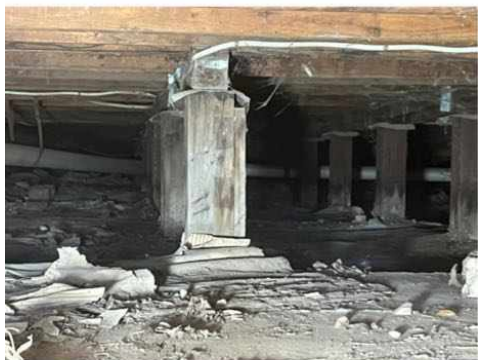
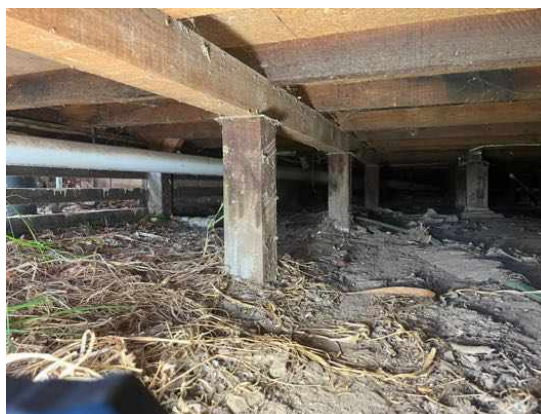
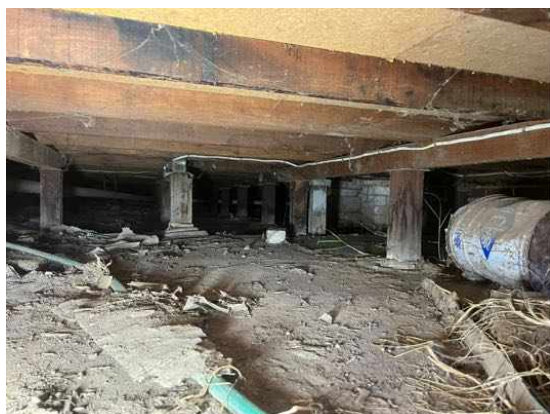
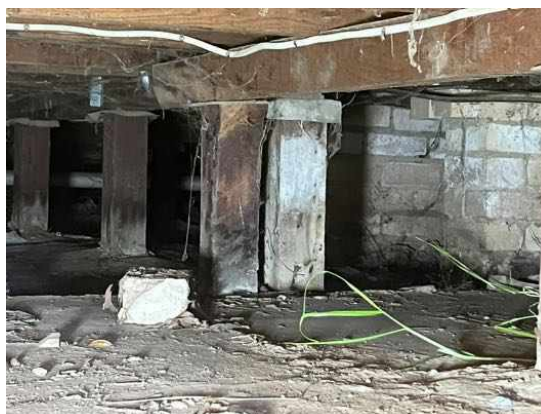
Finding 2.01

Building:	Main Building
Location:	Subfloor
Finding:	Timber stumps - Suspected deterioration
Information:	It was noted that the property has timber stumps. Inspection of the condition of the timber stumps - below the surface of the ground - is excluded from the scope of this report. However, it is suspected that several timber stumps are deteriorating, evidenced by secondary defects such as uneven flooring, visually-observable subsidence or major cracking within the property. Even without these secondary defects, deteriorated stumps may still be present.

Where timber stumps are failing, a high degree of maintenance or even replacement of stumps may be required in the short- to medium-term future. It is probable that there is some degree of wood rot or deterioration beginning to occur in areas that are currently inaccessible for inspection. Timber stumps are no longer used in current building practices due to their susceptibility to wood rot and deterioration over a

The client should be prepared that in purchasing a property with timber stumps, that the need to restump the property in the short- to medium-term future is highly likely, which involves expensive works.

A registered builder specialising in re-stumping may be appointed to provide a more invasive inspection of the timber stumps and provide estimates on any works that may be required.

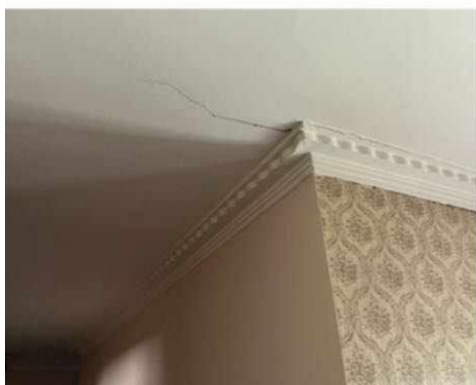
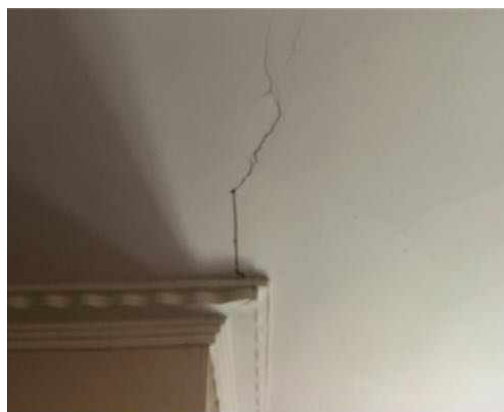
Finding 3.01

Building:	Main Building
Location:	Hallway
Finding:	Cracking - Damage Category 2 - Noticeable (up to 5mm)
Information:	Noticeable cracks are a common occurrence as a result of many primary defects. Such causes may include age, general wear and tear, expected building movement, general expansion/contraction of building materials in different weather conditions, and/or minor failings in the installation or application of building materials.

Noticeable cracks may result in minor sticking or jamming of associated doors and windows, which require easement. However, noticeable cracks are easily filled and repaired. A plasterer can be consulted to install an expansion joint at this point to allow for this movement during different weather conditions.

Monitoring of all cracking should be conducted frequently. Always contact a building inspector should cracks widen, lengthen, or become more numerous. Additionally, your building inspector should also be contacted if associated building elements such as doors and windows become more difficult to operate over time.

Relevant tradespeople, such as carpenters, painters and plasterers, should be appointed to perform remedial works, as deemed necessary.

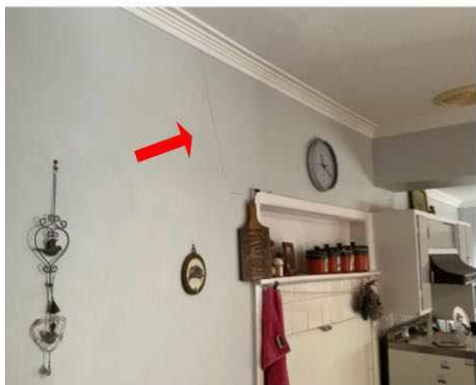
Finding 3.02

Building:	Main Building
Location:	Dining Room
Finding:	Cracking - Damage Category 1 - Fine (up to 1mm)
Information:	Although fine cracks are quite noticeable, they are often only considered to be an appearance defect, and usually do not indicate any structural damage. Generally, the cause of a fine crack is indicative of a separation between building materials and finishes (e.g. paint, plaster, etc.) along joints.

Cracking of this nature can generally be repaired with minor sanding, filling and/or repainting. Such works should be performed by a qualified painter or a general handyman.

Monitoring of all cracking should be conducted frequently. Always contact a building inspector should cracks widen, lengthen, or become more numerous.

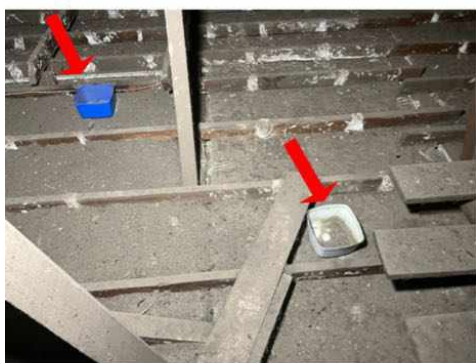
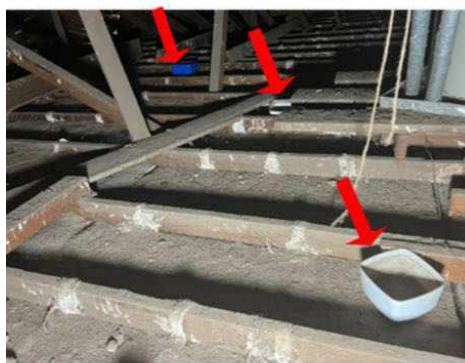
Finding 3.03

Building: Main Building
 Location: Roof Void
 Finding: Roof tiles deteriorated - Water leaks - other
 Information: Evidence of a water leak affecting the roof covering was identified.

It appears the tiled roof is not water tight.

Any leak occurring under normal weather conditions is considered a defect.

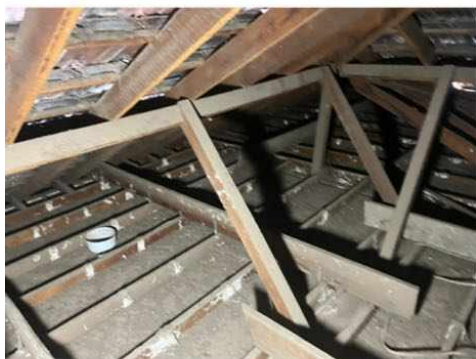
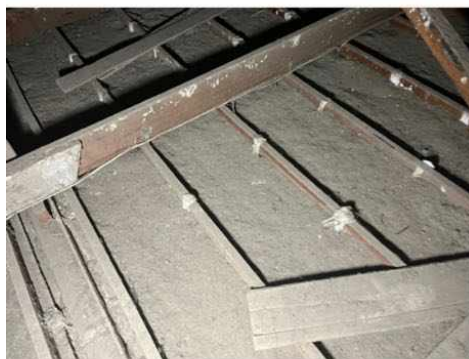
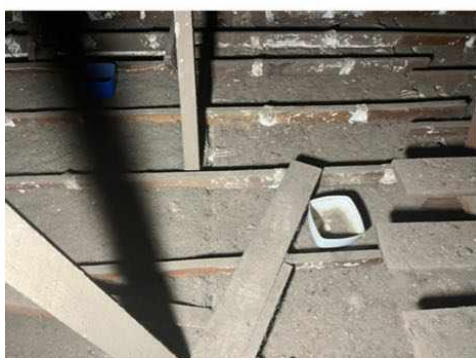
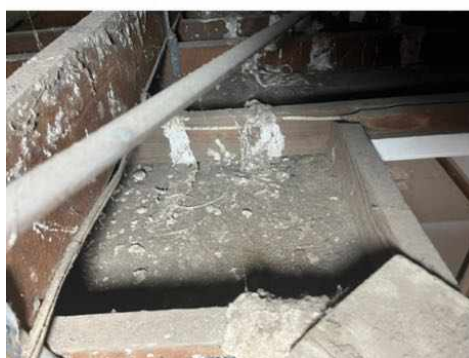
Finding 3.04

Building: Main Building
 Location: Roof Void
 Finding: Insulation - Missing (No Insulation)
 Information: Upon inspection of the roof void it was noted that insulation is not present.

Where insulation is absent, the area does not meet current Australian Standards. Installation of adequate insulation is required and should be conducted as soon as possible.

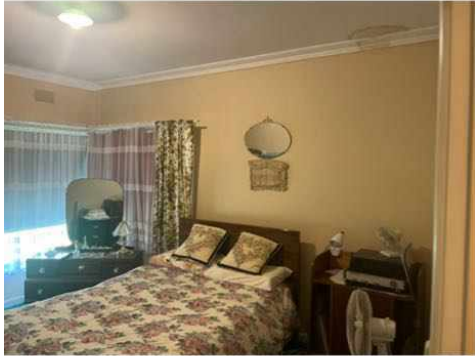
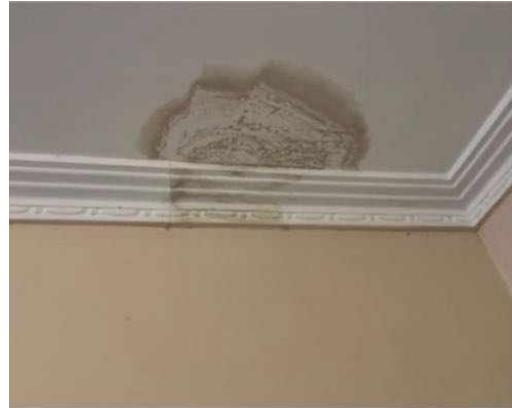
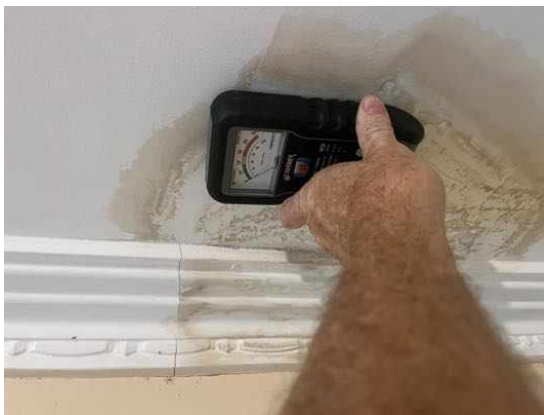
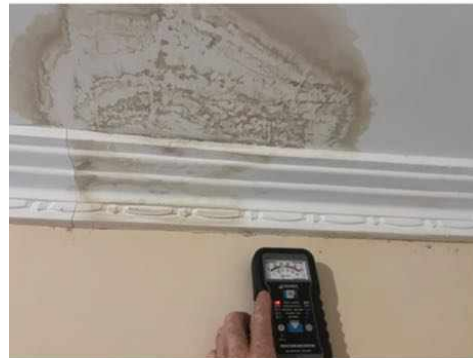
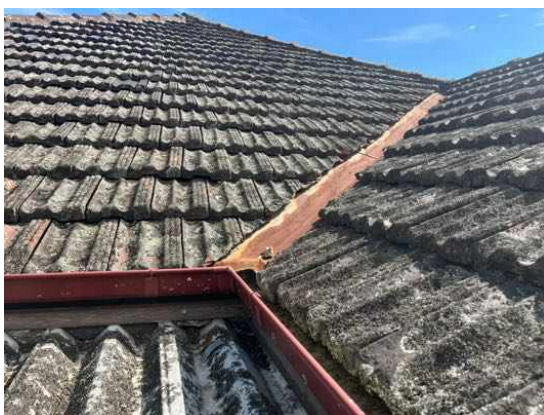
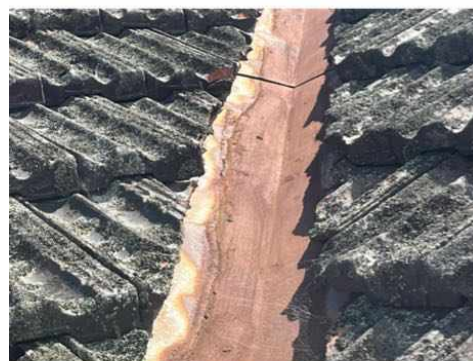
Finding 3.05

Building:	Main Building
Location:	Bedroom 1
Finding:	Ceiling - Water stained
Information:	Water staining to ceiling linings in this area was evident at the time of inspection.

While mostly an appearance defect, water staining can be indicative of more serious defects, which may be currently concealed by interior ceilings.

Further investigation identified the Valley Iron is rusted (but may not be leaking) and the vendor advised the roof was in fact repaired with repointing to the roof tiles.

It should be noted that the roof covering is considered to be in poor condition given the age of the structure and ongoing issues with water tightness will remain an ongoing concern.

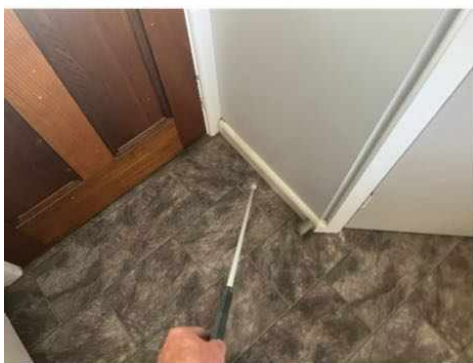
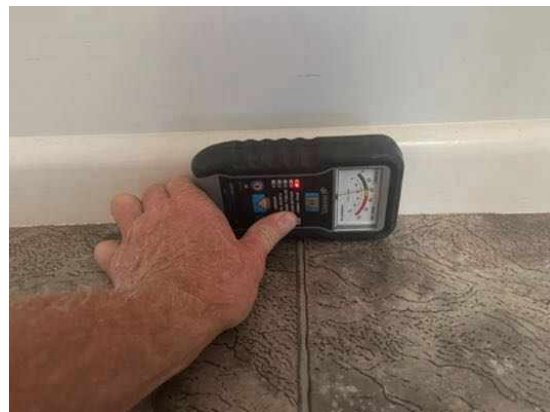
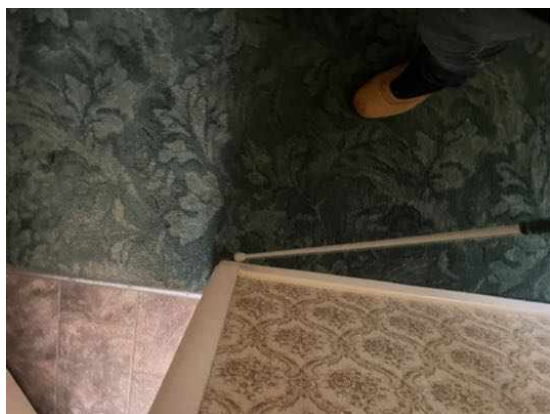
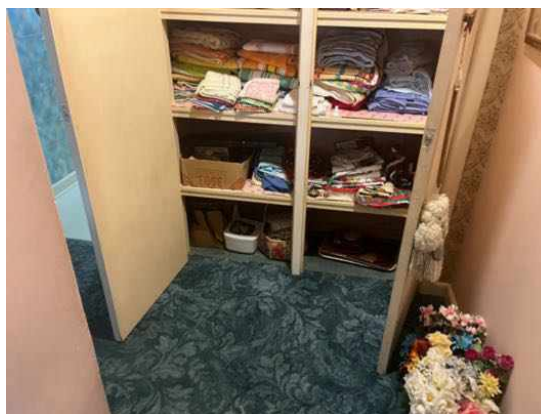
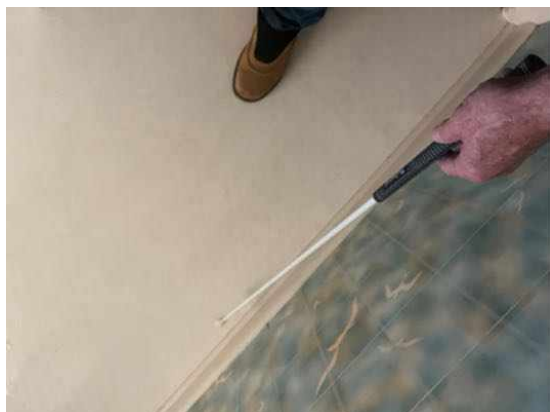
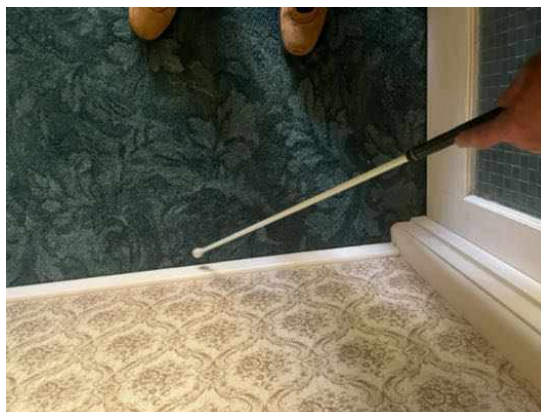
Finding 6.01

Building:	Main Building
Location:	All Areas
Finding:	Termite Techniques
Information:	All areas of the dwelling are checked with particular attention paid to wet areas which were closely assessed to check for excessive levels of moisture and temperature anomalies.

No evidence of termite activity was found inside the house at the time of the inspection.

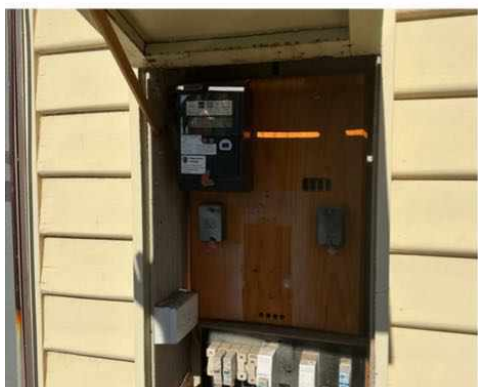
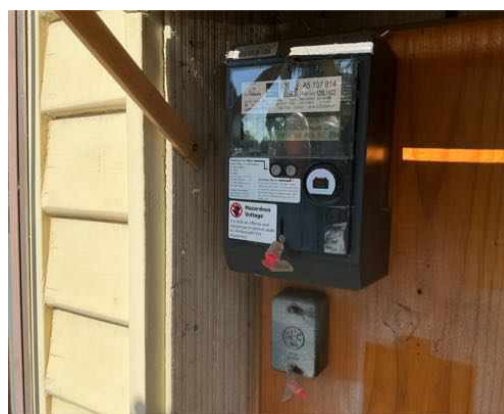
Finding 6.02

Building:	Main Building
Location:	All Areas
Finding:	Termite Management System - no evidence of a chemical installation
Information:	The application of a post-construction chemical termite barrier is highly recommended for all properties, particularly if live termite activity has been found on the site previously. Such barriers are highly effective in preventing termite attack on any timber building elements throughout the property.

There was no evidence of termite activity or active timber pest damage at the time of the inspection.

Where previous termite treatments have been undertaken at a property, a durable notice should be placed in the switchboard unit to indicate current termite barriers. At the time of inspection, it appeared as though no termite management system has been installed, with no evidence to suggest preventative works taking place.

The client may consider gaining further advice from a pest controller as to the costs and procedures involved with this application. It is recommended that obtaining such advice be a short-term priority.

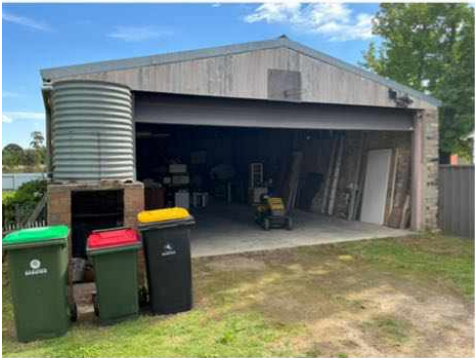
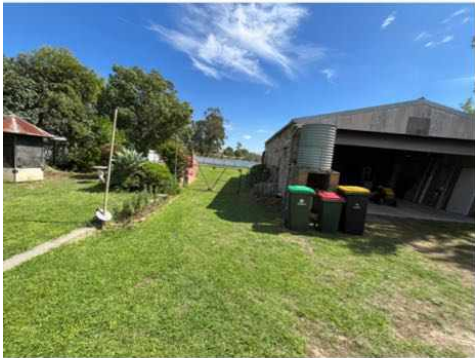
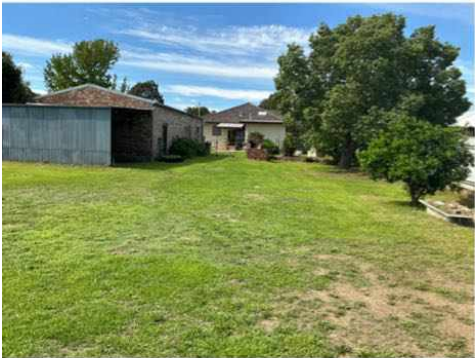
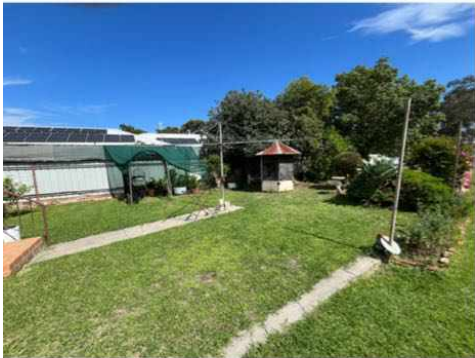
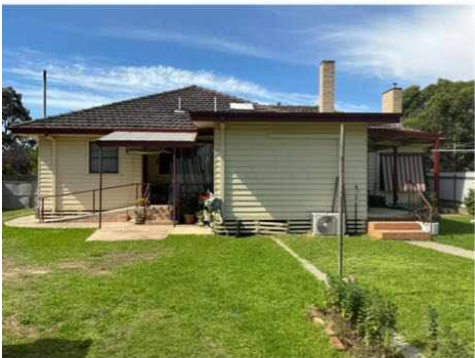
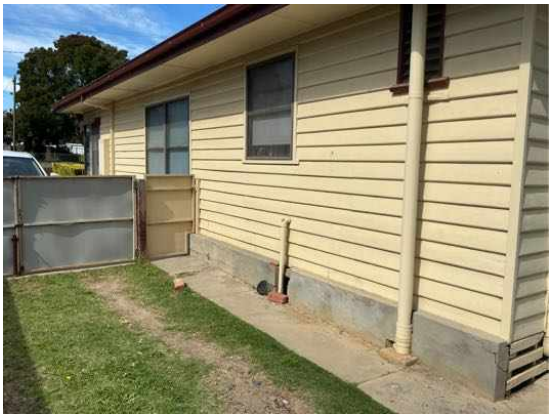
Building: Main Building
Location: All Areas
Finding: Additional Photos - Obstructions and Limitations
Information: These photographs are an indication of the obstructions and limitations which impeded full inspection of the property at the time of inspection. These obstructions can hide an array of defects and should be removed to allow full inspection to be carried out. A re-inspection is recommended once the areas are made accessible.

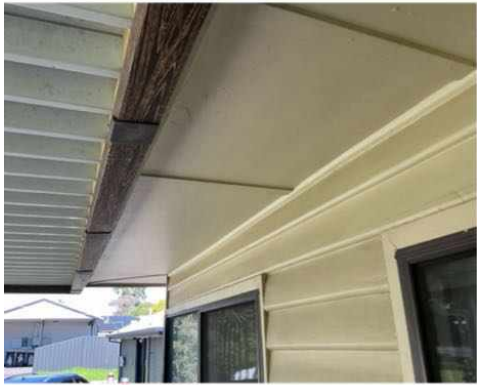
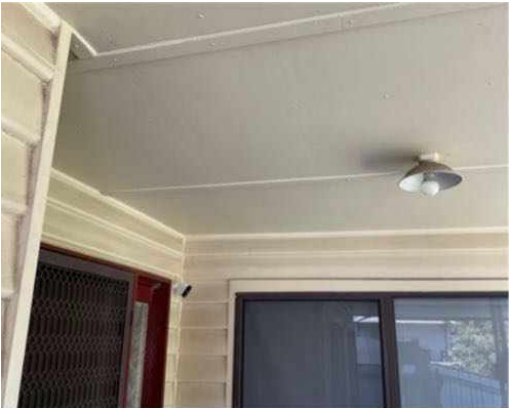
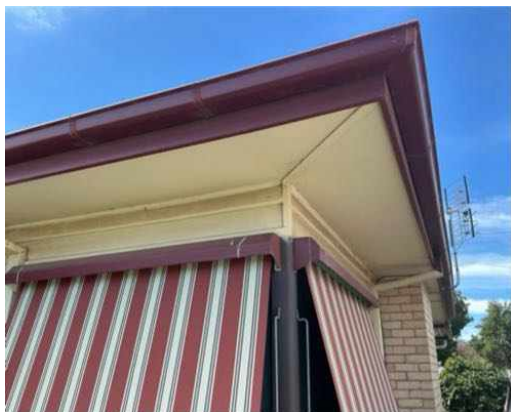
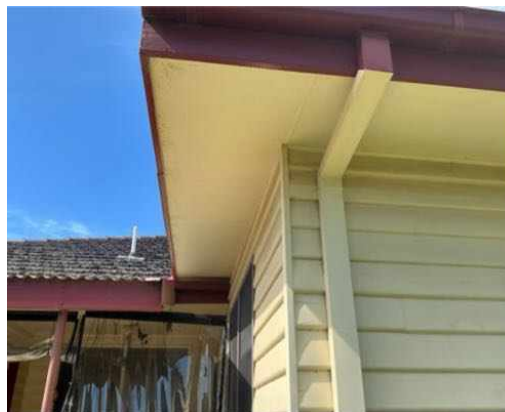
Building: Main Building
Location: Eaves
Finding: Asbestos - Suspected ACM Identified on Site
Information: Reporting on Asbestos is outside the Scope of this Report. This suspected defect is highlighted as a caution only. We suspect, based on our experience in the building industry, that there is a higher risk of the identified building element containing asbestos.

As Asbestos Reporting is outside the scope of this report, we advise that you consider a separate Asbestos Inspection and Condition Audit, which can include the taking of samples for definitive confirmation of the presence of Asbestos.

In the interim, the client is advised to act with caution, especially when considering any damage to building materials general wear and tear renovations extensions demolition and general maintenance activities due to the suspected presence of Asbestos.

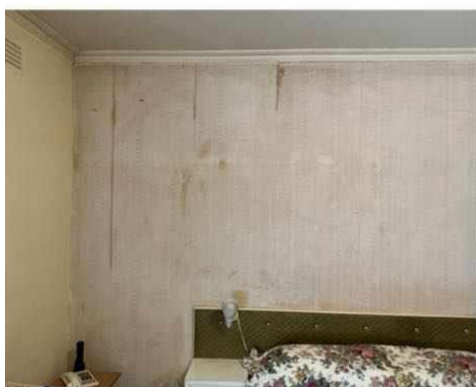
Building: Main Building
Location: Bedroom 2
Finding: Additional Photos - Obstructions and Limitations (Wallpaper)
Information: These photographs are an indication of the obstructions and limitations which impeded full inspection of the property at the time of inspection.

The wall paper is in poor condition and along with furniture and stored items, may hide an array of building defects.

It is up to the Purchaser to follow up and book a re-inspection once the property is vacated and emptied, if they believe one is required.
