# Building and Timber Pest Inspection Report

Inspection Date: Sat, 28 Mar 2026

Property Address: 23 Matson Cres, Miranda NSW 2228,  
Australia

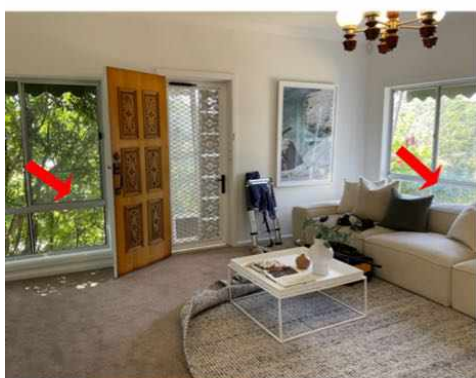
Building:	Building 1
Location:	Exterior walls - front
Finding:	Window opening restrictors missing.
Information:	The Building Code of Australia rules require all openable windows (where the internal floor is more than 2m above the ground outside) in residential rooms to be fitted with a suitable screen or restrictor. Windows located 1.7m above the floor level do not require protection.

Window restrictors are required where people who are vulnerable to the risk of falling have access to windows. This means all windows above ground level which do not have another fall prevention safety measure in place, such as a balcony or balustrade should have a restrictor.

These need to be added urgently for the safety of all persons.

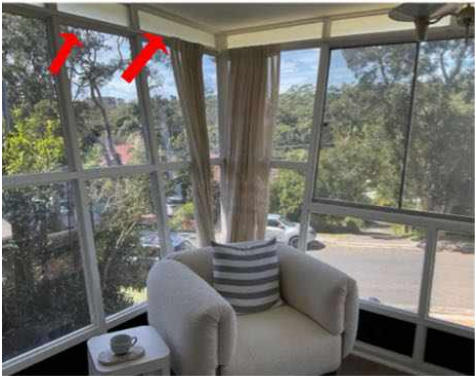
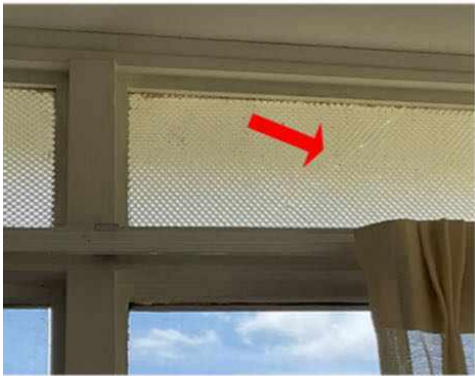
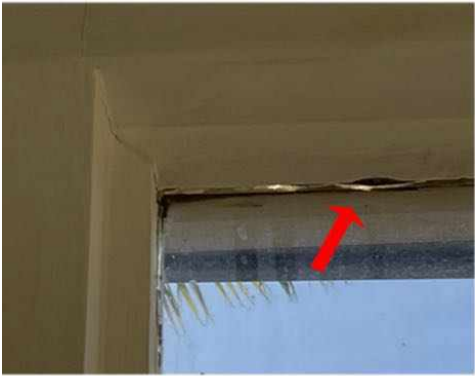
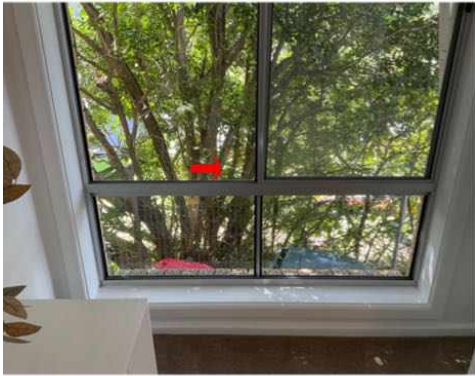
#### Finding 1.02

Building: Building 1  
Location: Sunroom  
Finding: Windows - Cracked  
Information:

Cracks were identified in the windows in this sunroom and lounge areas. Cracking in windows is generally the result of impact damage, and is likely to develop further when left unmanaged. The likelihood of this windowpanes further cracking and shattering is increased exponentially, providing a safety hazard in the area. The cracked windows also impairs the weather tightness of the building, creating potential for minor water leaks.

A qualified glazier is required to repair the window as soon as possible. Depending on the extent of the cracking, replacement of the window may be required.

Due to the unusual angles in the front sunroom windows - leaning outward, the glass, trim and putty holding these windows into their frames should be closely checked every year. Any area of even very minor wood rot need to be repaired immediately.

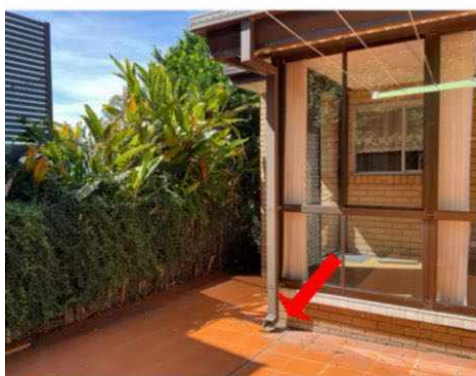
Building:	Building 1
Location:	Walls and front roof.
Finding:	Site drainage - Inadequate
Information:	The site drainage to the property was found to be inadequate at the time of inspection, creating subsequent water damage to subfloor and garage areas.

It appears in high rain events, water enters the rear subfloor and some moisture is coming up through the garage slab, evidenced by the water staining and rising damp found.

This moisture is suspected to be the cause of movement in the house walls and some subfloor walls leading to very uneven floors. This is also thought to be the cause of the garage slab concrete cracking however a structure engineer is required to assess these areas to determine what is causing the uneven floors and cracking.

Some gutters and downpipes have rusted. Some water pools on the front flat roof. The air conditioner, some floor wastes and hot water system overflows all run against the left house walls. Many rainwater drains and gutters are blocked from a lack of maintenance.

Where site drainage is inadequate, installation of an Agricultural (Aggie) Drain may be required. A qualified plumber should be appointed to further inspect the property and perform any remedial works as necessary. Secondary defects are likely to occur if left unmanaged.

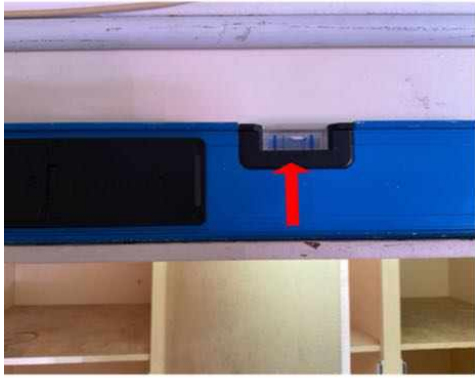
### Finding 3.01

Building:	Building 1
Location:	Most areas
Finding:	Flooring - Uneven
Information:	The internal flooring in many areas is out of level and uneven. Uneven flooring is likely to indicate minor defects such as expected movement of the foundations of the property, but may also indicate subsidence of the associated subfloor stumps.

It is advised that the flooring be closely monitored to identify any further movement. Where flooring remains relatively unchanged for an extended period of time (i.e. several months), it is likely that this defect has been caused by expected movement of the foundations of the property.

However, where flooring is uneven further, potentially invasive inspection of the subfloor structures and stumps in this area is required. In this case, works to repair are likely to be required, and would be carried out by a registered builder specialising in re-stumping.

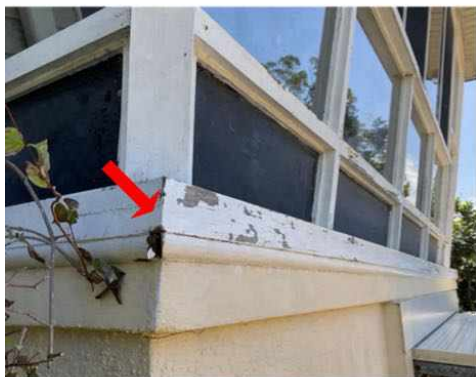
Building: Building 1  
 Location: Pictured areas  
 Finding: Wood rot  
 Information:

The building shows evidence of wood rot. Wood rot, also known as Fungal Decay, occurs when timbers and other cellulose building materials are exposed to damp conditions on an ongoing basis. This could be the result of exposure to weathering over a prolonged period of time, or the attraction of excessive moisture from other abutting building materials.

cause of the moisture that has created the visible wood rot should be identified and addressed in a suitable manner. Replacement of affected timbers may then be a necessary step in protecting surrounding building elements from such deterioration.

A qualified carpenter or registered builder may also be required to replace affected building materials.

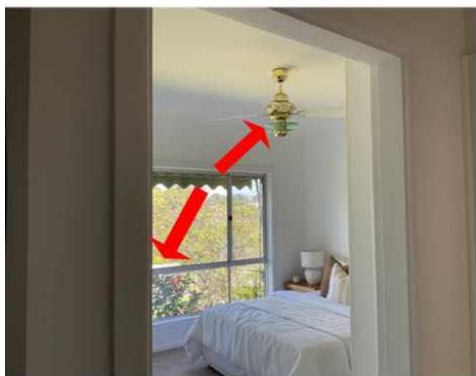
### Finding 3.07

Building:	Building 1
Location:	Master bedroom
Finding:	Building elements - Missing
Information:	The master bedroom door is missing and the light and fan does not work. A carpenter and electrician would be the trade responsible for rectification of these areas when convenient.

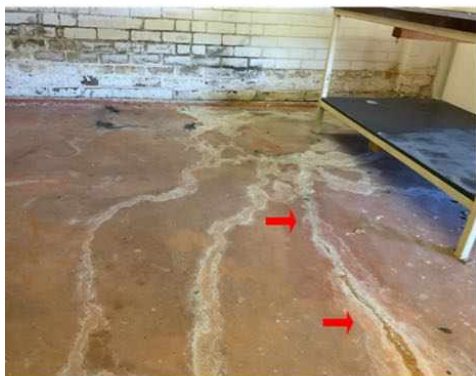
### Finding 3.08

Building:	Building 1
Location:	Yard and garage
Finding:	Crack in concrete slabs - Category 1
Information:	Cracks coded as Category 1 was identified in these pictured slabs. A Category 1 crack is described as a fine but noticeable crack, with the slab at an otherwise reasonable level. To be considered Category 1, the approximate width of the crack is less than 1.0mm, or a less than 10mm change in offset when a 3m straight edge is placed over the defect.

Category 1 cracks should be monitored for a period of 12 months. At the end of the monitoring period, identified cracks that are rated greater than Category 2 are considered defects, and require rectification.

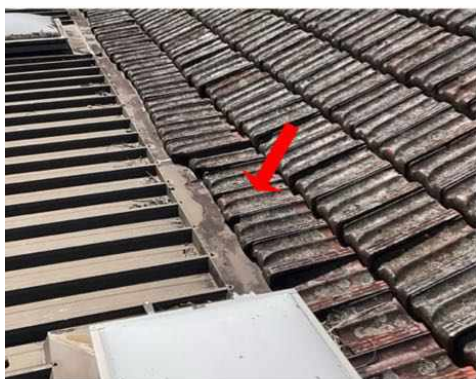
### Finding 3.13

Building:	Building 1
Location:	Roof Exterior
Finding:	Roofing areas - Weathered
Information:	Upon inspection of the exterior roofing, the majority of the roof areas were considered to be in fair condition. All fungi and leaf debris need to be removed for an accurate assessment. While weathering of these pictured areas is consistent with the age of the property, maintenance works are required.

Re-sealing and replacing small areas of gaps, damage or rust the may be considered

Consultation with a roofing contractor is highly advised to gain advice on cost of remedial works that may be required in the short to medium term.

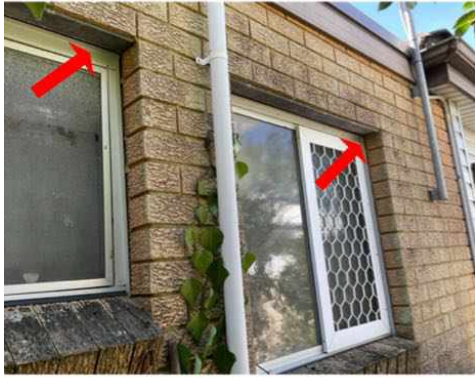
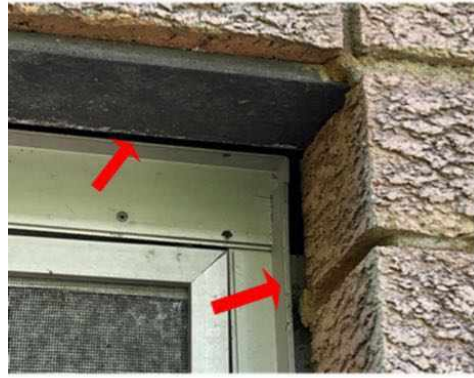
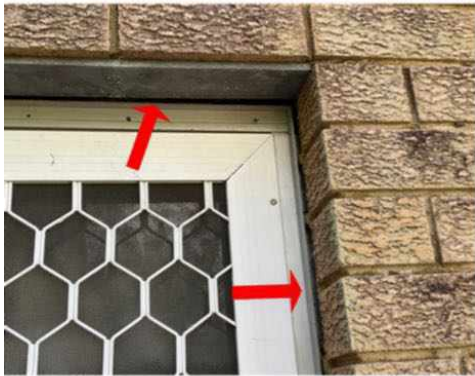
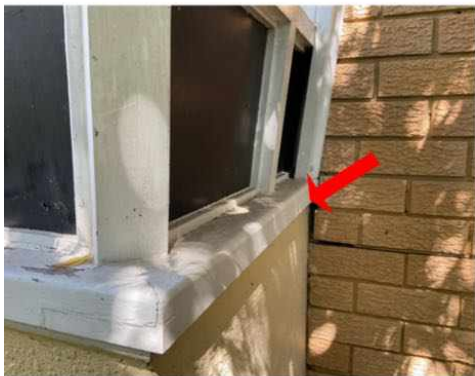
### Finding 3.14

Building:	Building 1
Location:	Pictured Areas
Finding:	Sealant (external) - Missing.
Information:	It was noted on inspection that areas of external sealant was missing to small areas of the external walls.

Flexible sealants should be applied to these affected areas to prevent any subsequent water damage that is likely to occur.

A sealant specialist or skilled handy person should be appointed to complete these works as soon as possible

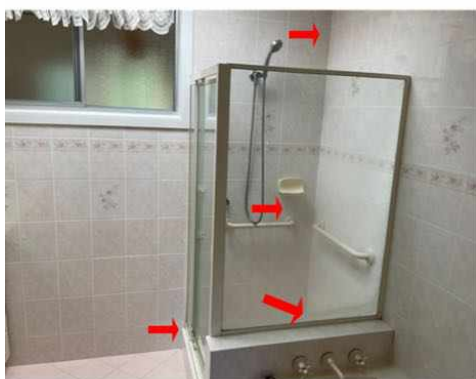
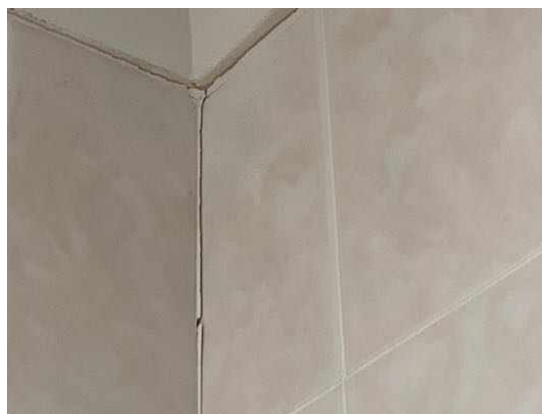
### Finding 3.15

Building:	Building 1
Location:	Kitchen and bathroom
Finding:	Sealant and grouting - Missing or damaged
Information:	It was noted on inspection that sealant or grout is degraded to these pictured wet areas.

Flexible and mould resistant materials should be applied to affected areas to prevent any subsequent water damage that is likely to occur. Regular maintenance and replacement of damage or missing or damaged sealant and grout is highly recommended to the wet areas, as this is a regular wear and tear defect. Sealant and grouting in areas that come into regular contact with water should be maintained for the long term care of your property.

A sealant specialist or tiling contractor should be appointed to complete these works as soon as possible

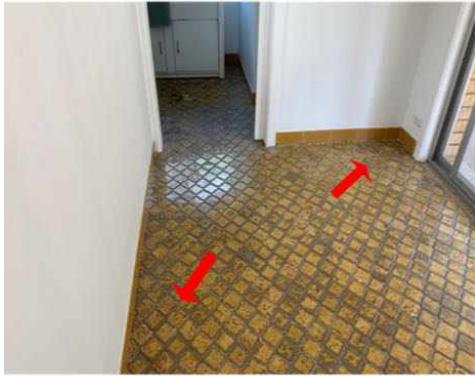
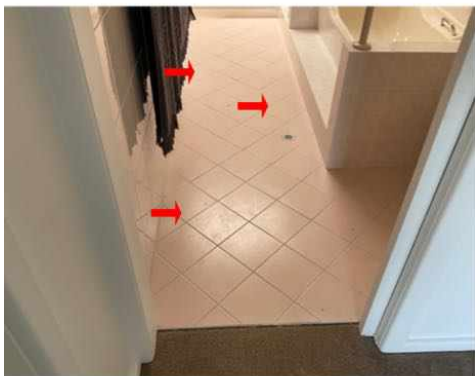
### Finding 3.18

Building:	Building 1
Location:	Kitchen, Bathroom, Laundry
Finding:	Tiles - Drummy
Information:	Drummy tiled areas were identified at the time of inspection. The term 'drummy' refers to tiles that have become detached from their fixing, despite otherwise being in relatively good condition. Such defects are generally caused by physical or moisture damage to the area. Drummy tiled areas may also be a direct result of poor workmanship during the construction process.

Specialist trades are available for these types of services. A registered builder may be required to undertake works if damage is extensive or if secondary building defects have resulted. Otherwise, it is advised that a tiling contractor be appointed to perform works as necessary. Immediate action is recommended to ensure that no further damage is sustained in the affected area.

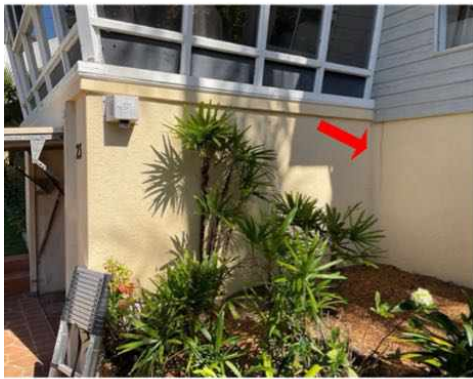
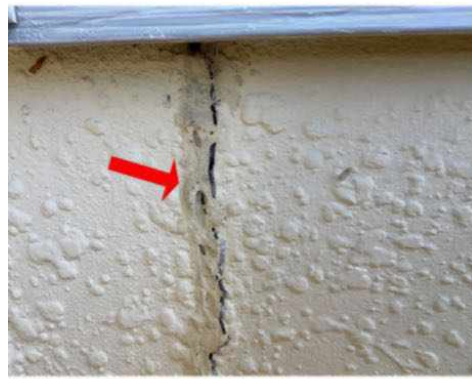
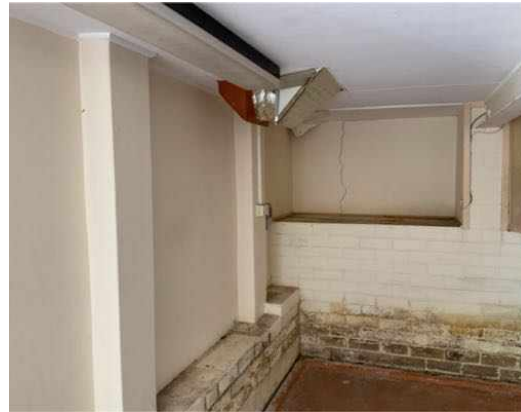
### Finding 3.21

Building:	Building 1
Location:	Pictured areas
Finding:	Render (external) cracking.
Information:	It has been observed that cracking under 3mm to some rendered surfaces has occurred. The degree of damage is described as "slight" noticeable cracks which are easily filled. Cracking of this size are generally less than 5mm in width.

Always contact your building inspector should cracks widen, lengthen, or become more numerous.

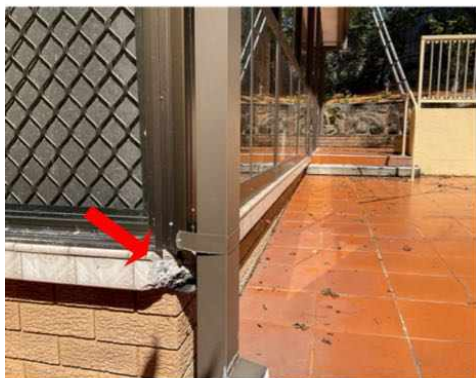
### Finding 3.24

Building:	Building 1
Location:	Rear right verandah corner and rear subfloor
Finding:	Concrete spalling
Information:	This verandah and rear subfloor has suffered minor Concrete Spalling. This is the breakdown of concrete via natural weathering and/or chemical reaction that results in sections of cement chipping off the main body – often resulting in fractured, compromised concrete. Spalling looks like pitted acne scarring and breaks off in flecks which can expose rebar.

A concreting contractor can provide advice on repairs of these damaged concrete areas when convenient.

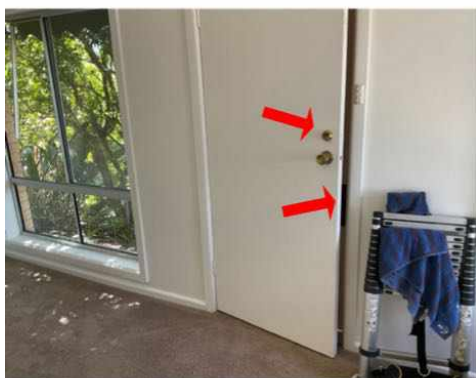
### Finding 3.25

Building:	Building 1
Location:	Entry
Finding:	Doors - Binding and upper front door lock not working
Information:	Binding and/or jamming of these doors and a jammed lock was evident during standard operation. This defect inhibits the functionality of the affected doors as well as creating potential for secondary defects to associated building elements, such as damage to the floor covering.

For minor causes, a qualified carpenter or general handyperson should be appointed to perform minor rectification works at client discretion.

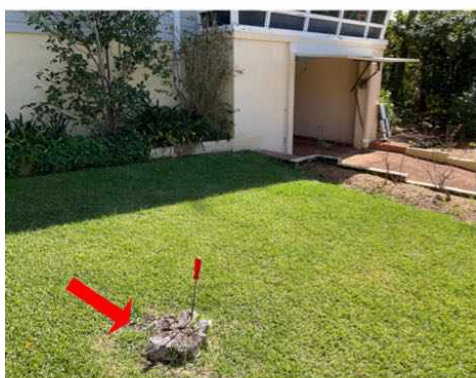
Building:	Building 1
Location:	Pictured yard area
Finding:	Tree stumps - left in ground
Information:	Tree stumps left in ground provide opportunity for termite attack as they are likely to be subject to rot and decay providing an attractive food source. Treatment and/or Removal of the stump is highly recommended. A pest controller and tree removalist should be engaged to perform such works.

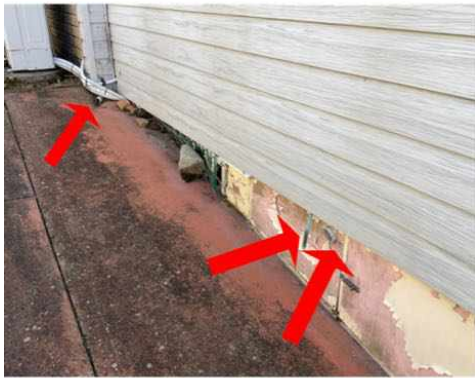
### Finding 6.05

Building:	Building 1
Location:	Pictured external wall areas
Finding:	Overflows - Not plumbed for drainage
Information:	The pictured overflow pipes are not plumbed or connected to suitable drainage, which has resulted in the surrounding area becoming excessively damp.

ensure that the area remains dry and free of any secondary defects.
